Tomen Y Bala Motte, Bala, Gwynedd

Archaeological Watching Brief

Prosiect Rhif / Project No. G2469

Adroddiad Rhif / Report No.1331

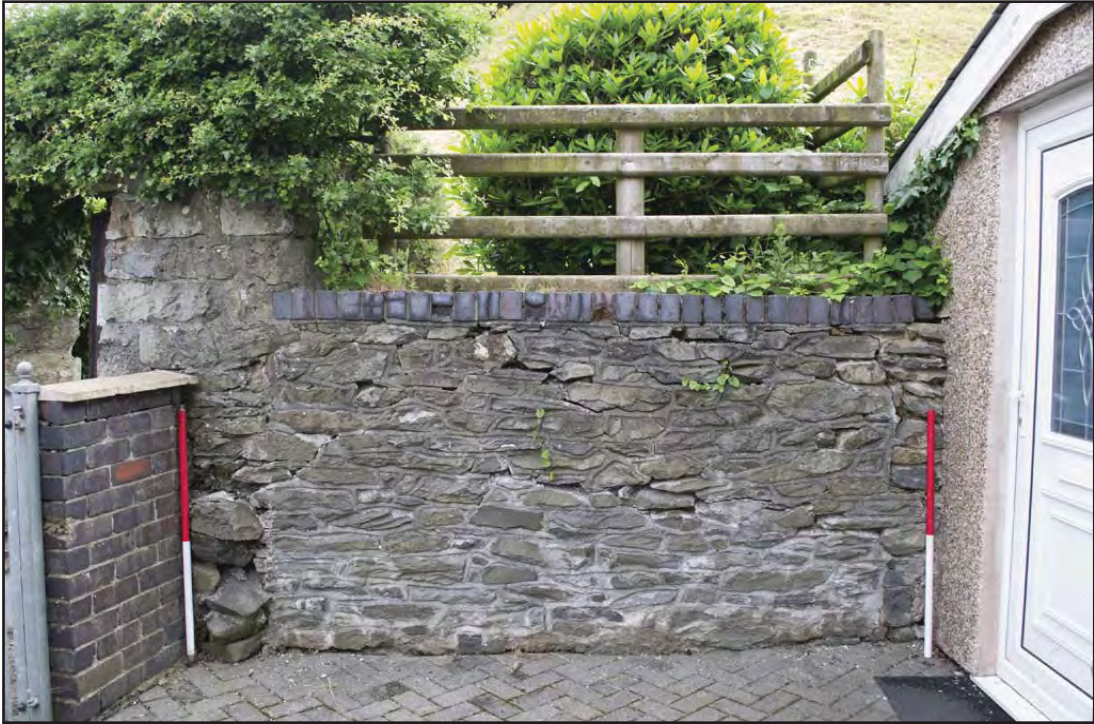
Wall F is located within the grounds of a private household and extends east from the gated entrance. The wall has a length of 3m and height of 1.5m. This section of the retaining wall is quite distinct as it has been repointed with cement, is comprised of smaller stones and capped with reduce fired bricks set on their sides. The condition of this section of the wall necessitated it to be carefully dismantled. A narrow slot (0.35m in width) was hand excavated along the rear of Wall F from the gated entrance to the approximate mid-point of the wall (Plate 20) to facilitate the removal of the stones of the wall, which were retained. The wall and earth were gradually reduced in height. The wall and earth were reduced by 1.45m.

Plate 11: Wall F (pre-commencement survey)

Rebuilding Methodology – At the south end of the wall and within the garden of the existing residential property it is necessary for Wall F to be dismantled in full and rebuilt. It is proposed that the recommended rebuilding detail Option A will be used (mass concrete fill). The ground to the rear of the wall will be excavated by hand as access for a machine is

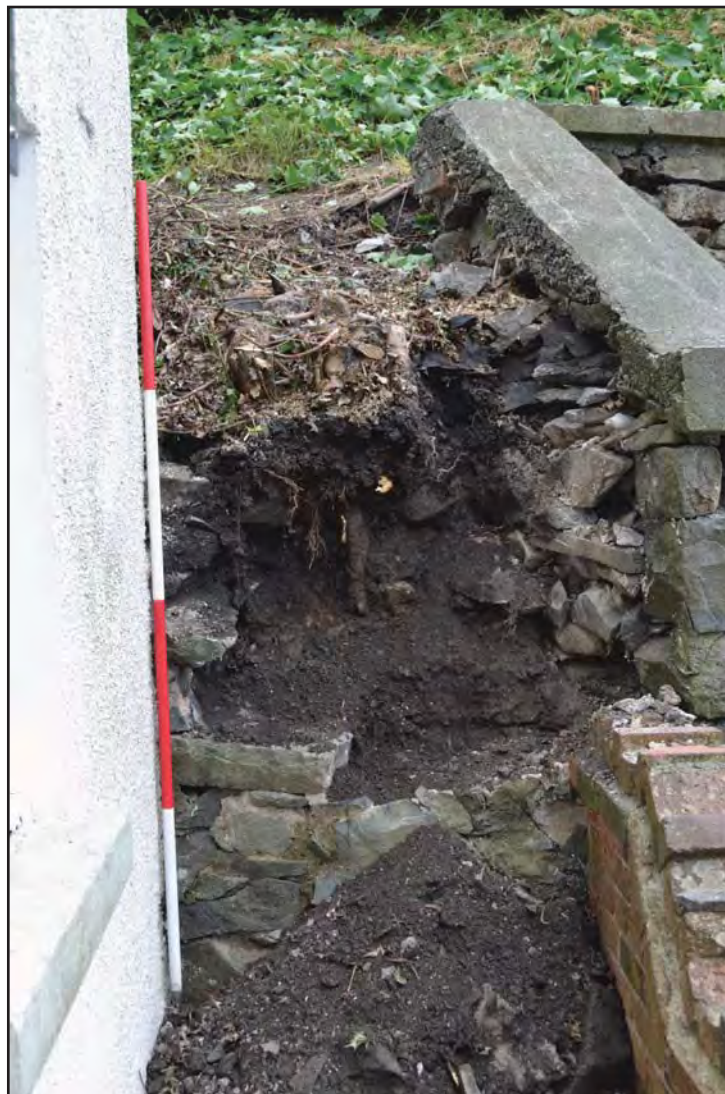
of a tree and its associated roots directly behind the wall. This was left in situ as any attempt to remove it risked disturbing a large area of ground towards the motte and destabilising Wall B which appeared to be single skinned (Plate 12). Ceramic and glass artefacts were found within the fill behind Wall A including a piece of Buckley ware (Plate 13).

Plate 12: Wall A with top 800mm removed

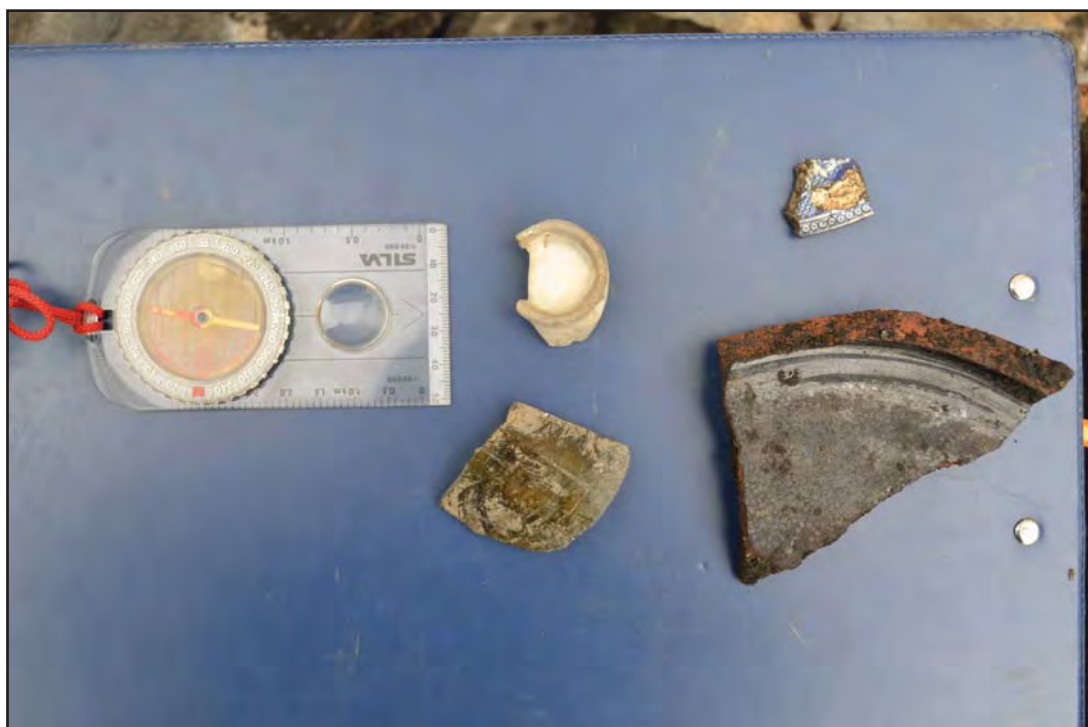
Plate 13: Artefacts from behind Wall A

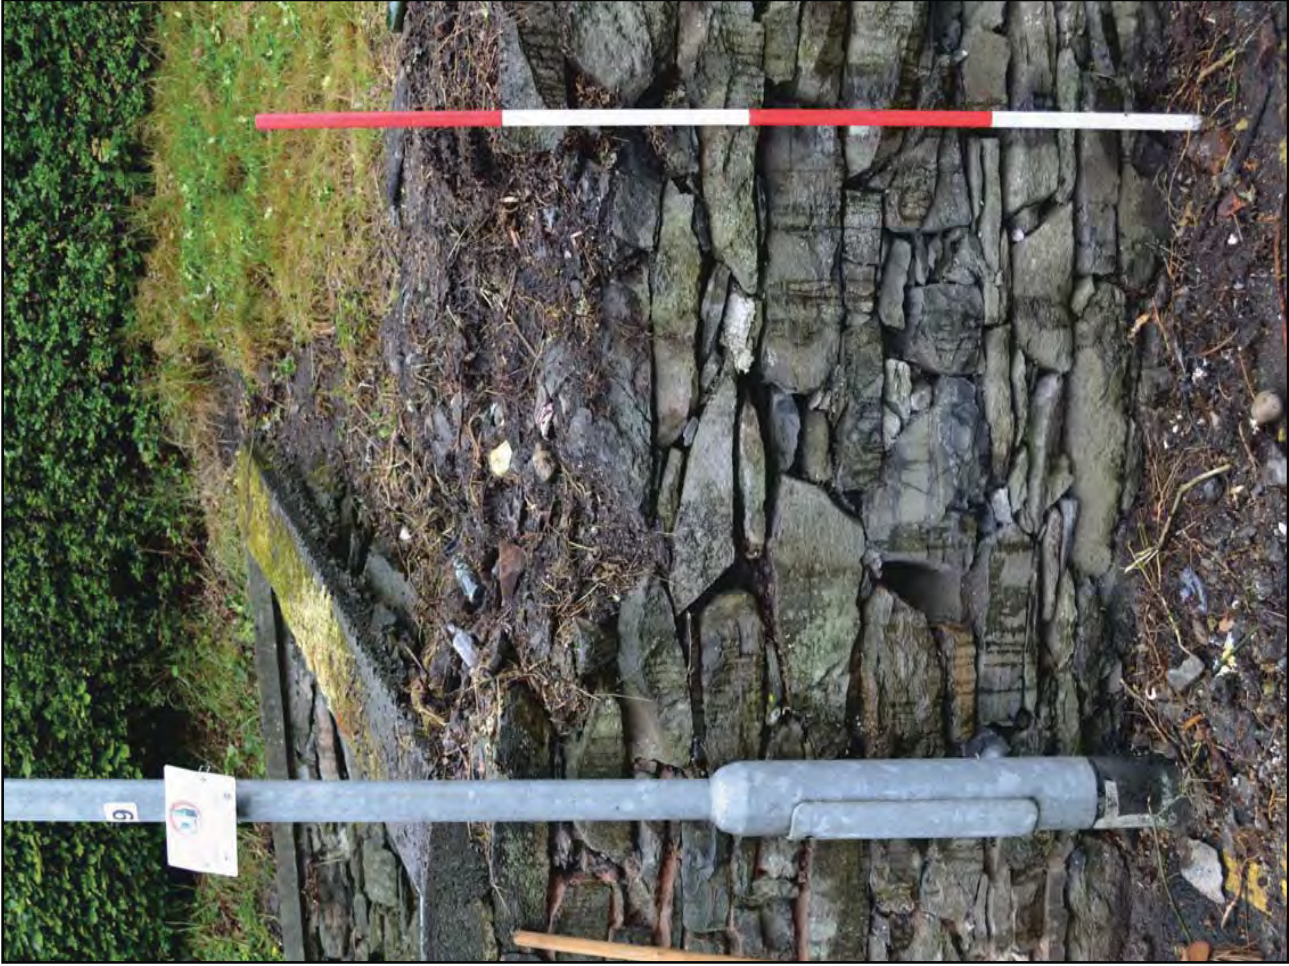
Plate 15: Wall E with top stones removed to aid root removal

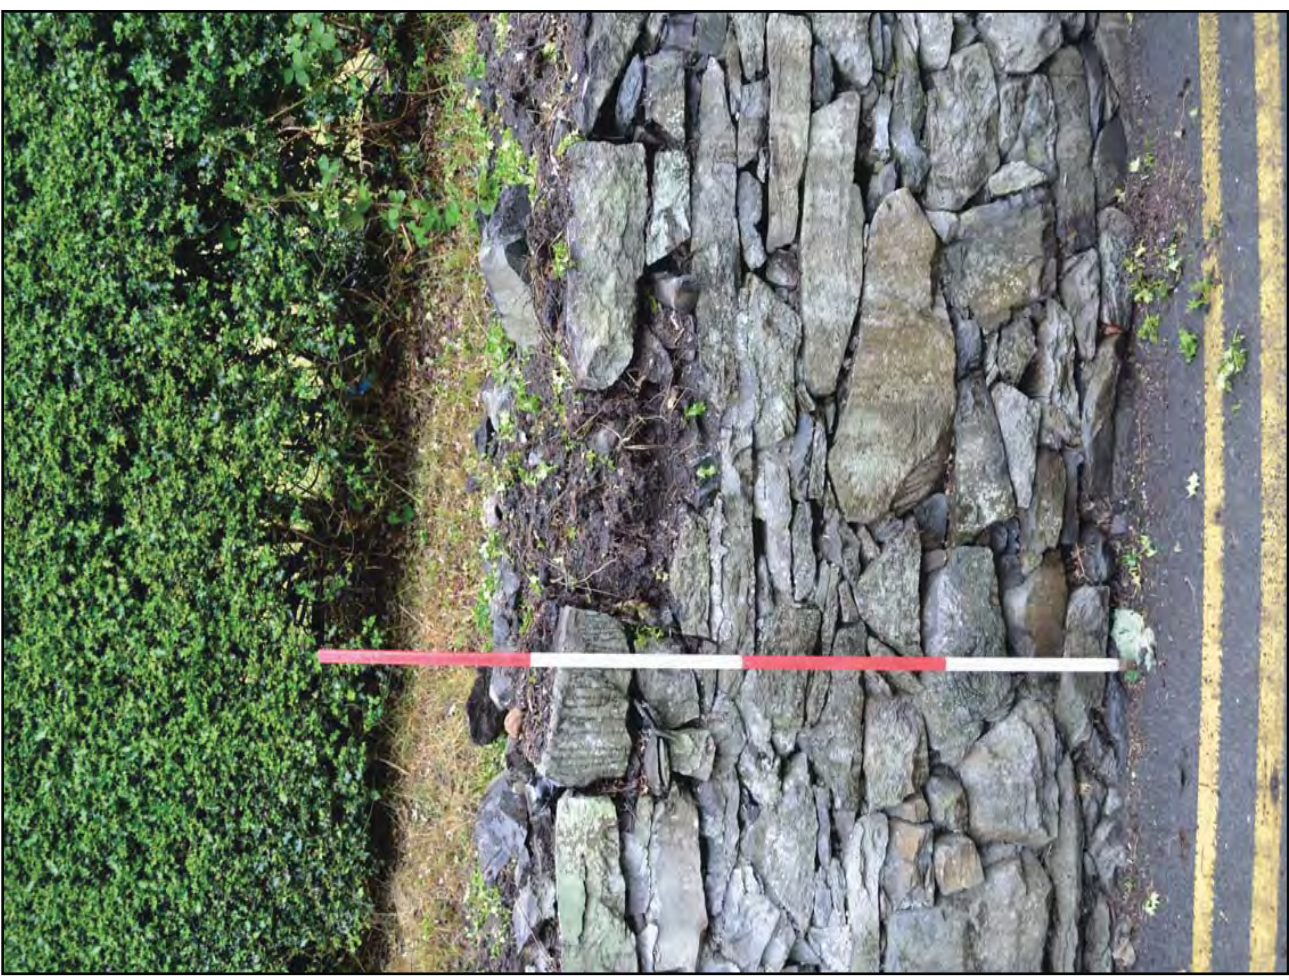
Plate 16: Wall E with large stone removed to aid root removal

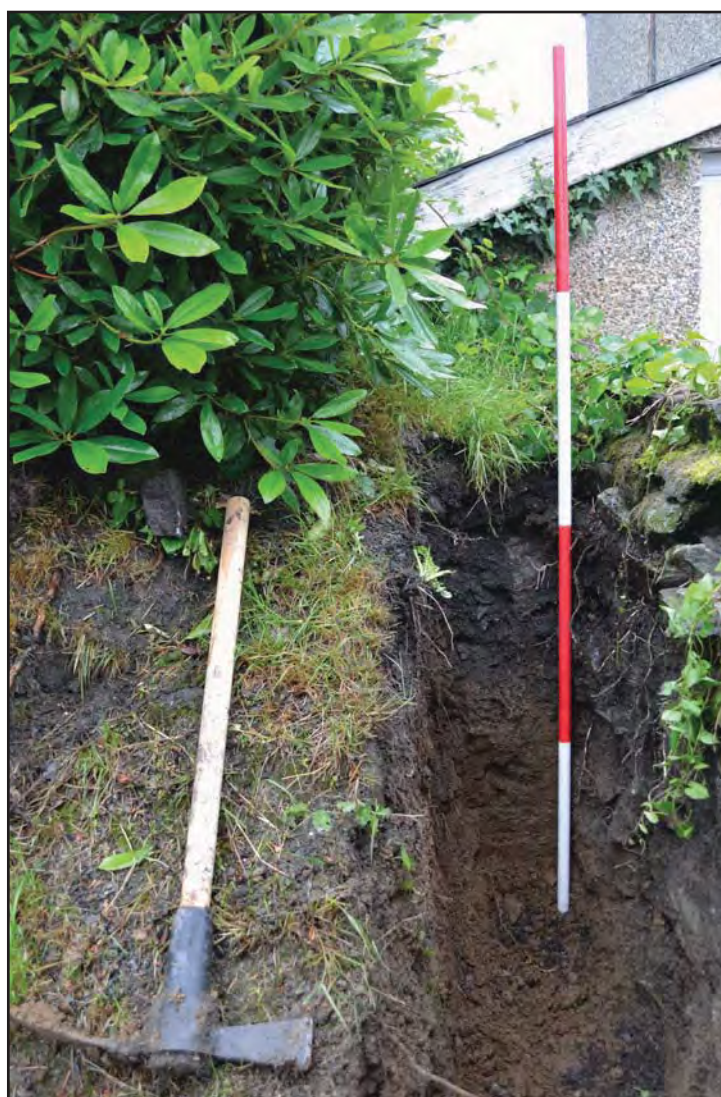
Plate 20: Area behind Wall F partially excavated

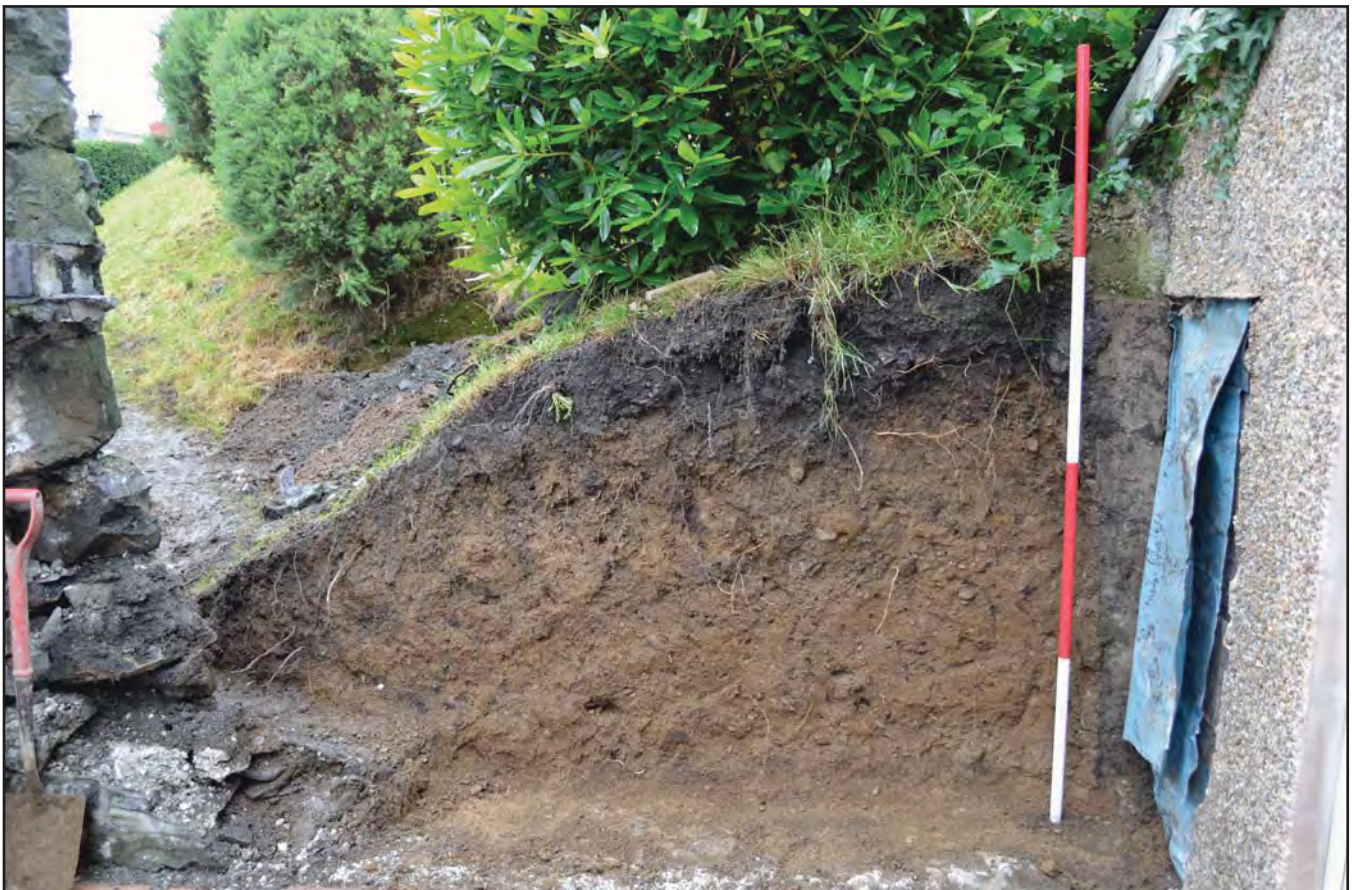
Plate 22: Section behind Wall F after excavation

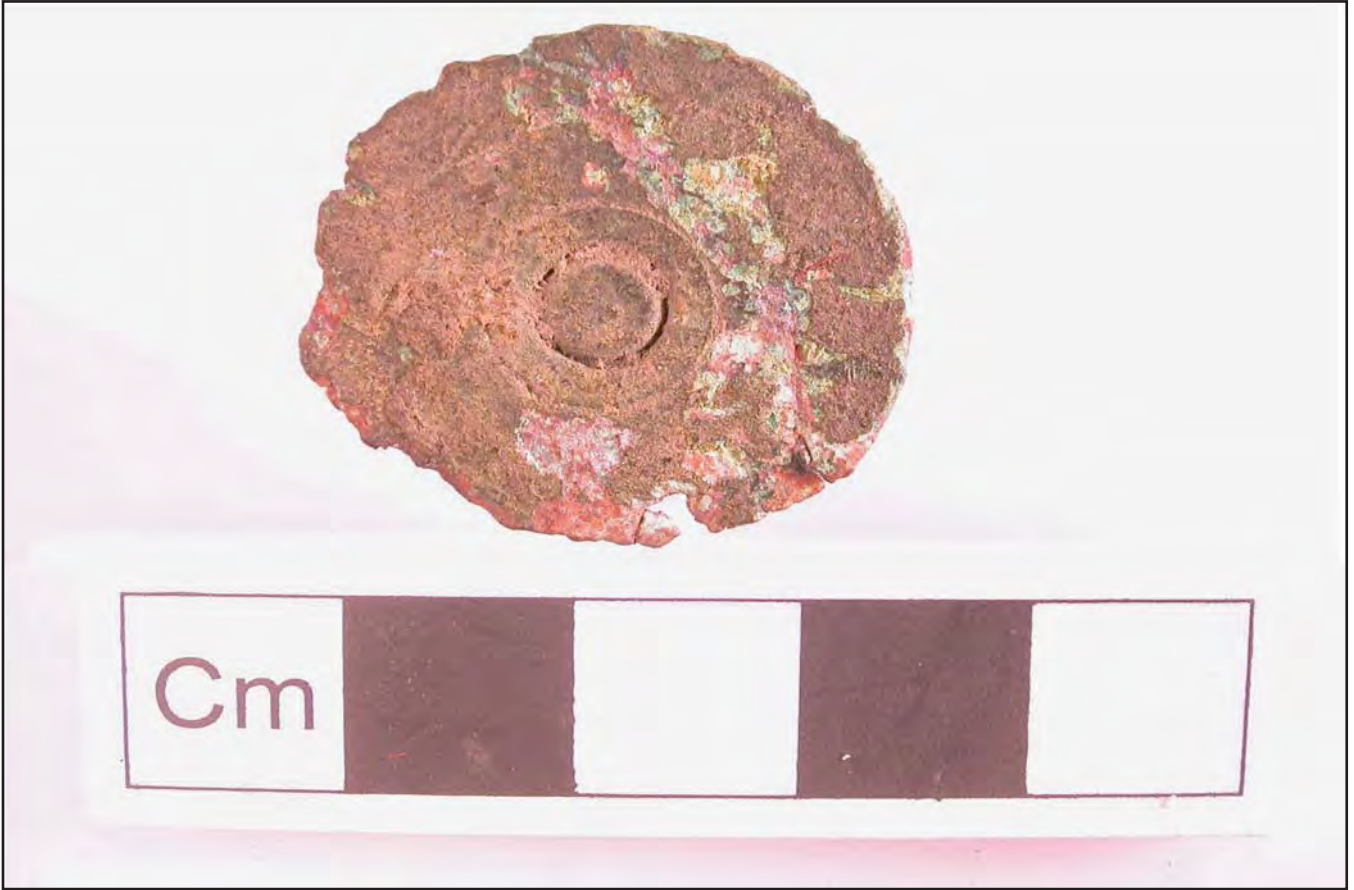
The dress fastener (GAT-25ECF3) is a copper alloy decorative boss or button with traces of applied silver gilt. The boss is circular in shape, and has some edge damage. The centre of the boss is surrounded by a deep circular incision with a further shallower incision further out towards the edge. On the back of the boss are the remains of an attachment spike, presumably to originally attach it to another object such as a back plate of a dress hook.

Plate 38: GAT-25ECF3 obverse view of dress fastener with scale

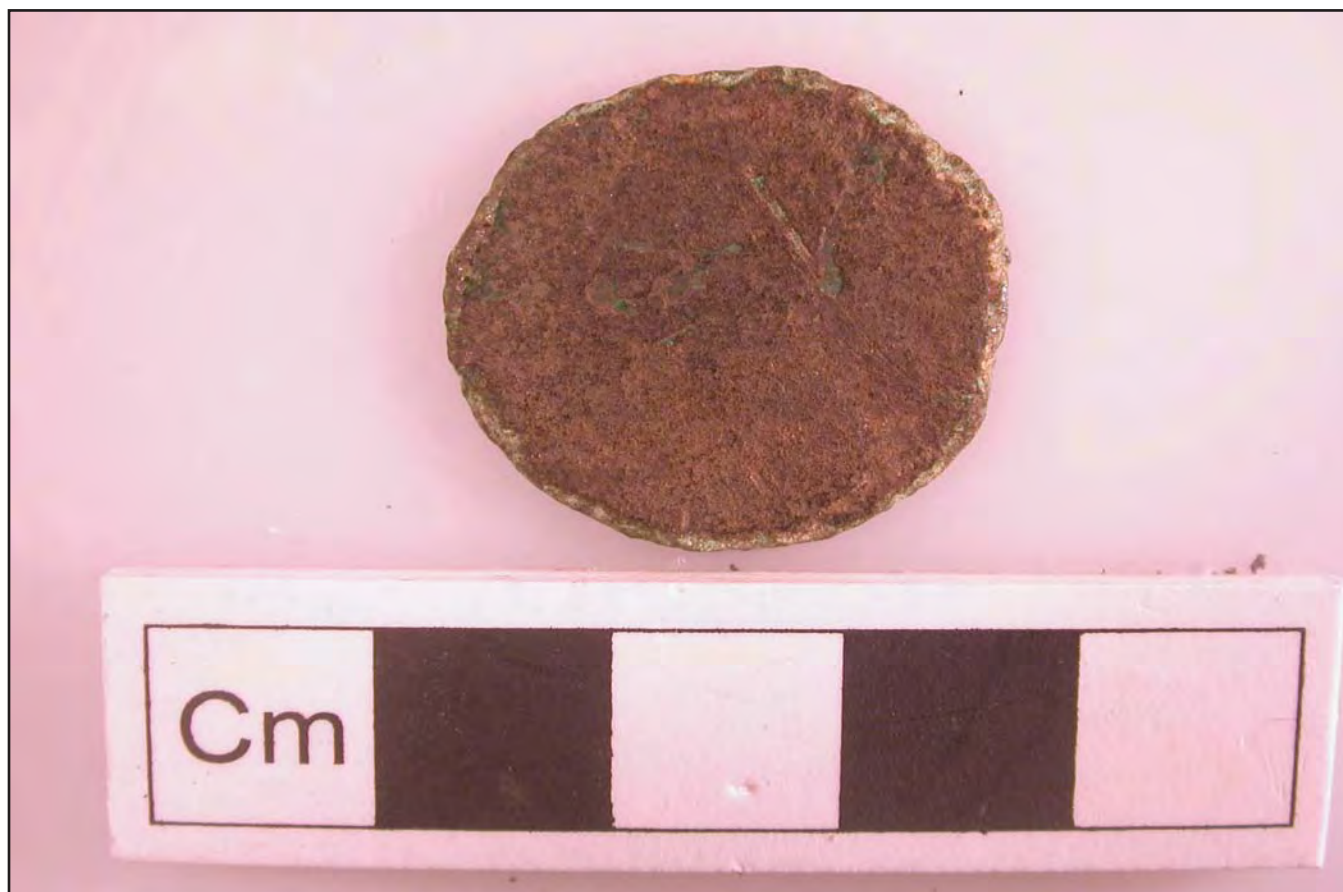
GAT-267709 is a penny or halfpenny of modern period, possibly Victorian (1819-1901 AD). The coin itself is extremely worn to the point where almost no detail can be seen on either side. However a slight indentation on what is presumably the obverse can be seen in the shape of what appears to be a woman (most likely Queen Victoria). There is moderate corrosion on the coin, more so on the presumed reverse. The coin is of a dark

Plate 40: GAT-267709 obverse view of possible Victorian penny or halfpenny with scale
