CASTELL CARNDOCHAN

Excavation report 2016-17

Project No. G2366

Report No. 1381

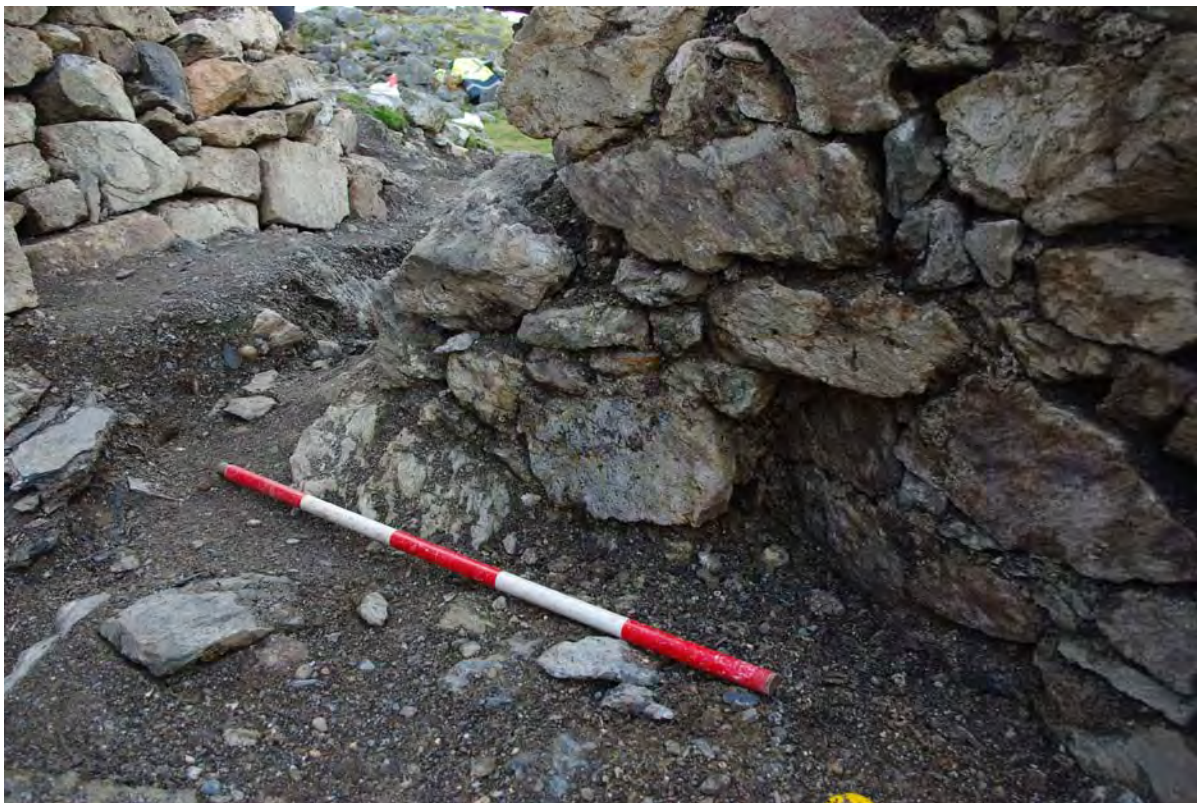
Fig. 13 Discontinuity in lower eastern wall of entrance passage (540)

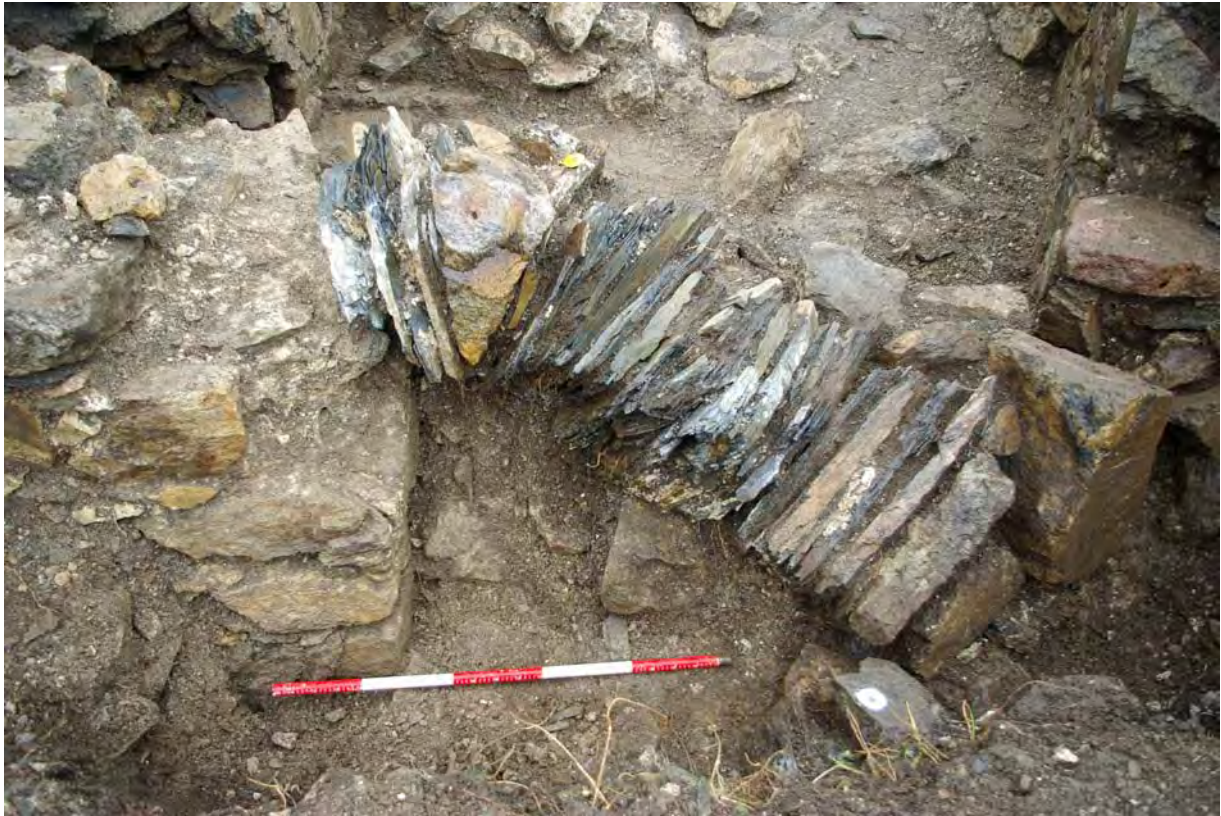
Before the excavation the entrance was entirely hidden by collapsed masonry that was in places over two metres deep. This had originated from the large apsidal tower, the ramparts and the entrance. This was mostly an undifferentiated deposit of random stone, gravel and crushed lime mortar (522). The lime had dissolved out of the top of the deposit leaving clean gravel and there was more mortar with depth. The rubble in the entrance contained fairly frequent squared-off blocks and slabs. Two large fragments of fallen masonry survived close to the base of the rubble layer. The first was a square block of masonry that has probably fallen from the collapse in the western wall. The second, in the outer end of the passage, was the remains of an archway (Figs 17 and 18). A little over half of the eastern side of the archway had fallen into the passage and remained in one somewhat fragmented piece. A distinctive wedge-shaped keystone survived close to the western end. Most of the remaining arch consisted of voussoirs made from low quality slate slabs. Almost all of the rest of the masonry in the castle was built from local tuff so the use of stone transported onto the site was of note. It seems likely that the slate was used as an architectural feature to emphasise the entrance. A single rectangular block of stone at the eastern end of the line of slate probably marked the end of the arch. The corner of the entrance passage on the eastern side had failed from the base. The lower part of the eastern corner was well preserved and the arch probably sprang from the squared-off

Fig. 17 Semi-collapsed arch (526)

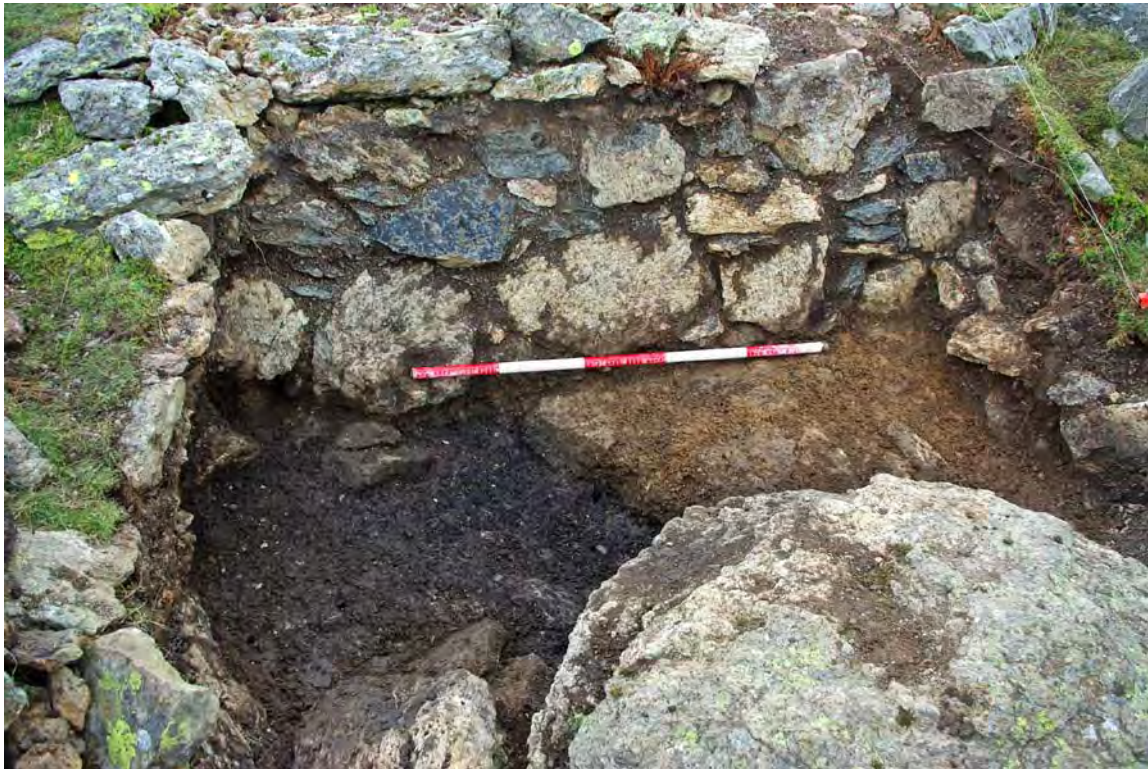
Fig 23. Dark humic buried turf layer (533) running under outer face of keep on left-hand side of trench with unexcavated levelling layer (532) on the right

Bedrock was identified across much of the excavation but the keep wall was not generally built directly onto this. On the outside of the keep a thin (0.04m to 0.09m deep) dark grey humic layer (533) ran beneath the outer face of the wall (Fig 23). This was interpreted as a buried turf line. It contained occasional stones along the line of the wall which had probably been added as packing or levelling stones during construction. The bedrock (518) in the interior of the keep was very uneven with some detached pieces still *in situ*. The cracks and crevices were, in places, filled with dark humic material (537), again probably the remains of a turf layer. This ran under the inner face of the wall on the north-west side of the trench. Many of the larger hollows in the bedrock had been infilled with stones and gravelly soil (536). Stones in this layer ran under the inner face of the wall indicating that the hollows had been infilled prior to the construction of the wall (Fig. 24).

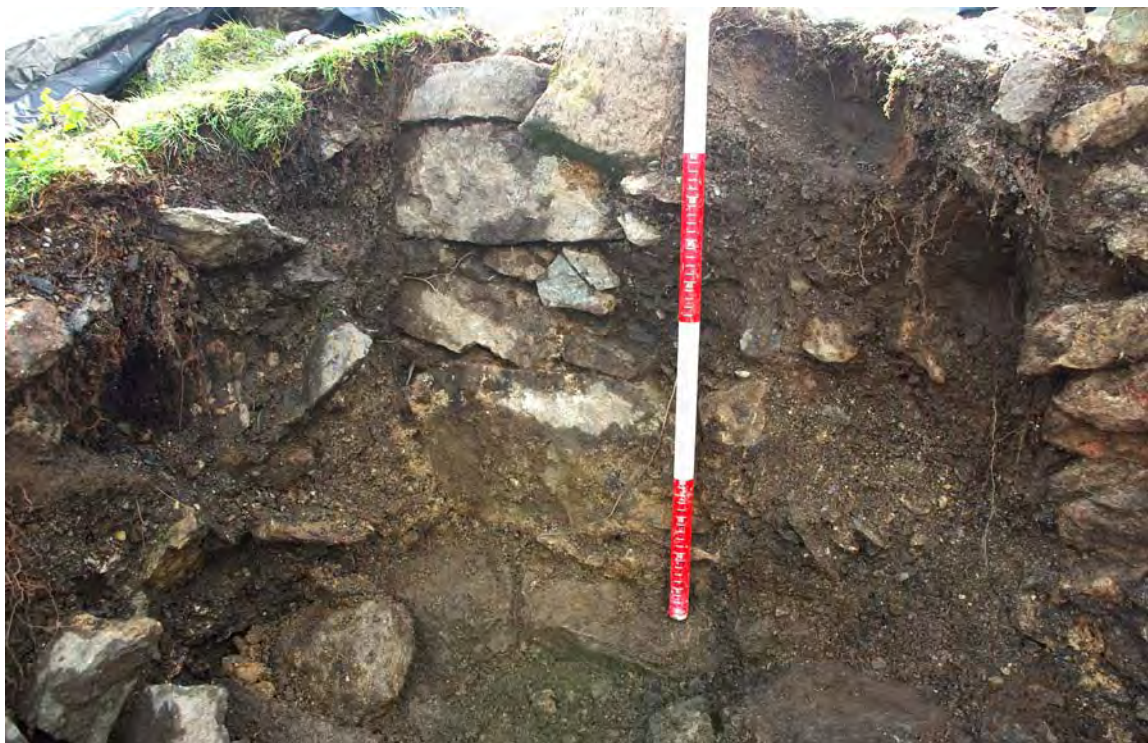
Fig 24. Stone levelling layer (536) running under inner face of keep wall

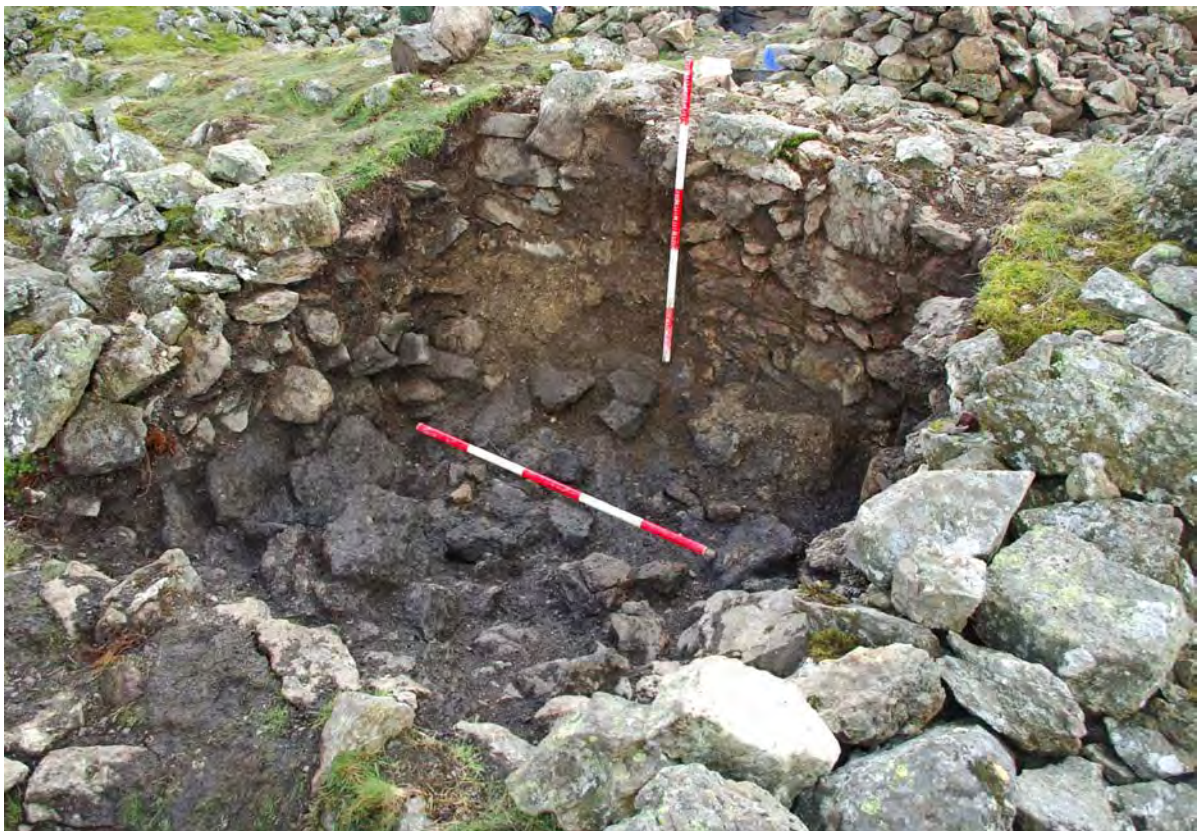
The wall was found to be well-preserved, apart from one collapse in the inner face (Fig. 25), with the top of the surviving masonry at the current ground level. The outer face was standing to a height of 0.87m and was built to a 28 degree batter (Fig. 26). The masonry comprised irregular local stones with their flat sides laid to make a fairly level face. The facing was uncoursed with substantial voids between the larger stones that were packed with galetting. The remains of degraded mortar could

Fig.25 Inner face of keep and shattered bedrock/turf layer (518/537)

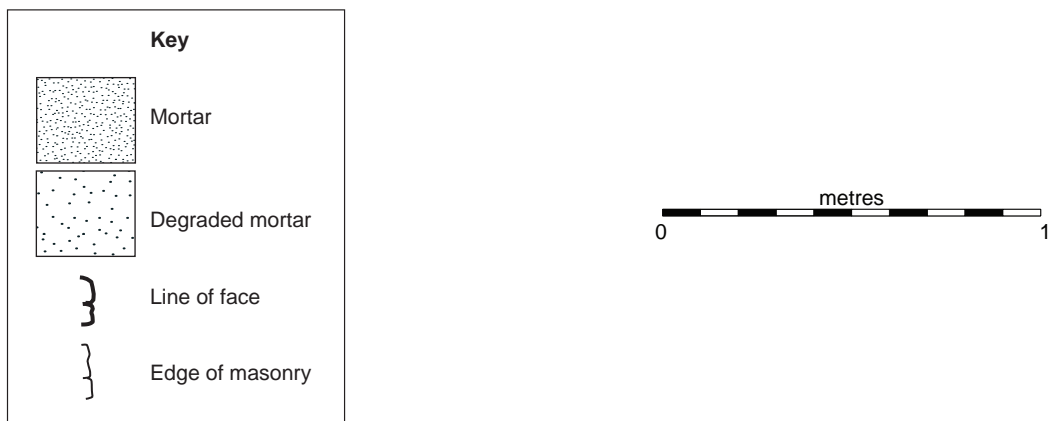
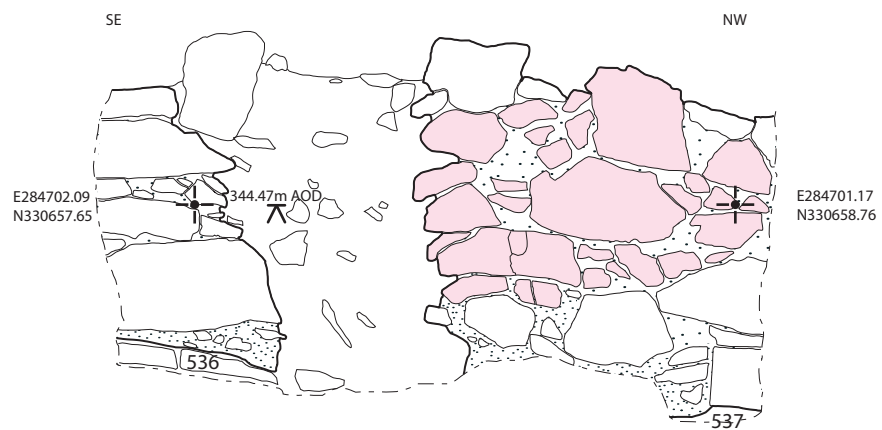
Fig. 27 Inner face of keep, NW facing elevation

There was a 0.45m wide collapse where the inner face had failed from the base. The stones in surviving wall to the north-west of this were reddened and in some cases fire-cracked (indicated in red on Fig. 27). There had clearly been an intense fire in the keep and this may have been the cause of the collapse. Many of the stones in the tumble in front of the wall were also heat affected on one face.

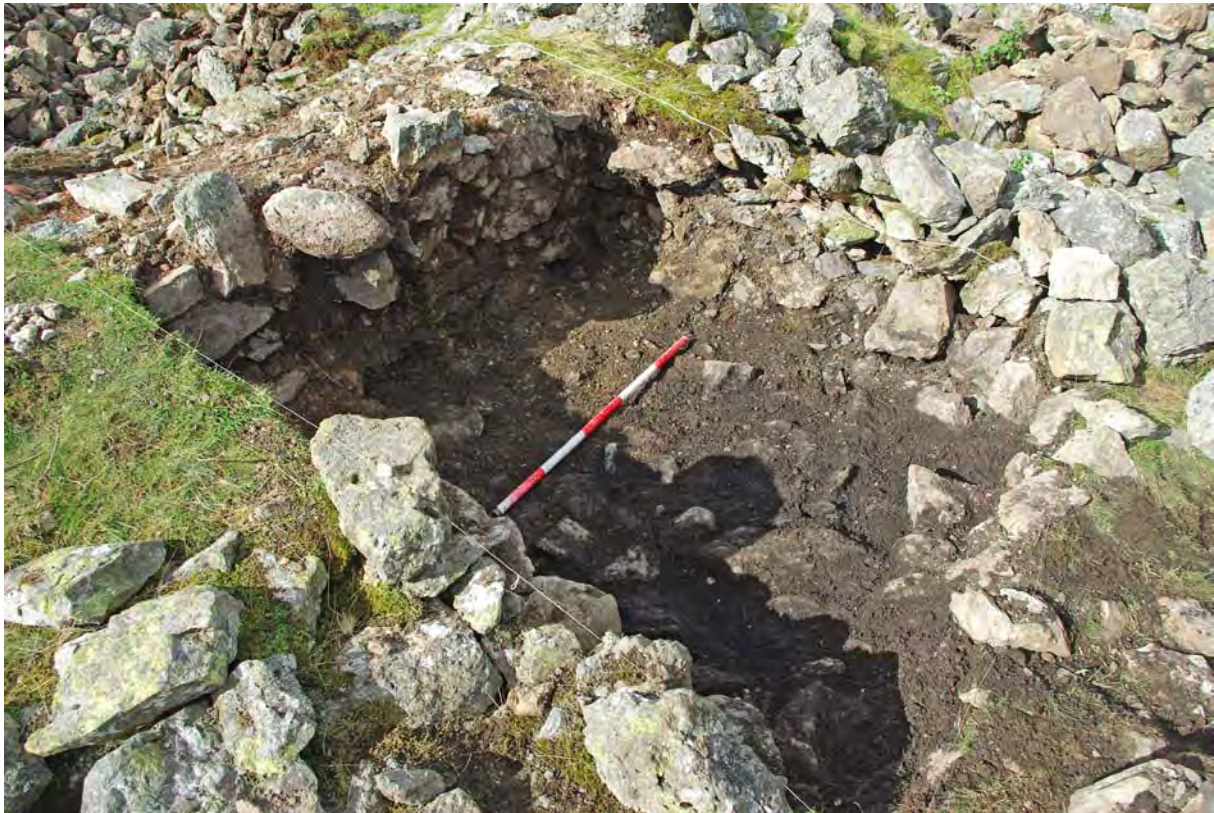
A deposit of black gritty silt with a high charcoal content (527) overlaid the levelled bedrock and mortar deposits in the interior of the keep (Fig.29). The charcoal ranged from small flakes to pieces a few centimetres long. The deposit also contained frequent pieces of fire-cracked and shattered stone and a collection of iron nails (Fig. 30). This deposit along with the heat affected stones within the wall suggests that there had been an intense fire within the keep. The burnt material was beneath the main collapse horizons so it is likely that the structure was destroyed by fire, when it still retained

structural timbers as opposed to the fire being a result of later activity. The burnt horizon was sampled and processed and is being assessed for material that could be used for dating purposes. The larger pieces of charcoal are probably the remains of larger structural timbers and would therefore be

Fig. 29 Destruction horizon 527 in keep

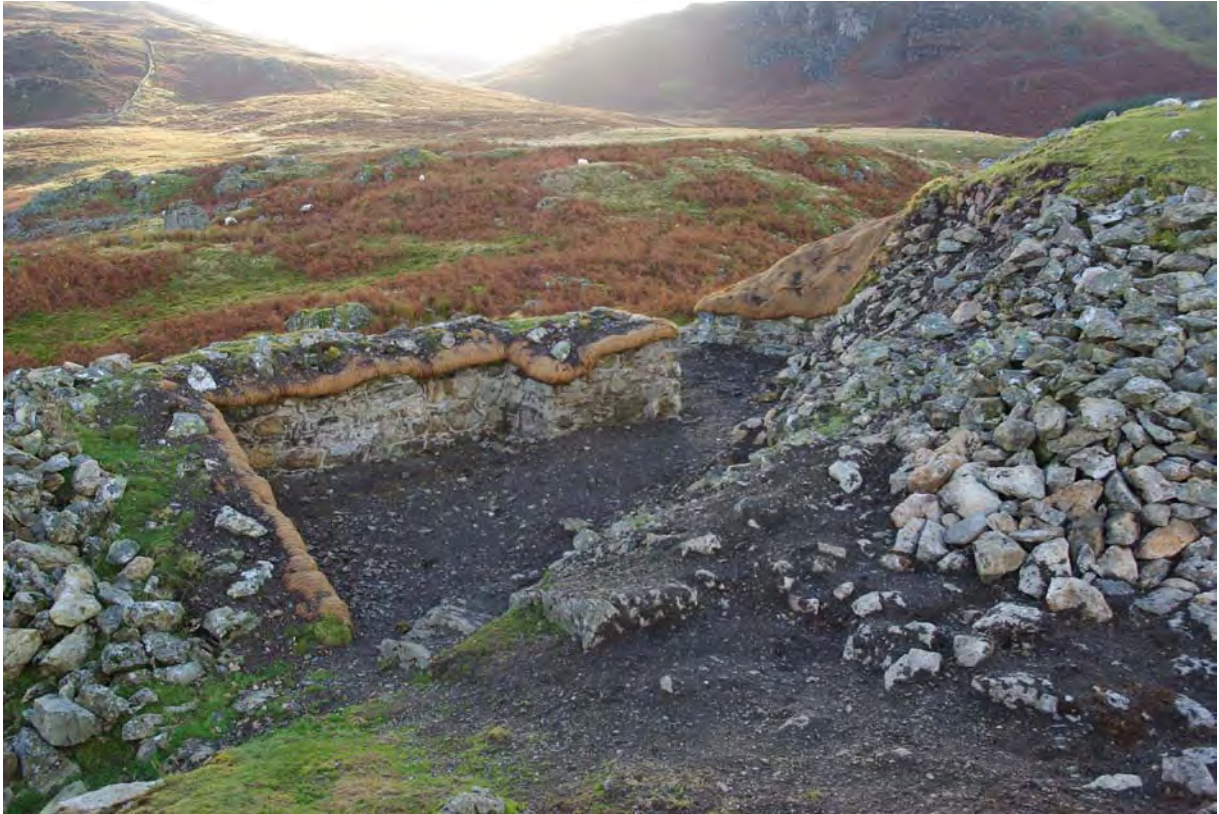
Fig. 31 Trench 1 after conservation

The conservation of the masonry was managed and arranged by John G. Roberts the Snowdonia National Park Archaeologist and funded by the Park and by a Cadw Ancient Monuments Grant. The works were carried out by Alwyn Ellis and his team from Stonewyrce Cyfyngedig using specifications prepared by Mike Garner. The majority of the exposed masonry was well-preserved although somewhat fragile due to loss of mortar in the upper facing. Facing had been lost in several small areas; the most serious collapse was in the central western wall of the entrance passage where the wall had failed at the base affecting both facing and parts of the core.

All exposed masonry was recorded photographically using a levelled camera with the sensor-plane parallel to the wall. These photographs were used as reference for the work. The original mortar was retained where it was still stable but it had been lost in all but the lower parts of the walls. Galetting stones were mostly still in place, even where the mortar had been lost, and the retention of these in their correct positions was seen to be a priority as they were one of the defining characteristics of the masonry style. The walls were repointed using lime mortar and the joints were left with a rough finish in order to blend in with the original masonry (Figs 31,32 and appendix). Collapses were rebuilt using the same style of masonry as the original and the edges of the new facing were marked with recessed pointing. In addition the stones around the edges of the new masonry were marked with 10mm diameter and 5-7mm-deep drill holes. It was decided to re-bury the lower part of the walls in order to make them less vulnerable to erosion and to create a level and safe surface for visitors. The outer end of the passage was carefully backfilled to just above the level of the top of the collapsed arch which was preserved *in situ*. This brought the level of backfilling to above the height of the extant facing on the outer corner of the west side of the entrance. One of the aims of the project was to provide an understandable and functional entrance so new masonry was added on top of the extant corner in order to define the outer end of the passage (Fig. 32). The backfilling and the path to the entrance used excavated material to provide a level surface (Fig. 32 and 33). Large stones were placed at the base and smaller stones were then packed in to provide a level and stable foundation. This was then covered with a mixture of gravel, mortar and other excavated deposits. This was not enough to completely fill all of the voids to the base of the backfilling but observations of re-excavated backfilled areas and rubble deposits had shown that the gravel packs tightly into the voids and provides a stable surface. It was estimated that about 30% of the excavated material (Hopewell 2015, 15) was gravel/degraded mortar. Not all the excavated stone was used in the backfilling process

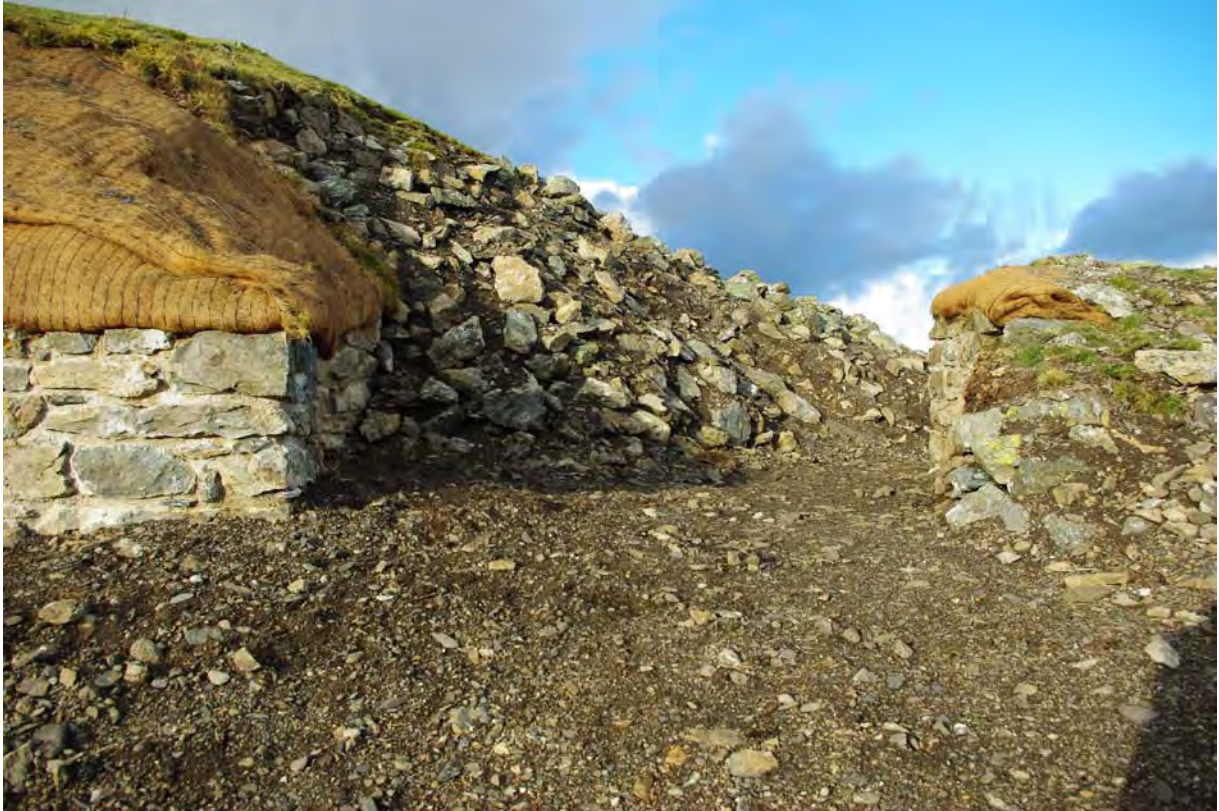
Fig. 32 Entrance from outside showing buttress/rubble slope

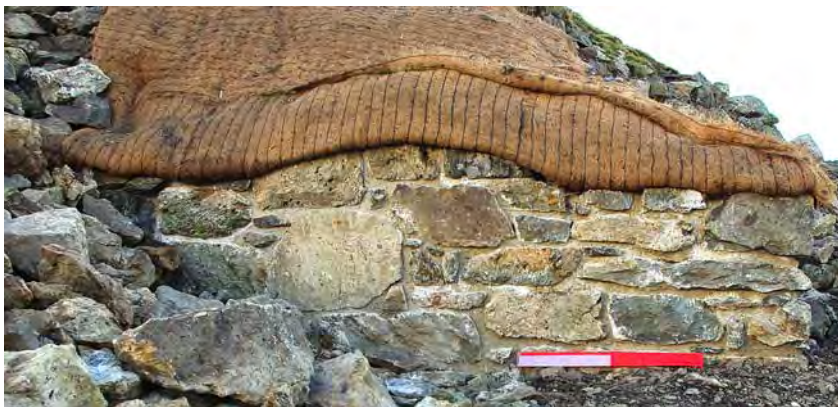
Fig. 48 Wall 529 after conservation.
Outer face curtain wall. No original facing visible at this level
