# BENARTH ROAD RETAINING WALL, CONWY

## Archaeological Watching Brief

Prosiect Rhif / Project No. G2527

Adroddiad Rhif / Report No. 1402

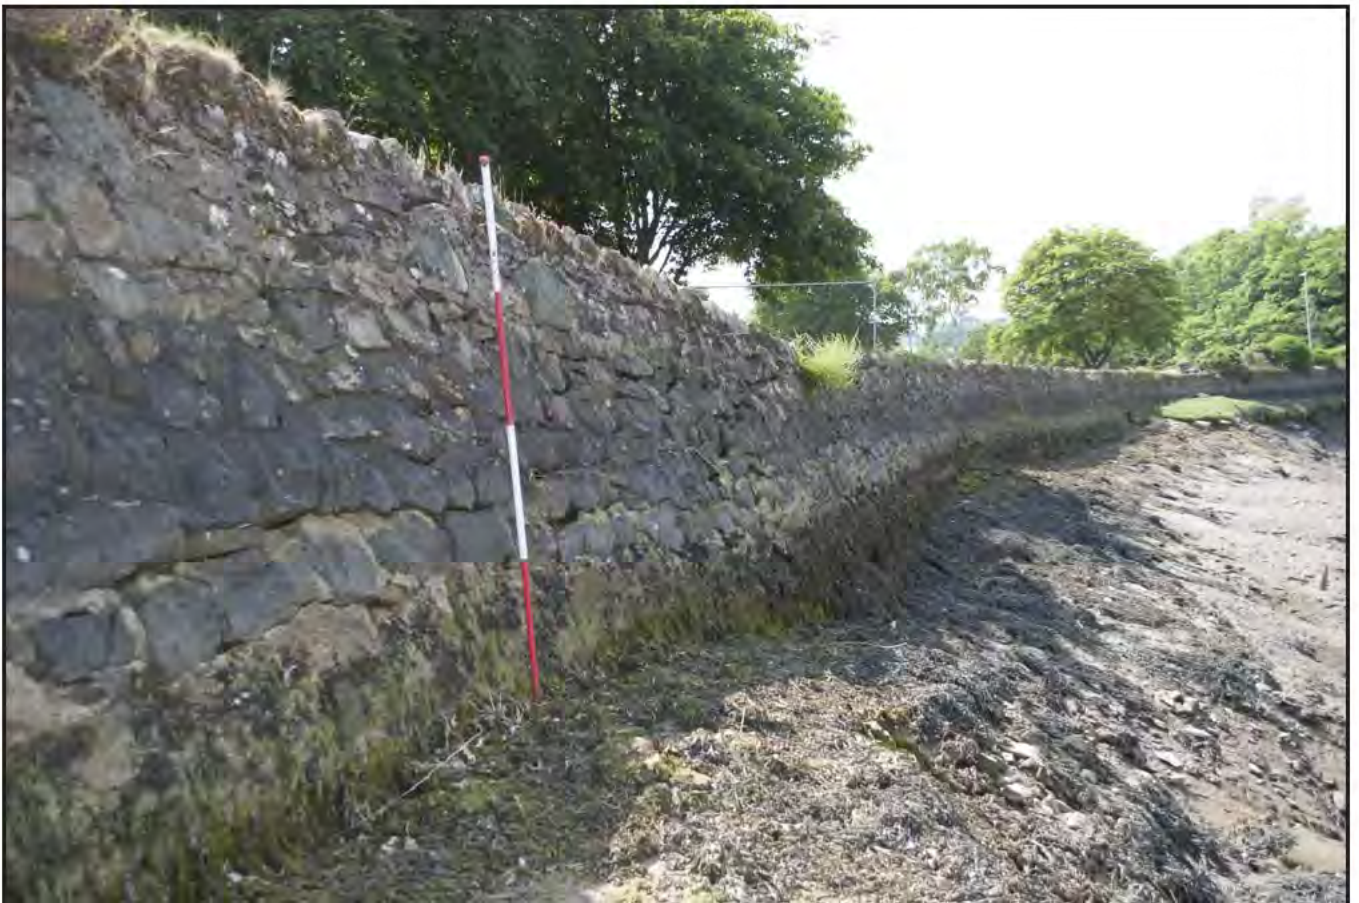
Plate 20: Collapsing section of wall, viewed from the NE (scale: 1x2m, archive image ref G2527\_017).

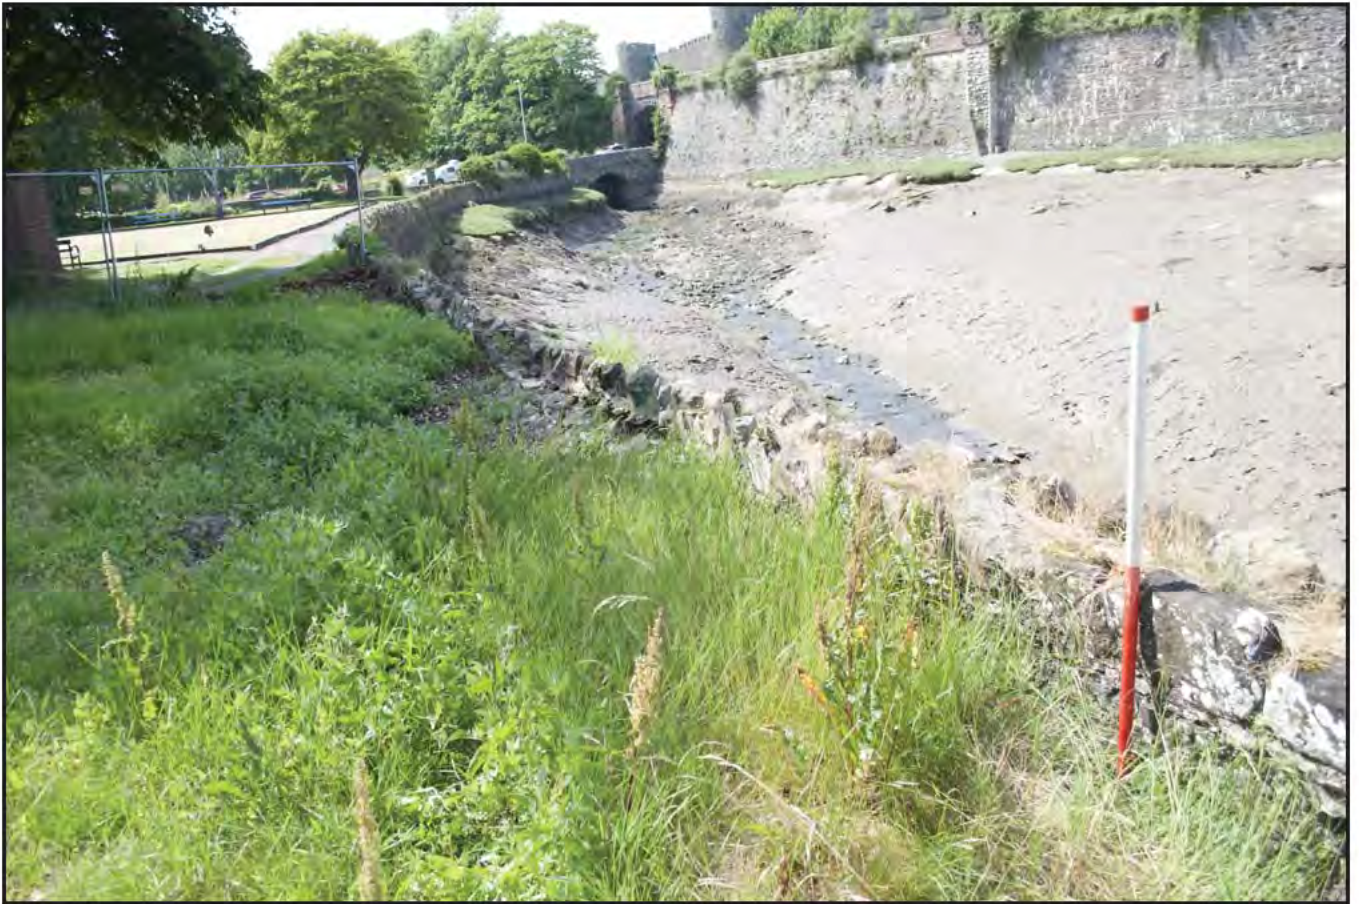
Plate 21: Southern side of collapsing section of wall, viewed from the SE (scale: 1x1m, archive image ref G2527\_023).

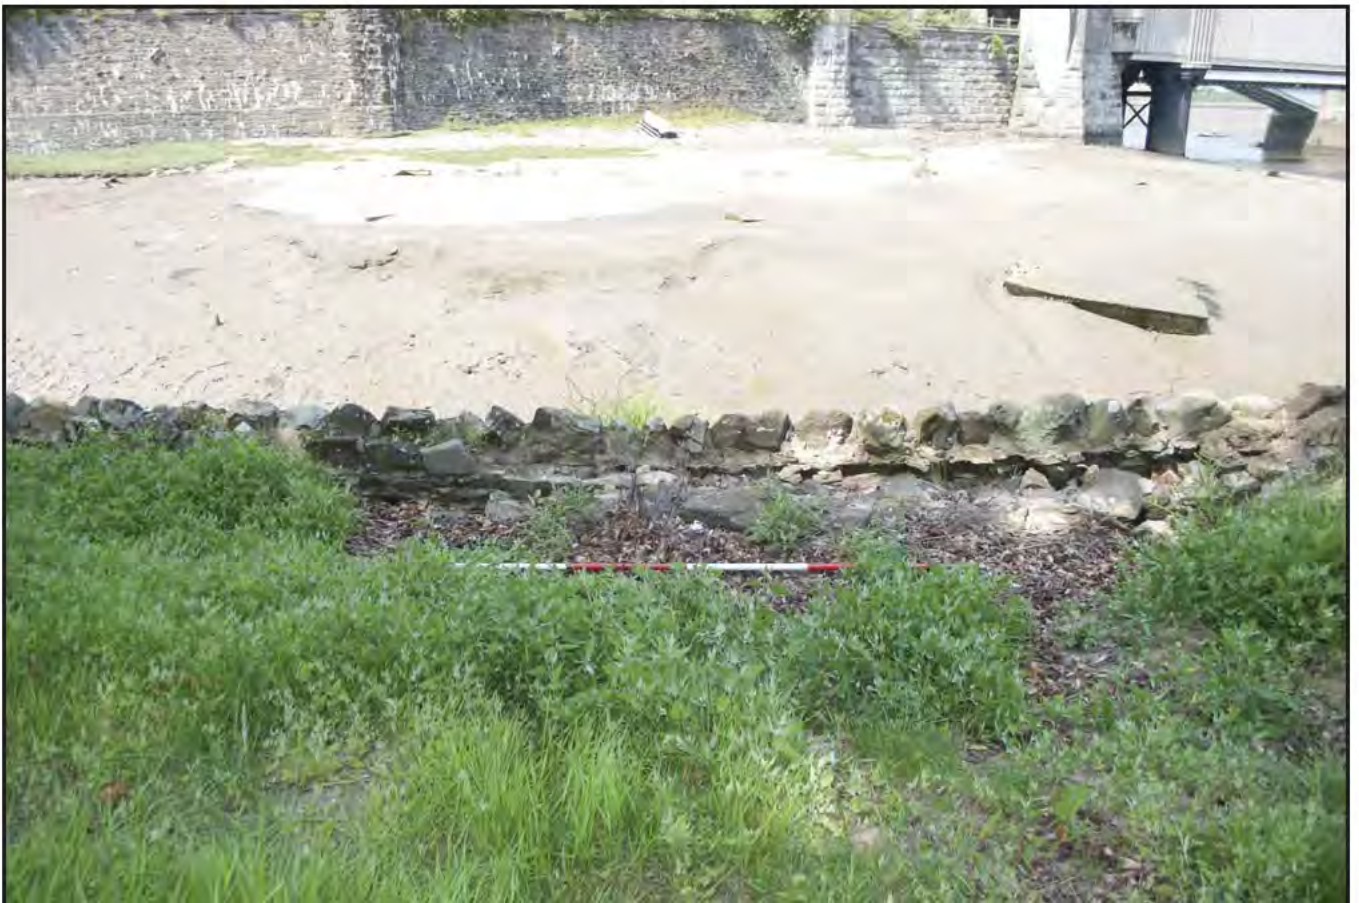
Plate 22: Southern side of collapsing section of wall, viewed from the S (scale: 1x2m, archive image ref G2527\_024).

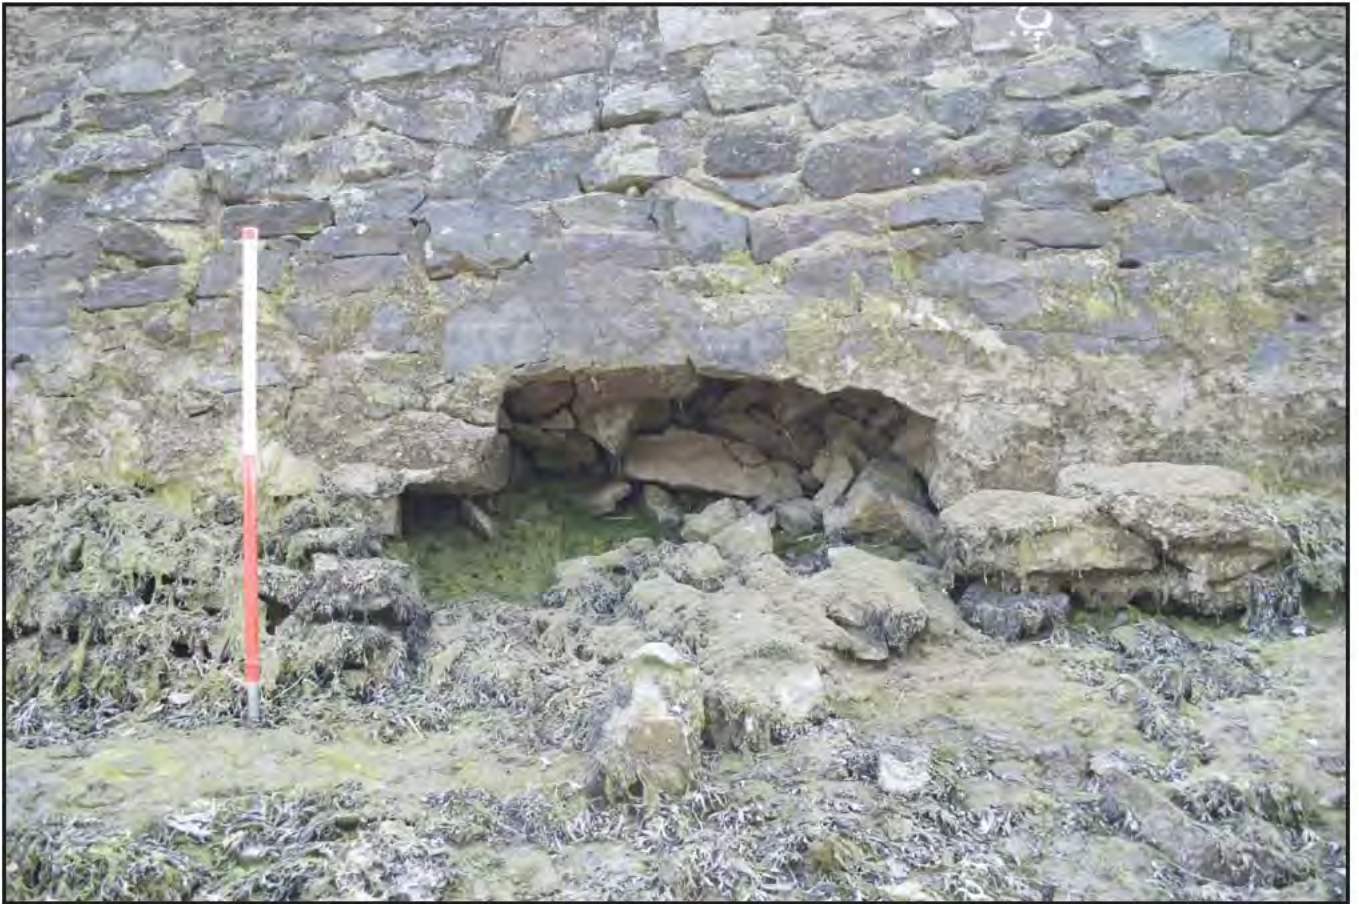
Plate 23: Collapsed part of wall, possibly a culvert, to the north of the bowling green, viewed from the NNE (scale: 1x1m, archive image ref G2527\_019).

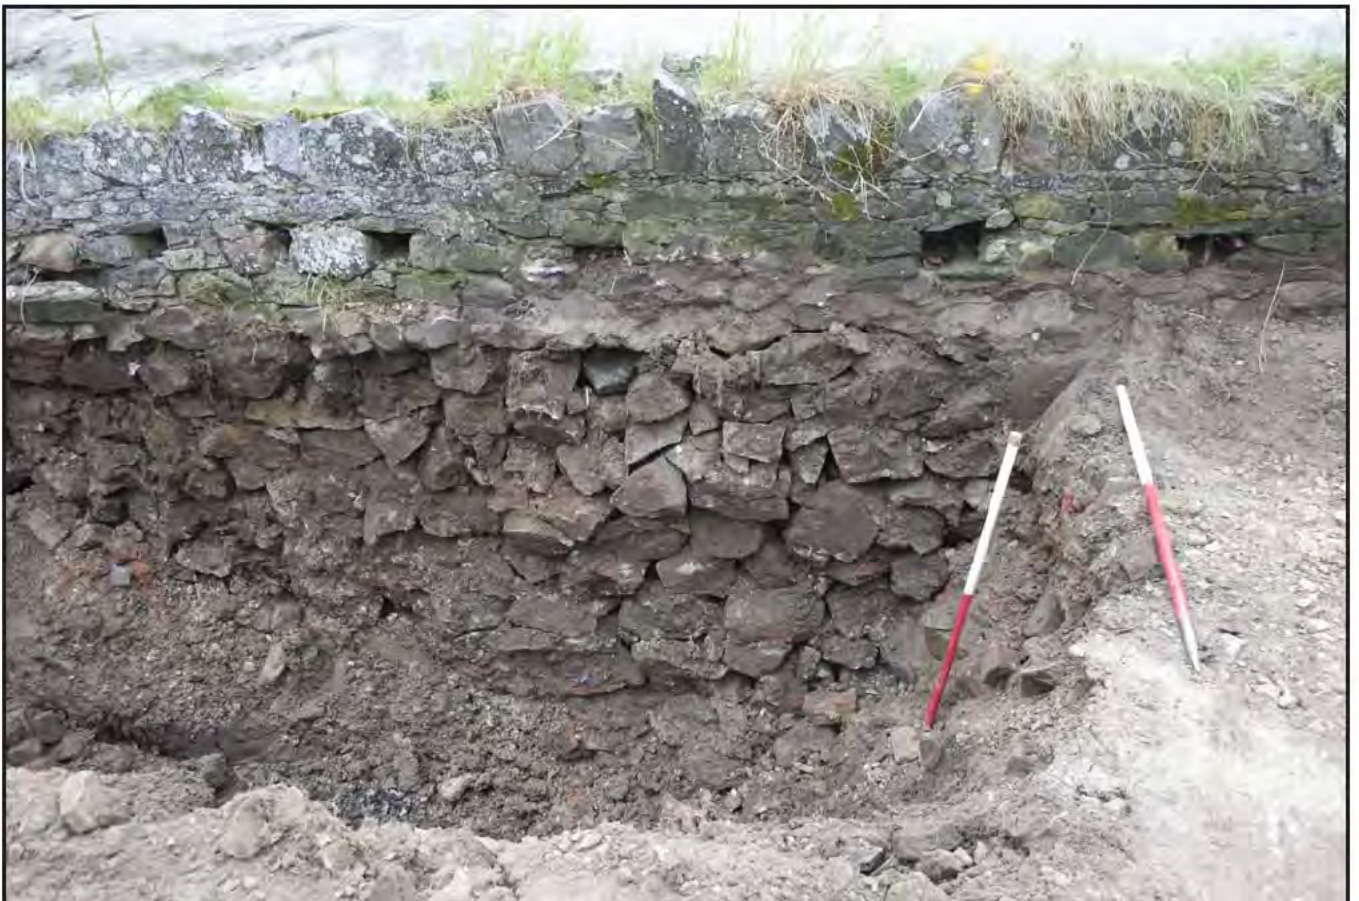
The original wall [001] on the southern bank of the Afon Gyffin is an early 20<sup>th</sup> Century rubble built revetment wall constructed from undressed, locally quarried stone. The stones are sub-angular and vary in size with the larger stones situated towards the base of the wall (Plate 24). The stones are bonded with lime mortar. Behind this wall were various layers of made ground containing demolition material from the construction of the wall, and backfilled material. The latter contained late 19<sup>th</sup> century glass and other material (Plate 43), and was of a very loose nature. Four glass bottles were recovered, including three containing distinctive embossed markings. A green glass bottle, 200mm tall, was embossed with IND COOPE & Co LD BURTON on TRENT. This usage was current between 1886 and 1934, so the bottle must date from between these years (Artefact 1; information from [www.breweryhistory.com](http://www.breweryhistory.com)). It also had 420 embossed on the base, indicating a standardised manufacturer's reference number. A 'codd' style mineral water bottle, 230mm tall and embossed with WILLIAM HILL, LLANDUDNO Est 1876 and W HILL to the base, was also identified (Artefact 2). The William Hill works were known as the 'Perseverance Works' and operated from its site in Llandudno from 1876 well into the 20<sup>th</sup> century, with this bottle being one of their standard ones. Artefact 3 was a small relish bottle 190mm tall, embossed

Plate 24: Revetment wall [001] showing the larger stones towards the bottom of the wall, viewed from the S (scales 2x1m, archive image ref G2527\_031).

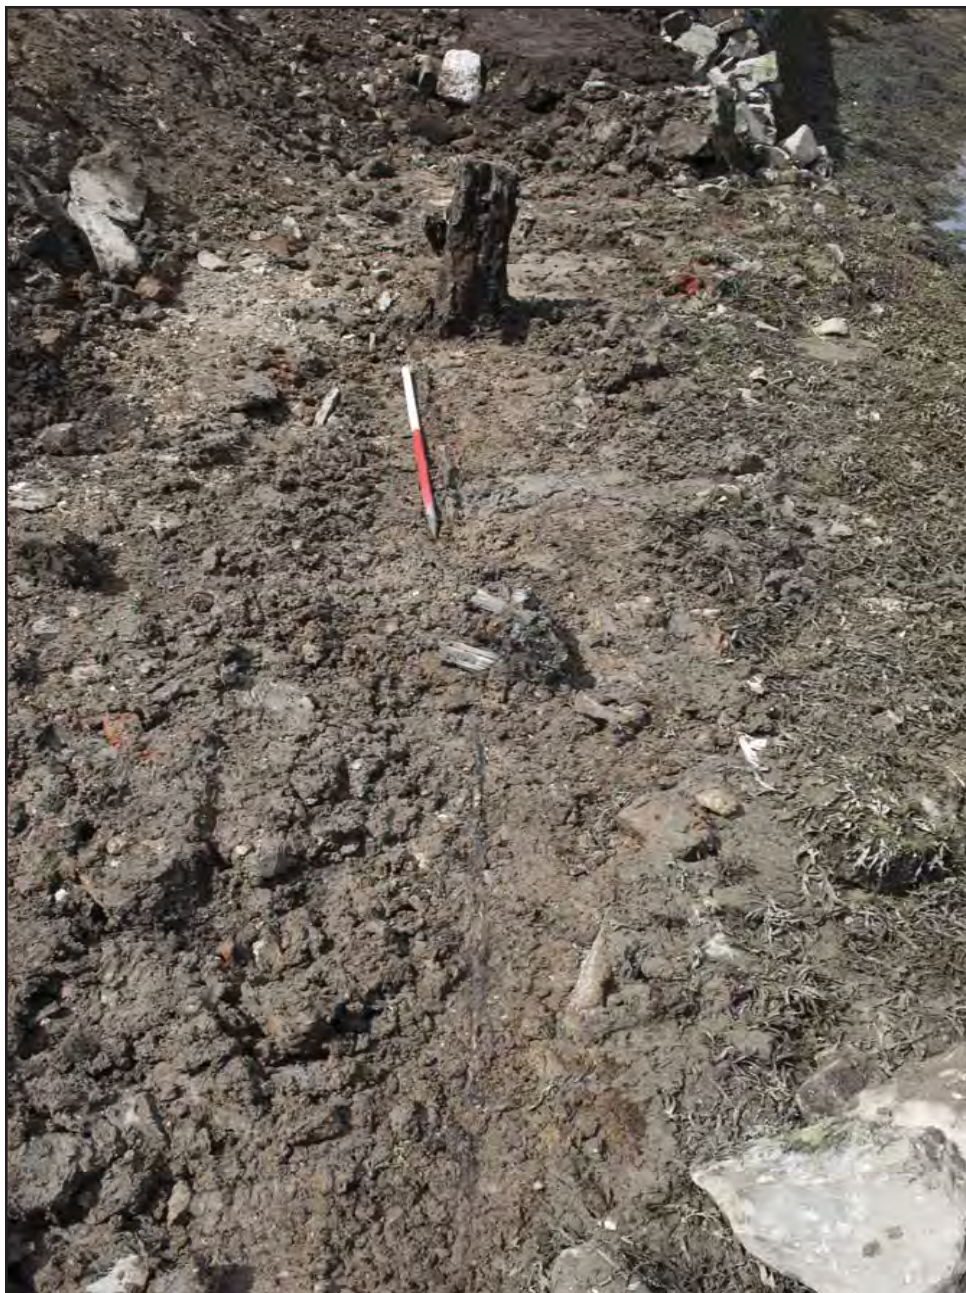
Plate 25: Wooden post and planks [005], viewed from the ENE (scale 1x1m, archive image ref G2527\_038).

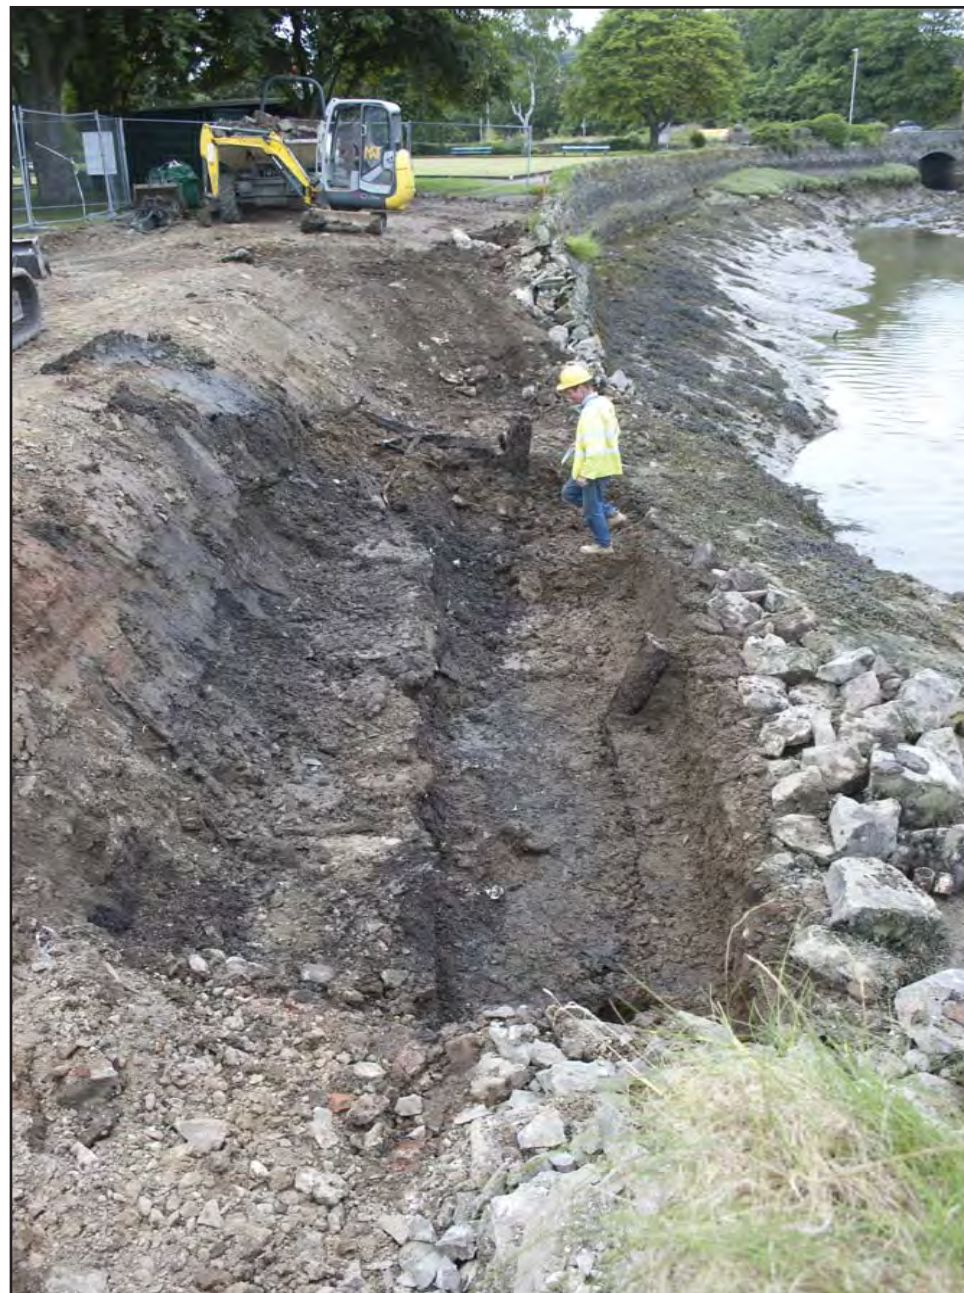
Plate 26: Wooden posts showing slightly different alignment to wall [001], viewed from the E (no scale, archive image G2527\_45).

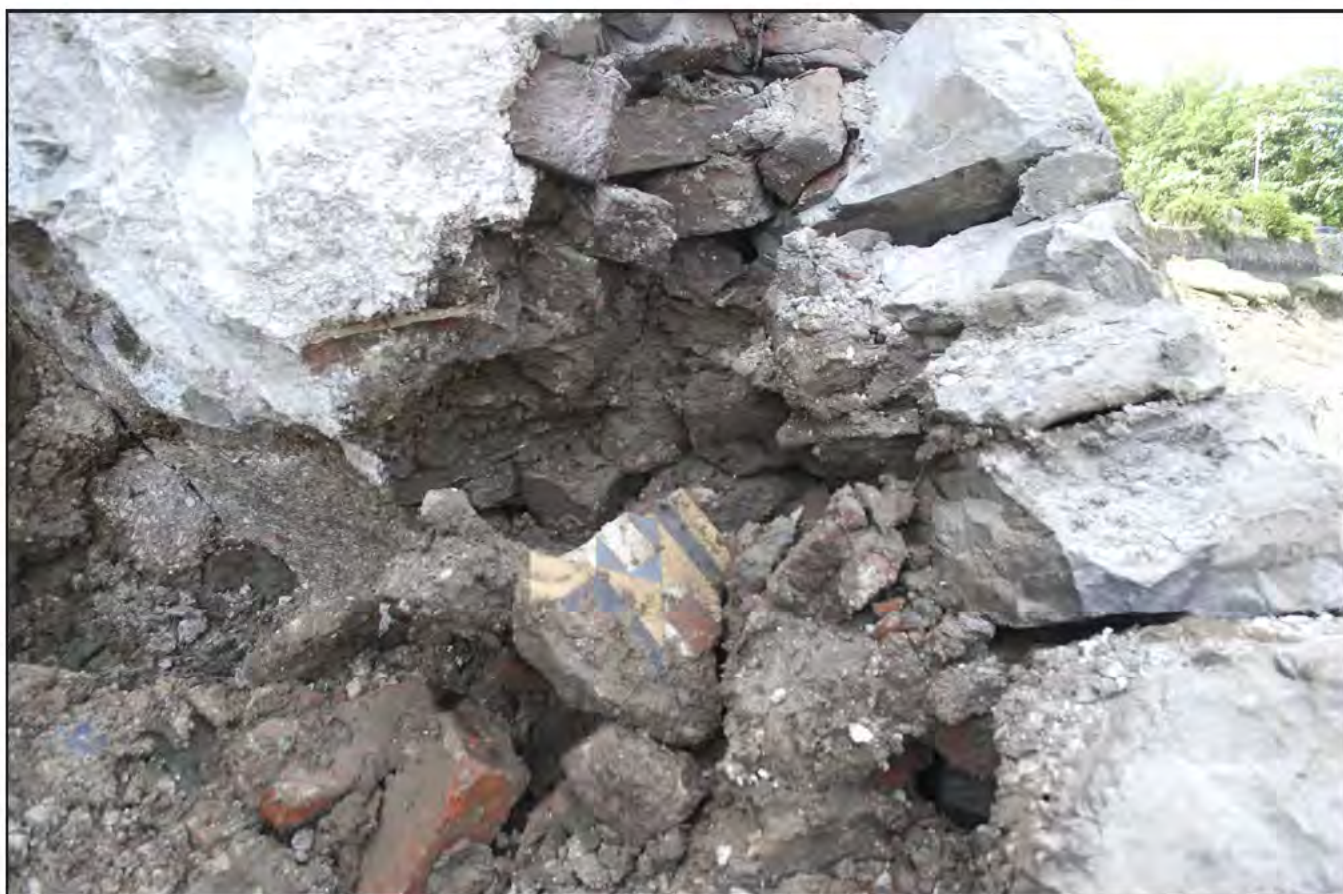
Plate 42: Late 19th century Minton style floor tiles fragment recycled within rubble backfill behind the retaining wall (no scale, archive image ref G2527\_077).

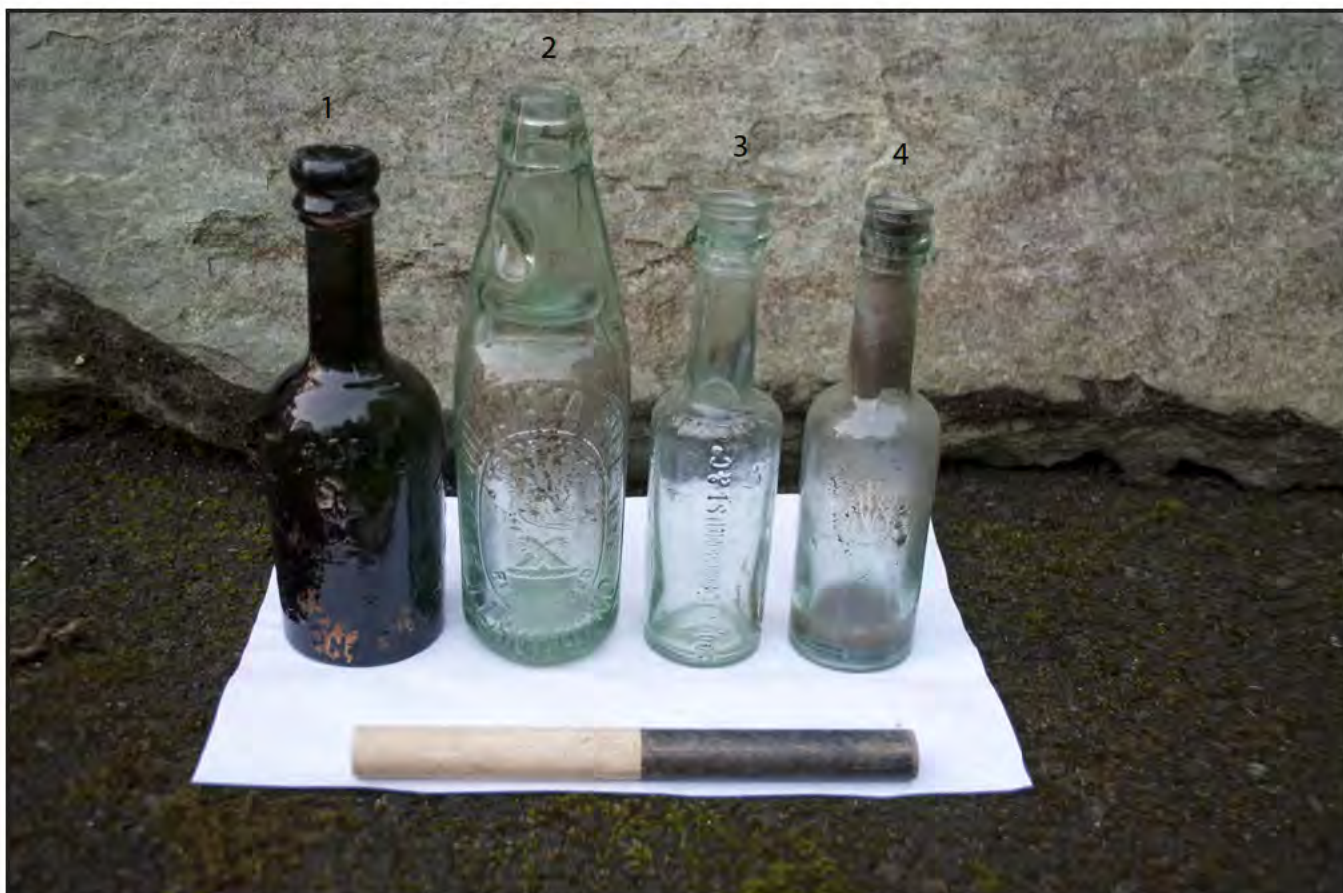
Plate 43: Nineteenth to early twentieth century bottles recovered from material behind the revetment wall (scale: 0.20m, archive image ref G2527\_094).

1 = Green glass beer bottle, embossed with "Ind Coope & Co Ltd Burton on Trent"

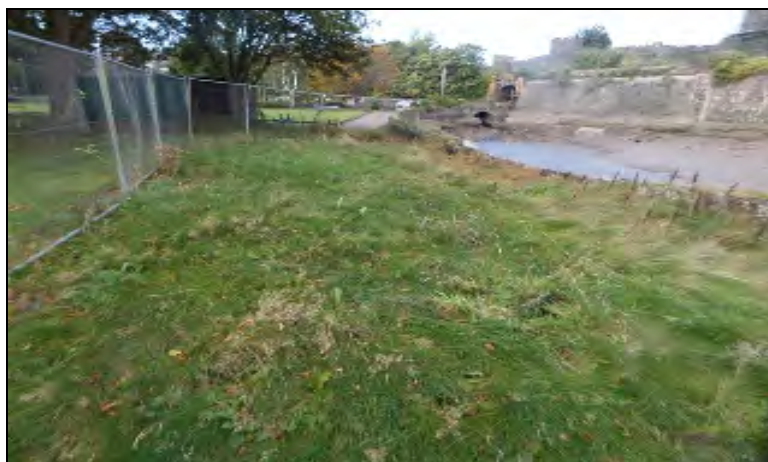
- 2.2.1 The area of investigation comprises a flat grassed area on the south side of the retaining wall where there is evidence of outward and downward movement of the retaining wall. The ground immediately behind the retaining wall is approximately 250mm lower than the surrounding ground as a result of the wall and ground failure and movement. The area and extent is shown on Plate 1 below:

Plate 1 – Area of Investigation
