MAENAN ABBEY, LLANRWST

Briff Gwylio Archeolegol/
Archaeological Watching Brief

Prosiect Rhif / Project No. G2616

Adroddiad Rhif / Report No. 1506

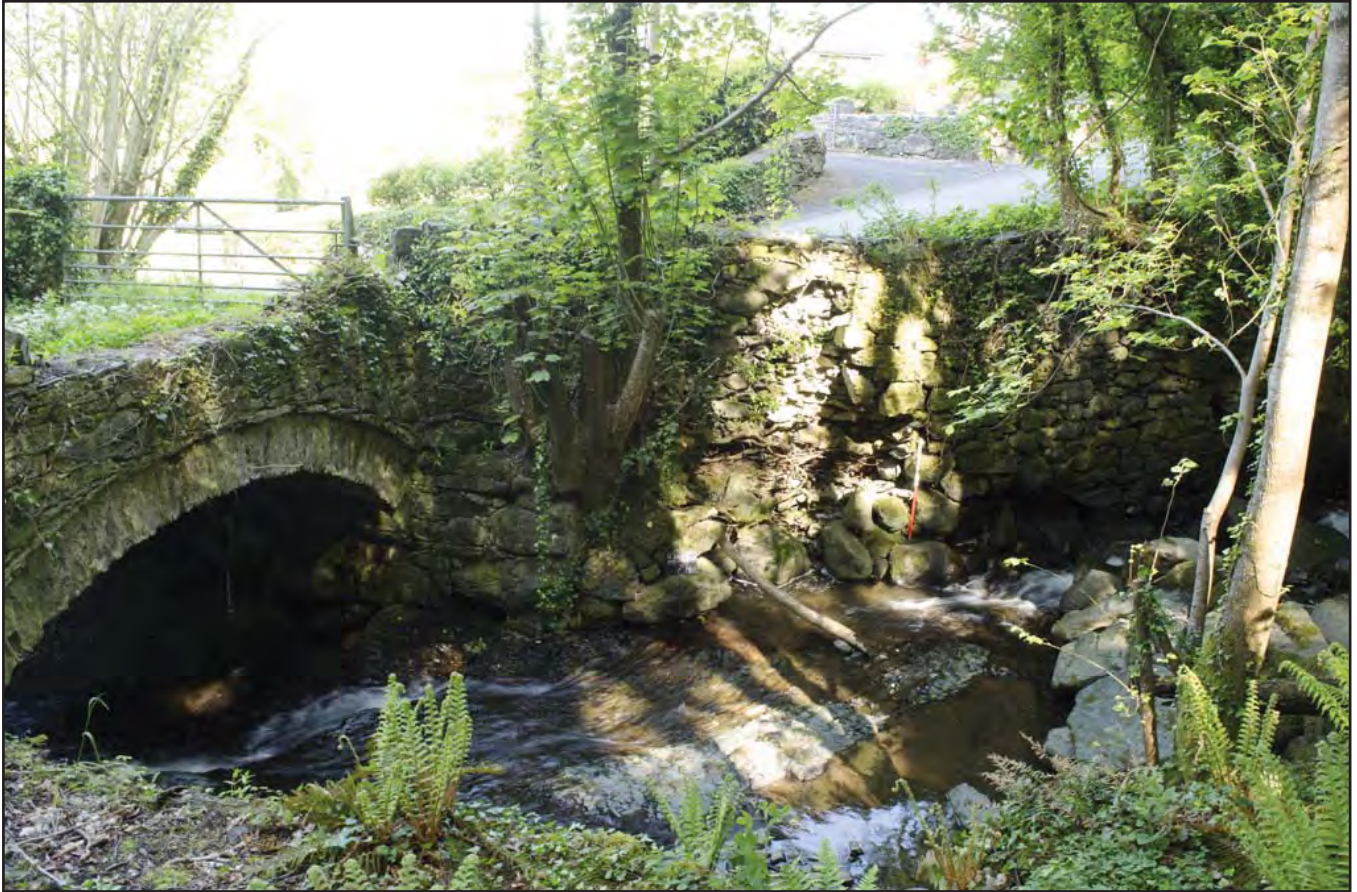
Plate 1: Location at the breach in the retaining wall, set amongst bridge, gate and road; scale: 1 x 1m; view from: SE (archive reference: G2616_006).

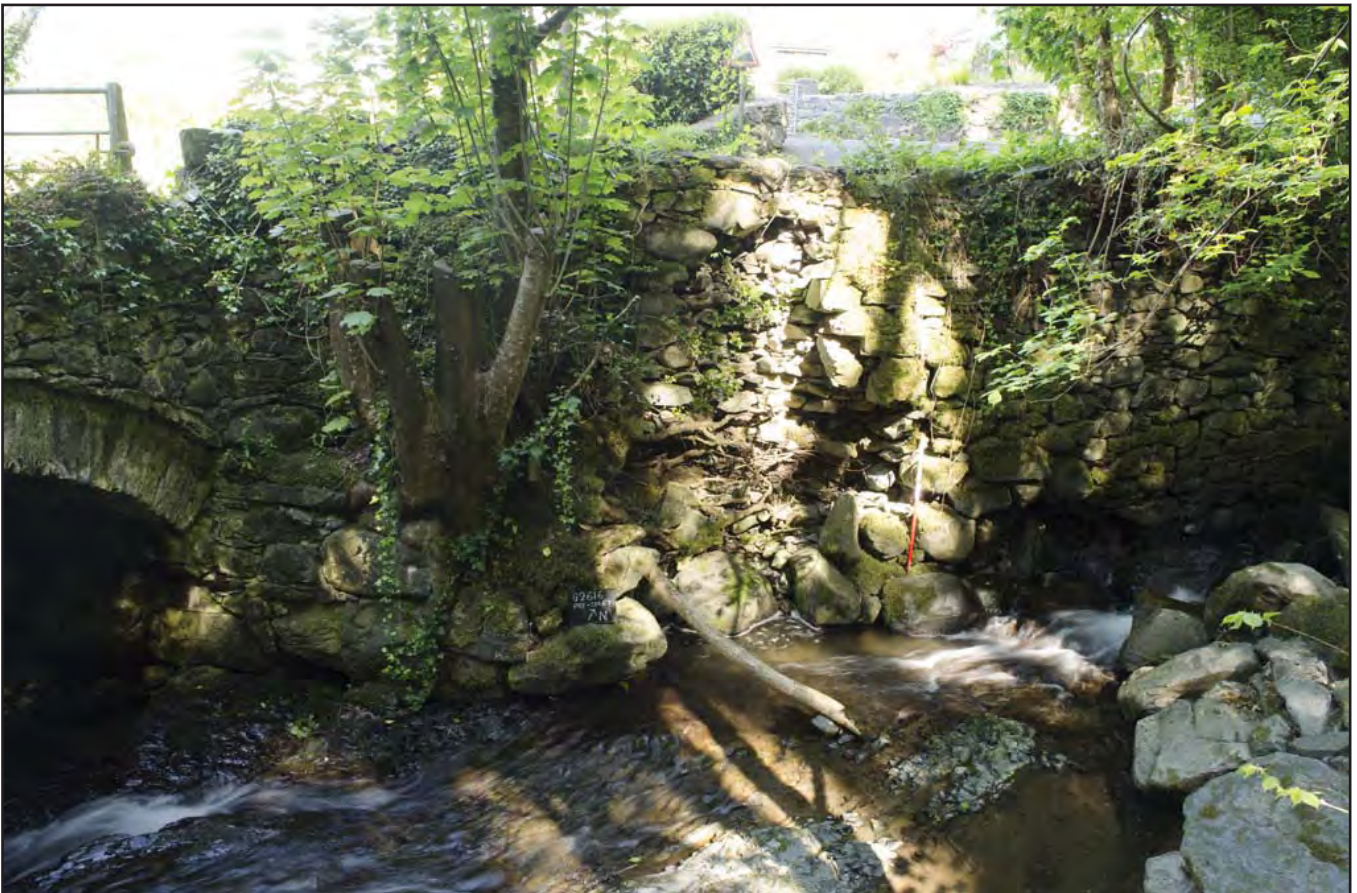
Plate 2: Location at the breach in the retaining wall; scale: 1 x 1m; view from: SE (archive reference: G2616_007).

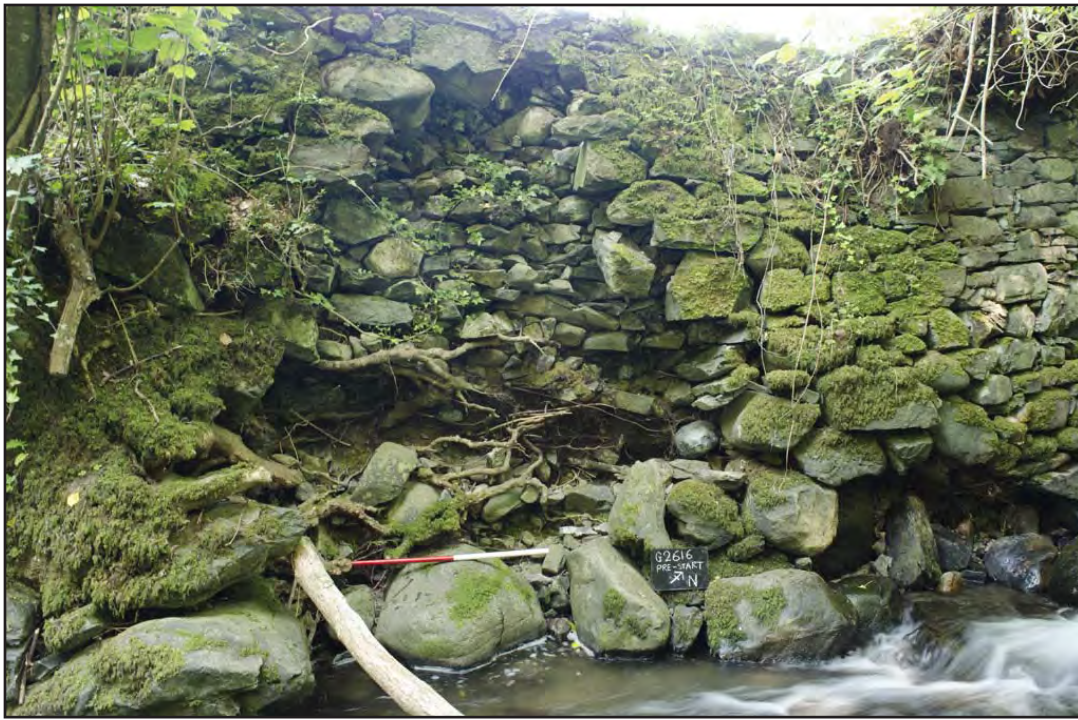
Plate 3: Breached section at wall; scale: 1 x 1m; view from: SE
(archive reference: G2616_014).

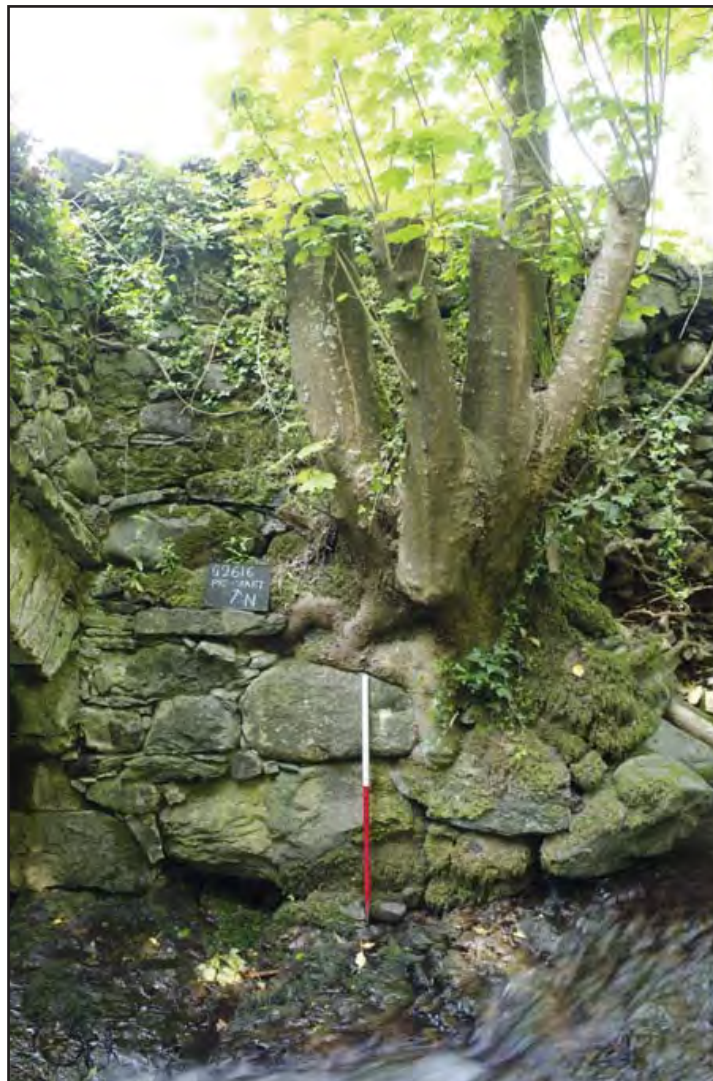
To the north-east of the bridge a short 2.1m long and 1.3m high length of the revetment walling may have originally formed part of the bridge abutment on the western side of the river (Plates 004, 022), otherwise the revetment walling, which has been renewed, was all of later 19th or 20th century in date, and had undergone a number of phases of repair. It is believed that the revetment walling generally dates from a phase of water management systems, probably of late 19th or 20th century in date, possibly associated with the presence of a local mill or the hydro scheme proposed by Lord Newborough in the early-mid 20th century, which made use of the existing weir shown on the late 19th century 1st edition Ordnance Survey map.

Plate 4: Section at retaining wall adjacent to bridge
with tree growing out of the wall; scale: 1 x 1m;
view from: SSE (archive reference: G2616_011).

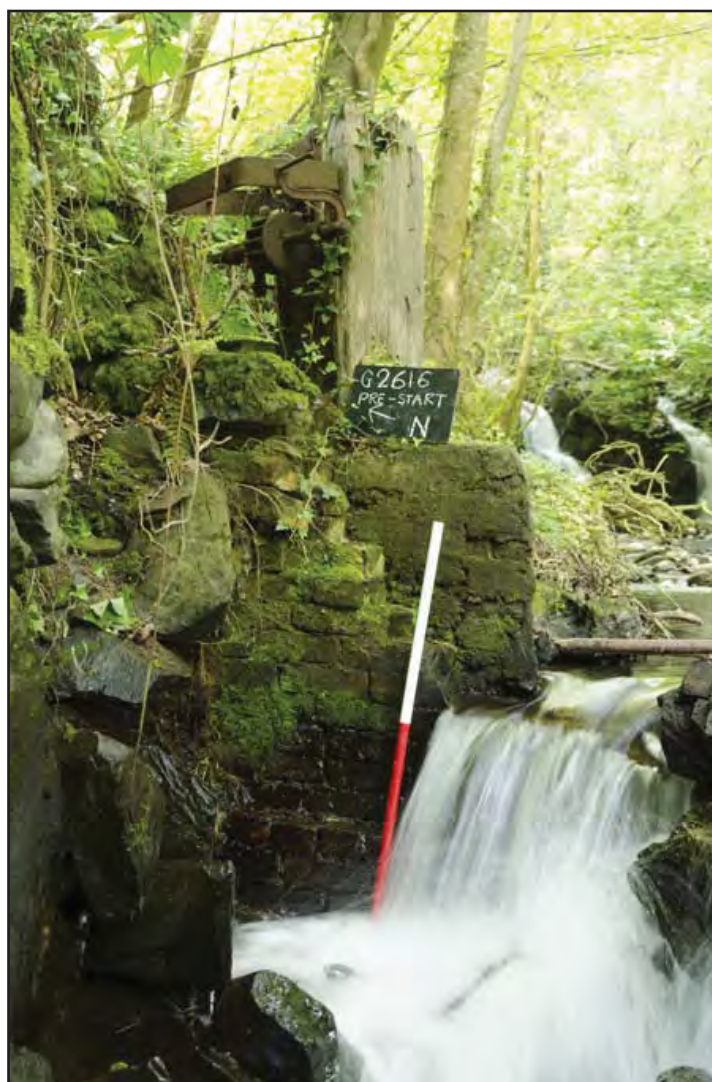
Plate 10: Close-up of remains of brick wall of weir sluice and sluice mechanism; scale: 1 x 1m; view from: W (archive reference: G2616_022).

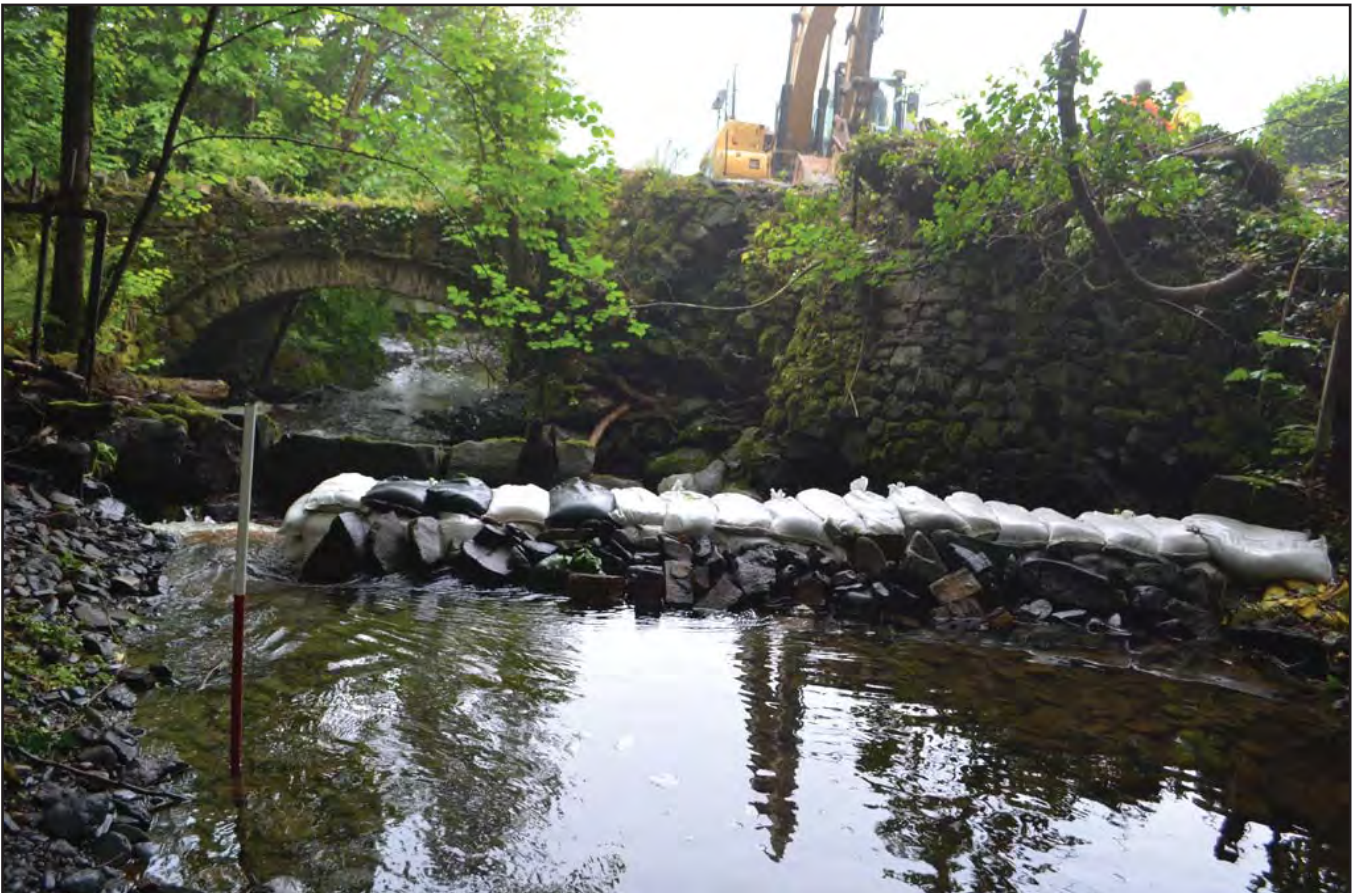
Plate 14: View from NE of weir showing sandbagging and the bridge to the rear; scale 1 x 1m; view from NE (archive reference: G2616_039).

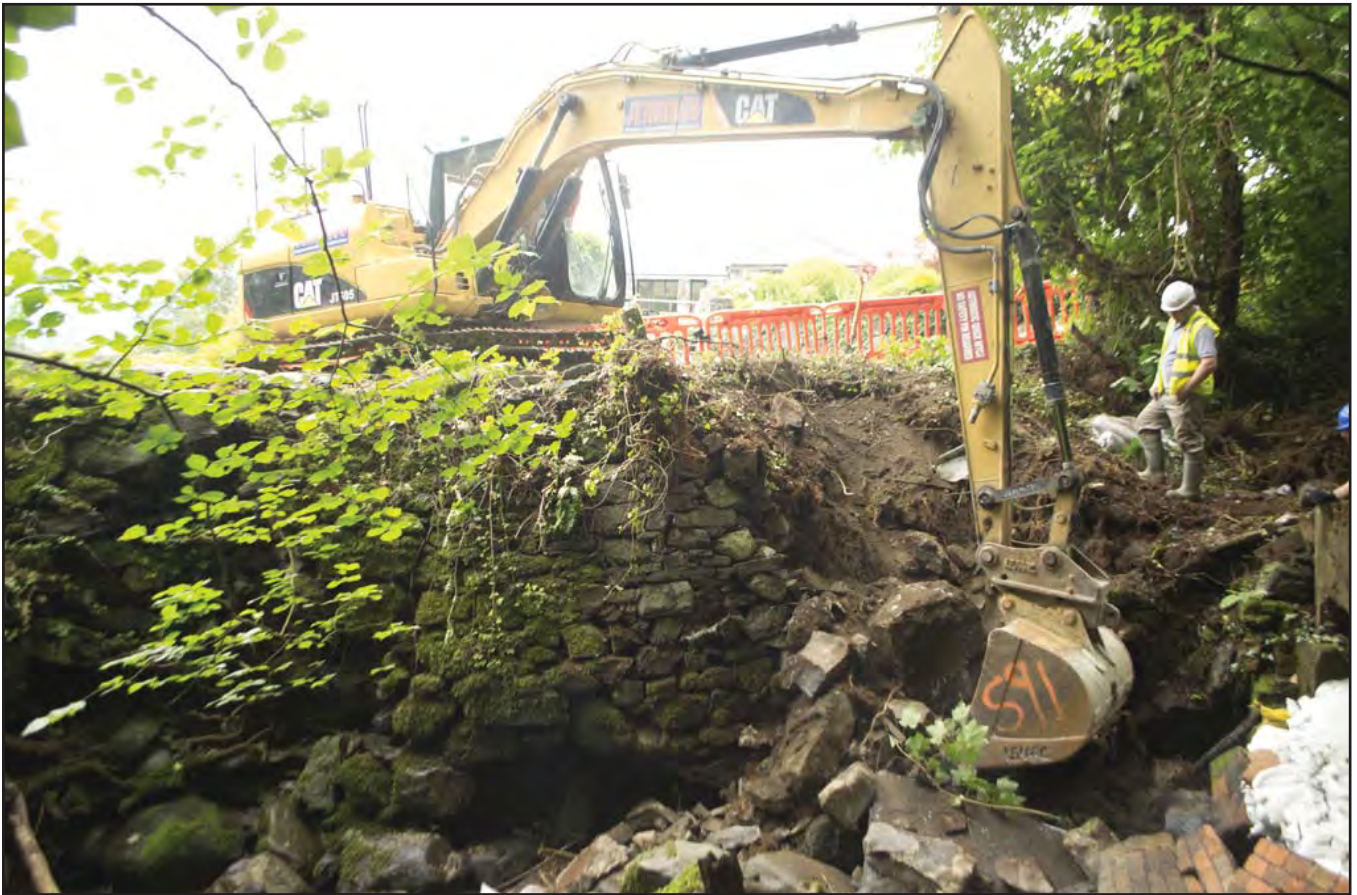
The stones of the revetment walling were noted to be 5% rounded and 95% angular stones, and up to 1m x 0.6m is size, with larger stones forming the base (Plates 015-016). They were of the local field stone, being a schist/gneiss, and of the same material as that noted in the quarry to the north, from where some of the stones may have come. The rounded stones appear to have been river-worn. No bonding was used in the wall construction, however occasional lime mortar attached to some of the stones suggests that they may have been re-used in the walling. The wall was roughly coursed, and a minority of the stones may have been roughly worked. The backfill behind the revetment wall (101) was a substantial light orangey brown silty clay loam with much bioturbation and root matter. It contained small to medium rounded and subangular stones, consisting of about 2% of the matrix, with occasional charcoal inclusions as well. Packed stones were noted behind the revetment 3.5m north-east of the bridge.

Plate 15: General view of revetment wall removal by machine; scale ; view from E
(archive reference: G2616_055).

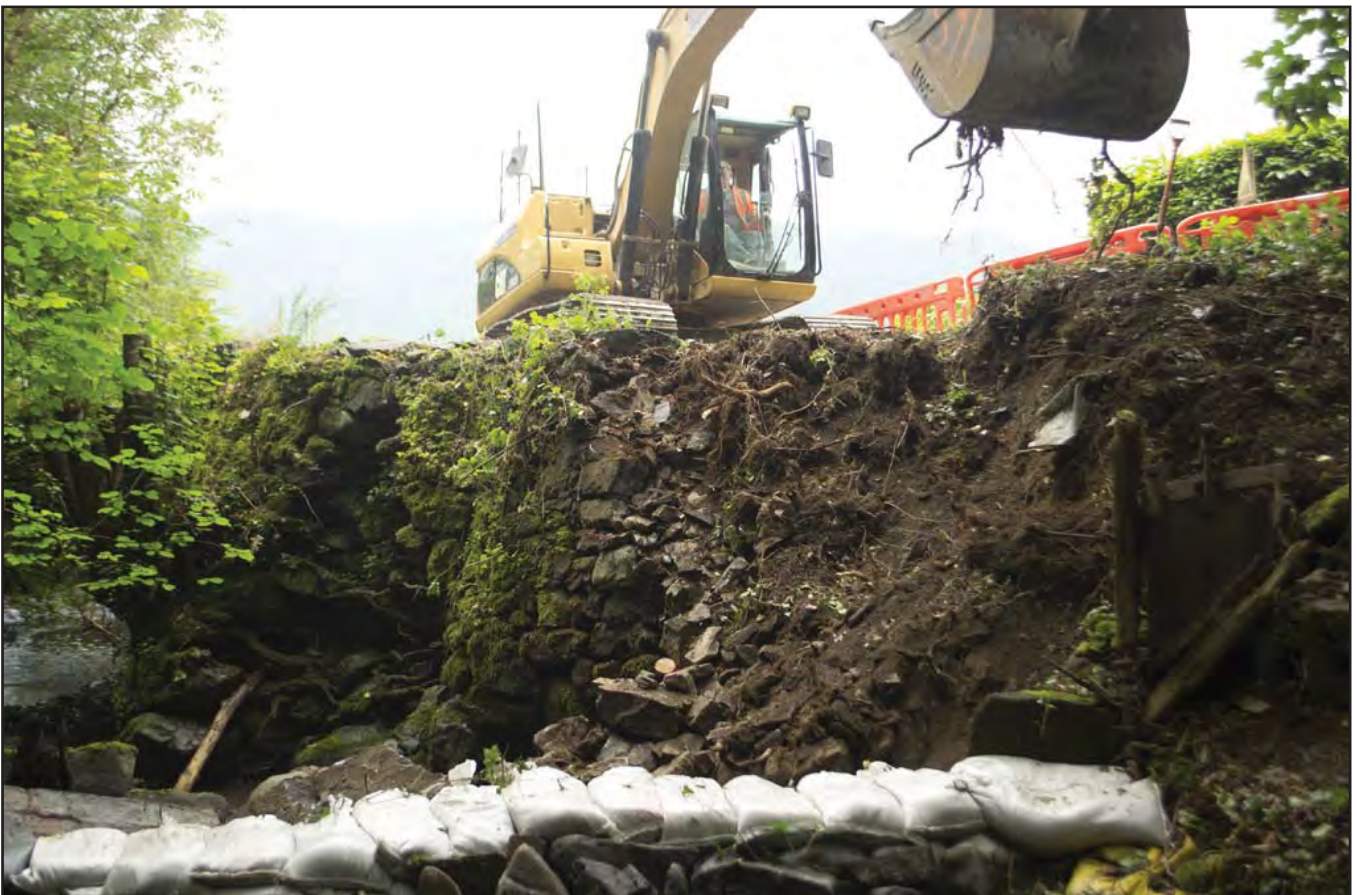
Plate 16: General view, as 54, but wider angled shot (from the river); scale ; view from NE
(archive reference: G2616_056).

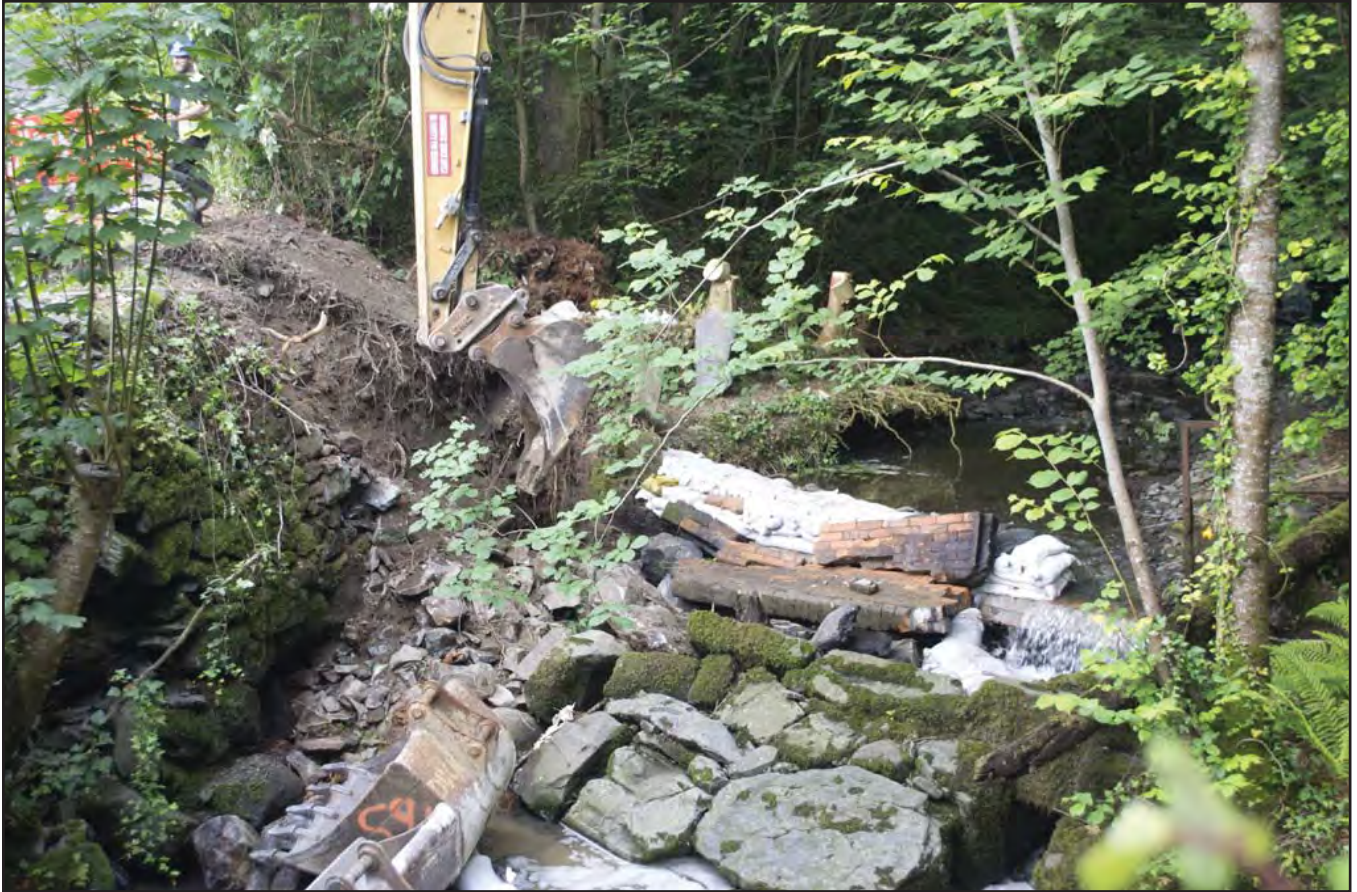
Evidence of the brick weir and sluice structure at the northern end of the revetment walling was noted (Plates 017, 021). This was noted to have been cut into deposit (101) on the western bank of the river. Through this was a brown ceramic drainage pipe was noted, which had also cut through deposit (101). It was surrounded by a wooden frame as it passed through the weir (Plate 018). This suggests that the revetment walls may be of a relatively recent date, or at least heavily patched. The walling and sluice gates are believed to be contemporary, and most of this material remains *in-situ*. It is believed that the brick walling and weir was put in during the early-mid 20th century as part of a hydro-electric scheme by Lord Newborough for the Maenan Abbey estate.

Plate 17: As above, but with a clay drainage/sewerage pipe cutting through the base of the weir wall; scale ; view from S (archive reference: G2616_062).

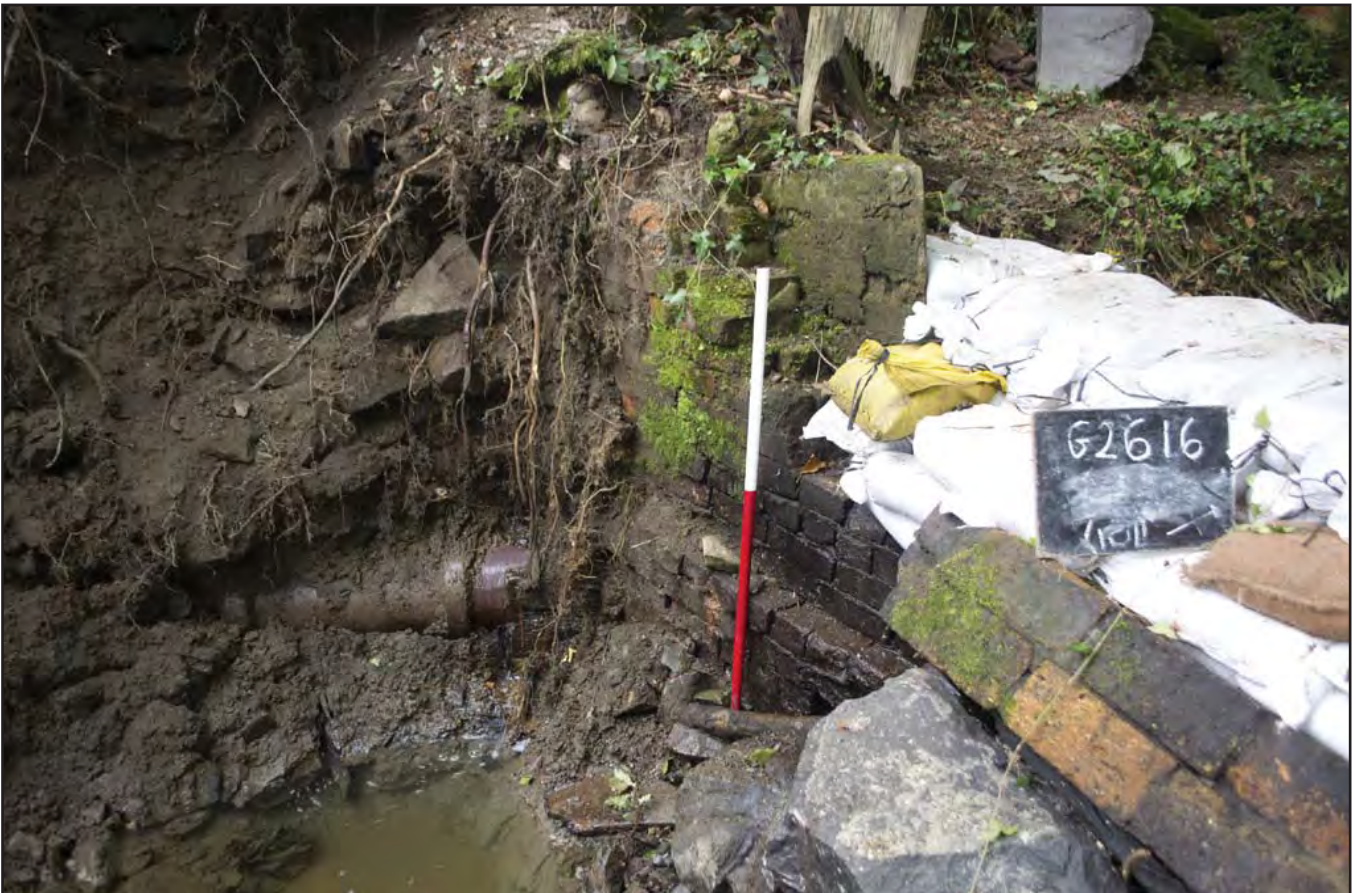
Plate 18: Detail showing the clay pipe and base of weir ; scale 1 x 1m; view from S (archive reference: G2616_066).

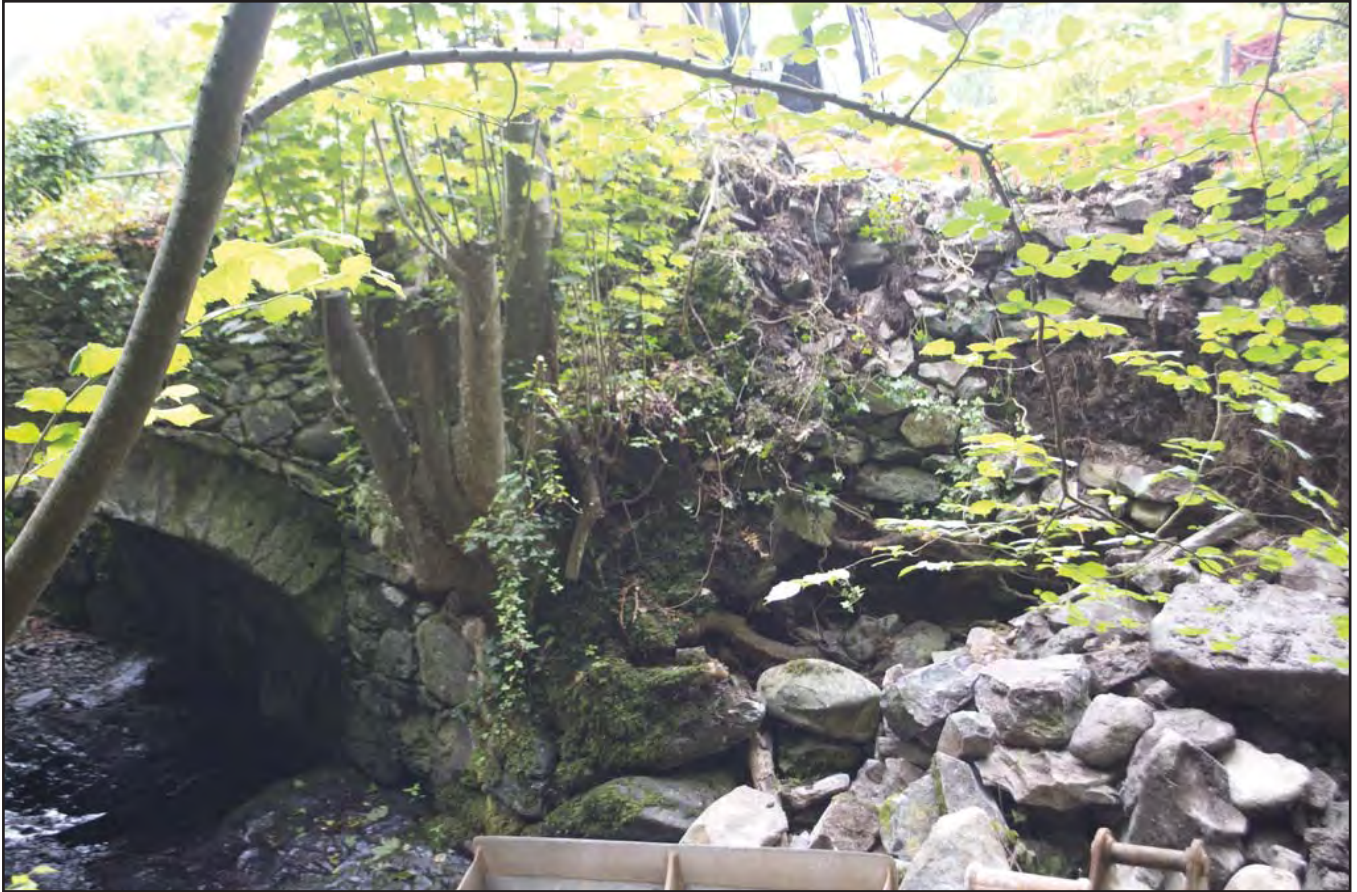
Plate 19: Detail showing collapsed walling in the return of the revetment wall near the bridge; scale: not used ; view from E (archive reference: G2616_072).

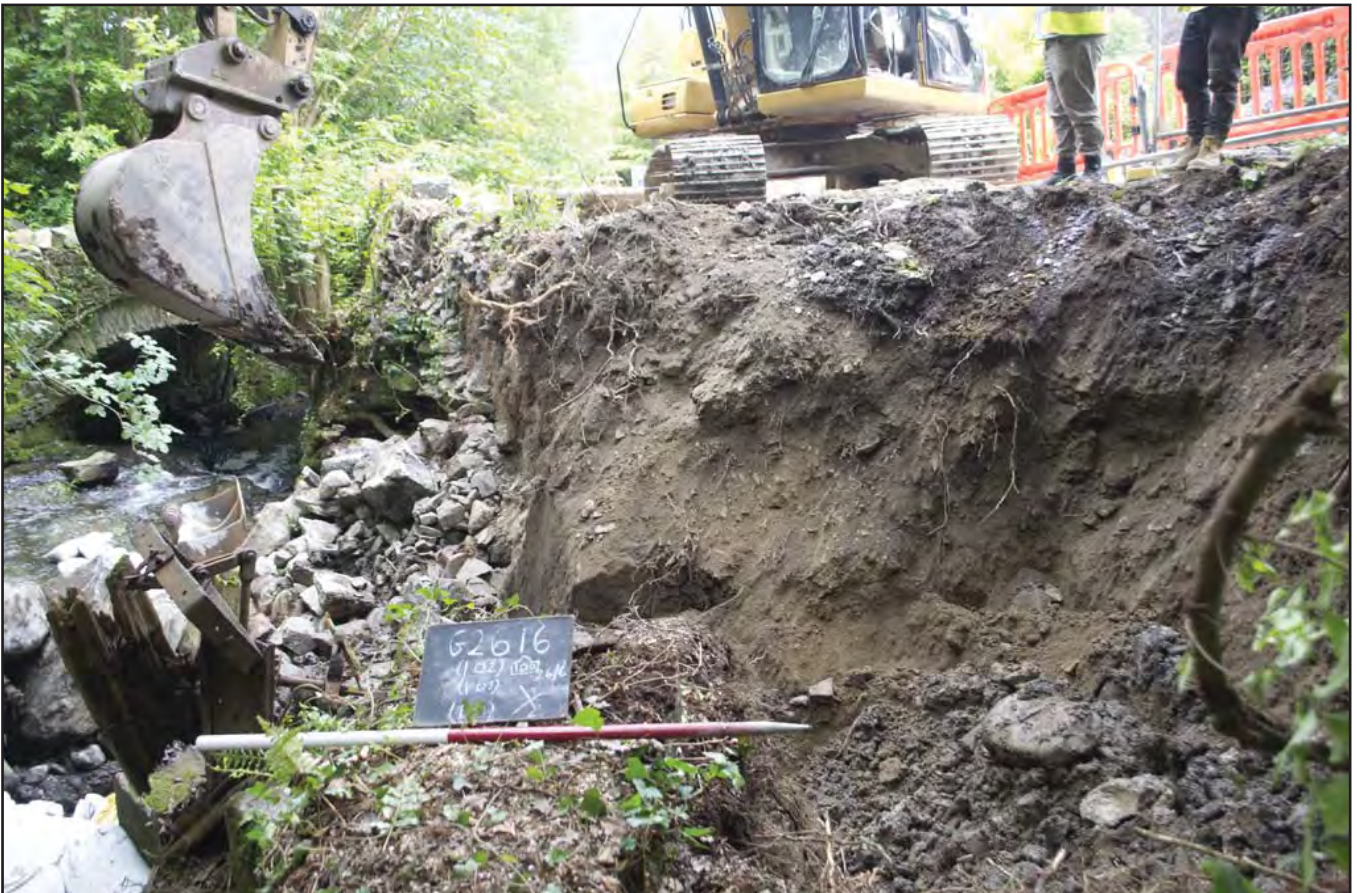
Plate 20: Rough section, machine cut, through revetment 100 and backfill 101, from the NW riverbank; scale 1 x 1m; view from NE (archive reference: G2616_078).

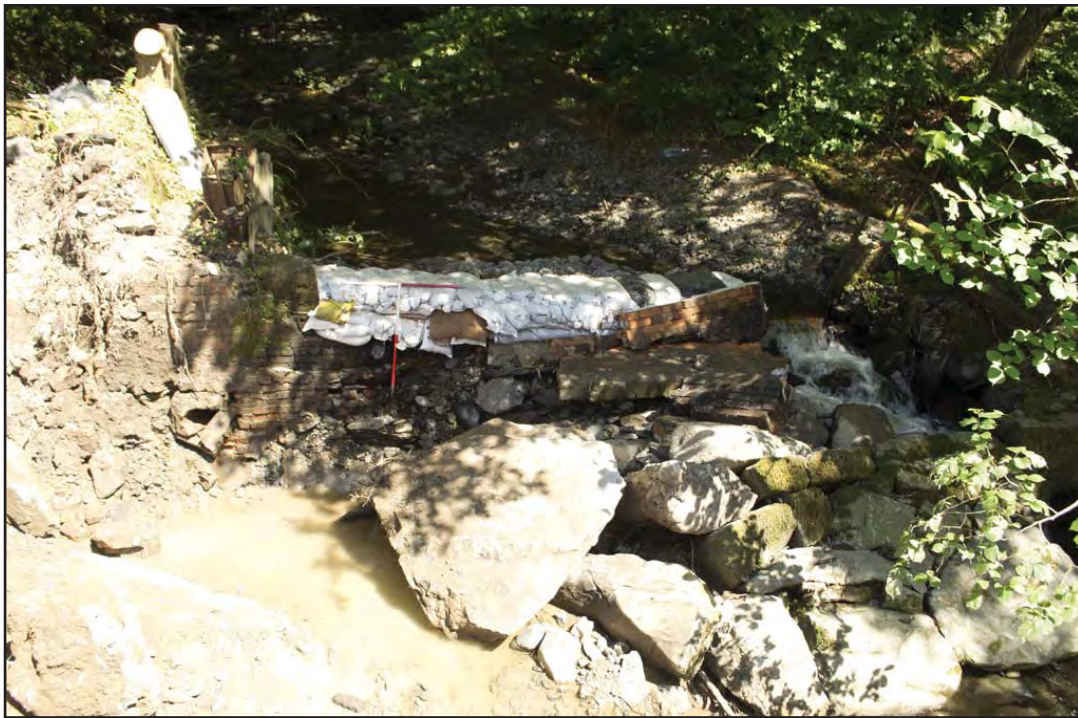
Plate 21: Remnants of brick wall (weir) and sluice at the N bank; scale 2 x 1m; view from WSW (archive reference: G2616_087).

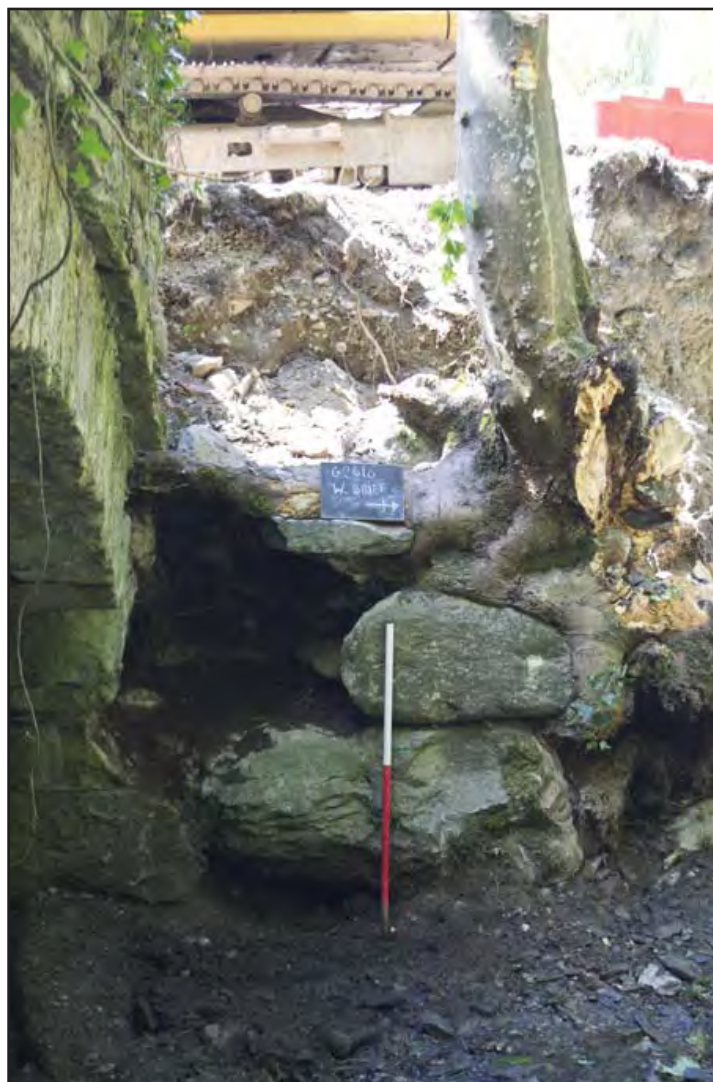
Plate 22: View of revetment walling [104] adjacent to the bridge part removed to enable the tree root removal; scale 1 x 1m; view from SSE (archive reference: G2616_110).

The courses of revetment wall stone work immediately adjacent to the bridge were removed by hand, while the matted, heavily rooted soil and stones around a large ash tree stump were removed by the excavator, pushed into the river and lifted out and set into the rubble stockpile, with the remaining stones removed by hand (Plate 022). It was noted that a small widening gap had been created in the bridge arch due to the roots of the tree. No obvious interface between the revetment walling and the bridge was noted, with the stones of the revetment walling rough bonded into the bridge, suggesting that some bridge material may have been removed when the revetment walling was built (Plate 24). It is possible that the lowest 2.1m wide and 1.3m high stretch of walling on the revetment side adjacent to the bridge originally formed part of the bridge abutment, due to the large and more regular proportions of the stones at this point.

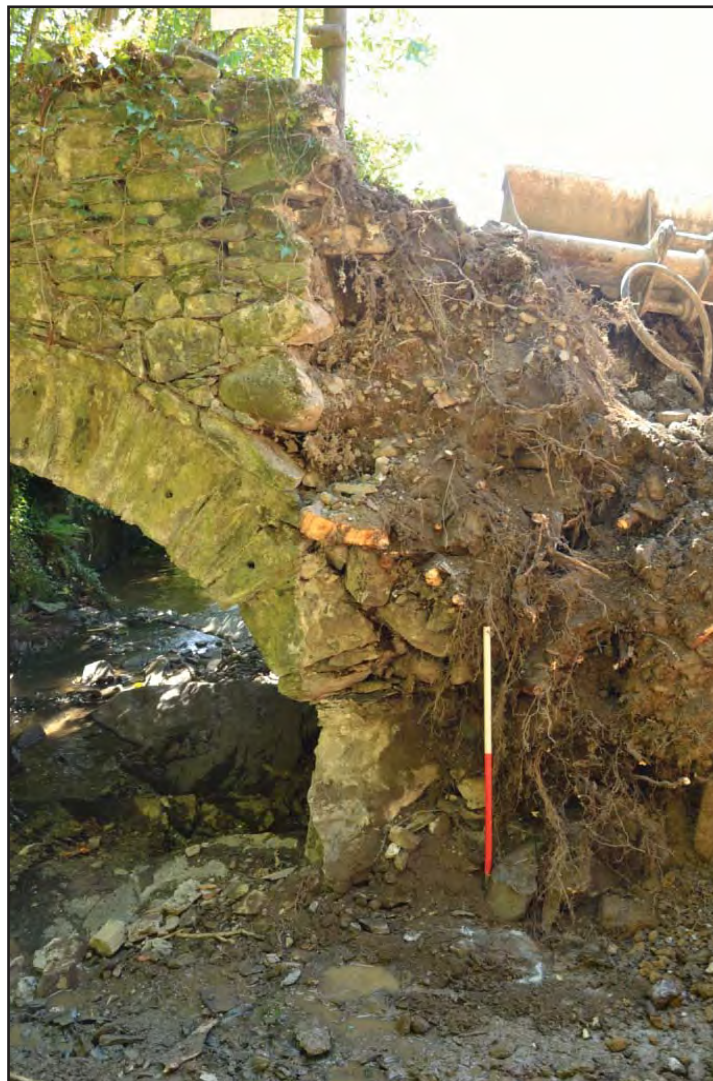
Plate 24: Exposed bridge arch after removal of tree and wall; scale 1x 1m; view from E (archive reference: G2616_119).

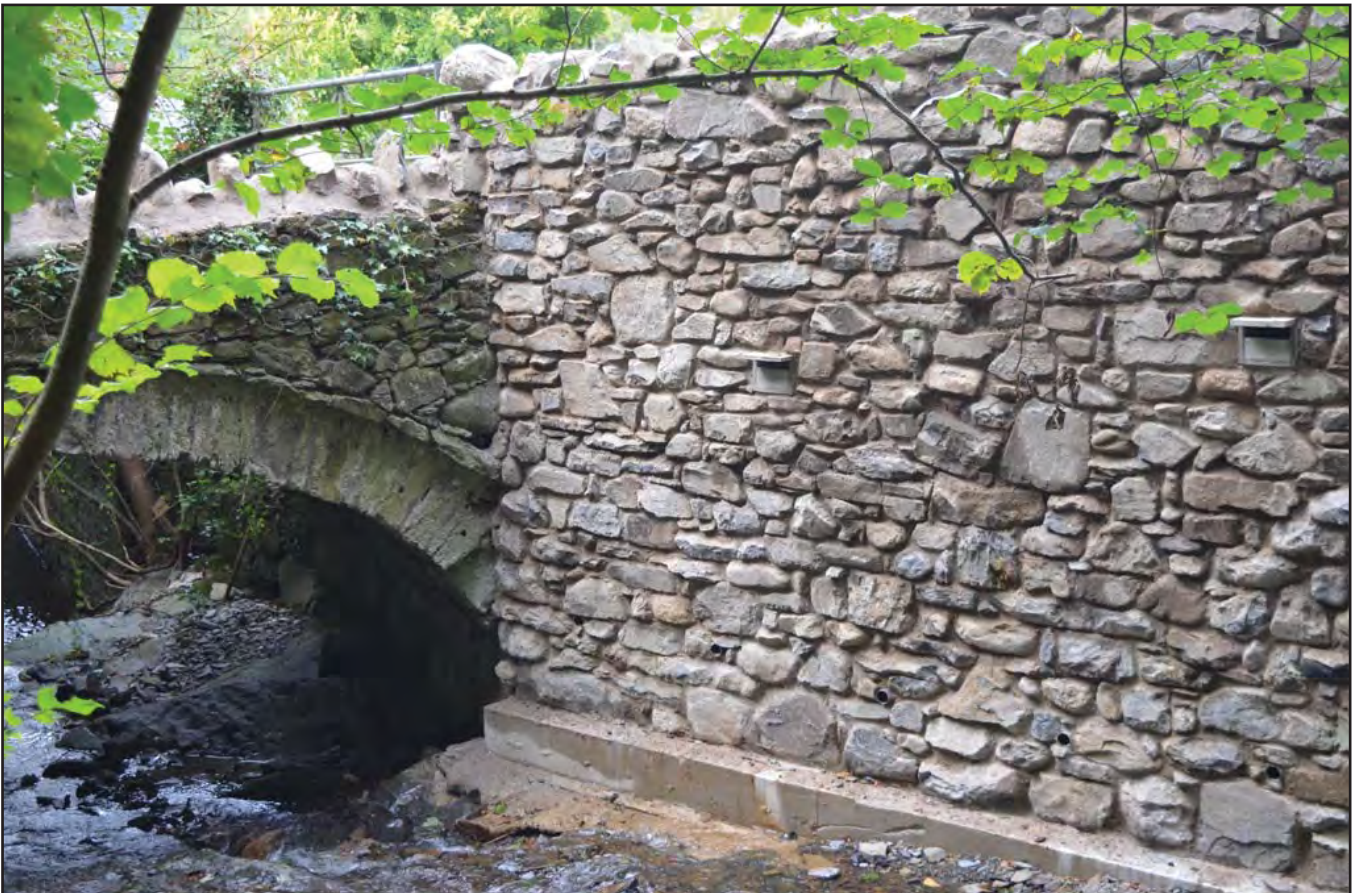
Plate 30: General view showing the butt joint of the revetment walling with the 18th century bridge; scale not used; view from SE (archive reference: G2616_148).
