THE OLD PARISH CHURCH, LLANIDAN,  
YNYS MON

ARCHAEOLOGICAL EVALUATION (G1261)

REPORT NO. 160

April 1995

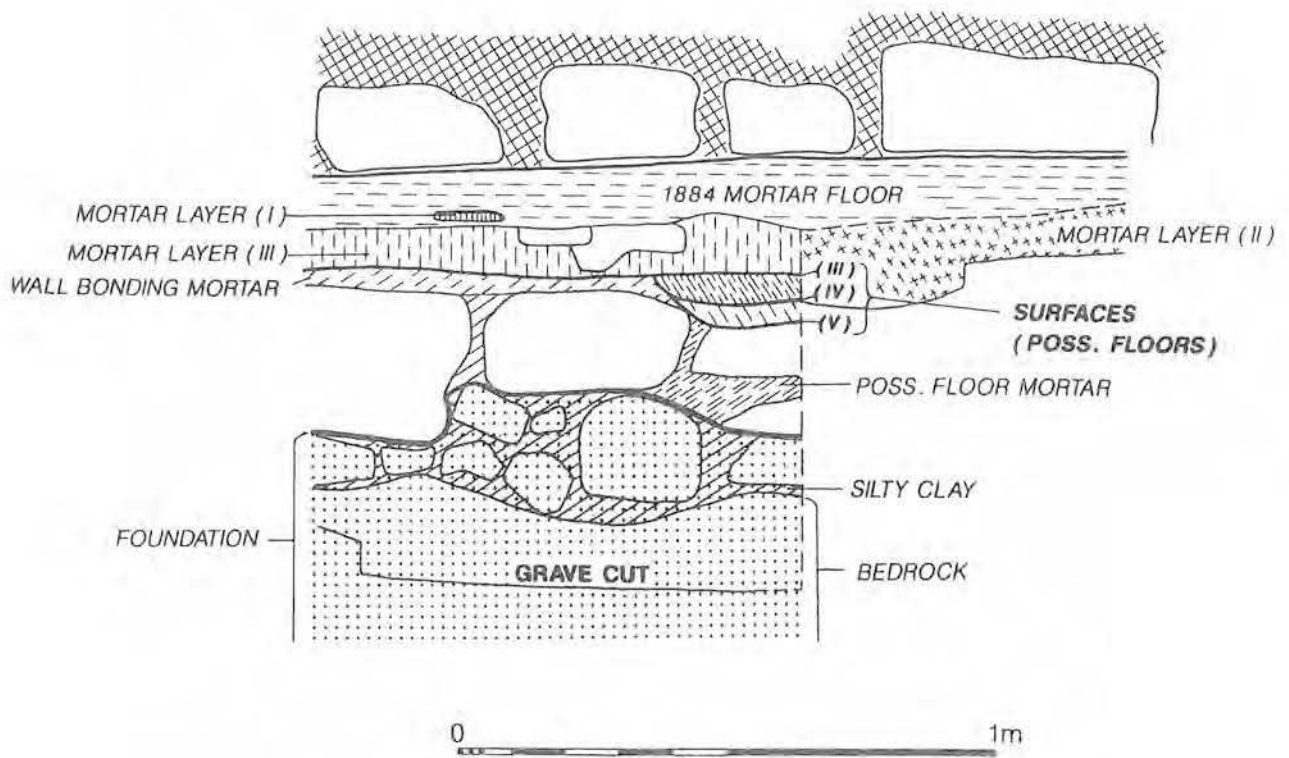
Fig. 3 Section of Trench 1.

A trench 1.55 m long and 1 m wide was excavated along the south wall of the nave, to the west of the south doorway.

Experience has shown that floor deposits within churches survive any later disturbance, by burials or floor lowering, against the walls and within the corners of a church and this proved the case at Llanidan. The nave had been floored in lime mortar, 100 mm deep, in 1844. On the removal of this flooring, a large stone slab was found extending beyond the trench at its western end. This restricted the area available for further assessment. The remaining area had been extensively disturbed by burial, destroying the majority of the original floor deposits. However, five successive mortar floor deposits were noted beneath the 1844 flooring. Floor I was noted 100 mm below the top of the 1844 flooring, Floor II, 150 mm below, Floor III, 220 mm below, Floor IV, 270 mm below, and Floor V, 320 mm below the top of the 1844 flooring. The levels are presented on the elevation drawing of this section of the wall (fig. 3) and on the interpretation section drawing (fig. 2) to facilitate comparison with the floor levels from the other evaluation trenches. A possible sixth floor deposit was noted where a patch of internal lime mortar was observed, 420 mm below the top of the 1844 flooring, at the level where the foundations met the stonework of the south wall of the nave. However, no definite floor level could be observed on the stretch of mortar exposed in this evaluation trench. In the north-east corner of the trench areas of floors II, II and IV were found which had not been disturbed by later burials. These deposits could be accurately matched to the floor deposits against the south wall, although they were at slightly lower levels, and are presented in the interpretive section drawing (fig. 2).

The east end of a burial had been excavated against inside of the south wall of the nave, to a depth of 0.78 m below the top of the 1844 flooring, and cut through floor deposits III, IV and V, and into the bedrock below the foundations. No grave cuts could be observed in the mixed deposit in the interior of the church.

The foundations were 0.1-0.25 m deep and lay above the bedrock of limestone which occurred at a depth of 0.62 m below the top of the 1844 flooring. The church had been situated on the edge of a rock dominant outcropping of limestone which resulted in the shallowness of the foundation courses.

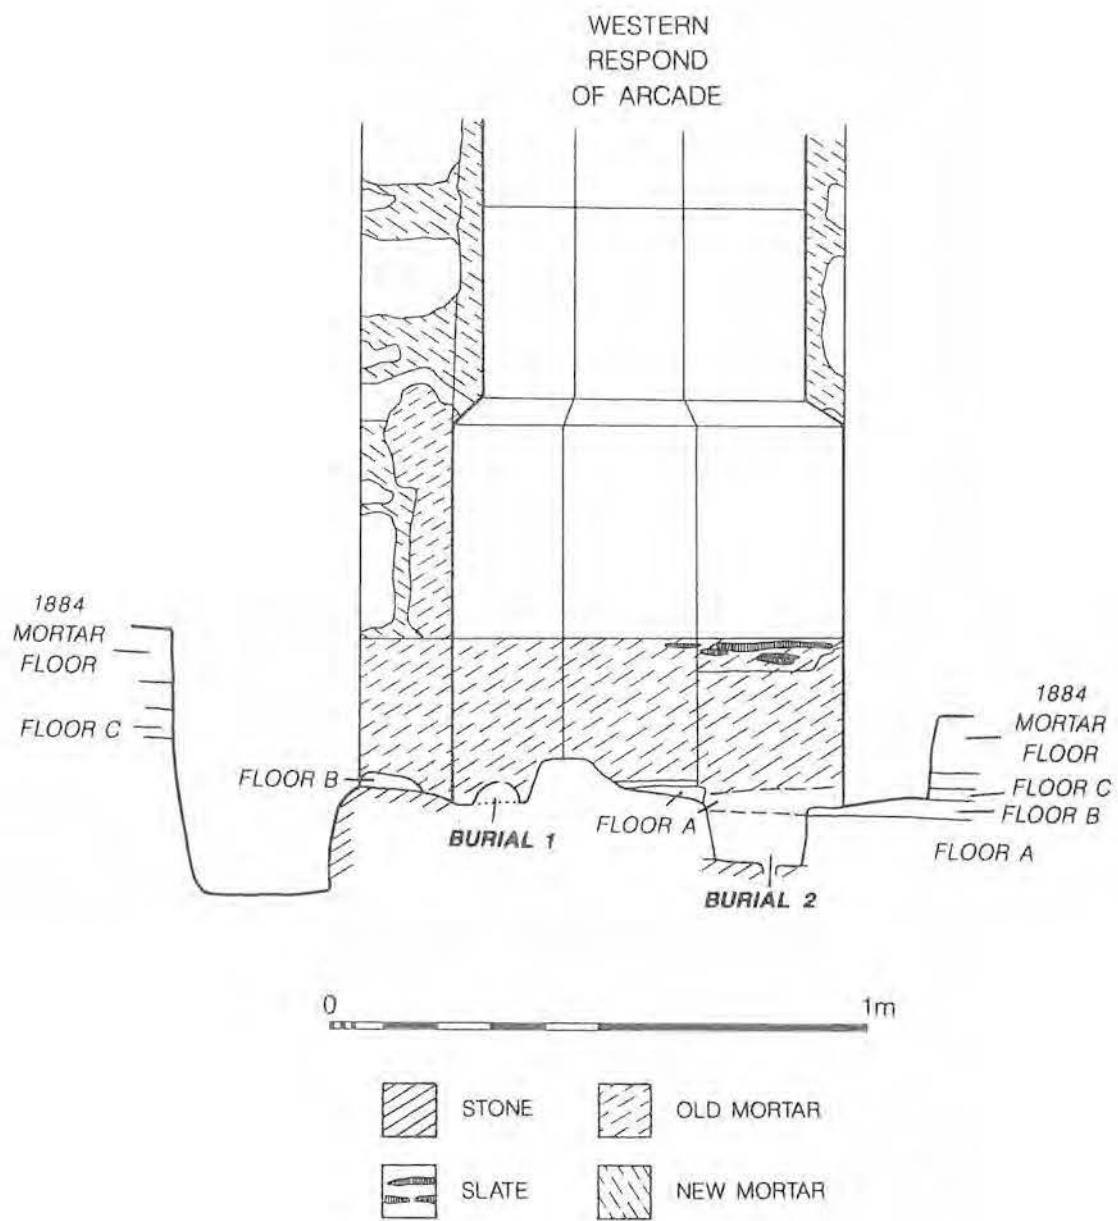
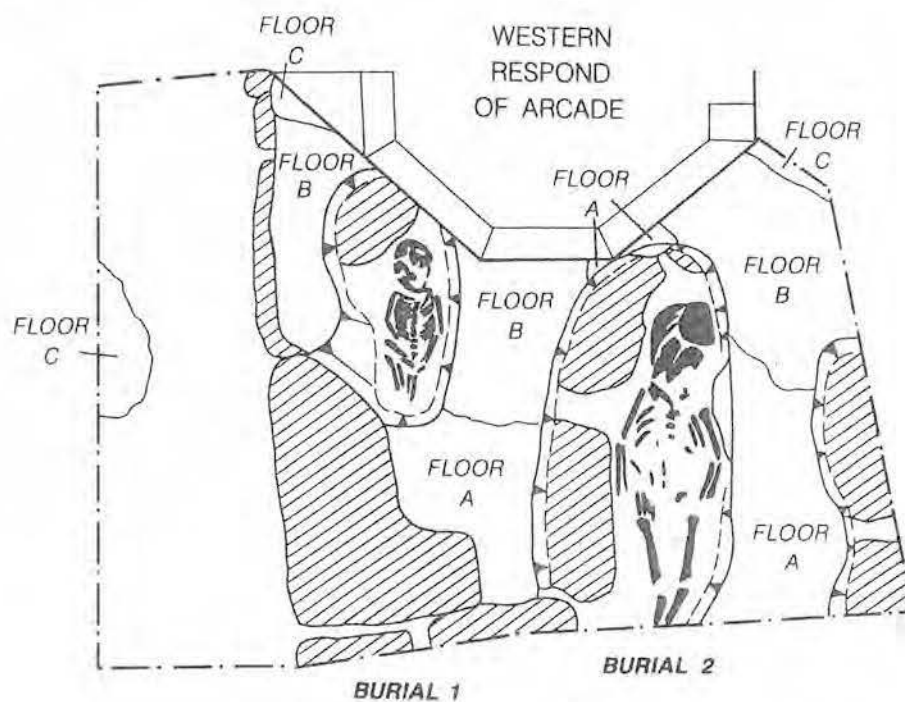
Fig. 4 Plan & section of Trench 2.

A trench, 1.5 m long and 1 m wide, was excavated from east to west across the western opening of the north arcade, and up against the western respond.

The stone foundations of the demolished north wall of the nave survived 0.3 m below the top of the 1844 floor surface in the nave, and 0.25 m below the 1844 floor surface in the north aisle. The western respond of the arcade lay directly on these foundations (fig. 3).

The floor deposits, in this trench, survived abutting the pier of the respond and the area directly above the north wall foundations where they had not been disturbed by subsequent re-flooring or burial. Three flooring surfaces were identified. Floor A consisted of a fine degraded lime mortar overlay the foundations of the north wall of the arcade and abutted the bottom of the arcade respond. It varied considerably in thickness around the stones of the foundation and lay 0.26 m below the top of the 1844 floor surface in the nave, and 0.18 m below the 1844 floor surface in the north aisle. This was the primary floor, contemporary with the construction of the north aisle in the late 15th century. Floor B was made up of a succession of lenses of clay and burnt material. These deposits may have represented more than one floor layer. However, they have been grouped together as they may represent occupation deposits, above the mortar floor A and abutting the arcade respond. It was possibly a clay floor, which may have been strewn with rushes or straw, which had been burnt on at least two occasions in an attempt to clean out the interior of the church. This deposit of lenses of material lay 0.25 m below the top of the 1844 floor surface in the nave, and 0.18 m below the 1844 floor surface in the north aisle. A later mortar floor (C) lay above the burnt flooring deposit (B) and abutted the arcade respond. Floor C lay 0.20 m below the top of the 1844 floor surface in the nave and 0.12 m below the 1844 floor surface in the north aisle. A patch of mortar flooring, of similar material to Floor C, was noted at the southern edge of the trench (fig. 4). A mixed deposit of clay and earth lay between Floor C and the 1844 mortar floor.

Two infant burials, one of which appeared to be post-natal, had been inserted through the floor deposits and into the foundations of the north wall of the nave. These burials lay between 0.25 m, and 0.38 m below the top of the 1844 floor surfaces.
