REPORT ON THE SEVENTH SEASON OF THE  
TRE'R CEIRI CONSERVATION PROJECT  
MAY TO SEPTEMBER 1995

REPORT NO. 185

prepared for Cyngor Dosbarth Dwyfor

December 14th 1995

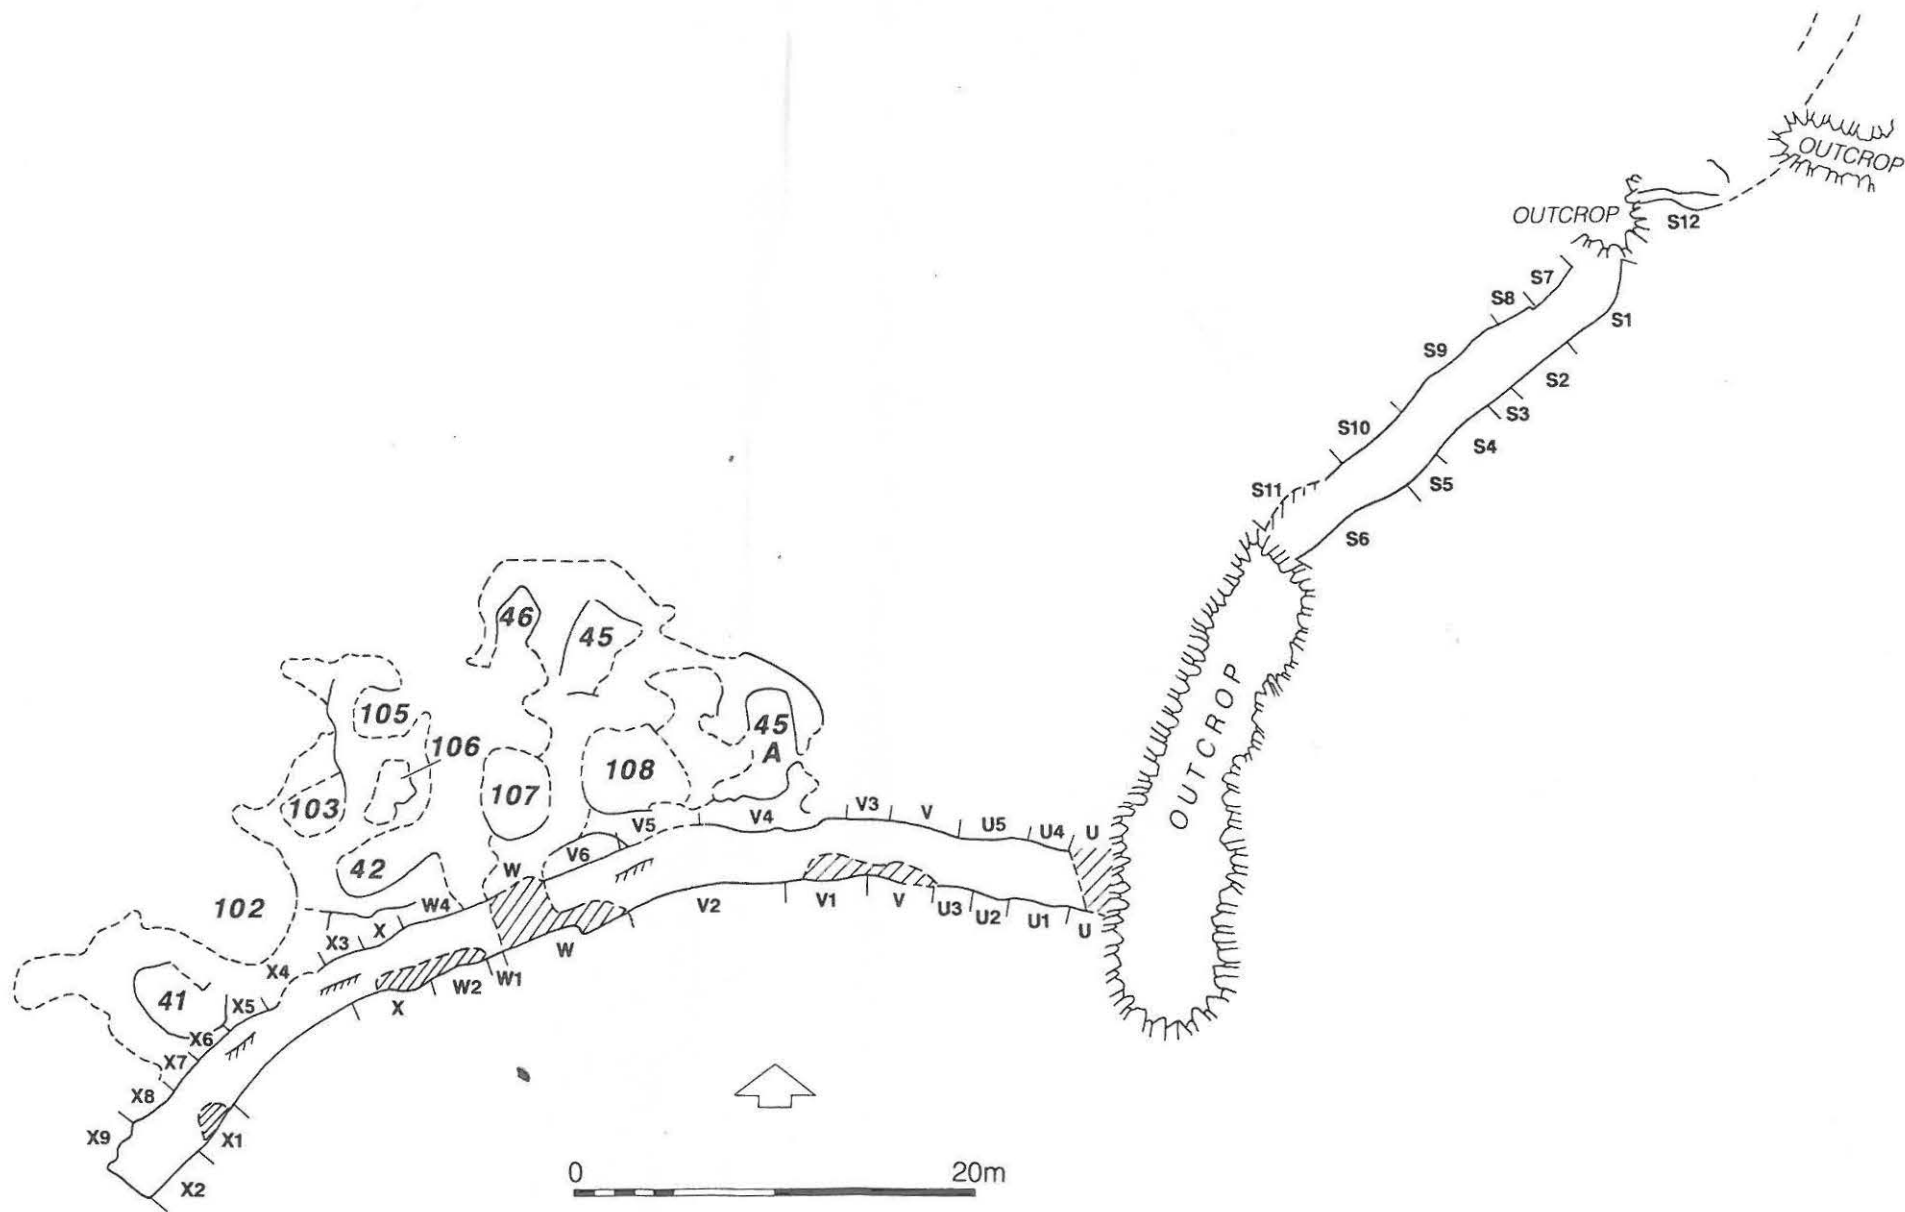
Fig. 3 Wall S to Y before conservation.

The western end of this collapse stands on bedrock but the eastern end has been carried over 2m down the slope by a movement in the scree. A 2m length of the facing however remains intact even though it is displaced and leaning back at an acute angle. The masonry has fallen to a point of stability and serves as a good illustration of the ability of the masonry to survive as a face even after severe disturbance. The collapse was planned and photographed (Plate 1) and no further action was taken.

The north-east end of this stretch of wall abuts a rock outcrop which separates collapses S1 and S12. This outcrop is not marked on the Plowman Craven (1980) or the R.C.A.H.M.W. (1960) plans. The face ran initially from north to south for 2.7m and consisted of little more than a few headers lying on the bedrock amid a jumble of core that had fallen from above (Plate 2). Beyond this the face turned to the south-west and was more stable rising quickly to a height of 1.0m before falling to 0.6m and then gradually rising to 1.8m. This part of the collapse was 2.9m in length and consisted of very untidy masonry that was probably a result of movement in the lower part of the wall (Plates 3 and 4).

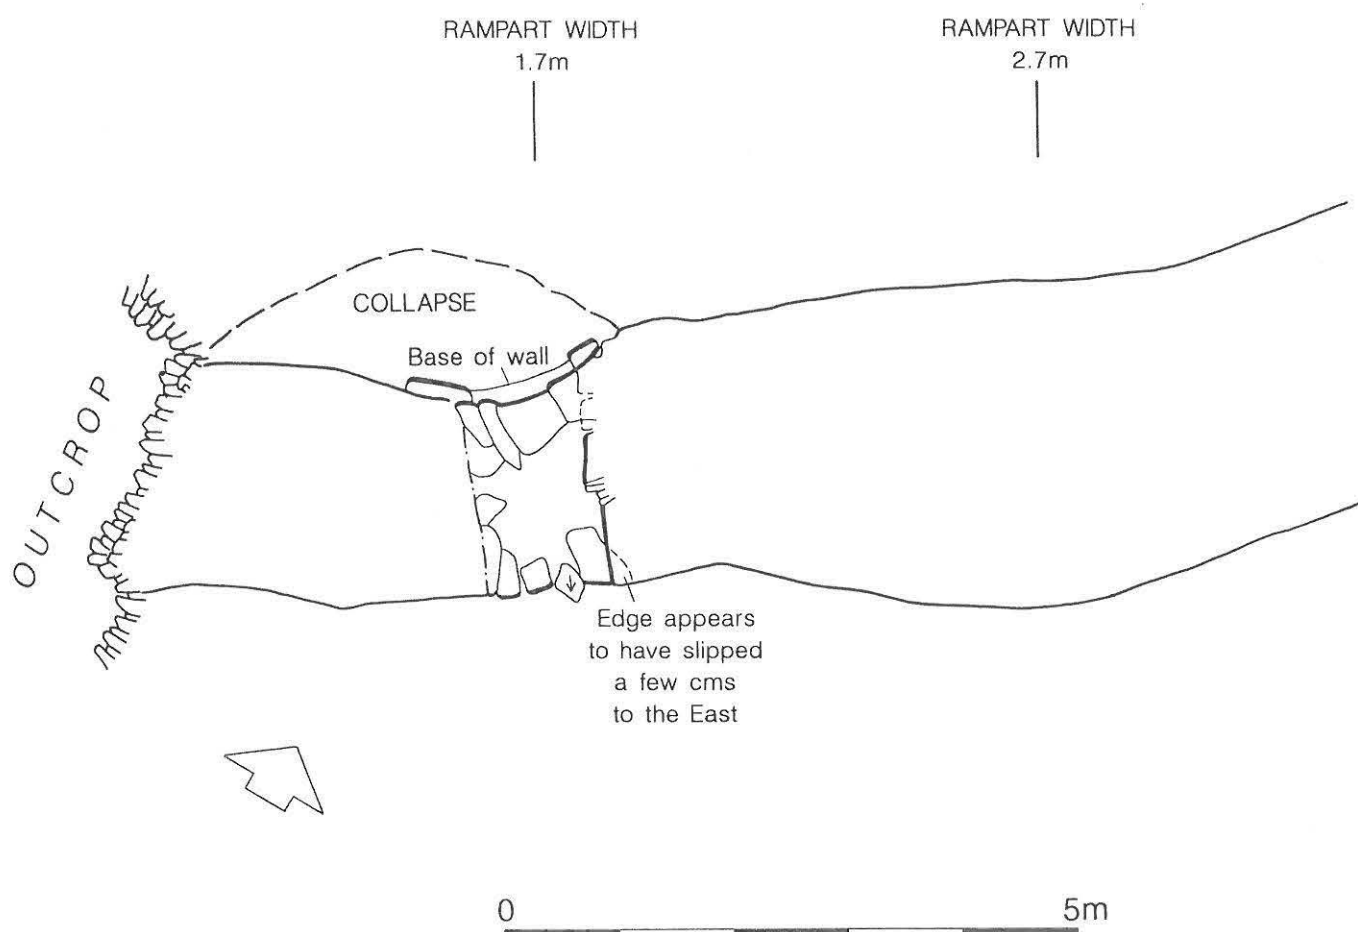
Fig. 4 Plan of collapses S6 and S11 after clearance showing possible entrance.

After clearance it could be seen that the basal course survived across the whole of the collapse with the face rising to 0.5m in places (Plate 35). It did not however follow the expected line but turned 3.5m from the outcrop, to form a shallow inturn (see Fig. 4). The rampart narrows from 2.7m to 1.7m at this point. The facing in the inturn was low and ragged and contained mainly small stones. This area resembled that around the blocked southern postern suggesting that there was another blocked entrance here. There was a corresponding dip in the outer face (Plate 36) but there were no straight joints in the masonry indicating the edge of an opening in the wall. Loose core was removed from the wall along the projected line of the entrance and a fairly convincing face constructed from mainly small stones laid as headers was identified in the expected position along the north-eastern side (Fig. 4). There was no surviving facing on the opposite side but the core in the passage was jumbled and small in contrast to the stones to the south-east. Close examination of the outer face showed that the facing was semi-collapsed and a straight joint may have existed on the north-east side of the entrance. Figure 5 illustrates the slippage that may have occurred as a result of a collapse further to the north-east. It should also be noted that the stones in the centre of the blocking face were smaller than the headers in the rampart to either side. This facing would therefore have eroded faster, perhaps accounting for the dips in the height of the wall at this point.

The balance of the evidence suggests that there is a blocked postern at this point but the lack of definite joints in the inner and outer facing and the absence of facing on the south-western side also allow other interpretations. The inturn and associated facing could represent a repair in the facing or a constructional detail such as one of the common and as yet unexplained changes in building style seen elsewhere in the ramparts.

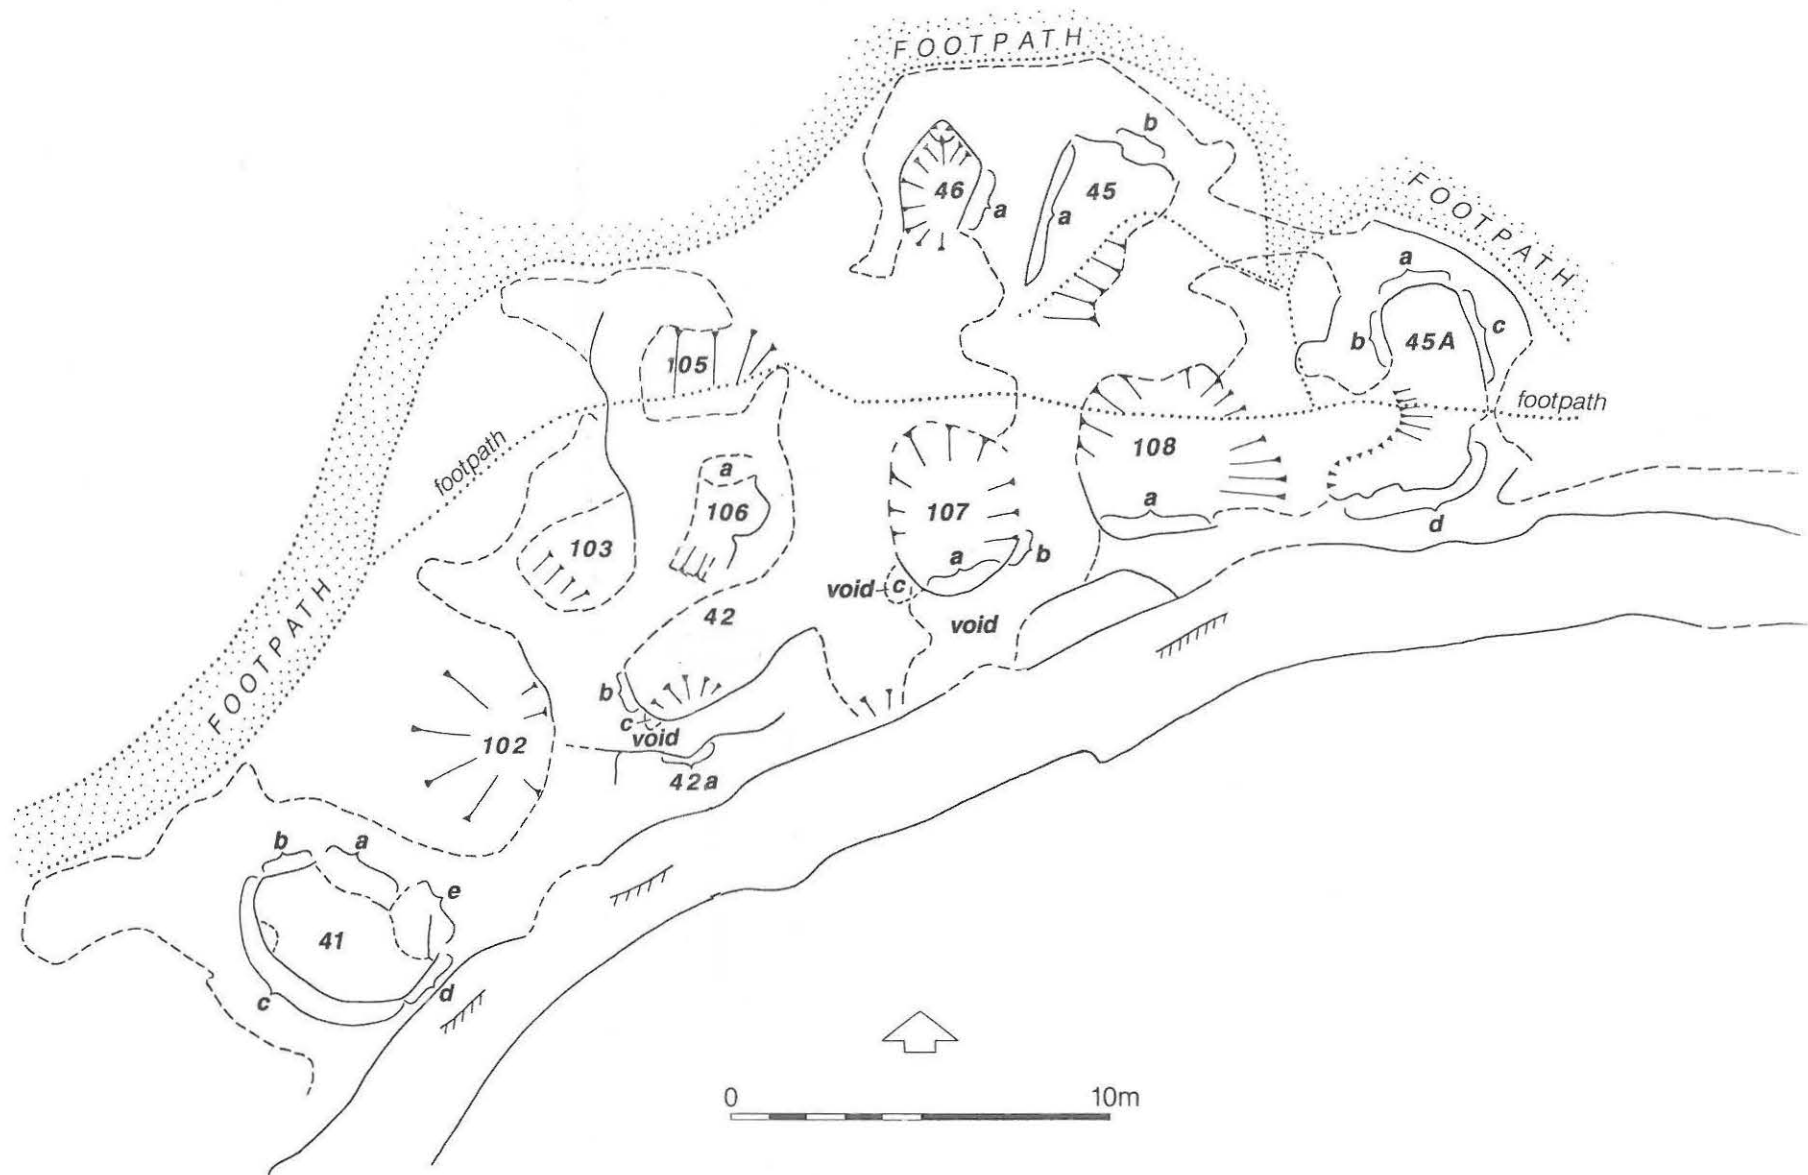
Fig. 6 Plan of huts centred around 107 before conservation.

The east wall of the hut was low with only occasional facing stones standing above the level of the interior (Plate 153). The core was standing above this. Several stones, shown on Plate 154, were added to the facing and the wall top was stabilised.

The wall tops in this area were fragile and prone to erosion. Several conservation techniques had been tested in the first season of the project (Boyle, 1990) but no firm conclusions had been reached. The most satisfactory method was found to involve locking upright stones together on the top of the wall core. This method necessitated the importation of large amounts of small stone from the scree and was found to be impractical in later seasons. Additional problems were revealed when the areas where this technique was first used were examined; the upright stones, when walked upon, had acted as levers, and had displaced some of the upper facing. This technique was clearly not suitable for the consolidation of fragile walls close to a footpath and was therefore not used during the seventh season.

Fig. 6 shows the hut as surveyed at the beginning of this season. Much of its perimeter, particularly on the east, was only visible as an overgrown slope. The hut was approximately square in plan with very rounded corners and internal dimensions of about 4.0m x 4.0m. The facing at the south end of the hut (108a) was mainly collapsed although occasional stones indicated its line. Examination of the wall top showed that the south wall of hut 108 abutted the east wall of 107 the outer face of which formed the west wall of 108. A 1.5m length of facing was identified at the north-east corner of the hut. This was low but stable.

The south-east side of the entrance (Plate 199) does not follow the line shown on Hughes' (*ca.* 1906) plan and is not parallel to the opposite side. The facing consists almost entirely of small stones and is noticeably different in style to that found elsewhere in the hut. The masonry style in 41e resembles that in several recent (*i.e.* within the last 100 years) sections of rebuilt masonry that can be seen around the fort. It is therefore very probable that this is a modern feature although it is not clear why the oblique line was chosen for the masonry. There seemed to be little virtue in disturbing the facing so several stones were added to the top to stabilise it and no further action was taken. The entrance passage was choked with loose, fallen stone. This was stabilised by the resetting of several stones in order to provide support for the facing to either side (Plate 200).

A minimal approach was adopted at first, which involved resetting as few stones as possible, in order to avoid excessive disturbance to the intact masonry. This produced a rough looking wall top which was not very durable. After some experimentation it was found that the most effective way of consolidating the wall top was to ensure that the top of the facing was stable and then to pack the core very carefully using small stones to fill the interstices between the larger stones in the core. The stones were not wedged tightly in order to avoid the displacement of the stones at the top of the facing. Stones were occasionally introduced vertically into the wall top in order to discourage lateral movement of the core. Plate 155 shows the wall above 45Aa after consolidation.

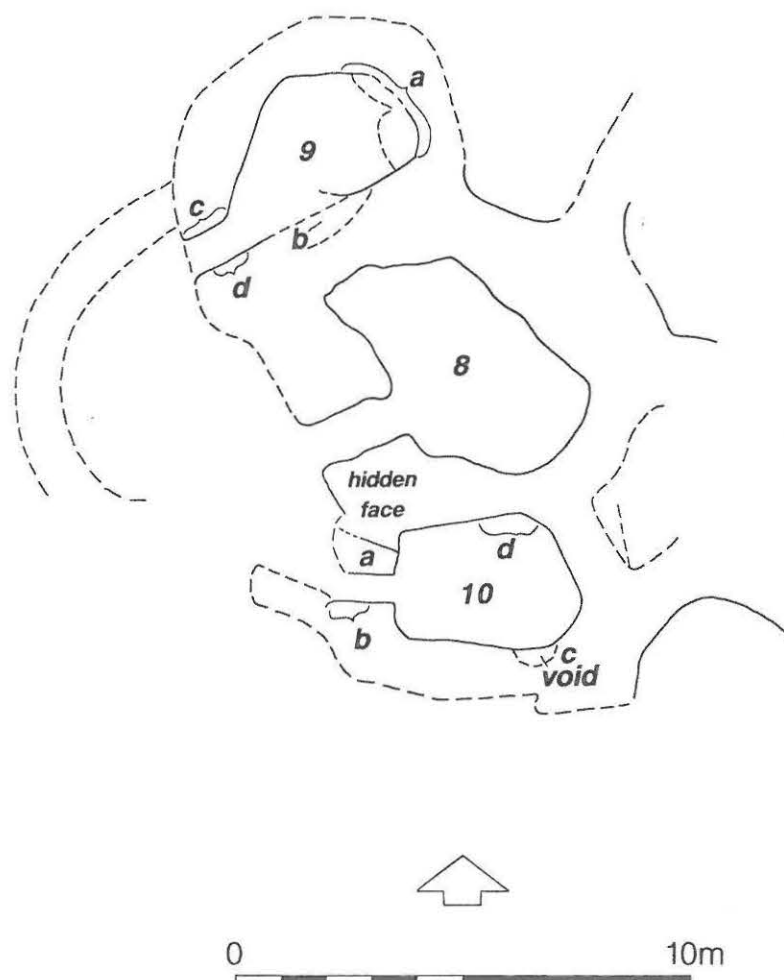
Fig. 9 Plan of huts 9 and 10 before conservation.

The treasure hunter hack and associated compartment like feature recorded by Dallimore (1978) had deteriorated considerably. There was a large void, measuring 1.9m x 0.7m, beneath facing that was little more than rubble, supported two or three long headers at the south and propped up on three fallen stones at the north (Plate 201). This area was on the point of collapsing completely and none of the facing was close to its original position. It was decided, in view of its proximity to the path, to clear this area and build a new face.

The top of most of the northern wall of the hut was overhanging the base by about 0.3m. This had resulted in a collapse in the upper part of the wall shown on Plate 231. The whole of the wall was examined in detail before any action was taken due to the danger of precipitating a serious collapse by removing stone from a curved area of overhang. The wall to the west of the collapse contained a high proportion of long headers and was stable. There was also a straight joint in the wall at the west edge of the collapse forming a break in the integrity of the face and suggesting that the masonry to the left hand side was self supporting. The loose stone was cleared down to the level of the two large triangular stones (A and B, Plates 231 and 232) in the centre of the collapse. The resulting dip in the face was filled with the new masonry indicated on Plate 232.

Clearance was started at the centre of the collapse. It soon became obvious that the facing to the north was partially supported by the stones in the collapsed masonry. The threatened facing was re-photographed. It had not been recorded in enough detail because it had not been anticipated that it would be under threat. The stones were marked in the 2m of facing to the north and west of the collapse. As clearance progressed the marked facing became increasingly unstable. Eventually, it was decided to dismantle some of the facing in order to prevent the damage that could be caused by an uncontrolled collapse. The masonry marked on Plate 202 was carefully dismantled. Plates 203 and 204 show the collapse after clearance. Only one possible basal stone survived confirming that the facing had been undermined. The line of the wall had been better indicated by the semi-collapsed facing above the void. Using this and the surviving stone as a guide, new facing was laid across the collapse (Plates 205 and 206). All but three of the marked stones were replaced close to their original positions. Slight adjustments were made where necessary because the facing had formed a slight overhang. Stones 2 and 6 could not be reused as they were part of the collapse and could not be integrated with the rest of the face. Stone V was replaced in order to make an adjustment in the lower part of the facing; the lower *in situ* stones were tilted forward and the replacement stone was used to provide a level platform for the facing above it. The wall was rebuilt to a height of 1.2m, this being the level of the ground on the outside of the hut.
