# LLANBABO CHURCH, ANGLESEY

## WATCHING BRIEF

Report No. 225

by K Geary

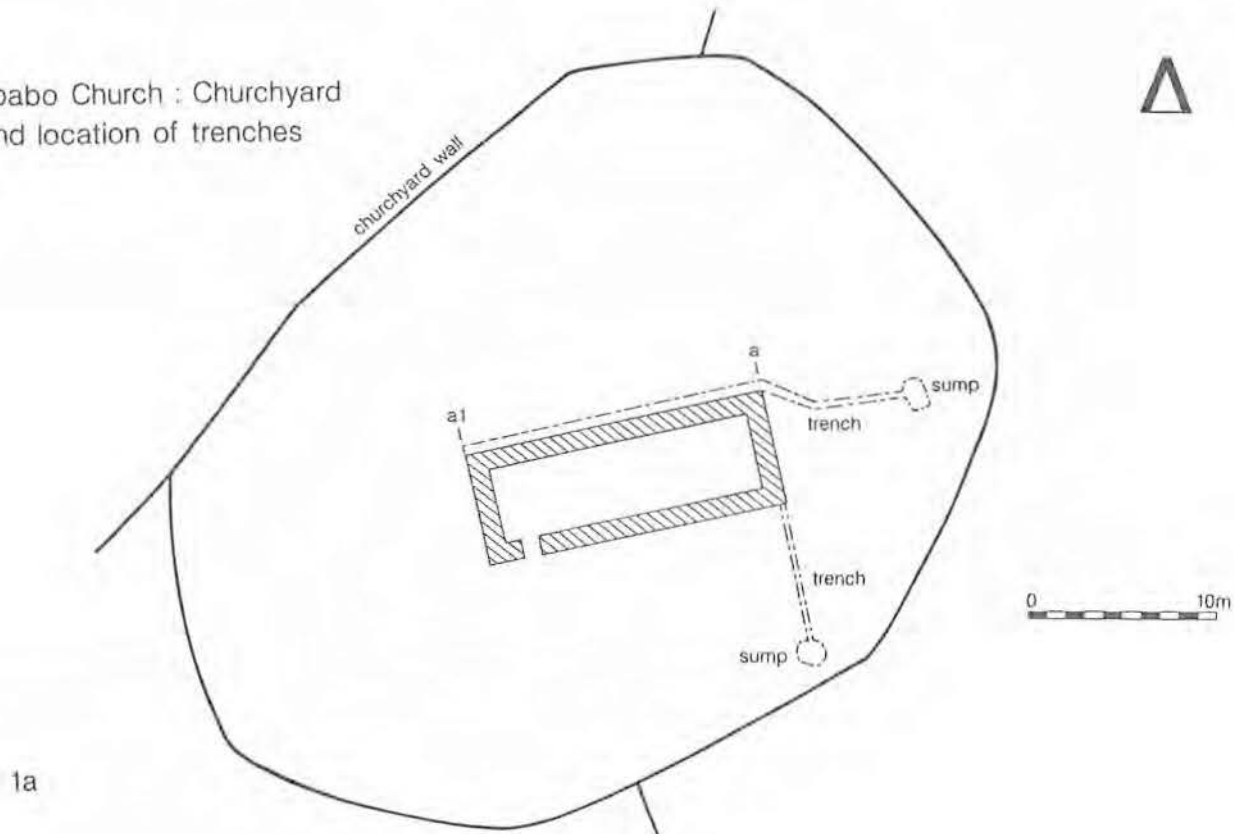
Llanbabo Church : Churchyard  
and location of trenches

The north trench was 0.60m wide and c.0.65m deep, running the full length of the church. The upper 0.23m consisted of turf and topsoil followed by 0.17m of soil mixed with mortar and slate and 0.07m of shale. Below that lay c.0.20m of clay with stone and charcoal inclusions. To the east of the church, the trench became narrower and shallower, approximately 0.25m deep and 0.30m wide, terminating in a pit 1.30m x 0.90m x 0.90m deep. A small quantity of human bone was recovered from the trench but no features were apparent except the foundation stones of the east wall and the east end of the north wall.

The south trench, which ran from the south east corner of the church to the boundary of the churchyard was c.0.30m wide and 0.50m deep. It also terminated in a pit 0.90m x 1.10m x 0.90m deep, dug adjacent to the boundary wall. The original ground surface of the churchyard sloped down to the southern boundary but it had been levelled by tipping building waste, including slate and lime mortar, down the slope. This layer of slate appeared in the pit 0.40m below the surface. Beneath this lay c.0.20m of mortar followed by a further c.0.20m of slate and shale which lay on clay with mortar inclusions. This was interpreted as disturbed natural clay and continued deeper than the 0.30m visible in the pit. A cut located at the base of the pit probably represented a burial.

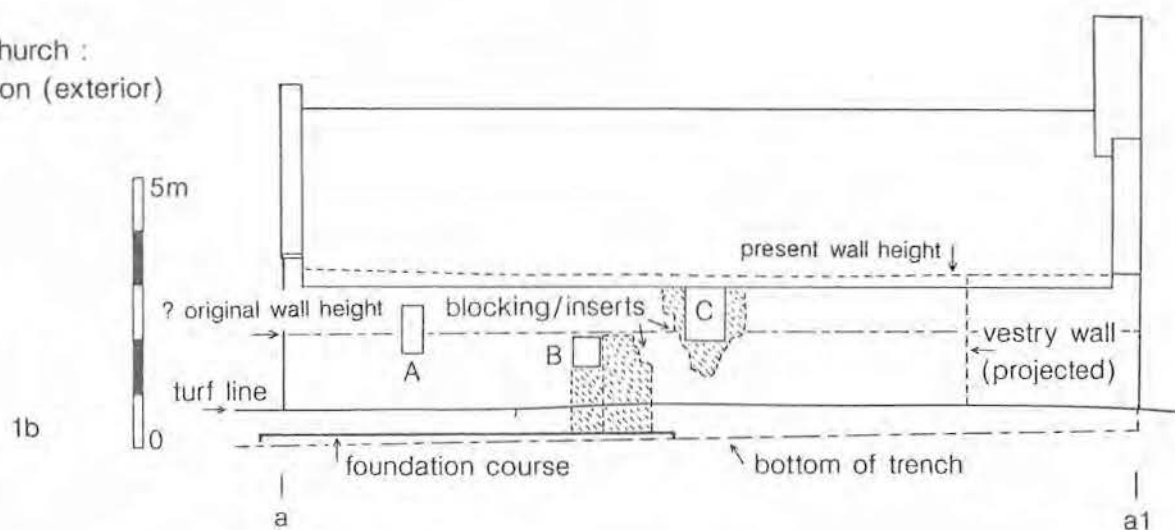
Llanbabo Church :  
North Wall Elevation (exterior)

The north wall of the church contained a narrow doorway c.0.65m wide, blocked to form a small window. The lintel had the letters R S inscribed into the mortar face. The lower levels of the blocking material, exposed by the drainage trench, were seen to protrude outwards suggesting that the door had been blocked from the inside. The opening for the door continued below the turf line to a level equal to the interior floor which was 0.35m lower than the external ground surface. To the west of the doorway was a vertical line in the masonry which may indicate the extent of disturbance relating to the insertion of the door or it may suggest the extent of the original nave. To the east of this line, the stones had a distinct pinky-red colour whereas those to the west in the wall of the nave were grey. Also visible in the drainage trench were the foundation stones of the chancel, extending 0.10 - 0.15m beyond the line of the wall. The foundation stones of the nave did not appear to protrude but the nave wall may have been deeper and the foundation stones consequently not visible. A change in the nature of the masonry and, more particularly the rendering, of the upper courses of the north wall may reflect the raising of the side walls as mentioned by Harold Hughes, although this was more obviously visible in the south wall, (*fig.1b*).

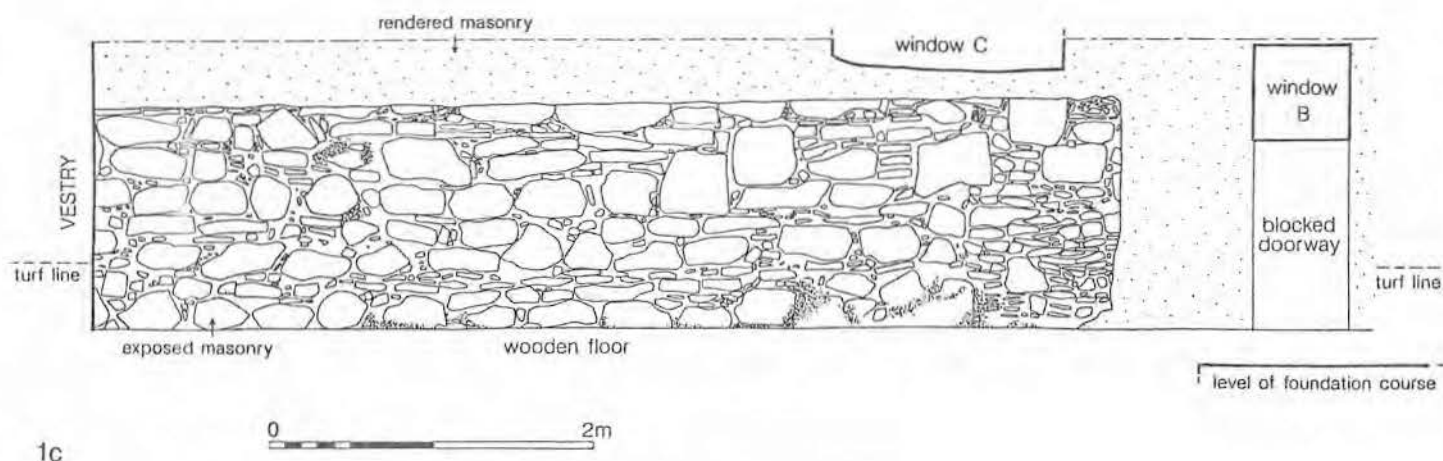
Llanbabo Church :  
North Wall Elevation (interior)

The removal of the plaster exposed an area of stonework 6.35m in length and 1.41m in height, constructed of rough coursed rubble with some large boulders, (*see fig.1c*). At a point approximately 5.5m from the corner of the vestry the coursing ended and the wall continued of smaller, uncoursed rubble to the end of the exposed

distance of 0.80m. The plaster was not removed beyond this point and it was not possible on this occasion to determine whether the change in construction continued for the rest of its length.
