Management of archaeological sites on Cochwillan Estate

GAT Project G1523

Report no. 285

October 1998

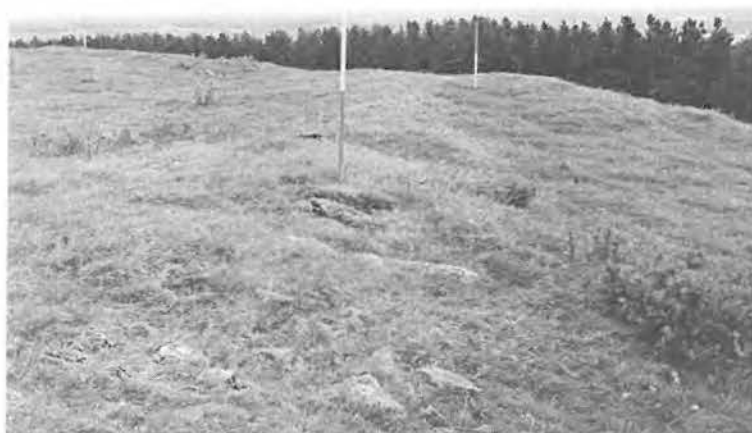
Figure 4 Hut group, Coed Bronydd-isaf, PRN 067. Showing damage to enclosure bank caused by earlier episode of stone robbing. Facing NW.

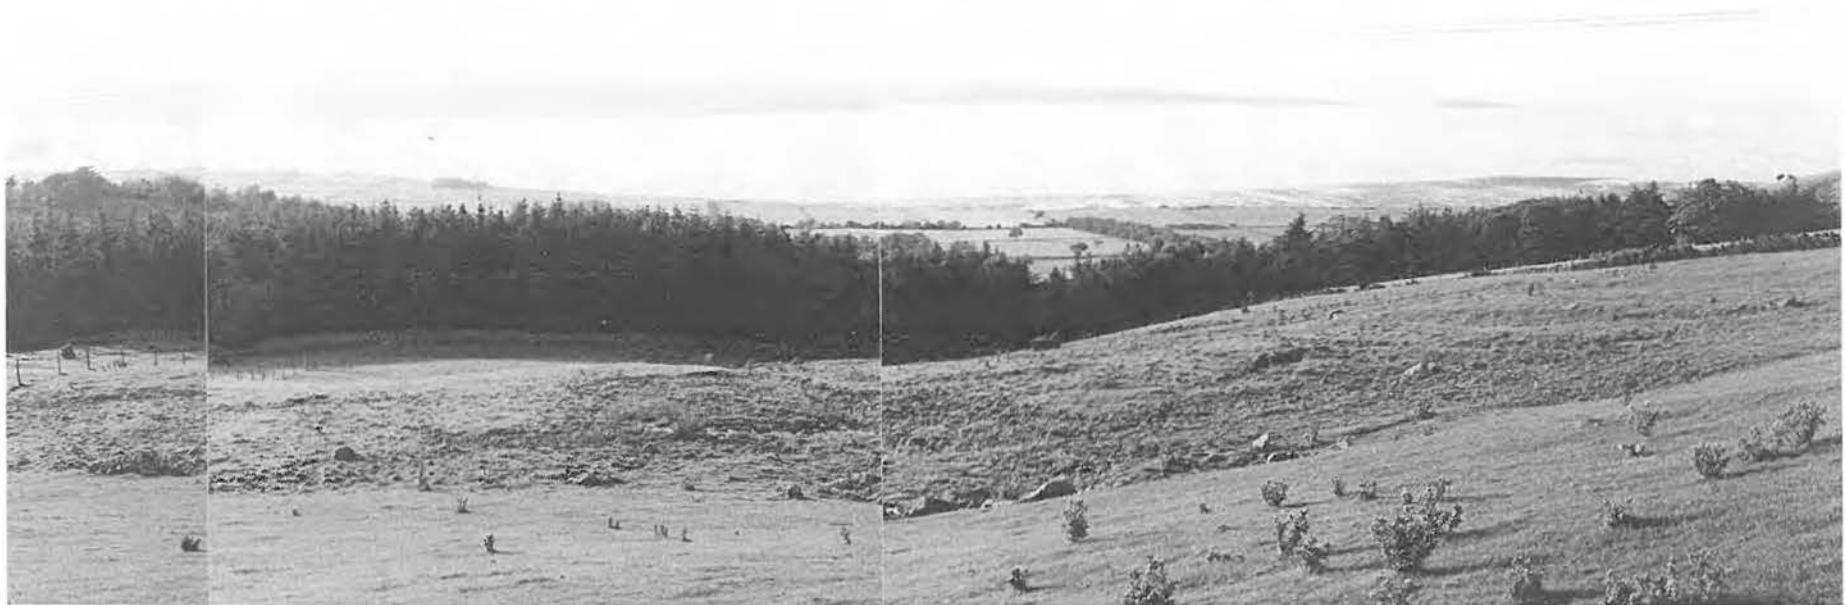
Figure 6 Hut circles, Nant Heilyn (PRN 068), showing landscape setting and area of drainage works to the S of the site. Facing NW. The arrow indicates the location of the site.

- Waterlogged ground conditions favour the preservation of organic deposits (such as timber and leather) and environmental evidence (such as pollen, insect remains and seeds), both of which are important archaeological resources. There is a strong chance that the boggy area located immediately to the south of the hut circles may have contained evidence of this kind, which could have provided a key source of contextual evidence for understanding the nature and economy of the site. Unfortunately, much of this potential material is likely to have been lost or damaged during the drainage works. However, despite the drainage works, the ground in the area is still fairly boggy, and it is possible that the soil deposits covering the hut circles remains moist. If this is the case, then organic material, particularly timber (for example, the remains of building posts), may well be preserved beneath the surface. To ensure that no further damage occurs to such potential deposits, it is suggested that the drainage regime of the area is not intensified. No further ditches should be cut, or drains sunk.

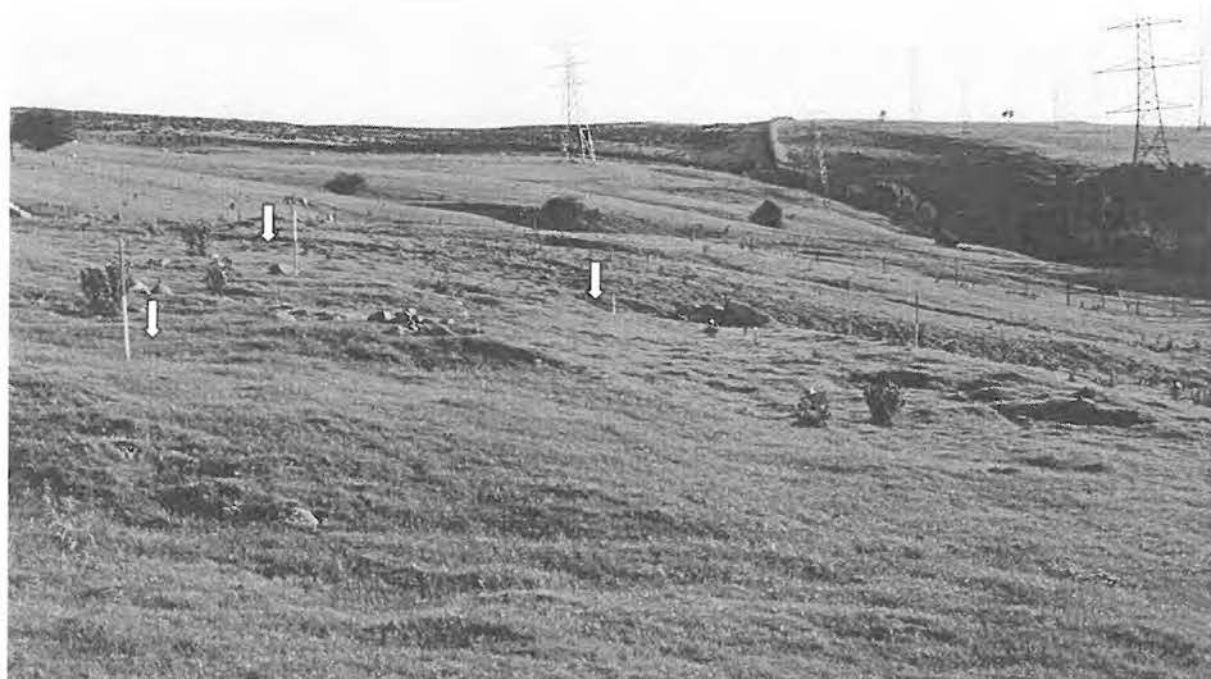
Figure 7 Hut circles, Nant Heilyn (PRN 068). The arrows indicate the central points of the three circles. The scale rods located next to the arrows are each 1m long.

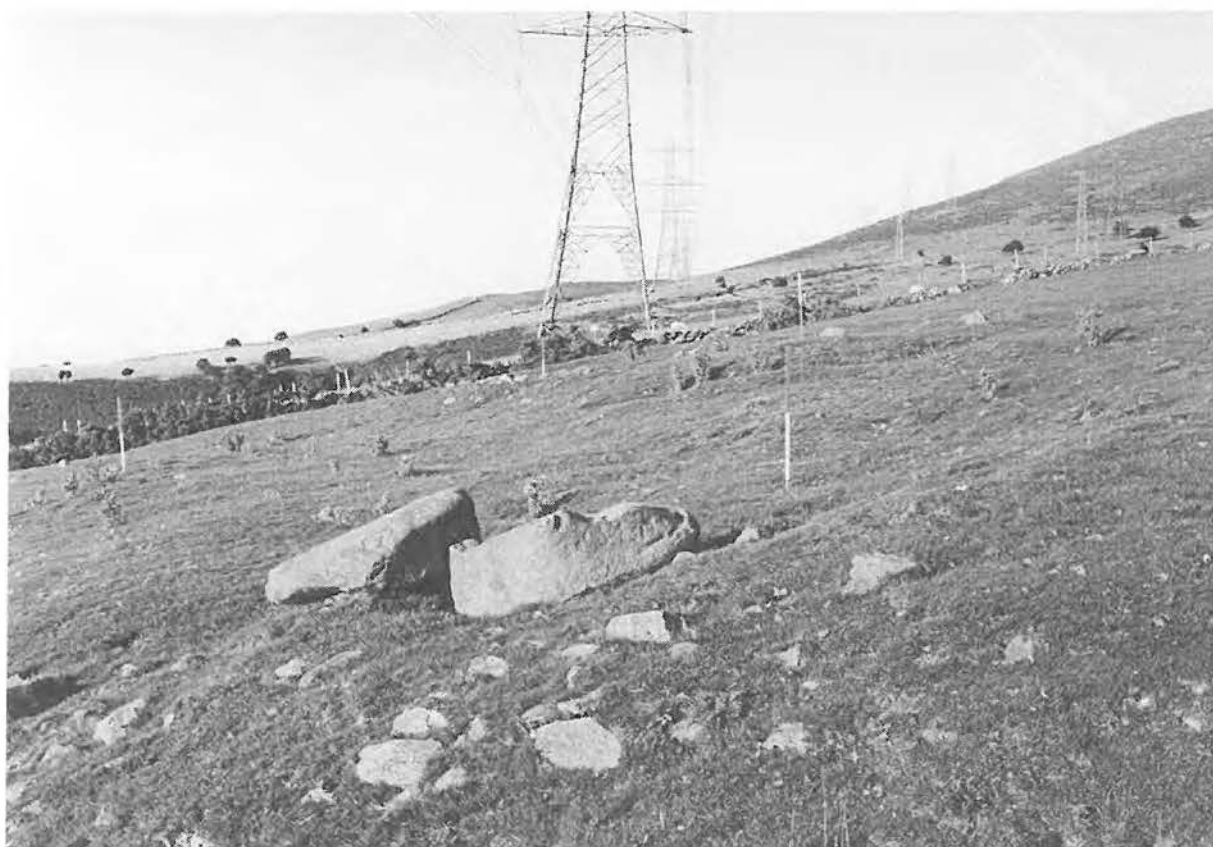
Figure 8 Hut circles, Nant Heilyn (PRN 068), showing the displaced entrance stones. Three of the 1m scale survey rods are located at the central points of the circles. The fourth rod (to the left of the photograph) is located at the crest of the terrace.

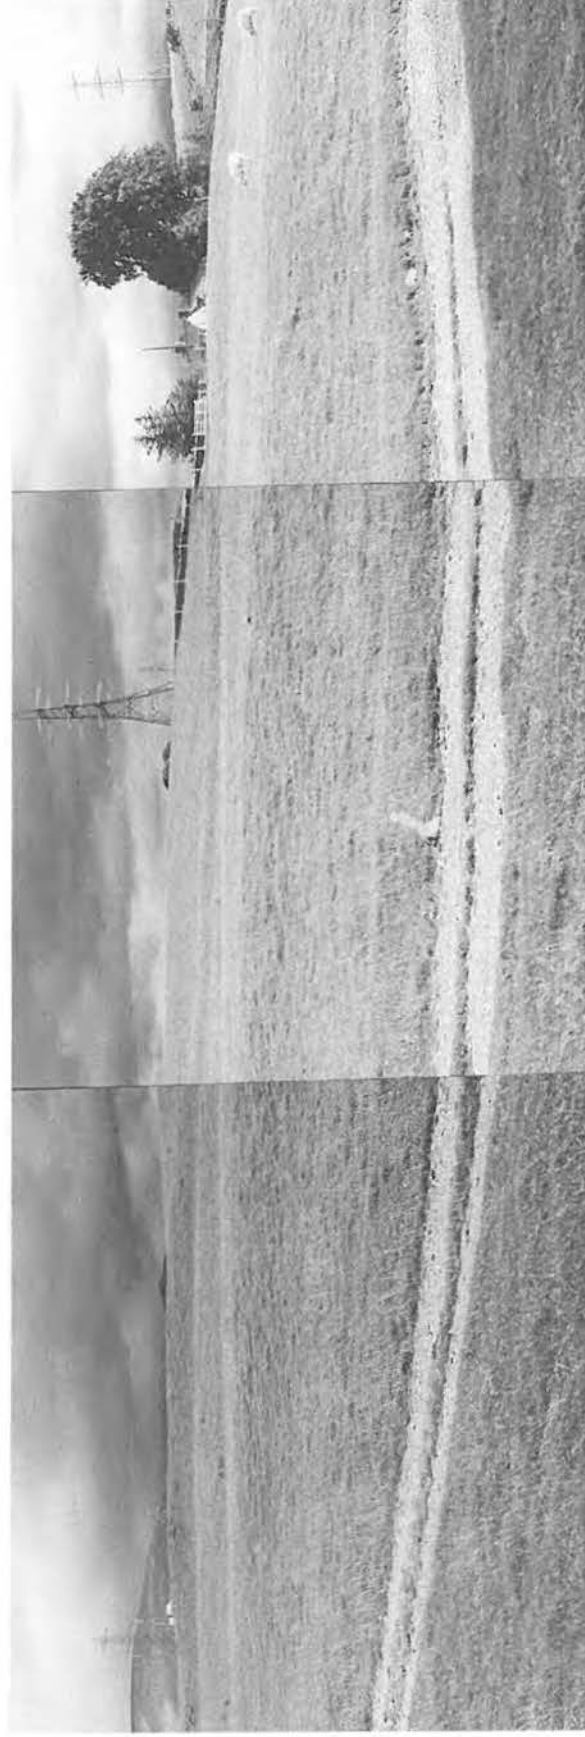
Figure 9 Lynchets and terraces, Bronydd-isaf (PRN 069), Facing SE.

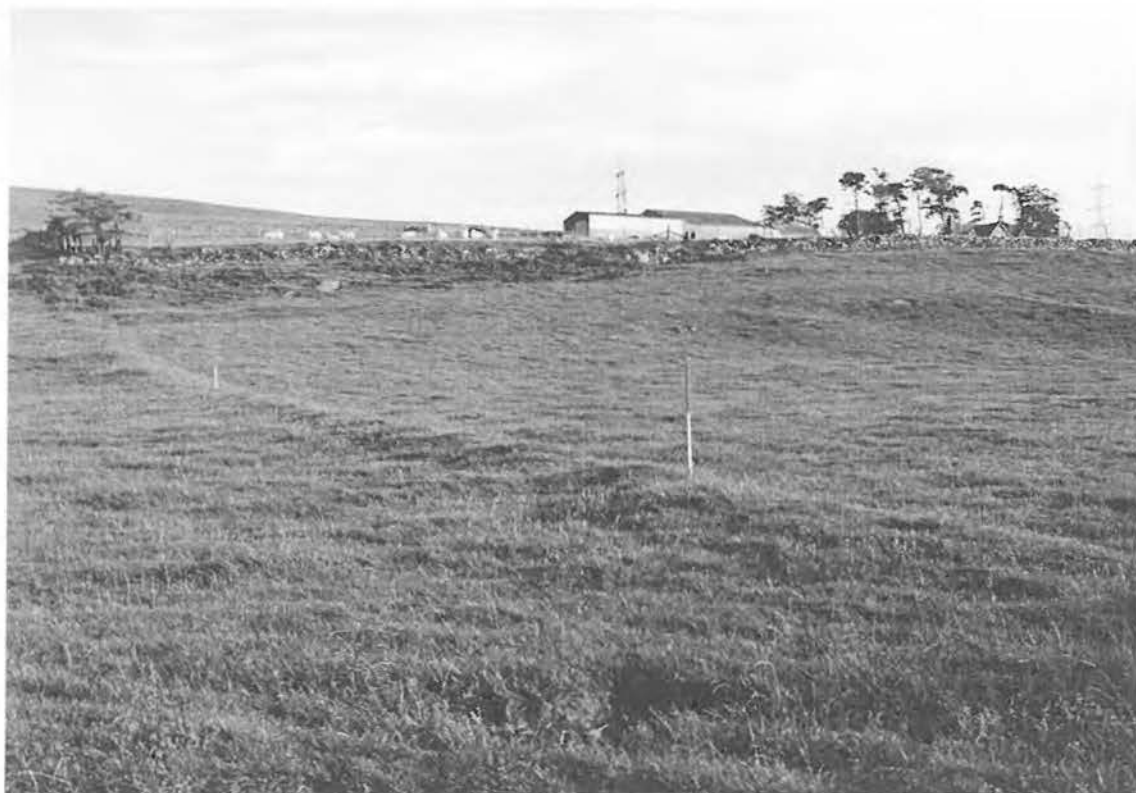
Figure 10 Relict field boundary, Coed Ty'n-yr-hendre (PRN 070). Facing SE.
1m scales.

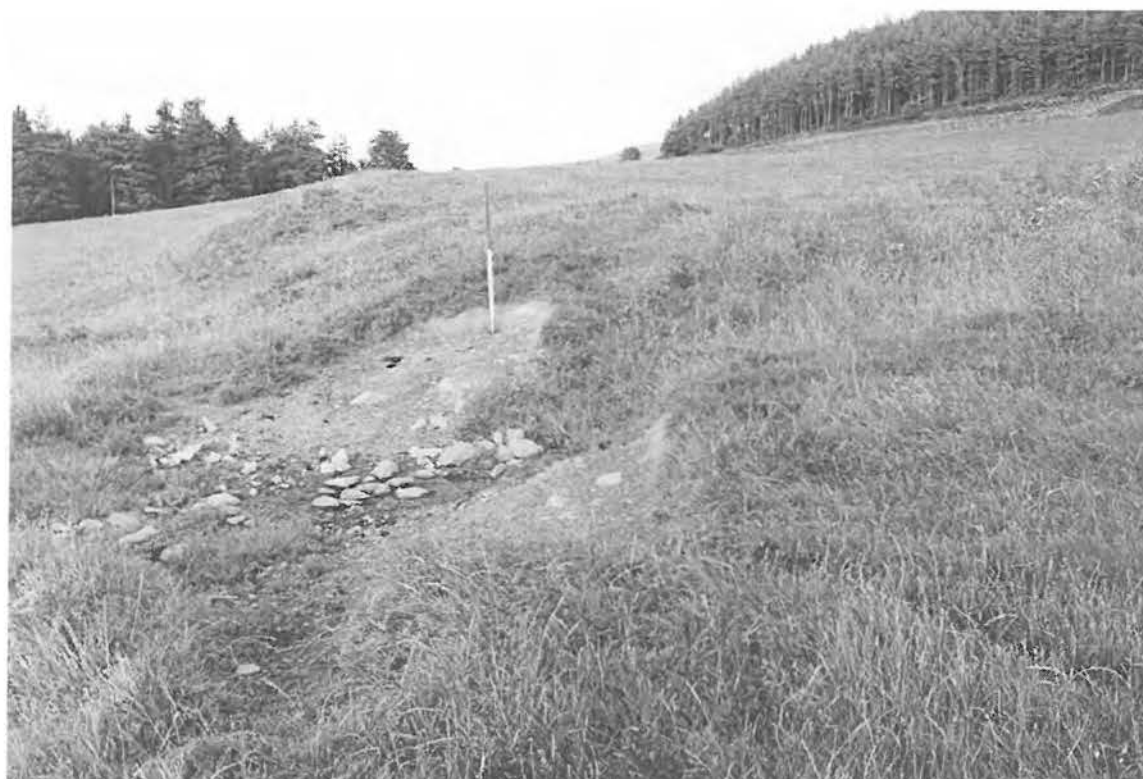
Figure 11 Lynchet, Coed Ty'n-yr-hendre (PRN 070). Showing erosion
caused by stream action and animal poaching. Scale rod is 1m.

- The levels of poaching (animal erosion) on the banks and lynchets should be monitored, particularly for those features truncated by the stream. If significant areas of erosion (exposed soil deposits) develop, then stock levels should either be reduced for a length of time sufficient to allow regeneration of the protective turf layer, or should be excluded from the area of damage by the erection of fencing.
- No further land improvement (such as ploughing or bulldozing) should occur within the field that contains these features.
- As far as is possible, farm vehicles and machinery should not be driven over the features themselves. Where this is unavoidable, no single regular route should be followed; this should help to minimise the impact of wheel erosion on any one feature.

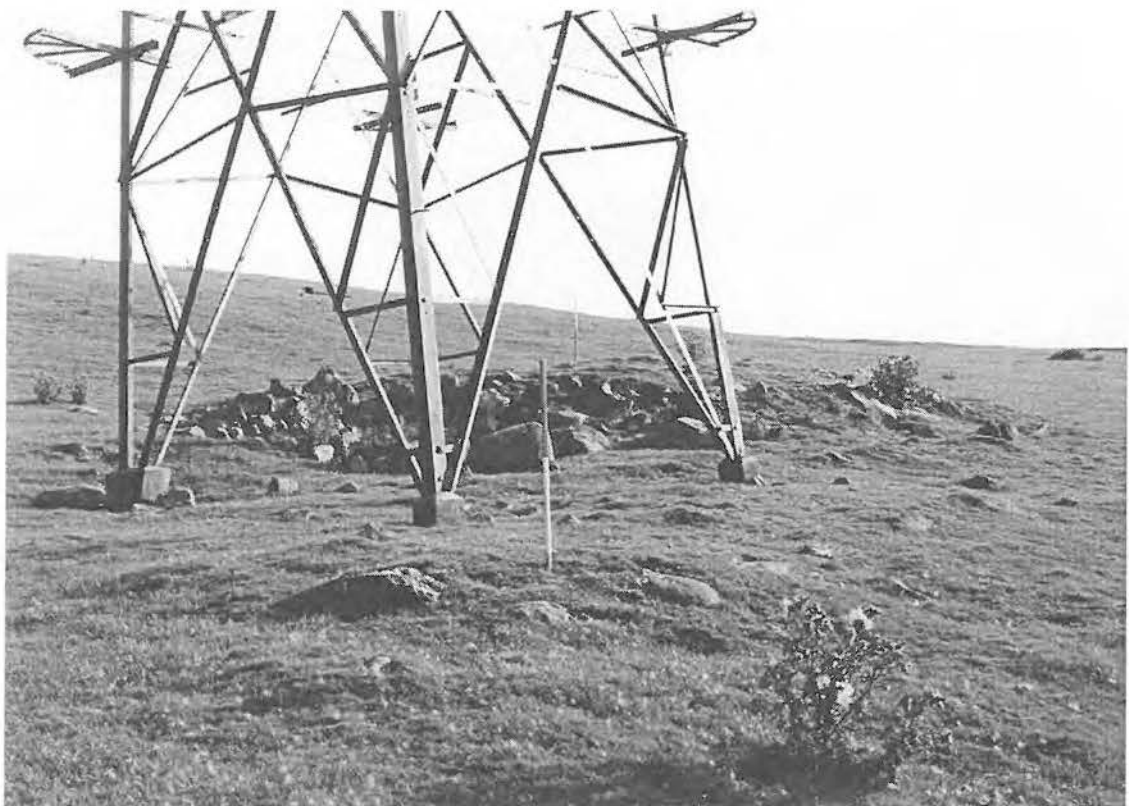
Figure 13 Site of long hut, Nant Heilyn (PRN 071). Scale rod is 1m. Facing SE

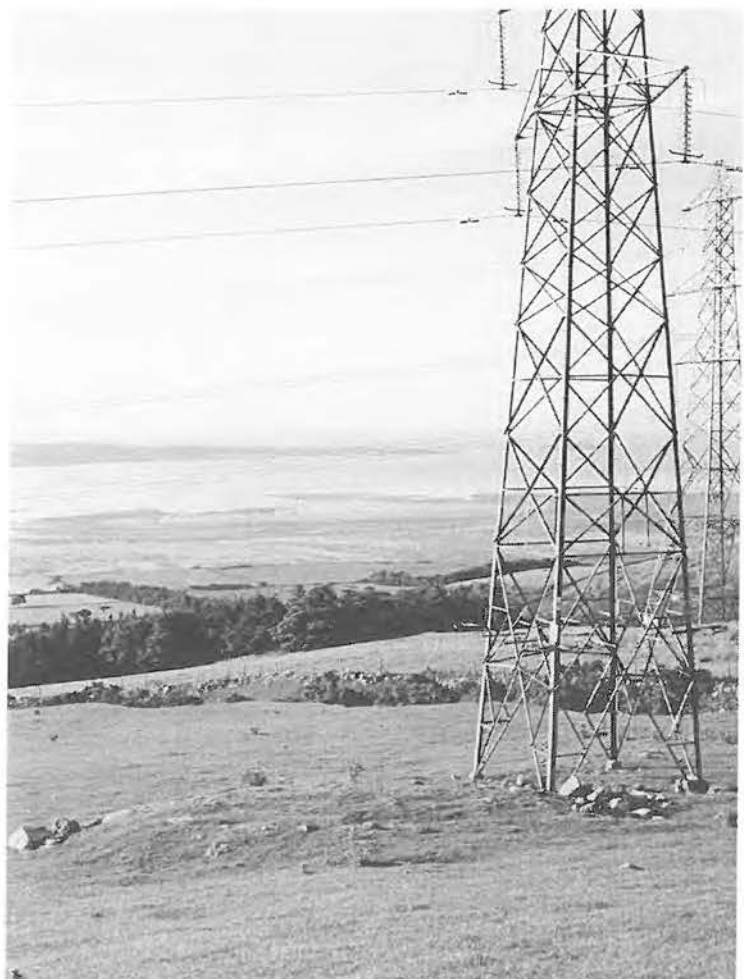
Figure 14 Site of long hut, Nant Heilyn (PRN 071). Facing NW

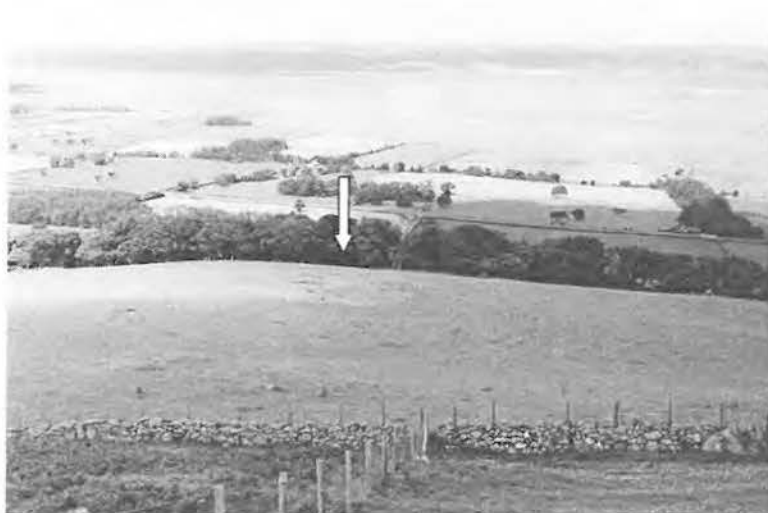
Figure 18 Enclosure, Crymlyn Oaks (PRN 074). The arrow points to the centre of the enclosure. Facing NW.

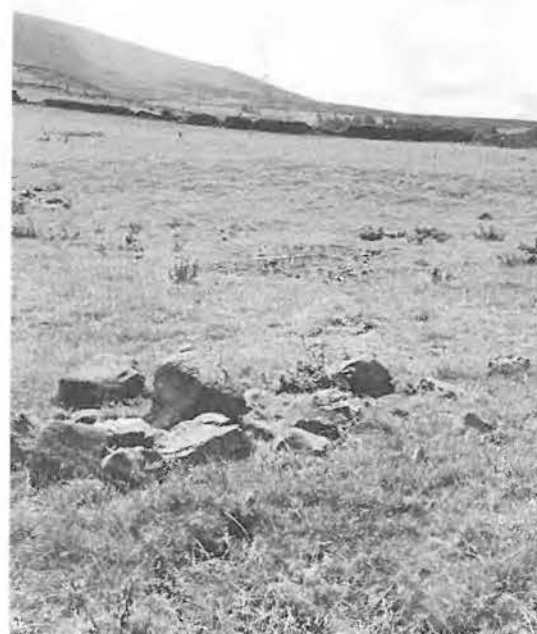
Figure 19 PRN 074, showing small stone dump, and erosion scar caused by animal trampling around feeder area. Facing SE.

- Protect against the possibility of further damage being caused through stock trampling, by ensuring that the site is no longer used as a feeding area.
- Maintain stock levels at or below those of current practice to ensure continued protection against soil erosion. The site may need to be fenced off in the event of increased stock presence.
- Tidy up the area within the enclosure. Remove items of farm rubbish (wooden pallets etc). Remove recent dump of stone currently situated near the enclosure bank at the north west of the site.

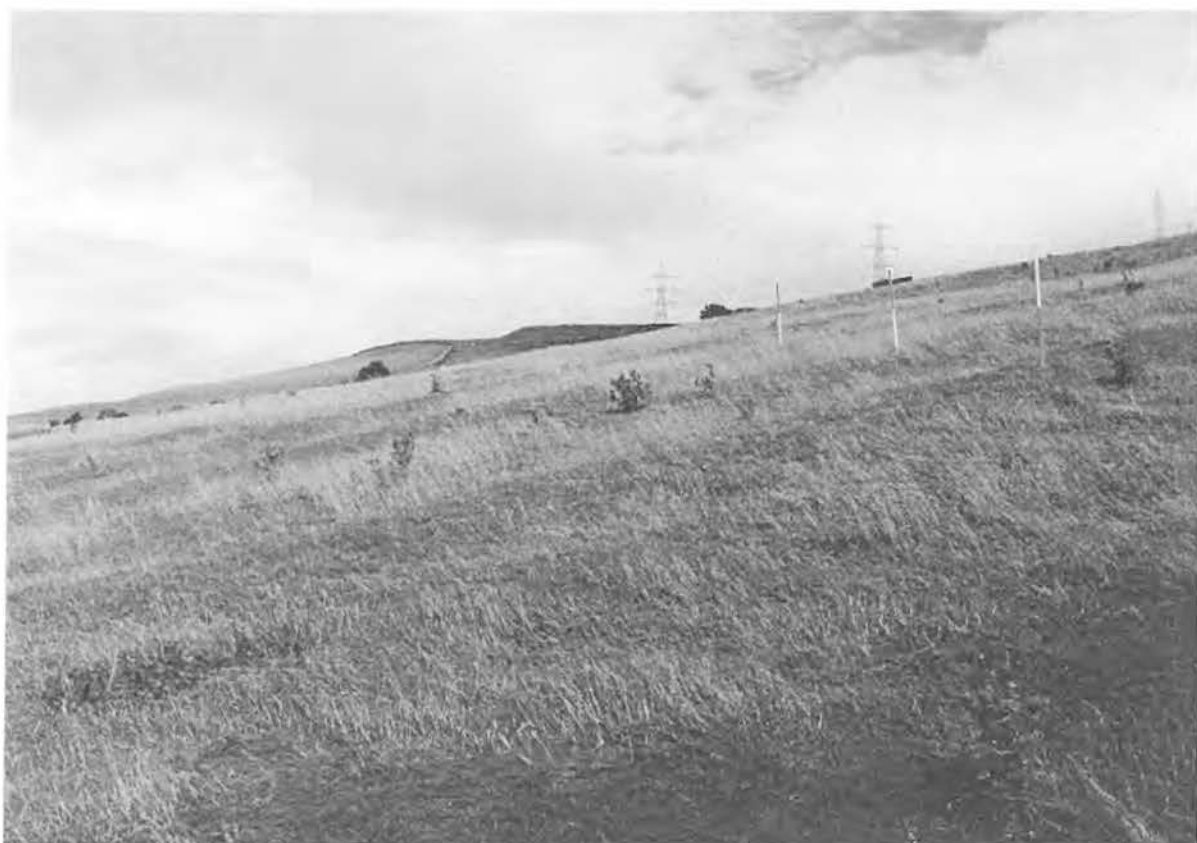
Above: Figure 20 Ridge and furrow, PRN 7487. Facing NE.
The 1m scale rods are located on three consecutive ridges.

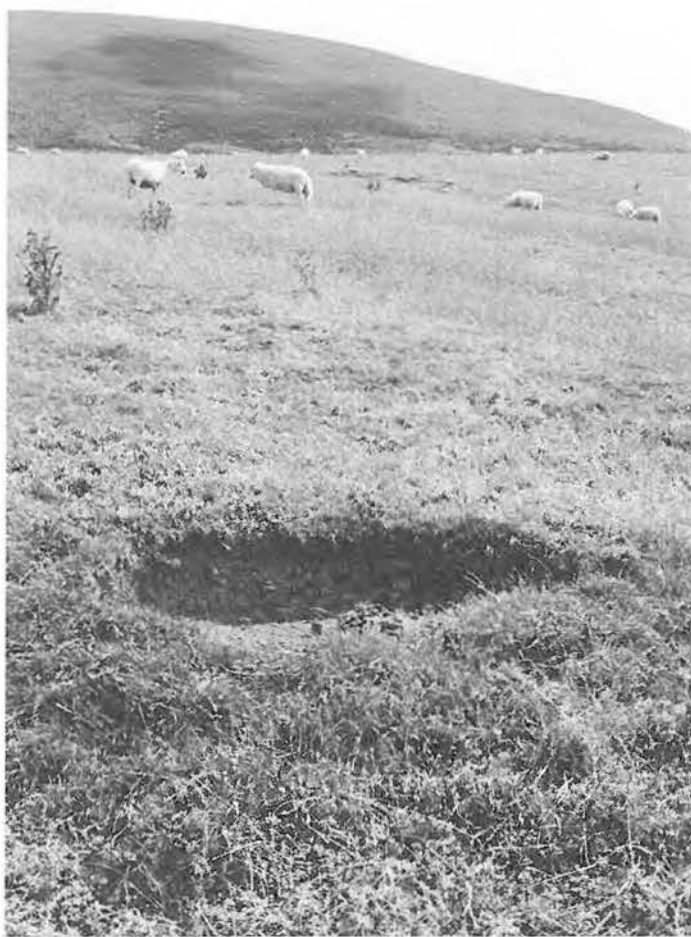
Right: Figure 21 Eroded area on ridge and furrow (PRN 7487), resulting from animal poaching. Facing SE.

- The levels of poaching (animal erosion) on the banks, lynchets and areas of ridge and furrow should be monitored. If significant areas of erosion (exposed soil deposits) develop, then stock levels should either be reduced for a length of time sufficient to allow regeneration of a protective turf layer, or should be excluded from the area of damage by the erection of fencing.
- No further land improvement (such as ploughing or bulldozing) should occur within the field that contains these features.
- As far as is possible, farm vehicles and machinery should not be driven over the features themselves. Where this is unavoidable, no single regular route should be followed; this should help to minimise the impact of wheel erosion on any one feature.

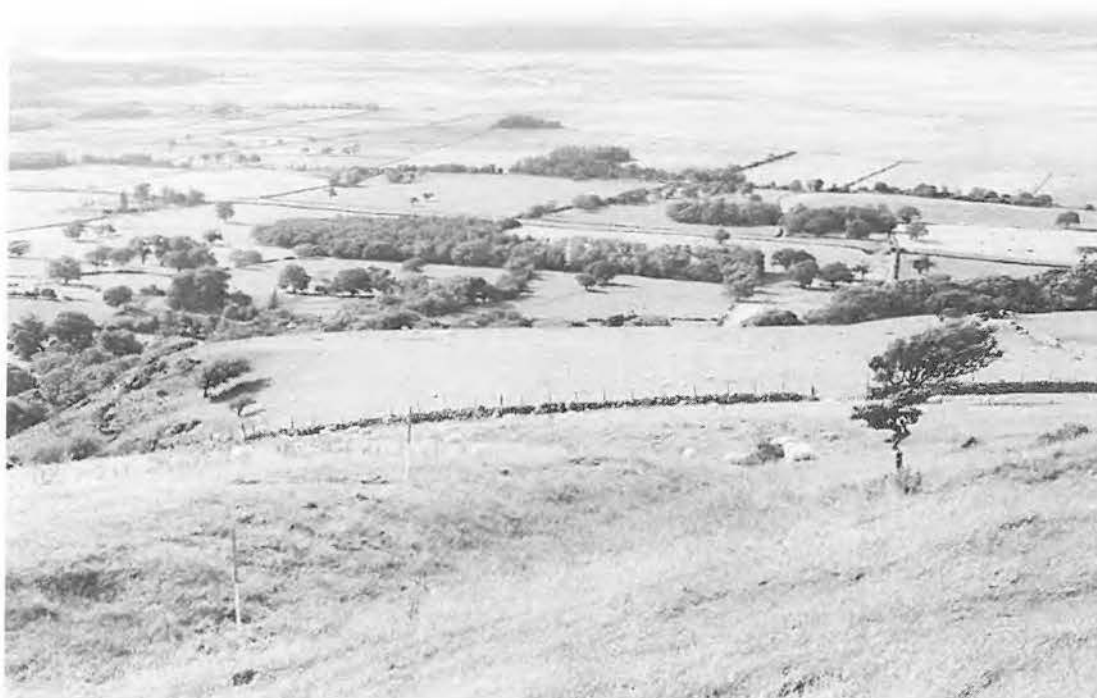
Figure 22 Holloway (PRN 7487). Facing W.

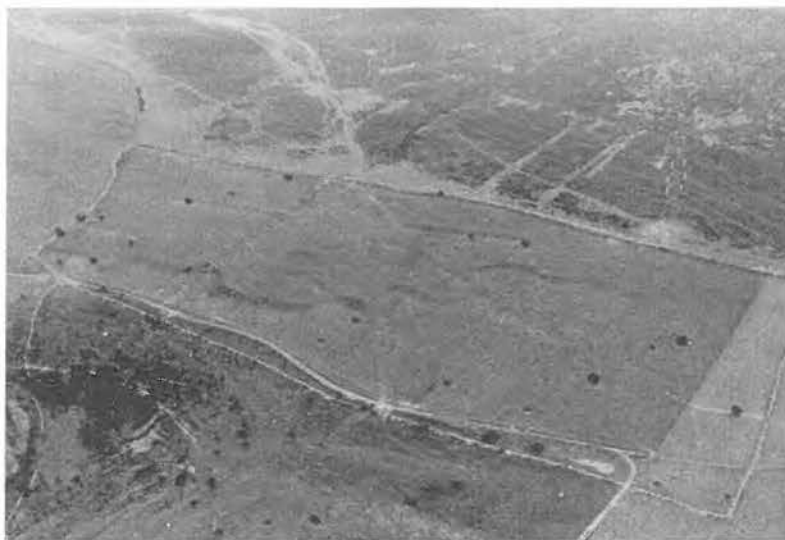
Figure 23 Aerial photograph of early fields and associated features, PRN 6617.

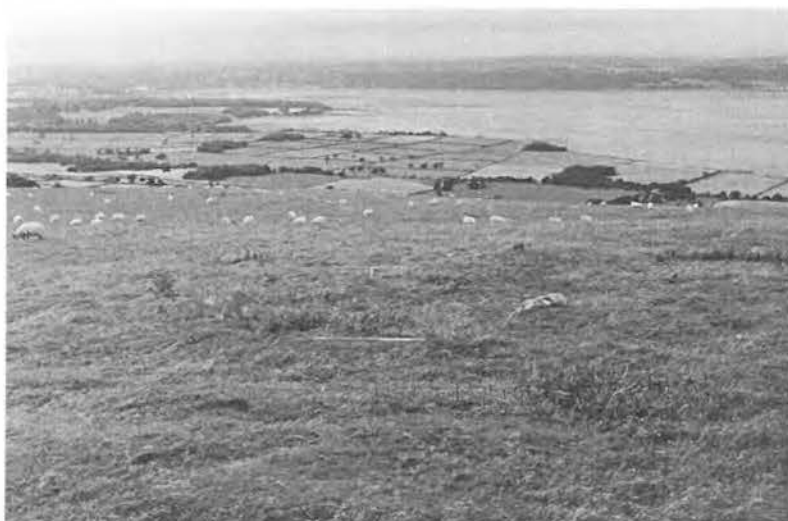
Figure 24 Site of possible circular building platform (feature 20, appendix 2, map 1), PRN 7487. Facing NW. Scale rods are 1m.

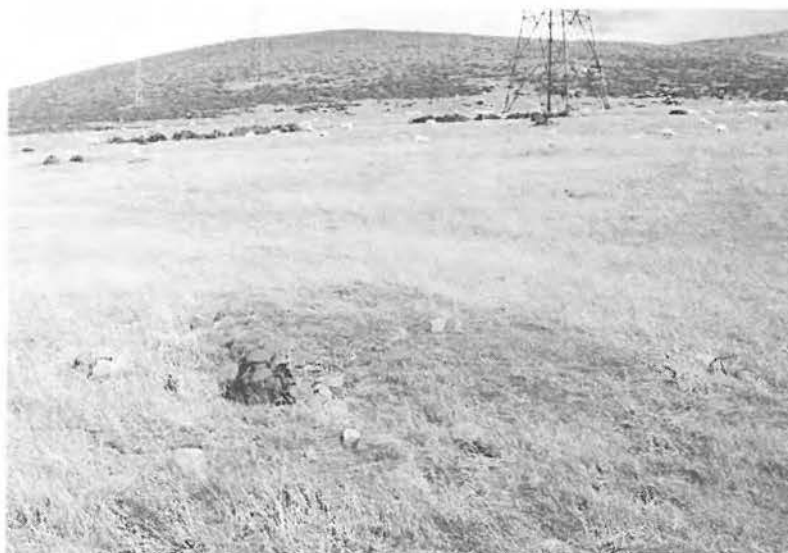
Figure 25 Clearance cairn (feature 16, appendix 2, map 1), PRN 7487. Facing East.
