YMDDIRIEDOLAETH ARCHAEOLEGOL GWYNEDD
GWYNEDD ARCHAEOLOGICAL TRUST

REPORT ON THE NINTH SEASON OF THE
TRE'R CEIRI CONSERVATION PROJECT
MAY TO OCTOBER 1997

D. HOPEWELL

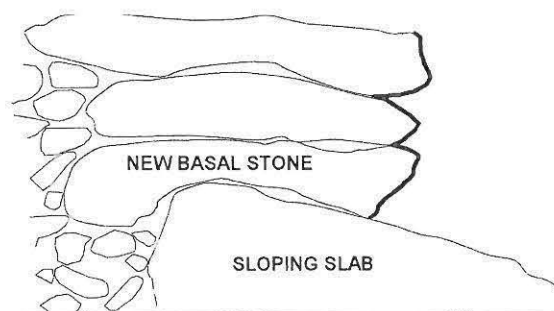
Fig. 6 Collapse Y10, method used to secure the base of the wall.

This was a serious bulge in the wall (Plates 117 and 118) creating 3.5m wide area of instability. The facing was standing to a height of 1.7m at either side but in the centre had fallen to a height of 1.7m. The base of the wall was standing on a large flat slab that was tilted forwards at an angle of about 25°. More seriously, the facing appeared to be resting on one small stone which was in turn standing on the tilted slab. This was obviously very unstable and an uncontrolled collapse here could result in the loss of a considerable amount of masonry. It was therefore decided to dismantle the unstable facing with a view to providing a stable base to the wall.

The *in situ* stones within the unstable area were numbered 1 to 97 (see Plate 117). Further stones (A to Z) were marked outside this area in case of unexpected collapse but as they were not affected they are not marked on the Plate. A V-shaped section of facing was carefully dismantled (Plate 119). It is usual, when dealing with large collapses where the rampart stands to over 2m in height, to have severe problems with the unstable core that was originally retained by the facing. In this case however the core consisted of large stones that were well locked together. It was confirmed during the clearance, that the wall was indeed resting on one small stone and was on the point of collapse. The tilted slab (Marked TS on Plate 120) was at the bottom of the cleared area and no further dismantling was possible without the loss of a lot more *in situ* masonry. The slab was very large and could not be reset. As the slab was sloping at an angle of about

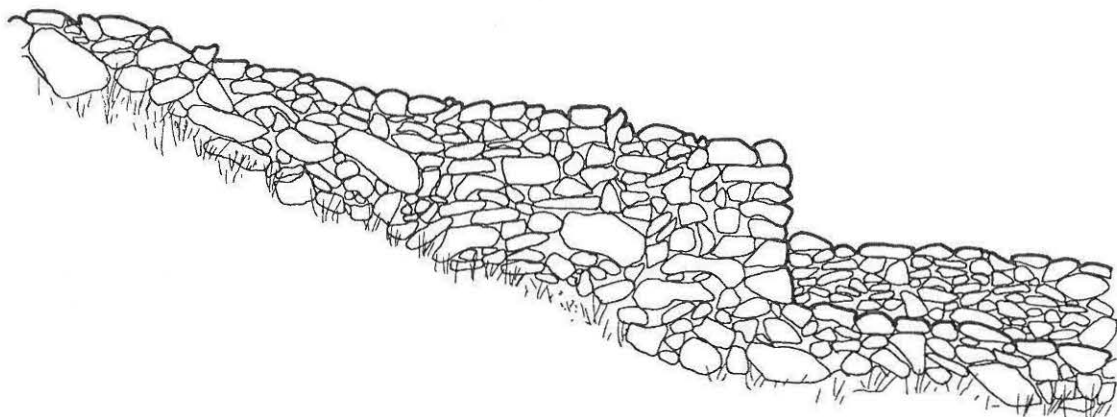
Fig. 7 Reconstruction of step in rampart at Z8.

It was noticed, during the conservation of the wall tops, that there was a line of facing running across the wall at the south-west end of Z8. The 0.3m to 0.5m high facing formed a step in the top of the rampart (Plate 203). This type of feature has not been previously identified on Tre'r Ceiri. The facing did not continue down into the wall and it seems that the function of the step was to compensate for the steep change in ground level between the top of the outcrop and the wall below. If, as the presence of the parapet implies, the walls were designed to withstand foot traffic, this type of structure was necessary as a steep gradient on the wall top tends to result in erosion. The partial reconstruction drawing (Fig. 7) is one possible interpretation of the remains. It is not known however, if there was more than one step or if the parapet continued across the top of the outcrop but the drawing clearly demonstrates the method of compensation for the sudden change in ground level.

The step was stable apart from one stone that had obviously fallen from the inner corner. This was lifted back onto the wall.

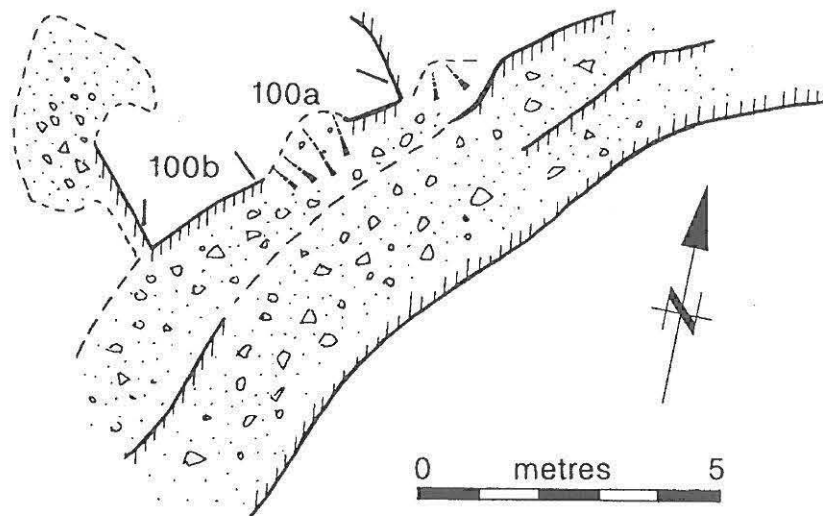
Fig. 9 Plan of hut 100.

The hut was planned and examined at the beginning of the present season and there was found to be little change from the above descriptions. There was some obvious instability in the south-east wall and some erosion to the south west wall where a well-established minor footpath crossed the hut.

The eastern corner of the hut was well defined but there had been a serious collapse in the south-eastern wall where 1.7m of facing could not be traced (Plate 209). This was a part of a larger area of collapse that also impinged on the inner face collapse Y15 (above). The collapsed masonry was cleared but there was no definite surviving basal course. Plate 210 shows the collapse after clearance. Stone A was a large upright, standing behind the expected line of the face. No definite line could be extrapolated from the jumbled stone but it appeared that the base of the wall had fallen forwards causing the masonry above to collapse. New masonry was needed in order to support the wall to either side. As the line of the wall had been lost, stone was added in an irregular fashion (Plate 211). Three additional stones were added to the top of the *in situ* facing in the corner of the hut.

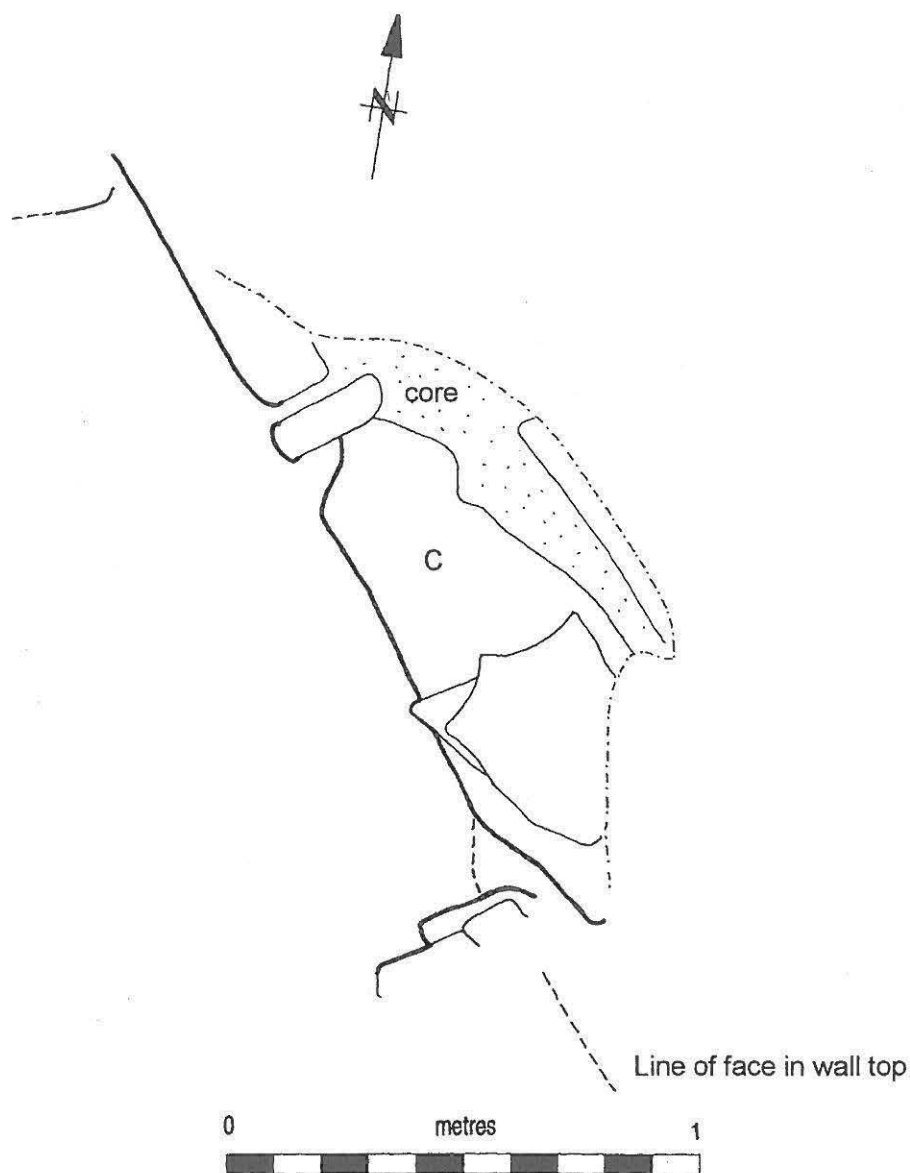
Fig. 20 Plan of collapse 3d, after clearance.

The eastern end of the hut had also been reduced to a rubble slope (Plate 255). In addition to this part of the vegetation mat from above had fallen down the slope and was now growing amongst the stones. The remains of the corner of the hut were however still visible.

The collapse was cleared revealing a large basal stone between the corner of the hut and the facing revealed during the clearance of 3c (Plate 256 and Fig. 20). The junction between the dividing wall and the continuation of the face beyond 3d was however not entirely clear. The lower part of the wall, (stones C and D etc) could not be traced behind the dividing wall for more than 0.2m. The top of the wall was overhanging (stone E and above) but could be traced on this line behind most of the width of the dividing wall. The loss of only the base of the wall behind standing masonry cannot easily be explained. It could have been the result of subsidence and it is even possible, although unlikely, that the line of stone visible in the wall top behind the dividing wall had been added during the excavation of the hut in 1904. It can probably be assumed that the dividing wall was built against the original roundhouse wall, as in other huts, but further investigation was not possible without the destruction of *in situ* masonry.
