A470(T) DOLWYDDELAN TO  
PONT-YR-AFANC IMPROVEMENT

ARCHAEOLOGICAL RECORDING

Report number : 345

Ymddiriedolaeth Archaeolegol Gwynedd  
Gwynedd Archaeological Trust

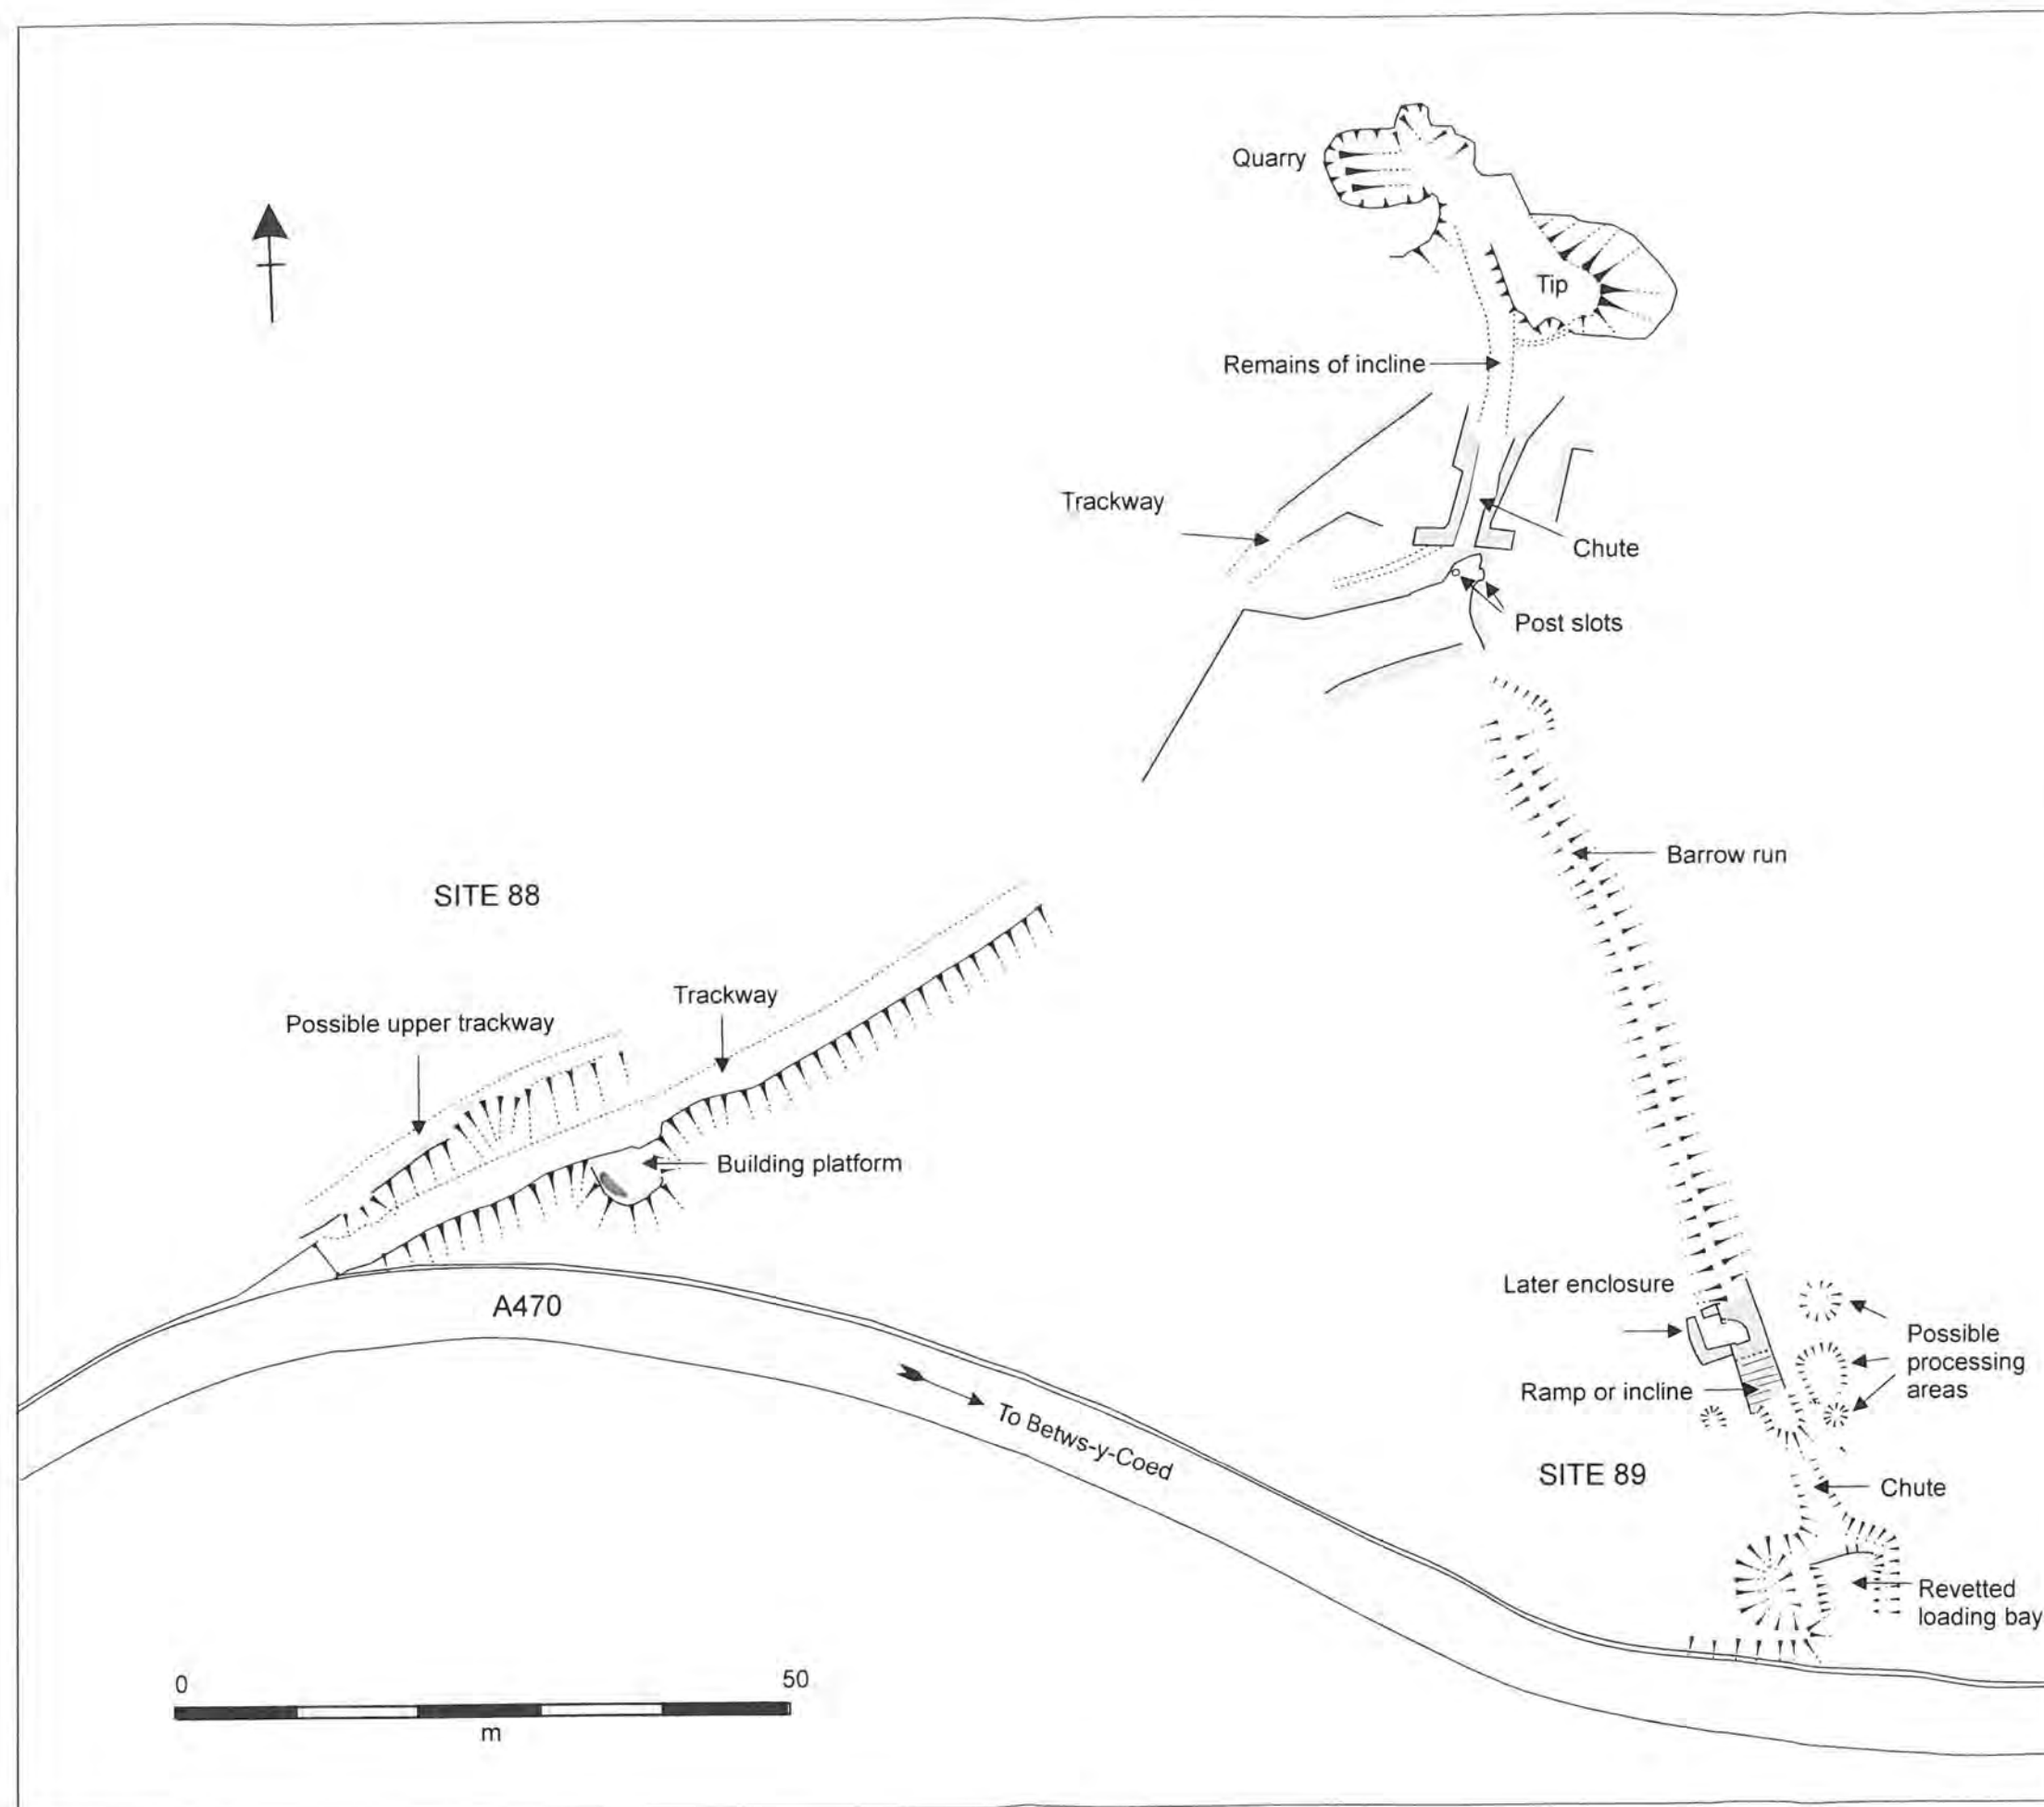
Fig. 7 Sites 88 and 89, quarry workings

Sites 88 and 89 form part of a larger complex of quarry workings and buildings (Fig. 7). There are no known written records of this quarry and it is not known what was extracted. There are however large amounts of quartz around the workings. It is unlikely that quartz extraction would be financially viable so it can be assumed that a mineral associated with the quartz veins was being extracted. The quarry itself stands 200m north of the road. An incline, terminating in a large stone chute, stand beneath the quarry. One or possibly two trackways run from this point to site 88 and a raised barrow run runs to site 89. None of the above features will be affected by the road. This part of the plan was compiled from the earlier assessment report and the 1:500 Longdin and Browning plan.

Site 88 will not be substantially damaged by the road but site 89 will be entirely destroyed. Both sites were planned using a total station and all inner and outer elevations were photographed in detail. The photographs were catalogued and have been retained in the archive.

*Recommendations for further mitigatory measures:* Watching brief on site 89.

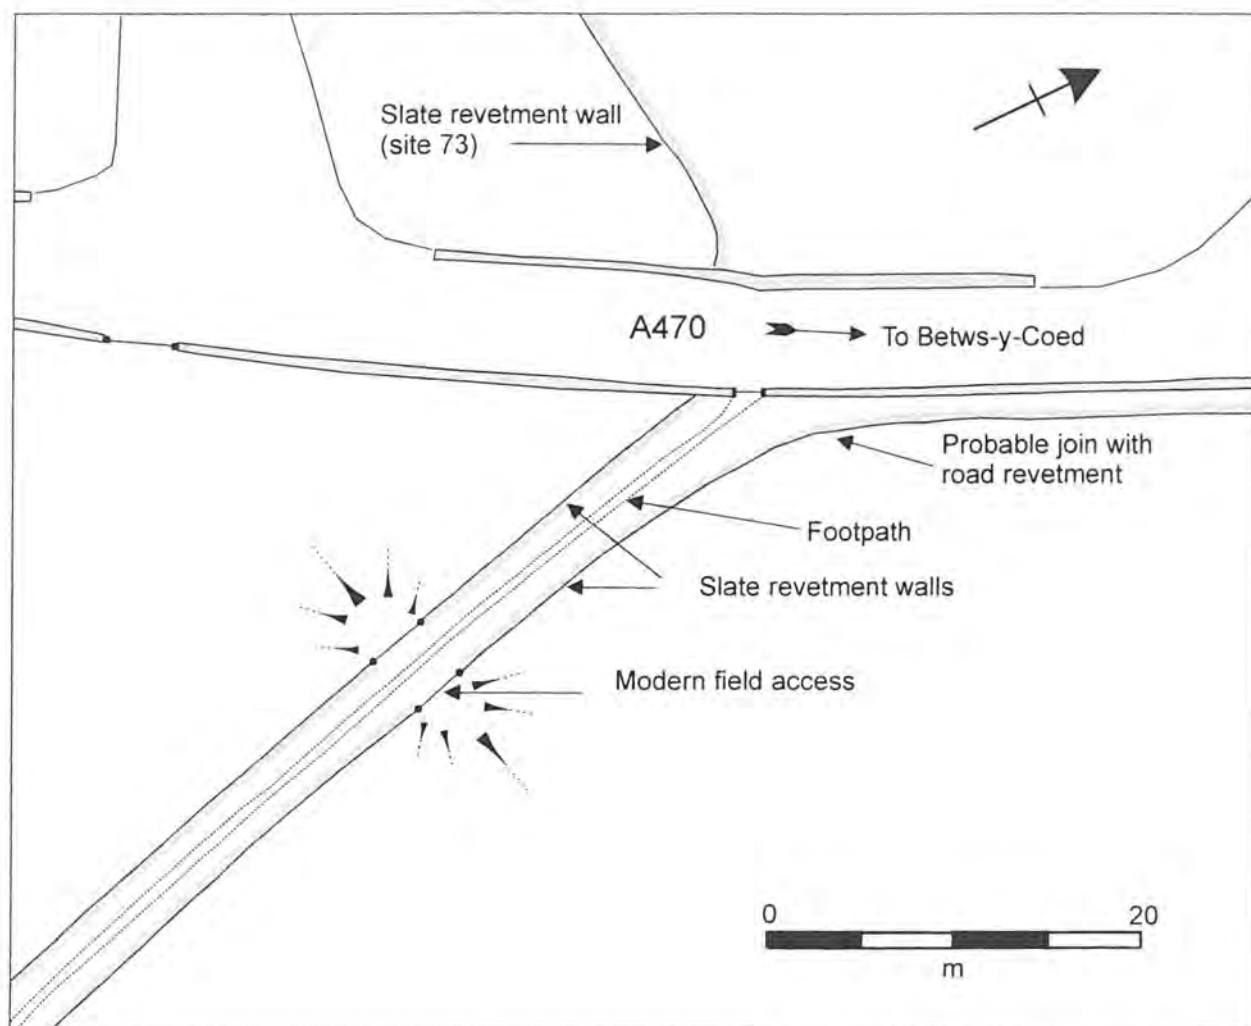
Fig. 4 Site 74, Tramway converted to footpath and location of site 73

The tramway adjacent to the road (Fig. 4) is revetted on both sides by a 1.0m high wall constructed from poor quality slate, much of which has decayed into a very soft product. The road revetment to the north-east appears to be of a similar construction and no definite straight joint or discontinuity could be seen between the two walls. There is however a semi-collapsed area of facing close to the road where the wall changes direction somewhat abruptly which may mark the point where the two walls meet. The raised area of the tramway is 2.6m wide. A modern field access has been constructed at a point 21m from the road by slightly reducing the height of the revetment walls and adding rough ramps to both sides of the tramway.

*Recommendations for further mitigatory measures:* Watching brief in order to record any constructional details

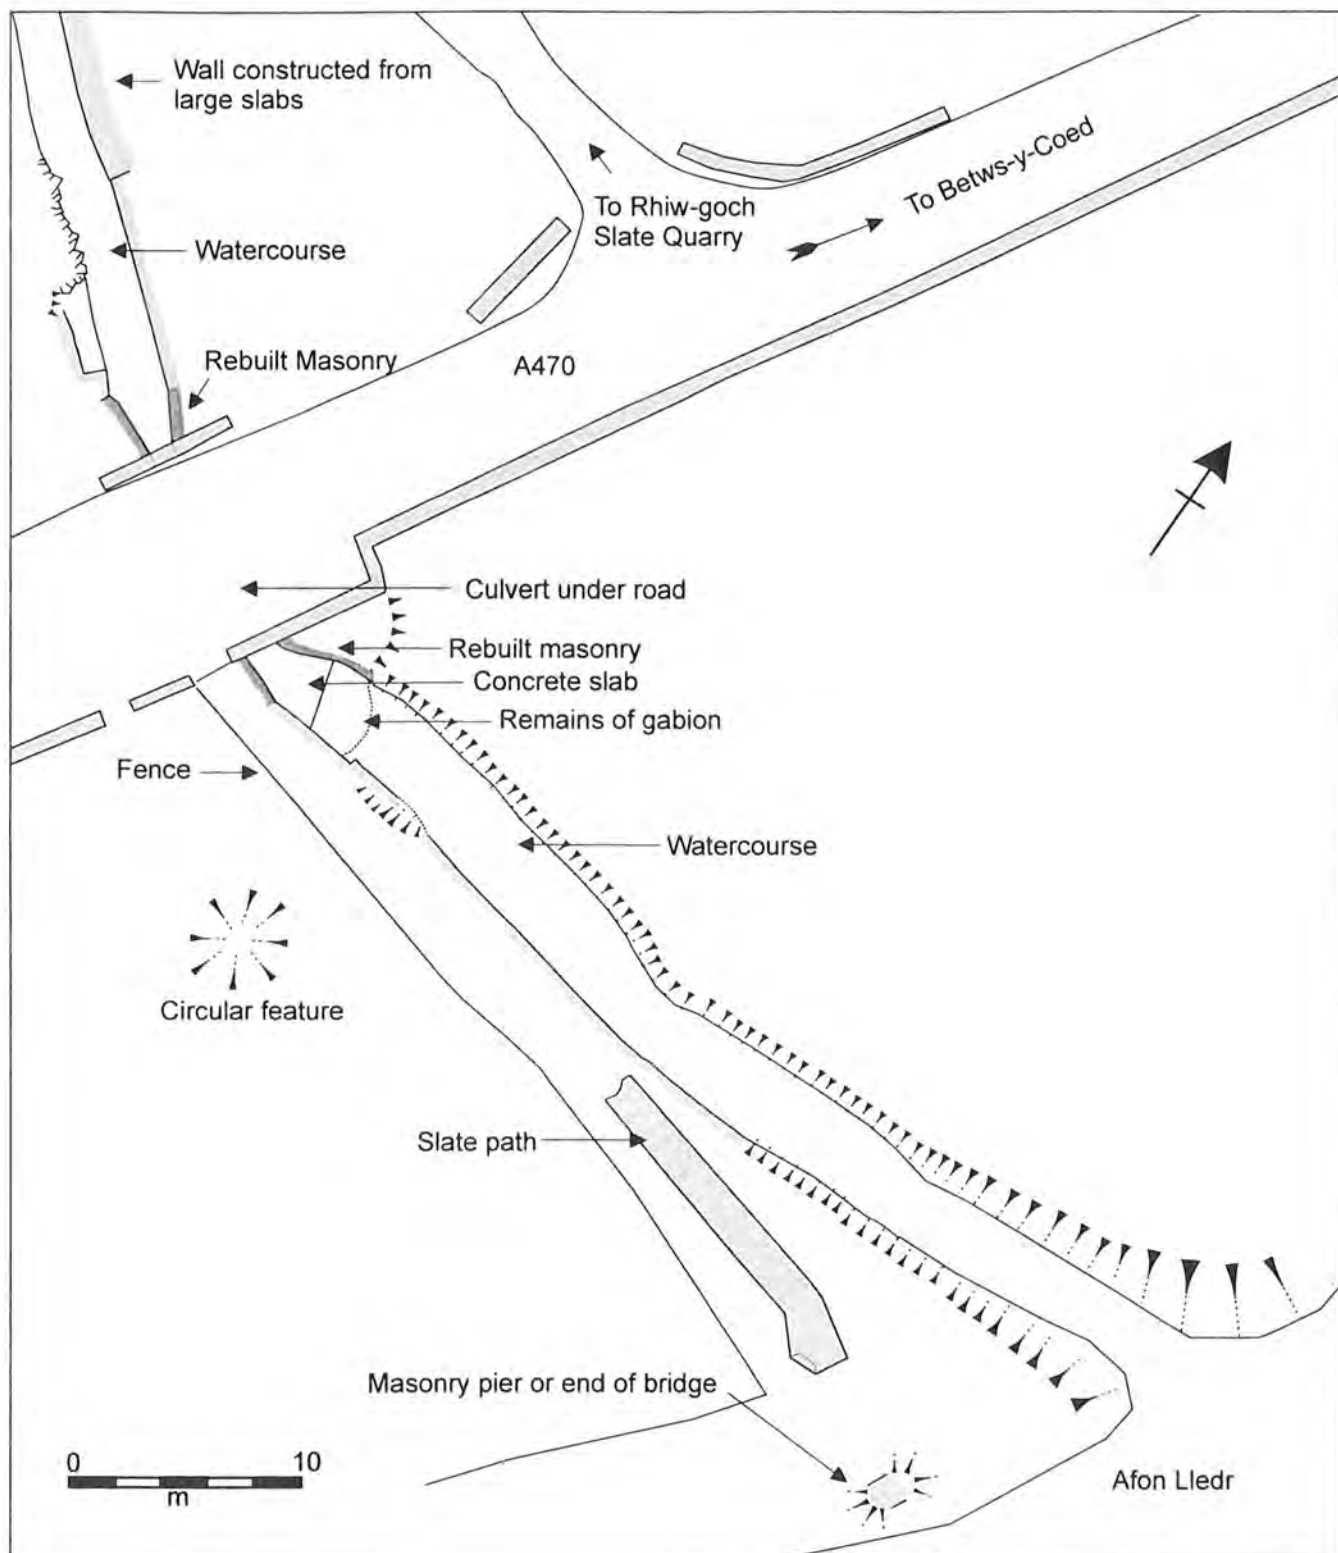
Fig. 5 Site 79, remains of culvert and bridge

A watercourse or leat runs from the remains of Rhiw Gôch slate quarry to the Afon Lledr and passes under the road via a culvert (Fig. 5). The majority of the edge of the leat is flanked by drystone revetment walls suggesting that it is entirely artificial as opposed to a modified natural stream. The culvert under the road is a recent pre-cast concrete construction. The leat walls adjacent to the culvert were also rebuilt at this point. A concrete slab and the remains of a gabion are also visible in the bed of the leat. Elsewhere the original masonry is standing to a height of around 0.9m. The area to the north-west of the road has been extensively landscaped and an incline from the quarry has been converted into a track.

The leat walls to the south-east of the road have been badly eroded in places resulting in several serious collapses. Part of a raised slate pathway can be seen adjacent to the leat 24m to the east of the road. This is standing to a height of 0.5m and is 1.6m wide. It is flagged with large slate slabs running the entire width of the path. This can be traced for 16m at which point it appears that the path was carried towards and presumably over the river on stone piers.

*Recommendations for further mitigatory measures:* Watching brief.

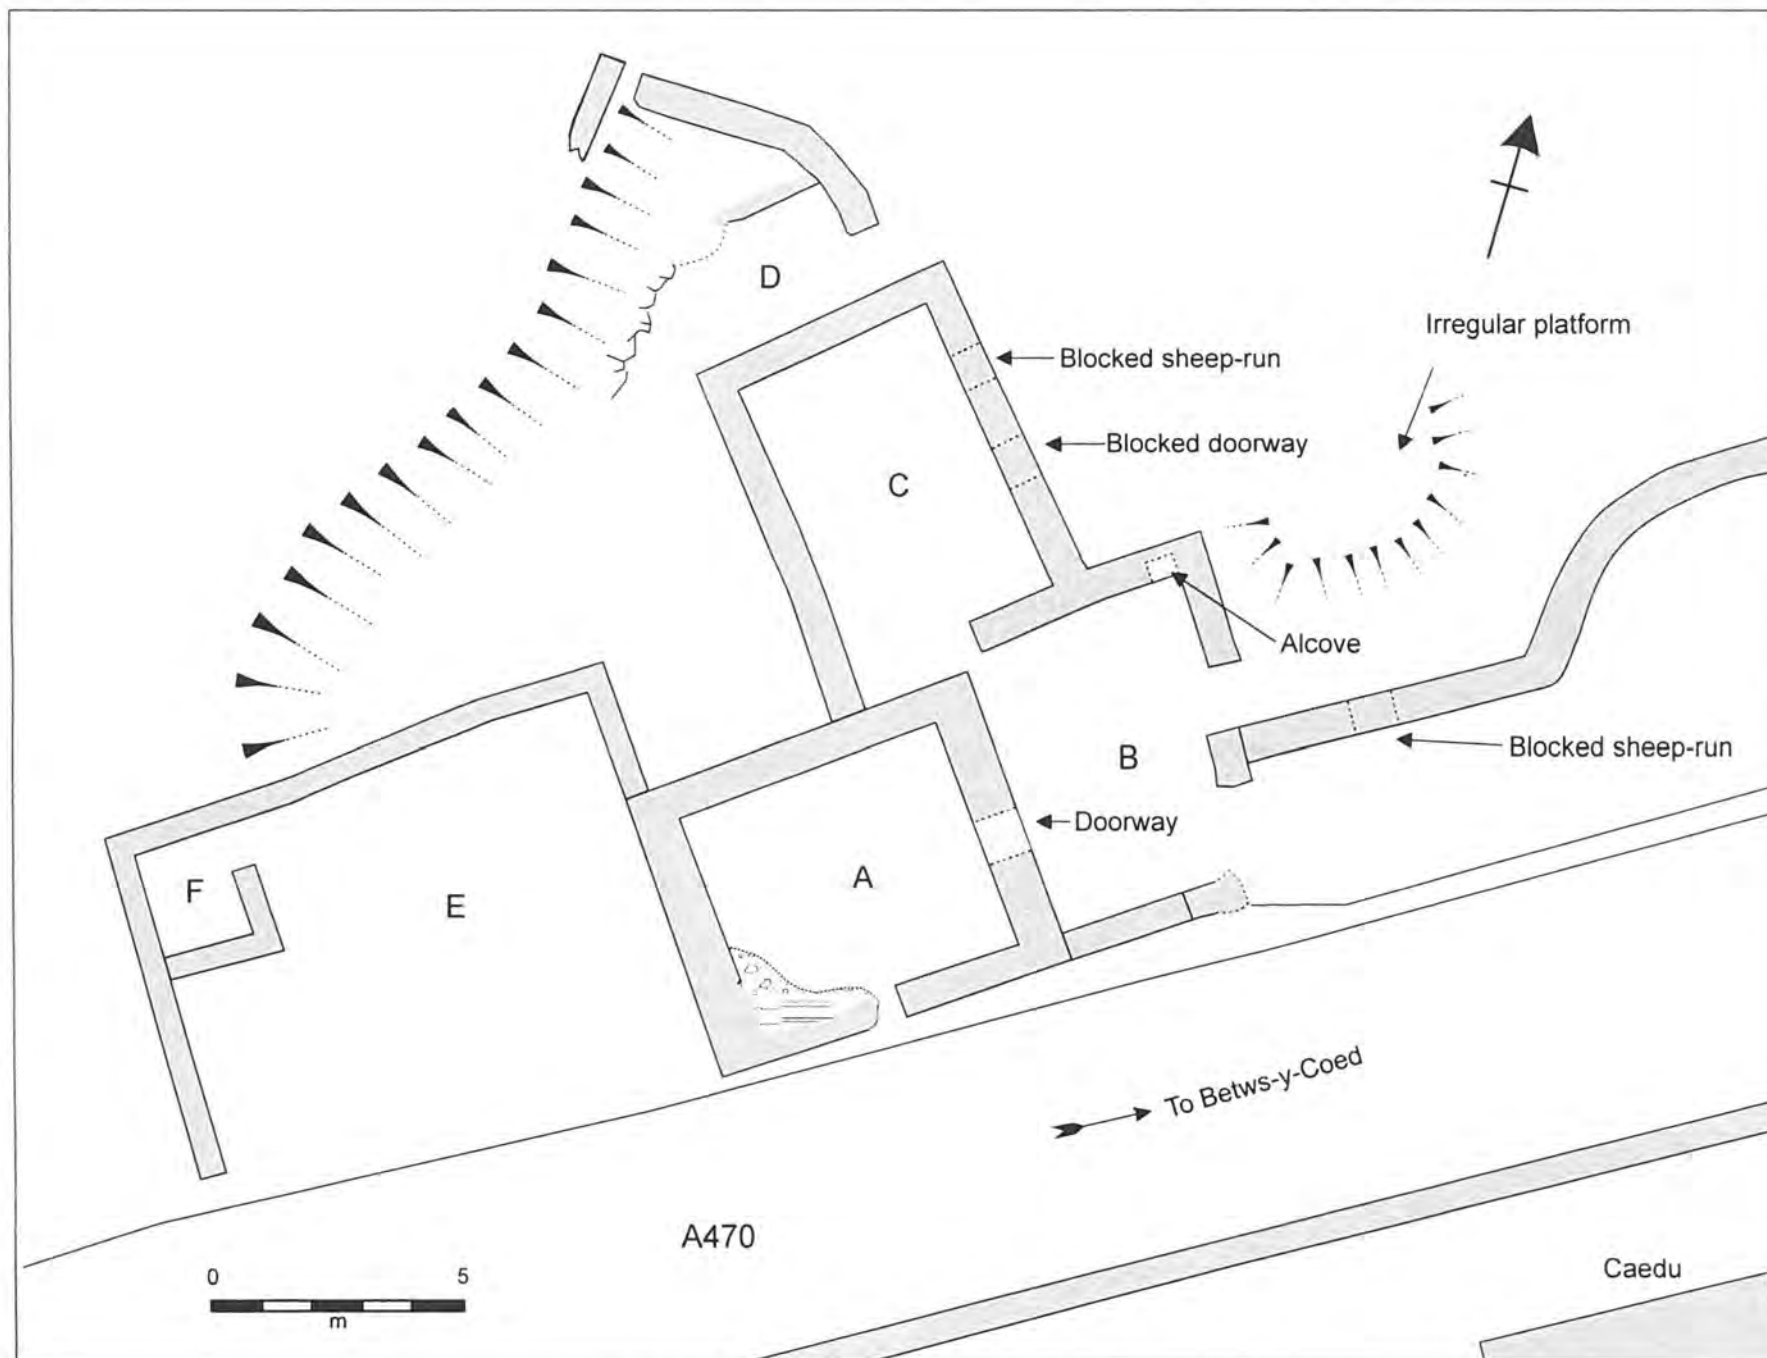
Fig. 6 Site 86, ruined building and sheep pens

Compartment A is a former agricultural building with internal dimensions of 5.5m x 4.4m and a 0.95m wide and 1.65m high entrance in the north-eastern wall. The masonry in this building is much more substantial than in the other sheepfolds. The walls stand to a height of close to 2.0m and are constructed from large blocks of stone interspersed with smaller slate slabs. The end walls are 0.9m thick and the side walls 0.7m thick. The southern corner of the building has been partially destroyed, probably by a road traffic accident.

*Recommendations for further mitigatory measures:* Watching brief on platform to the north-west of compartment C.

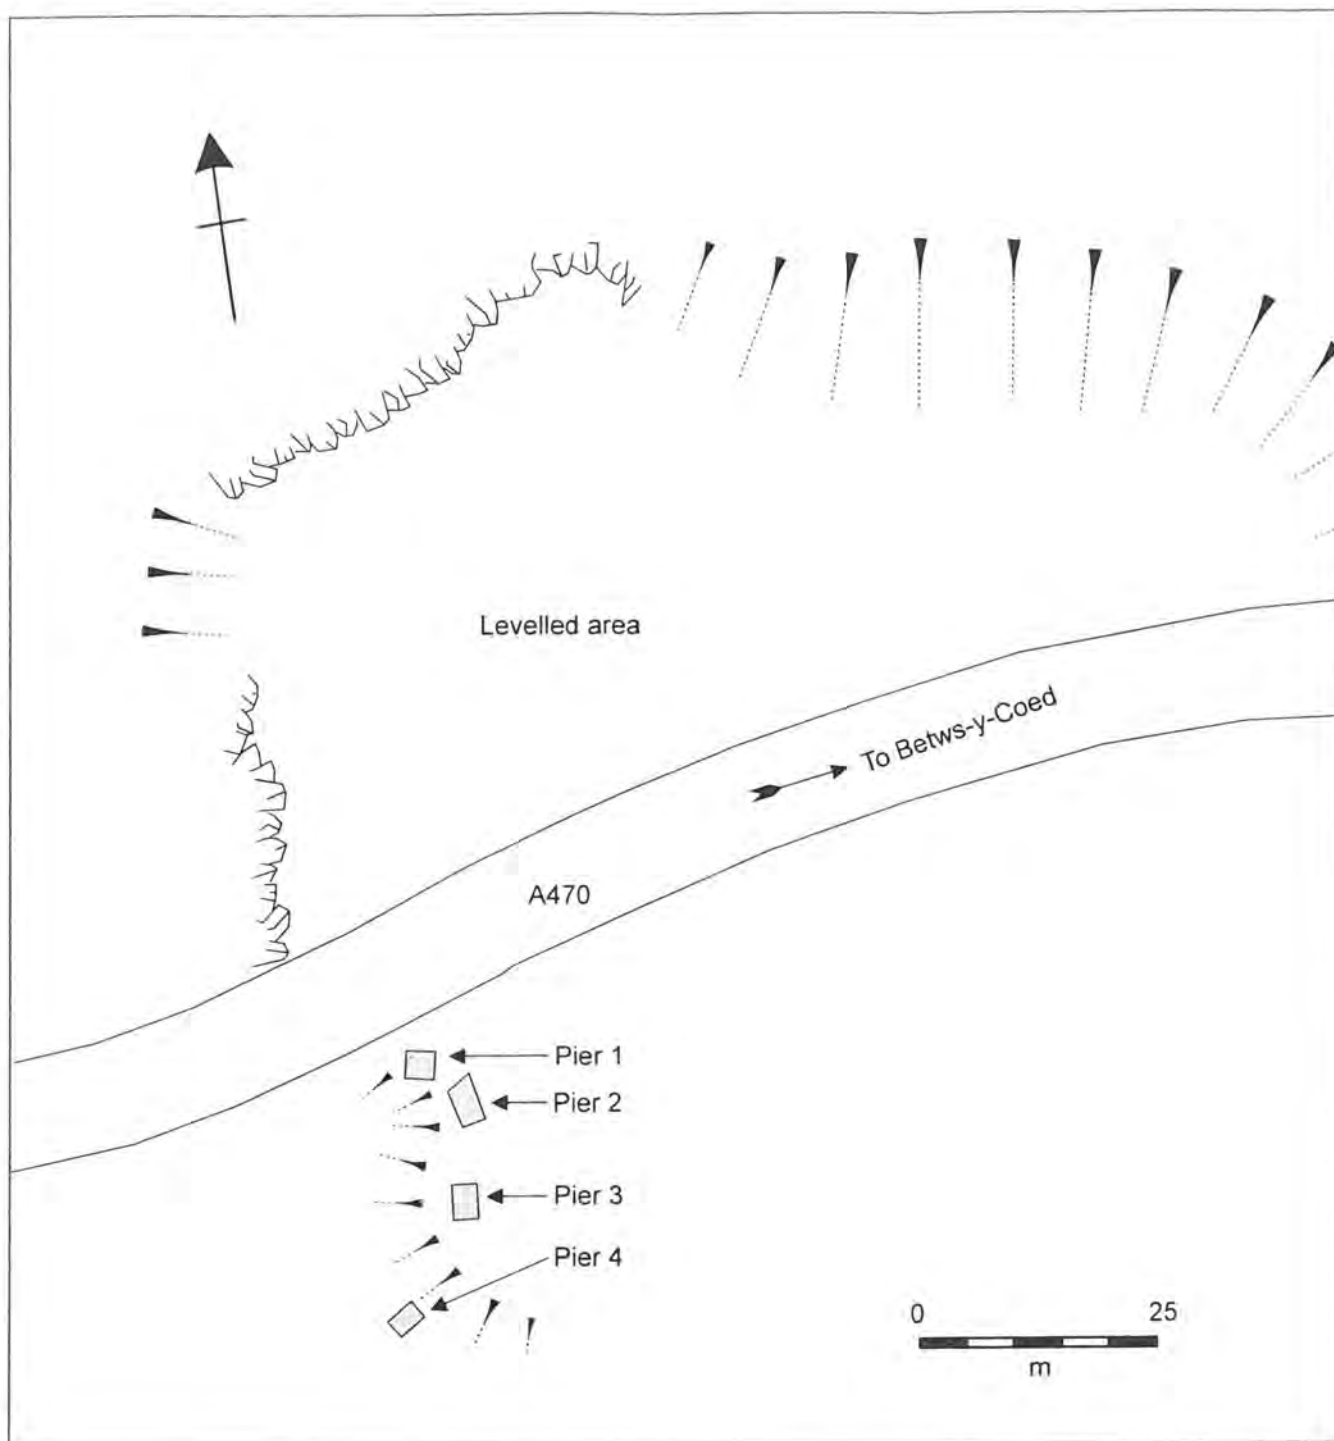
Fig. 8 Site 91, four stone piers

Four stone piers stand on a rocky outcrop just to the south of the A470 (Plate 9 and Fig. 8). Three are rectangular in plan and one is subrectangular. All are constructed from a mixture of roughly mortared slate, rhyolite and other stone. Each pier is capped with very coarse unshuttered concrete. The piers form a roughly semicircular alignment.

Pier 1 stands to a height of 2.2m and has dimensions of 1.5m x 1.4m in plan. The north-western corner has begun to collapse and only stands to a height of 1.5m.

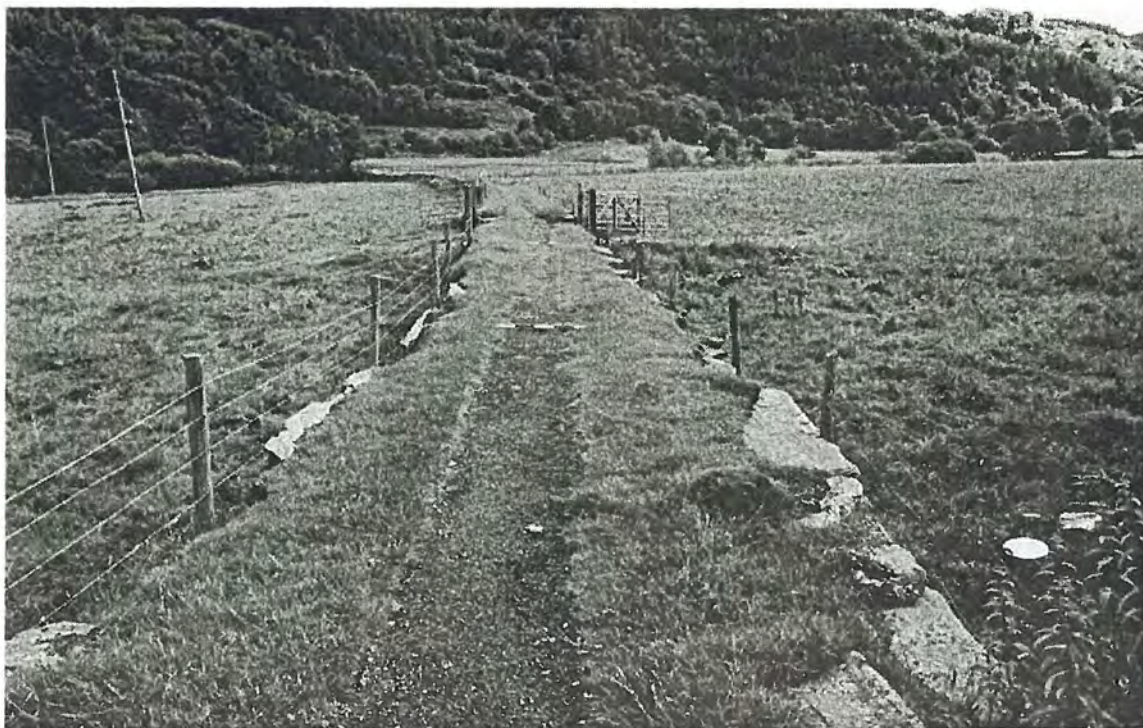
The revetment walls were photographed in 2m sections between the field access and the road. The photographs were catalogued and have been retained in the archive. Plate 1 shows a view along the tramway from the road.

Plate 1. Site 74; view along tramway from the road

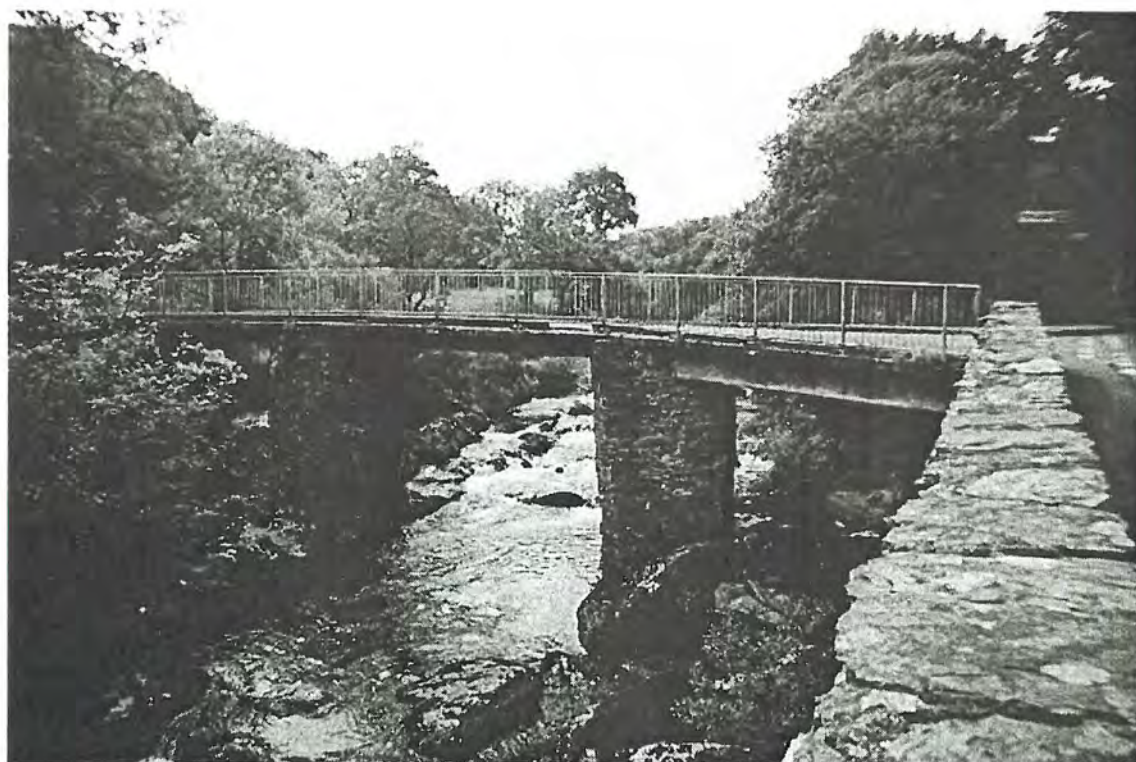
This bridge was formerly a listed building but was later removed from the list presumably as the original structure has largely been replaced by two steel girders and a reinforced concrete roadway (Plate 2). The stone piers are all that remain of the earlier bridge and these will not be affected by the road improvements. General photographs were taken of the bridge but no further recording was undertaken.

Plate 2. Site 83, Pont-y-Pant, showing rebuilt roadway

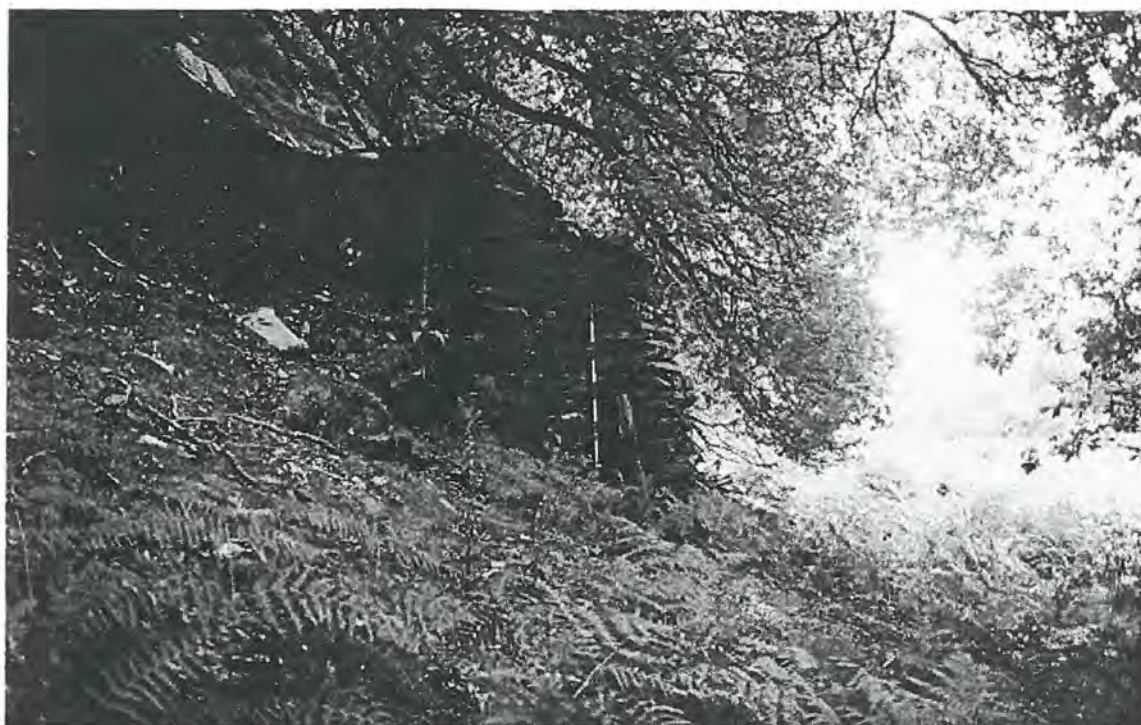
The surviving northern wall is 0.9m thick and stands to a height of 3.0m on a very steep slope. The end of the wall is battered back. The wall continues up the slope for close to 40m but has completely collapsed in several places. The masonry consists of large slate slabs built to a good face. Two trees and a barely perceptible bank adjacent to the road may mark a continuation of the line of the wall to the road. The stone from this section may have been reused in the present road wall.

Plate 3. Site 84, northern wall

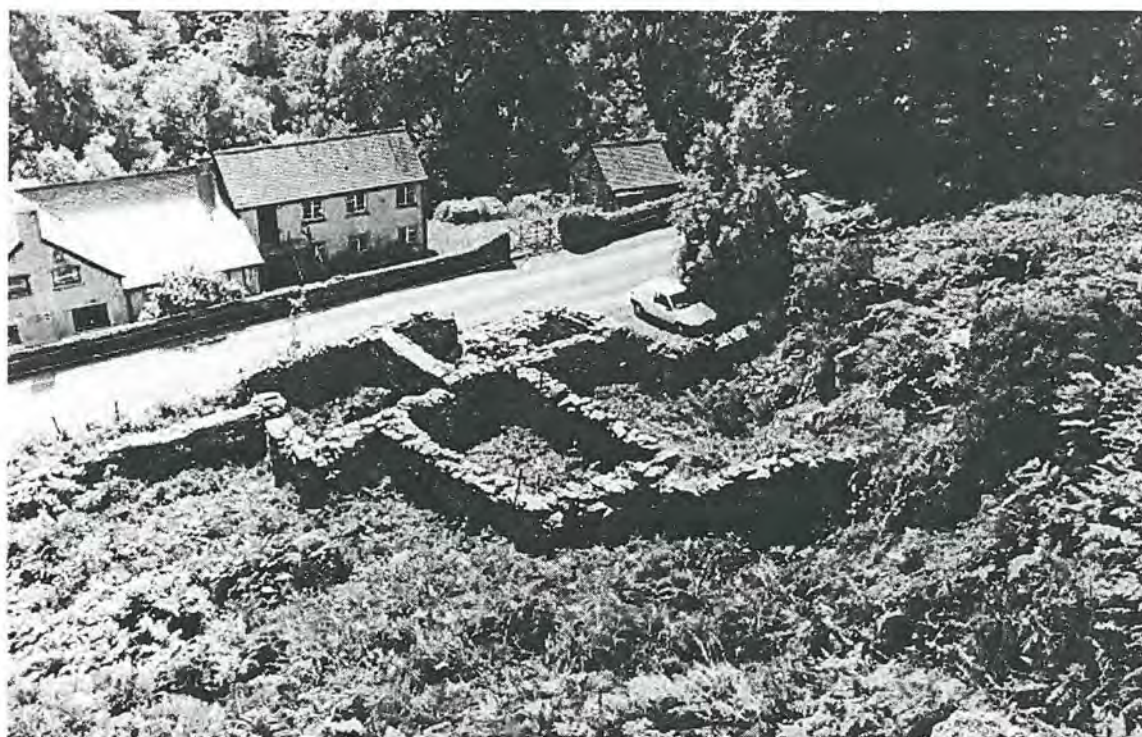
A complex of sheepfolds, centred around an earlier agricultural building, stand on the north side of the A470 opposite Caedu (Plate 4 and Fig. 6). A detailed survey was undertaken based on offsets from known points taken from the Longdin and Browning 1:500 plan. The results are shown on Fig. . Each of the six compartments was allocated a separate letter in order to simplify the descriptions and photographic records.

Plate 4. Site 86, sheep pens etc

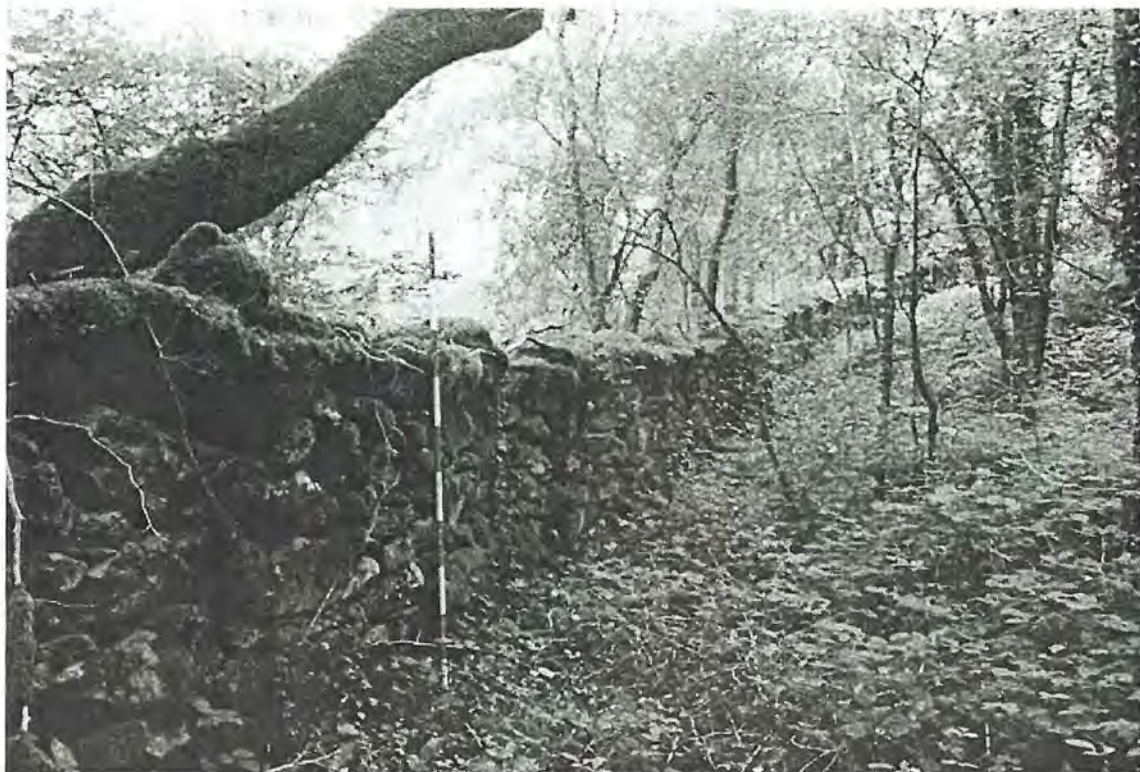
The wall runs through almost impenetrable undergrowth for much of its length. The wall was accessible in the valley bottom at about SH76255402 (Plate 5). At this point the wall stands to a height of around 1.6m and is 0.6m wide. The masonry is built to a rough face from large sub-rounded stones. It appears that little of the wall apart from that immediately adjacent to the road, will be affected by the road improvements. Photographs were taken at the point where the wall abuts the road wall but the masonry was almost completely obscured by dense foliage.

Plate 5. Site 87, wall in valley bottom

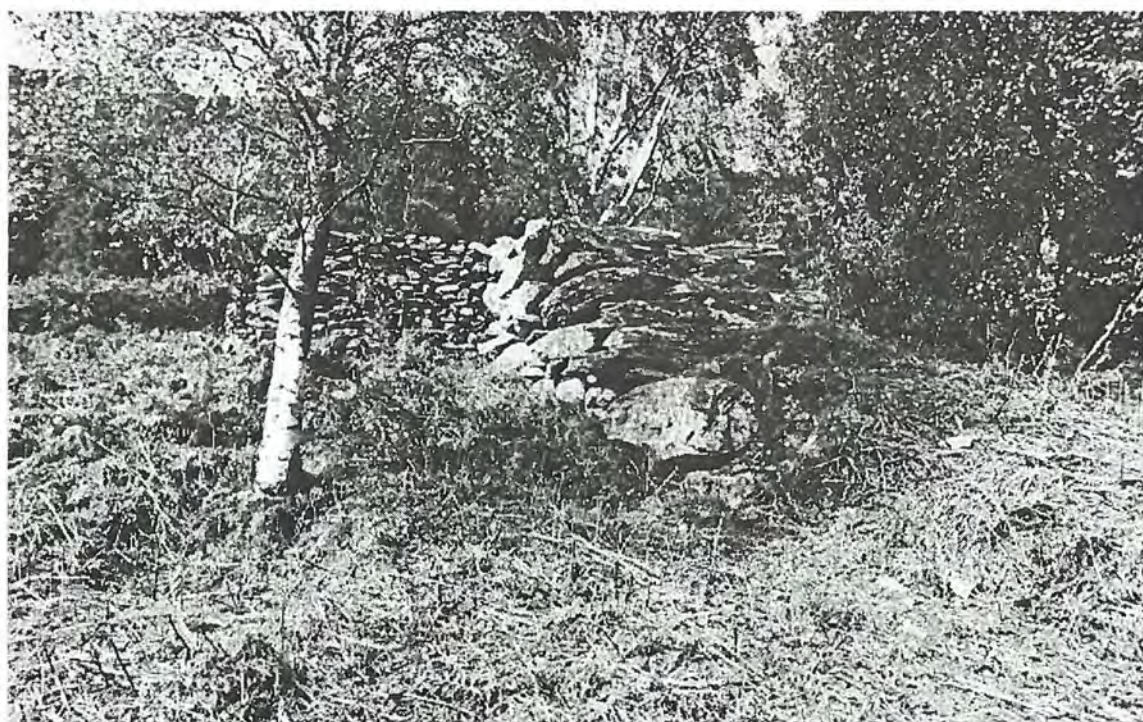
The raised barrow run from the quarry runs to a drystone ramp or small incline (Plate 6). This structure stands to a height of 2.0m at its northern end and has dimensions of 9.3m x 2.9m. The northern half of the structure originally formed a level platform. This was subsequently partially dismantled in order to build a rectangular shelter (Plate 7). The southern half of the structure forms a steep ramp running down towards the road at an angle of about 40°. The end of the ramp runs into a 13m long chute, now entirely grassed over.

Plate 6. Site 89, stone ramp

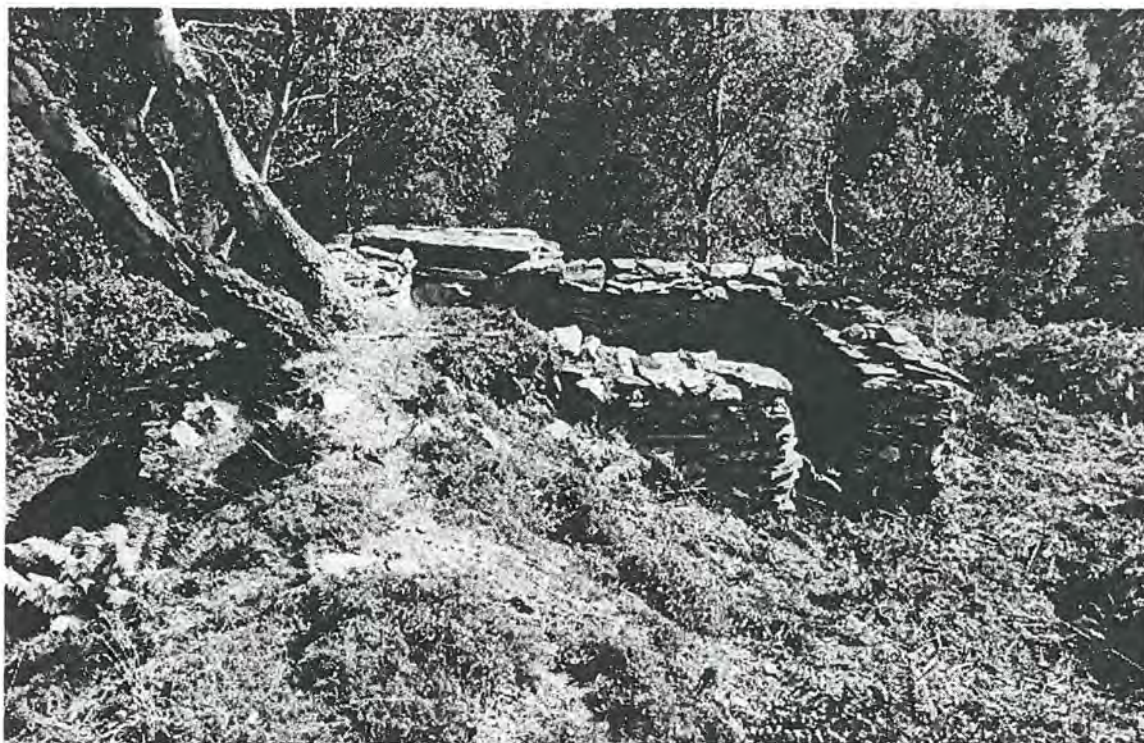
The later shelter cut into the stone ramp presumably post-dates the other structures, as the ramp and therefore the barrow run, chute and loading bay would have been rendered inoperative by its construction.

Plate 7. Site 89, barrow run and later shelter.

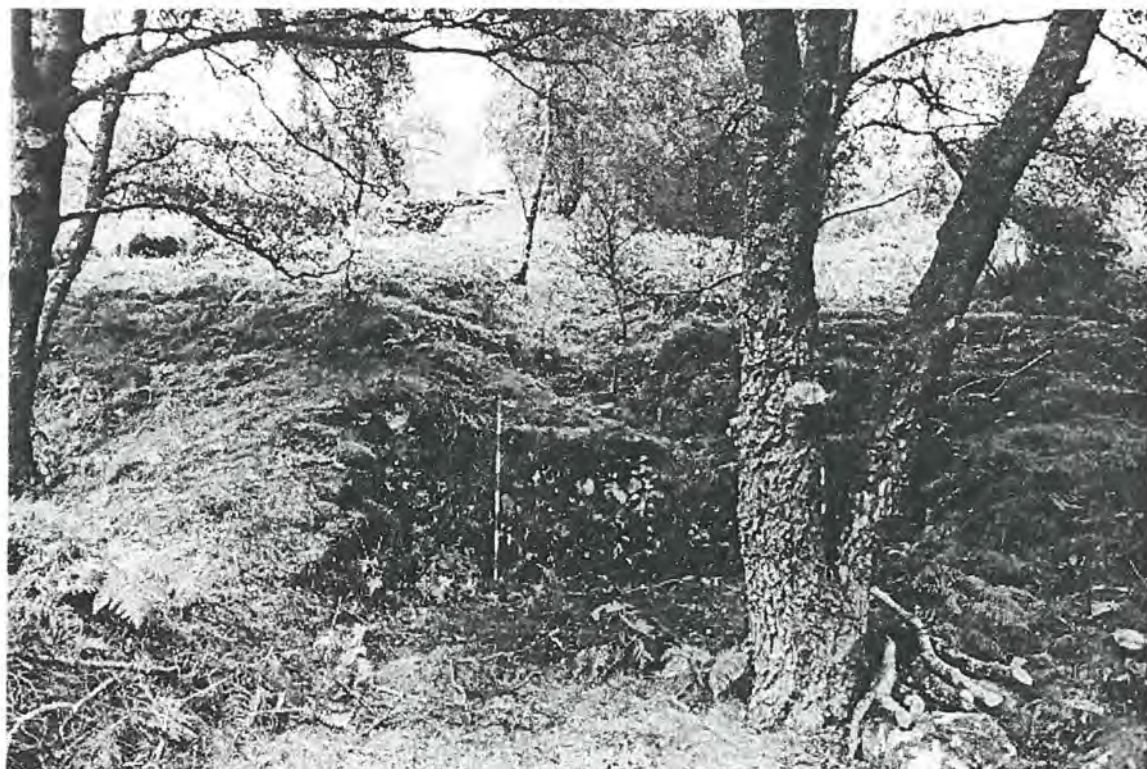
A loading bay with dimensions of 4.9m x 5.9m has been cut into the slope below the ramp (Plate 8). A drystone revetment wall standing to a height of 1.6m forms the back wall of the bay.

Plate 8. Site 89, loading bay

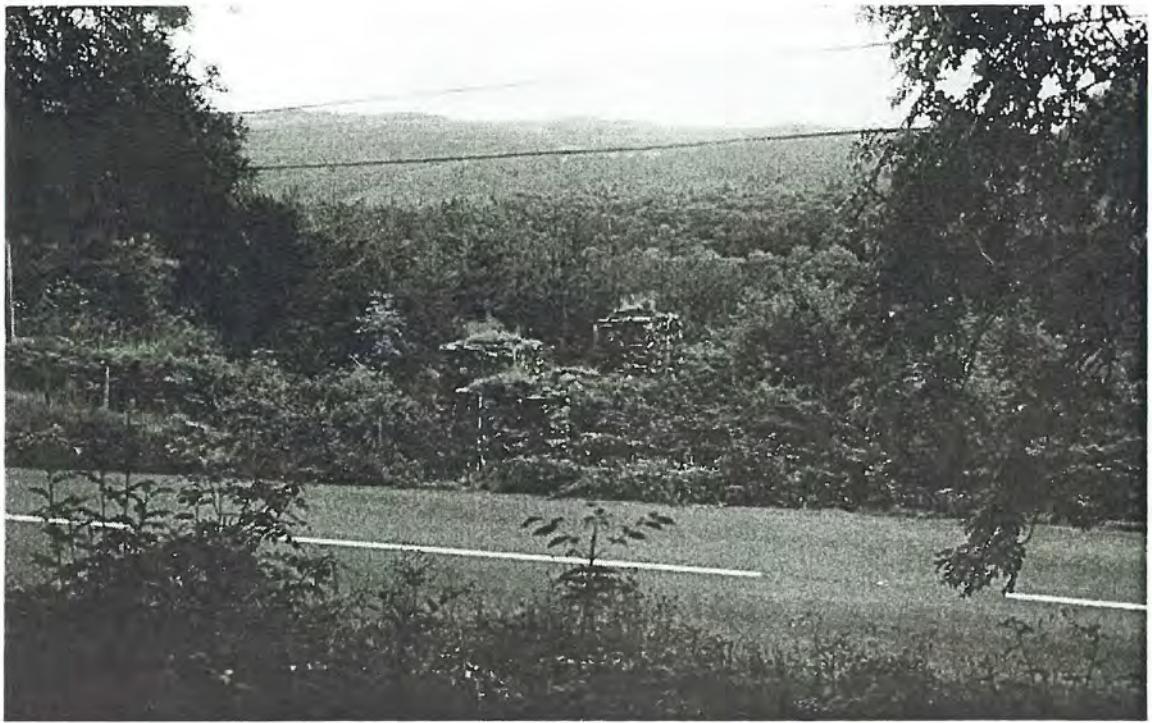
Plate 9. Site 91, piers 1 to 3

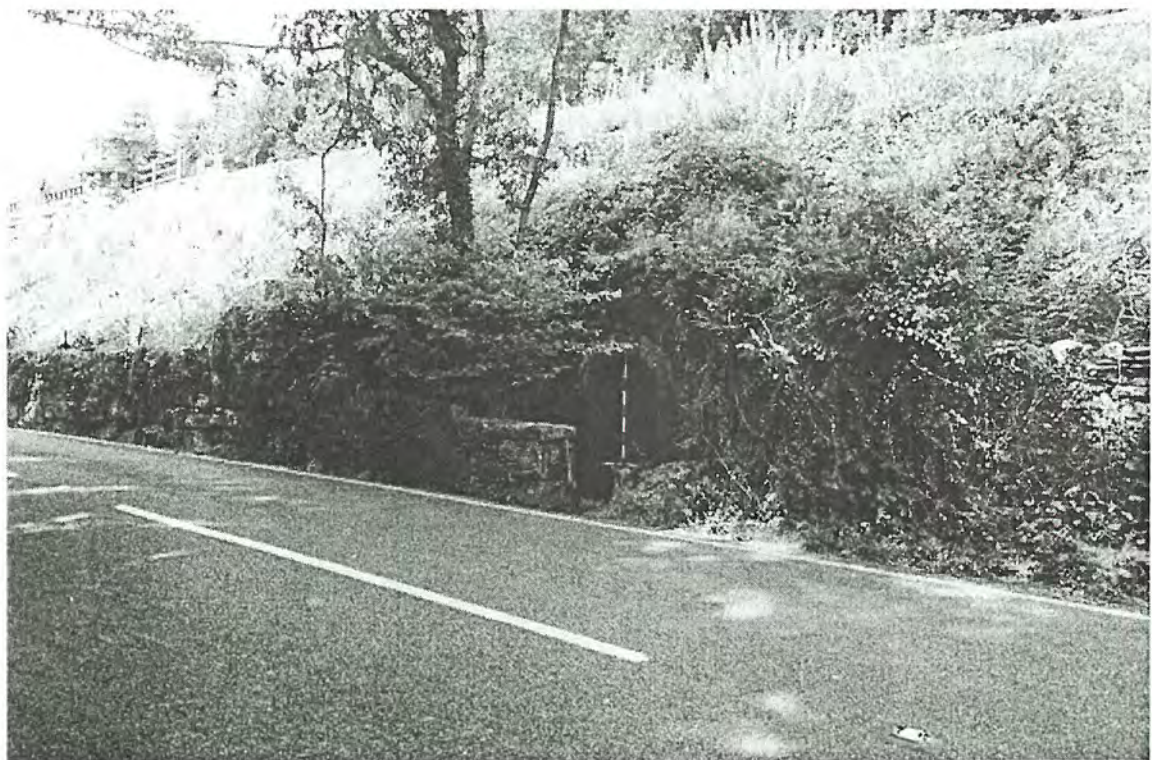
Plate10. Site 93, Culvert beneath the viaduct

*Recommendations for further mitigatory measures:* Avoidance of damage to culvert under the embankment.

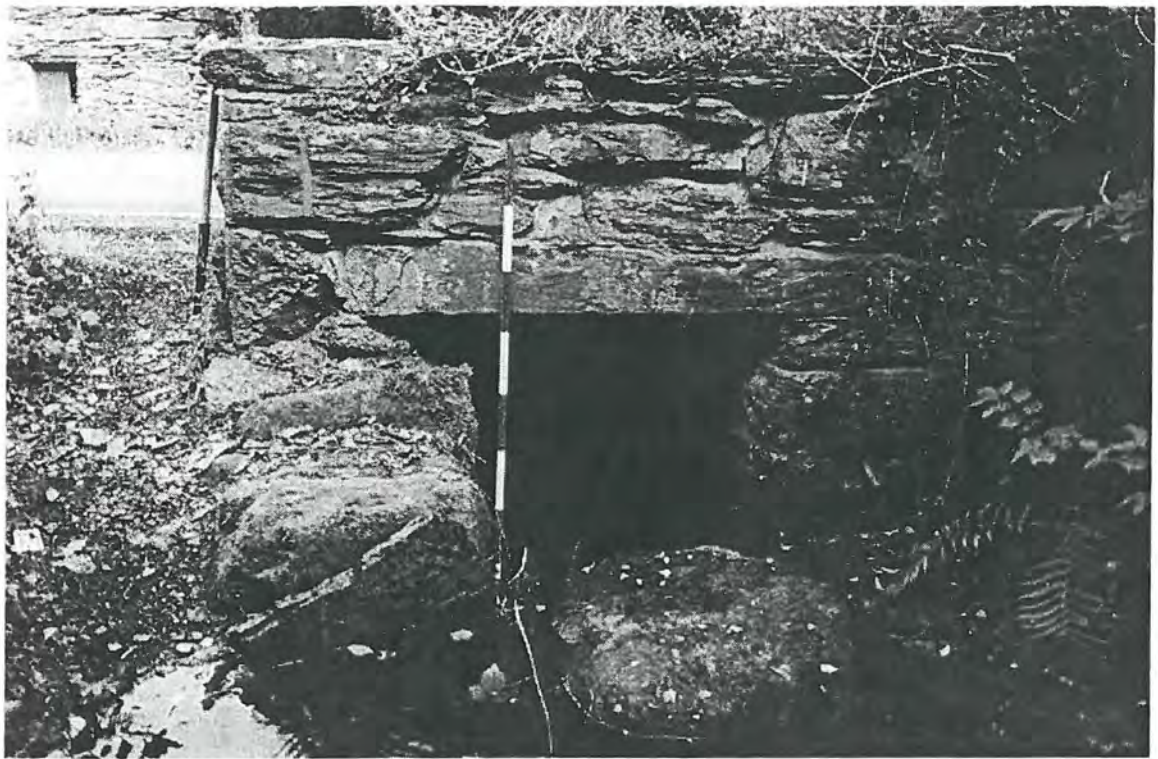
Plate 11. Site 93, culvert beneath the road
