A470(T) DOLWYDDELAN TO  
PONT-YR-AFANC IMPROVEMENT

ARCHAEOLOGICAL RECORDING

Report number : 345

Ymddiriedolaeth Archaeolegol Gwynedd  
Gwynedd Archaeological Trust

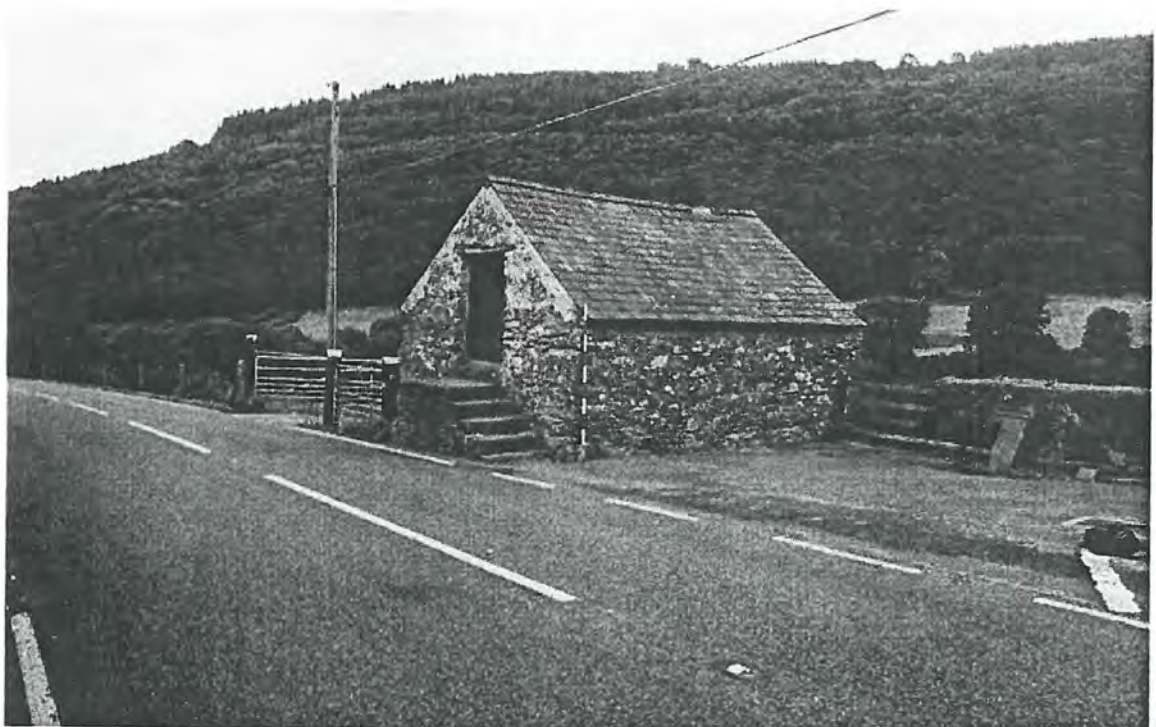
Plate 12. Site 94, building opposite Tan-yr-Allt

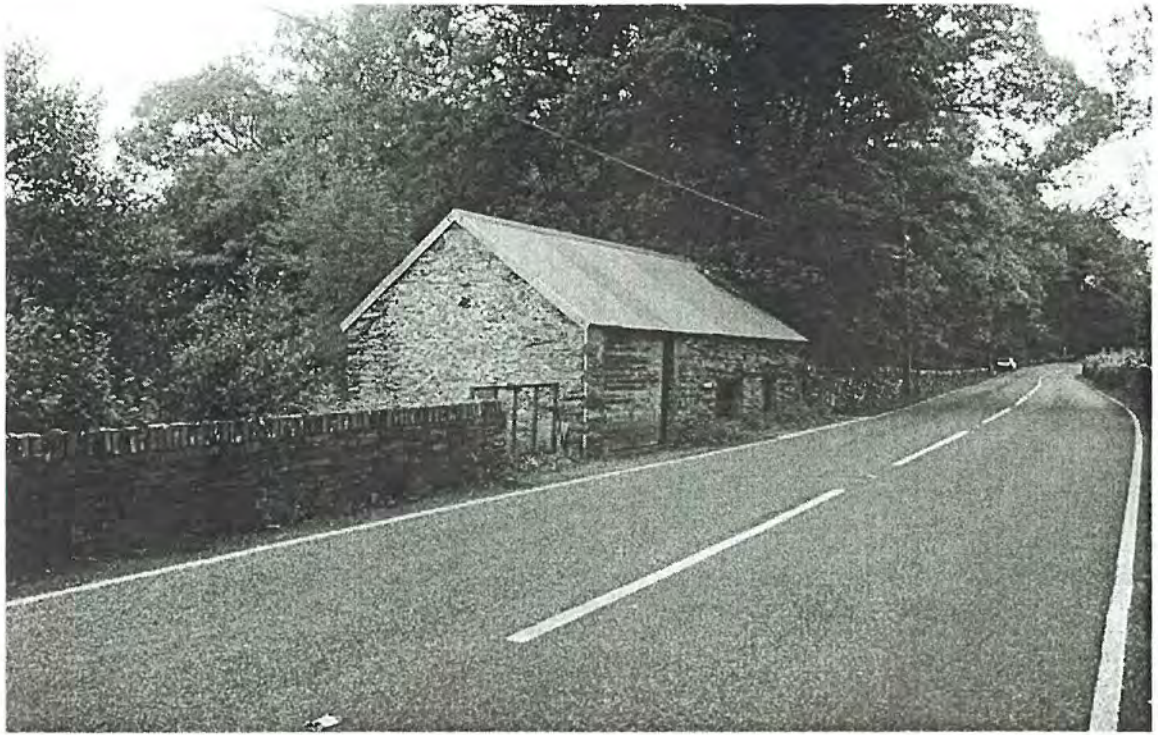
Plate 13. Site 94, building to the west of Tan-yr-Allt

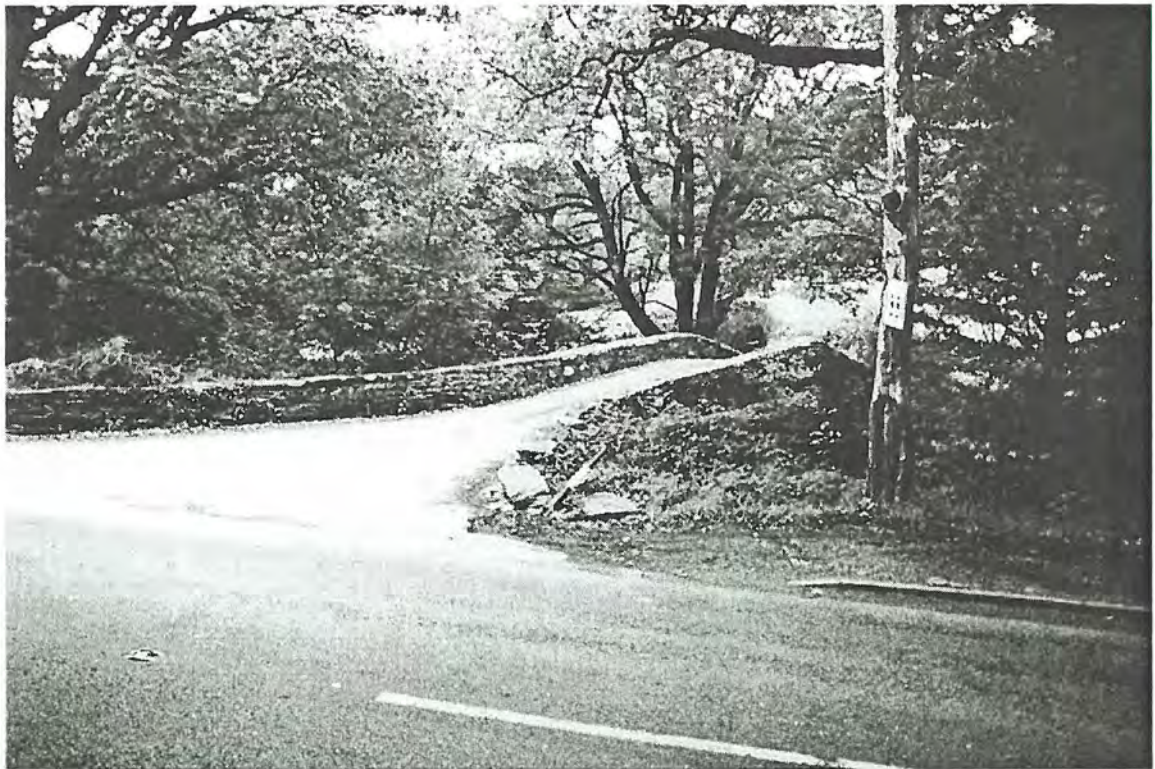
The north-eastern wing wall is in good condition but showing evidence of several repairs. The inner face stands to a height of 0.8m and consists of mortared stone with a coping of large flat slabs. The wing wall joins to the later road wall at a point 1.3m beyond a post box set back from the side of the bridge. The end of the opposite wing wall has been destroyed and is now marked by a line of rubble.

Plate 14. Site 99, Pont-ar-Lledr, general view showing wing walls
