TRE'R CEIRI MONITORING VISIT

7TH JUNE 2000

Report number : 365

Ymddiriedolaeth Archaeolegol Gwynedd
Gwynedd Archaeological Trust

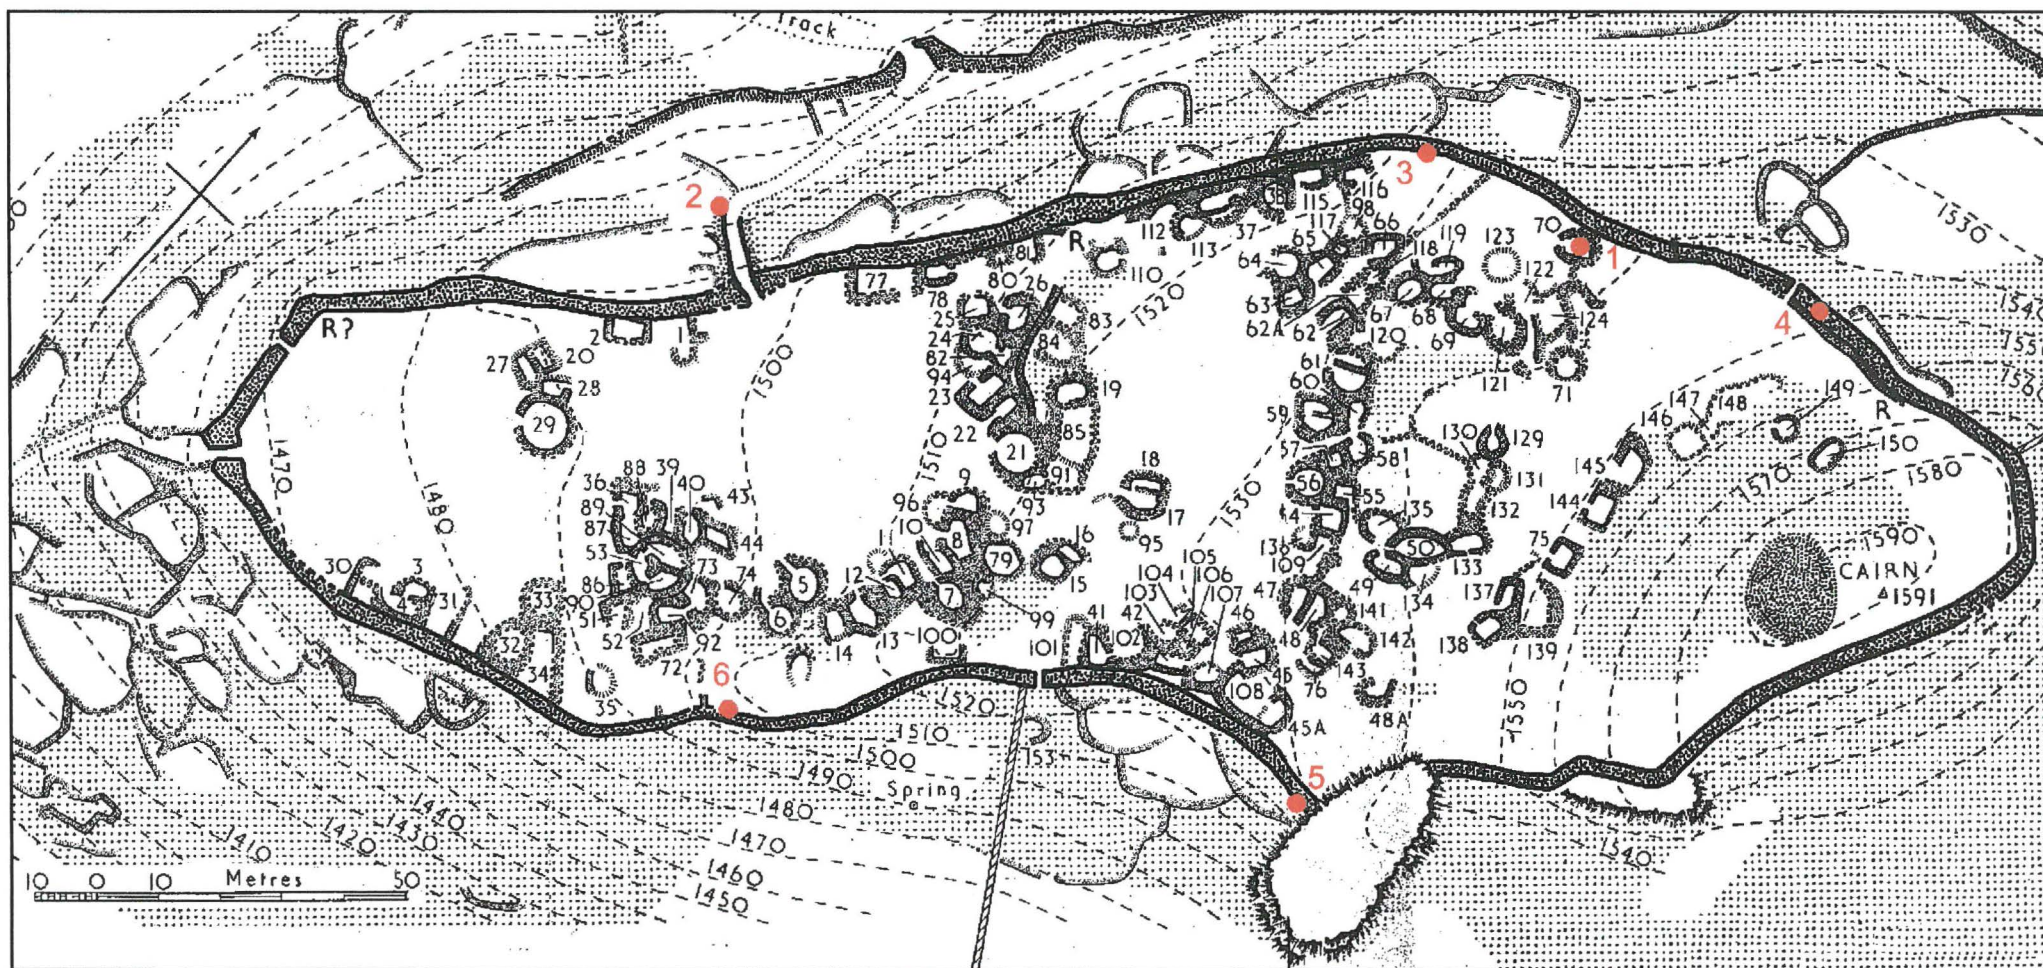
1. A 0.2m deep hole, with dimensions of 0.2 x 0.3m, had been dug into the floor of hut 70. The hole had been dug into material that had been reinstated during the 10th season of the conservation project and no *in situ* remains had been disturbed. The excavation extended to below the wall foundations and the stability of the northern wall of the hut was being threatened. The hole was therefore backfilled.

2. A single stone had been slightly displaced on the top of one of the outer flanking walls. This was in an area of original masonry and lichen growth patterns indicated the stone's original position. The stone was pushed back into place.

3. The action of visitors walking along the wall top had caused a patch of wall core to become loose. A few loose stones that were causing the instability were repacked into the core.

4. Two stones had been kicked off the end of the reinstated parapet. These were reset in order to stabilise the rest of the masonry.

5. A large stone in an area of reinstated masonry was balancing precariously on the edge of the outer rampart face. The stone appeared to have been pulled off by a visitor attempting to climb the rampart at this point. The stone was reset in its original position and the core was repacked behind it.

6. A loose stone on the inner face was stabilised by the addition of a single packing stone.

Fig. 1 Tre'r Ceiri (after RCAHMW 1960) showing points of instability identified in the June 2000 monitoring visit
