**MALLTRAETH TIDAL DOORS IMPROVEMENT SCHEME  
ARCHAEOLOGICAL RESEARCH, RECORDING AND MONITORING PROGRAMME**

**GAT Project Number G1578  
GAT Report Number 367**

**June 2000**

**MALLTRAETH TIDAL DOORS IMPROVEMENT SCHEME  
ARCHAEOLOGICAL RECORDING AND ARCHIVAL RESEARCH PROGRAMME**

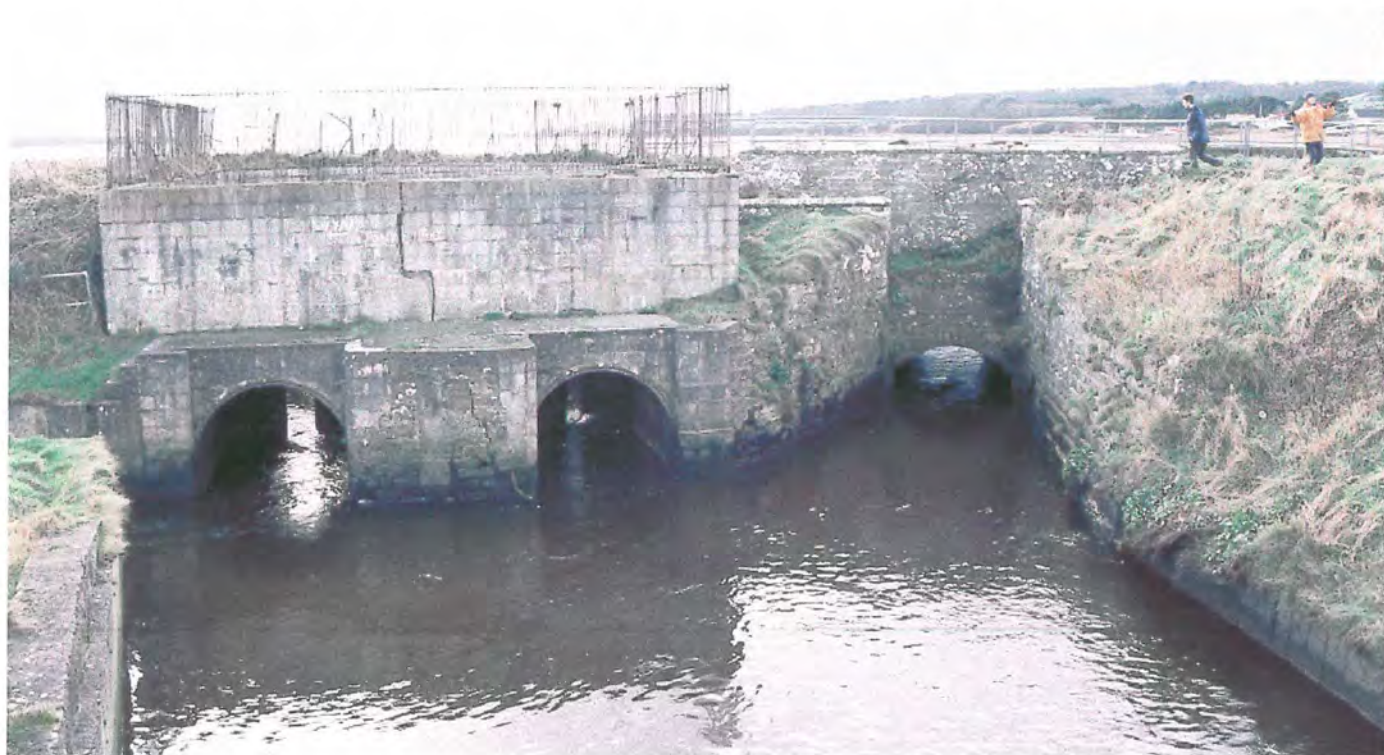
**G1578 MALLTRAETH TIDAL DOORS IMPROVEMENT SCHEME**  
**NEGATIVE NUMBER: colour transparency G1578/1/10**  
**SUBJECT: Tidal doors on south drain, north and south culverts. Facing south.**

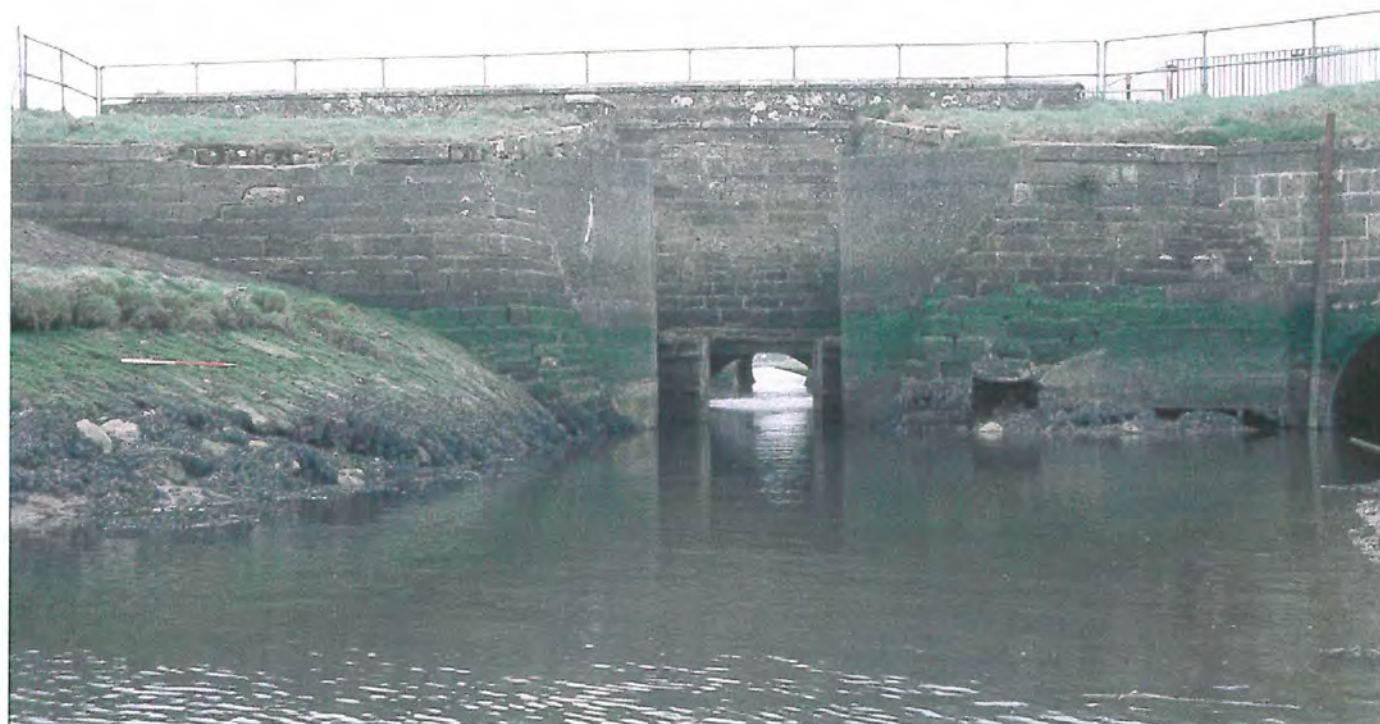
**NEGATIVE NUMBER:** colour transparency G1578/3/21

**SUBJECT:** Tidal doors on south drain, north culvert. Facing north.

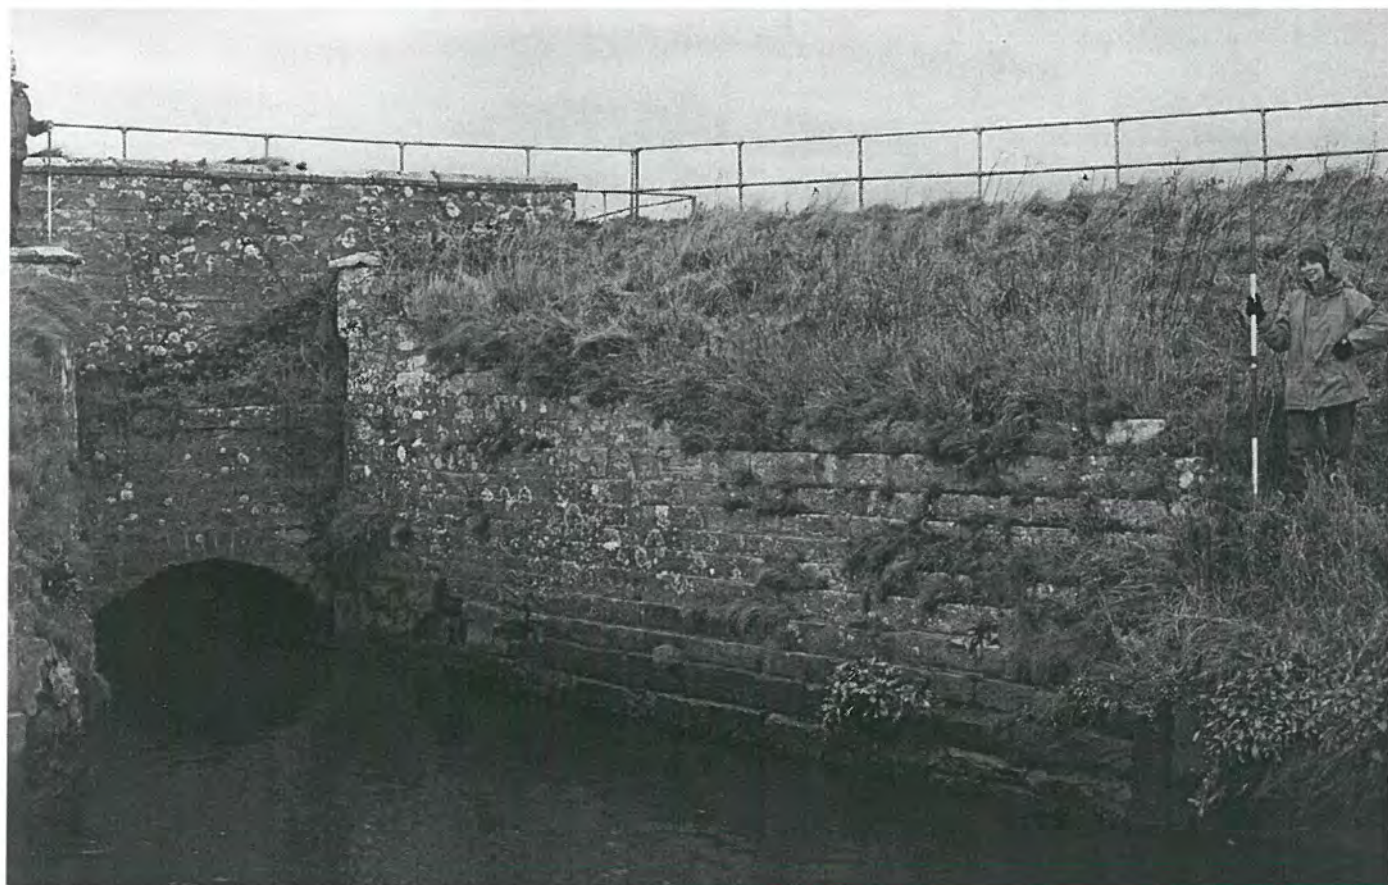
**G1578 MALLTRAETH TIDAL DOORS IMPROVEMENT SCHEME**  
**NEGATIVE NUMBER: b&w G1578/1/13**  
**SUBJECT: Stepped wing wall, north side of north culvert. Facing south west.**

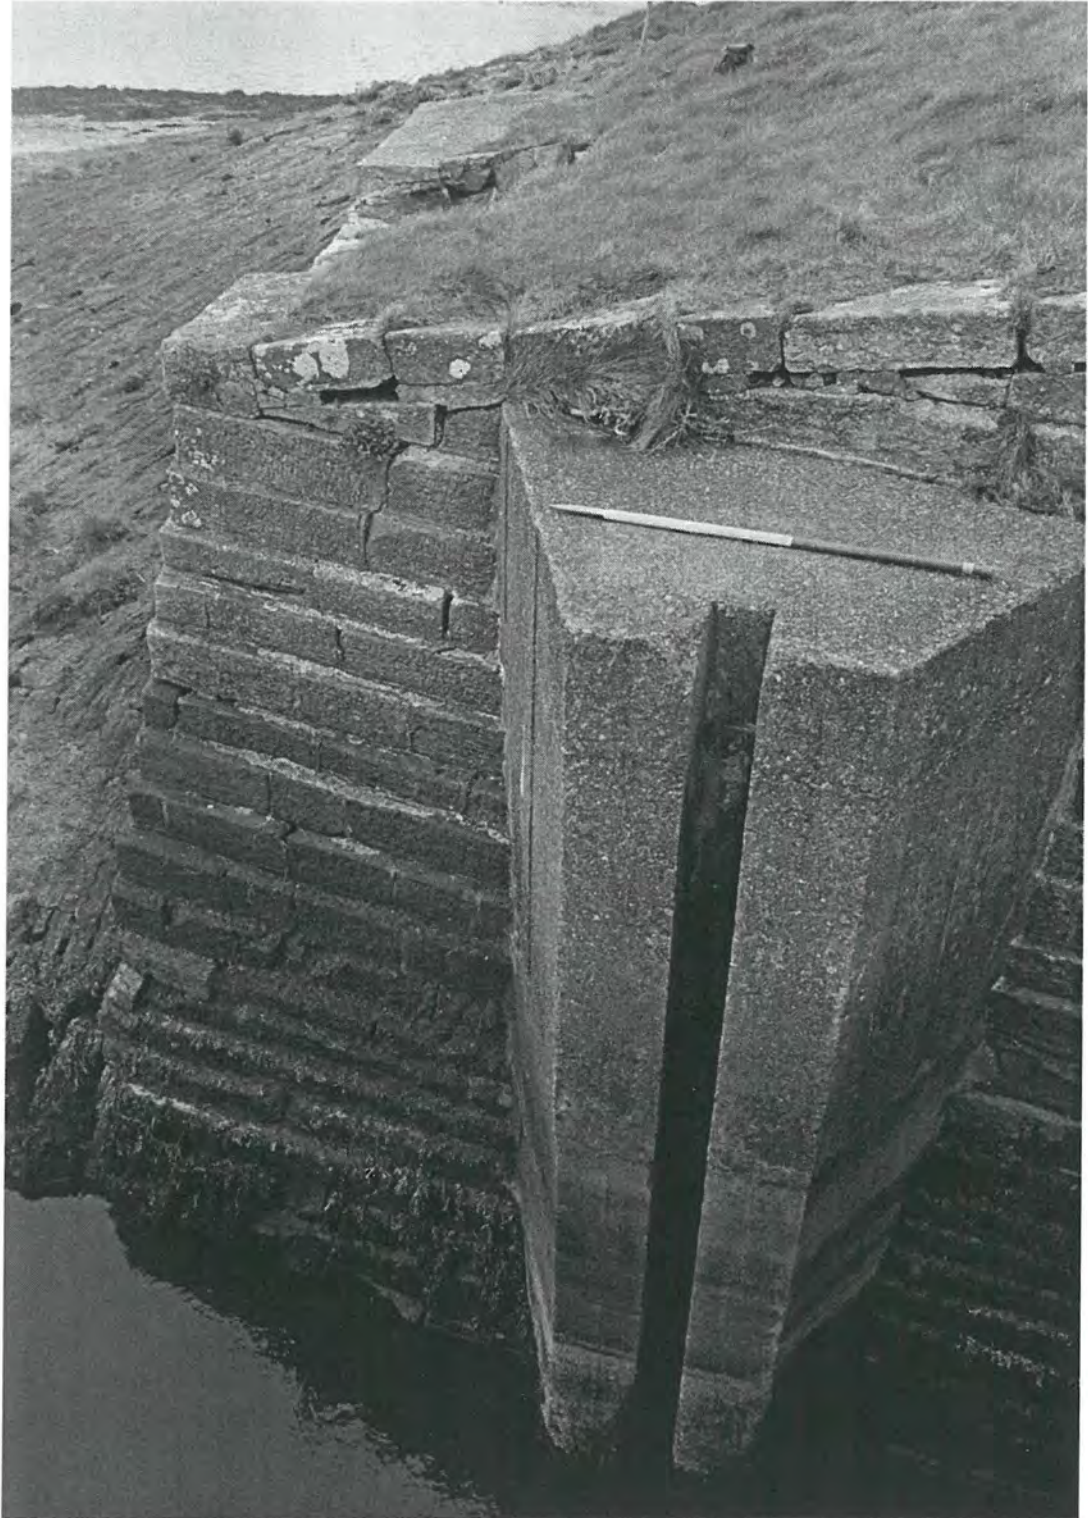
**NEGATIVE NUMBER: b&w G1578/2/22**

**SUBJECT: Stepped wing wall, south side of north culvert. Facing south west.**

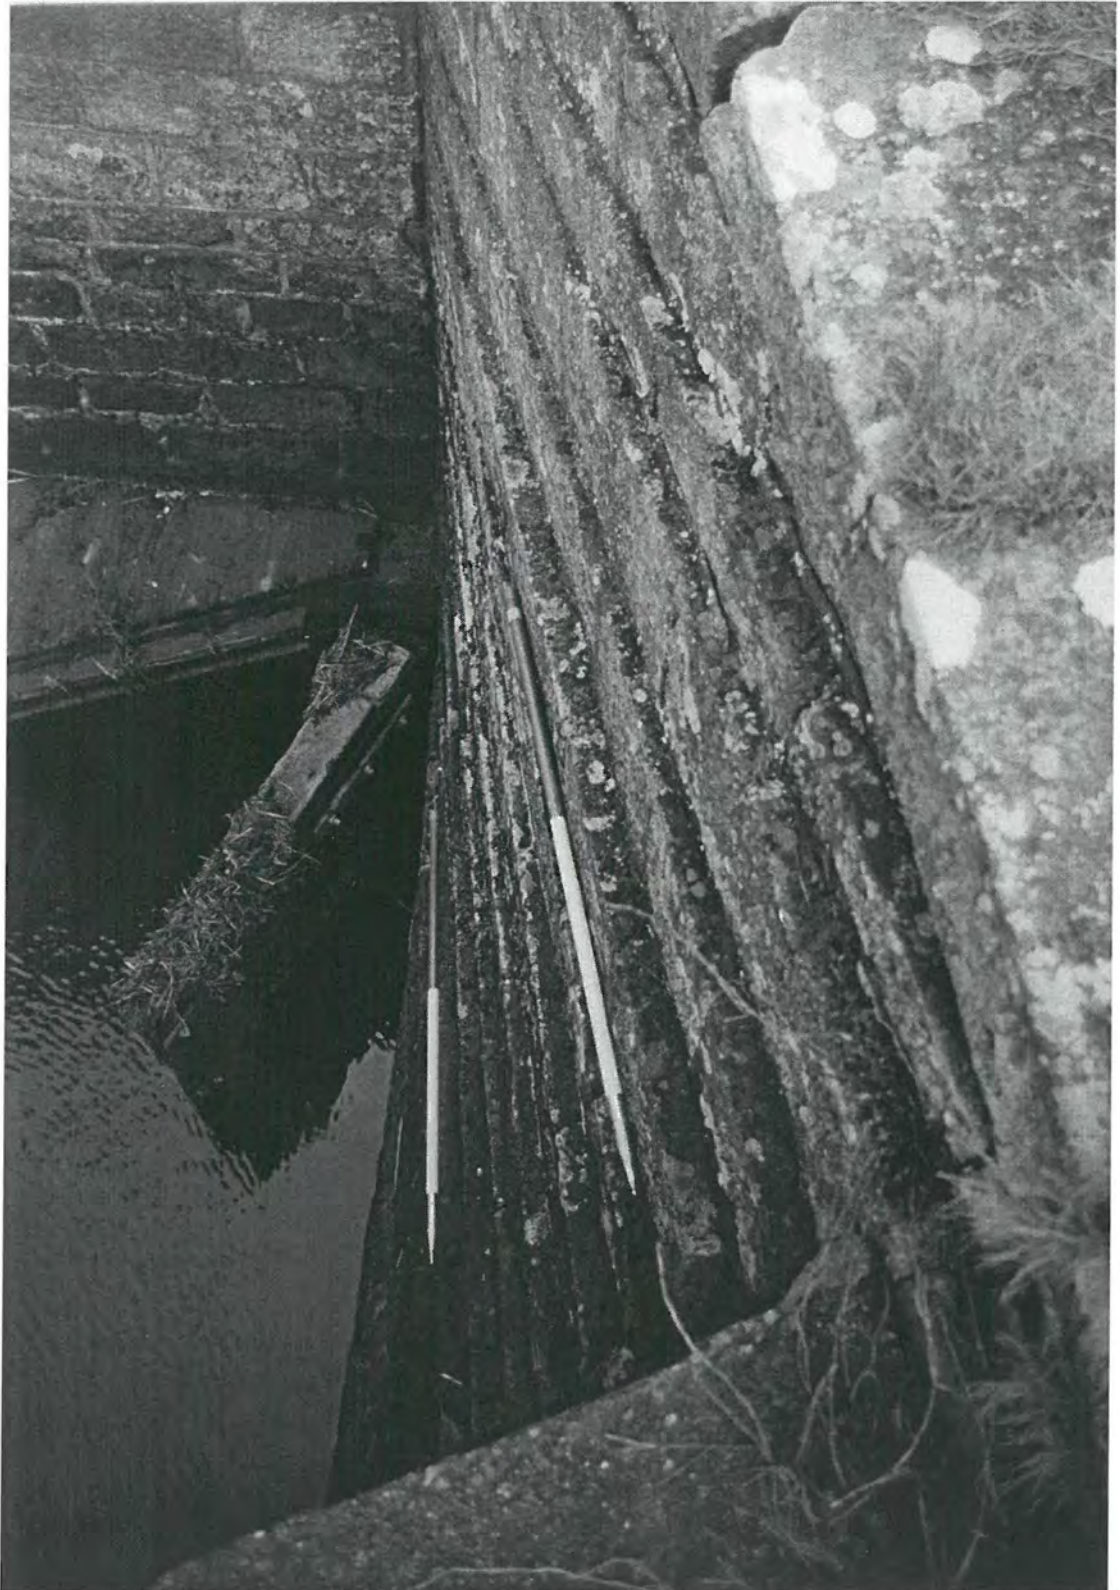
**NEGATIVE NUMBER: b&w G1578/3/29**

**SUBJECT: Detail of stepped wing wall, south side of north culvert. Facing north.**

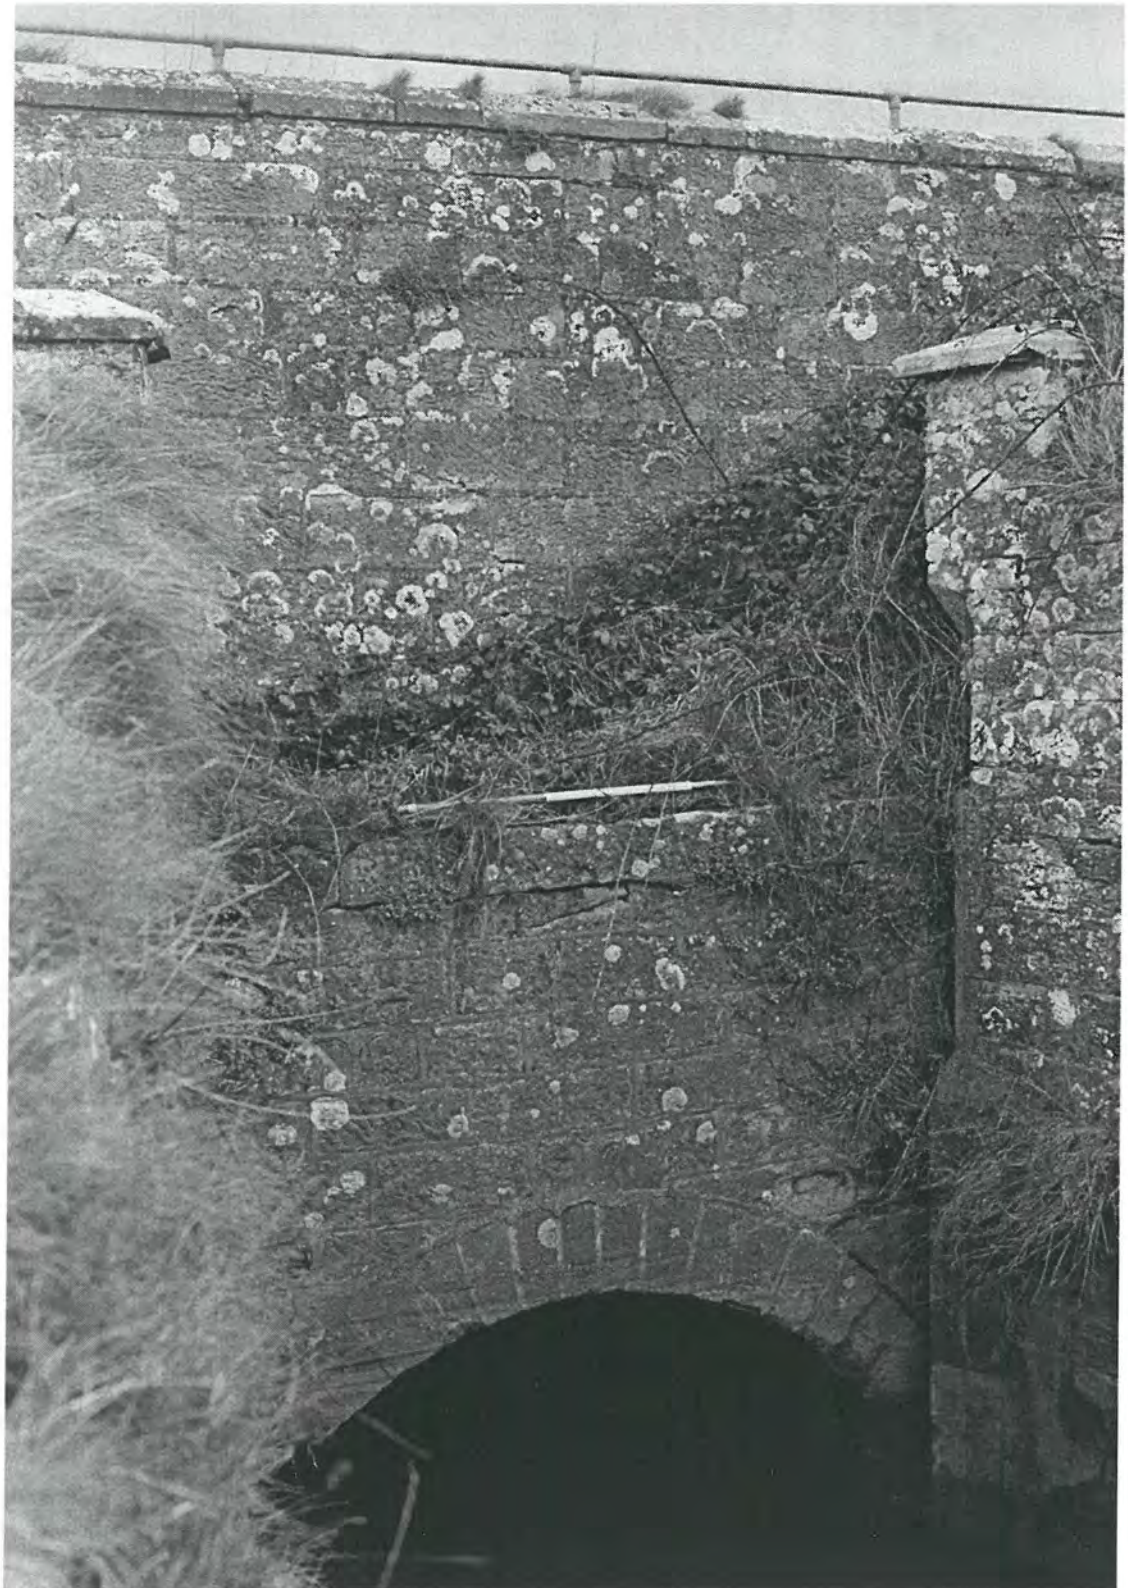
**G1578 MALLTRAETH TIDAL DOORS IMPROVEMENT SCHEME**  
**NEGATIVE NUMBER: b&w G1578/1/10**  
**SUBJECT: Access steps, north side of north culvert. Facing south.**

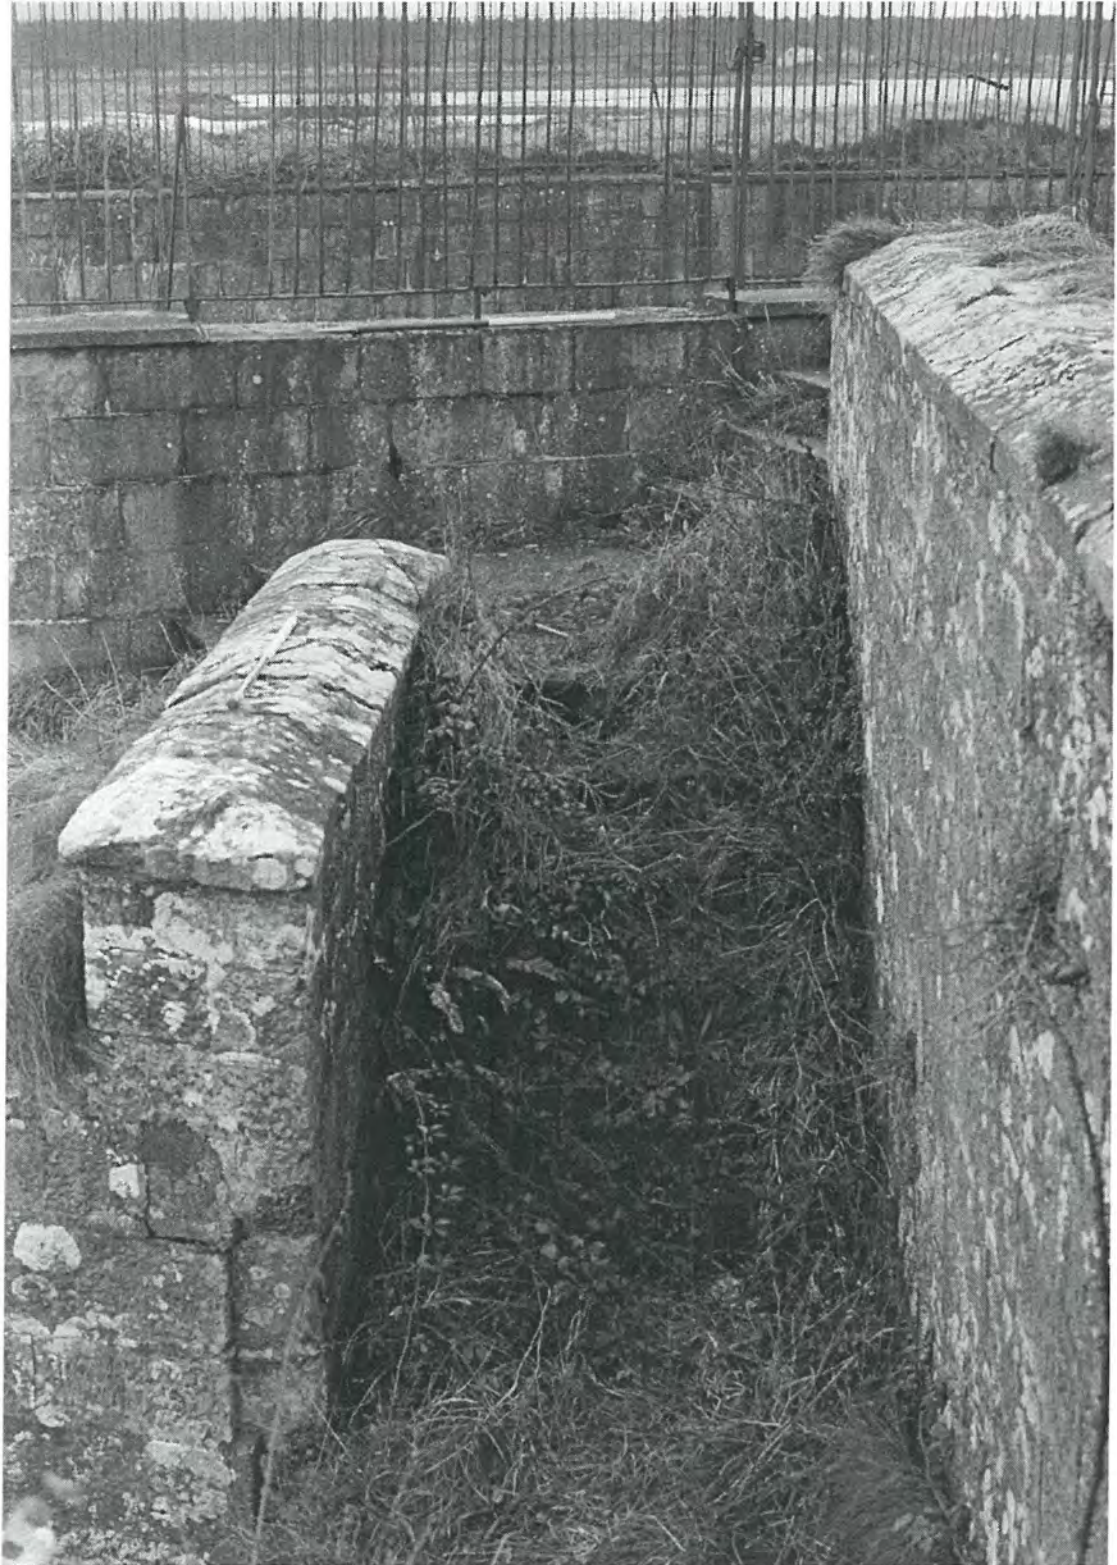
**NEGATIVE NUMBER: b&w G1578/1/20**

**SUBJECT: Access steps, east flight, north side of north culvert. Facing west.**

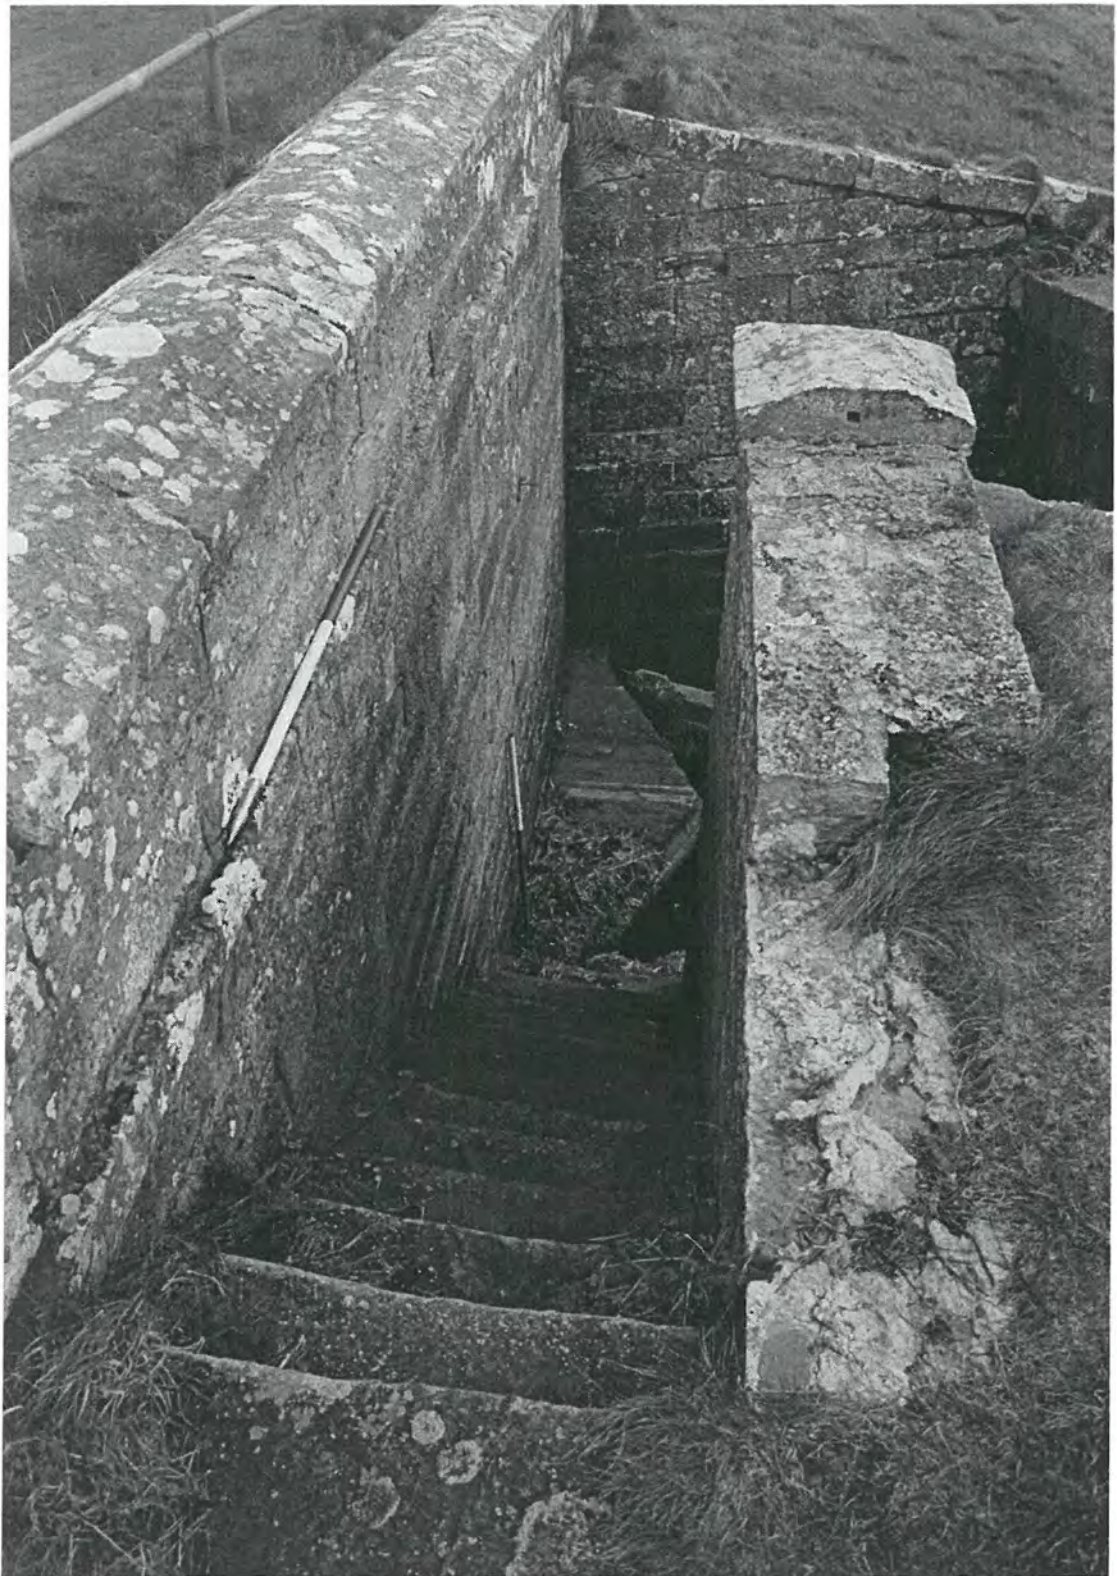
**NEGATIVE NUMBER: b&w G1578/2/9**

**SUBJECT: Access steps, south side of north culvert. Facing east.**

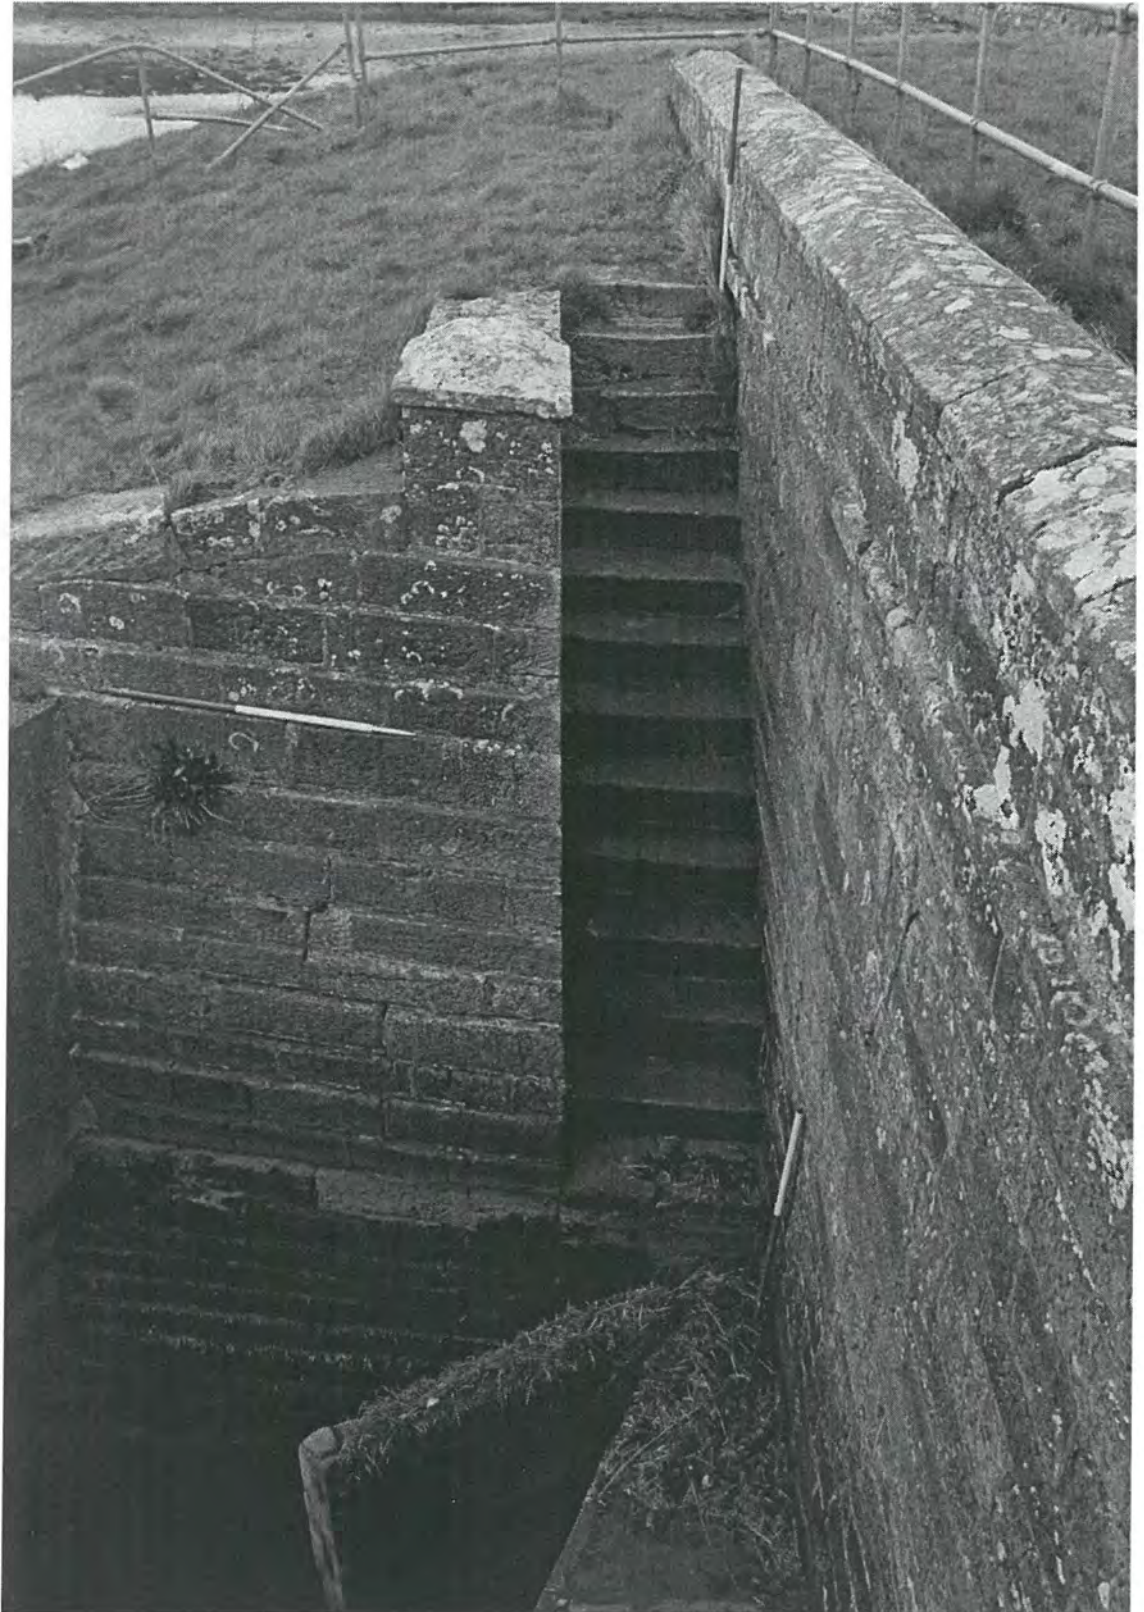
**G1578 MALLTRAETH TIDAL DOORS IMPROVEMENT SCHEME**  
**NEGATIVE NUMBER: b&w G1578/2/15**  
**SUBJECT: Access steps, south side of north culvert. Facing west.**

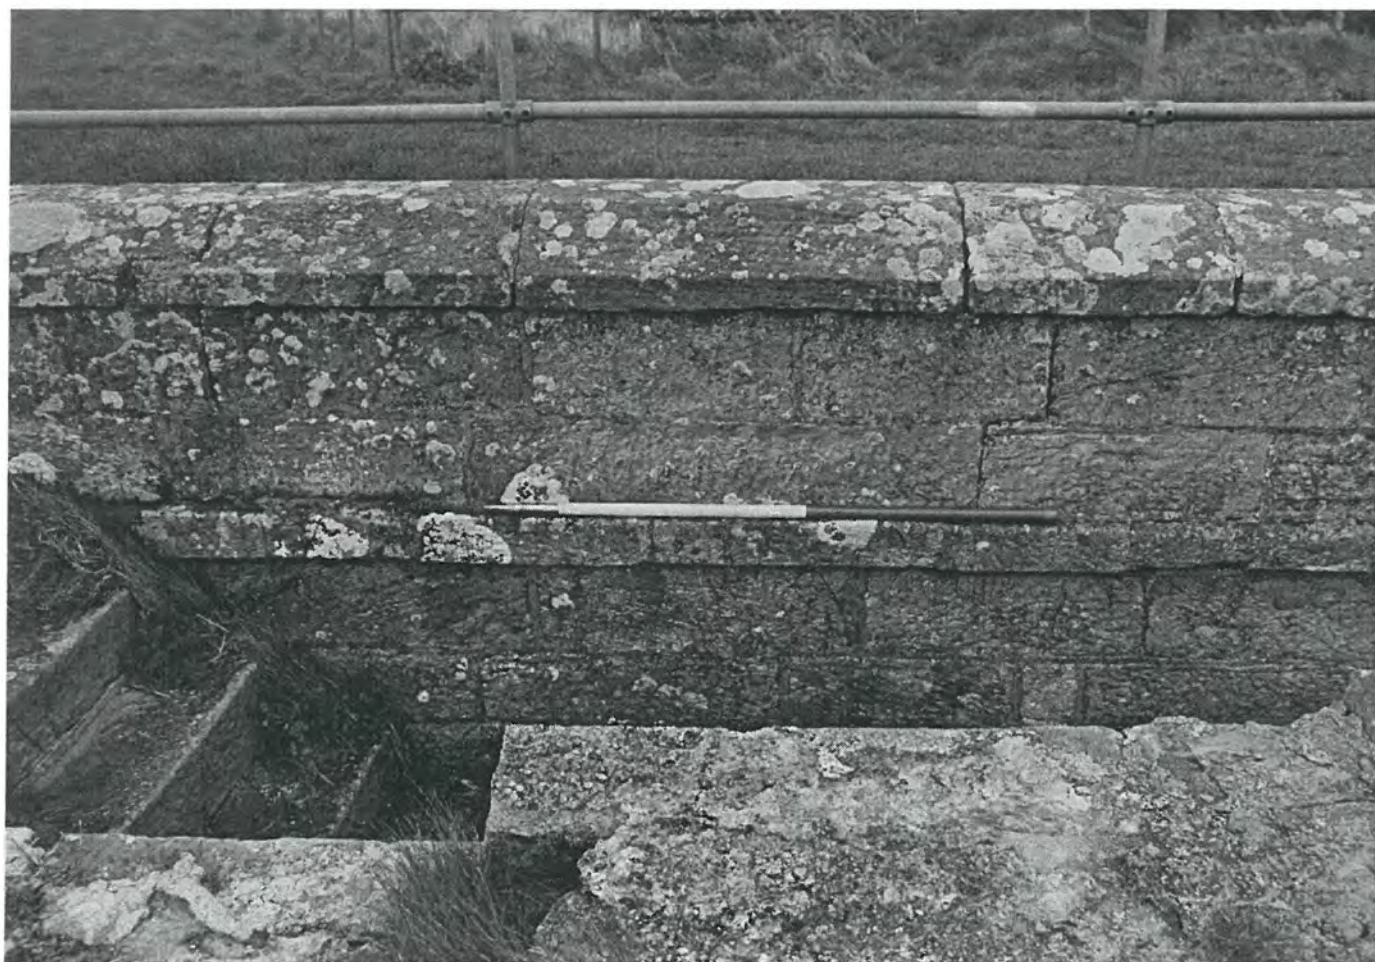
**NEGATIVE NUMBER: b&w G1578/2/12**

**SUBJECT: Detail of ashlar & dressed slab capping stones at walling on south side of track across culvert.**

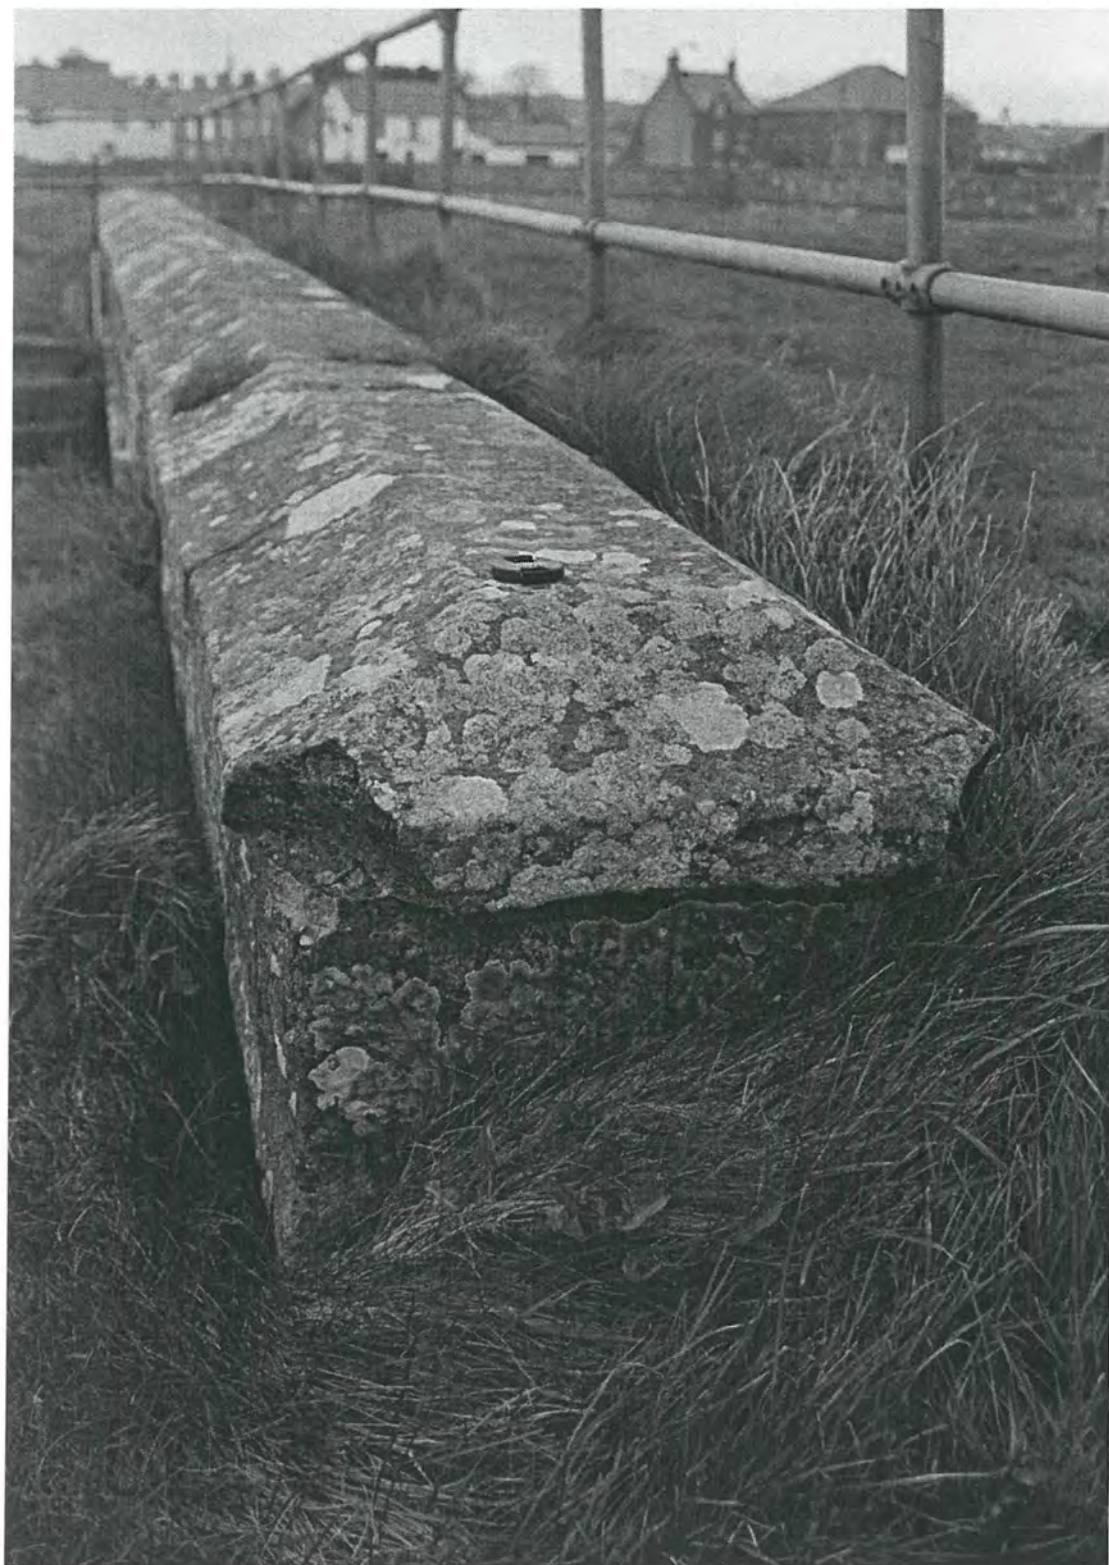
**NEGATIVE NUMBER: b&w G1578/2/23**

**SUBJECT: Detail of dressed slab capping stones, south side of track across culvert. Facing east.**

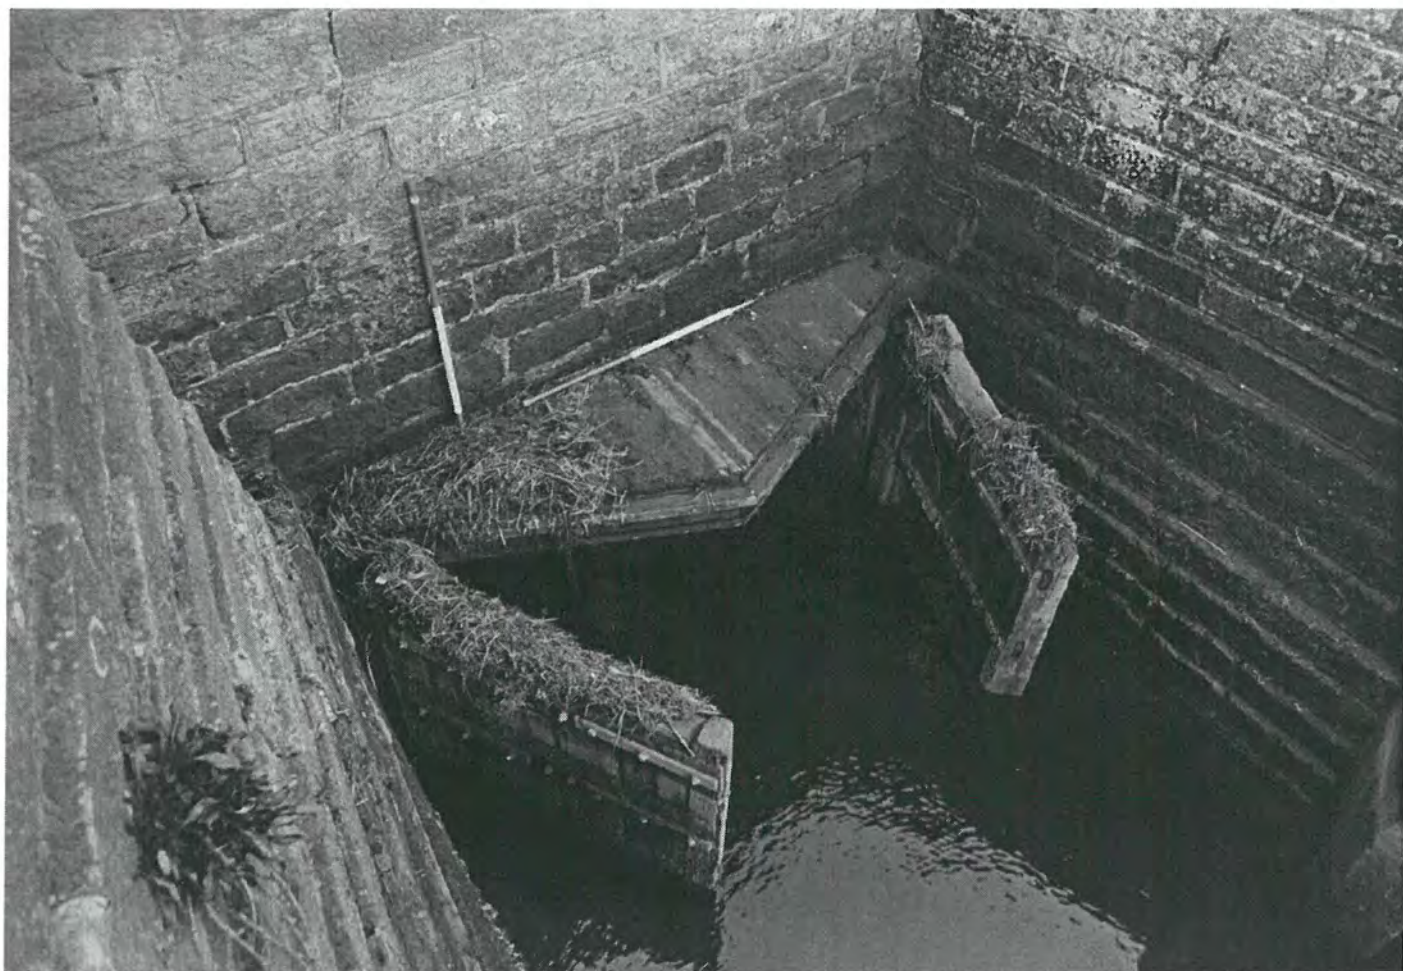
**NEGATIVE NUMBER: b&w G1578/3/12A**

**SUBJECT: Wooden tidal door, south side of north culvert. Facing north east.**

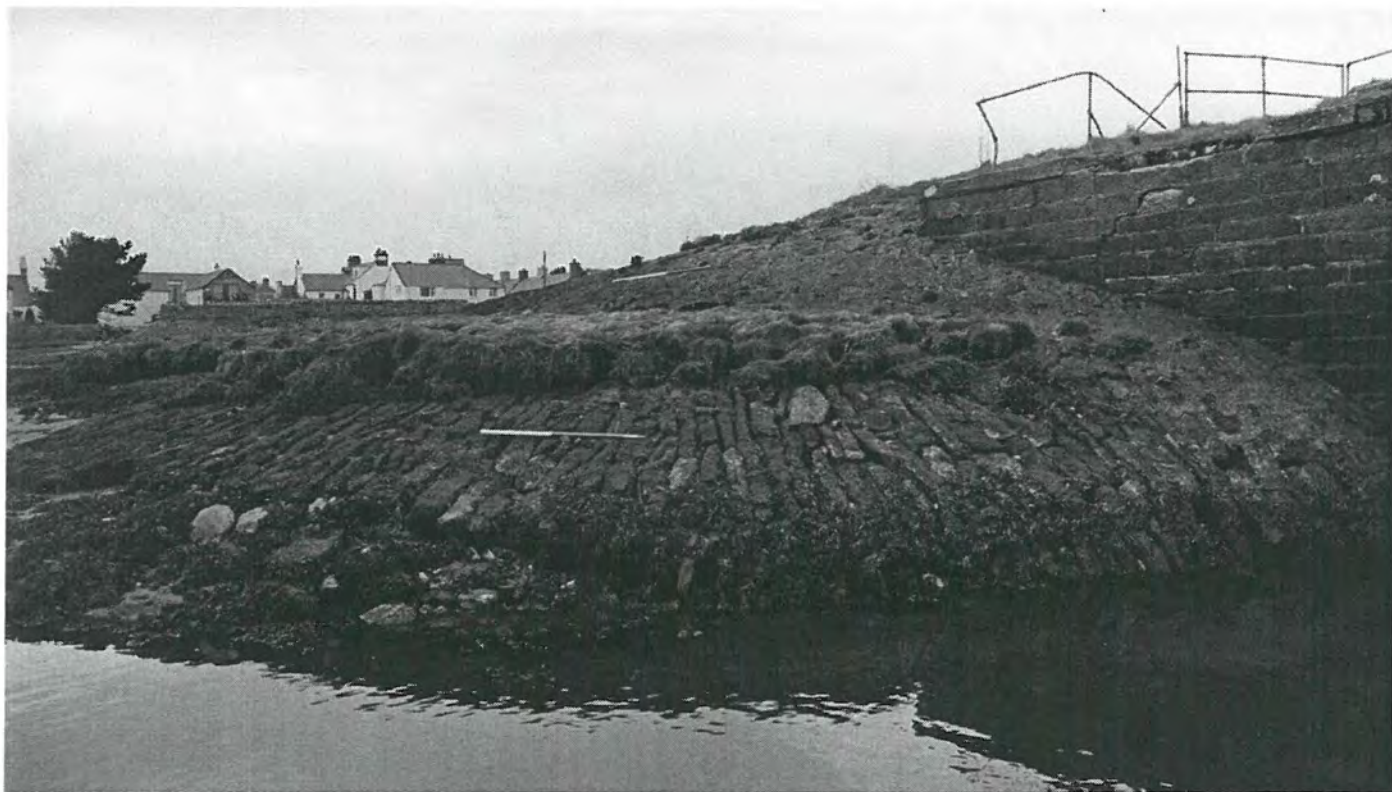
**G1578 MALLTRAETH TIDAL DOORS IMPROVEMENT SCHEME**  
**NEGATIVE NUMBER: b&w G1578/3/8A**  
**SUBJECT: Stone pitching south west of north culvert. Facing north west.**

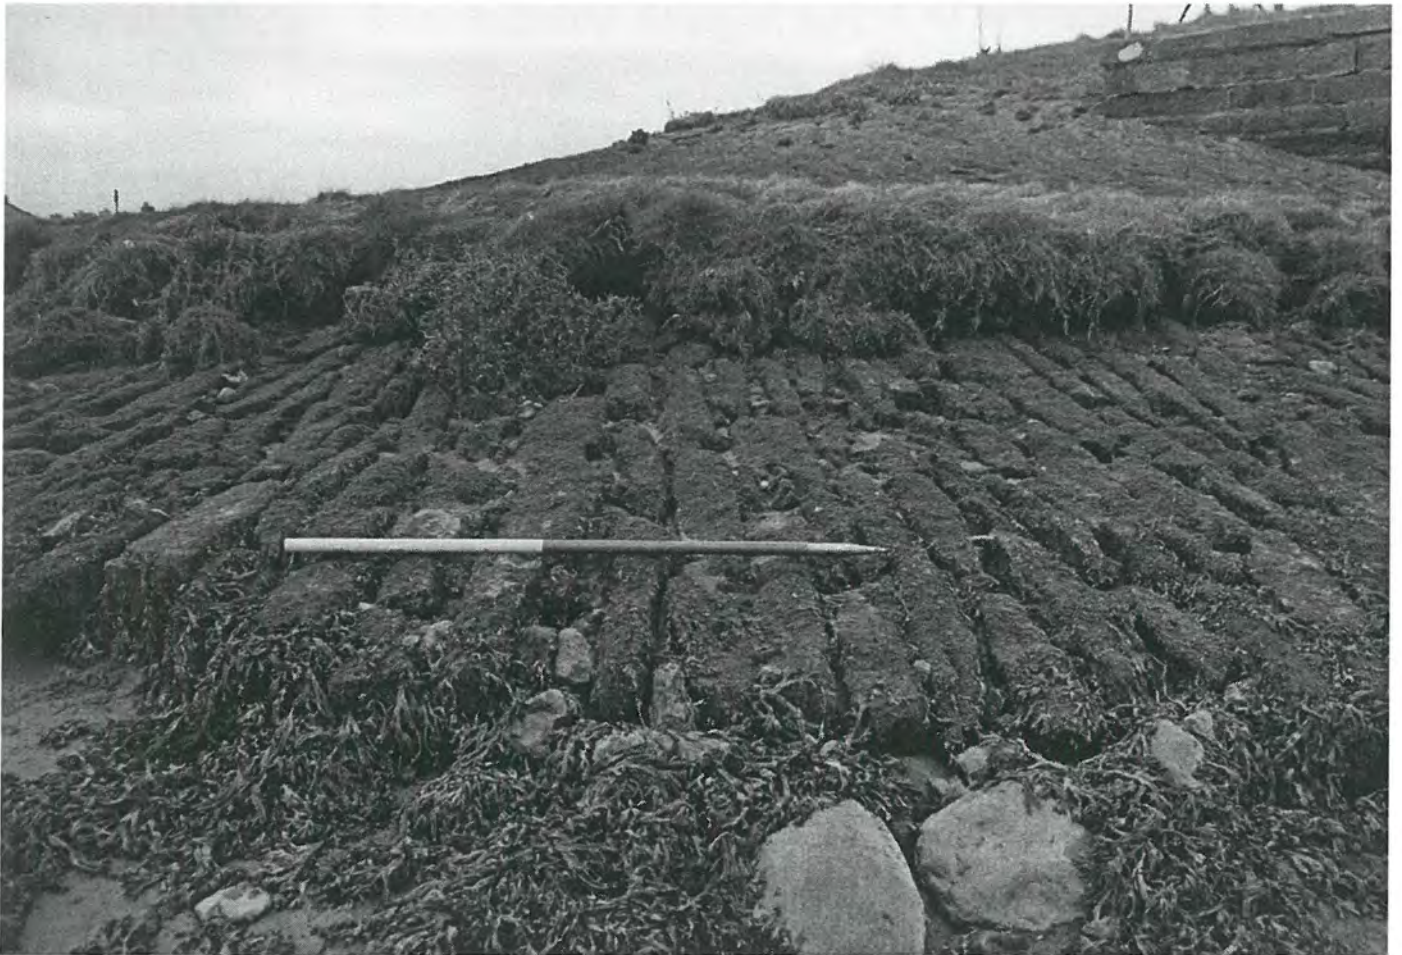
**NEGATIVE NUMBER: b&w G1578/2/36**

**SUBJECT: Detail of stone pitching south west of north culvert. Facing north west.**
