# **Restoration of Waterwheel, Header Tank and Rising Main at Gilfach Ddu, Llanberis.**

## **Archaeological Recording Interim Report**

## Archaeological Recording Interim Report : number 2

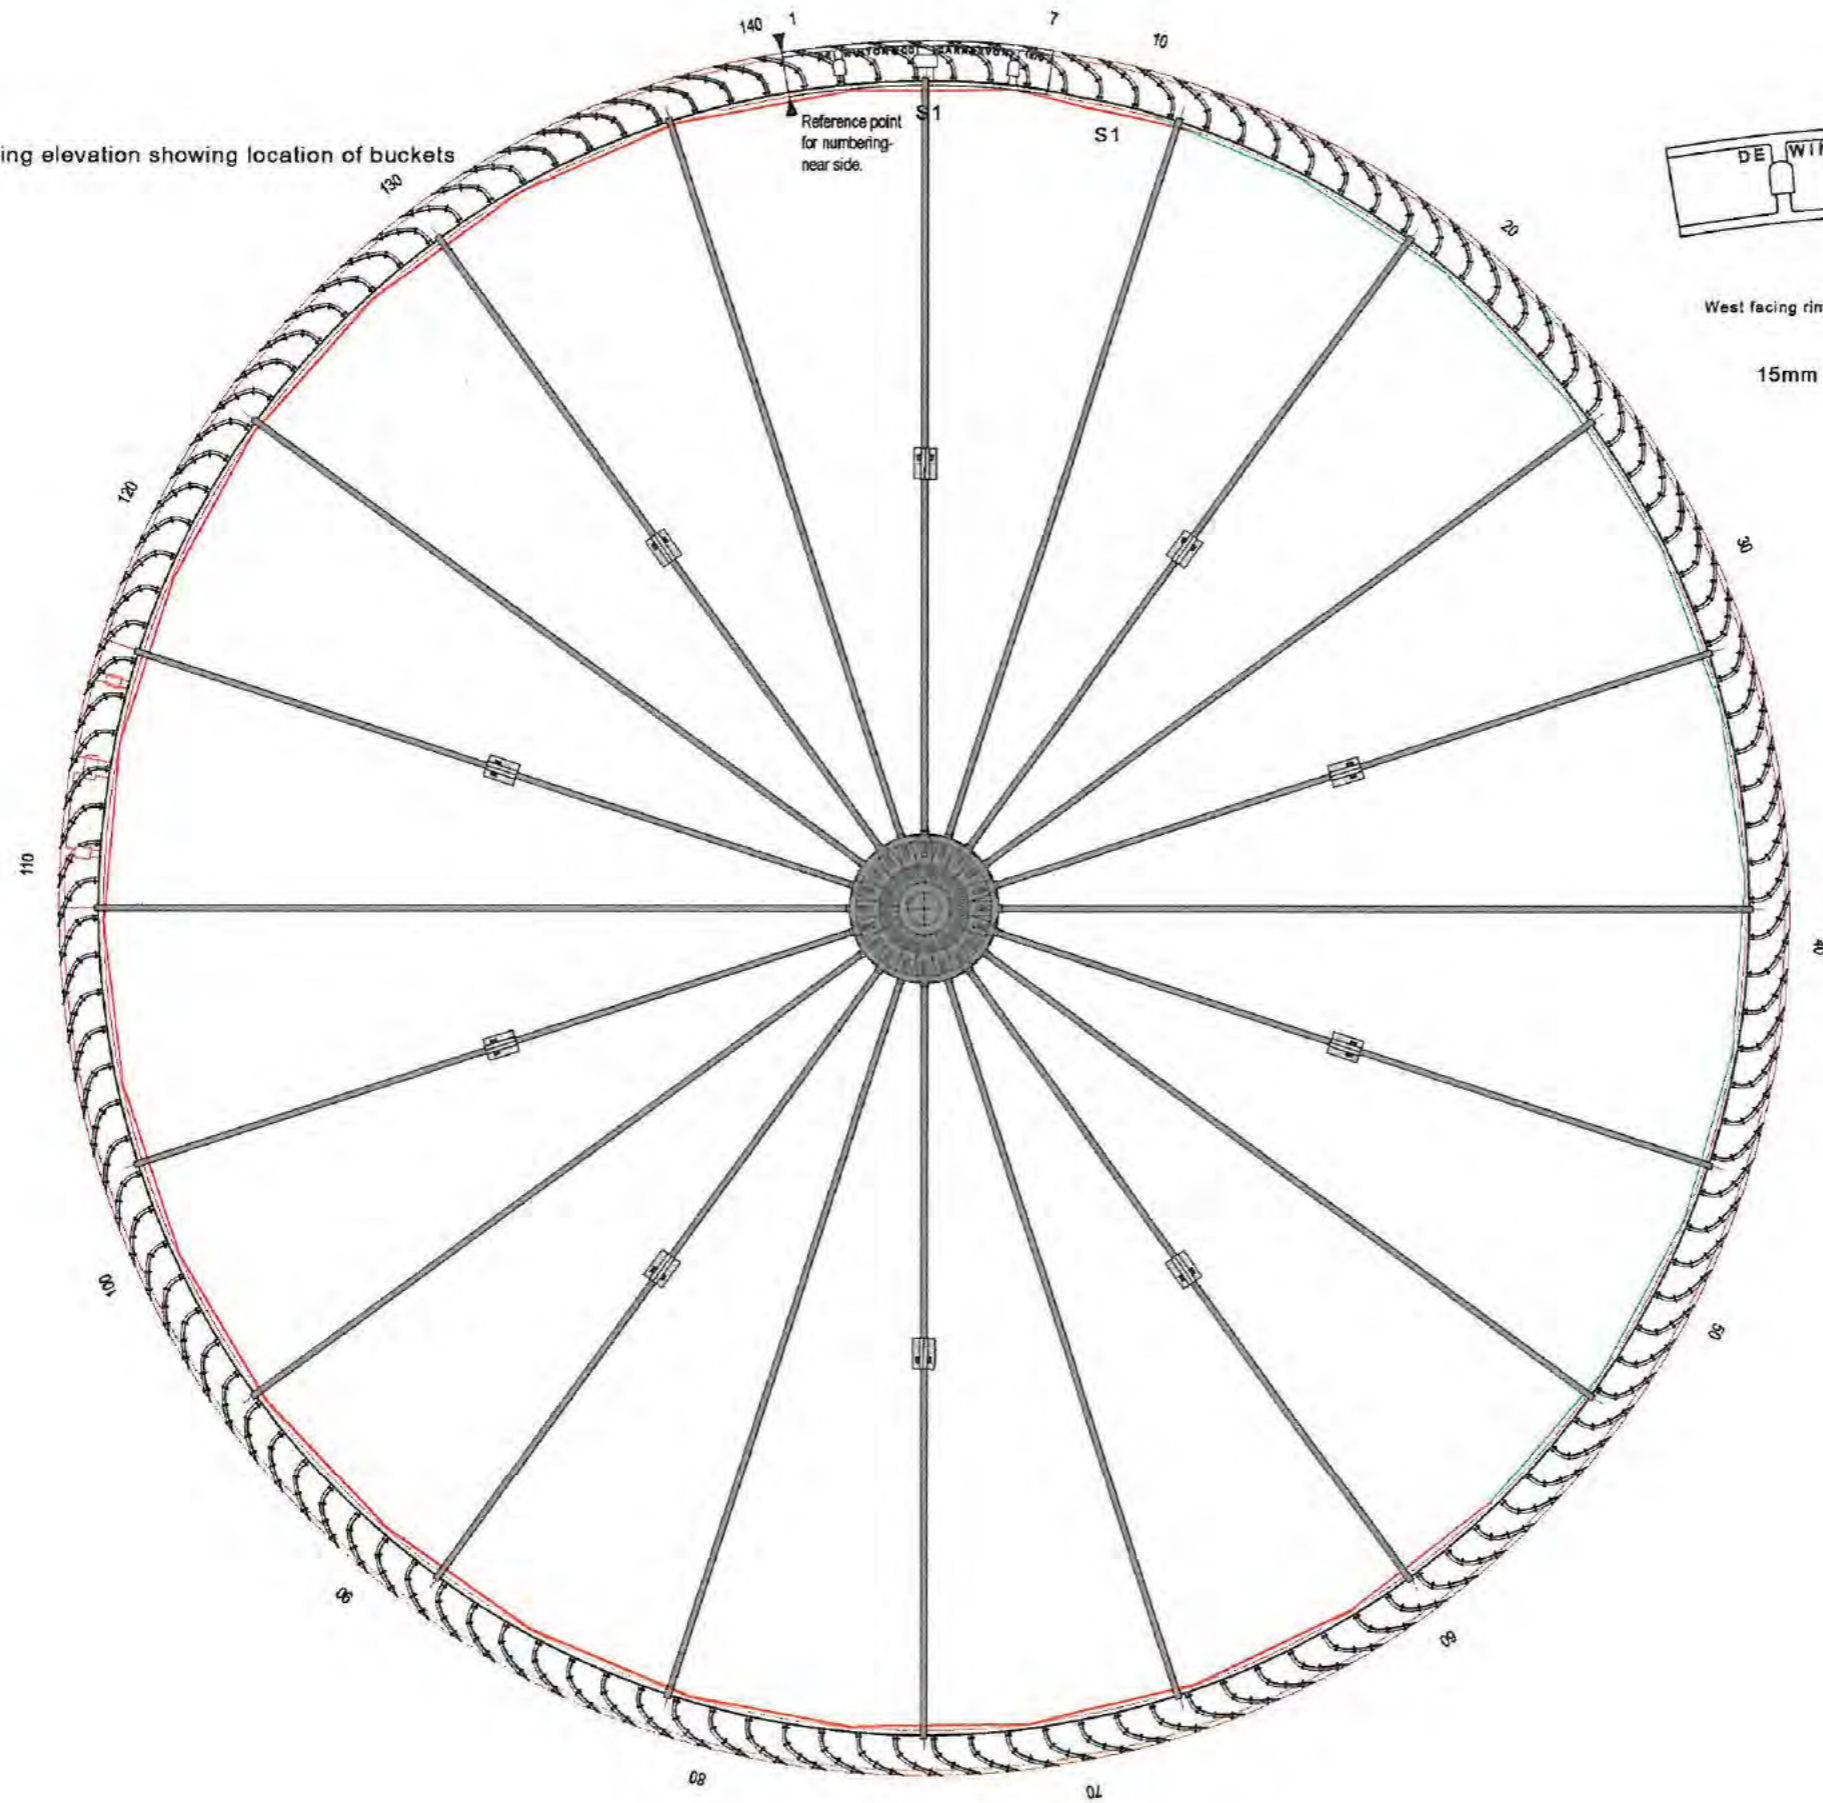
West facing elevation showing location of buckets

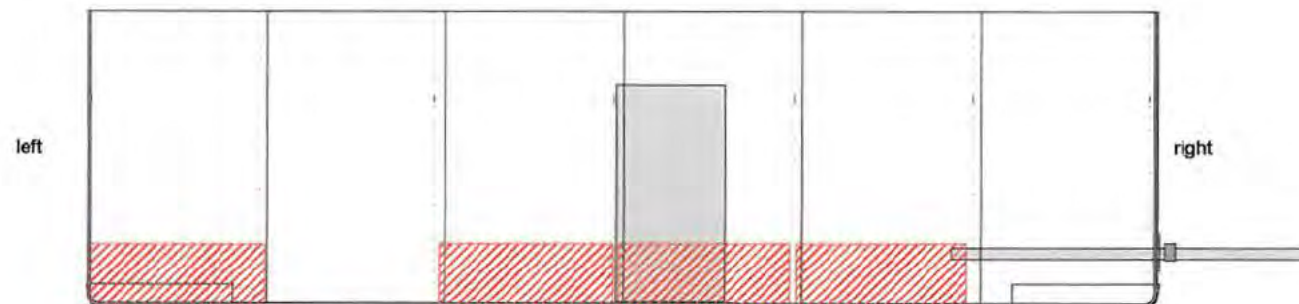
front elevation viewed from outside

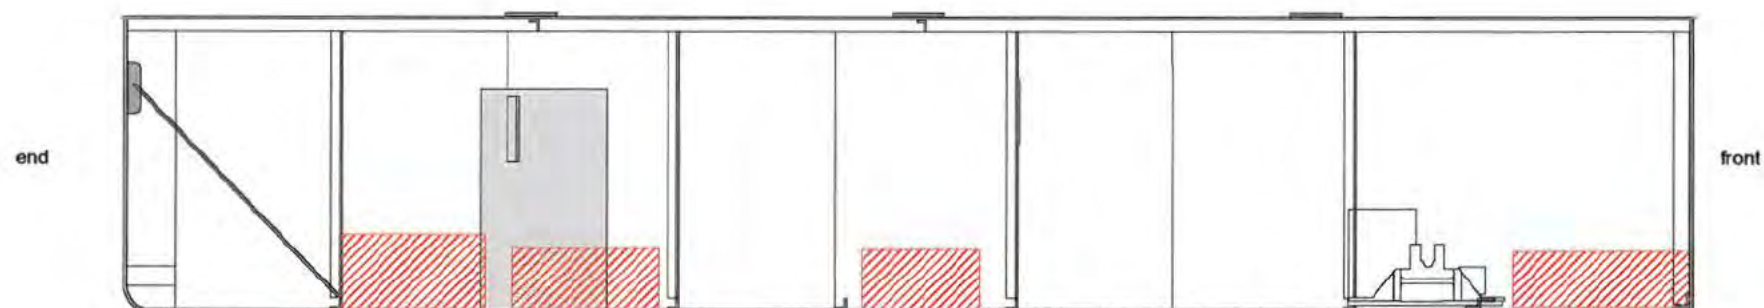
right elevation viewed from inside

= areas proposed for replacement

In brief, the structure will be scaffolded out to provide a safe working space. Restoration work will involve thorough cleaning of the corroded surfaces by appropriate means prior to cutting out defective areas and welding in new items or patches of wrought iron or coreten steel, to be date stamped '2000'. All accessible surfaces will be painted with specified materials.

The accompanying drawings, figs \Gilfach 03 - 05, highlight proposed areas for replacement or patching. The precise areas affected will be recorded during the forthcoming restoration process, as will any hitherto unrecorded features or aspects of construction.

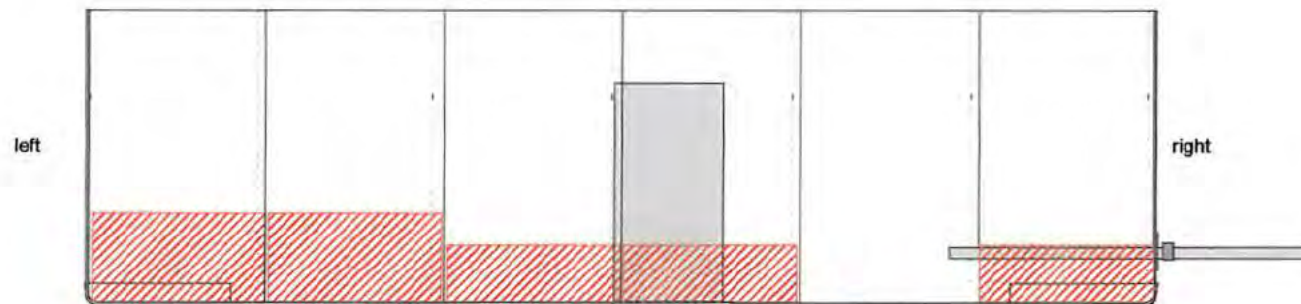
end elevation viewed from inside

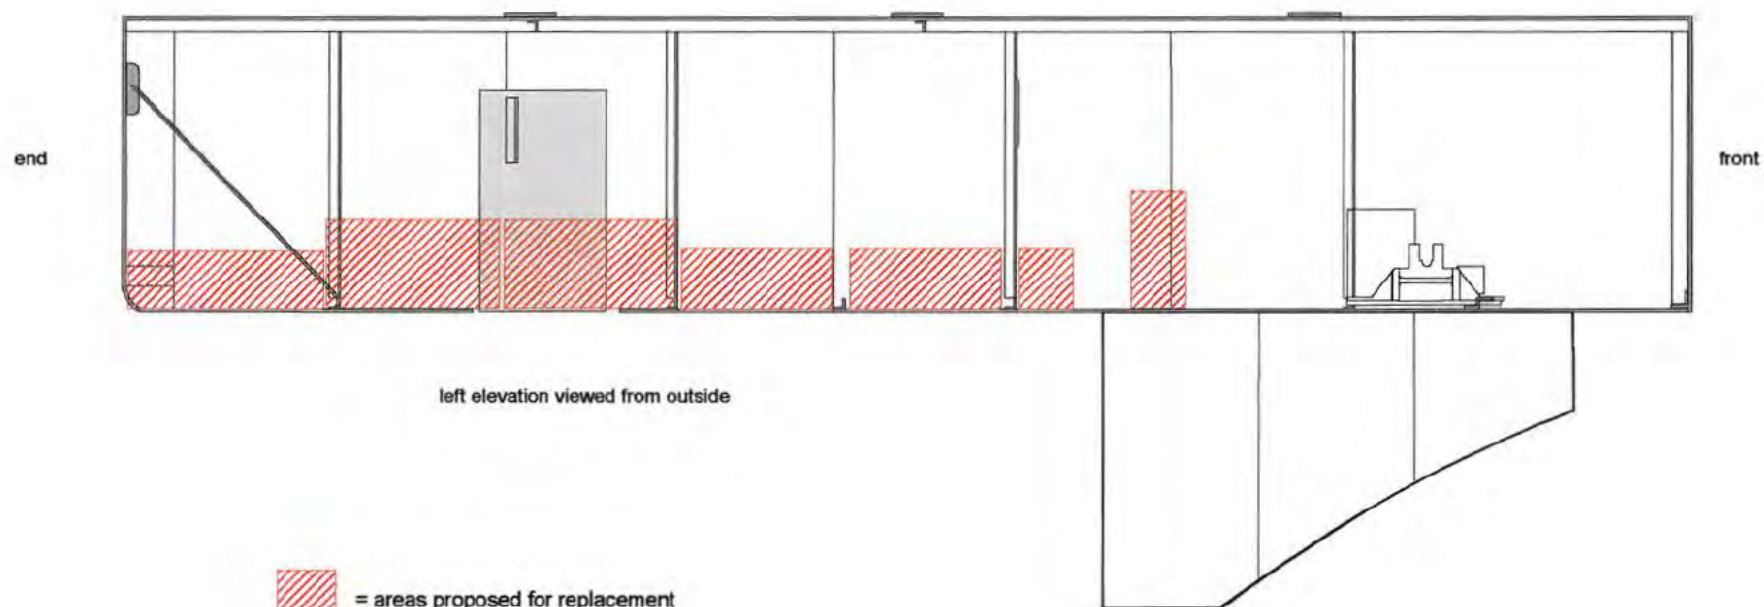
left elevation viewed from outside

= areas proposed for replacement
