A470 (T) DOLWYDDELAN TO PONT-YR-AFANC  
IMPROVEMENT : SITE 74

ARCHAEOLOGICAL RECORD

Report No. 384

October 2000

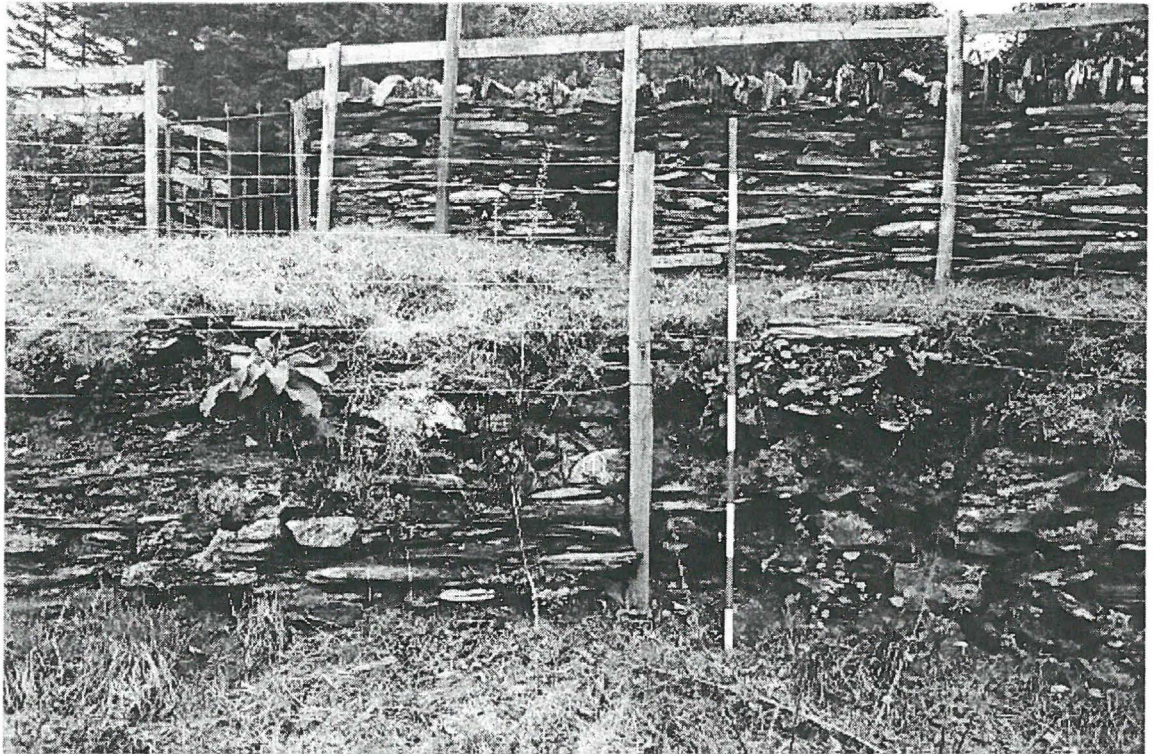
Where the north-western end of the tramway merges into the revetment wall the nature of the wall construction changes. The tramway is constructed of long, thin slate slabs, neatly laid in fairly regular courses. The stones of the revetment wall are blockier, and generally smaller, though some long slabs are still used. The coursing becomes very irregular, and in some places the stones are so randomly laid that there is no coursing evident at all. Both walls are drystone, and the slate used is of poor quality.

The point of change is not marked by a vertical joint, or other clear break in construction, though three long slabs laid on top of each other do end at this point. There is a berm, over 1m wide, between the face of the revetment wall and the roadside wall at this point, which appears to be the continuation of the tramway. The curve of the tramway and the continuity of the tramway and road revetments suggest that they were constructed to be used together.

Plate 1: Feature 1, junction of tramway and road revetment

A watching brief is recommended during the taking down of the tramway and the road revetment, so that details of construction can be recorded. The new masonry should be in character with the original, but the two should be distinguishable. An obvious straight joint should not be constructed where the road revetment meets the tramway, as one is not visible at present.

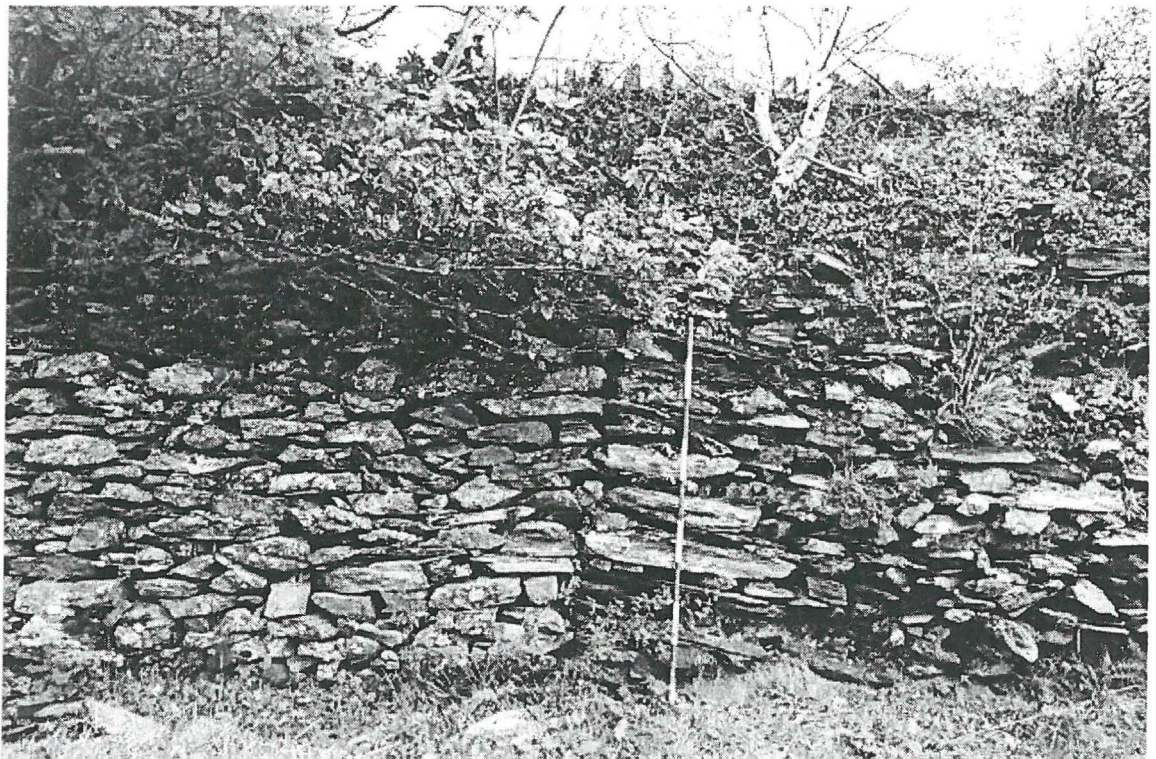
The most interesting features of the revetment wall were a series of vertical joints, which formed a distinctive part of the original construction technique. These joints were fairly evenly spaced; a gap of between 8 and 10m seems to be the intention, although there are occasional intermediary joints, and a gap of c. 20m between features 6 and 7. These features are actually sections of walling built in a repeating pattern. Each section is composed of a southern face built of large slabs, and not bonded with the wall to the south, so creating the vertical joint. Typically this southern face is battered. On the northern side the slabs are bound into a more irregular section of wall, built of smaller, blocky stones. This ends at the next joint, where it is not bonded to the next section of slabs. In some cases the pattern was clearer than others, features 9, 12 and 13 were difficult to identify, but only in the case of feature 7 was the basic pattern not followed. In this case the unbonded joint was to the north of the slab section, rather than the south. The rough walling to the north lacked vegetation cover, and may have been rebuilt.

Plate 2: Feature 3, a typical vertical joint

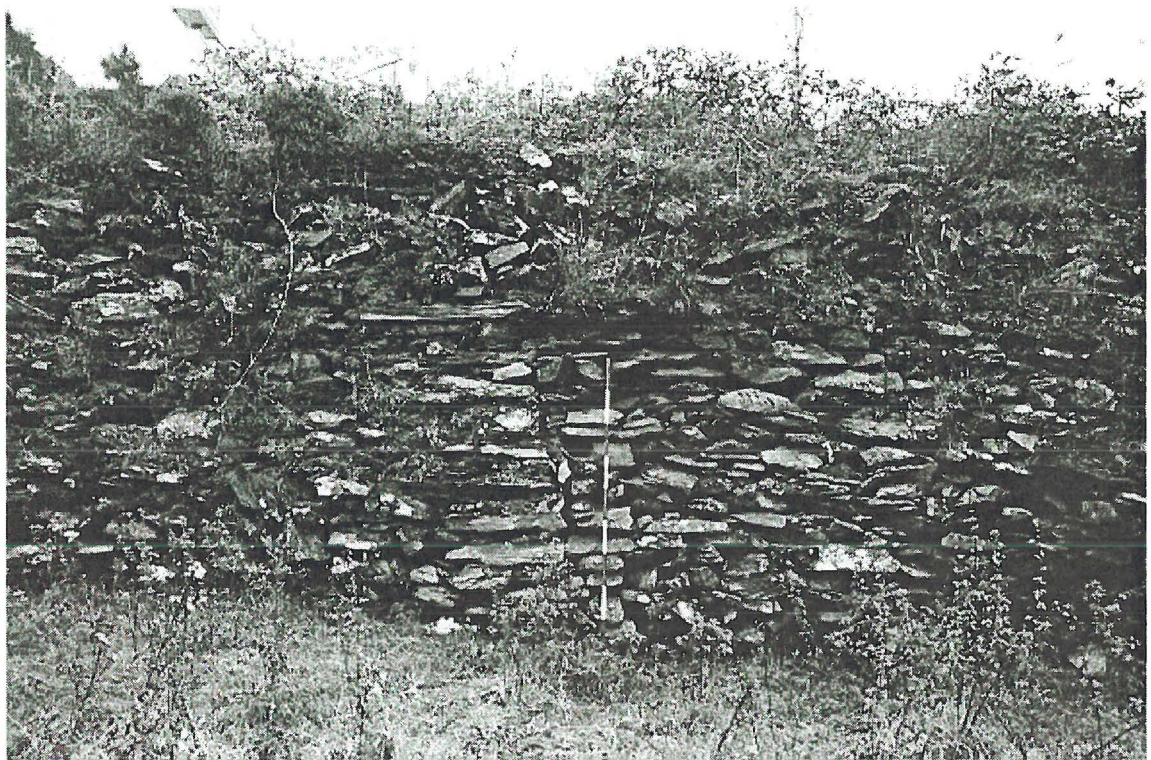
Plate 3: Feature 7, an atypical vertical joint

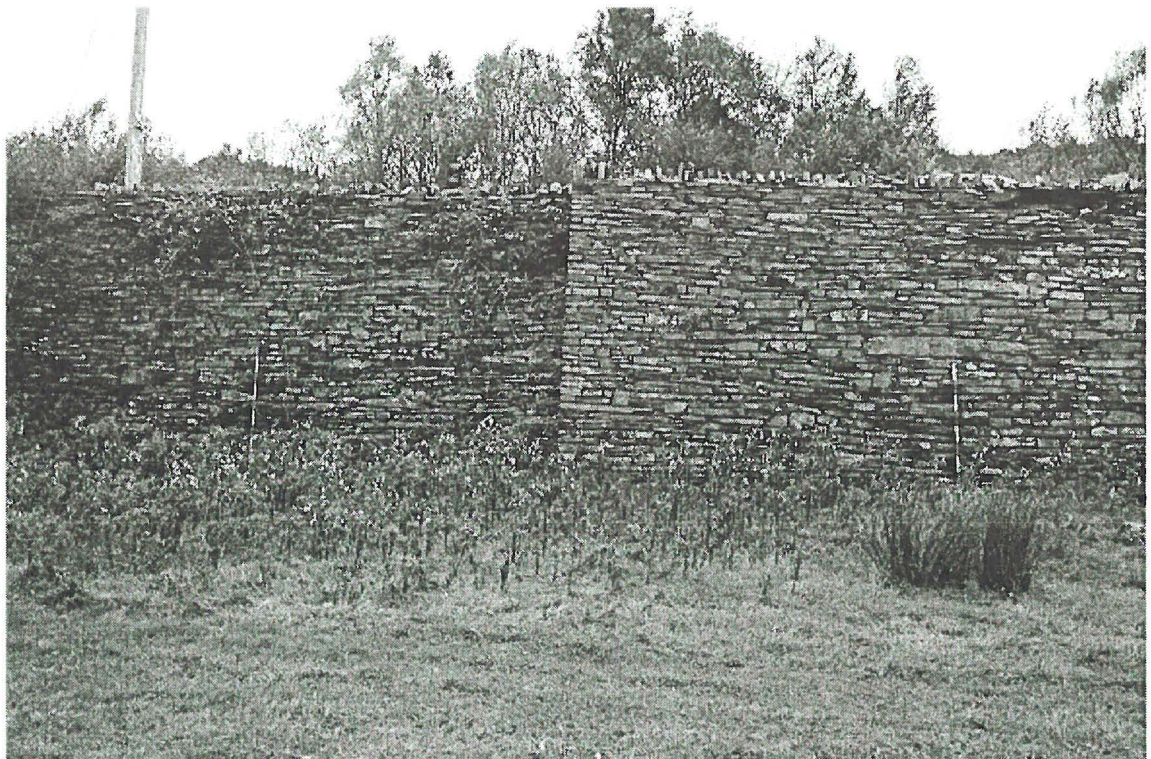
Towards the northern end of the study area there is a lay-by at the side of the road, and this has a revetment wall which is stepped out beyond the general line. This section is neatly faced and well built, with much more regular coursing than is normal elsewhere. The revetment wall is continuous with the roadside wall on top, and the facing stones are bonded

with cement. Ceramic pipes are visible in 3 lines up the face of part of this wall. This is clearly a later construction related to the present road. It butts onto the existing revetment wall, and is not bonded with it. At the north end of this section, feature 16, the facing ends in a jagged, unfinished edge, and the northern return is left completely unfaced. Why the facing was never completed is unclear.

Plate 4: Lay-by buttress

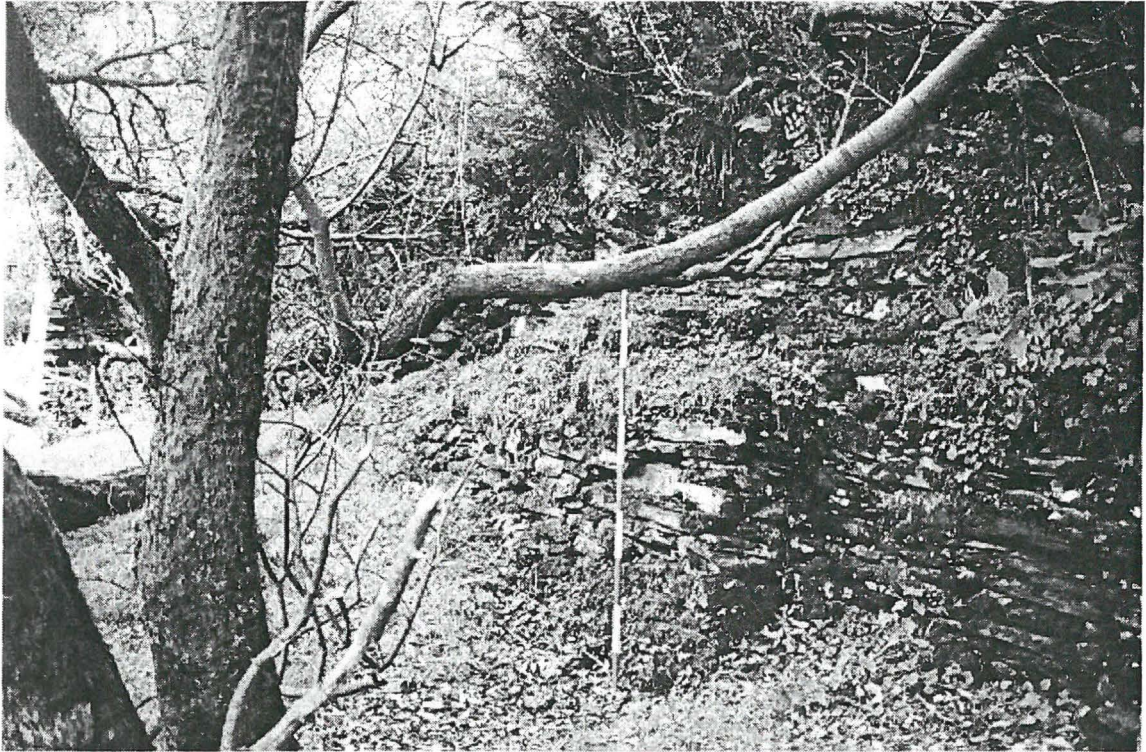
The northern part of the revetment is abutted by two low buttresses. Feature 17 is a simple reinforcing buttress, rather collapsed at its southern end. Feature 18 merges back into the revetment at its northern end, and seems to have been constructed to support a slight change in angle of the wall. The revetment above feature 18 has many loose stones, some out of line, and clearly suffered from weaknesses.

Plate 5: Feature 17, a buttress at the base of the road revetment

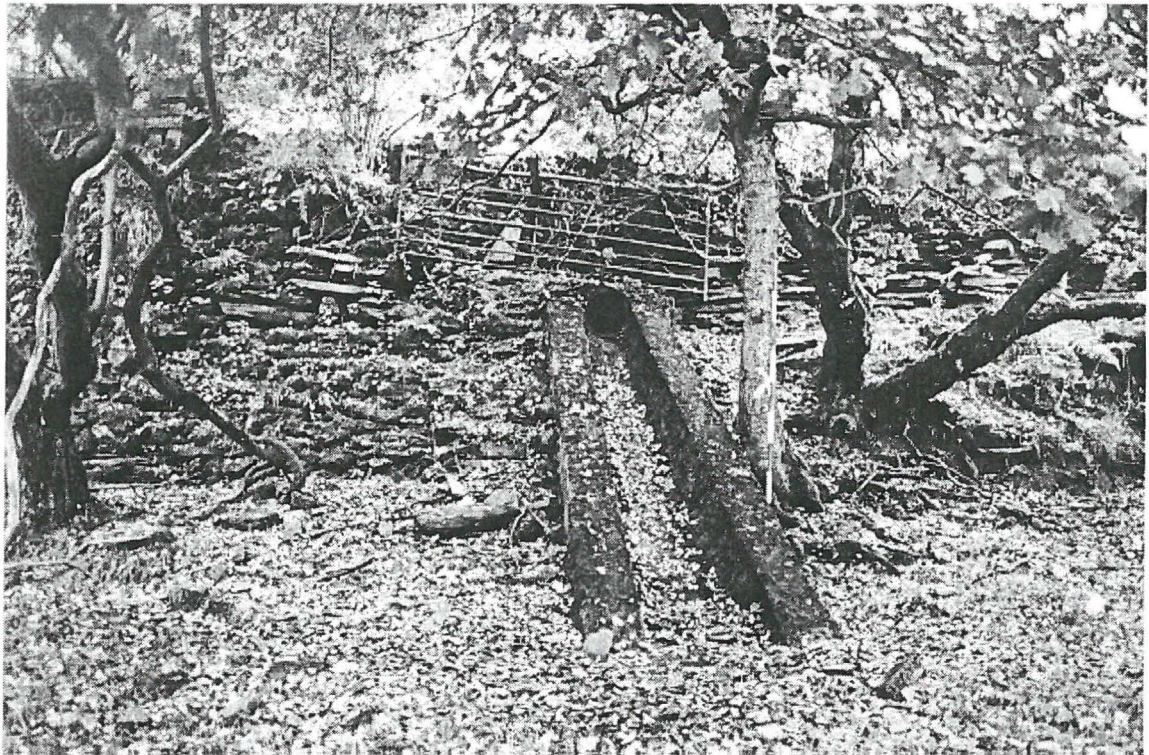
Feature 21 is a concrete chute carrying water from a concrete drain, 0.4m in diameter, which emerges from just below the level of the base of the roadside wall. At this point the revetment as such ends, and only the roadside wall continues. However, the roadside wall rests on top of a steep embankment, presumably the unfaced continuation of the terrace revetted by the main wall. The roadside wall continues to the gate in the corner of the field, after which the boundary is only a post and wire fence.

Plate 6: Feature 21, a drain and concrete chute
