# TRE'R CEIRI FOOTPATH IMPROVEMENTS

## ARCHAEOLOGICAL MONITORING

Report No. 396

G1595

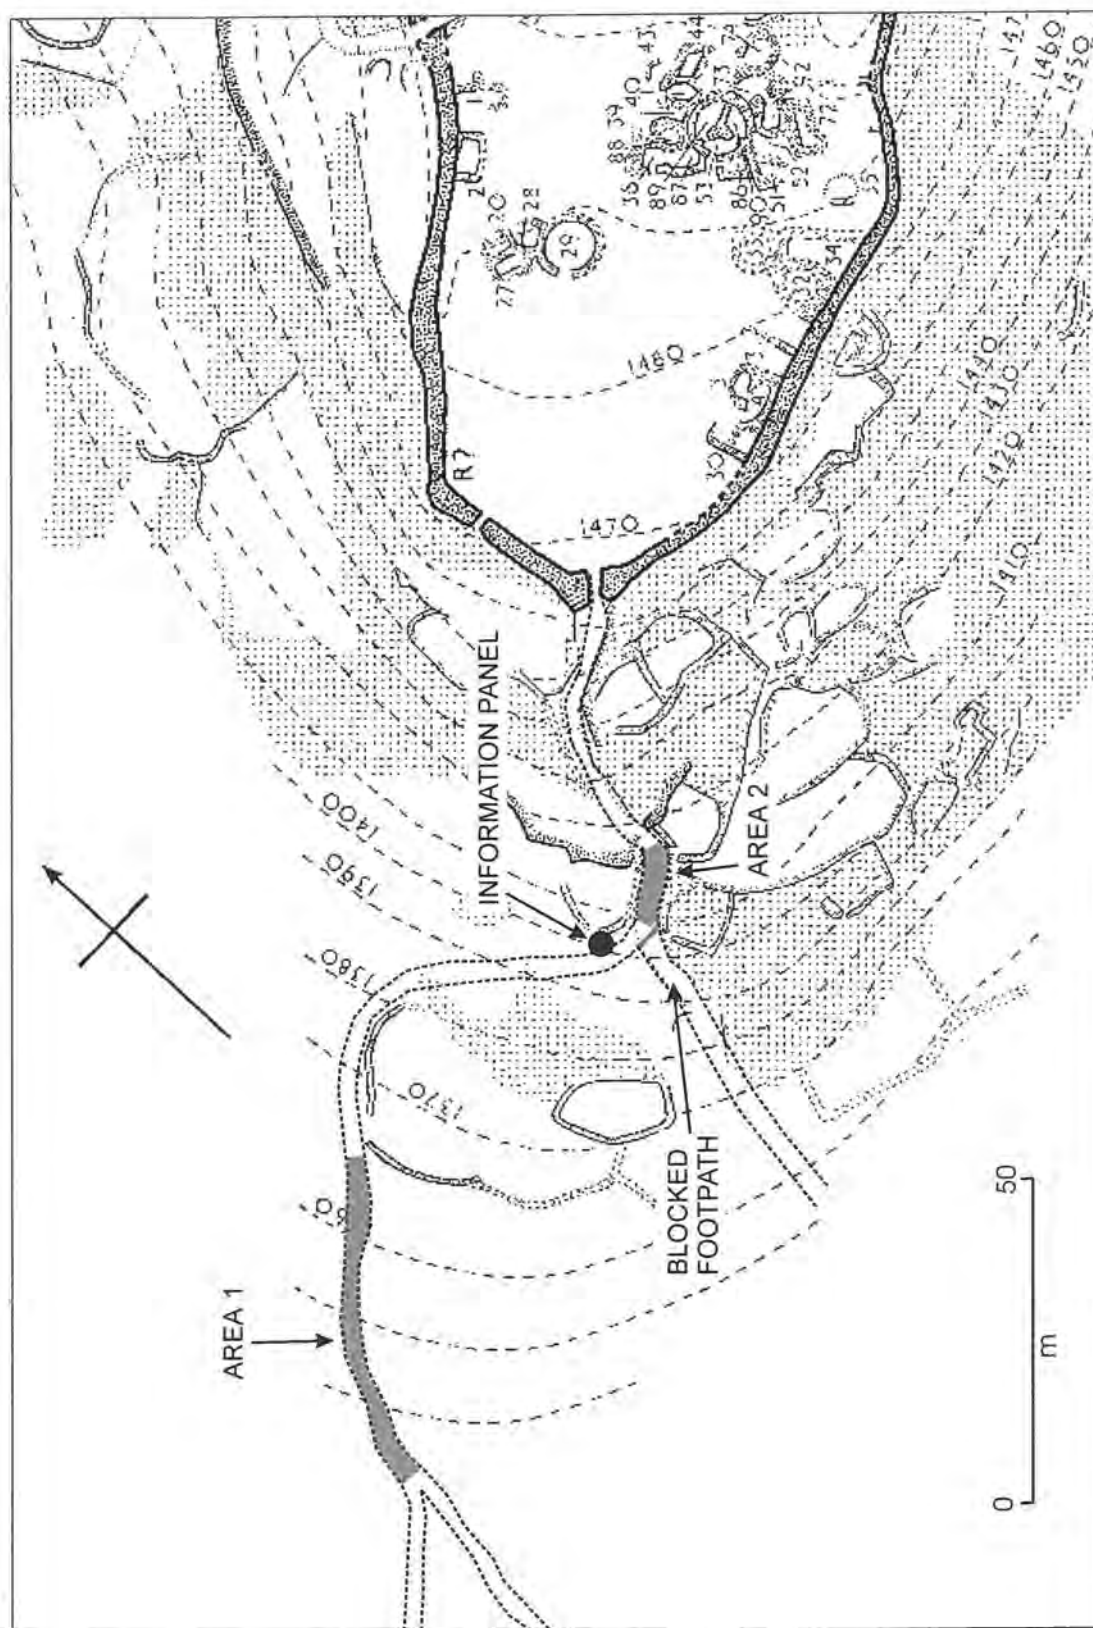
Fig. 1 Tre'r Ceiri; Location of improved footpaths (after R.C.A.H.M.W. 1960)

Two lengths of footpath to the south-west of Tre'r Ceiri were consolidated. The lower part (area 1, Fig. 1) consisted of a 60m length of erosion between a fork in the path at SH37083450 and a break of slope at SH37133455. This section of the path did not impinge on any archaeological features as the extra-mural enclosures do not extend beyond the break of slope at SH37133455. The area was inspected before the consolidation works commenced. The erosion along the line of the footpath had cut into natural peat and shattered stone. This was further excavated to a depth of 0.3m by the contractors in order to embed stones into the ground thus forming the footpath. No archaeological features were disturbed. The large stones needed for steps in the path were imported from scree that was well away from the Scheduled Ancient Monument using a four wheel drive vehicle. A few smaller stones were taken from the scree adjacent to the path. Certain areas of scree around the monument have been denuded of large stones presumably by the original builders of Tre'r Ceiri. Any major changes in the composition of the scree would therefore have archaeological implications. The collection of stones was therefore carried out under archaeological supervision and was kept to a minimum in order to avoid changing the character of the scree in the area.

The second area of consolidation (area 2, Fig. 1) was centred around SH37193454. The erosion had occurred on a 10m length of footpath between two of the extra mural enclosures on what was probably the line of the original path into the south-western entrance. Erosion had reduced the path to fairly uniform natural small scree. Further disturbance was kept to a minimum and was closely monitored by the writer. Five shallow steps were built into the path. The five large stones necessary for this procedure could not be imported from the scree to the outside of the scheduled area as the area close to the fort was not accessible to the four wheel drive vehicle. The stones were therefore taken, under the supervision of the writer, from several patches of rubble in the larger enclosures above the path. Great care was taken to avoid any disturbance to the walls of the enclosures and other archaeological features in the area. Shallow holes were dug in order to embed the stones into the path. These were cut into natural scree and no evidence for the survival of the original pathway into the fort was uncovered.
