TRE'R CEIRI MONITORING VISIT

JUNE 2001

Report number : 417

GWYNEDD COUNCIL

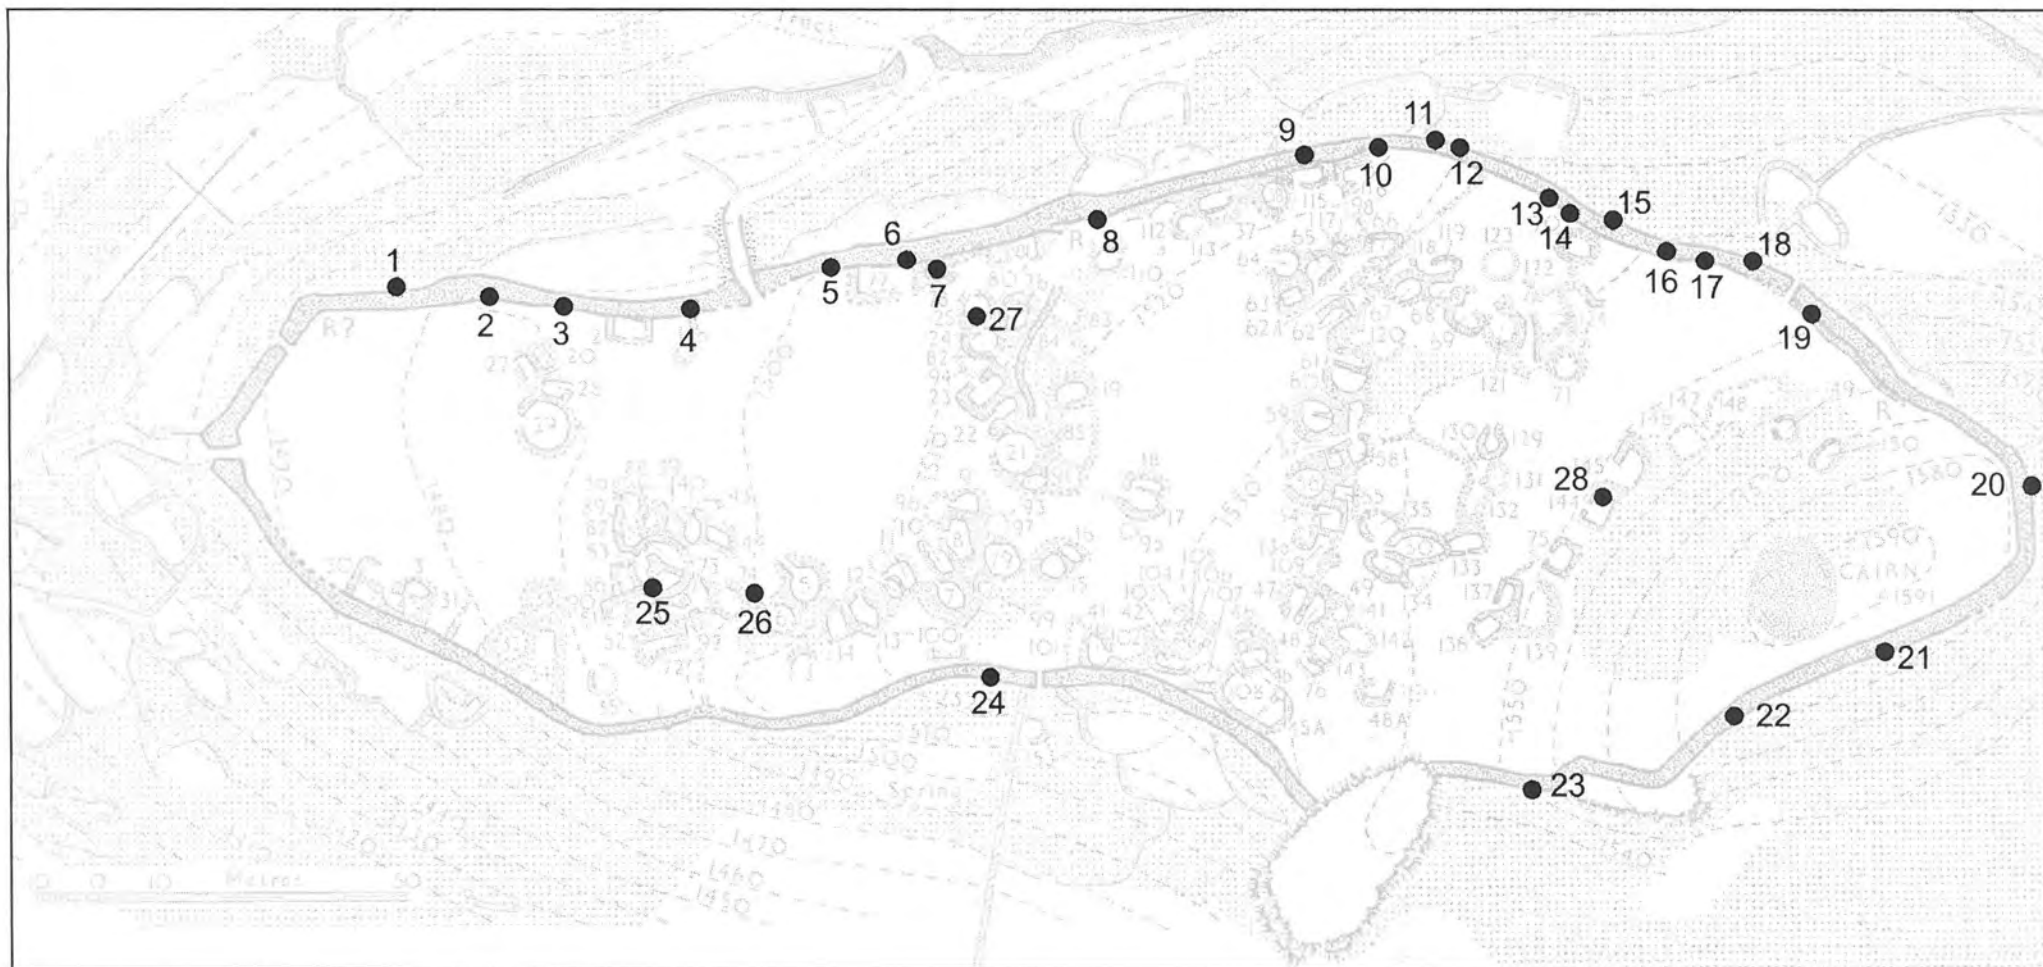
Fig. 1 Tre'r Ceiri (after RCAHMW 1960) showing points of instability identified in the June 2001 monitoring visit

The following minor areas of damage were identified and were marked onto a plan of the site (Fig. 1). Written records were kept of all works.

Twenty-three areas of instability were identified, all but one of which appeared to have been caused by visitors walking along the tops of the rampart.
