TRE'R CEIRI MONITORING VISIT

NOVEMBER 2001

Report number : 429

TRE'R CEIRI MONITORING VISIT: NOVEMBER 2001 (G1605)

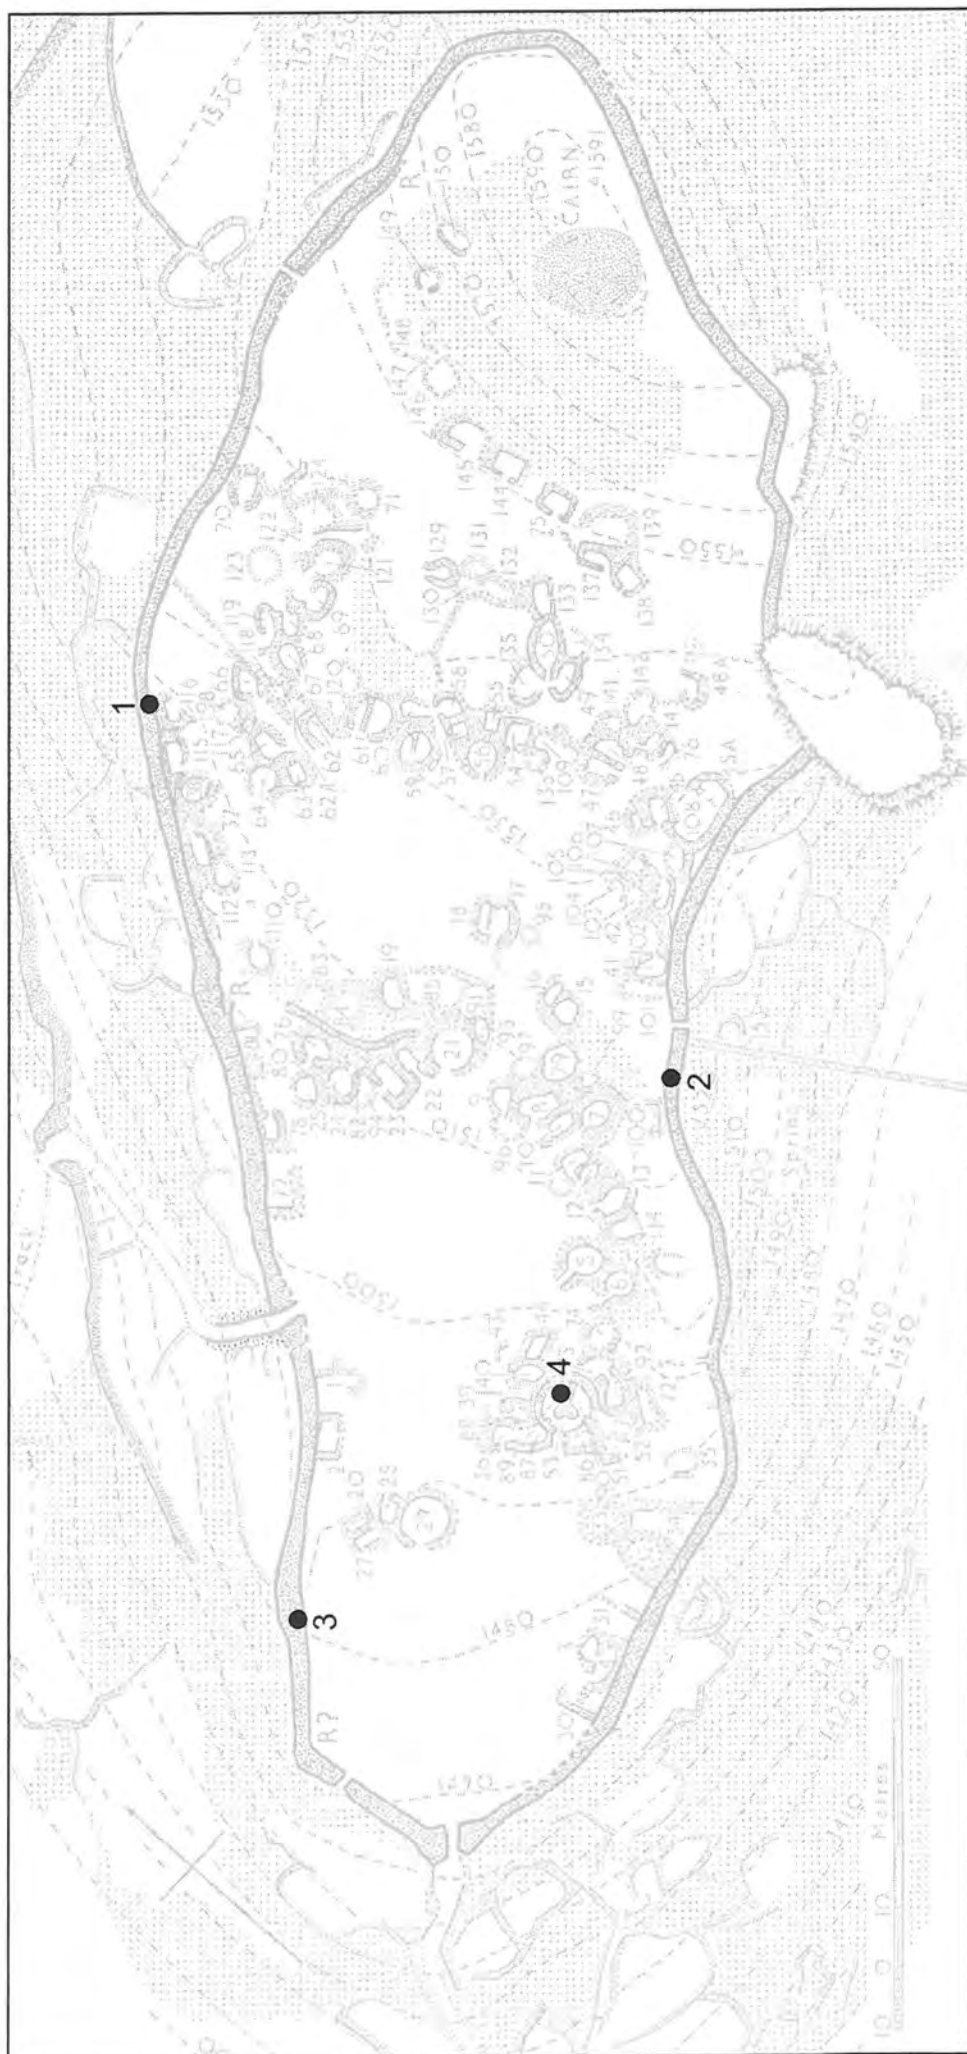
1. The wall core had become loose at this point and two original stones on the inner face were beginning to work loose. The core was repacked thus providing support for the facing stones which did not need to be reset.
2. There is a change in the height of the ground level causing a slight step in the wall top. The stone at the edge of the step had worked loose and the core was beginning to spill forwards. The stone was reset and the core repacked. No *in situ* facing was disturbed.
3. A stone had been pulled out of the wall core causing a patch of instability. The stone was replaced and the core repacked.

4. Hut 89. About a dozen stones had been pulled out of the hut floor at the base of the Y-shaped partition and used to build a small length of rough walling on top of the original masonry. No *in situ* masonry had been damaged but this type of hole digging has been observed to have been one of the major causes of irreparable damage to the huts on Tre'r Ceiri as it undermines the basal course of the wall making repair/reconstruction almost impossible. Fortunately the partition had not begun to subside into the hole and it was possible to pack the stones back into the hut floor.

Fig. 1 Tre'r Ceiri (after RCAHMW 1960) showing points of instability identified in the November 2001 monitoring visit
