The Iron Waterwheel at Gilfach Ddu

Archaeological Monitoring and Recording at the Welsh Slate Museum, Llanberis

Report number 430

Prepared for Posford Haskoning Ltd
By Andrew Dutton

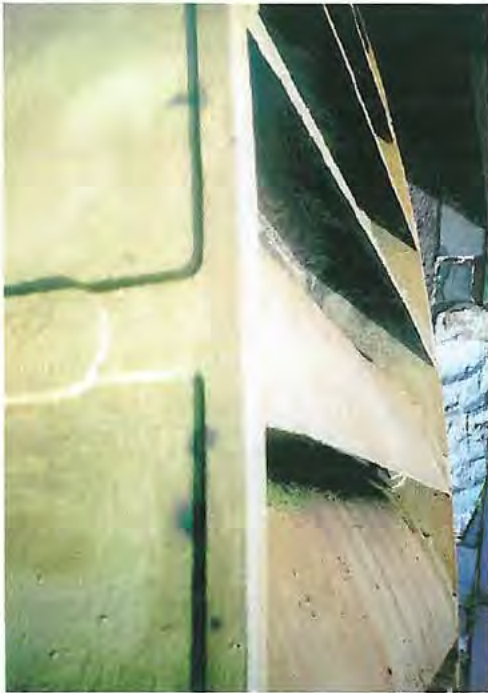
Plate 4 : Pre-restoration view of the original buckets fixed to the internal flanges of the shroud with square headed bolts.

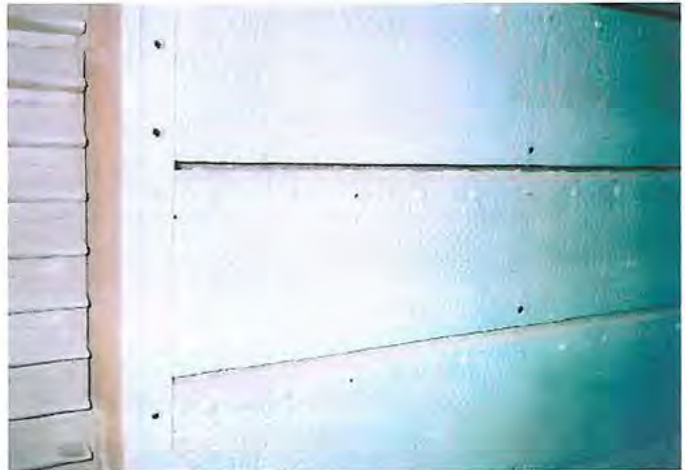
Plate 5 : The sole plates have been removed and the back of the buckets revealed. Here they have been grit blasted and coated with a weldable primer. A combination of rivets and bolts can be seen and the holes through which the sole plates were attached.

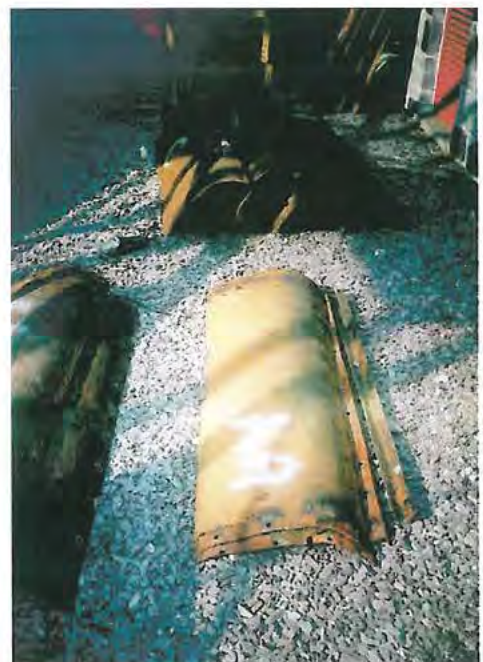
Plate 6 : Sound elements from the most corroded buckets were salvaged for re-use. The buckets were dismantled on site prior to being taken away to be cleaned and incorporated with newly fabricated components.

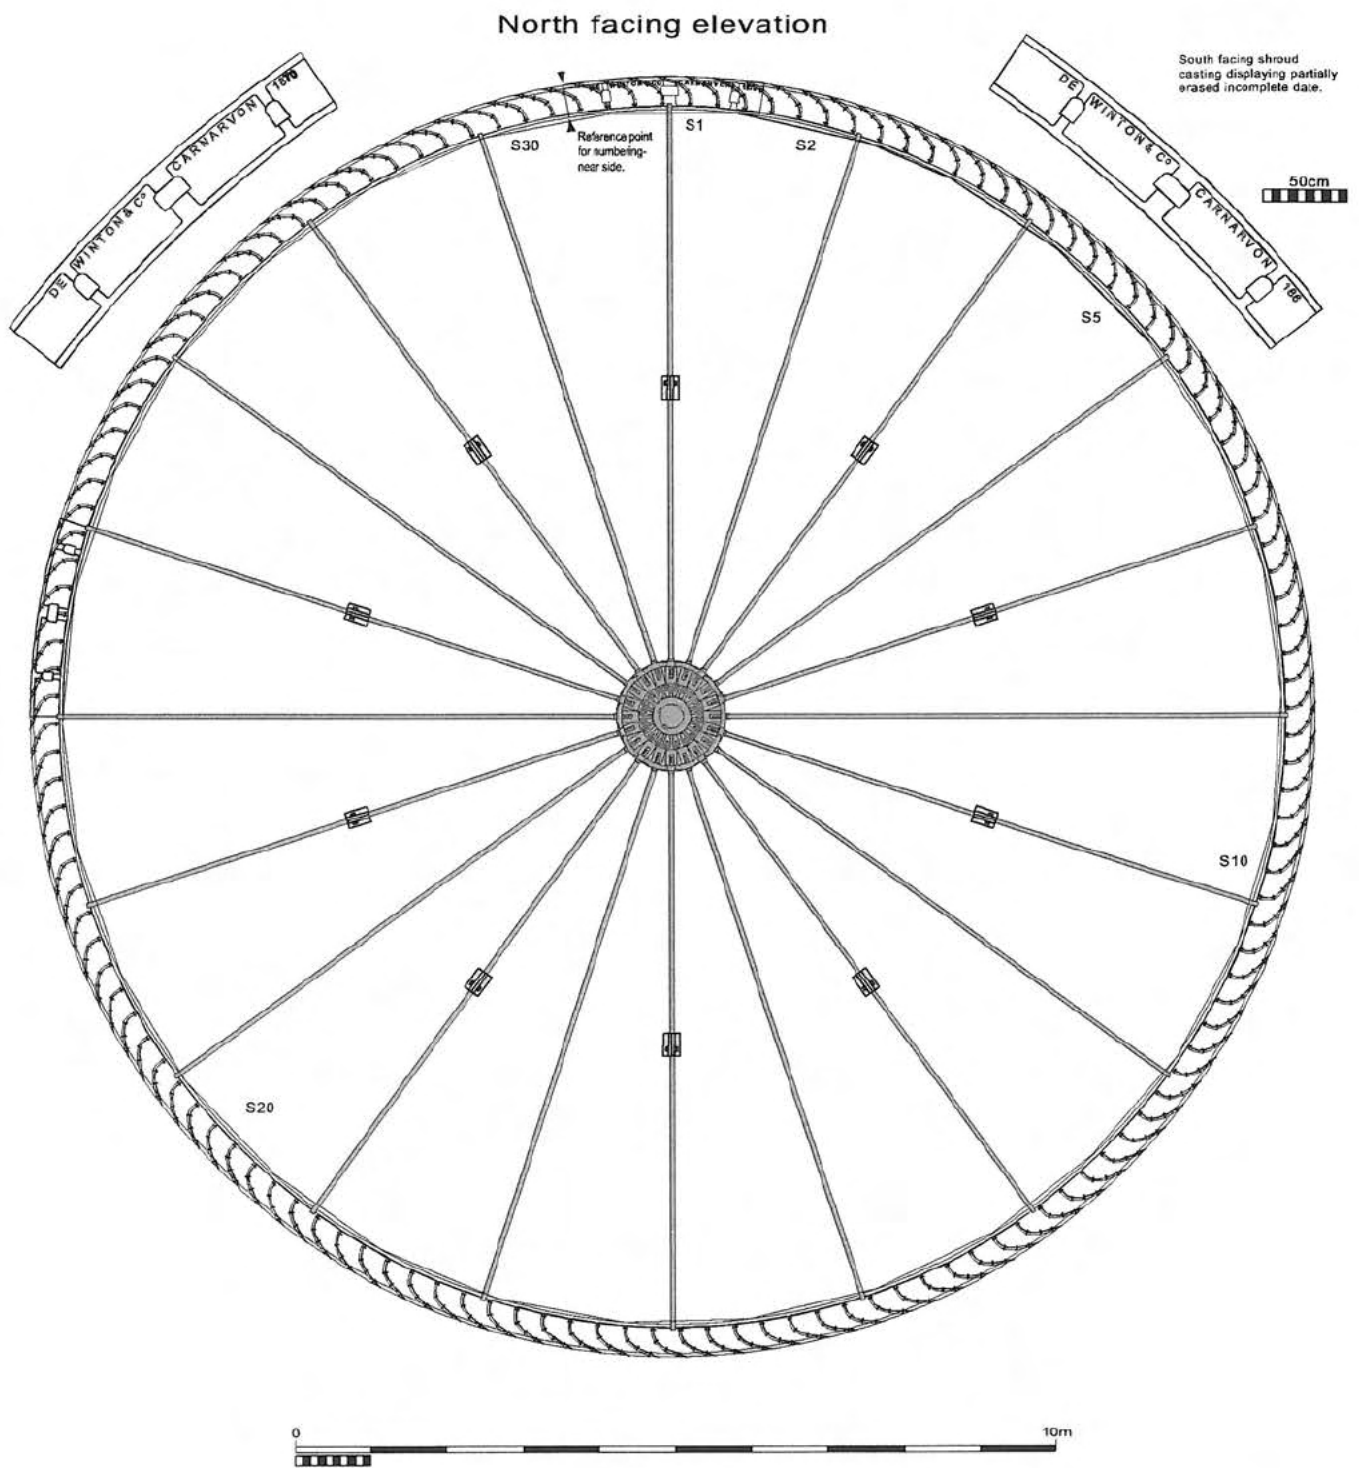
Fig 5 : North facing elevation of the wheel as viewed from the entrance. The left hand trailing edge of the shroud casting dated 1870 is the reference point for the numbering of the sole plates and the buckets. Buckets removed from the shrouds and subsequently replaced are indicated as is the replaced spoke brace.

A total of 15 buckets were removed and either entirely or partially replaced. Each replacement component is formed of steel with riveted construction as in the originals and date stamped in three places along the leading edge.

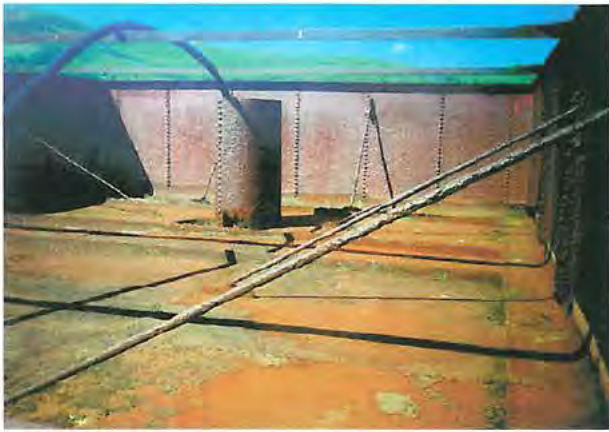
Scheduled Monument Consent accepted that all or substantial parts of both tank and riser might require complete renewal within the scope of the restoration process. An initial, largely visual appraisal of the overall construction had suggested that there was likely to be considerable deterioration of the metal at a number of structurally key locations where the metal was badly corroded or holed. allowed for the possibility X

Plate 10 : general view of the header tank before restoration. Note the scaling and the holes in both tank and riser overflow stack.

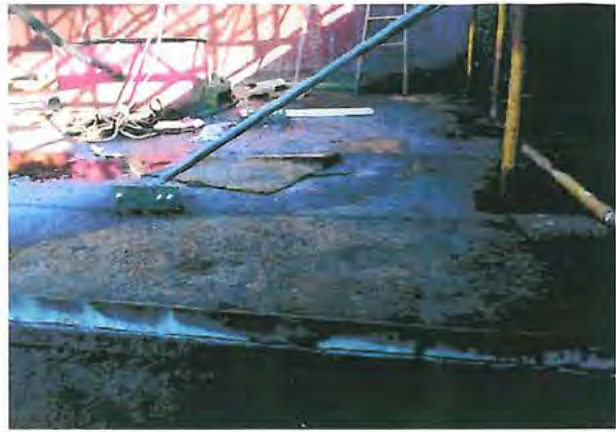
Plate 11 : New upstand, gusseting and internal bracing. Compare with the originals shown in Plate 10. The scaffold is supported on the wall top through holes cut in the tank base and were welded back later.

To ensure the structural stability of the header tank the existing internal bracing was replaced wholesale. The replacement components were welded to the existing toe of the original, which was retained for this purpose. Although the replacements are more substantial, the result reflects the nature of the original. Likewise new gussets were welded in as required to both wall and base to reinforce the more wasted areas. When this work was completed the tank was cleaned and those areas requiring new metal were clearly identified. Affected areas were cut out and used as templates for the new patches, which in order to remain readily identifiable were not ground off (pl.13). Although remaining visible the patches are not incongruous to the overall appearance of the monument especially when viewed from a distance.

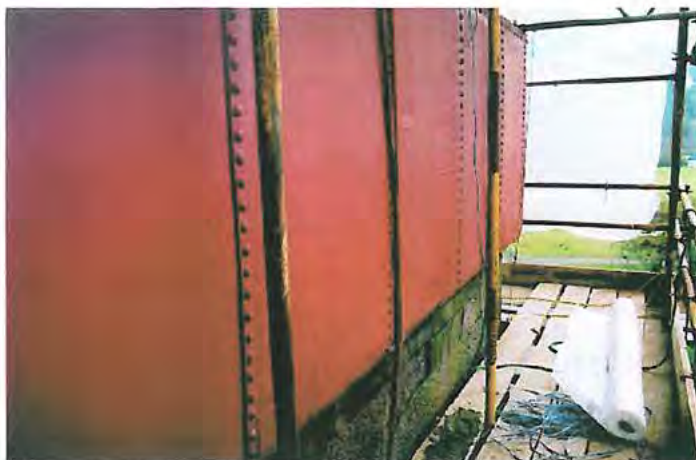
Plate 13 : The external north side of the tank during repairs. New metal has been welded in where necessary and the patches of non-original material left visible as indicated here. Bowling Mill stamp was found on sheet at north-west corner.

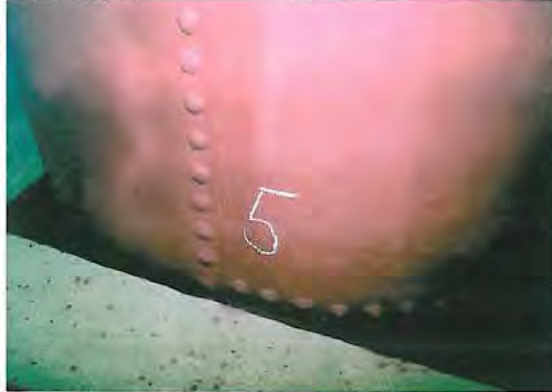
Plate 14 : Hand riveted, staggered seam joining together plate sections 5,6 and 7. Compare the clean dome headed, hydraulically welded seams with the cone shaped hand riveted seams.

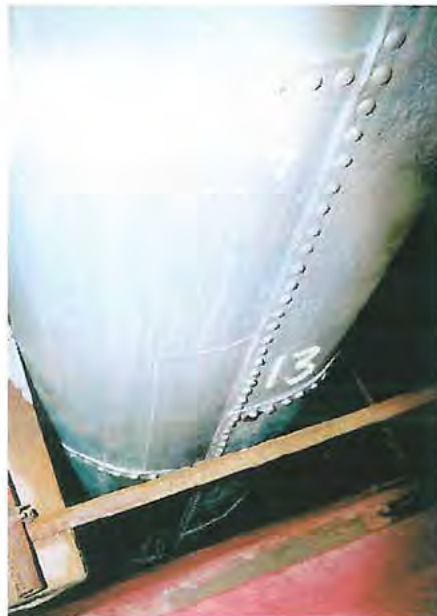
Plate 15 : The mid to lower sections of the riser joined between plates 13,14 and 15. The hand welded seams here are distinguishable by both external cone shaped heads and studs which indicate that the head of the rivet is inside the riser. Note the sections of new metal welded in place.

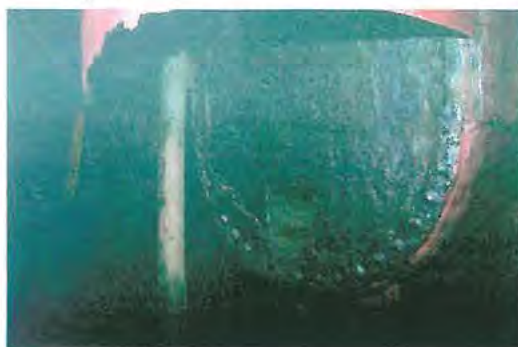
Plate 16 : The riser inlet elbow - note the rectangular access hole cut in the end plate that revealed the contemporary concrete repair.

The custom-made union section that converts the incoming circular section main to the D section riser is angled slightly down and not square on to the mouth of the pipe, yet there seems to be some purpose here. The stanton supporting the base of the riser has been cast to hold an angled, not horizontal cylindrical section. Does this suggest that an original intention was for the inlet pipe to enter at an inclined angle and that the present alignment is botched or perhaps a later replacement?

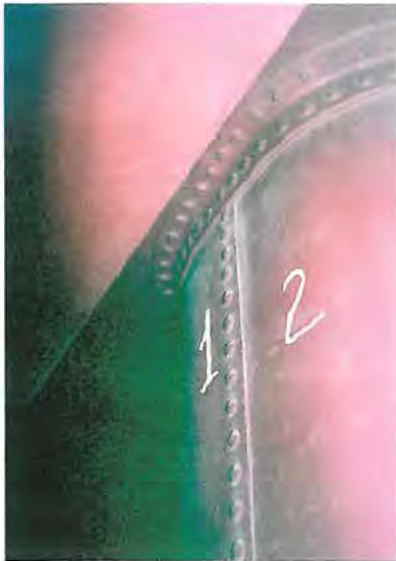
Plate 17 : The uppermost sections of the riser were still in very good condition and after grit blasting and painting appeared as new.

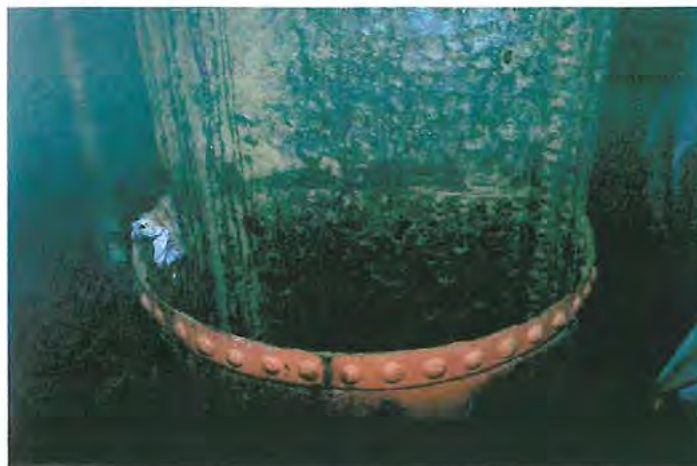
Plate 18 : Where whole new sections were required to be fitted these were welded in inside of the original area so leaving the riveting as original throughout.

Plate 18 : New sections tailored from dimensions of removed sections used as templates.

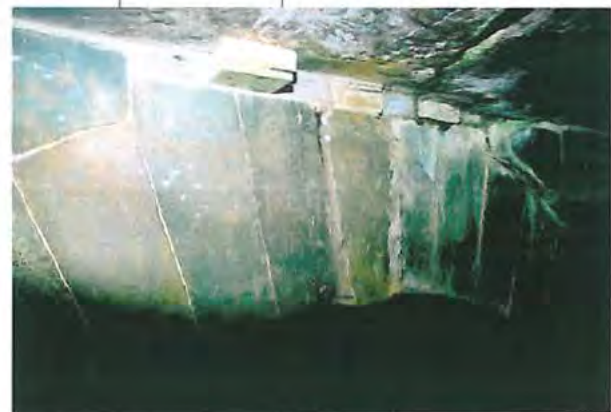
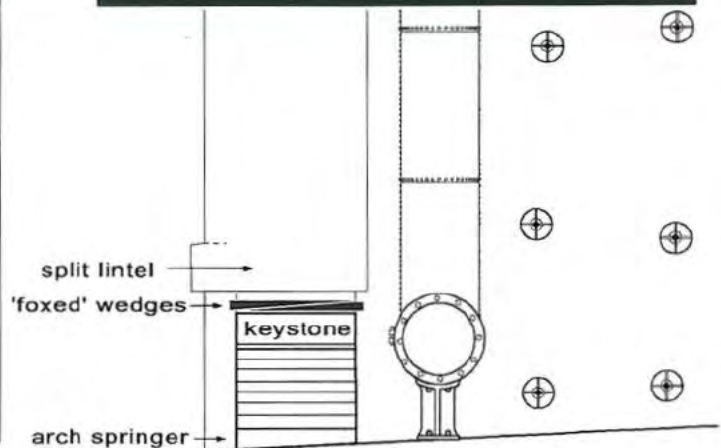
A number of structural defects in the fabric of the wheel housing were identified from the surveys and these were addressed during the second phase of the refurbishment. The first and potentially most serious of these was the stability of the tailrace arch. It was previously noted that the base lintel was cracked through and that beneath this was a shallow arch, the keystone of which was held in by iron wedges, now much corroded. The arch is built of sawn and shaped slate blocks and is mortar bonded, and was probably a later insertion to lend support to the cracked lintel above. The old wedges had the appearance of being "foxed" and it was proposed to replace these on a like-for-like basis. Removal of the originals showed them to be nothing more than four irregular lengths of scrap iron wedged in on top of each other. Replacement "foxed" wedges were inserted over the keystone and into the gap both sides and mortar pointed (Fig.14).

Fig 14 : South facing section / elevation showing tailrace arch and location of wedges above keystone.
