# BRIDGE ON THE FARM TRACK AT MYNYDD BLEWOG, LLANFFLEWYN, ANGLESEY

## WATCHING BRIEF

Report No. 436

Project No. G1738

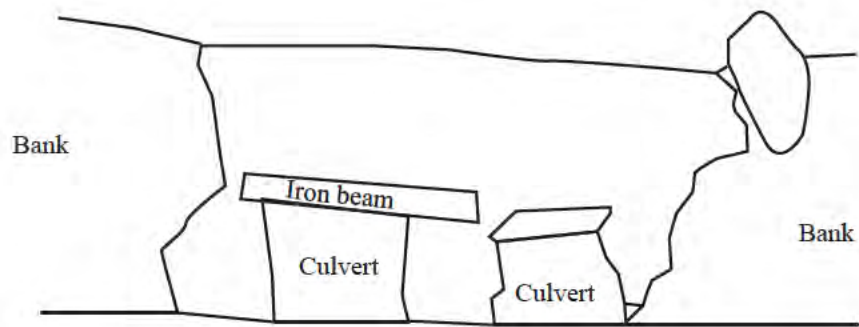
Figure 6a: Sketch elevation of south face

The demolition allowed the construction of the bridge to be understood. The side revetments had been built to canalise the stream, and the track on either side of the bridge had been built up by a maximum of 1m with stone and crushed slate. This stony deposit extended over the top of the side revetments. A central

support was built on the north and south sides of the bridge, but these did not appear to extend the full width, leaving the centre of the bridge unsupported. The lintels were laid so that they rested on the side revetments and the central supports. The drystone faces were built on each side, with some rubble behind them, but a void left in the middle. The concrete road surface was laid over the top.

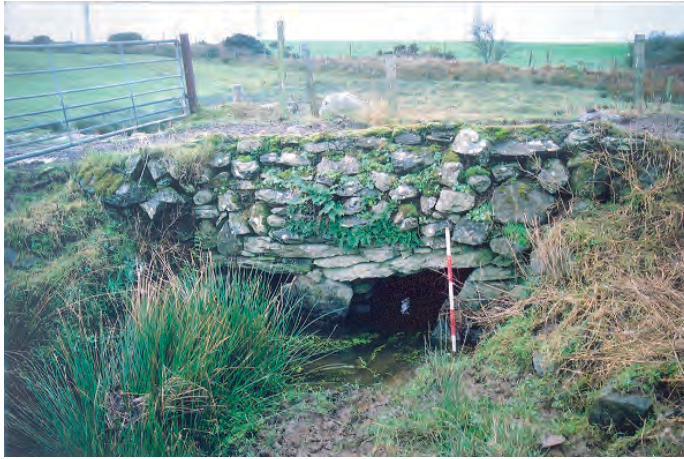
Plate 1: north face of bridge

The bridge measured 5m by 3.8m, and was 1.8m high on its southern side and 2.0m high on its northern side. Two lintelled culverts carried the stream under the road (plates 1 and 2). These culverts were 0.7m wide and composed of large stone slab lintels bridging the gap from the bridge sides to a central support. There appeared to have been no central support under the middle on the bridge, where the lintels, with little to hold them up, had slumped into the stream. The western culvert on the southern side of the bridge had two box-sectioned pieces of iron instead of stone lintels. These seemed to have been an original feature of the bridge.

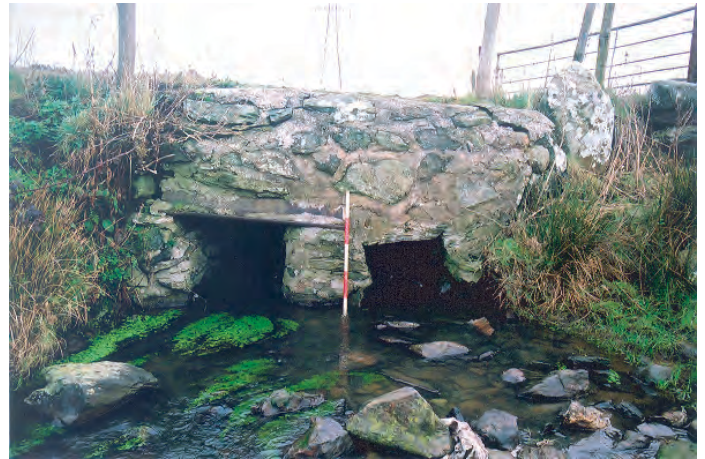
Plate 2: south face of bridge

The bridge was of drystone construction, though the southern face had been crudely pointed with mortar, presumably to help consolidate it. On both faces drystone walling, of irregular courses, had been constructed above the culverts up to the level of the road. The road surface was of stones consolidated with concrete. When a large section of the concrete road surface was lifted off the bridge it was revealed that the apparently strong construction was a façade only. Behind the facing there was nothing to support the road surface, and, as mentioned above, the lintels covering the culverts were also largely unsupported in the middle. Only the strength of the concrete had prevented the bridge from collapsing (plate 3).

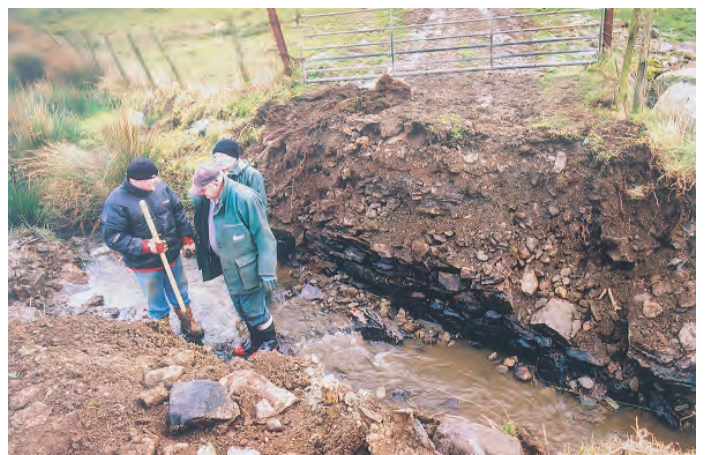
Plate 4: after demolition was completed

A mechanical excavator was used to remove the concrete road surface, and to loosen the stone faces of the bridge. The stones were moved into the excavator’s bucket by hand, and then deposited on the bank of the stream. The stones were to be reused in rebuilding the bridge. The central supports were removed, as the channel needed to be widened to improve the stream’s flow (figure 5), but the side revetments, lining the stream channel, proved to be sufficiently well built to be incorporated into the new bridge (plate 4).

To rebuild the bridge the Environment Agency team intended to build up the side revetments to the height of the road surface, and to span the gap with iron beams supporting sleepers (see figure 5). This will change the appearance of the bridge considerably, but the original stone is being reused. It was not possible to rebuild the bridge to resemble its original appearance because of the need to widen the stream channel by removing the central supports.
