# TRE'R CEIRI MONITORING VISIT

Report number : 453

Prepared for  
**GWYNEDD COUNCIL**

## **TRE'R CEIRI MONITORING VISIT: MAY 2002 (G1605)**

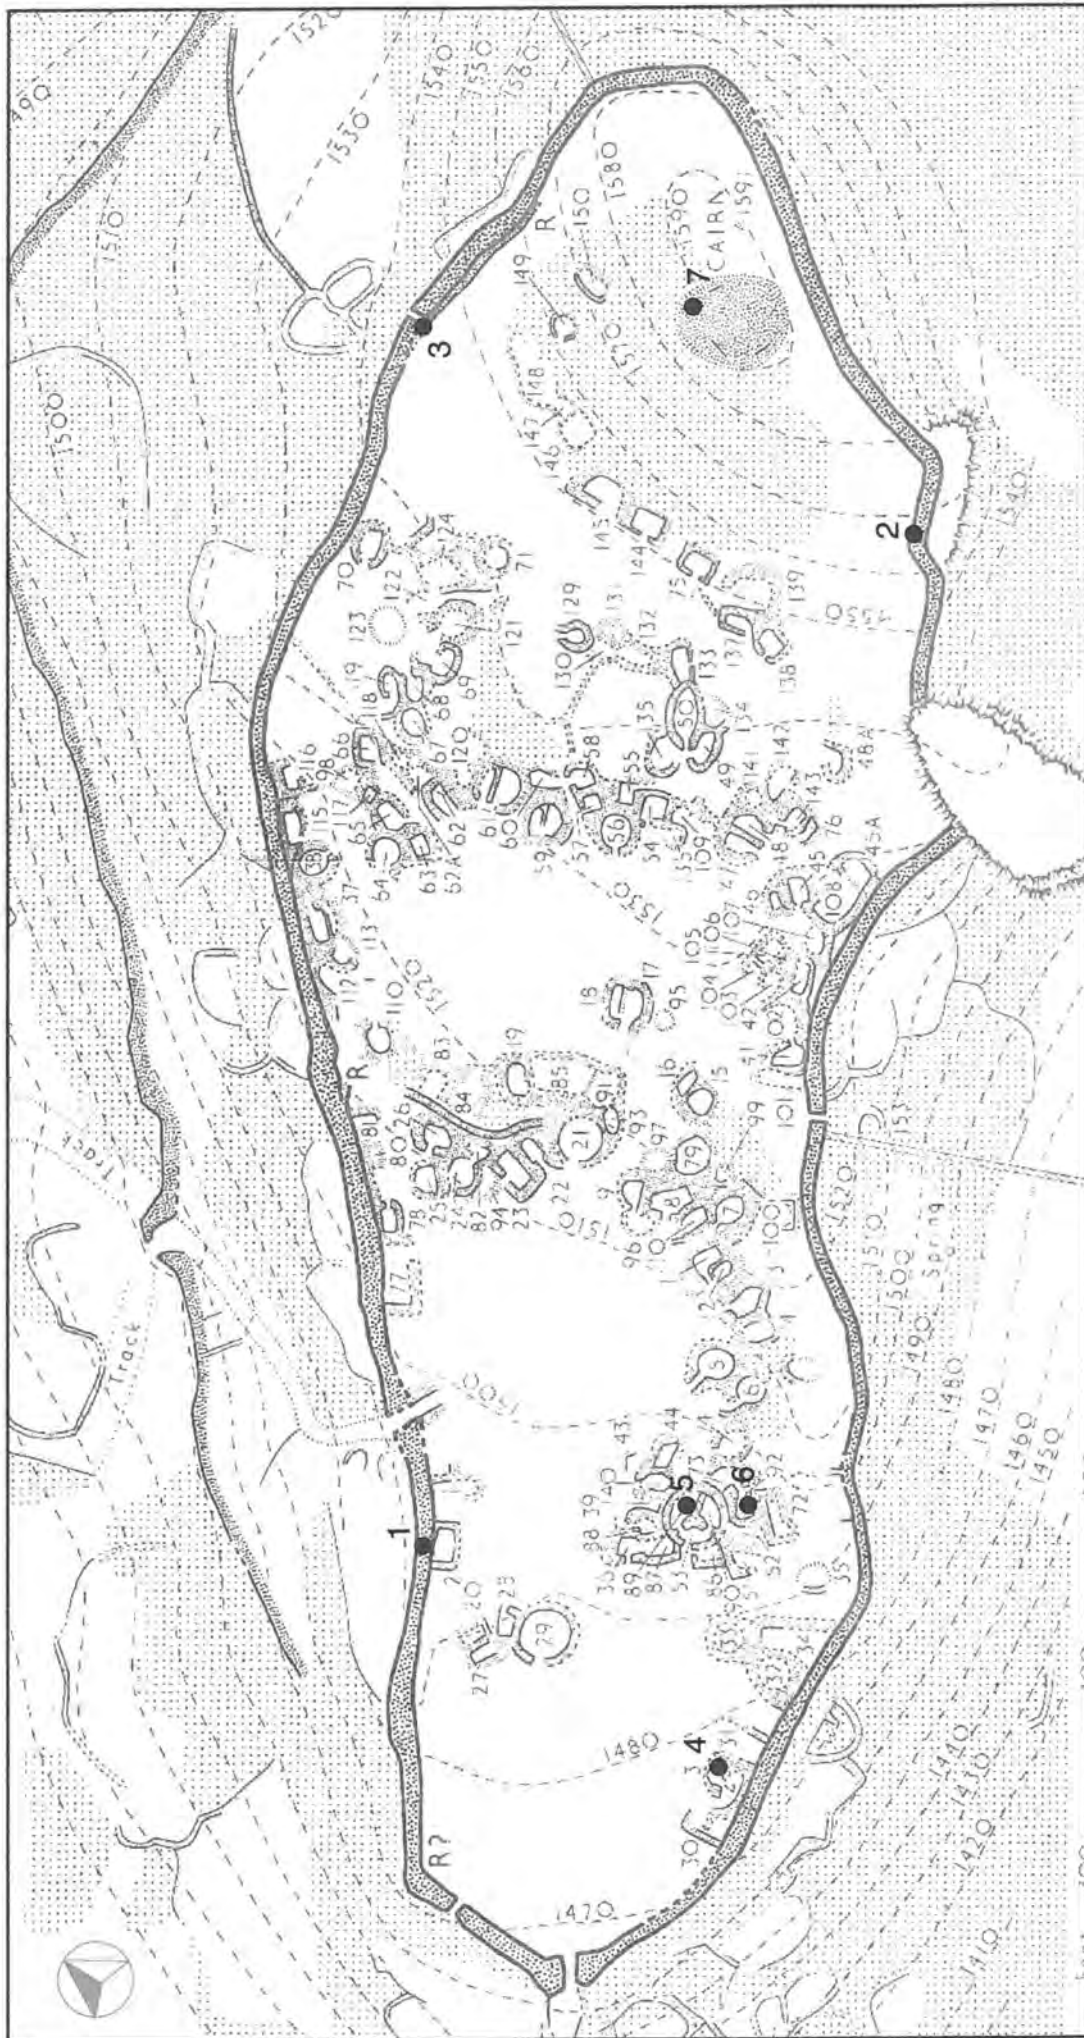
Fig. 1 Tre'r Ceiri showing points of collapse identified in the May 2002 monitoring visit (after R.C.A.H.M.W. 1960)

The following minor areas of damage were identified and were marked onto a plan of the site (Fig. 1) Written records were kept of all works.

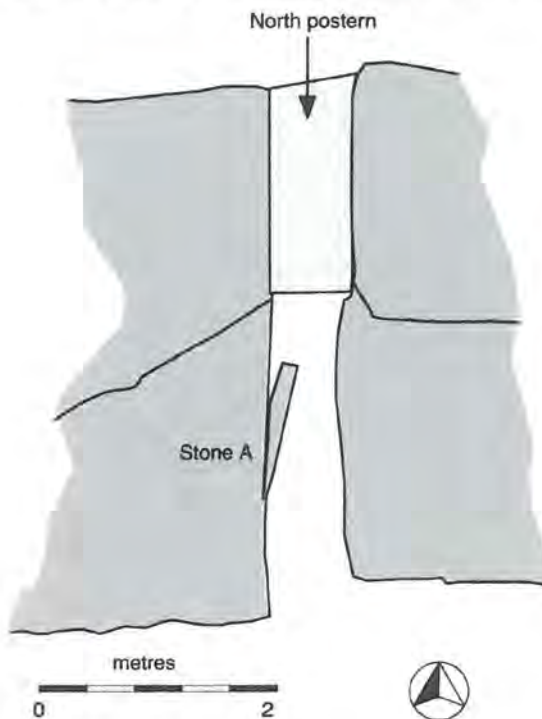
Fig.2 Collapse 3

3. A flat edge-set stone at the base of the wall in the north postern has been pushed forwards by the weight of stone behind it. The stone is at the base of the wall, 1.2m from the inner end of the western side of the unroofed part of the passage (stone A Figs 2 and 3, Plates 1-3). The stone has pivoted from its southern end and the northern end is about 0.2 metres out of alignment. The stone can be seen in its original alignment on plate 1 which was taken during conservation work in 1989. Stone A was originally held in place by stones B and C which rested on top of it. Fig. 3 shows the present arrangement of the stones. Stone B has fallen behind stone A and stone C still rests lightly on stone A.

There does not, however, appear to have been any substantial slumping of the wall above. A large slab (stone D) runs deep into the wall. The weight of the stone on the inner end has produced a cantilever effect, thus supporting the face above the outer end. Stone A is not currently supporting any weight and stones A, B, C and E are loose in the wall. It is likely that stone A will fall out of the wall entirely if no action is taken. This would leave a large unstable void in the wall base. Core material is already falling forwards and if this is allowed to continue it is likely that the stones supporting stone D and the face above it will be displaced causing a substantial collapse in the passage. This would be serious from both an archaeological and a health and safety viewpoint.

The fact that stone A no longer supports any weight may make the stabilisation process easier. It may be possible to remove stone A entirely, clear out the displaced core material behind it and repack the core. Stone A could then be replaced and wedged into place with stones B, C and E. Similar procedures were successfully carried out several times during the original conservation project. It may be

possible to insert wooden supports beneath stone D during the above procedure. The wall above should be recorded in detail and the stones numbered before any action is taken. If there is any movement in the upper facing when stone A is removed it is likely that a section of facing will have to be dismantled and reinstated.

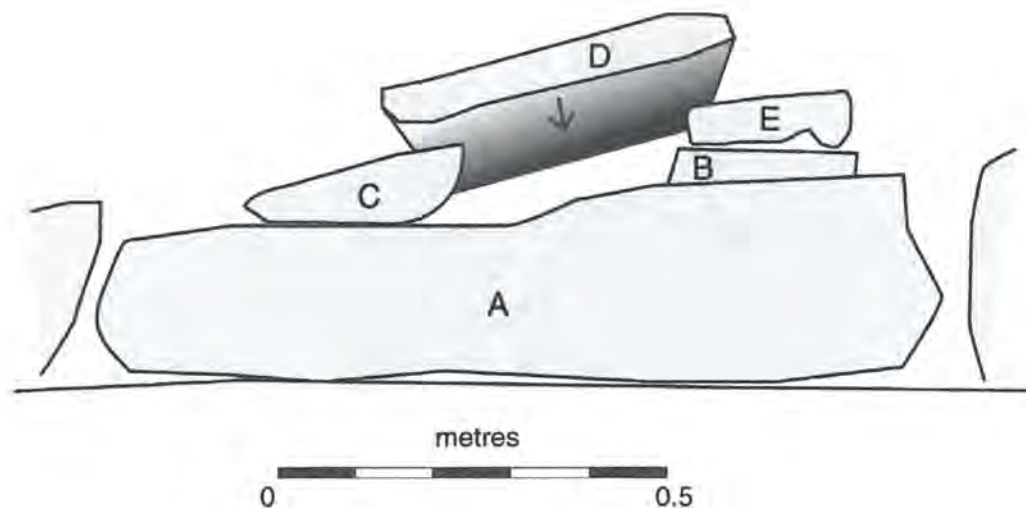
Fig. 3 Collapse 3 showing the arrangement of the individual stones

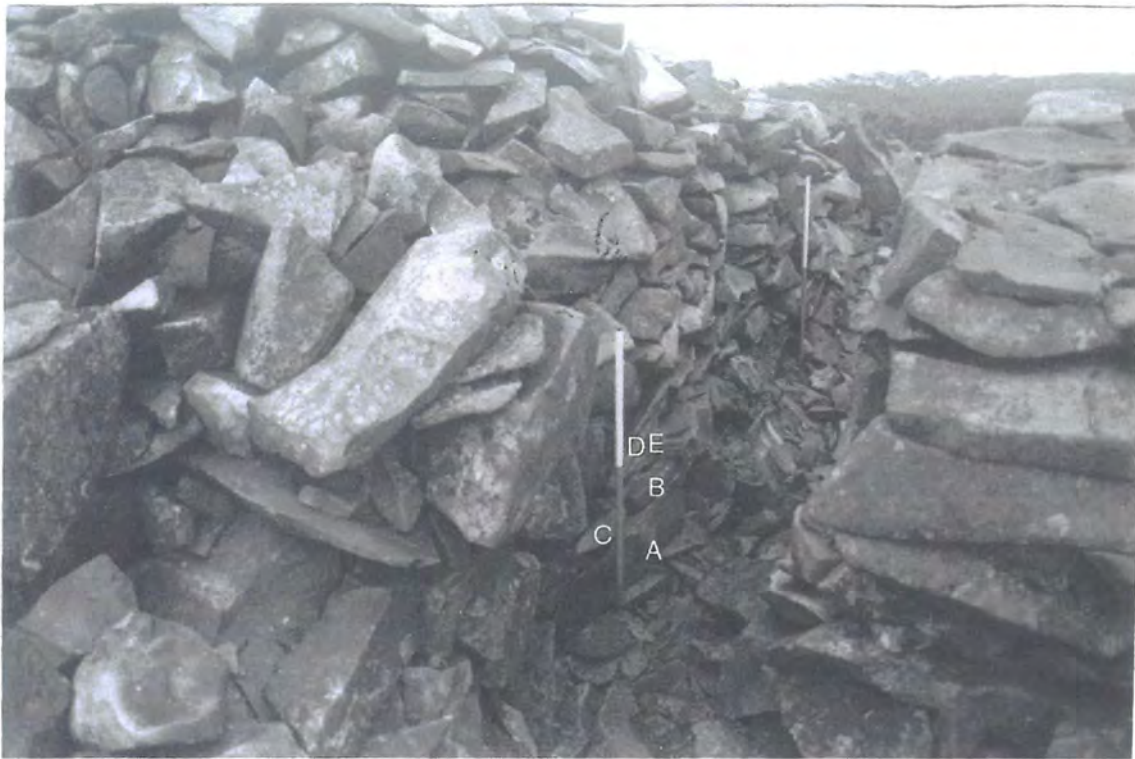
Plate 1 Collapse 3 in 1989, from the south-east

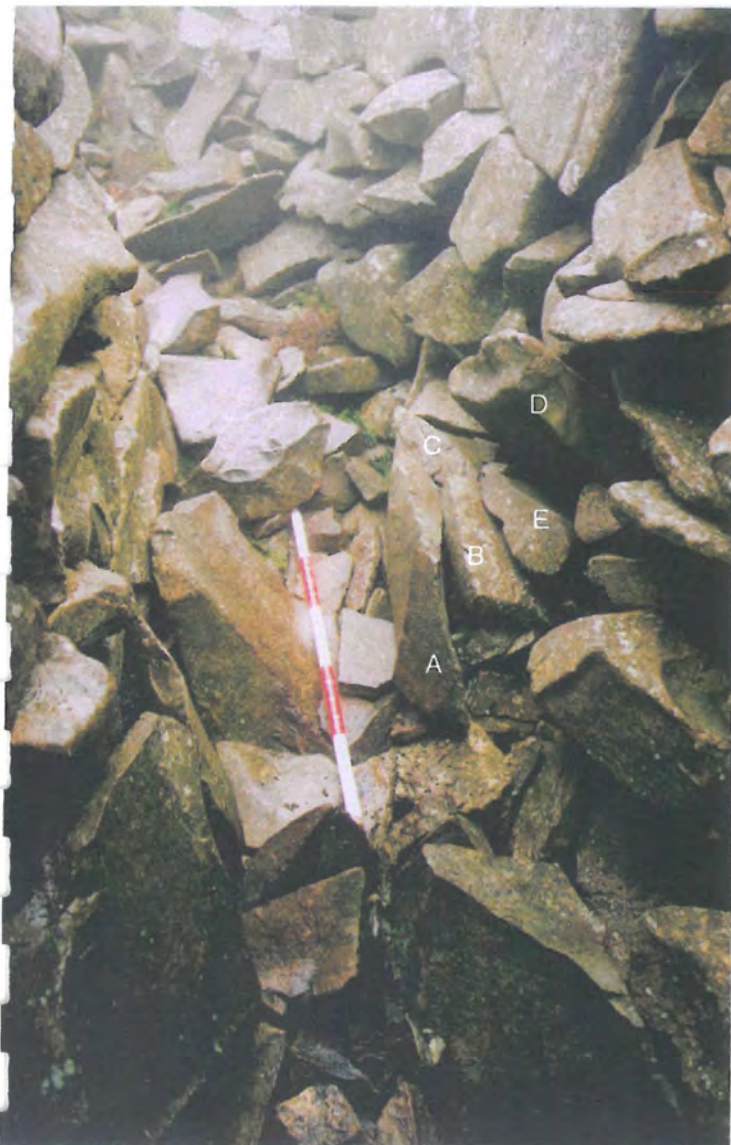
Plate 2 Collapse 3 in 2002, from the north

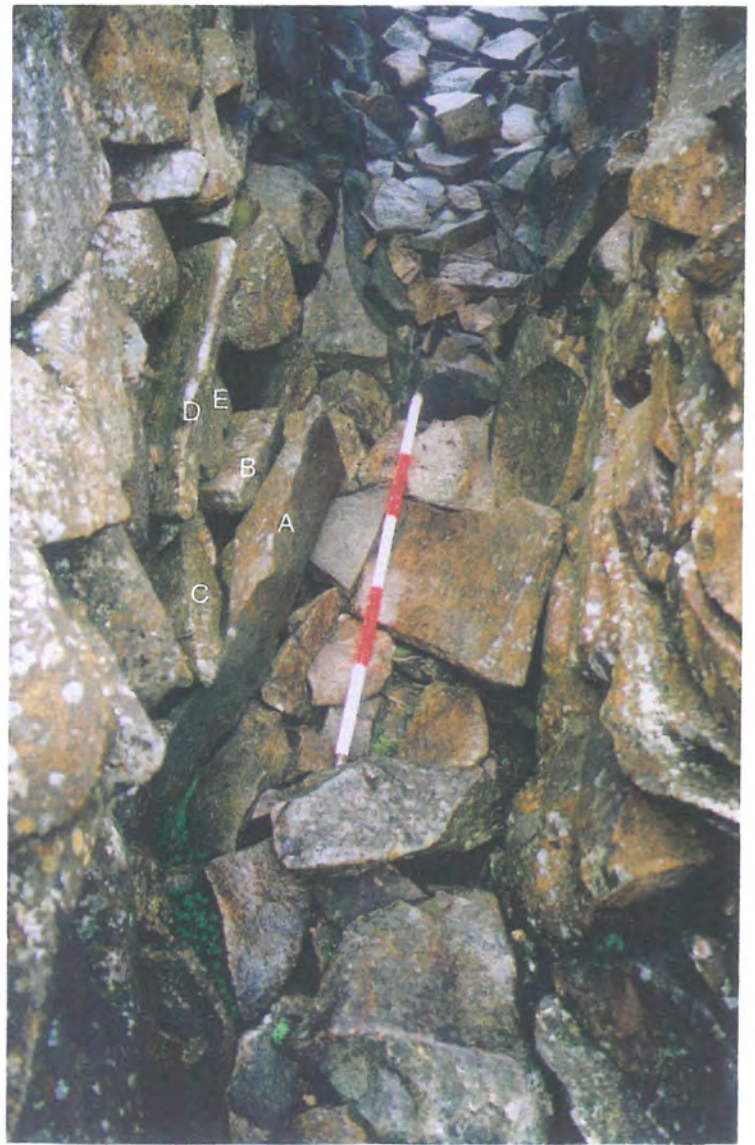
Plate 3 Collapse 3 in 2002, from the south

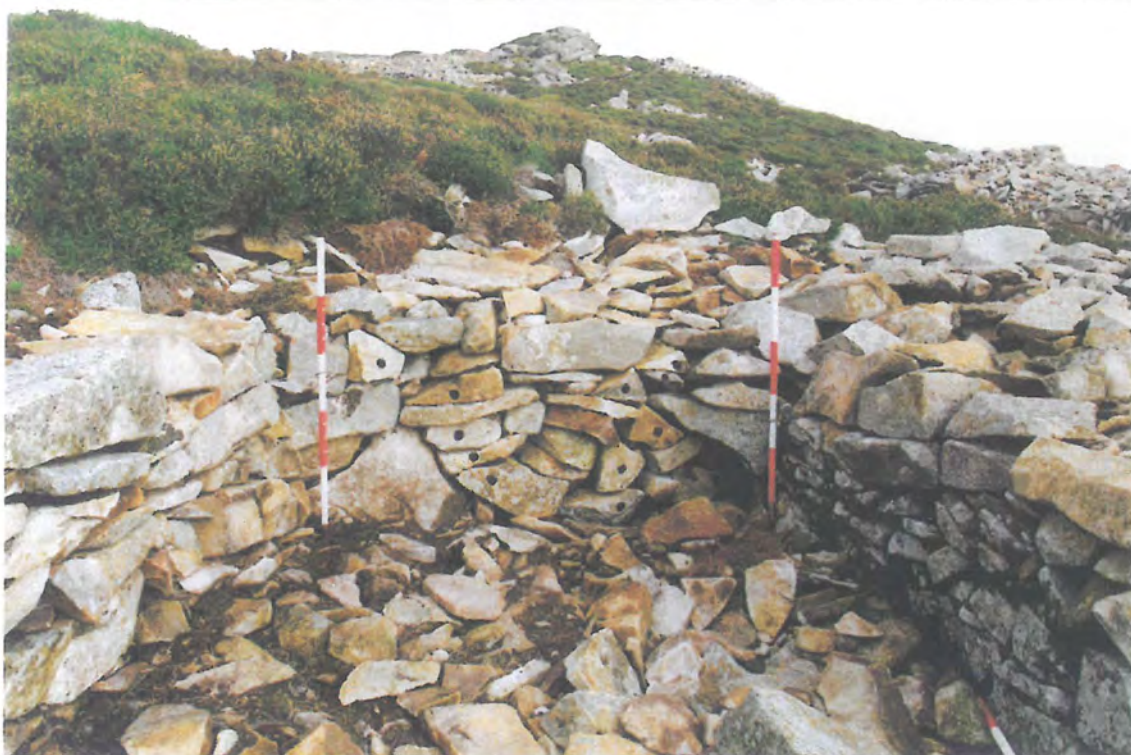
Plate 4 Hut 3 after conservation in 1997

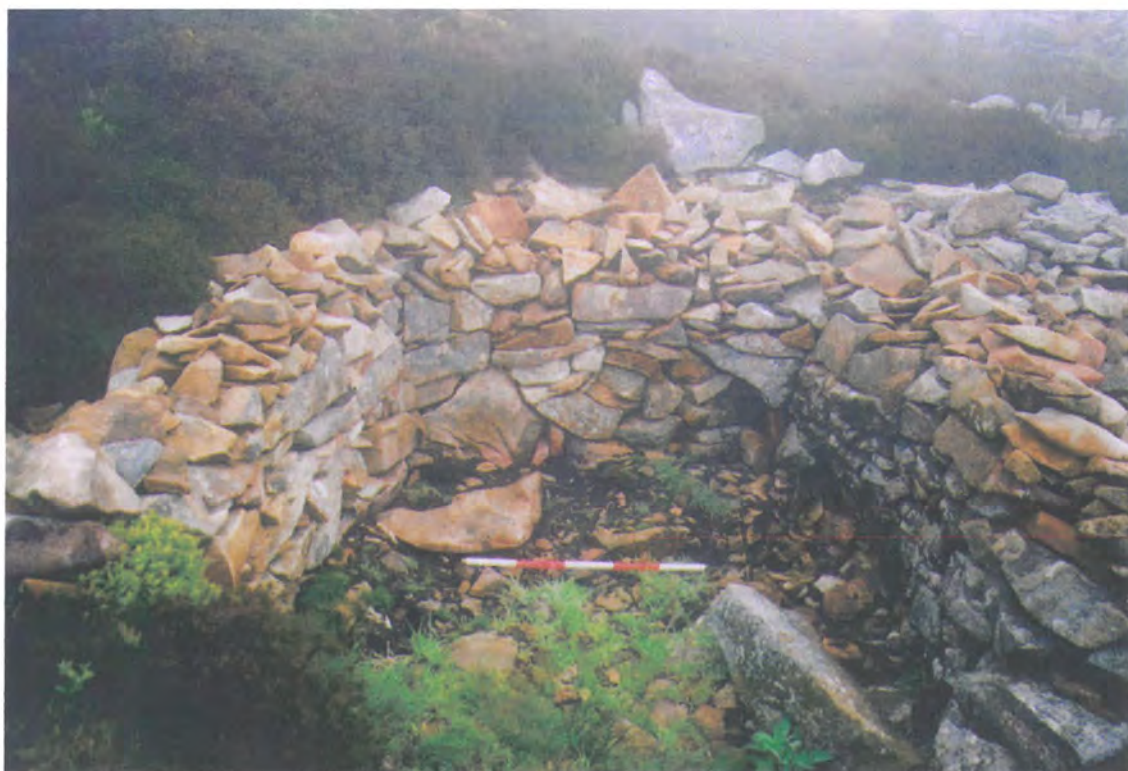
4. Hut 3. A substantial amount of damage has been done to the floor of hut 4. Plate 4 shows the hut after conservation in 1997. The floor had been carefully reinstated to help support the overhanging eastern wall. Stones have been removed to a depth of between 0.2m and 0.3m from the eastern end of the hut and neatly piled on top of the walls (Plate 5). The damage compromises the stability of the eastern wall and is very unsightly. Reinstatement requires reference to the 1997 photographs and report. The material was therefore not reinstated during the monitoring visit.

Plate 5 Hut 3 after damage to floor in 2002

The damage to hut 3 and the instability in the north postern should be stabilised as soon as possible. The north postern gives particular cause for concern because visitors commonly walk through this feature and the loose stone could be accidentally kicked out thus precipitating a collapse. The stabilisation of the two collapses should be relatively straightforward and the cost should not exceed the contingency budget.
