TRE'R CEIRI MONITORING VISIT

Report number : 468

GWYNEDD COUNCIL

By
D Hopewell

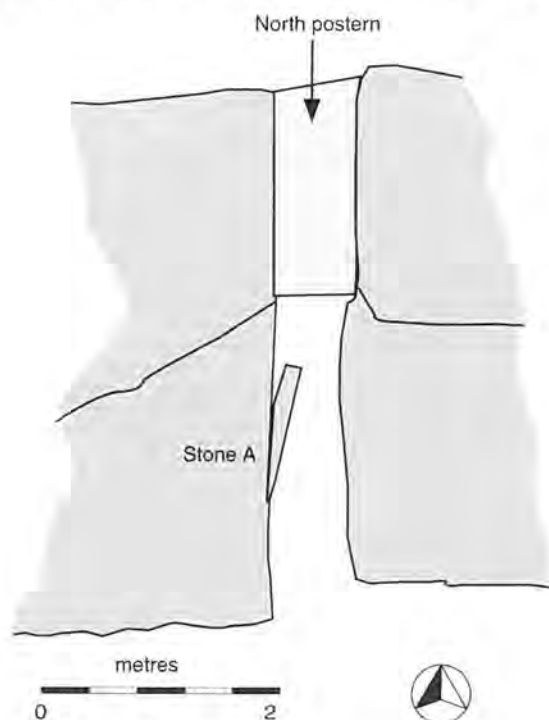
Fig.2 Collapse 3

3. The following problem was first recorded in the previous monitoring meeting in May 2002. A flat edge-set stone at the base of the wall in the north postern had been pushed forwards by the weight of stone behind it. The stone is at the base of the wall, 1.2m from the inner end of the western side of the unroofed part of the passage (stone A Figs 2 and 3, Plates 1-3). The stone had pivoted from its southern end and the northern end was about 0.2 metres out of alignment. By December the stone was further out of alignment and was loose in the wall. The stone can be seen in its original alignment on plate 1 which was taken during conservation work in 1989. Stone A was originally held in place by

stones B and C which rested on top of it. Fig. 3 shows the arrangement of the stones in May 2002. Stone B had fallen behind stone A and stone C was still resting lightly on stone A. There had not, however, been any substantial slumping of the wall above. A large slab (stone D) runs deep into the wall. The weight of the stone on the inner end has produced a cantilever effect, thus supporting the face above the outer end. Stone A was not supporting any weight and stones A, B, C and E were loose in the wall. It was likely that stone A would fall out of the wall entirely if no action was taken. This would have left a large unstable void in the wall base. Core material was falling forwards and if this was allowed to continue it was likely that the stones supporting stone D and the face above it would be displaced causing a substantial collapse in the passage. This would have been serious from both an archaeological and a health and safety viewpoint.

It was obvious by December that stone A was no longer supporting any weight and that the wall when inspected was reasonably stable. The main danger was loss of core from the lower part of the wall. It was felt that any further loss of material combined with frost action in the winter could further destabilise the facing. It was therefore decided to stabilise this area during the December monitoring visit. Stone A had moved forwards sufficiently to allow the displaced core to be cleared away. Stones

B C and E were therefore marked and removed from the wall and the core was cleared. Stone C was found to have broken in the wall and was unsuitable for reuse. Stone A was pushed back to its original position and core was packed behind it. Stones B and E were replaced close to their original positions but could not be wedged into the triangular profiled hole without the addition of another stone. Stone L was therefore added to the wall, displacing stone E slightly to the right, in order to wedge the three stones tightly between stones A and D (see Plate 4). A large void remained where the broken stone C had previously rested on stone A. Stone C was replaced with a flat slab (I) and a further stone (J) was introduced into the wall. This was carefully selected from the scree and was fitted into a gap in the inside of the wall as a header thus tying the face into the core. A further smaller stone H was wedged between stone J and the original masonry (stone H) in order to lock the face together. The new masonry was deliberately not built to a regular face in order to blend in with the adjacent irregular wall base. Stone A was still liable to be pushed forwards again because the floor in front of it consisted entirely of small loose stones. These were therefore cleared away and a single wedge-shaped stone (F) was tightly fitted into the floor in front of a large immovable slab (G plates 3 and 4) thus producing a small lip in front of stone A. This area will be carefully monitored during site visits in the future.

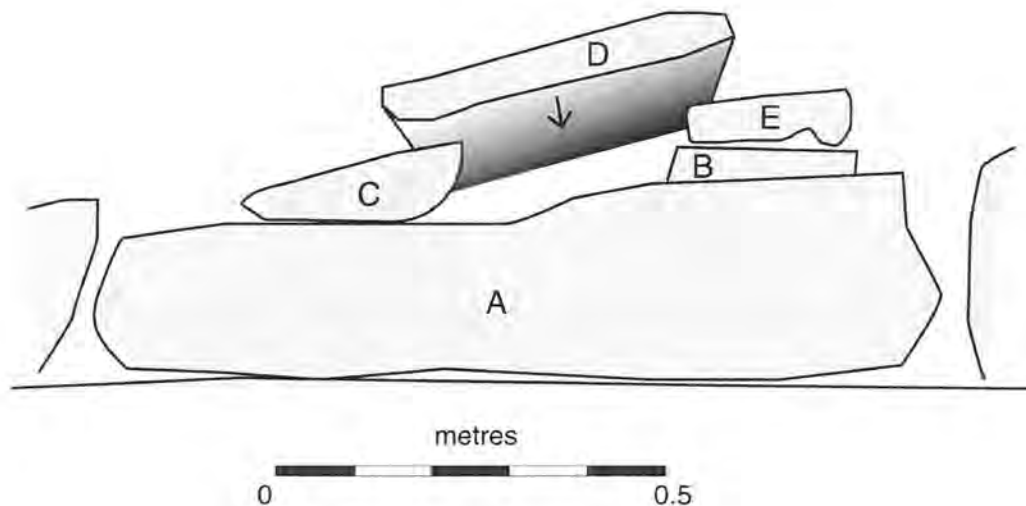
Fig. 3 Collapse 3 showing the arrangement of the individual stones

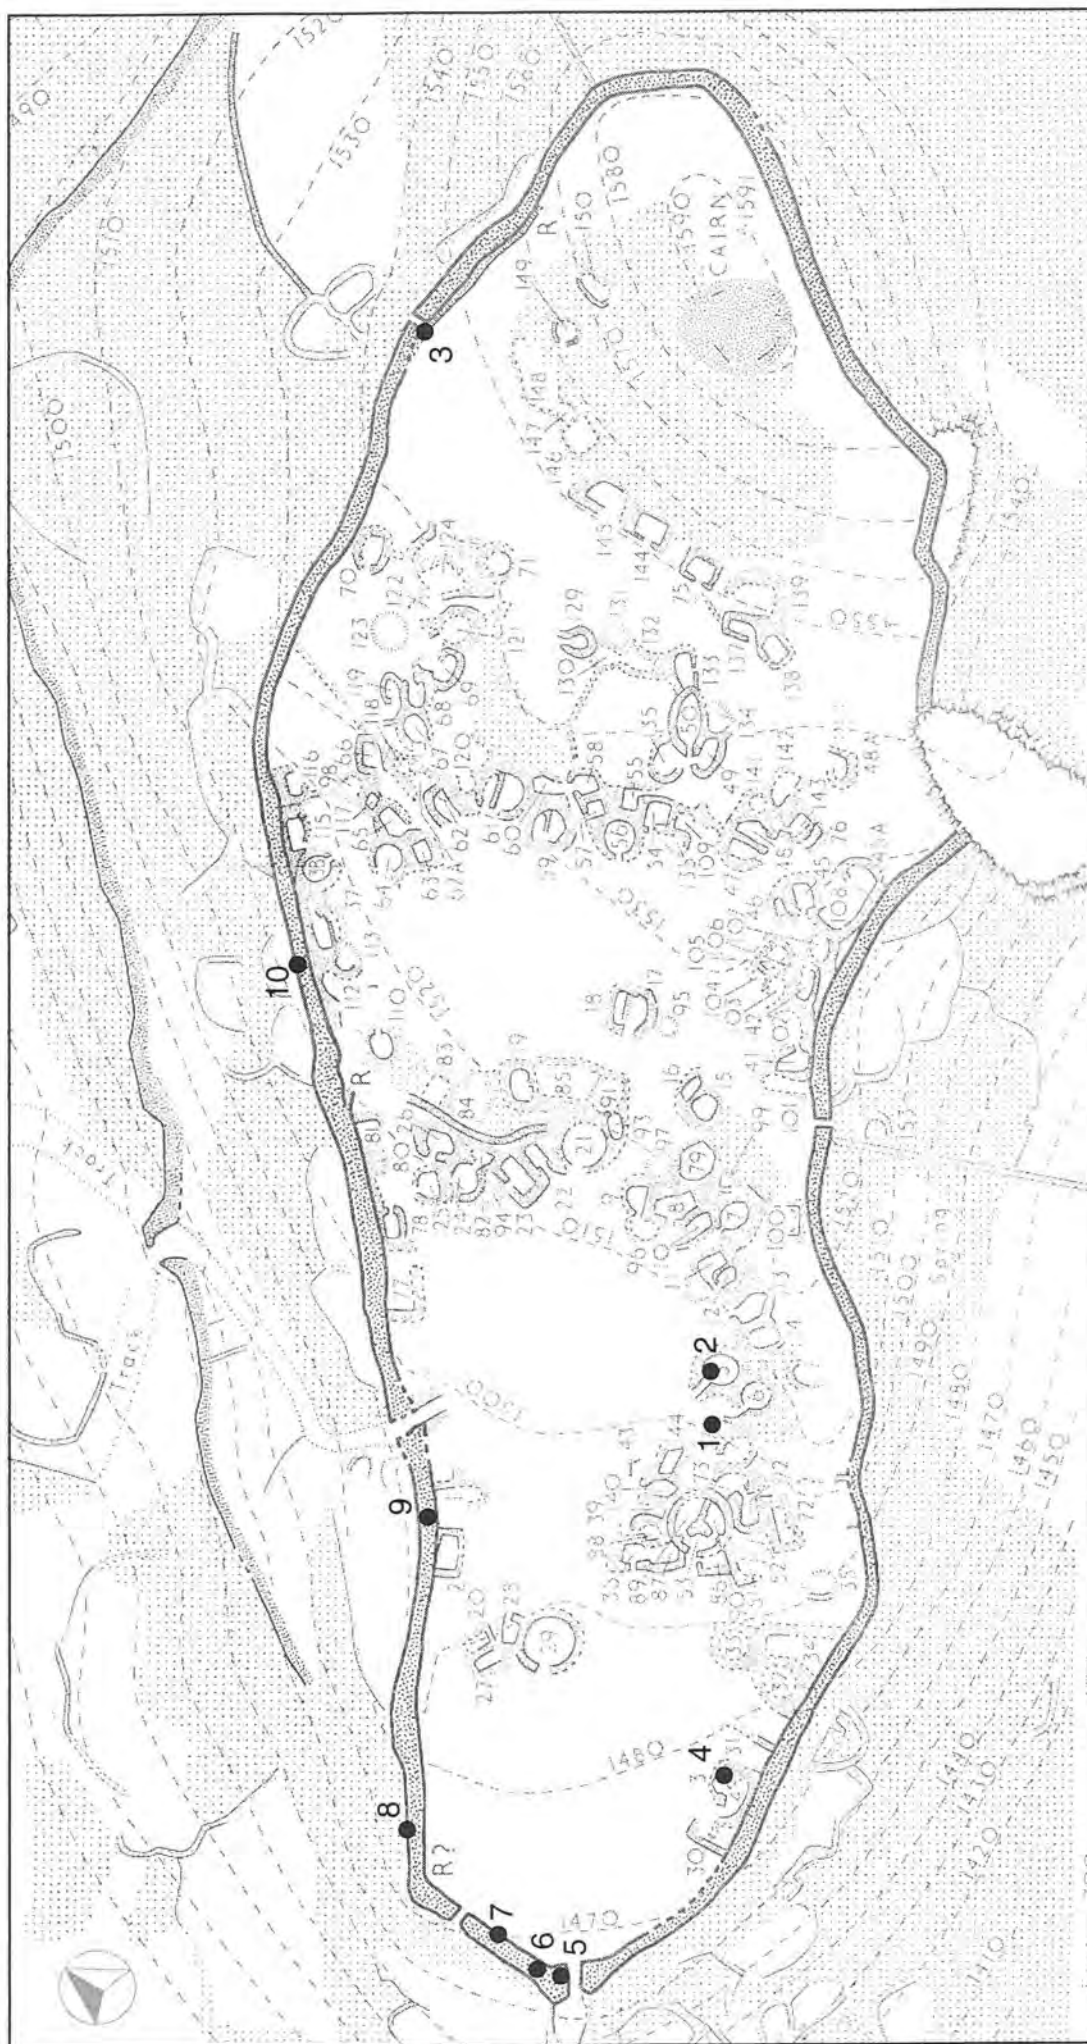
The following minor areas of damage were identified and were marked onto a plan of the site (Fig. 1). Written records were kept of all works.

Fig. 1 Tre'r Ceiri showing points of collapse identified in the December 2002 monitoring visit (after R.C.A.H.M.W. 1960)

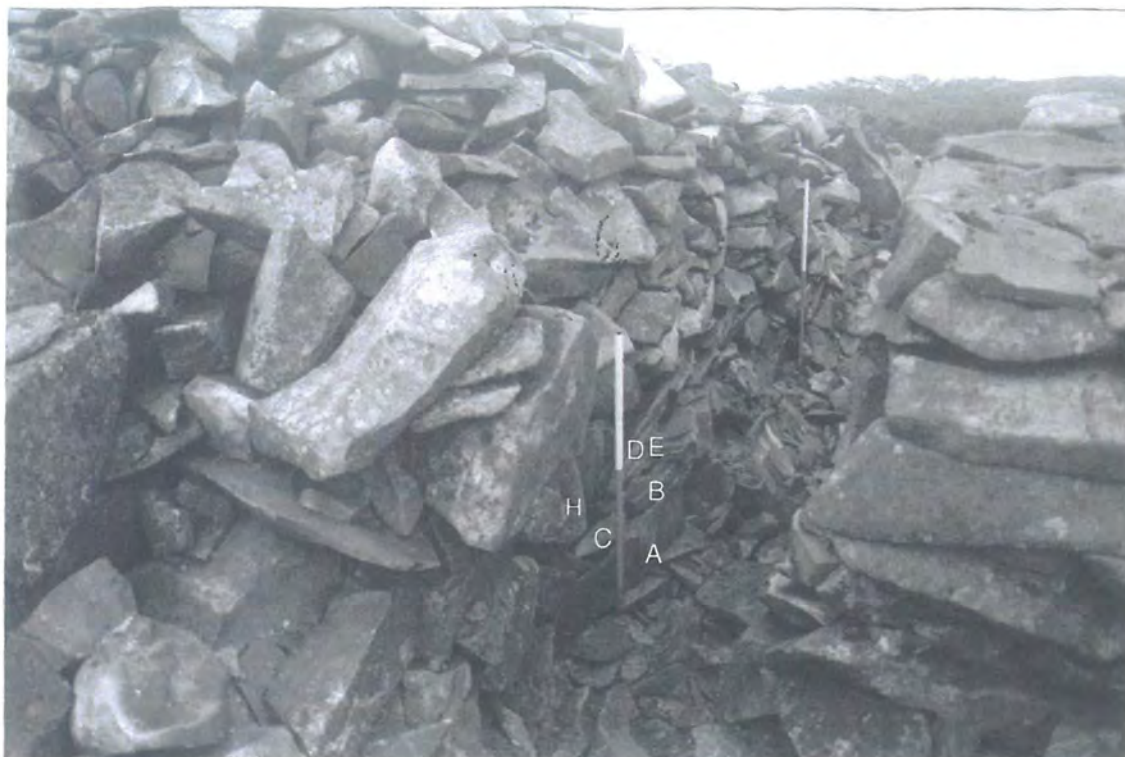
Plate 1 Collapse 3 in 1989, from the south-east

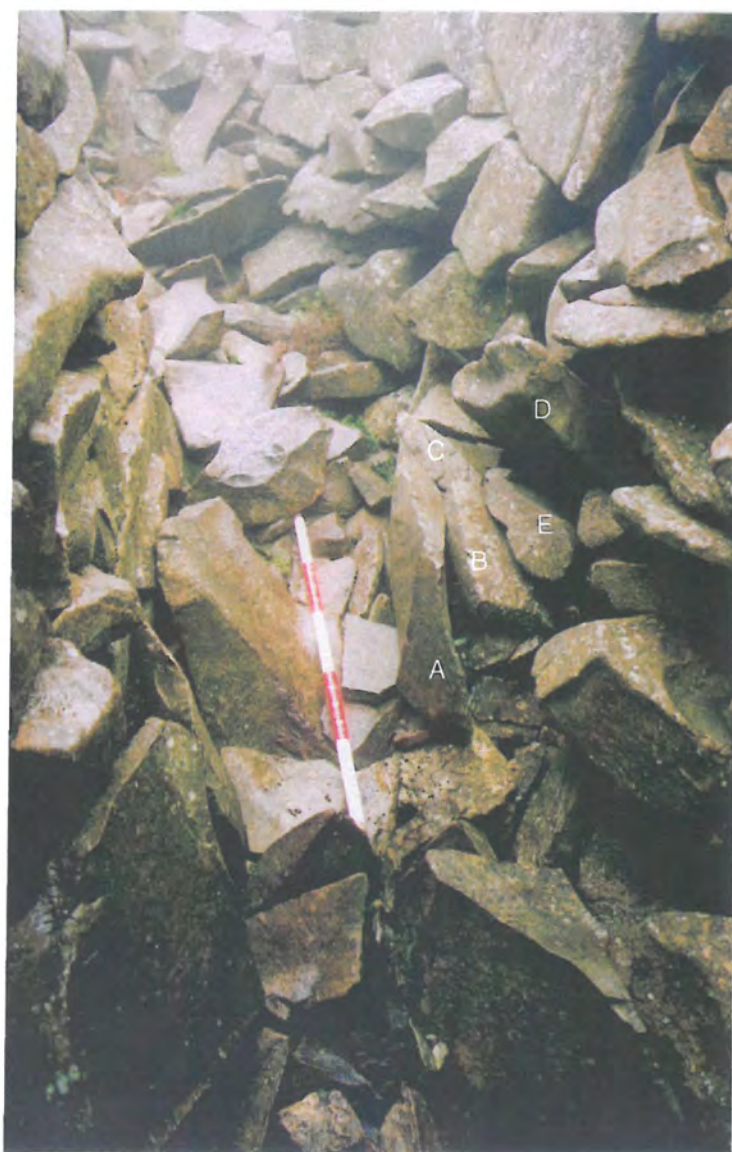
Plate 2 Collapse 3 in 2002, from the north

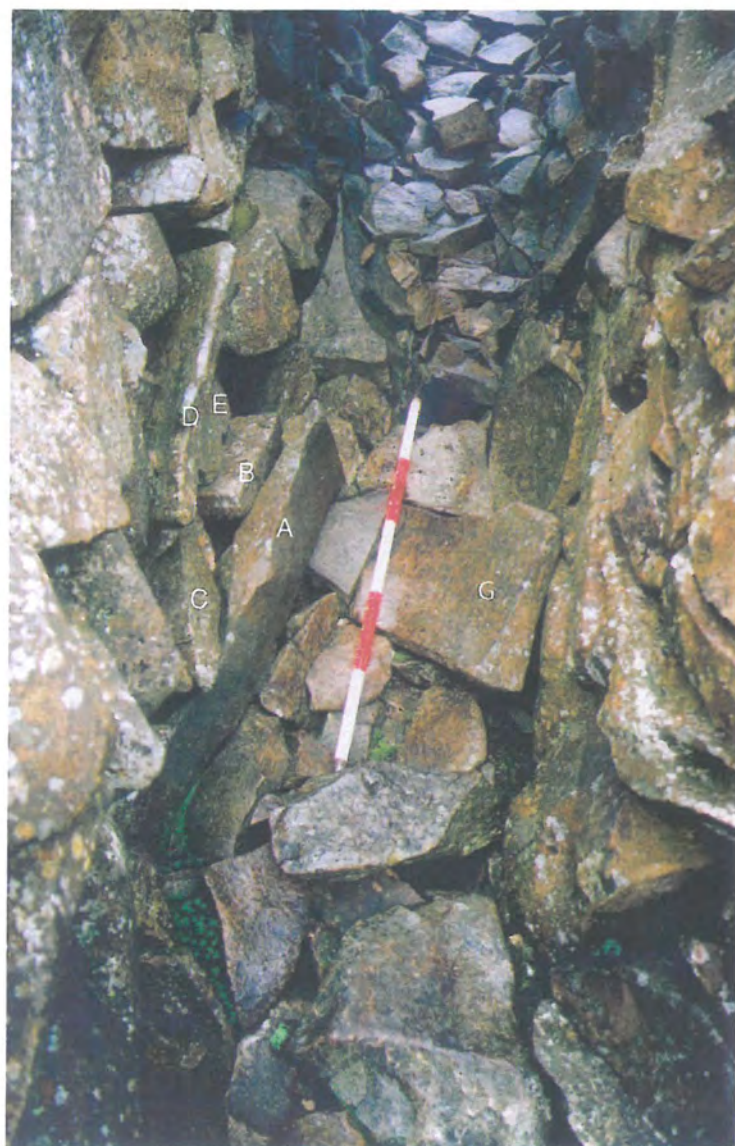
Plate 3 Collapse 3 in 2002, from the south

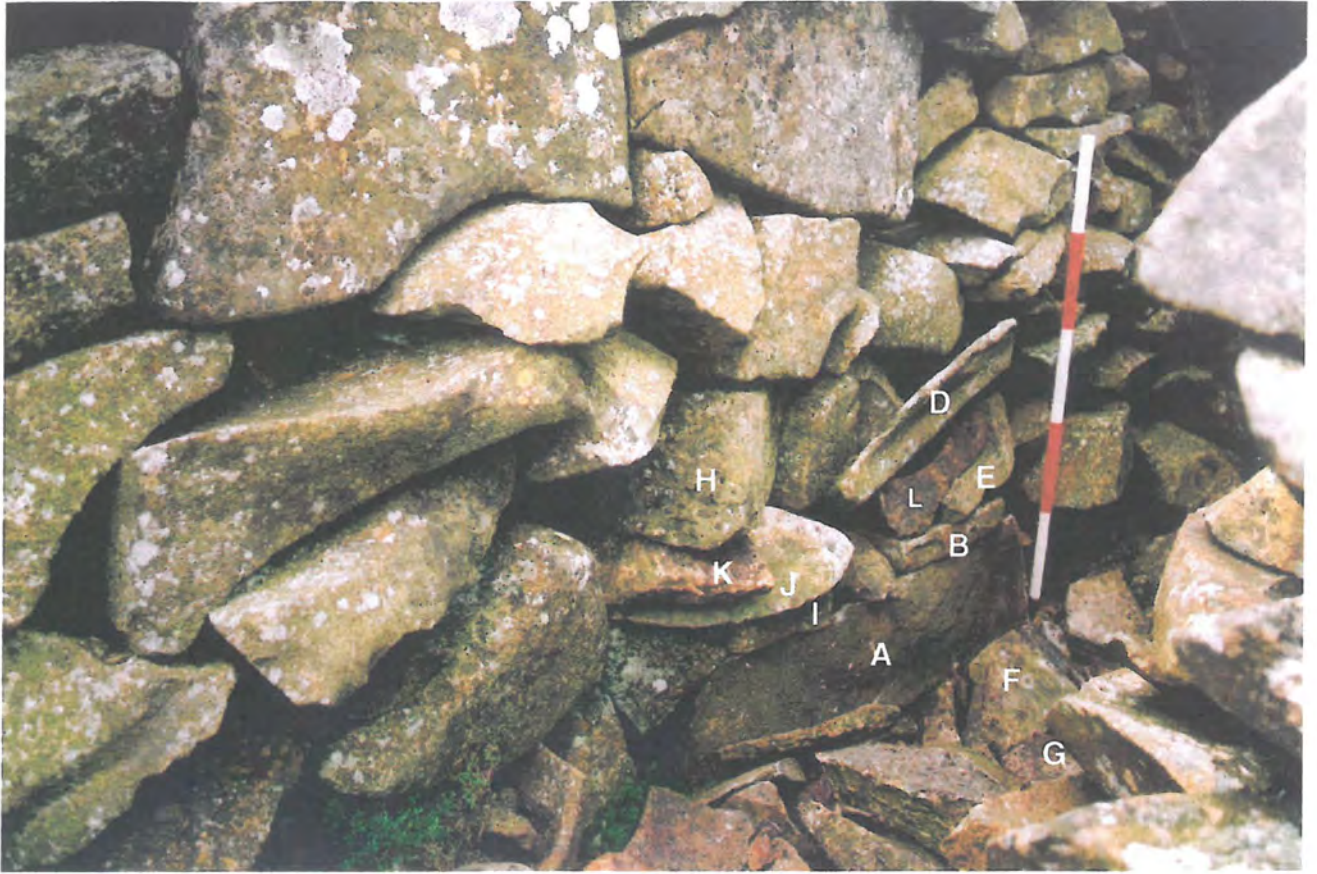
Plate 4 Collapse 3 in 2002 after conservation, from the south-east
