# TRE'R CEIRI MONITORING VISIT

JUNE 2003

Report number : 486

## **TRE'R CEIRI MONITORING VISIT: JUNE 2003 (G1605)**

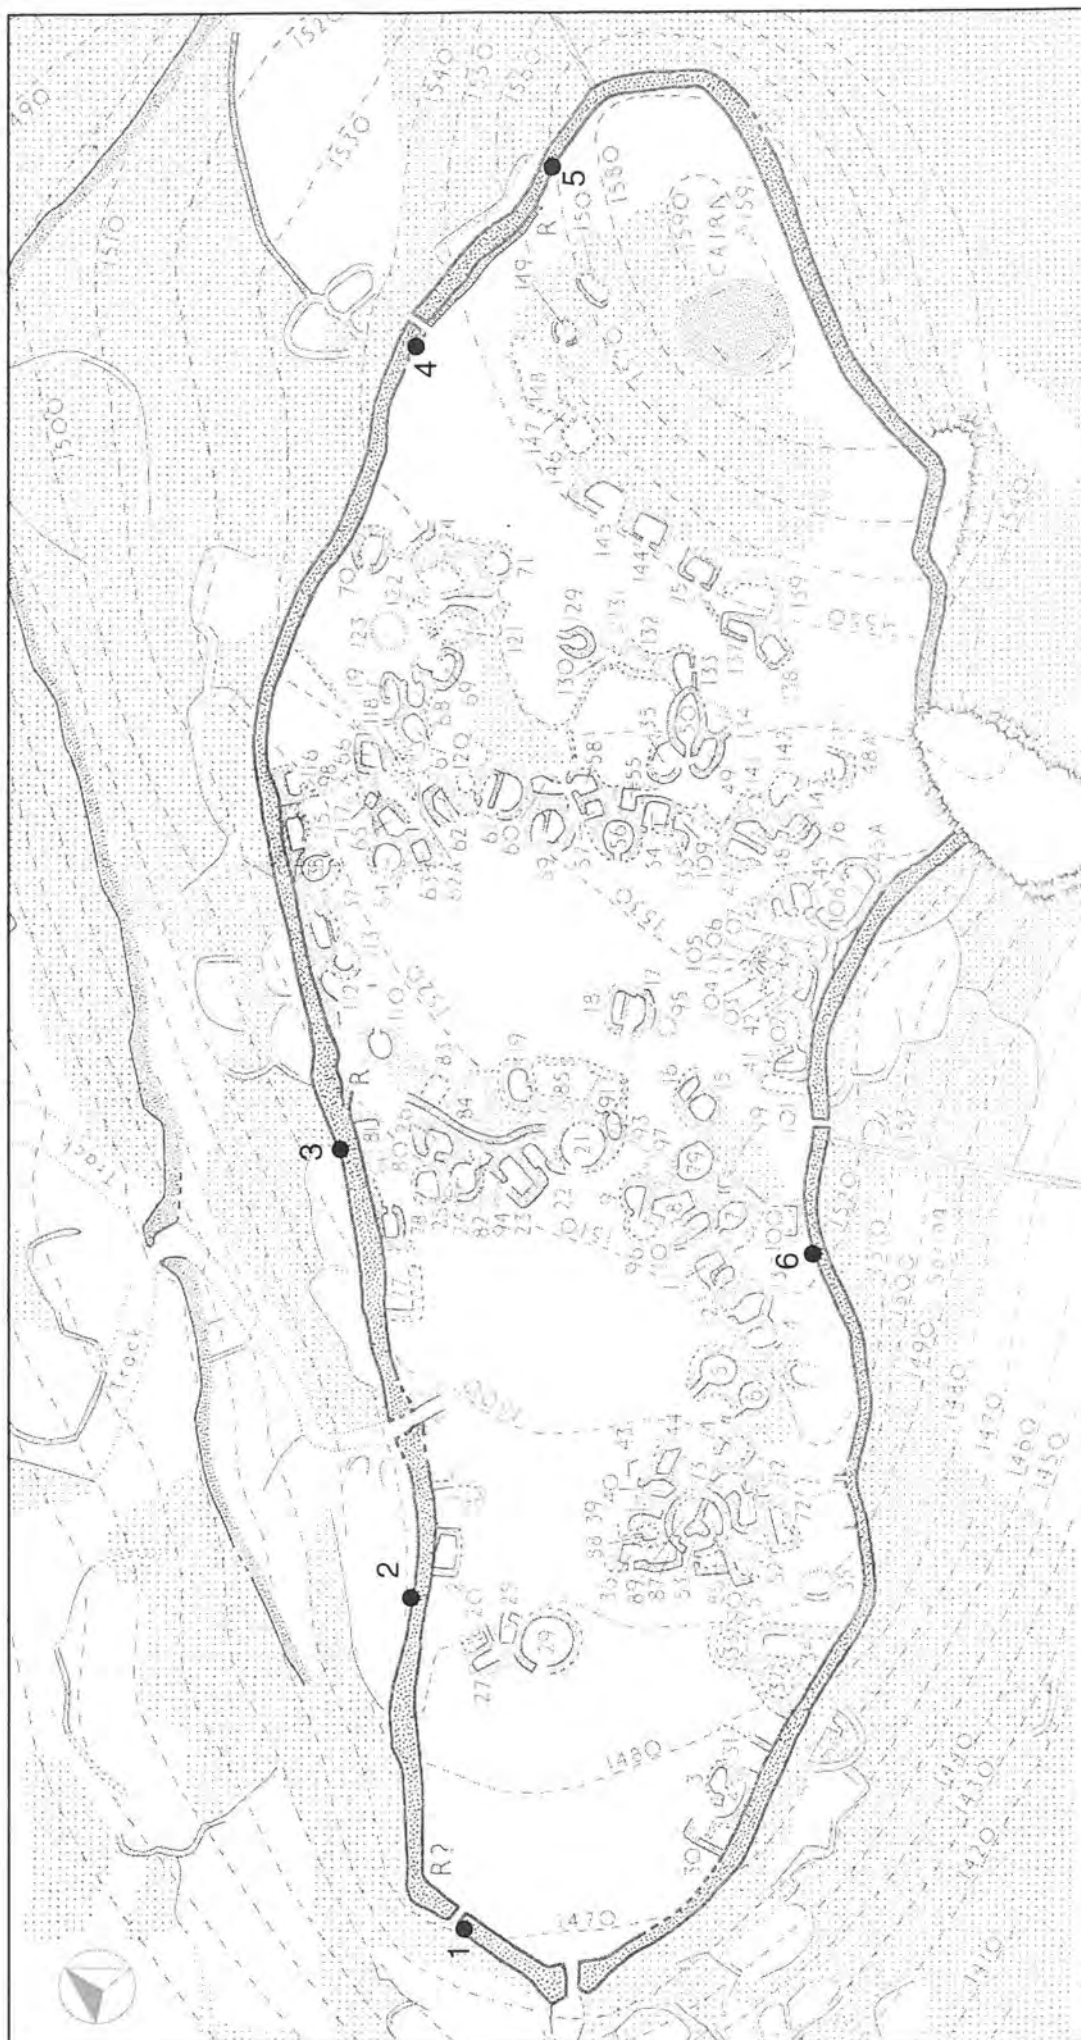
1. A large header had been pulled from the top of the outer face and was lying on the wall top. This appeared to be an example of deliberate damage. The stone was replaced in its original position.

2. Another header had been pulled from the top of the outer face and was lying on the wall top. The stone was replaced in its original position.
3. Yet another header had been pulled from the top of the outer face and was lying on the wall top. The motive for lifting up heavy stones and leaving them on the wall top is unclear. The stone was replaced in its original position.

4. A large flat header on the inner wall top had been pulled forwards as a result of visitors climbing onto the ramparts close to the north postern. The stone was pushed back into place and the core was repacked.

5. There were two loose headers on the top of the inner face where the rampart climbs towards the cairn. This was clearly threatening the stability of the masonry further up the slope. The stones were left in place and two wedge-shaped packing stones were inserted thus locking the headers in place.

6. Two flat slabs had worked loose on top of the inner face. The slabs were reset and the core repacked.

Fig. 1 Tre'r Ceiri showing points of collapse identified in the June 2003 monitoring visit (after R.C.A.H.M.W. 1960)
