**A470 DOLWYDDELAN TO PONT-YR-AFANC
IMPROVEMENT
(G1722)**

**ARCHAEOLOGICAL WATCHING BRIEF
PONT-AR-LLEDR**

REPORT No 501

INTERIM REPORT ON A WATCHING BRIEF AT PONT-AR-LLEDR, 6 NOVEMBER 2003. G1722

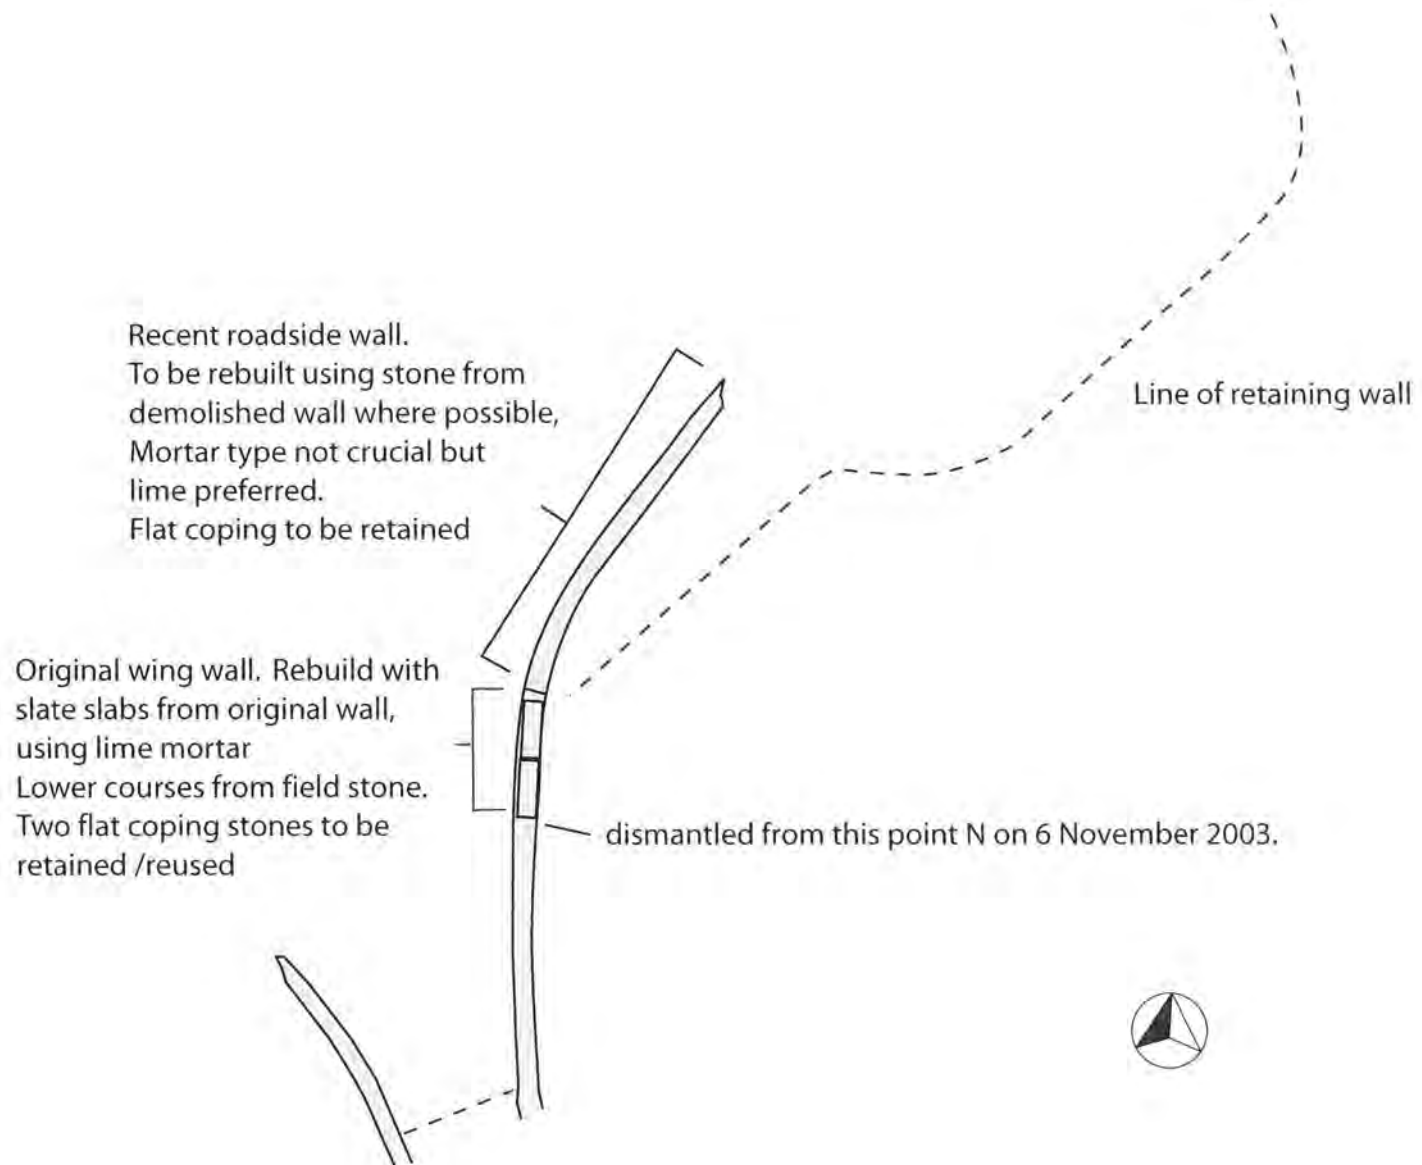
There were clearly two phases of masonry here (Fig. 1). The end of the bridge wing wall had partially collapsed but could be seen to differ in several respects from the adjacent roadside wall although both phases were superficially of a similar construction. The wing wall was found to be of rough local slate slabs and retained traces of lime mortar. The outer face was standing between 1.4 and 1.6m from the current ground level. The basal courses were of local field stone (not slate). The wall was capped with flat slate coping stones with dimensions of 1.4m x 0.5m x 0.2m. Part of the upper part of the wall had been rebuilt using cement mortar presumably after being damaged by traffic. Two openings in the lower part of the outer face (indicated on Plate 1) acted as drains from the road. The drain on the right hand side was carefully constructed with a slate base and cap. The drain on the left was roughly built and could possibly be the result of a stone falling out of the wall facing. It was however still channelling water. It was noted that much of the eastern wing wall and bridge parapet was in a poor condition. The roadside wall contained some reused local slate but also contained field stone and quarried Anglesey black limestone. This was roughly bound using a coarse cement mortar. Flat coping was also used but the stones were irregular and smaller. This phase of the wall probably dates from the last time the road was upgraded (?1970s). The flat coping stones and use of some slate suggests that this was a previous attempt to reconstruct the end of the wing wall.

Fig. 1 Pont-ar-Lledr, sketch plan at 1:200 showing mitigatory recommendations

The wing wall will be rebuilt on a different alignment in order to tie in with the new retaining wall. It is recommended that as much of the original stone is used as possible. It was noted that some of the slate had degraded and was very friable and may have to be replaced. It is suggested that local slate could be recovered from Prince Llewellyn quarry tips as a replacement. This should consist of rough undressed slabs. It is recommended that the original masonry style should be emulated and that lime mortar should be used. A straight joint should be incorporated in the masonry between the reconstructed wing wall and reconstructed roadside wall in order to indicate the two different phases of masonry.

The roadside wall will also be rebuilt on a different alignment and will form part of the new retaining wall. This will have a core of reinforced concrete. It is recommended that the stone retained from the original wall should be reused. The choice of mortar is less important here but lime would be more aesthetically pleasing and would emphasise the difference between the new retaining wall to the north-east and the partly reconstructed masonry. The retention and reuse of the flat coping stones is again recommended.

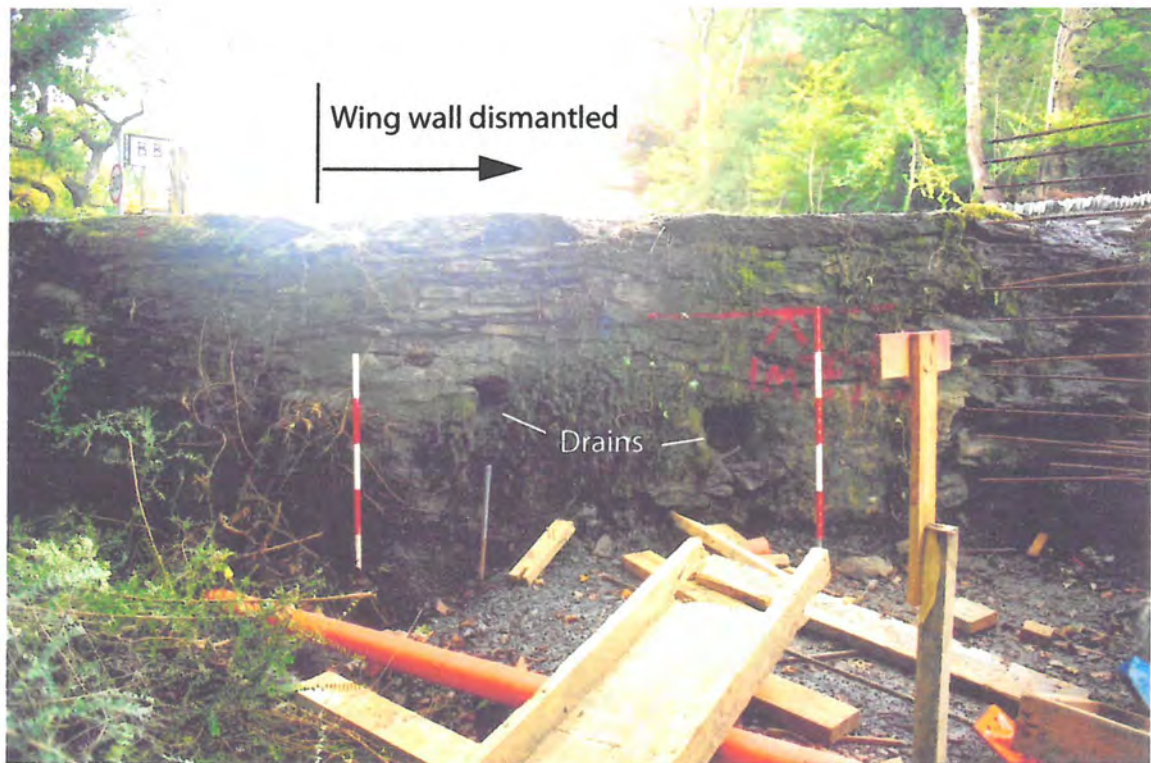
Plate 1 Pont-ar-Lledr wing wall, eastern face

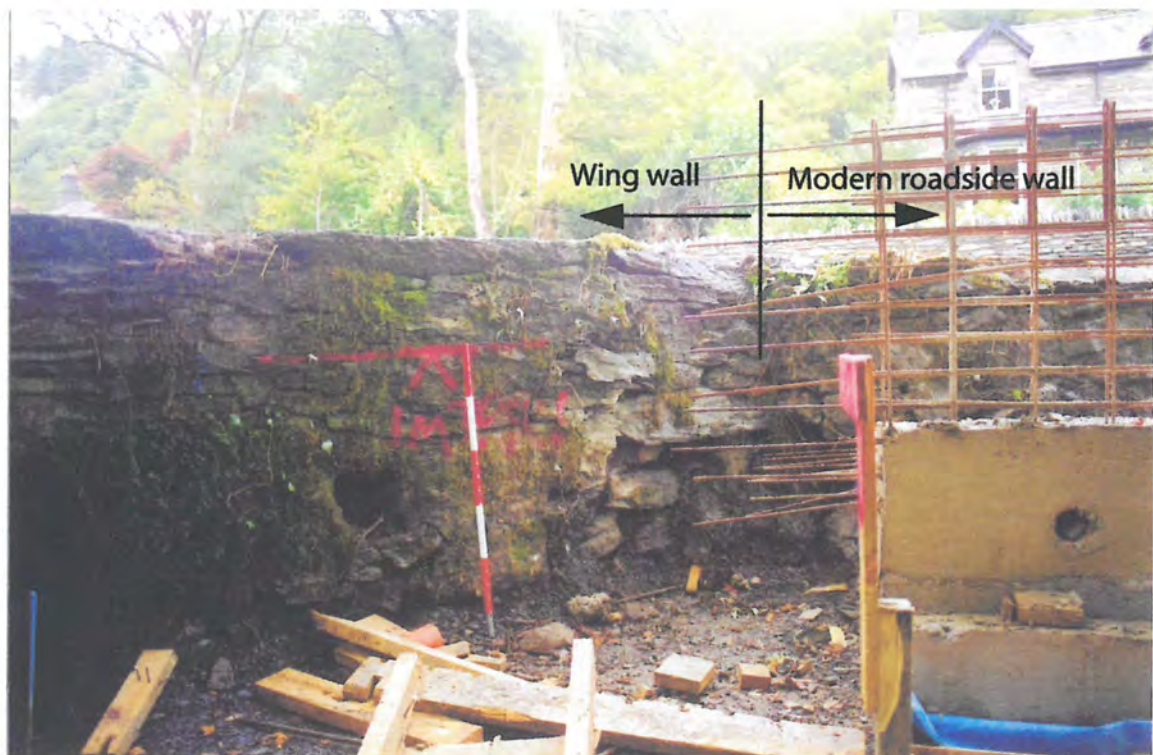
Plate 2 Pont-ar-Lledr wing wall, eastern face and adjacent roadside wall
