TRE'R CEIRI MONITORING VISIT

MAY 2004

Report number : 534

GWYNEDD COUNCIL

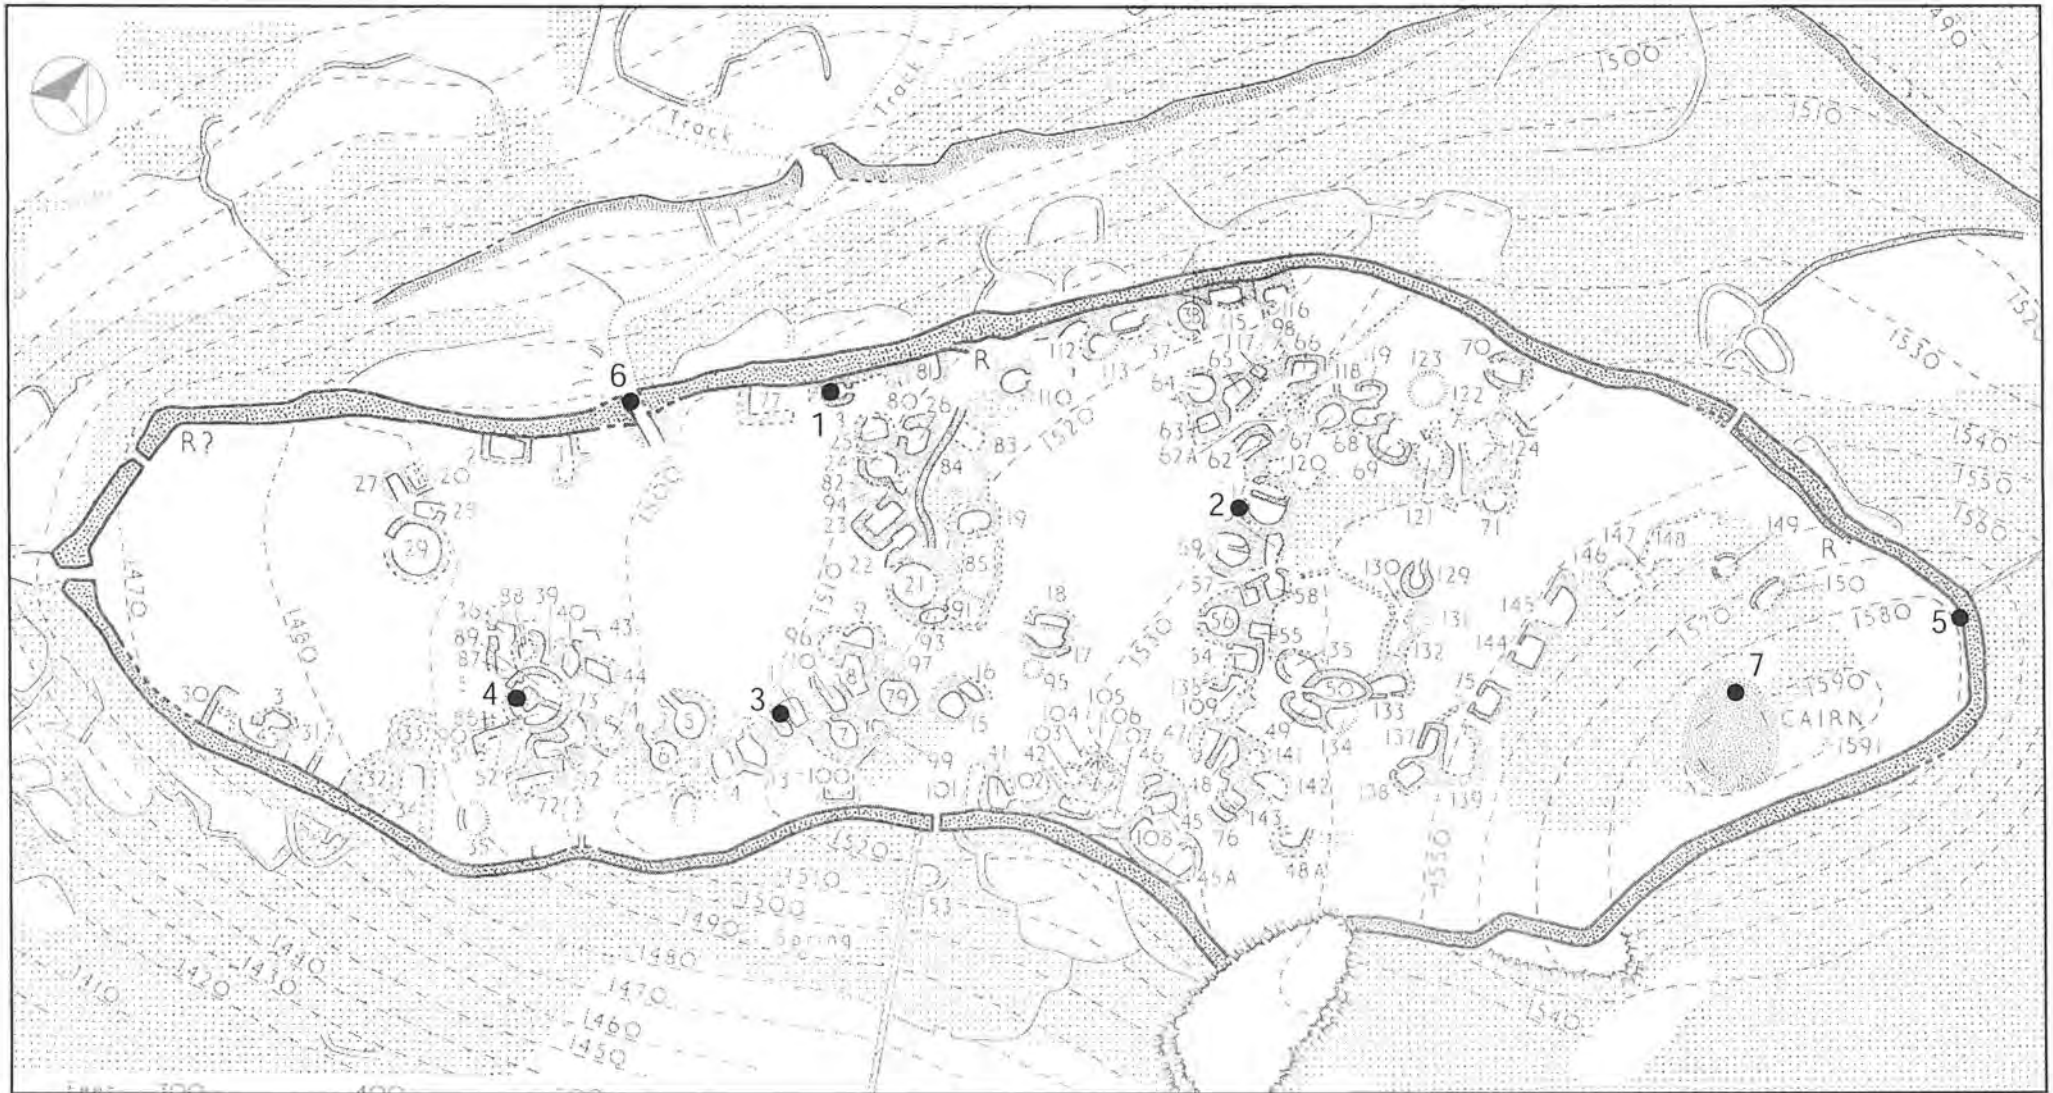
The following minor areas of damage were identified and were marked onto a plan of the site (Fig. 1). Written records were kept of all works along with digital photographs where necessary.

Fig. 1 Tre'r Ceiri showing points of collapse identified in the May 2004 monitoring visit (after R.C.A.H.M.W. 1960)

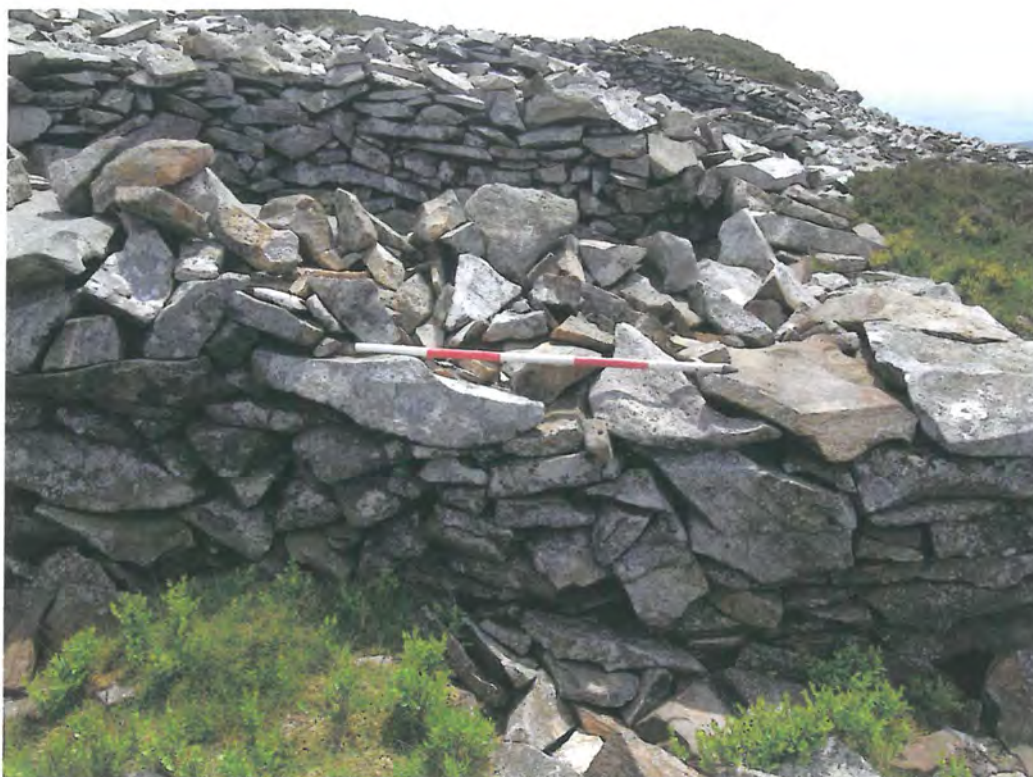
1. Hut 77. A small hole had been dug in the floor of the hut. This was filled back in using weathered stones on the surface.
2. Hut 60. A large slab on the end of the wall had been turned over thus destabilising the core. This was reset in its original position and the core was repacked.
3. Hut 11. Several stones, some containing drill holes indicating conserved masonry, had been removed from the face and top of the dividing wall between huts 11 and 12 and piled on to the main hut wall top. The damage was photographed (Plate 1) and the masonry was reinstated (Plate 2).
4. Hut 53. A small hole had been very recently dug in the floor of the hut; the grass was still green beneath the removed stones. The hole was infilled and weathered stones were used on the surface.

Plate 1 Hut 11 southern wall, before reinstatement

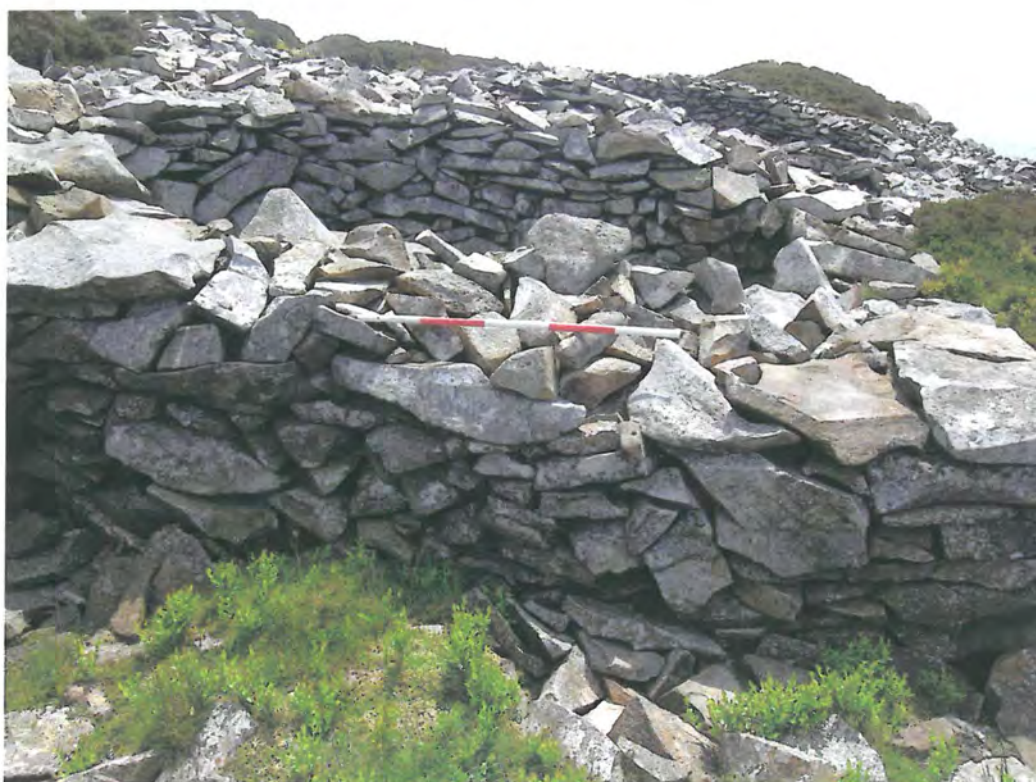
Plate 2 Hut 11 after reinstatement

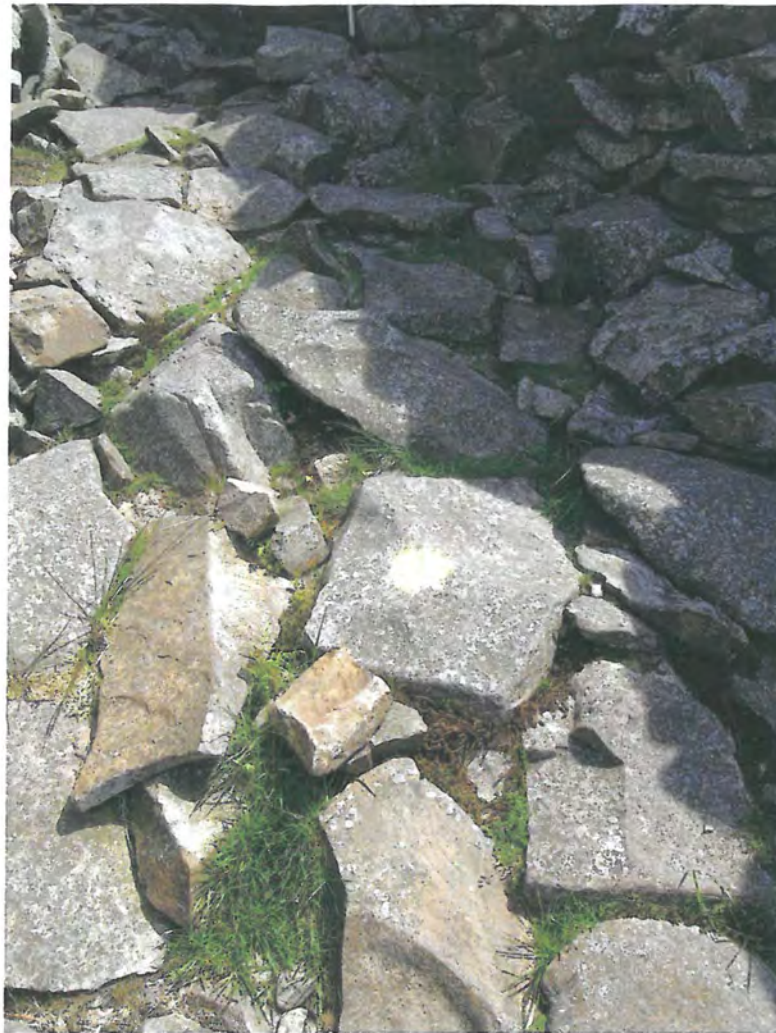
6. The conserved masonry in this area has weathered very well and vegetation has grown in between the stones of the floor because of the damp conditions in this part of the fort. Unfortunately this process has been somewhat marred by the deposition of a large blob of yellow paint on one of the floor slabs (Plate 3). This appears to be an oil-based marker paint. An ineffectual attempt had been made to scratch off the paint at some point but it was still visually intrusive.

The level of damage recorded during this monitoring visit was relatively high and was mainly deliberate as opposed to being a result of general erosion. The blob of paint in the north-west entrance could well be an ill-considered survey point, set up during a university or school field trip.

Plate 3 Paint on north-east entrance passage floor

The majority of the paint was scraped off using a steel blade and the surface of the stone was painted with a peat solution in order to aid the regrowth of moss and lichens.

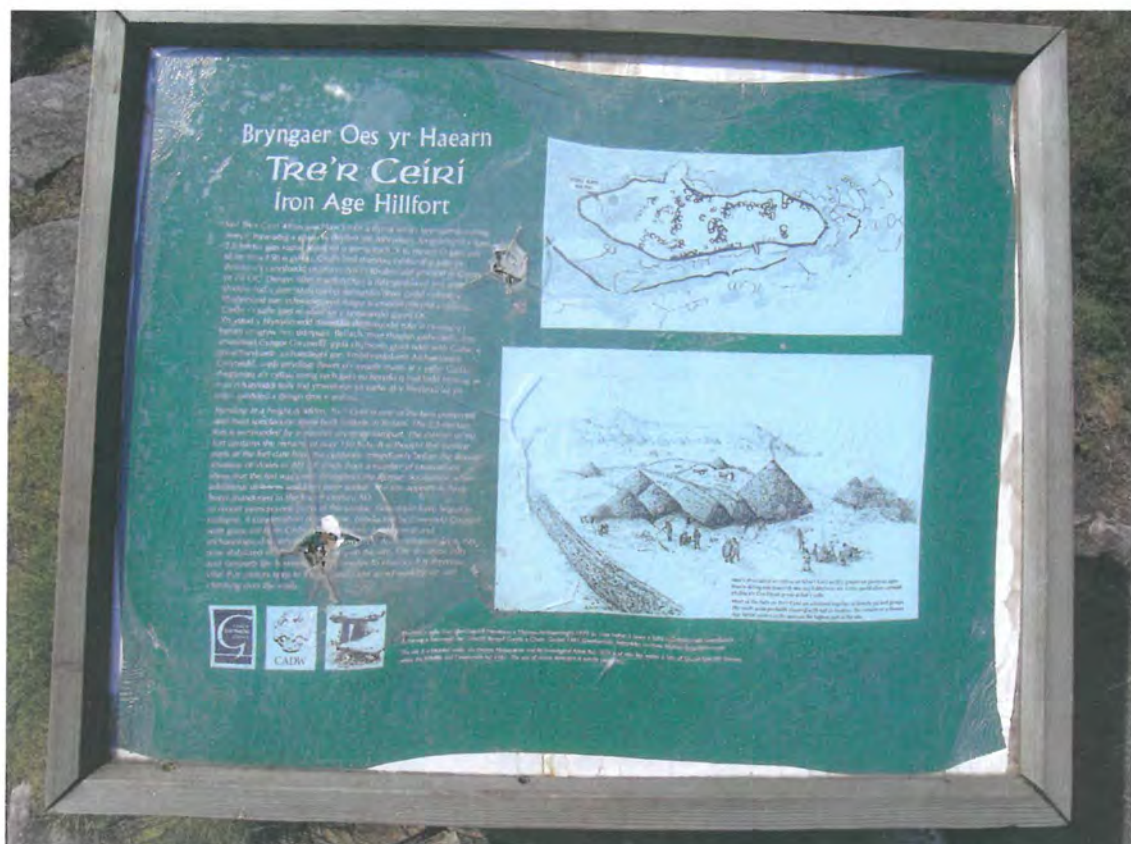
The information board by the cairn has been vandalised. Two holes have been smashed in the Perspex covering (Plate 4). The board on the approach to the south-west entrance has also been damaged. The Perspex has clearly been attacked with a rock and is scratched and cracked. The board at the north-western entrance is a little scruffy but still intact. The frames and legs of all of the boards are stable and intact.

Plate 4 Damage to the cairn information board
