**REGENT HOUSE,
17, CHURCH STREET, BEAUMARIS**

**ARCHAEOLOGICAL WATCHING BRIEF DURING NEW
CONSTRUCTION AND RENOVATIONS AT REAR OF PROPERTY**

GAT Project No. G1807

Report No. 585

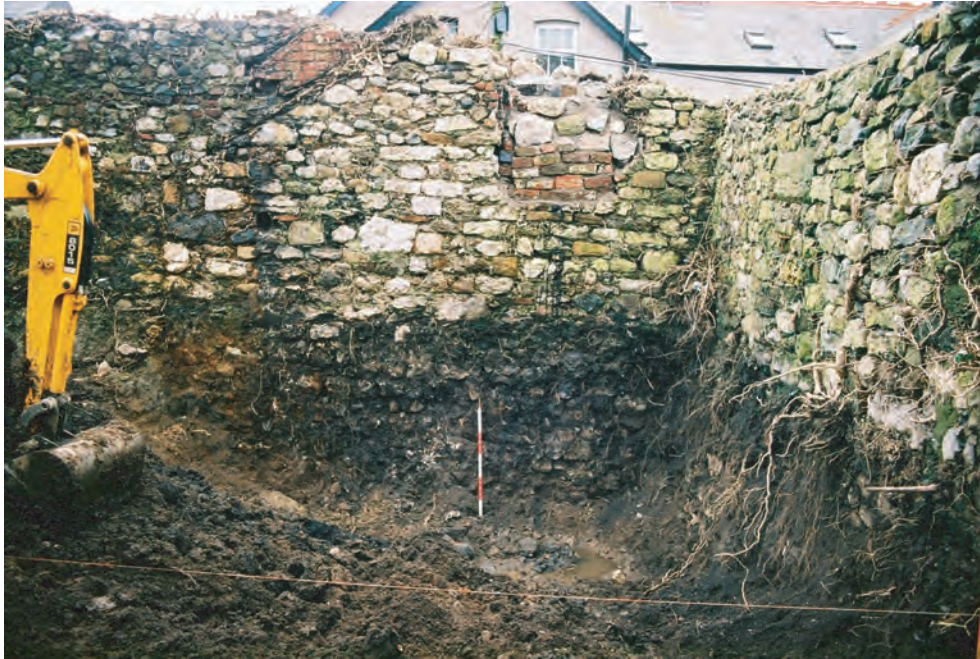
Inspect all exposed walls. The outline of the former smithy, which may have also previously been a boiler house for the adjoining glasshouses seen on the 1919 map (Fig. 3b) was visible in the exposed facing of the south yard wall (Fig. 6).

Regent House, Beaumaris Fig. 6 Outline of Smithy/Boilerhouse in south yard wall during excavation for sub-floor void. 1m scale

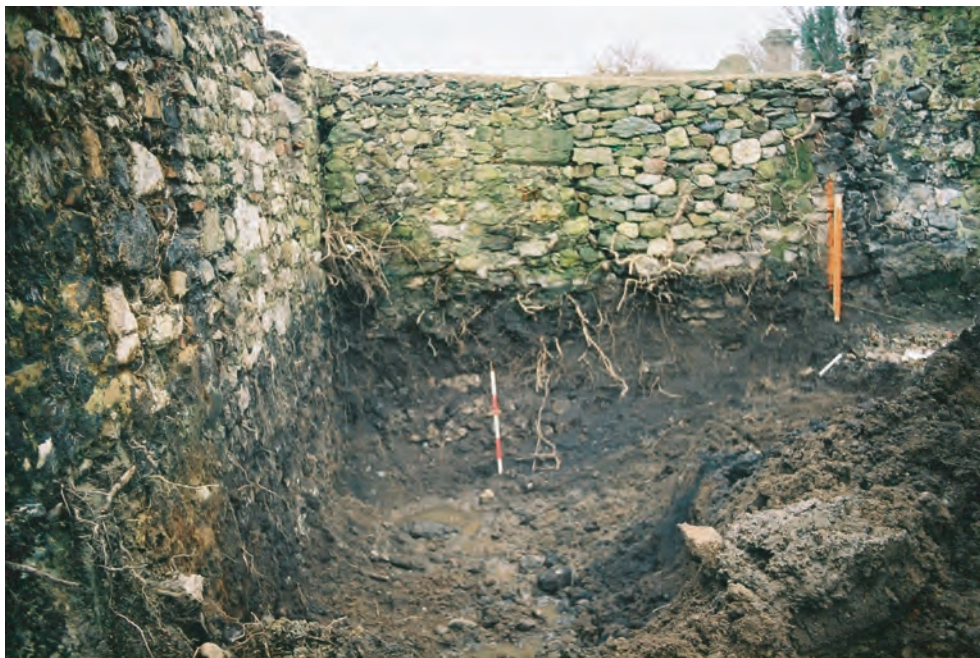
The west wall of the yard has a crudely blocked gap, possibly a remnant of an earlier entrance, when the yard formed part of the gardens to the west (Fig. 7).

Regent House, Beaumaris Fig. 7 Blocked gap in west yard wall during excavation for sub-floor void. 1m scale

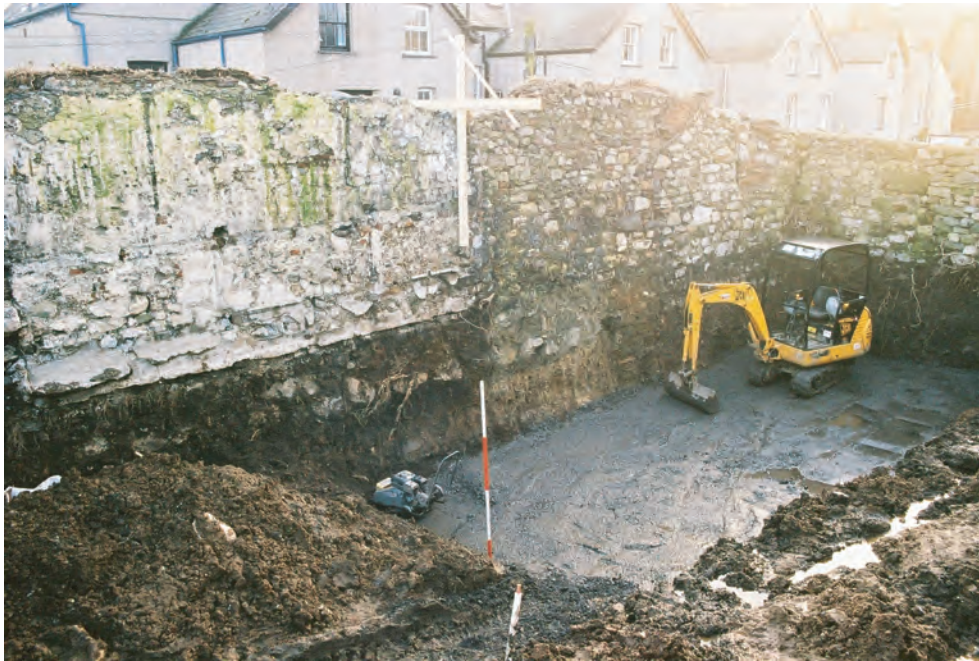
At this time the sub-floor void for the new building was being prepared for insertion of the concrete raft and the subsoil was no longer visible (Fig. 8).

Regent House, Beaumaris Fig. 8 Sub-floor void after excavation showing exposed subsoil beneath the south wall of the yard. From the north. 2m scale.

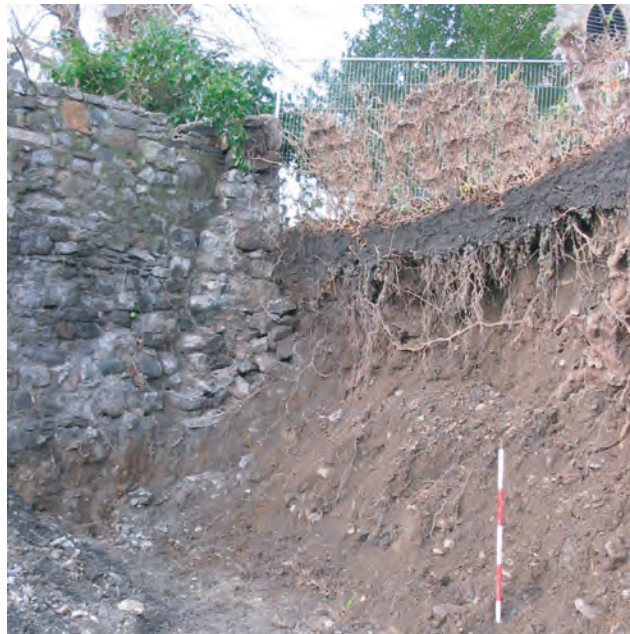
There is a thickening at the junction of the churchyard wall with the yard and stable walls suggesting a bonded joint (Fig. 9). This indicated that all are contemporary and that the churchyard wall is a late feature, possibly 18th century or not much earlier.

Regent House, Beaumaris Fig. 9 North-west corner of the yard after collapse of the churchyard wall, showing the bonded junction of the house yard and churchyard walls. From the east. 1m scale.

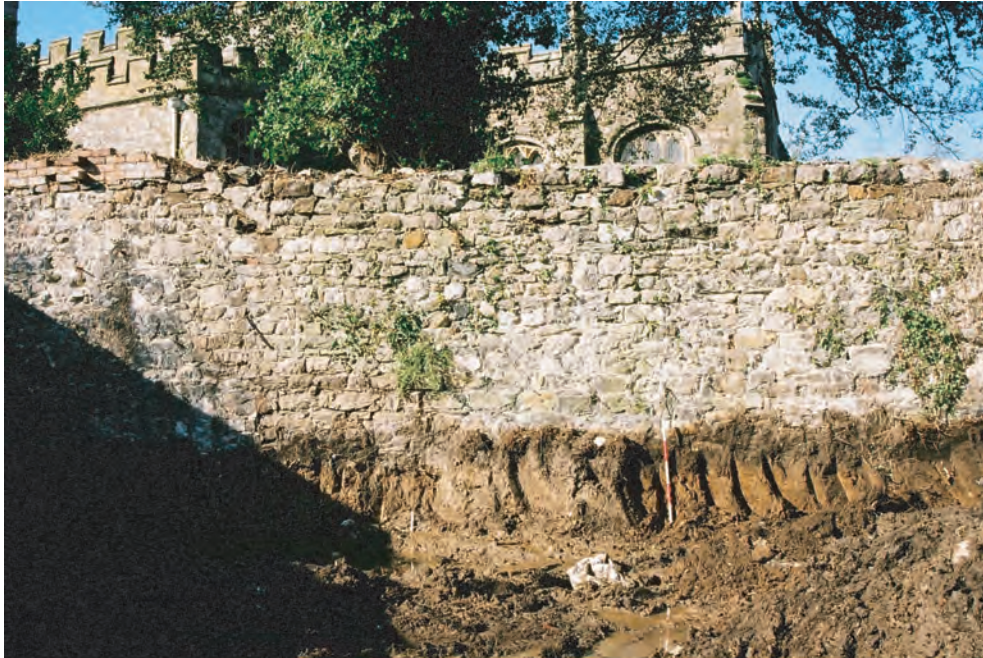
Machining down of yard surface still in progress, about 70% complete. Affecting only post-medieval made-ground except close to the churchyard retaining wall where the subsoil was ramped up about 1m wide downslope from the churchyard wall. Excavation of the yard surface here left the footings of the churchyard wall exposed and largely unsupported (Fig. 10).

- The churchyard retaining wall was of one build of rather irregular roughly-coursed blocks with no real footings (Fig. 10). It was originally about 1.6m in height and built mainly of limestone. It was later increased in height by about another 0.8m with the addition of four or five courses that included sandstone as well as limestone. Finally it a few courses of machine-made bricks were added. There were no other structural features in the wall.

Regent House, Beaumaris Fig. 10 Churchyard retaining wall after excavation for new building footings showing exposed subsoil beneath base of wall. From the south-east. 1m scale.

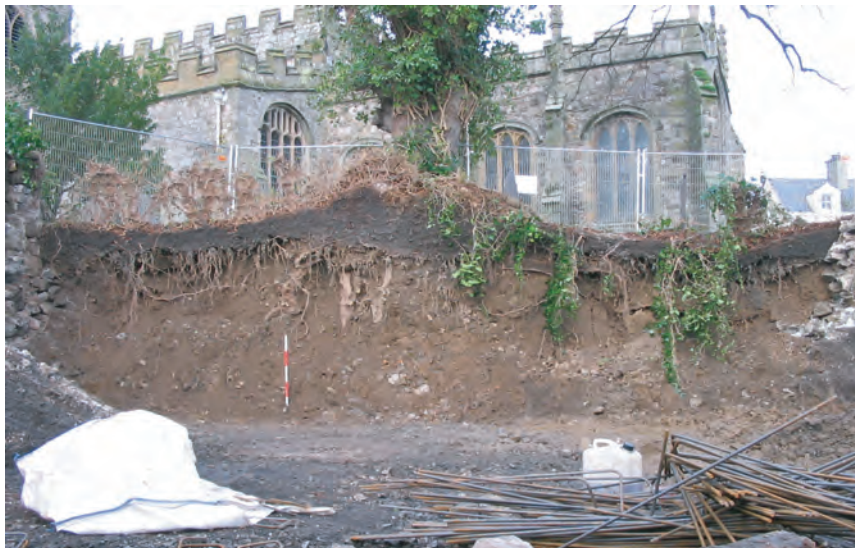
Visited after a report that the churchyard retaining wall in the yard had collapsed. At the same time the rear wall of the stable against the churchyard had also collapsed. The rubble from the collapsed walls had already been cleared away ready for rebuilding at this point, revealing quite clear sections. The churchyard section in the yard was over 2m high and two features were visible, filled with silty material, just possibly the edges of grave cuts, although no human remains were exposed (Fig. 11). The height of the exposed section precluded any manual investigation for health and safety reasons.

Regent House, Beaumaris Fig. 11 Churchyard after collapse of retaining wall and removal of rubble showing exposed features in section. From the south-east. 1m scale.

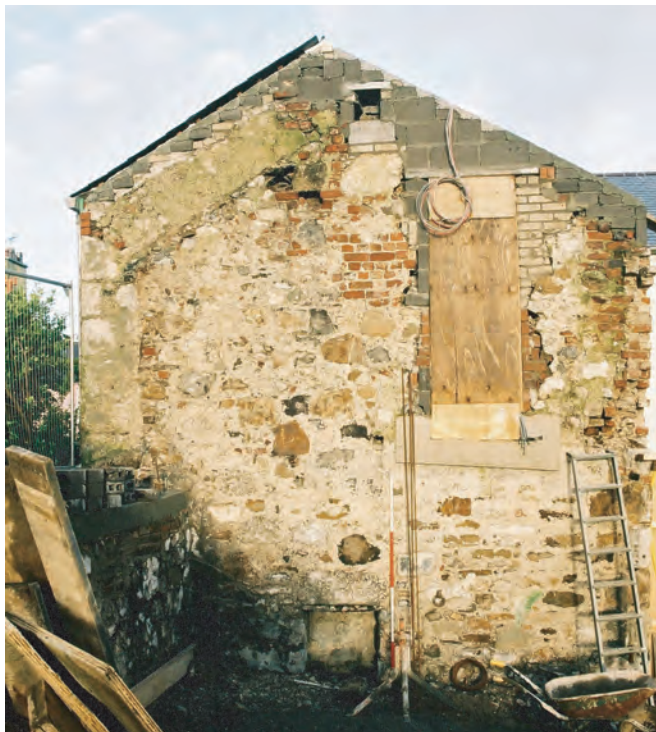
The east gable of the stable was conterminous with the west gable of the adjoining house and the only feature was a small fireplace at ground floor level (Fig. 12).

Regent House, Beaumaris Fig. 12 Interior of stable at east side showing blocked fireplace, line of removed roof and bonding with house wall. From the south-west. 1m scale.

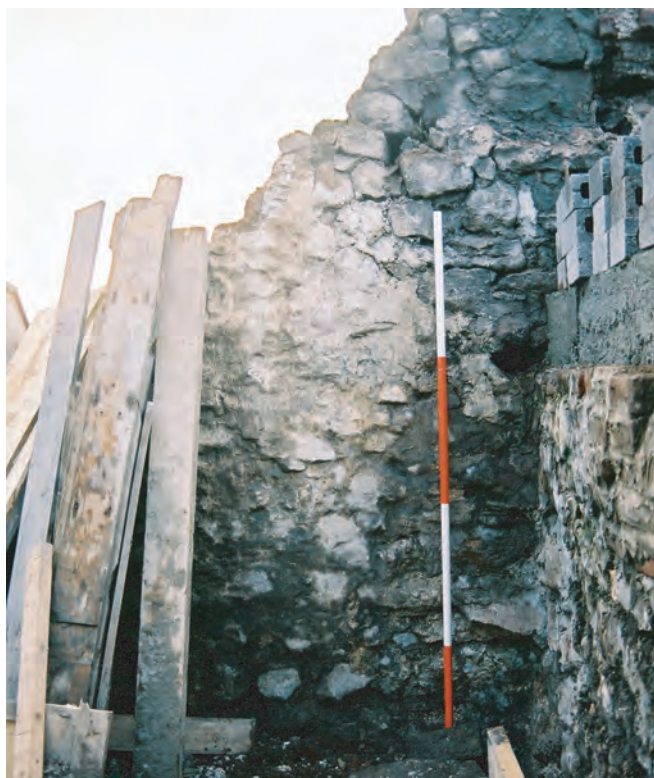
Visited after report that the west gable wall of the stable had collapsed. This had been left free-standing after removal of the roof with the requirement that this should be conserved and incorporated in the new building. The walls were inspected and photographed. The gable wall was of rubble with a clay binding so had little integral strength. The render of lime plaster on the interior of the remains of the west gable showed a relict roof line beginning at 1.40m above the floor level (Fig. 13). This demonstrated that the stable had originally been a single storey structure with the upper hayloft added later. While a single-storey structure the wall plate for the

Regent House, Beaumaris Fig. 13 Interior gable of stable at west side after collapse of gable wall showing an earlier roof line of a single storey building. From the north-east. 1m scale.

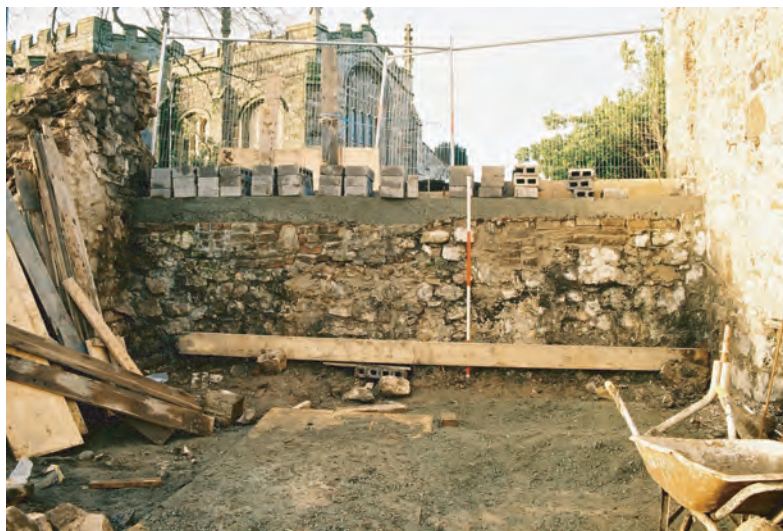
roof on the north was about on a level with the churchyard surface (Fig. 14). The extra storey was added probably in the 19th century by laying a concrete plinth on the old wall roof plate and building a brick wall. The front of the building was entirely rebuilt in brick, probably because the old stonework was unsafe.

Regent House, Beaumaris Fig. 14 Interior of stable at junction with churchyard during reinforcement. From the south-east. 1m scale.

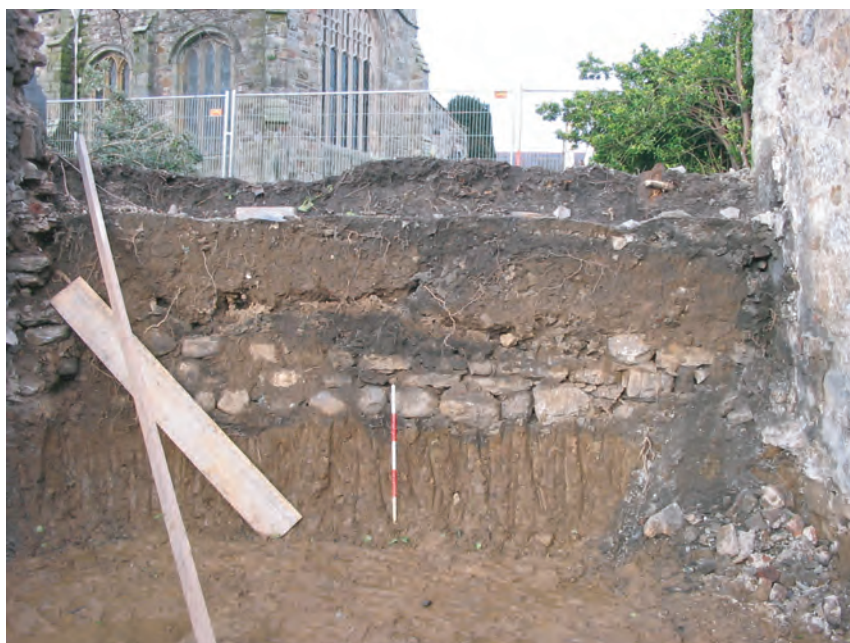
Visited to view the excavation of the floor within the stable. This might show any earlier floor levels and there might be an area of preserved subsoil surface that had not been truncated like the yard area. There was some potential for earlier, perhaps medieval features therefore. The existing stable floor lay directly on the subsoil surface with no earlier floor level. The subsoil was clean and visible with no cut features (Fig. 15) apart from a modern drain pipe that ran around the periphery of the building from a brick-built drain.

The section within the stable revealed a roughly laid dry stone wall behind the former stable wall. This is most likely to have been simply a retaining wall for the churchyard terrace, rather than a separate structure (Fig. 15). It is quite different from the main churchyard retaining wall, as existed in the yard, agreeing with the earlier interpretation, from the desktop assessment, that the churchyard wall construction took place at a different time from that of the stable, because of the change in line of the churchyard close to the point where it meets the corner of the stable (Figs 3a and 3b).

Regent House, Beaumaris Fig. 15 Interior of stable at junction with churchyard after collapse of wall and excavation of subsoil showing exposed revetting behind the wall line and absence of subsoil features. From the south-east. 1m scale.

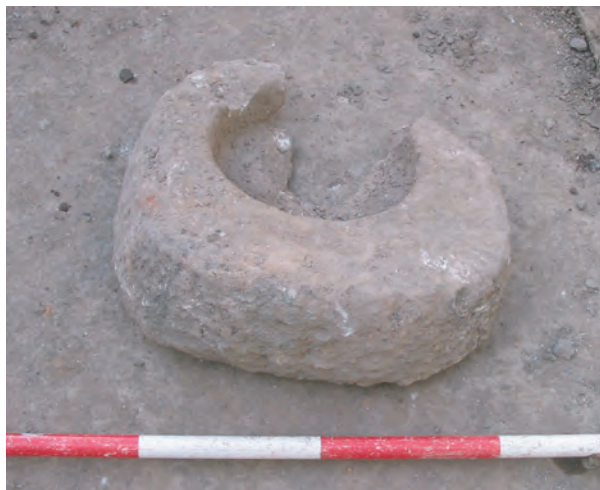
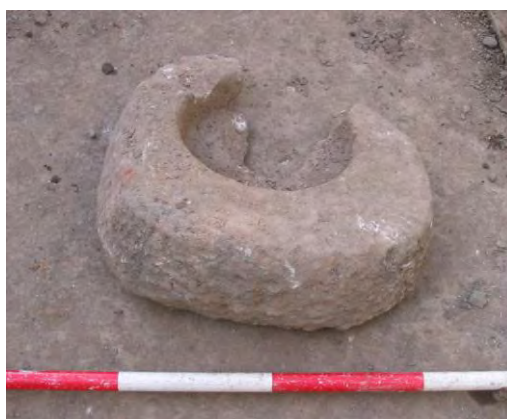
Stone bowl or quern from stable wall

Prior to this visit the remains of the fallen stable gable had been demolished to allow new construction and in the stones use for the wall two re-used stone objects had been found. One was a broken, roughly-shaped, sub-rectangular block in which a bowl had been carved (Fig. 16). This may have been a stoup basin from the church or a medieval bowl quern (grinding stone) and needs further study. The other was a coping stone (Fig. 17) similar to those used on the castellation around the main roof and chancel of the church (Figs 11 and 14). It is potentially useful because it could tie the time of construction of the stable closely to that of the church. However, the church is of several phases of construction. The description by the RCAHMS states that the original construction of the main body of the church was in the early 14th century but there were various additions during its life, particularly the addition or reconstruction of the chancel c. 1500 at which time the walls of the aisles were raised and battlemented. The RCAHMS also states that the roofs of the chancel, naves and aisles have been renewed, that the tower was remodelled in the early 19th century and the church restored in modern times. The coping stone is very rough and may have been a rough-out that had not been finished, so possibly a broken reject or, perhaps more likely was an original badly weathered piece from the reconstruction of c. 1500 that was replaced during maintenance of the church during its later life. It is also uncertain whether the stone came from the original lower storey of the stable or the added upper storey. If from the latter then an early 19th century date would be likely.

Regent House, Beaumaris Fig. 16 Bowl or quern from collapsed rubble of the west gable wall of stable.
Scale with 20cm divisions

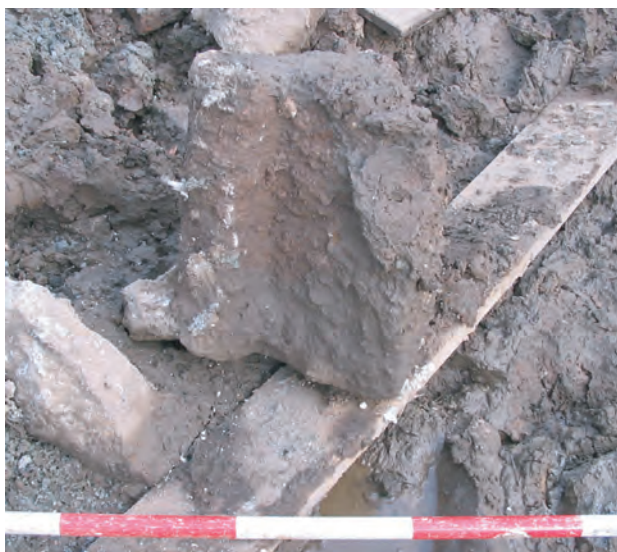
- The stone objects from the collapsed stable wall could indicate a date *c.* 1500 for the building but perhaps are later re-used materials, deriving from a phase of early 19th century date refurbishment of the church. The use of clay binding rather than lime mortar could support the latter date. Both objects need further study and it is hoped they may be donated to the Oriel Ynys Mon, along with the other finds and archive records from the evaluation excavation.

Regent House, Beaumaris Fig. 17 Unfinished church roof coping stone from collapsed rubble of the west gable wall of stable.
Scale with 20cm divisions
