St Rhedyw's Church

Llanllyfni

Archaeological Watching Brief

GAT Project No. 1862

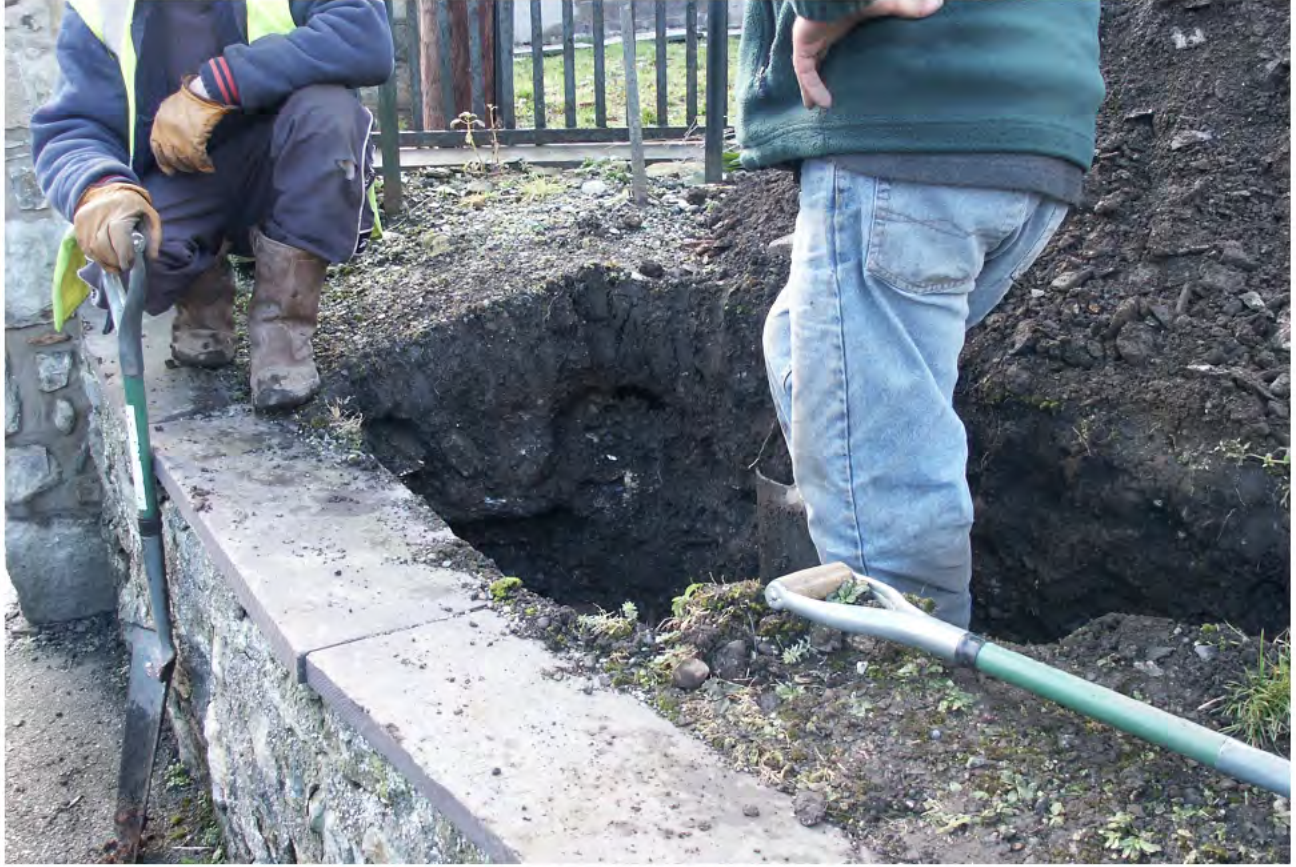
It was expected that some human remains would be unearthed during the excavation of the trench but in the event there were none. The raised area comprised building rubble and soil, with fragments of slate and gravestone. The proximity to the retaining wall suggests this area was consolidated with rubble when the wall was built. It was agreed that the former gas pipe should be breached 1.0m further towards the gate than anticipated as a large dressed slate slab lay across the trench at a depth of 0.40m in the area that the pipe was to be accessed. This slab did not appear significant but its removal might have destabilised the wall.

Plate 1. North-Facing Section of Trench Cut

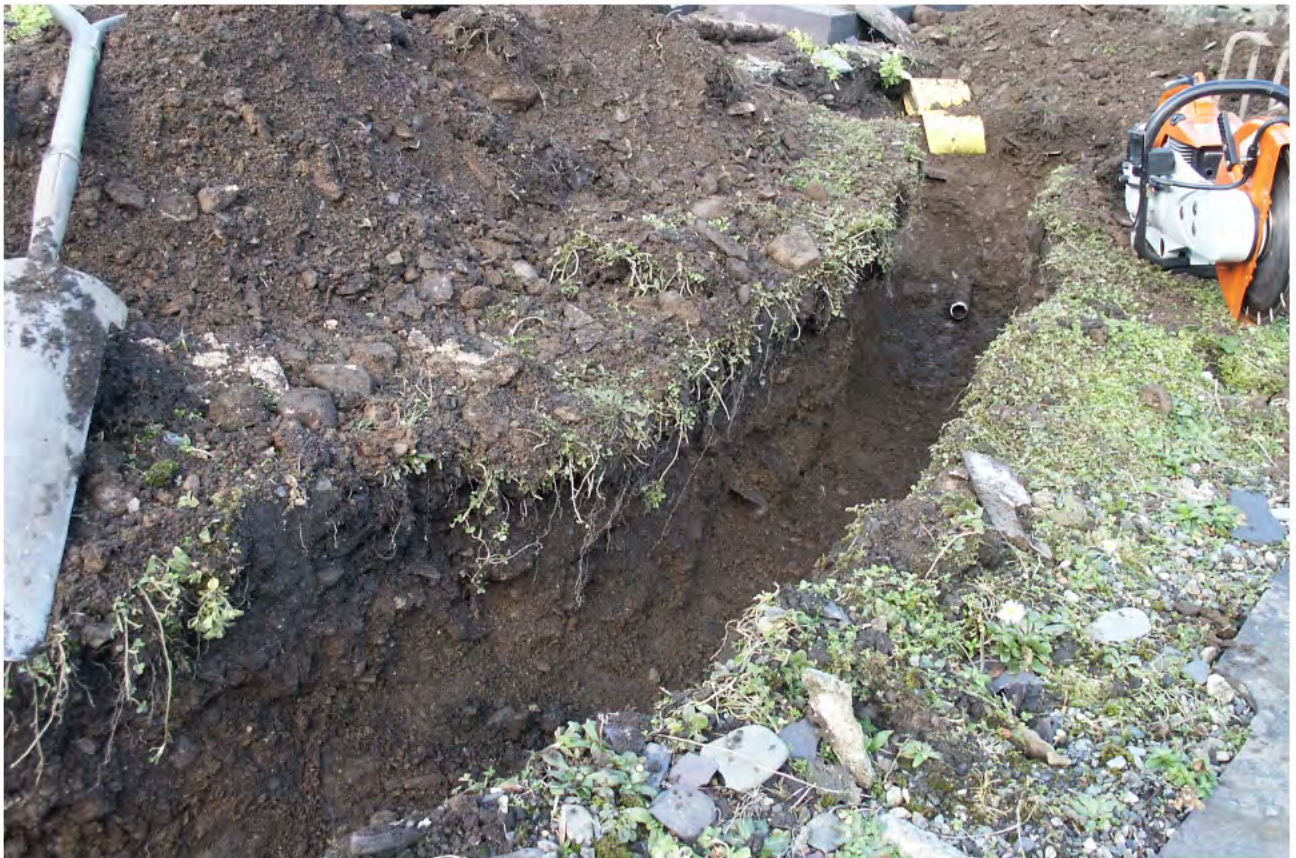
A 0.60m deep trench was excavated by hand across the corner of a raised area inside the church gate (see Figure 2). The trench was excavated to take an electrical conduit from the gate, under a flat threshold stone, under and behind the retaining wall of the church and across the corner of the cemetery meeting up with and utilising an old iron gas supply pipe which fed directly into the nave.

Plate 2. Trench. Viewed from South-East
