A470 BLAENAU FFESTINIOG
TO CANCOED IMPROVEMENT
ARCHAEOLOGICAL RECORDING REPORT
G1874

Report number : 621 part 1

Prepared for
White Young Green plc and Gwynedd Consultancy Environment Directorate
December 2005

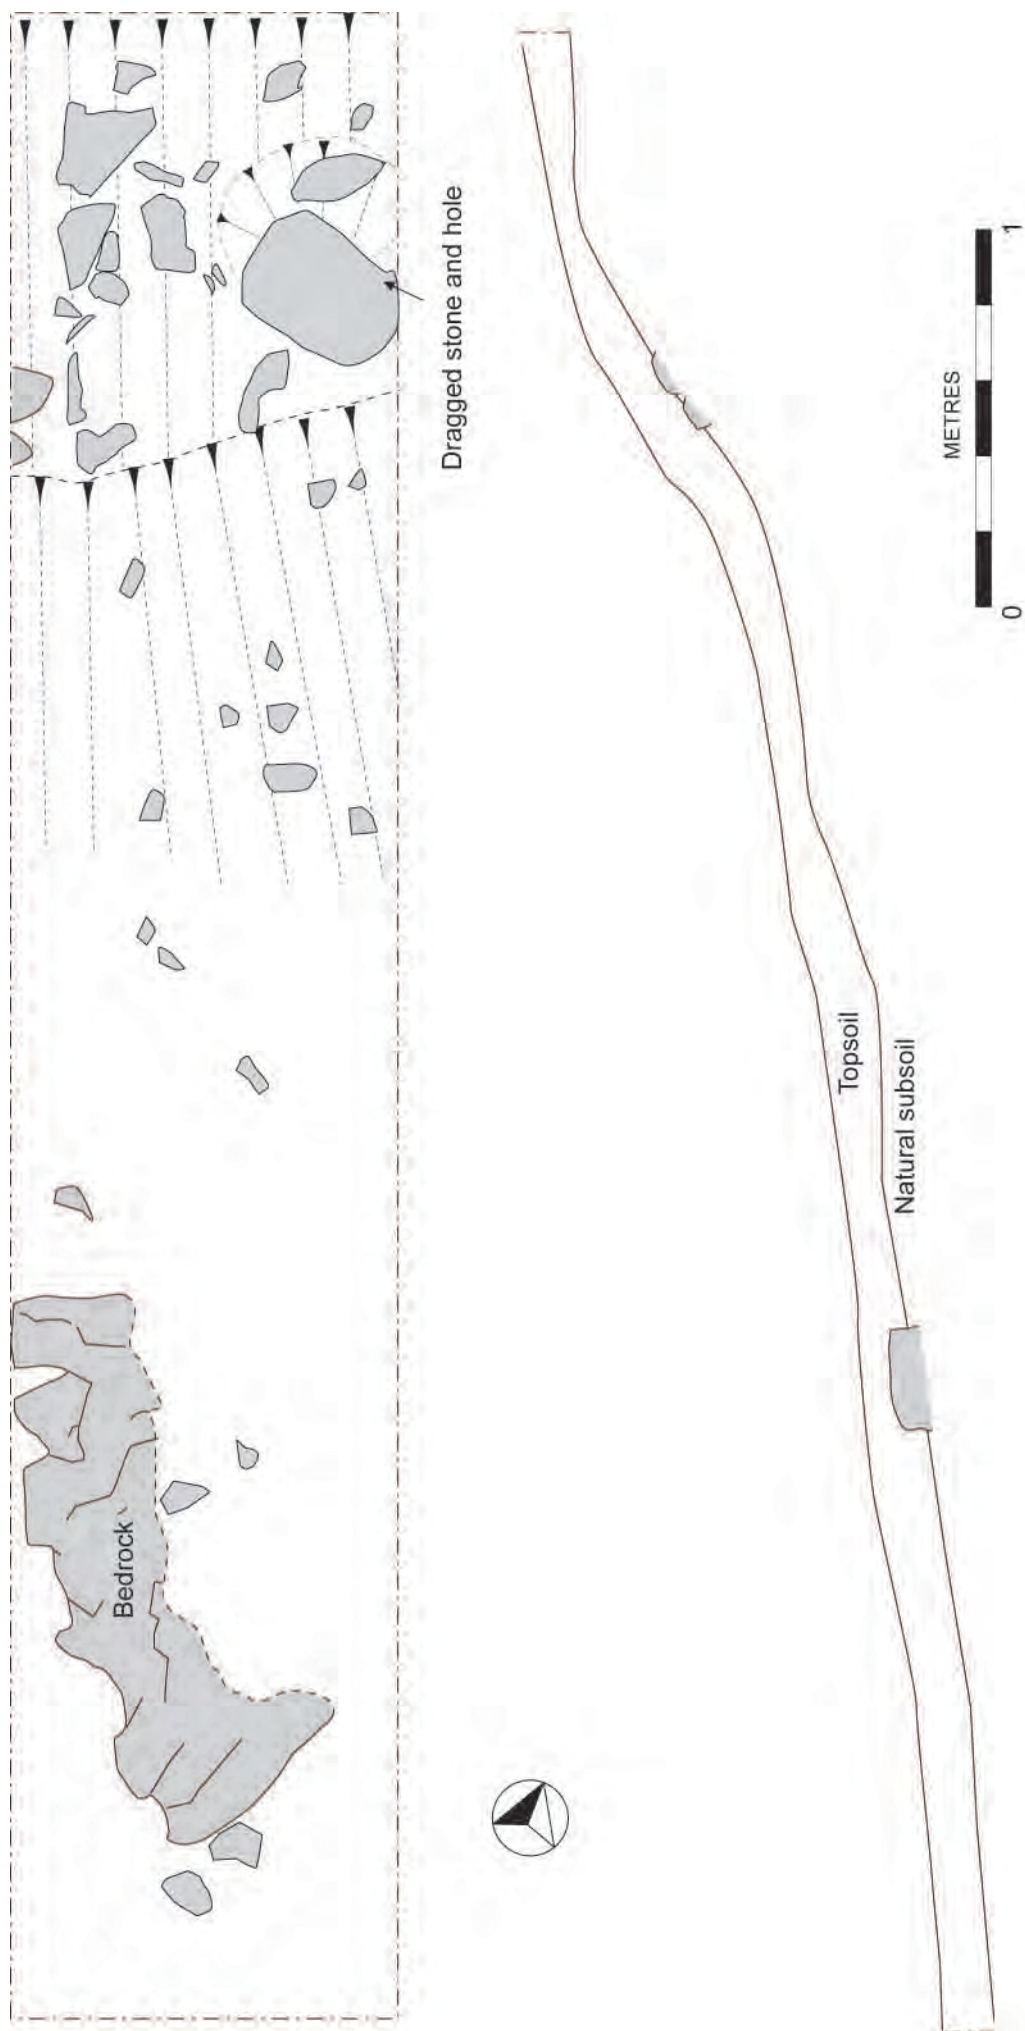
Fig 10 Site 17, subrectangular scoop. Plan and north-east facing section

A 5m x 1m trench was hand dug along the northern half of the feature (Fig. 10 and Plate 2). The turf and topsoil was 0.15m deep and contained frequent modern finds including broken glass, tin cans and plastic wrapping. One sherd of 19th century Buckley ware was also recovered from the same context. The finds were distributed throughout the context indicating modern disturbance. This was overlying typical subsoil of the area: mid-reddish-brown silt containing slate fragments. Shattered bedrock was visible on the north-western end of the trench along with one larger stone that had been partially dragged from the subsoil, leaving a hole. The subsoil level dropped gradually to the south-eastern end where bedrock was exposed.

It seems likely that this area was cut back during one of the later 20th-century programmes of road improvements. The single 19th-century find was almost certainly re-deposited from a nearby location. The lay-by is a sheltered location that has probably been used as a stopping point for many years. This site can now be reallocated to Category D - Minor and damaged sites.

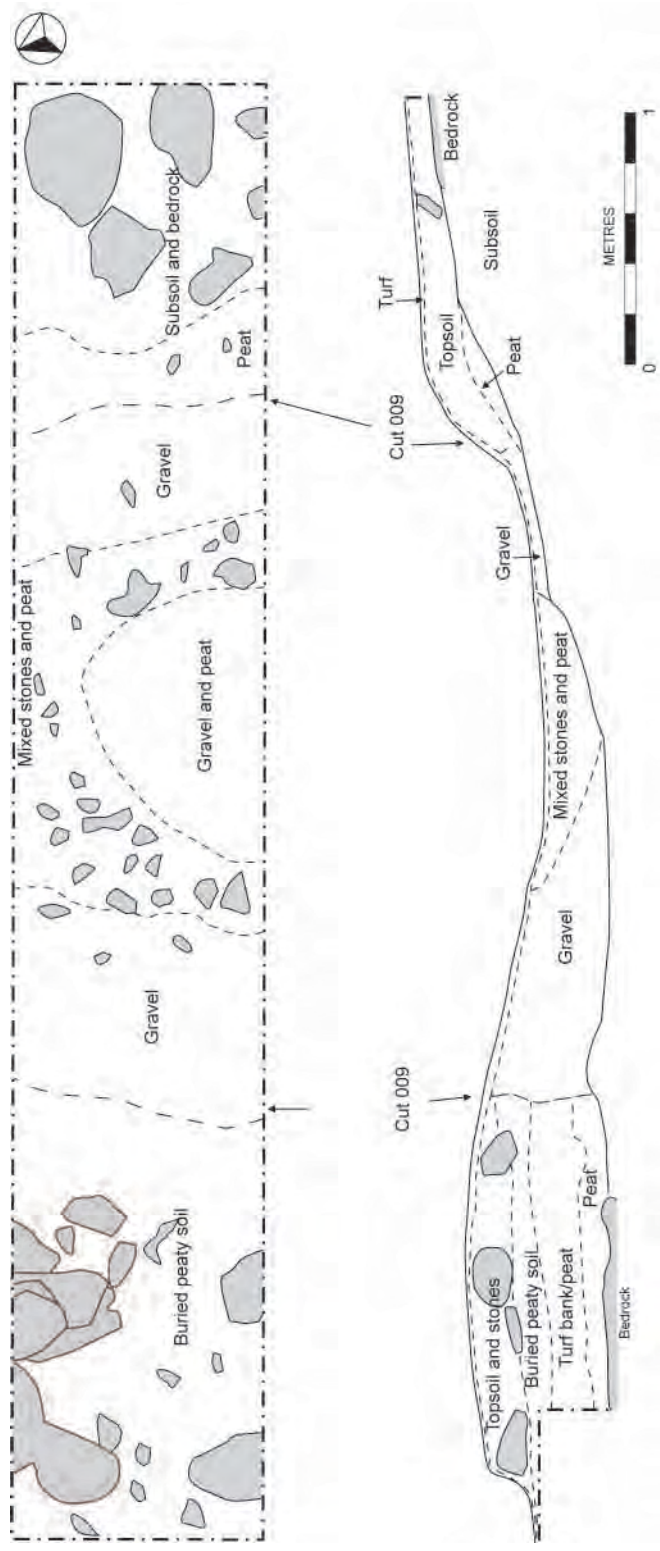
Fig. 12 Site 25 Small circular feature. Plan and south-west facing section

A 5.8m x 1m trench was excavated across the centre of the feature (Fig. 12 and Plate 4). The turf and peaty topsoil were removed revealing stones and peat at the north-western end of the trench and subsoil and bedrock at the south-east. A mixture of gravel, peat and stones filled the central part of the hollow. Upon further excavation it was found that the earliest feature was a turf and peat bank covered by a buried peaty topsoil. There was no dating evidence from this feature but it seems likely that it was a continuation of the low bank that runs along the lower side of the pre-turnpike road.

This was truncated by a vertical cut (009) that marked the edge of the gravel, small stones and peat deposits and defined the edge of the hollow. The gravel and other fills appeared to be a mixture of tipped horizons. The gravel was very well sorted and, in places, very clean, suggesting that it was from a quarry. The remains of a small fire of brushwood were found low down in the gravel. Some un-burnt wood was still extant. The deposits were not waterlogged so this confirms that the feature is of no great antiquity. A long, slate slab was sitting close to the bottom of the feature. No other finds were recovered from the feature. A jumble of stones, on peaty topsoil on top of the bank at the north-west of the feature, appears to be up-cast from the hollow.

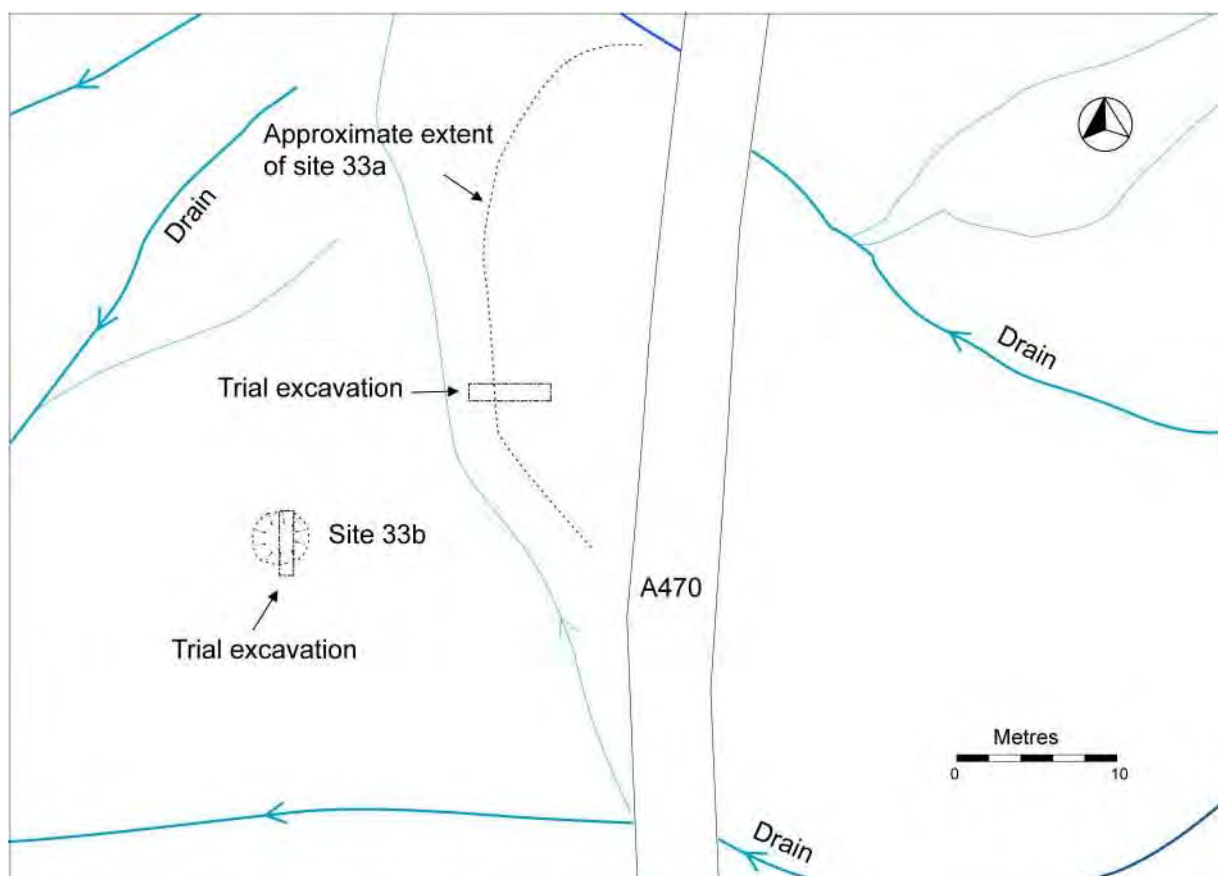
Fig. 13 Sites 33a and 33b, Embanked curvilinear feature and possible cairn

The feature is no longer visible. A level working platform of compacted slate waste was built over it during repairs to the A470 revetment wall during the last 5 years (Fig. 13). Plates 5 and 6 show the site in 1992 and 2005.

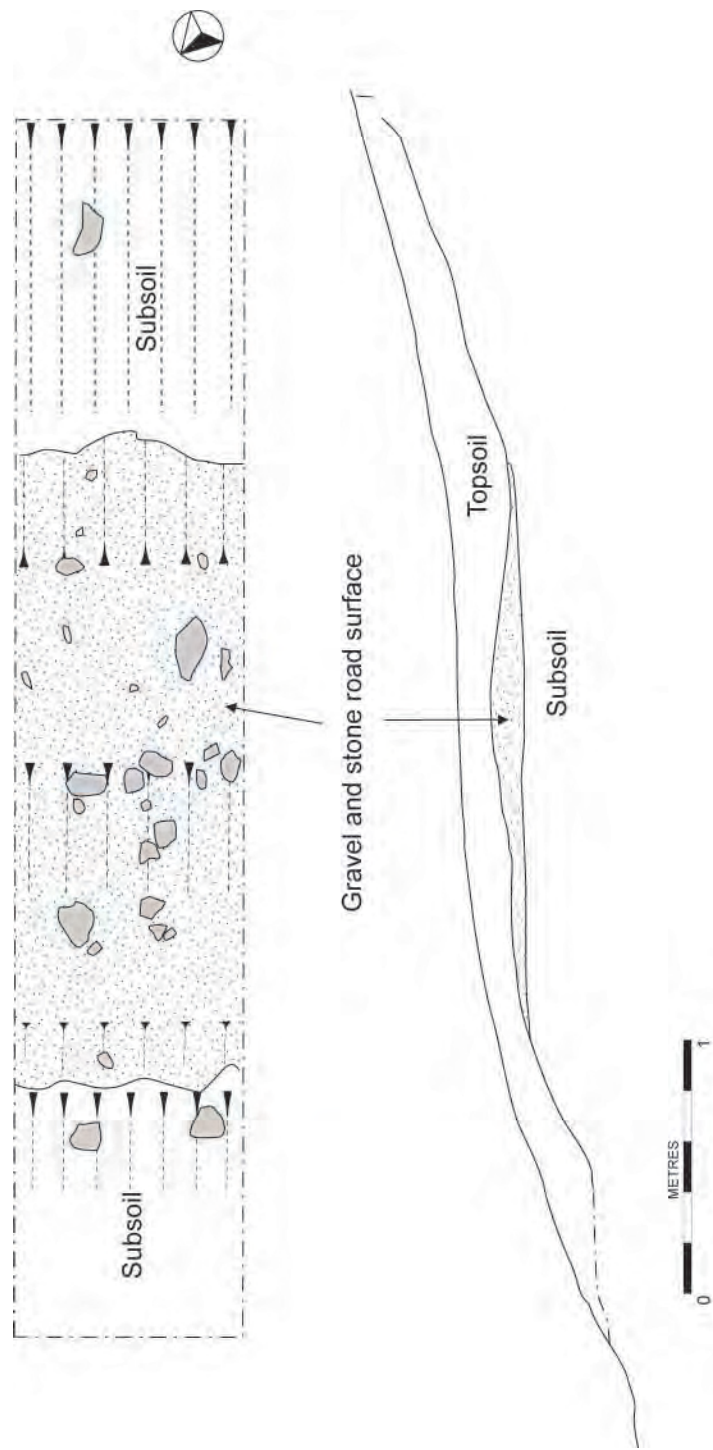
Fig. 17 Site 39b road. Plan and south-west facing section

A 5m x 1m trench was excavated across the feature (Fig. 17 and Plate 12). A 2m wide road surface was found to lie directly beneath the shallow topsoil. This was slightly cambered and 0.2m thick in the centre. The metalling consisted of compact gravelly silt containing occasional larger stones and was almost certainly derived from the local subsoil. This site can now be reallocated to Category C – Sites of district or local importance. The road is discussed in a wider context below.

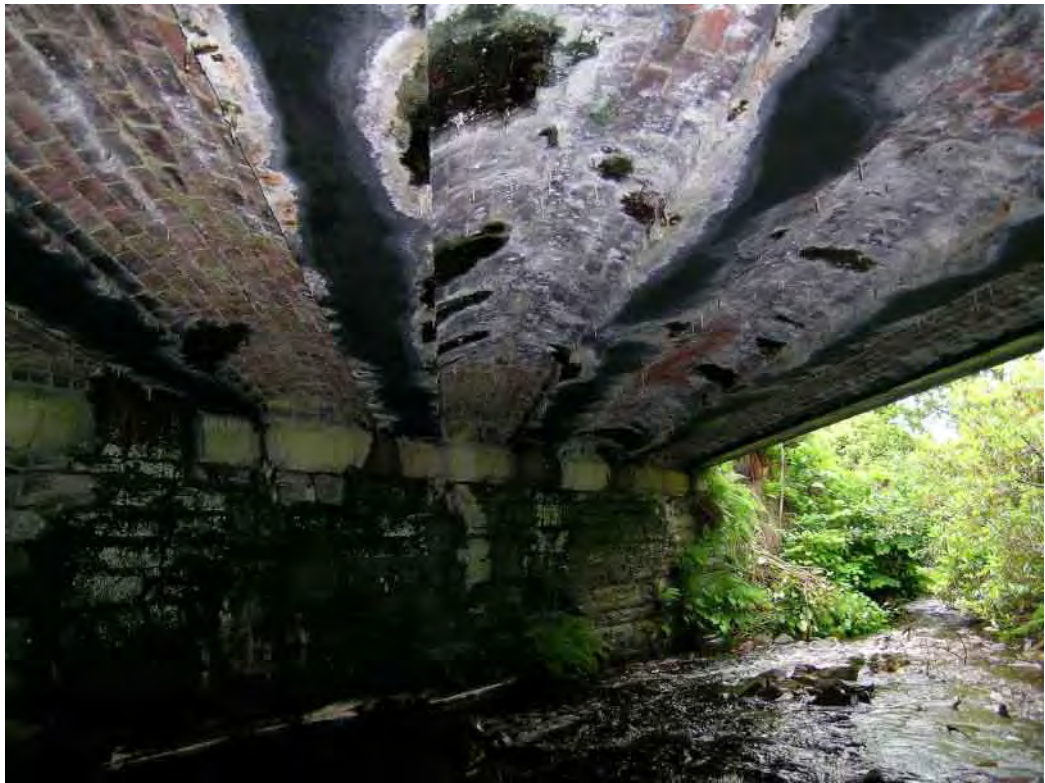
Plate 23 Bridge 68, underside

The superstructure (Plate 20) is more substantial than that of bridge 67 although they share many constructional details such as the presence of 6 cast iron girders. Bridge 68 is in much better condition and details of the 4 central girders carrying the line load are not visible due to the presence of crushed slate ballast above and brickwork below.

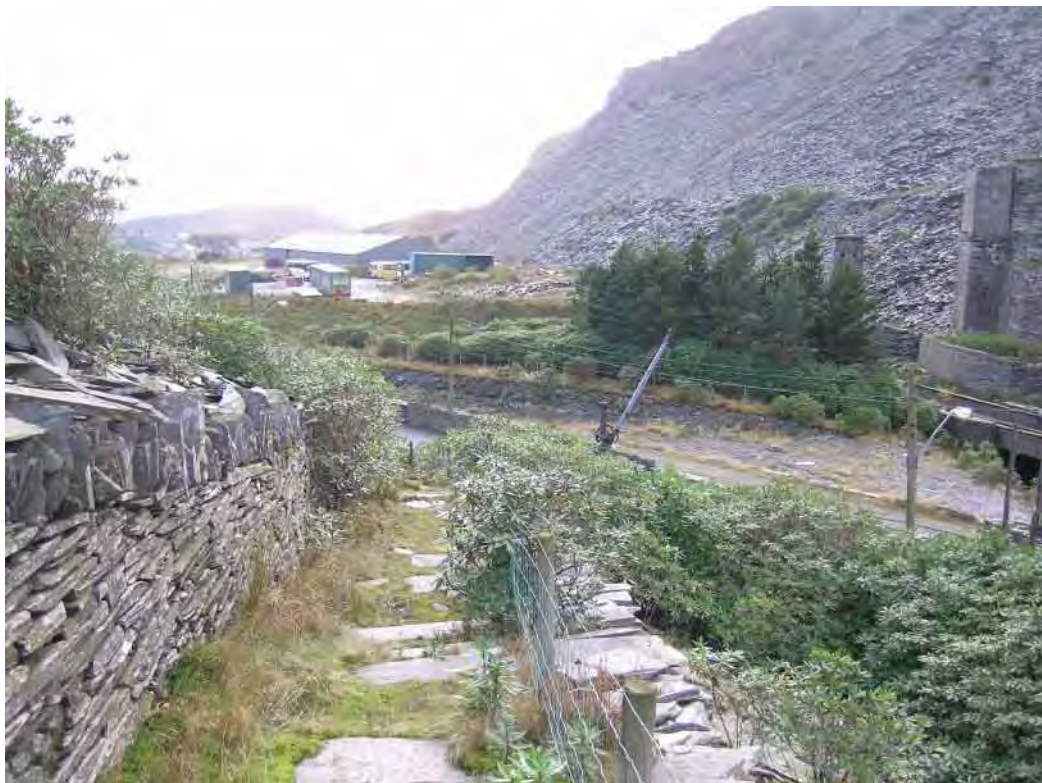
Plate 48 Site 4 Footpath

A slate-paved footpath (Plate 48) runs from the present A470, close to the Pant yr Afon works, to the Llechwedd Quarry Mill and worker dwellings. The path is steep and terraced into the slate tips. It is 2.4m wide and bounded on the south-east by a dry-stone wall and to the north-west by a modern fence, surmounting a 14m high dry-stone revetment. The path is stepped in places and surfaced with slate slabs laid lengthways into the slope. The slabs are rounded and worn from many years of foot traffic. The path dates from the latter half of the 19th century. Only the lower part will be affected by the road improvements.

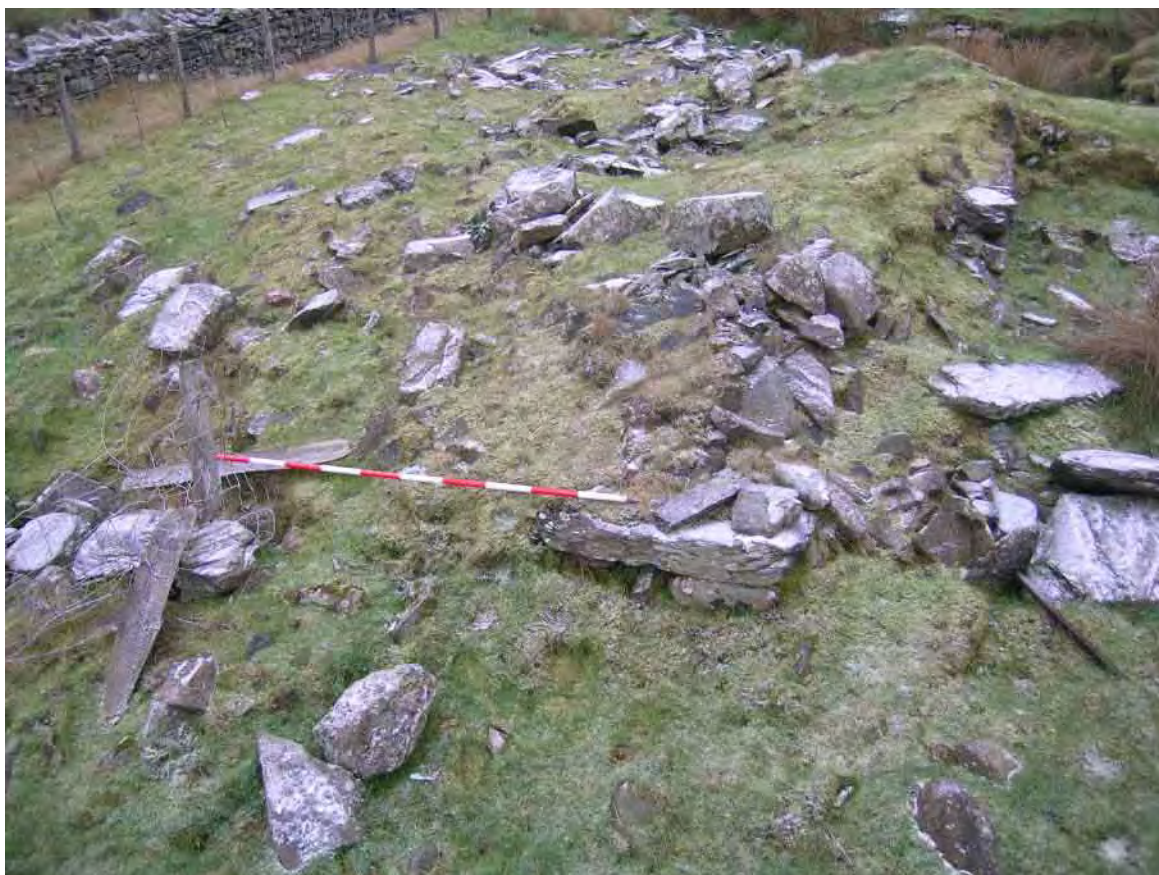
Plate 75 Site 31 Remains of the Crimea Inn

The 1901 6" OS map shows the remains of two buildings in this position. These were the Crimea Inn and associated outbuildings. The northernmost building, probably the inn itself now lies beneath the current layby. The foundations of the other building, apparently L shaped within a rectangular compound are still visible. Much of the masonry is obscured by rubble but at least 0.5m of the walls appear to be upstanding. The edges of the compound walls lie 3.2m from the edge of the current blacktop (Plate 75). The Inn was built soon after the completion of the improved road of c. 1854 – 1857 gaining its name from the recently concluded Crimea War.

A basic record has been made of the site and avoidance is recommended.

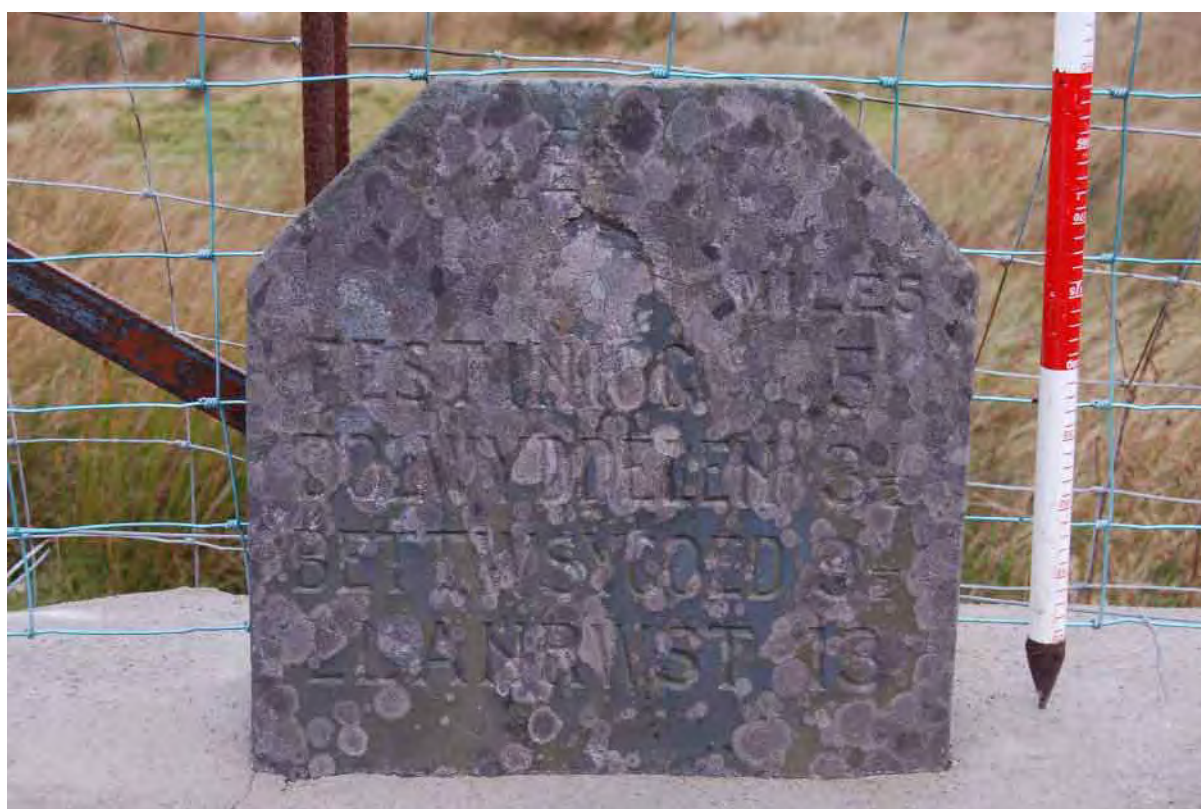
Plate 76 Site 32 Slate turnpike milestone

A slate milestone is located on the west side of the road opposite the Crimea Inn (Plate 76). The stone dates from the days of the Portmadoc and Beaver Pool Turnpike Trust founded in 1864. The stone bears the inscription

The stone has cracked along the cleavage plane of the slate.

The milestone should be relocated to the roadside as close as possible to its current position. It should be noted that the stone is in poor condition and will require specialist conservation.
