GAT Project No. 1890

Llanrwst Almshouse, Llanrwst

Archaeological Watching Brief

Report No. 630

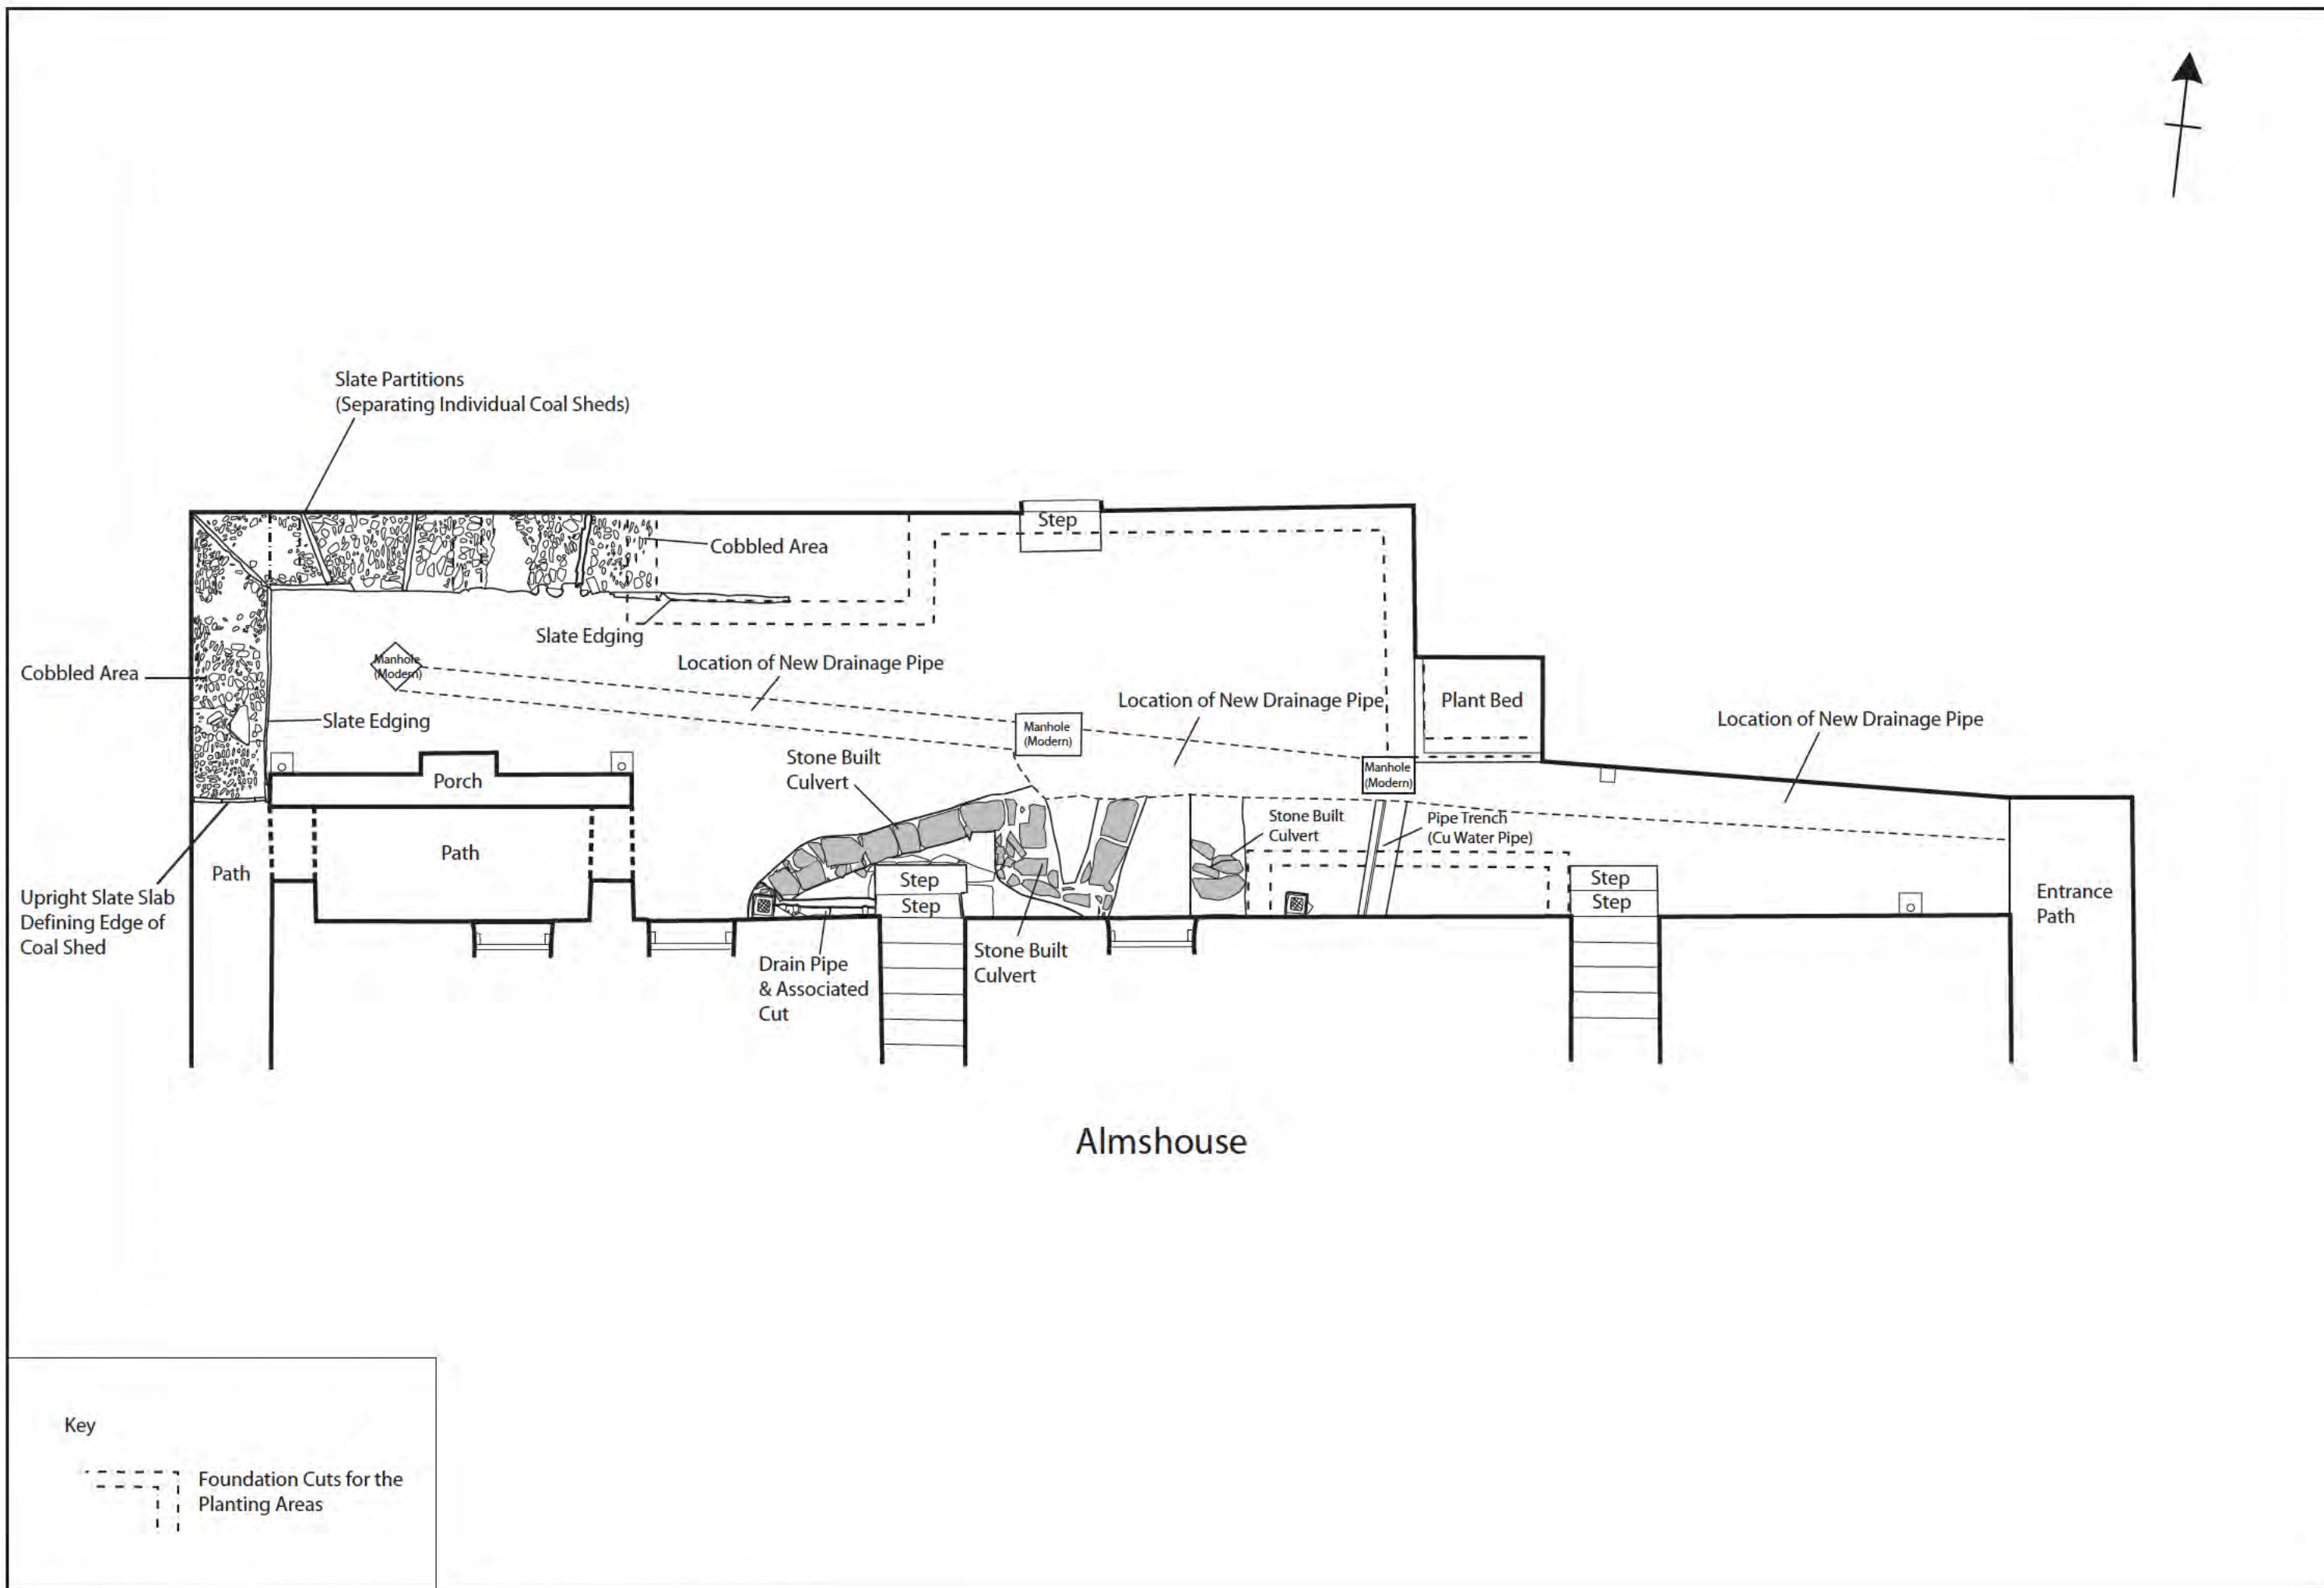
Figure 2: Plan of Watching Brief Area to the Rear of Llanrwst Almshouse (Scale 1:80 @ A3)

The initial stage of the watching brief was monitoring the removal of the slate floor slabs. This exposed the cobbled floor surface of the coal sheds at the western end of the yard (Figure 2). The cobbles covered an area 1.00m wide and 3.90m long. The cobbles were disturbed but still contained remnants of coal dust on the surface (Plate 2). A slate edging surrounded the outside of the cobbled area, whilst an upright slate slab defined the southern wall of one of the former sheds (Figure 2; Plate 2). The flower bed along the north wall was removed, exposing the remainder of the coal shed/toilet block area. Both the cobbles and the slate edging were more disturbed along this area, but it was possible to identify several of the slate partitions which originally separated the coal sheds (Figure 2; Plate 7). The remaining slate slabs across the rest of the backyard, had been laid on a thin sub-base of pea gravel, whilst several patches of orange sand reflected where some of the slabs had recently been re-laid, probably during maintenance work on the drainage system that ran thorough the yard. This sub-base was removed and the ground level reduced by 0.30m, exposing a cultivation deposit, dark-brown in colour with inclusions of charcoal flecking, mortar and pieces of coal (that latter two could possibly be linked to the 19th refurbishment and the construction of the coal sheds). At the southern end of the yard, a series of culverts were identified, cutting the natural clay and sealed by the cultivation soil (Figure 2). There were four culverts leading from under the Almshouse and continuing north towards the centre of the yard. The culverts varied in width, between 0.40m and 0.80m and with using rectangular slabs of stone used as capping stones (Plates 5 and 6). The culverts were shallow, c.0.20m deep, with stone sides and a slate base. They were all truncated by the modern drainage cut which ran through the centre of the yard (Figure 2). The longest example, which ran on a southwest to northeast alignment, had partially collapsed and had also been cut by a ceramic drain pipe that ran along the Almshouse wall

(Figure 2; Plate 5). A 20th century copper pipe was also identified in this area, running northwards from the Almshouse. The pipe was thin, several centimetres wide, and was laid in a 0.40m wide pipe trench, which was truncated by the large drainage cut in the centre of the yard (Figure 2). The drainage trench was connected to the Almshouse and contained the sewerage and rainwater pipes from the building, which ran through a set of manholes before exiting the yard under the passageway. The pipes were ceramic and were laid during the twentieth century. The pipe trench was re-cut and the pipes replaced with plastic versions. The manholes were also repaired. The new pipe trench followed the alignment of the original and did not expose any archaeology as the area had been extensively disturbed when the original pipe trench was laid.

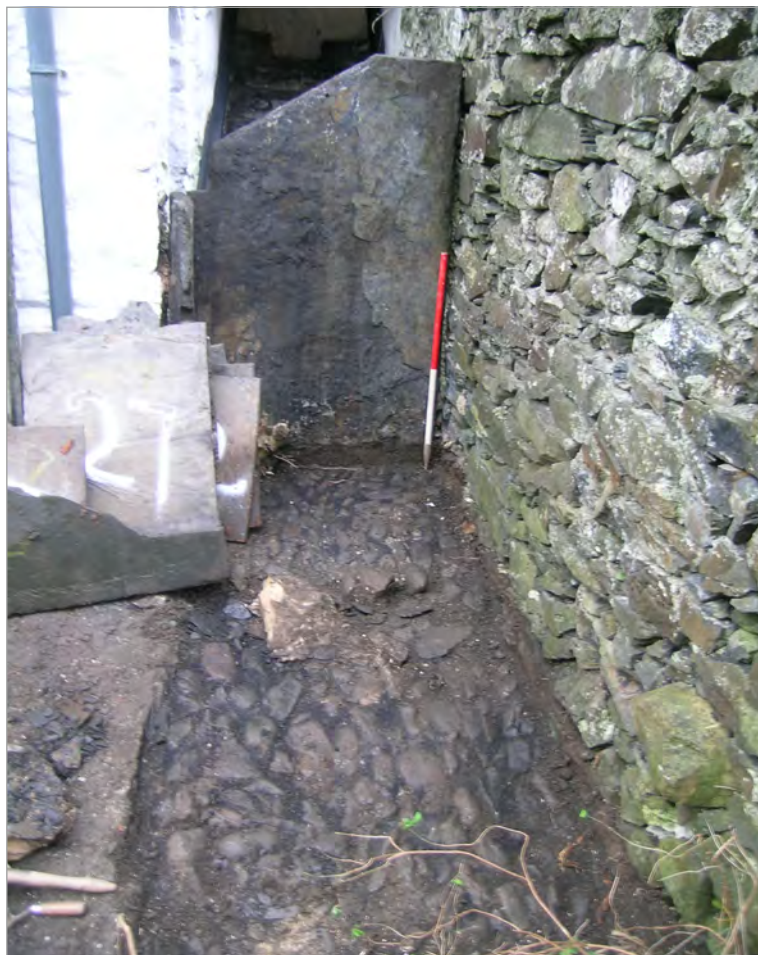
Plate 2: View South of Former Coal Shed Wall
and Cobbled Floor Surface

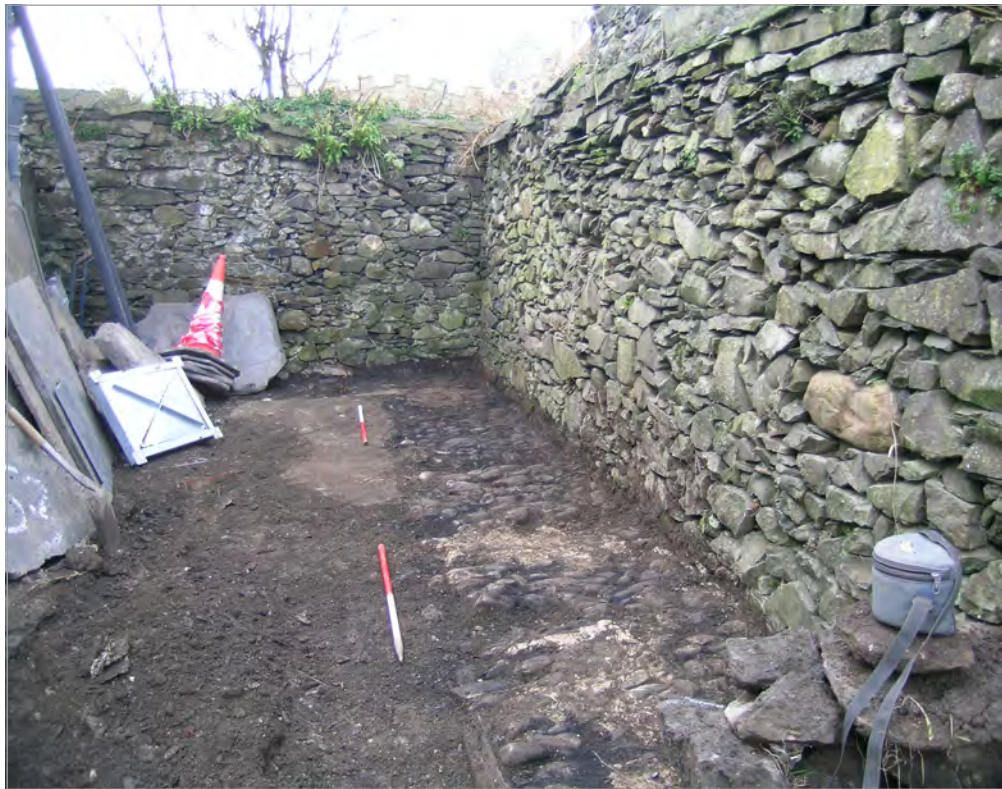
Plate 7: View West of Former Coal Shed Area with Surviving Cobbled Floor. (Note: Coal Dust on the Cobbles and Redundant Roof Slates Embedded at the Top of the Boundary Wall)

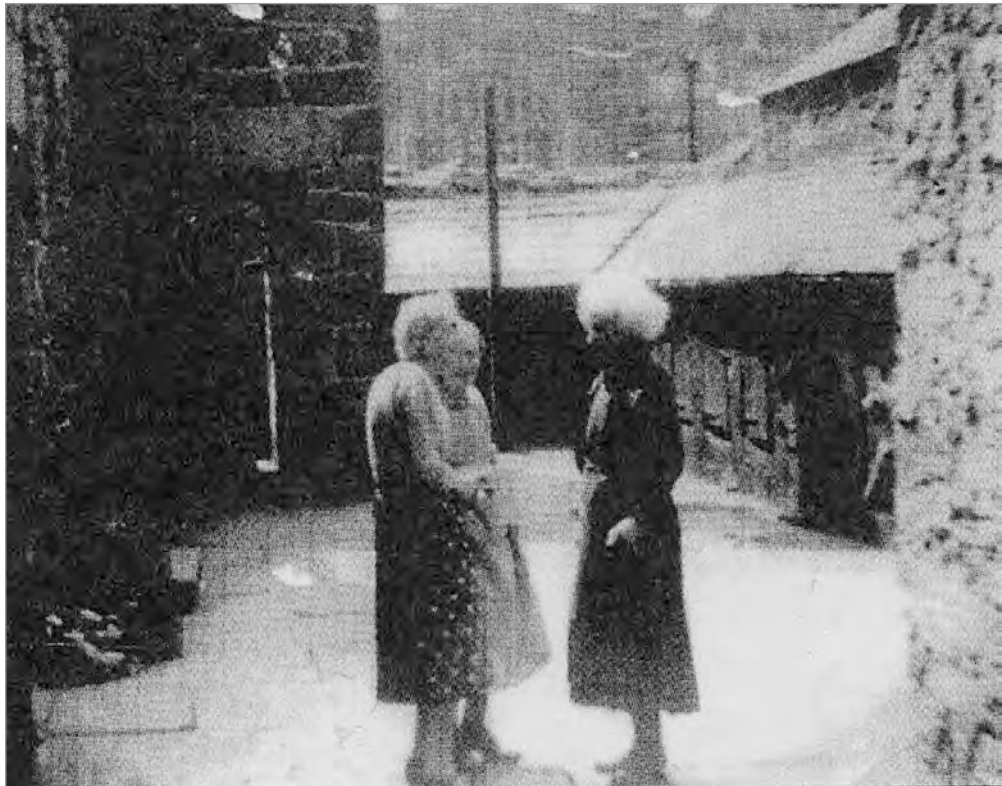
Plate 8: Mid-Twentieth Century Photograph of the Watching Brief Area. (Note: Coal Sheds to the Rear with Slate Roofing and the Slate Paving Slabs on the Floor.) Source: *Hen Luniau Llanrwst a'r Cyffiniau*
