Archaeological Survey and Recording at Plas Coch, Llanedwen

GAT Project No. 1973
Report No 707
prepared by
David Longley and Tanya Berks
November 2007

Plas Coch

Archaeological recording and assessment has been undertaken in advance of proposed demolition works in the Victorian period western block and in certain areas of the main building at Plas Coch, Llanedwen Anglesey. A record has been made by photography and measured survey in accordance with a brief prepared by Gwynedd Archaeological Planning Service.

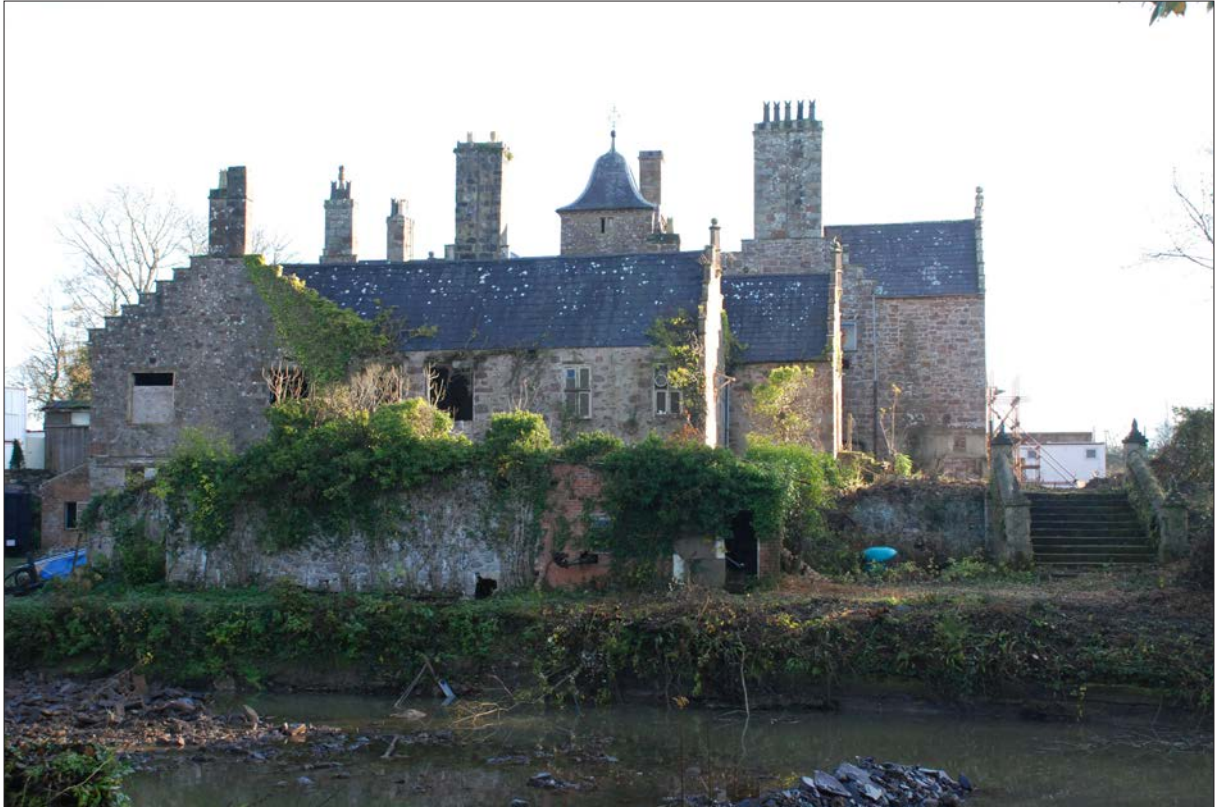
The western complex at Plas Coch from the lake

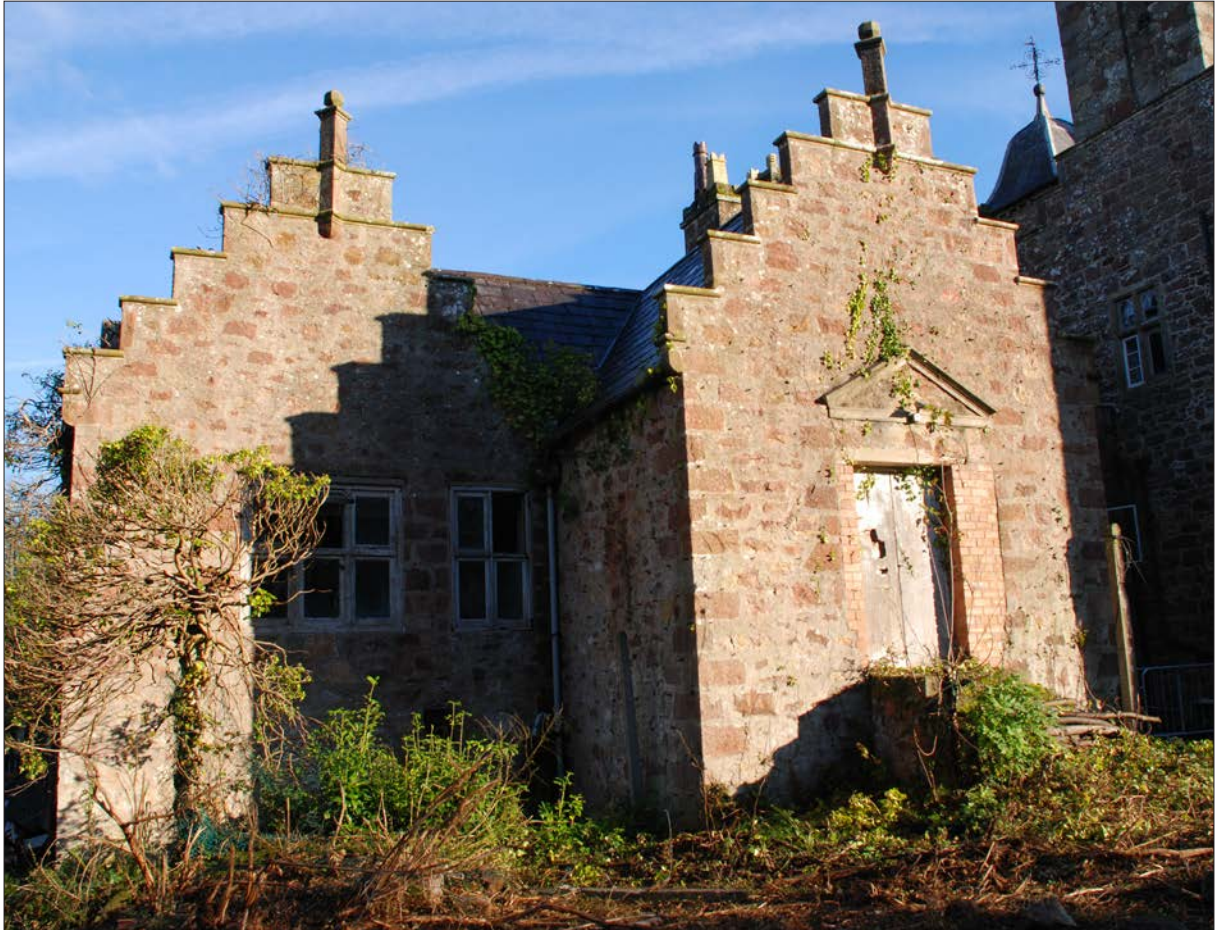
The southern facade of the western buildings

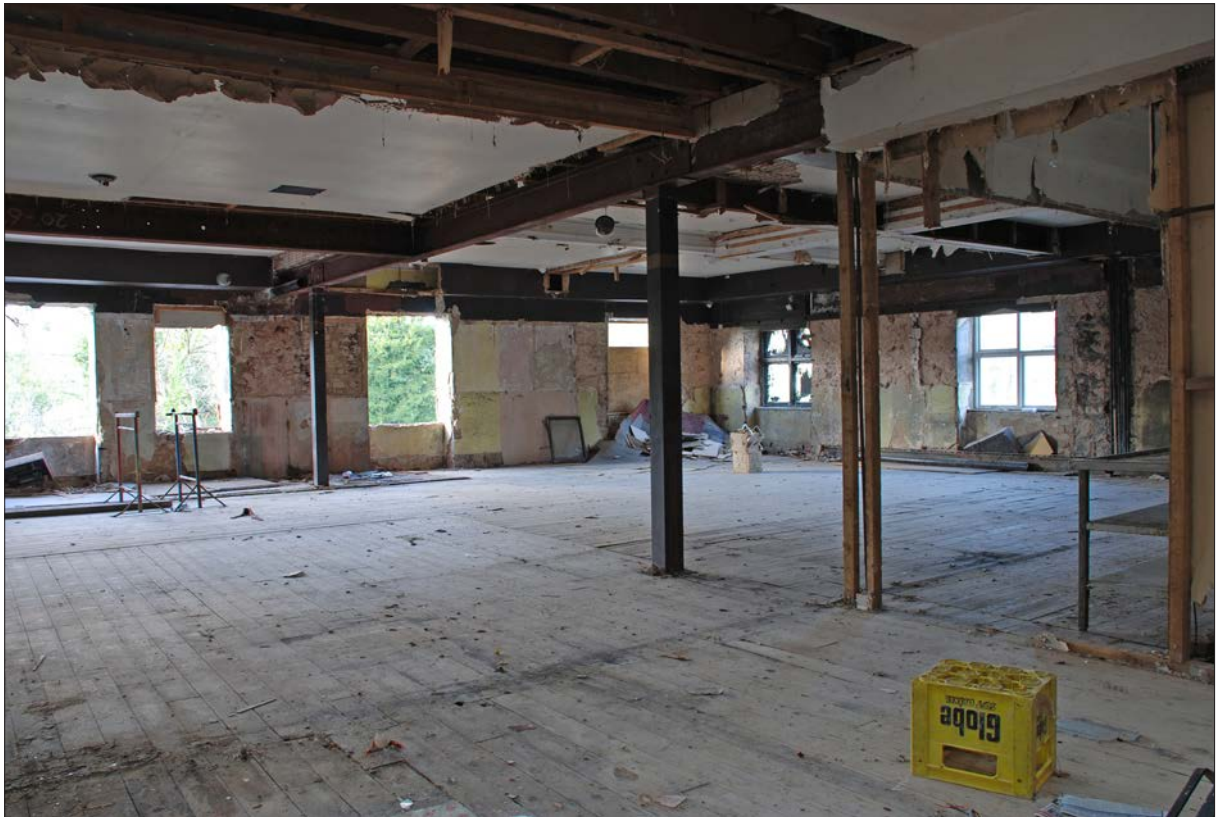
The Upper Ground Floor looking towards the windows which overlook the lake. The former billiard room was against the right hand wall.

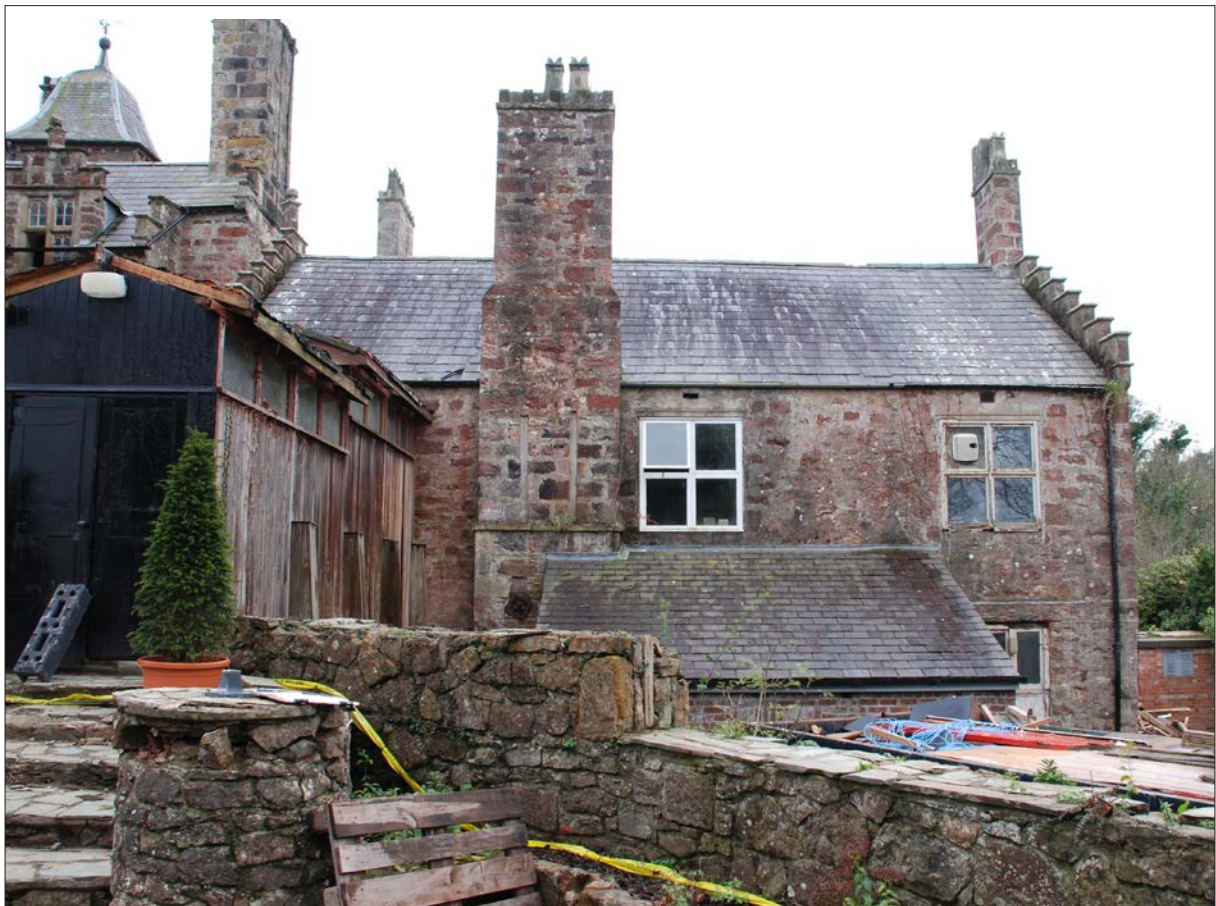
The northern facade and entrance to the night club

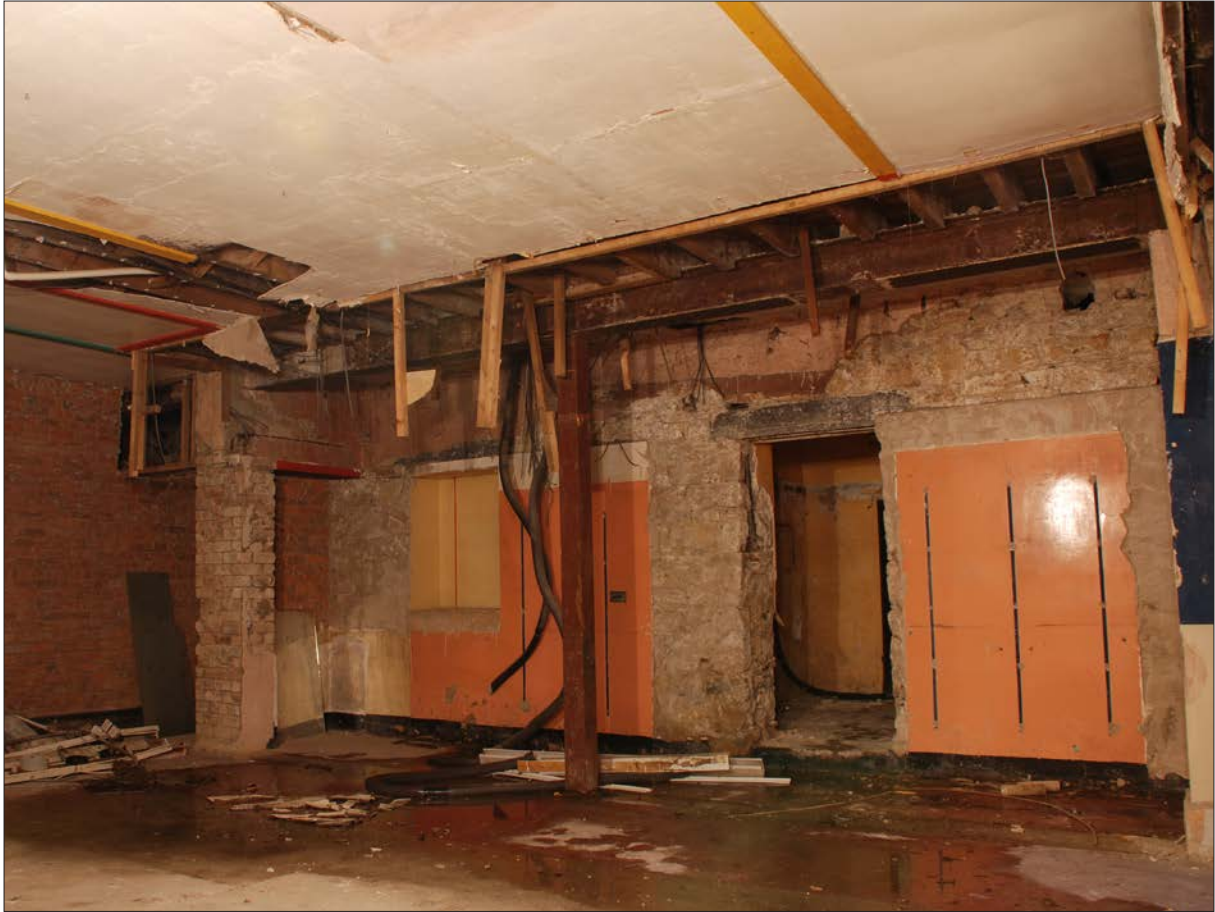
The Lower Ground Floor looking towards the subterranean room on the south

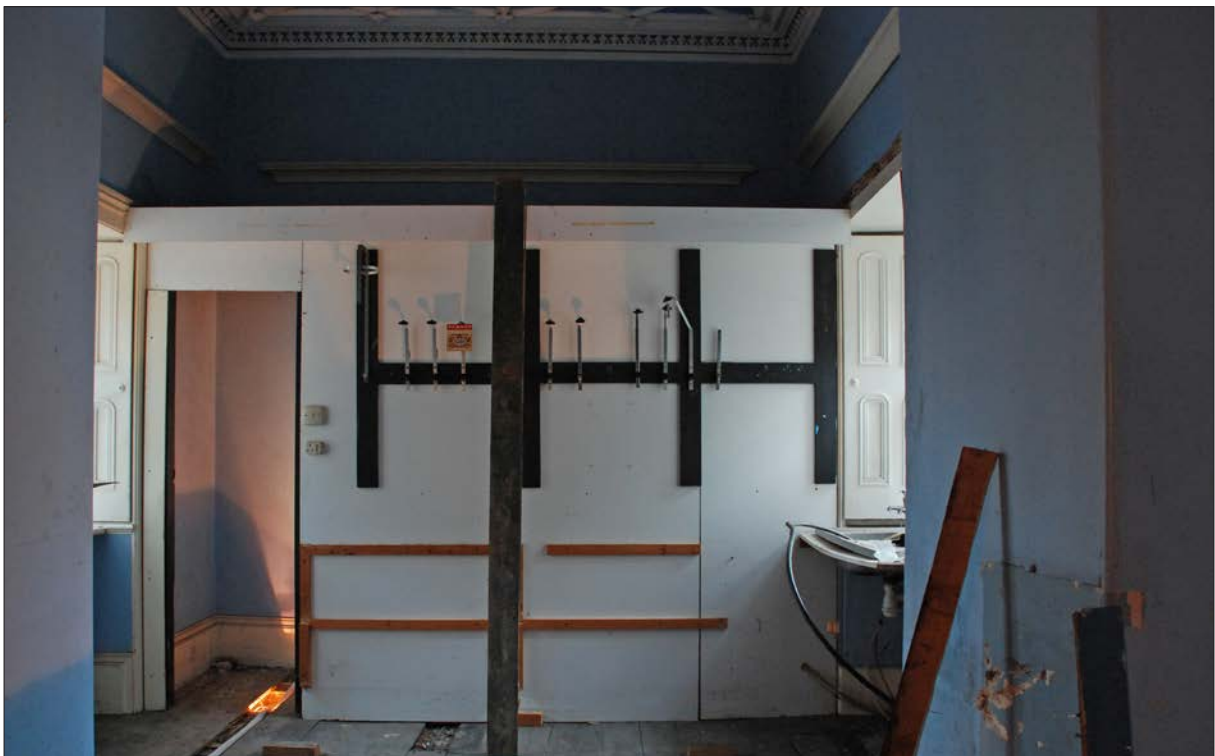
The second area is on the first floor of the late sixteenth-century porch wing. The demolition involves the removal of a modern stud and chipboard partition, extending across the width of the first floor room. The partition stands 1m from the east wall and oriel window and is pierced for doorway access to the window. The partition formed part of the arrangement of a small drinks bar servicing the 'Wedgwood' room at the back of the porch. The supports for liquor optics are still in place. The third area involves rooms on the first floor above the early Victorian dining room. The original design of this room involved lath and plaster partition at almost two-thirds along the length of the masonry structure. In modern times the larger component, on the south side was again subdivided with a stud and plasterboard partition and the insertion of a perpendicular partition to form a small corridor. The proposal for demolition is the removal of both the plasterboard partition and the lathe and plaster partition and corridor partition to expose the larger space.

The first floor above the porch and the stud partition scheduled for demolition

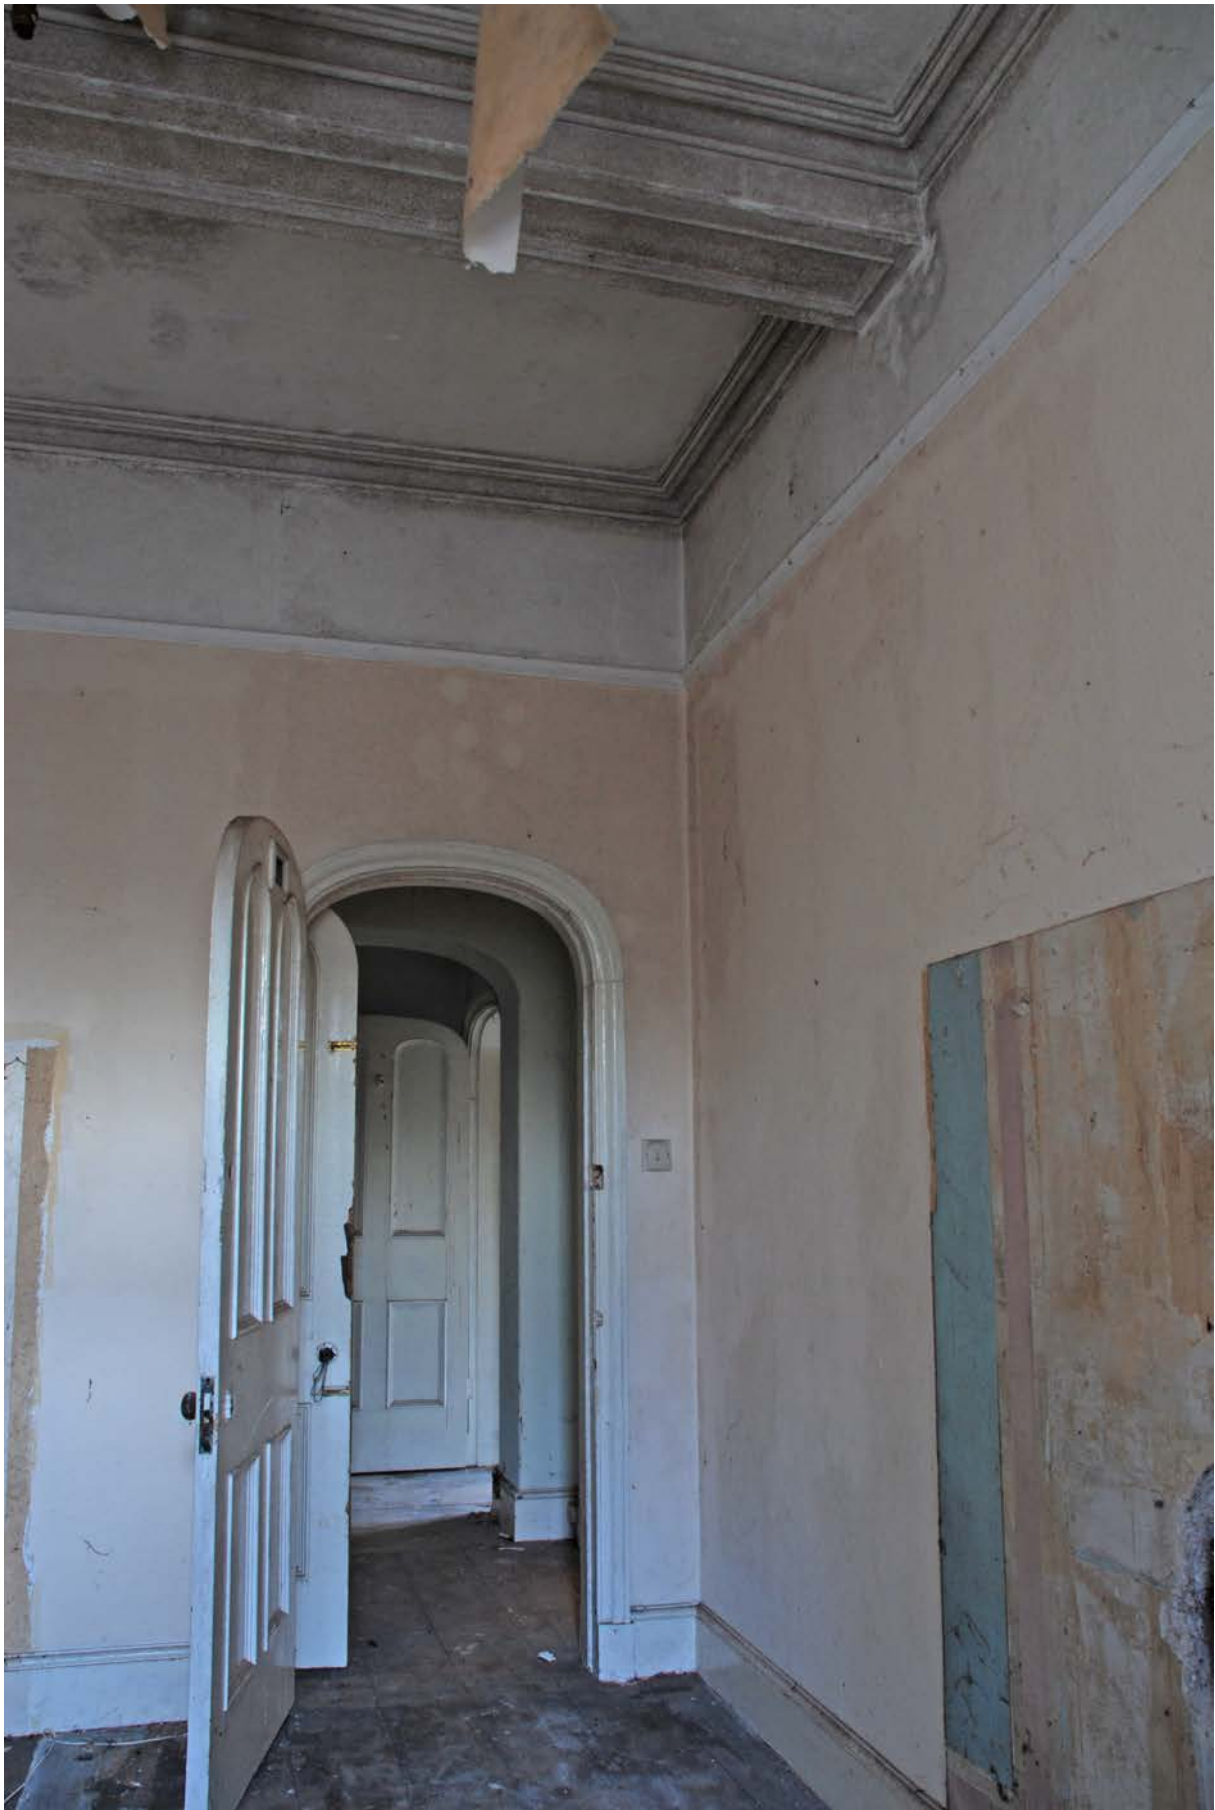
The room above the early Victorian dining room with lath and plaster partition scheduled for removal
