ST. BENEDICT'S CHURCH, GYFFIN

ARCHAEOLOGICAL WATCHING BRIEF

GAT Project No. G1977

Report No. 739

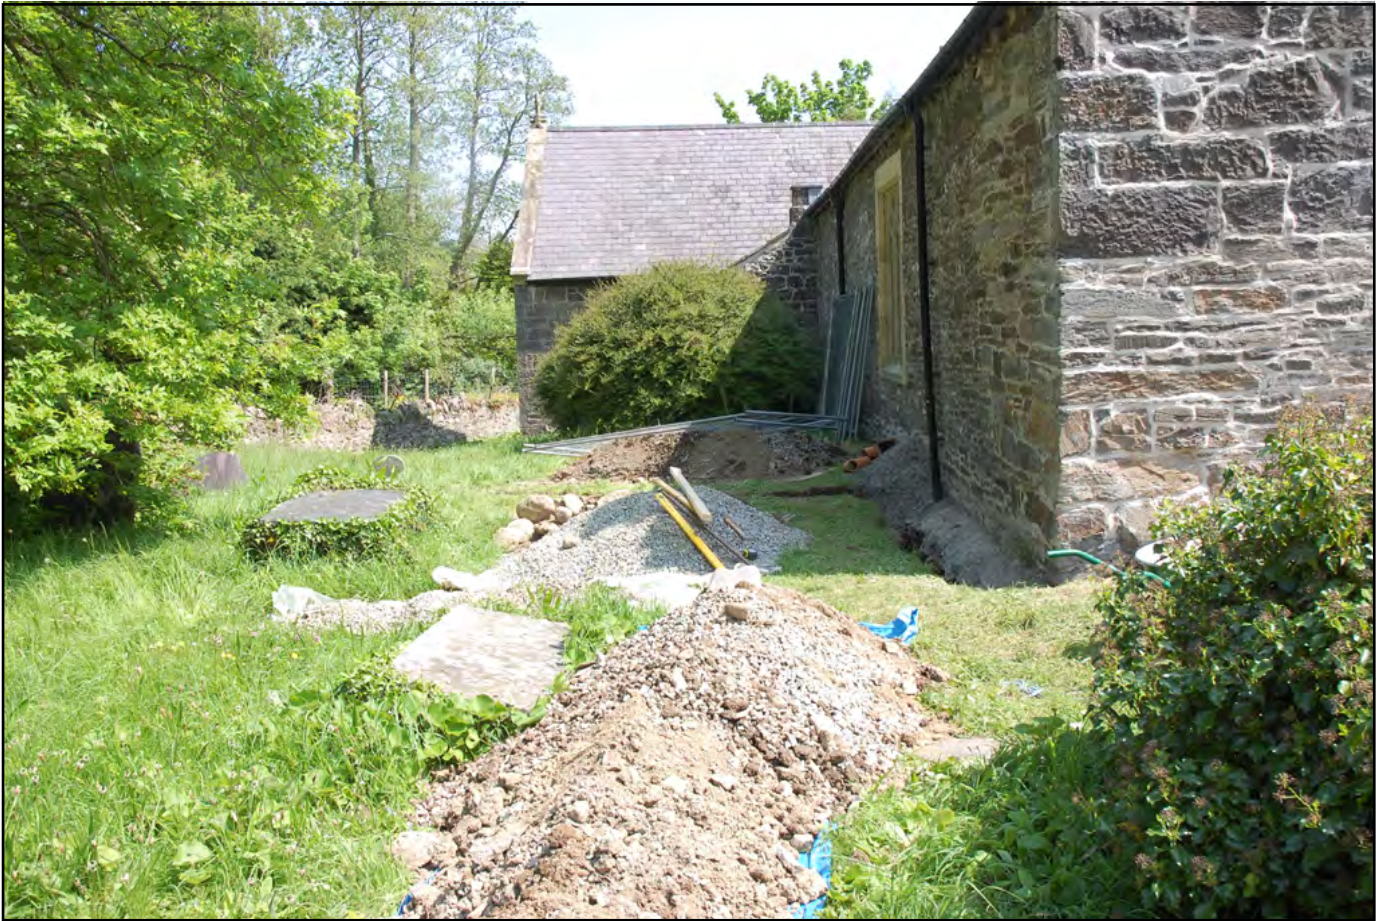
The works programme included the removal of the gravel to accommodate a new drainage channel, which was to be sealed with concrete and the gravel replaced (Plate 01). No distinctive archaeological activity was identified: activity was limited to a thick deposit of bioturbated topsoil into which were mixed randomly sorted sub-rounded stone (provenance unknown). The foundation course for the church was identified within the trench and a photographic record was taken (Plate 02). The foundation course comprised irregular sub-angular stones. The alignment of the foundation course was slightly offset from the superstructure, extending up to 0.30m from the base of the superstructure.

Plate 01: View northeast of groundworks area along north facing elevation

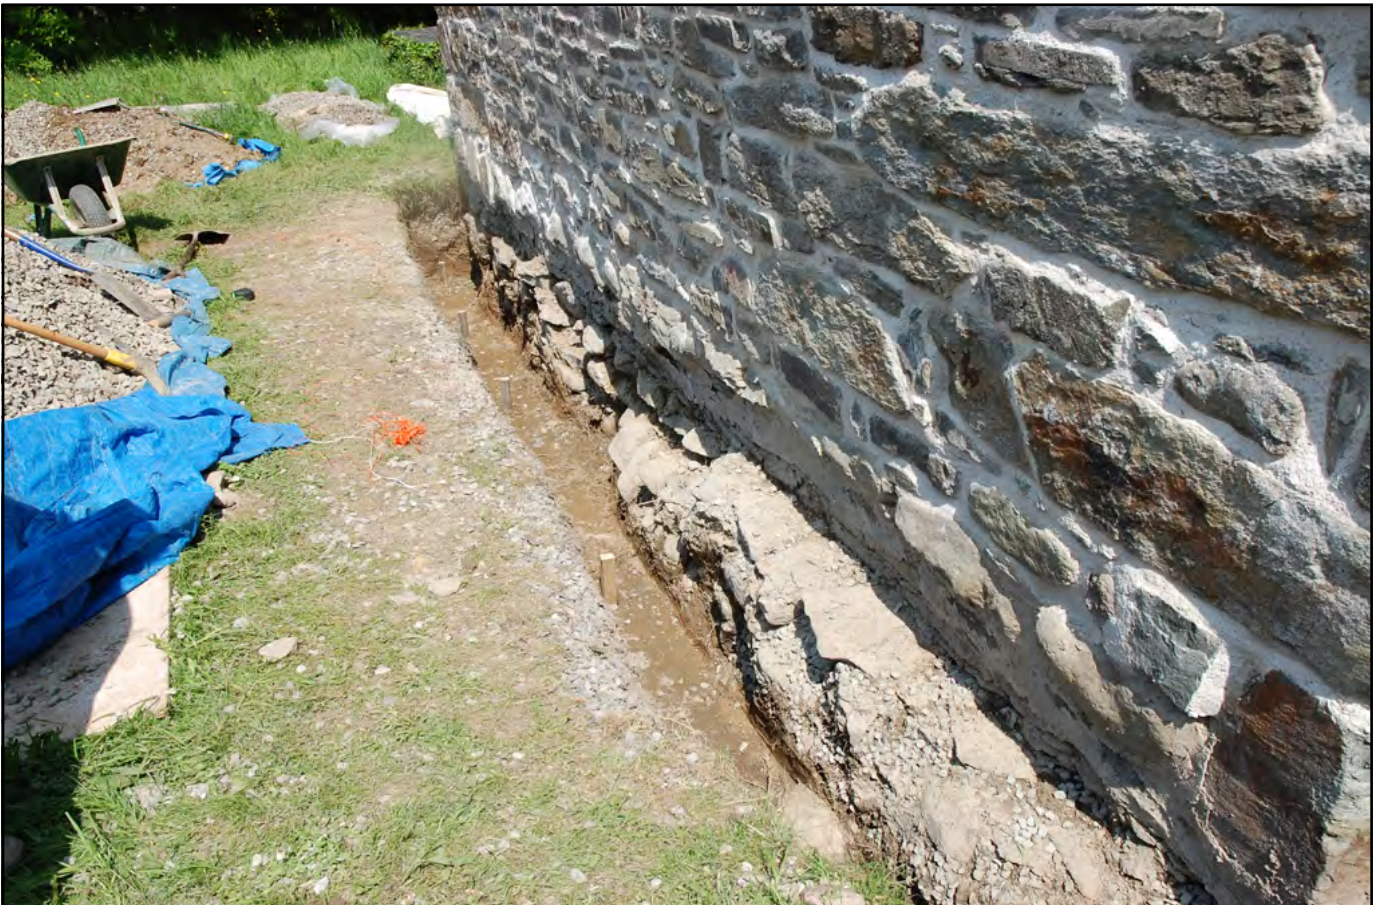
Plate 02: View of groundworks area along west facing elevation. Note foundation course

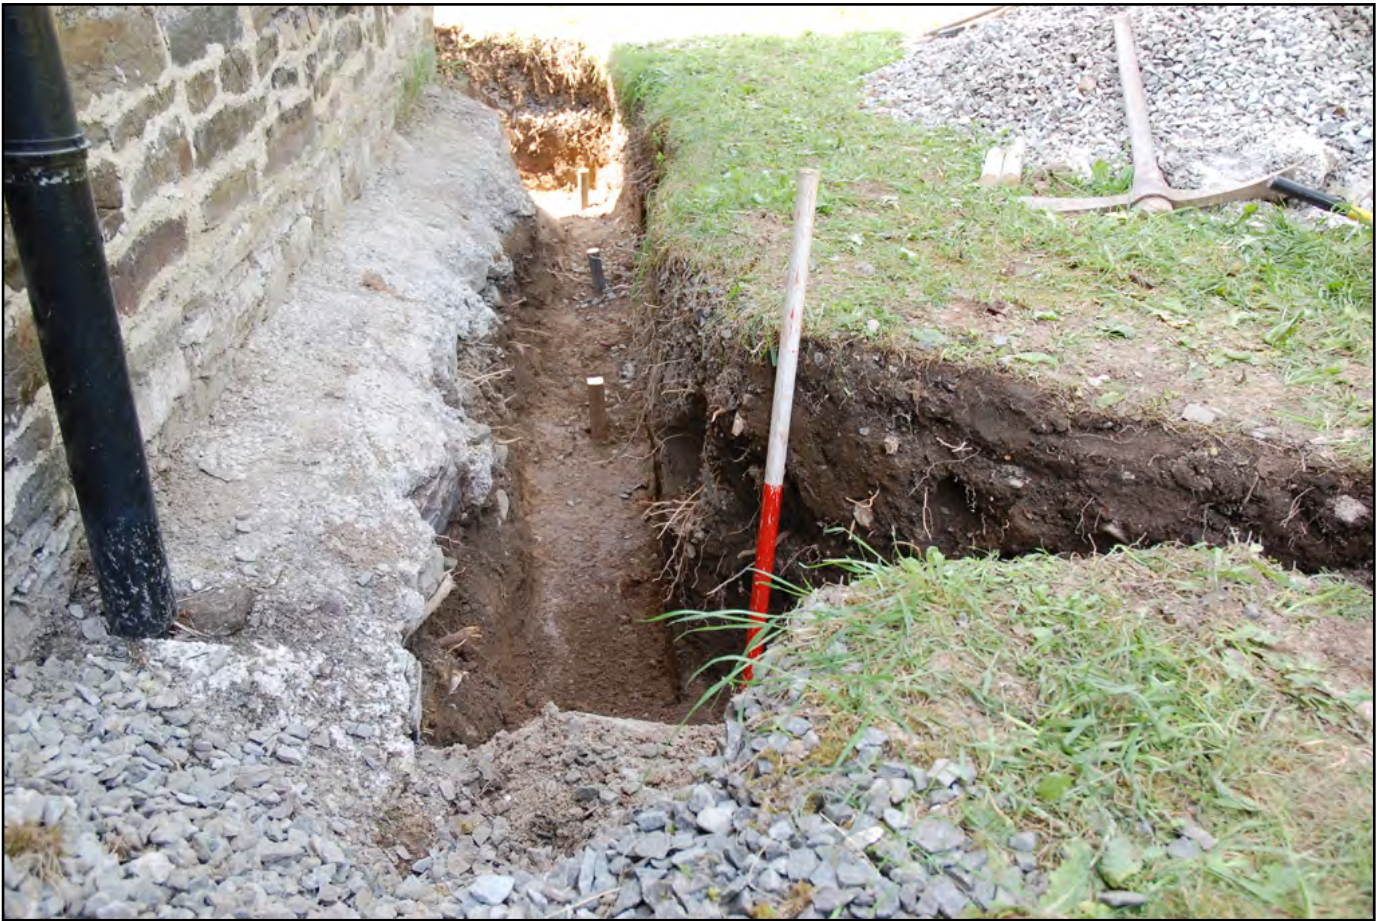
A stone-filled soakaway was identified at the junction of the new and existing trenches (northern elevation; see Plate 03). The soakaway comprised a 0.60m deep stone-filled pit. The stones were irregular in size and included sub-rounded and sub-angular examples. The provenance of the soakaway was unclear, but was assumed to be post-medieval in date and possibly part of the 1900 restoration. Within the new drainage trench, the exposed sections comprised mainly a thick demolition/rubble layer incorporating slate and stone fragments and pieces of plaster and/or mortar (Plate 05). This deposit was extant to a depth of 0.70m (the full depth of the trench was 0.80m). Below this deposit was a bioturbated soil. It appeared that the rubble layer was associated with the 1858 restoration.

Plate 03: Location of sump and start point of new drainage trench

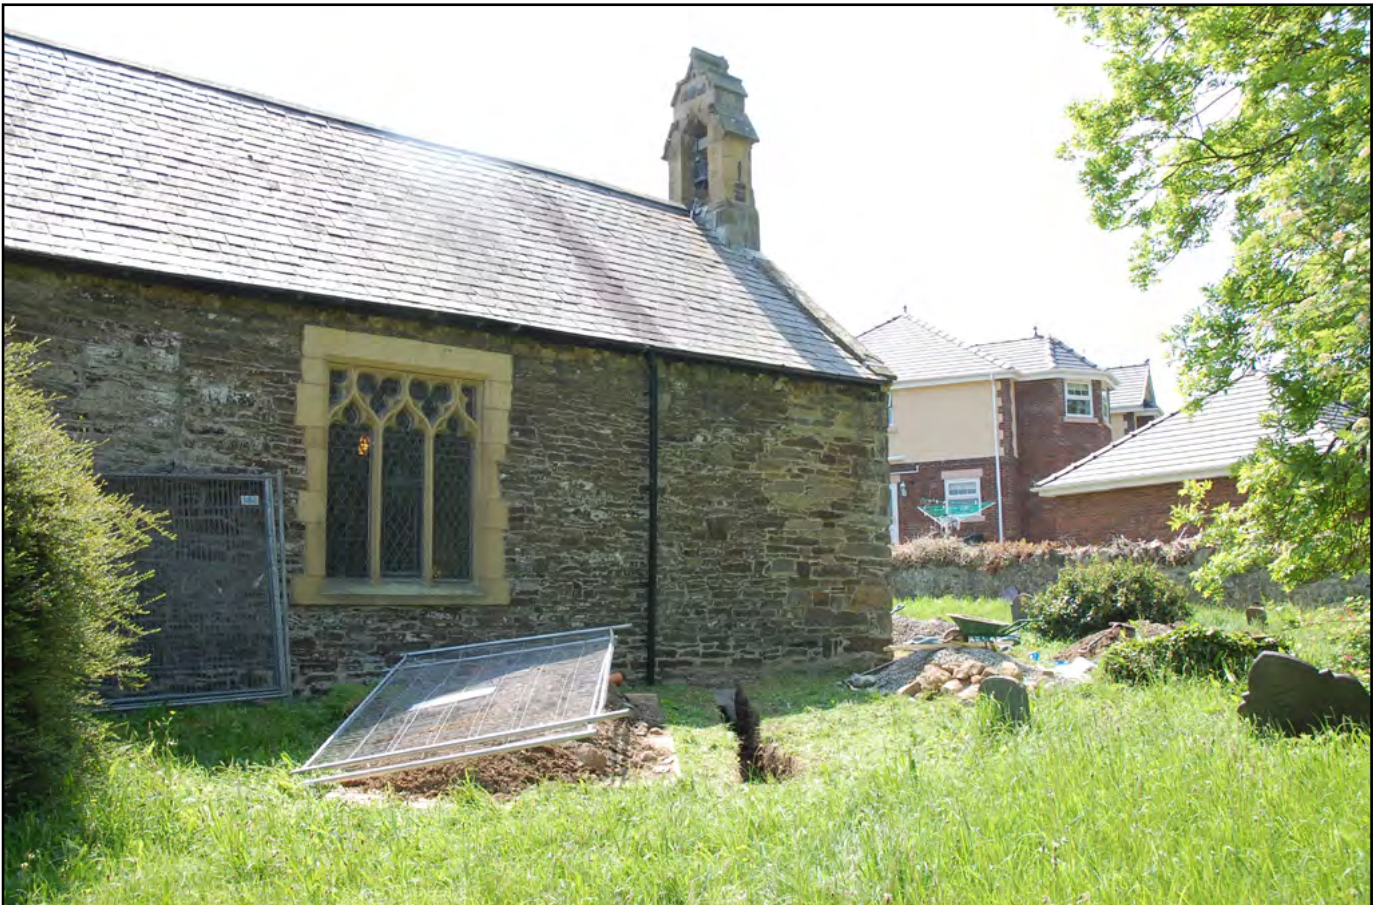
The new cut measured 5.0m in length, 0.50m in width and 0.80m in depth (maximum fall) and was excavated at a 45° to the existing trench (Plate 04). The trench cut through the northern portion of the graveyard in which there were no headstones and no visible topographical features, so the archaeological potential is unclear.

Plate 04: View southwest of new drainage trench

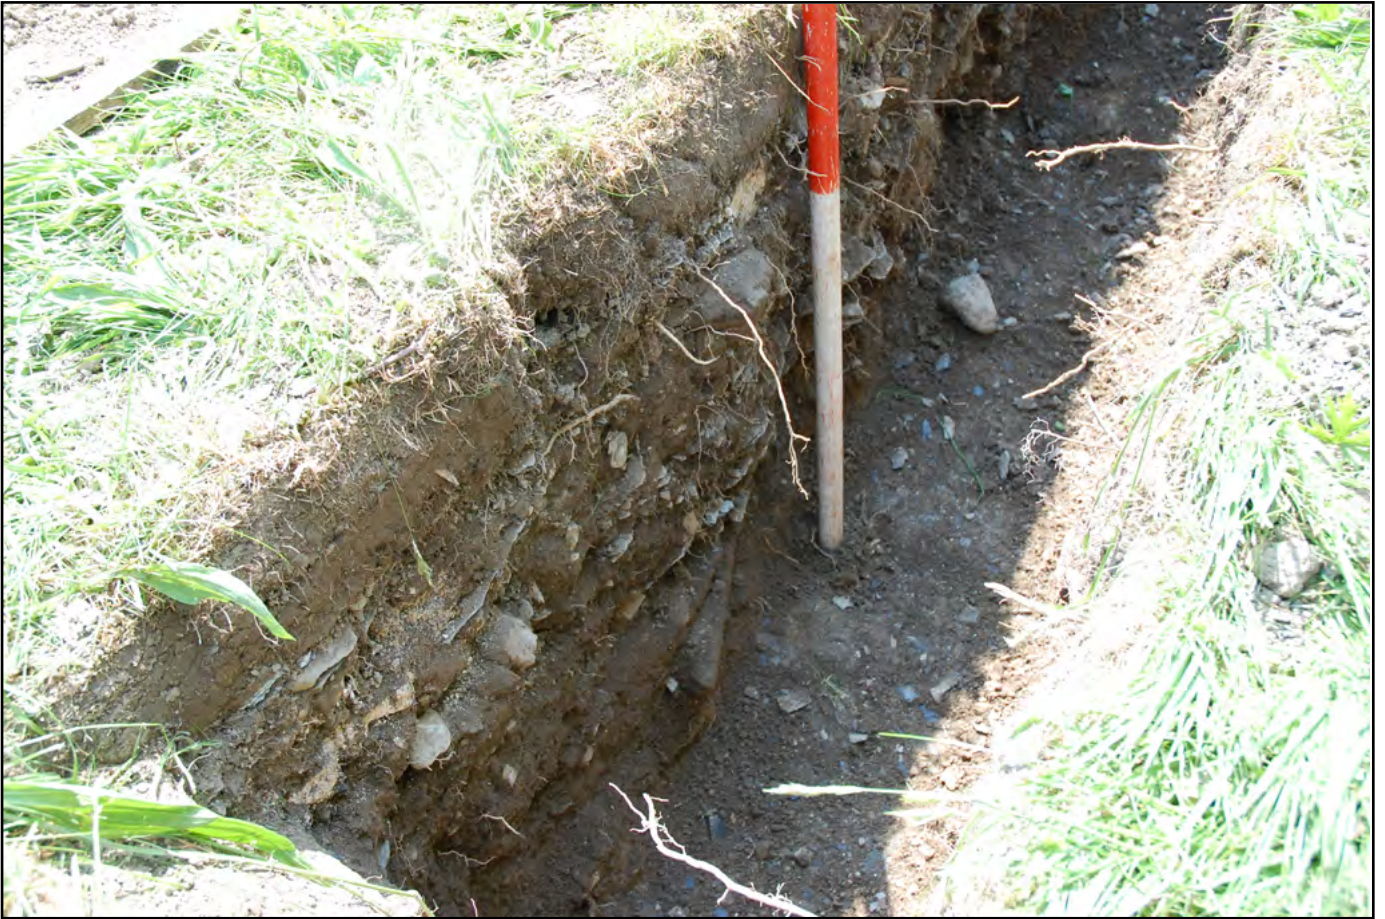
Plate 05: Close-up of exposed section within new drainage trench detailing buried roof fragments

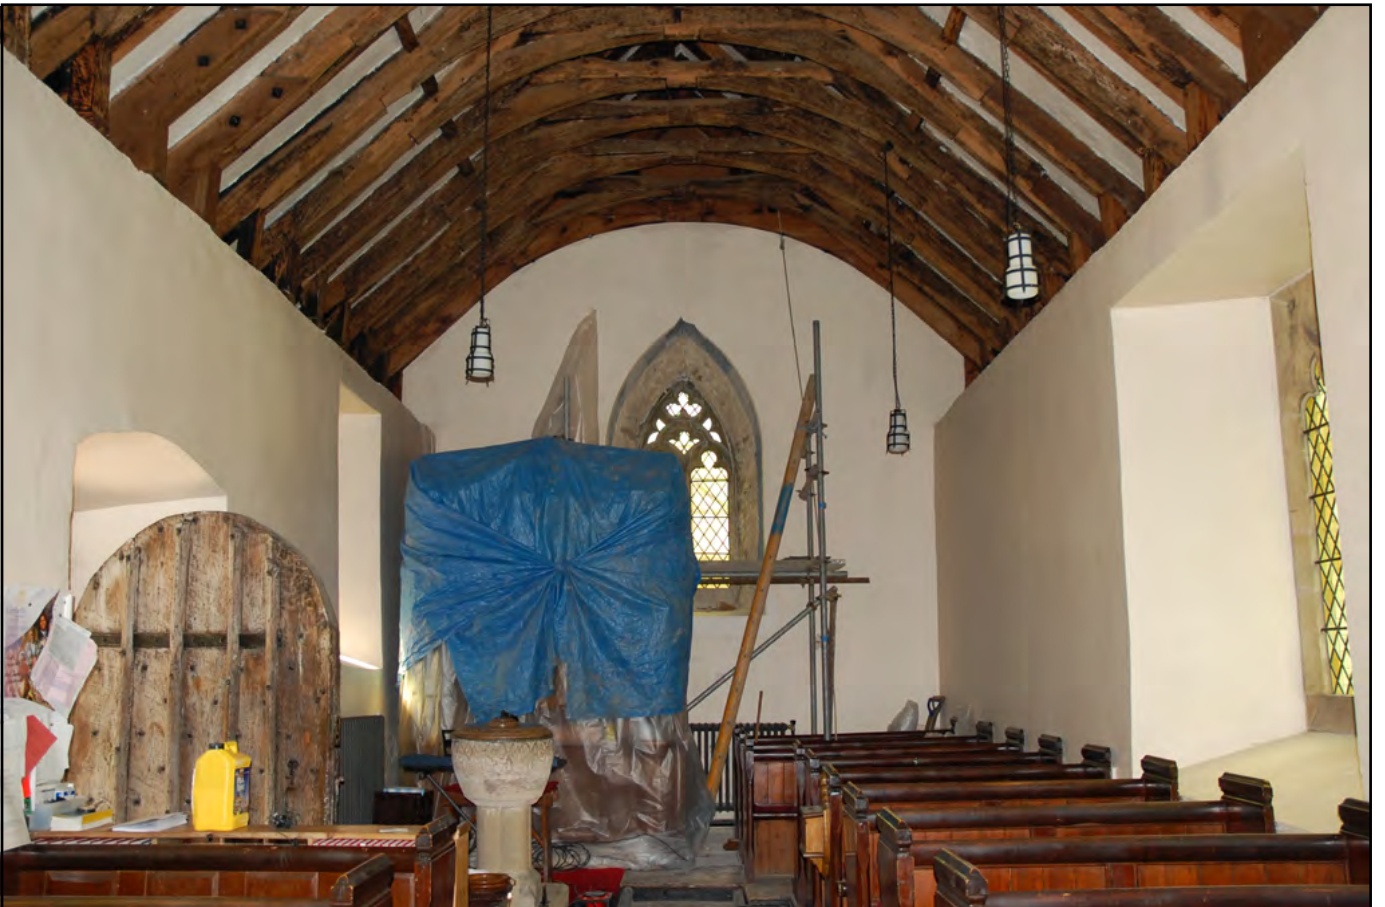
Inspected some of the internal repair work conducted around the existing south window. The window was installed during the 1858 restoration and the repair work aimed to repair a cavity that had formed around the window. A photographic record was taken of the exposed masonry along with a general record of the internal church fittings (see Plates 06 to 08 for examples).

Plate 06: Location of internal repair work around the existing south window

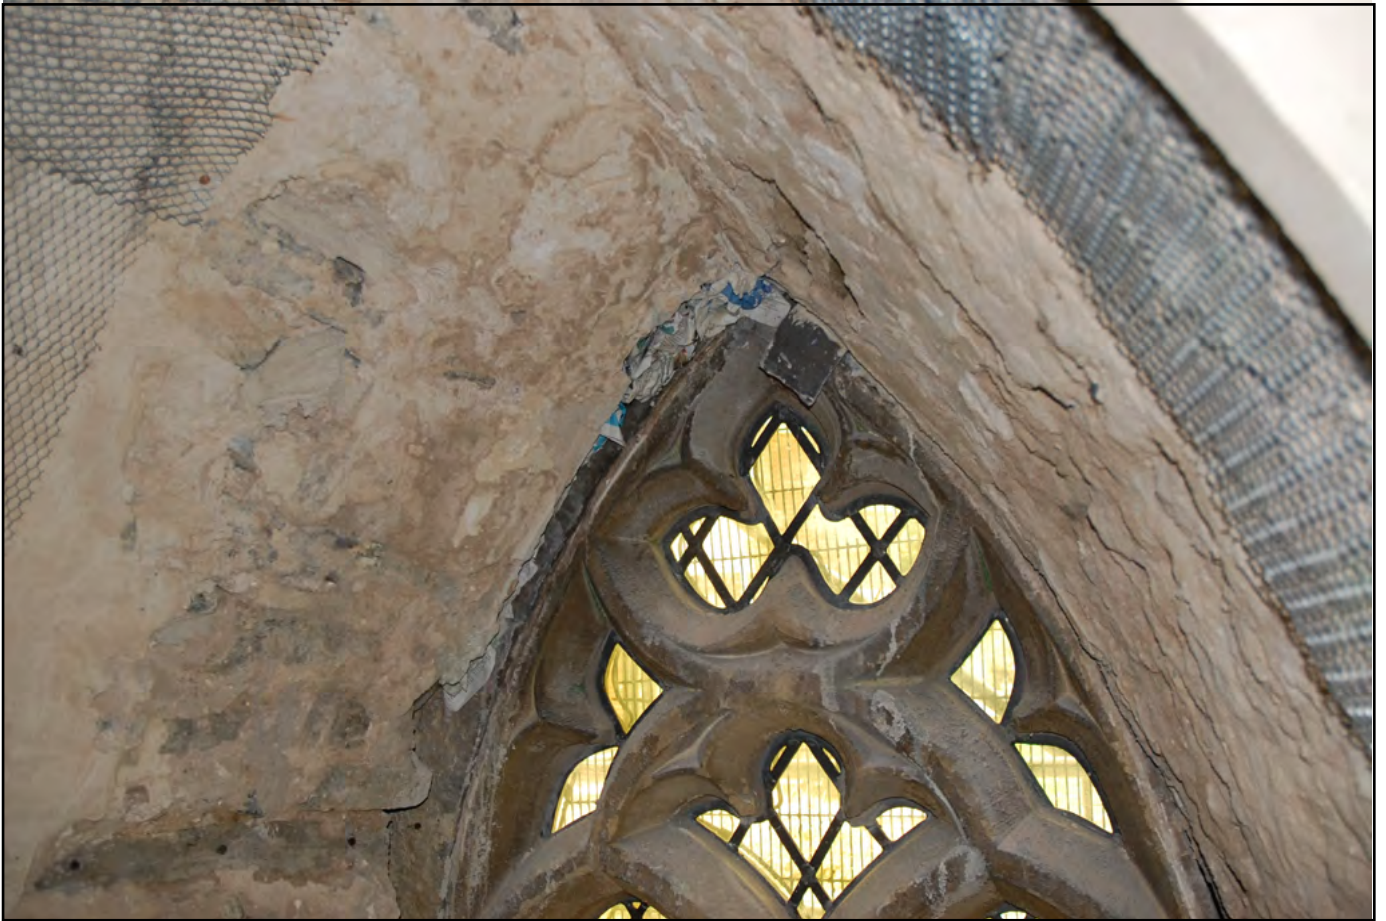
Plate 07: Detail of internal repair work around the existing south window

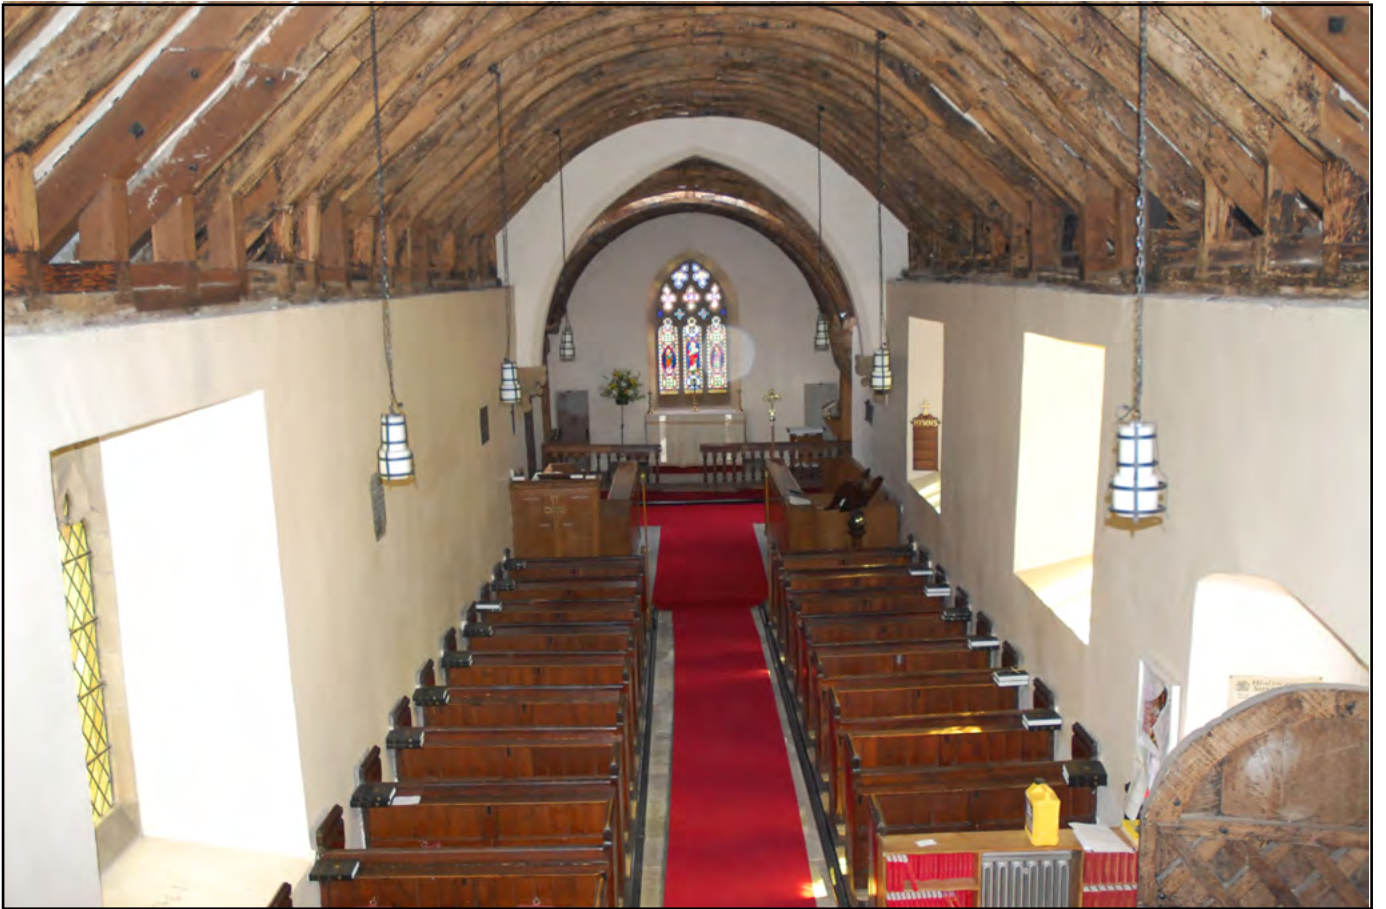
Plate 08: View across church from the location of the south window

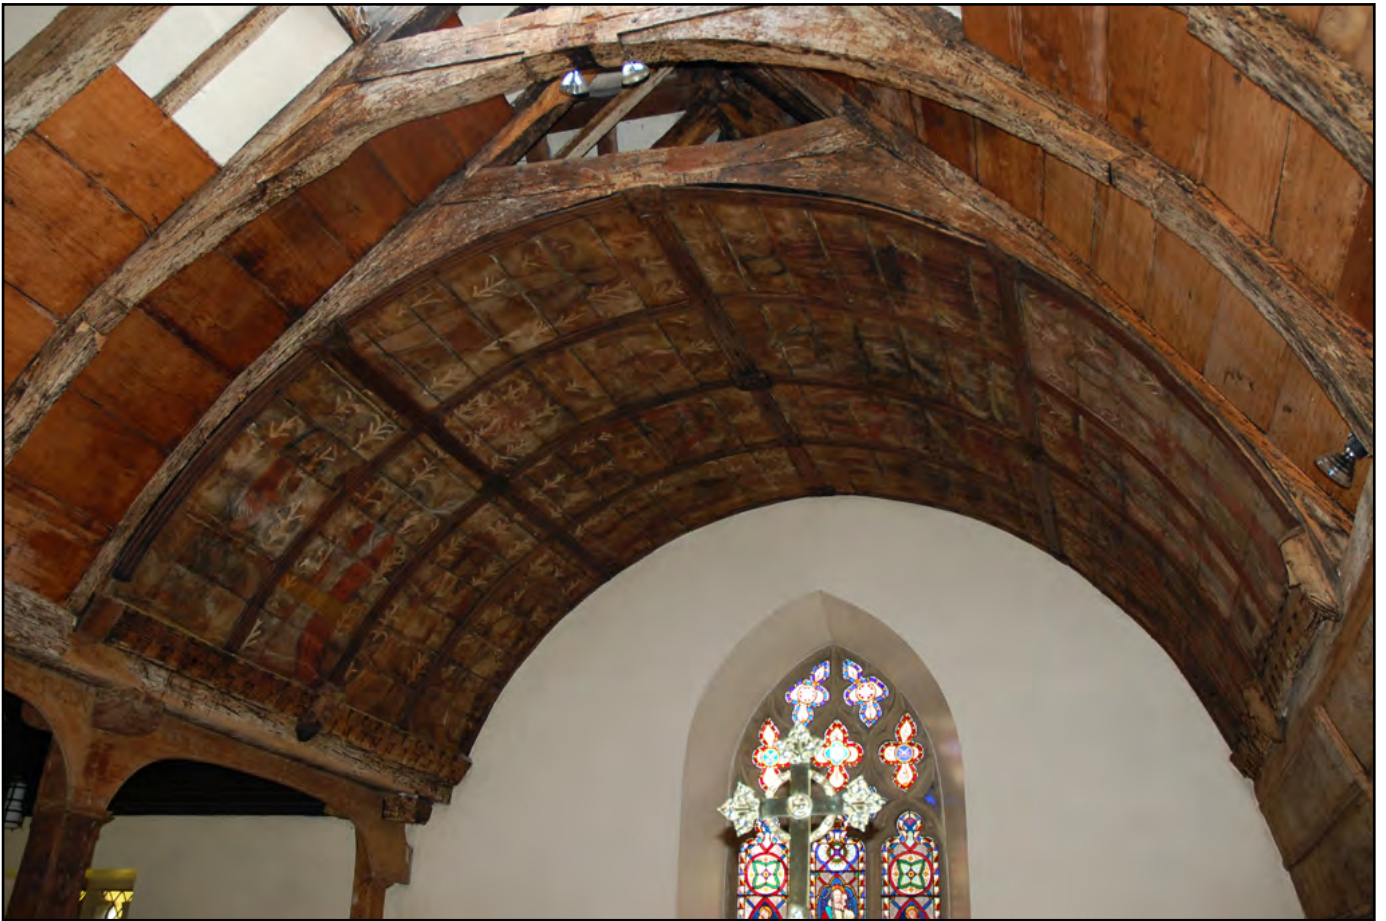
Plate 09: General Shot of Painted Celure

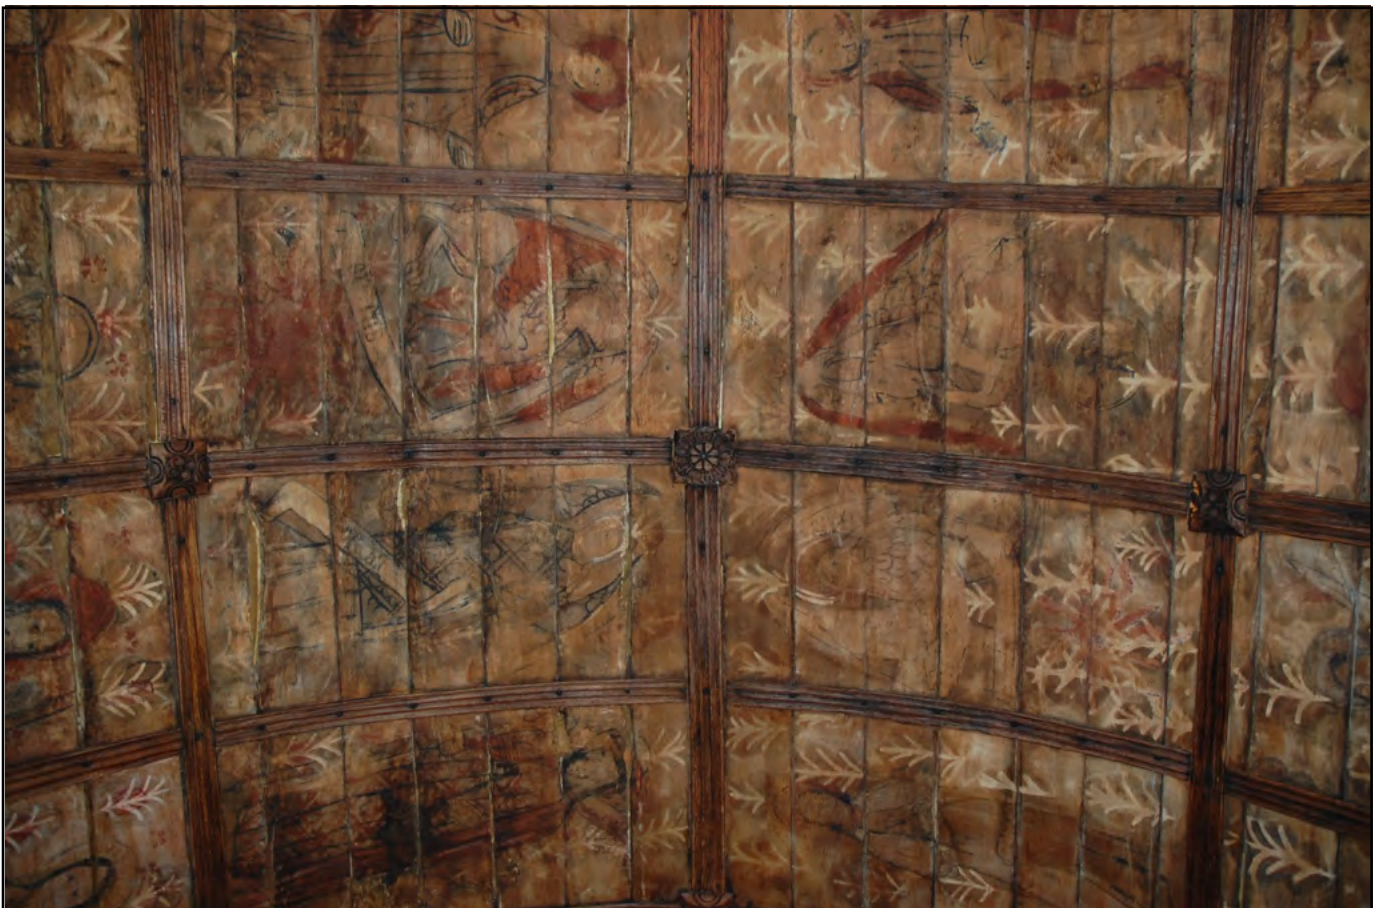
Plate 10: Detailed Shot of Painted Celure
