Moelfre Lifeboat Station: **Moelfre, Anglesey**

Archaeological Assessment & Building Record

> GAT Project No. 2104 Report No. 844 January, 2010

Gwynedd Archaeological Trust Report No. 844

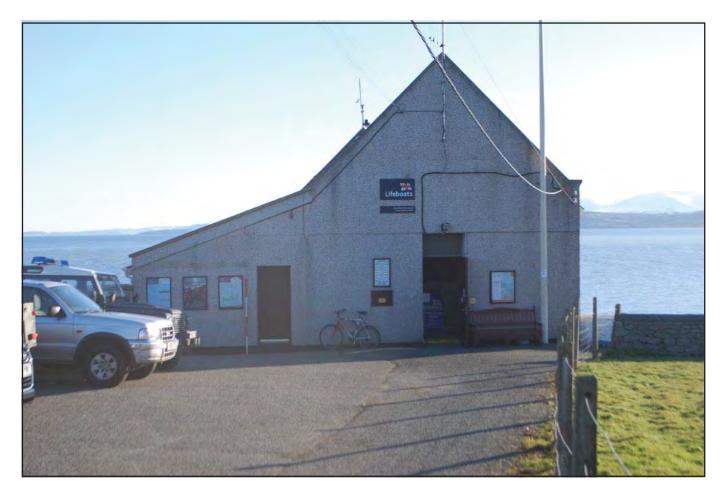
Feature 1 (Plates 1, 2) Lifeboat Station SH 5152 8652 Period: Modern Category: B Impact: Considerable

Plate 01 – Lifeboat station from the northeast

Recommendations for mitigatory measures: Level 2/3 Photographic Building Recording (this has been carried out). Partial Watching Brief.

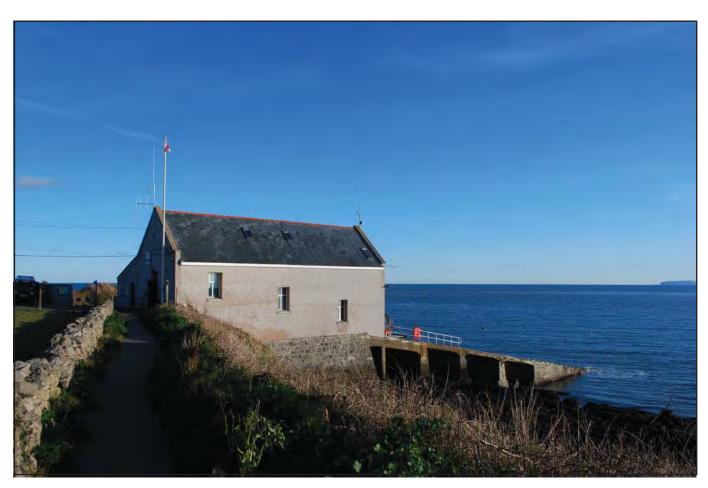
Plate 02 – Lifeboat station from the southwest

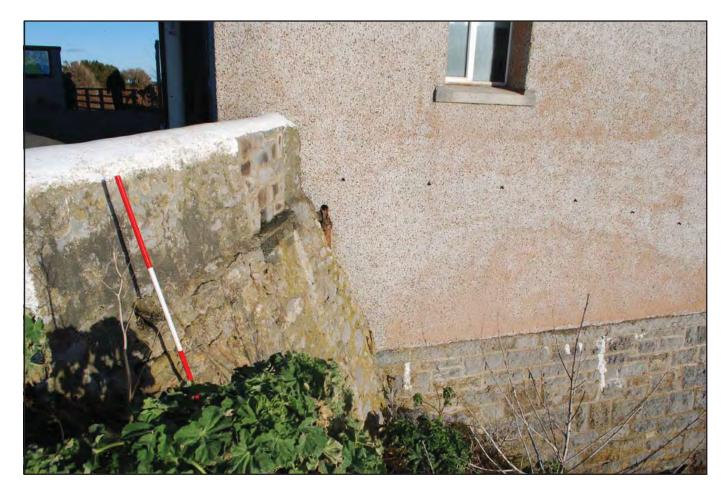
Feature 2 (Fig. 9; Plate 3)Former Lifeboat StationSH 5143 8637Period: ModernCategory: B Impact: None

Plate 03 - Detail showing retaining wall south of lifeboat station; scale 2.0m

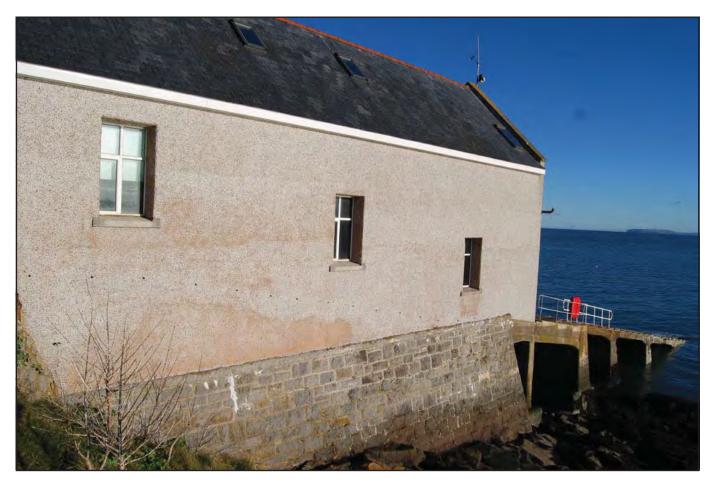
Plate 04 – 1909 plinth and later slipway of lifeboat house; the slope is reflected in the positioning of the lifeboat house windows

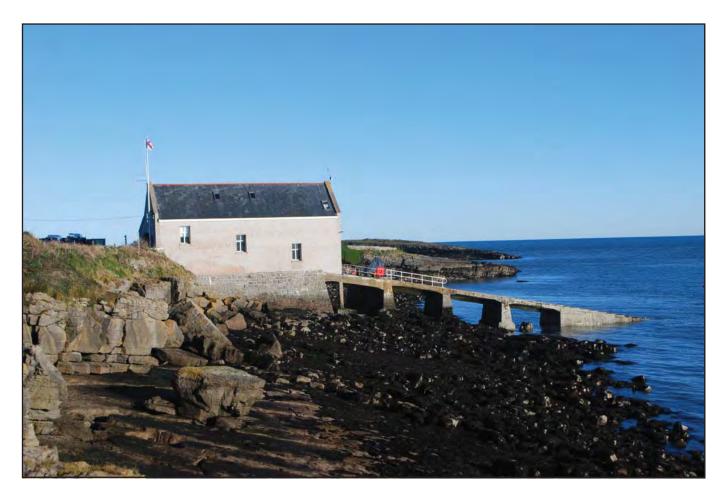
Plate 05 – The lifeboat station from the south; the 1983 adaption can be seen in the extension of the building in the first few metres of the slipway

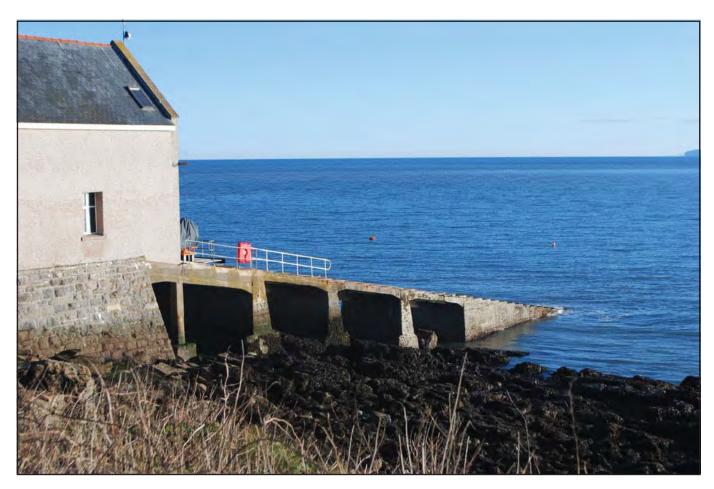
Plate 06 – Detail of concrete construction of slipway

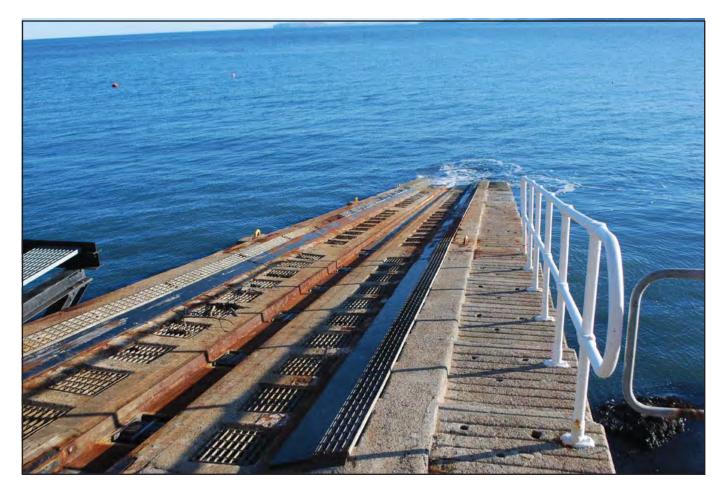
Plate 07 – The slipway from the west

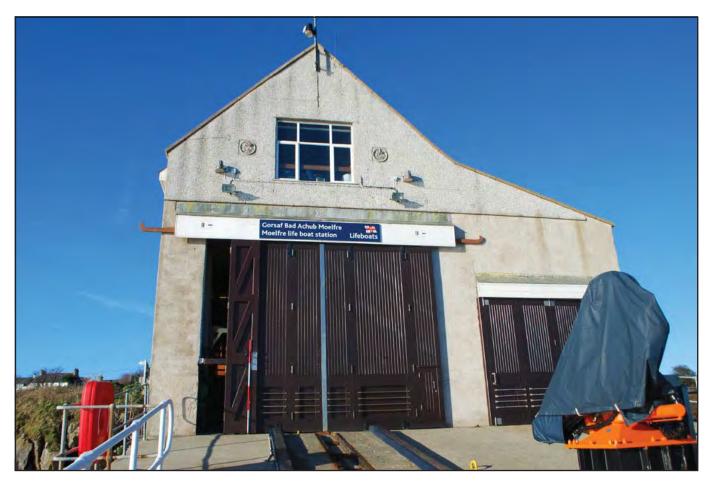
Plate 08 – The lifeboat house from the east

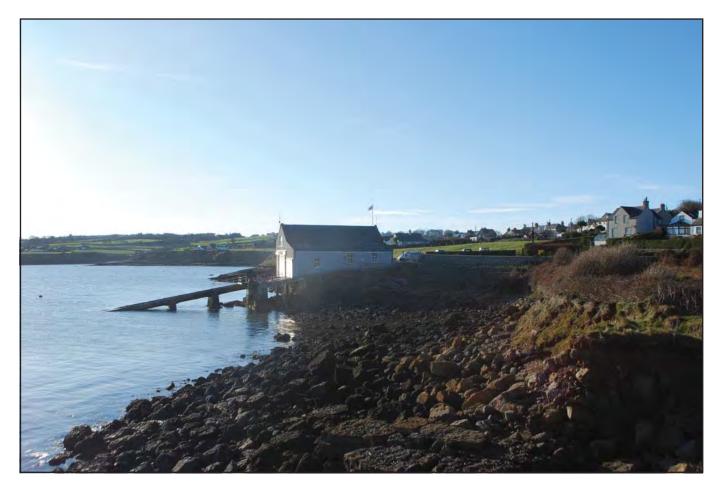
Plate 09 – The lifeboat house from the northeast

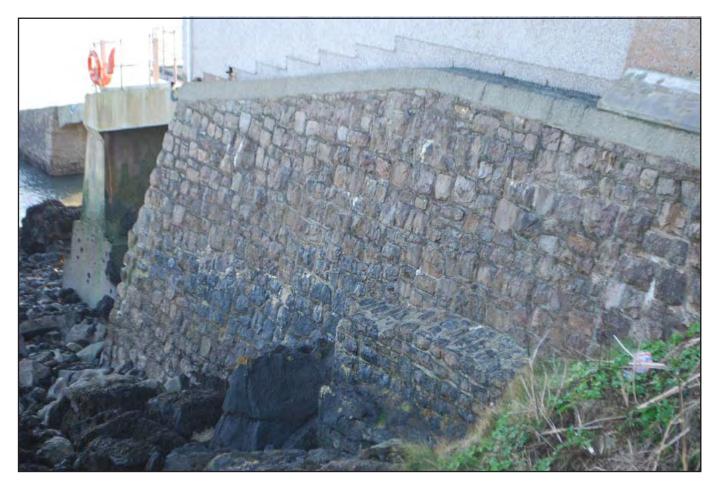
Plate 10 – The 1992 plinth extension to the north of the lifeboat house

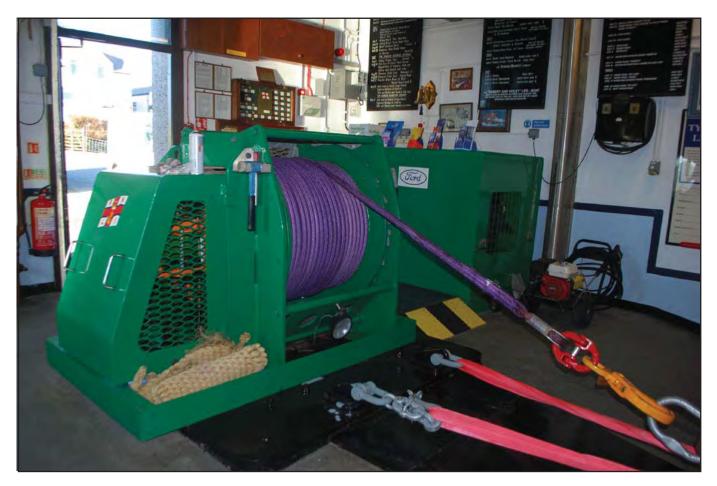
Plate 12 – Hydraulic winding gear within lifeboat house

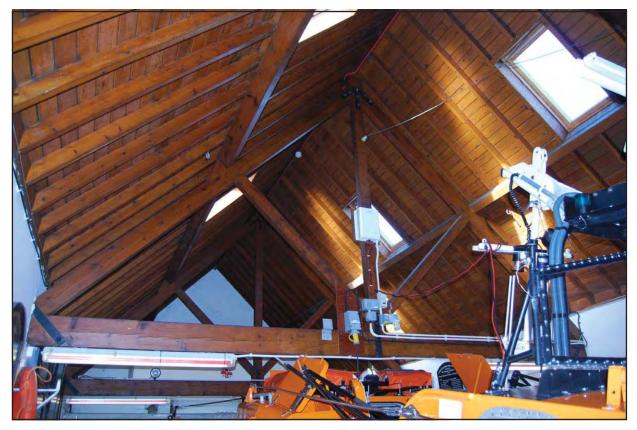
Plate 13 – Detail of roof structure

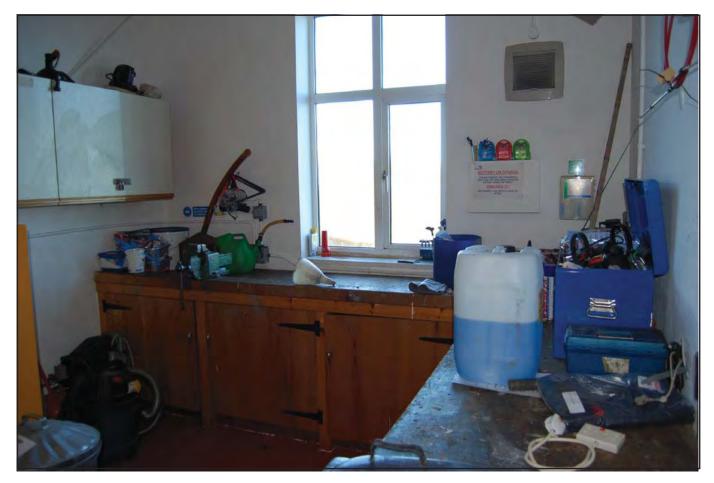
Plate 16 – Workshop in lean-to north of main boathouse

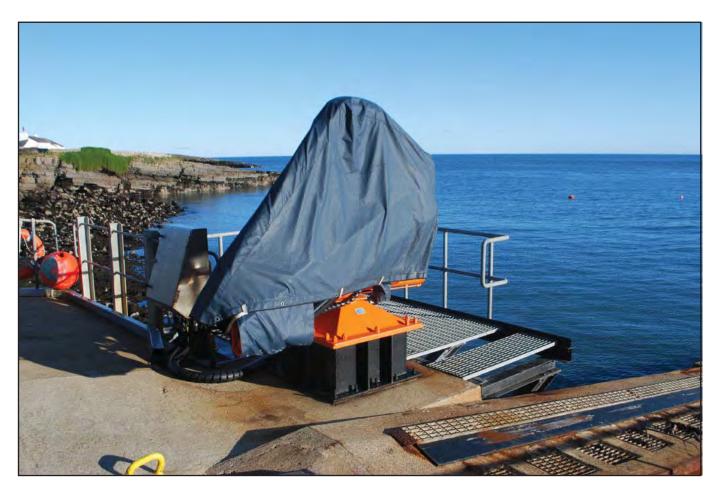
Plate 18 – Hydraulic lift to place inshore lifeboat on slipway

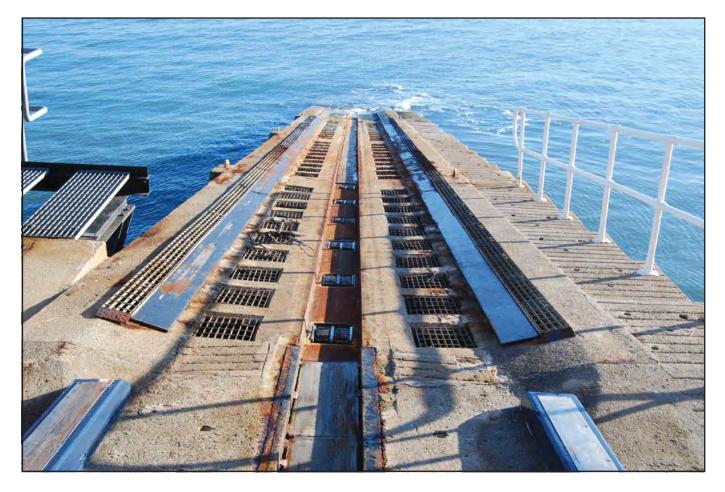
Plate 19 – The slipway, taken from the boat house

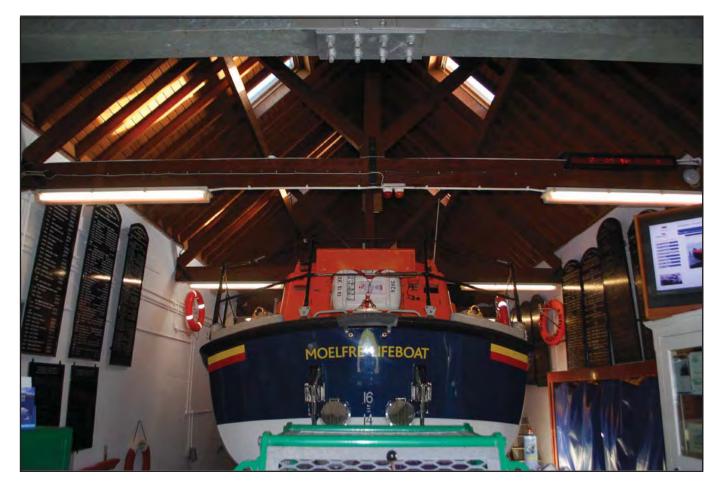
Plate 21 – General view of interior of lifeboat station from the northwest

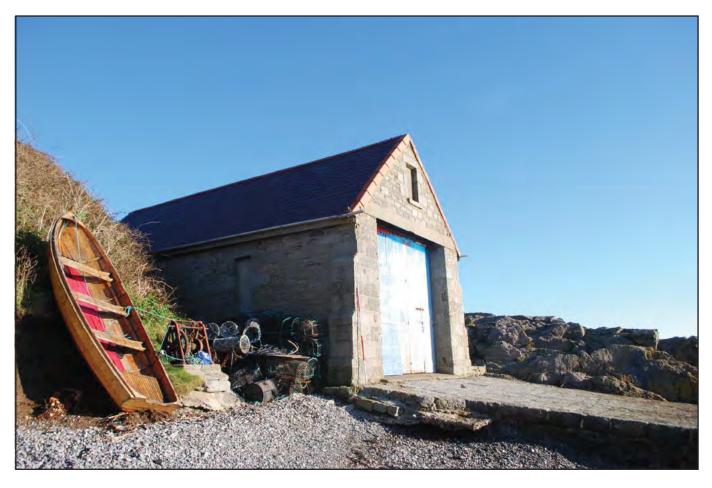
The remains of a lifeboat station and slipway built in 1875, and replaced in 1909 by a new lifeboat house and slipway located about 300m to the north (Feature 1).

Plate 22 – Former RNLI boathouse dating from 1875 (ranging pole: 2.0m)
