# St. Mary's Church: **Conwy**

## Archaeological Watching Brief

GAT Project No.2157

Report No. 950

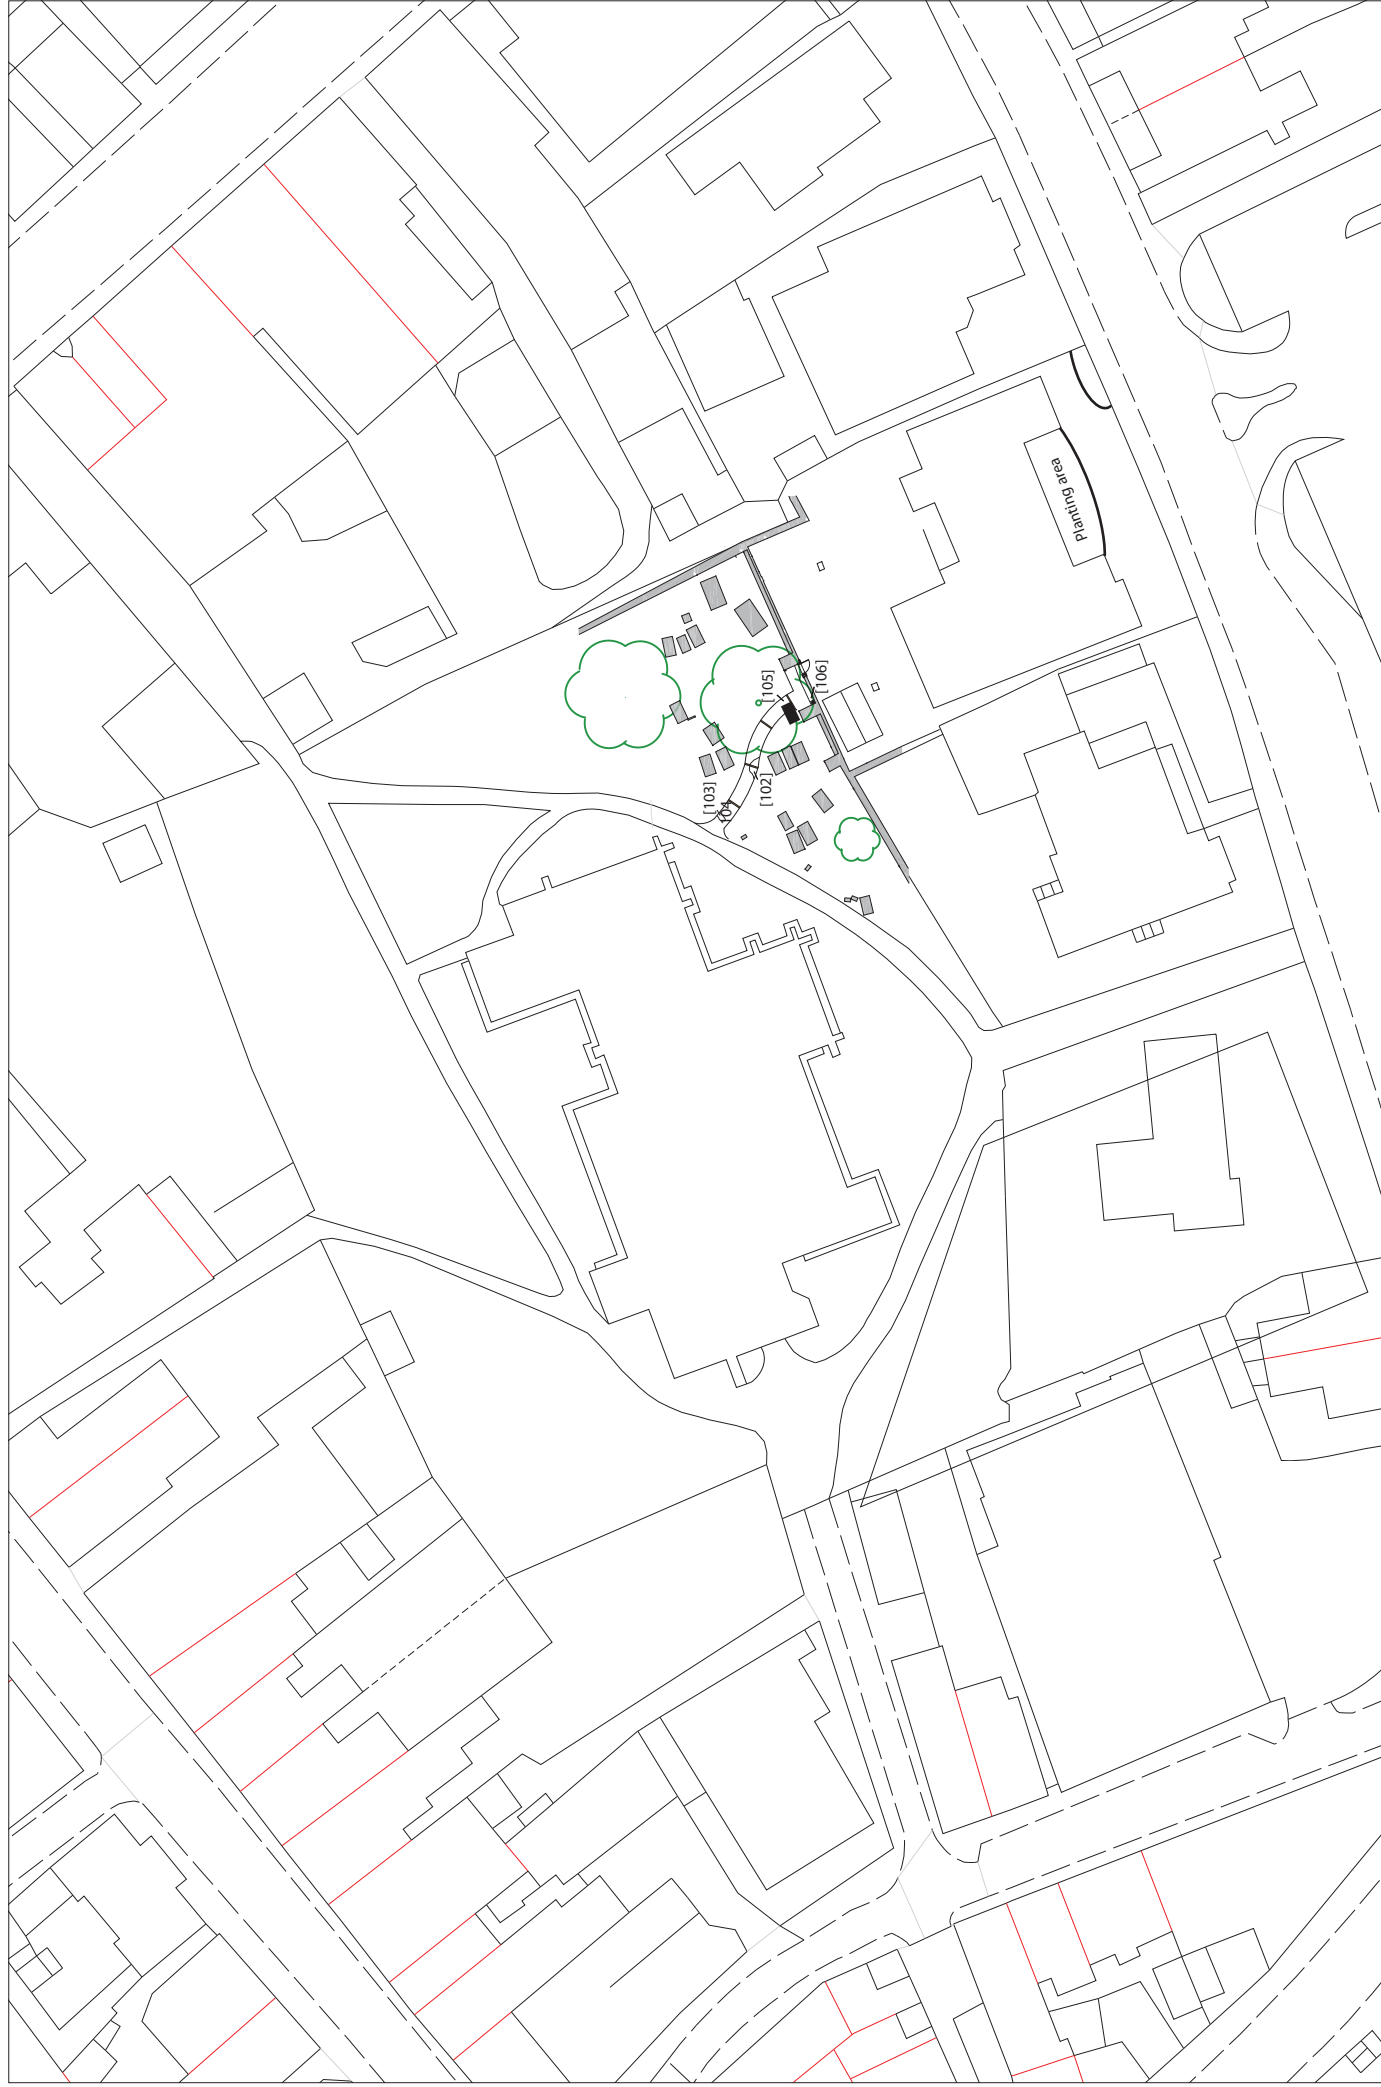
Fig. 2 Location of features identified in the text. Features identified in the text are shown in brackets. Background information taken from *Tarmaster Jones*  
Drawing no AL/2047/5/08/PL01

A possible grave cut [103] was noted 1.95m north of the tarmacadam path (Fig.2). It was 0.8m wide and 0.9m of the western end of its length was visible in the trench. The fill consisted of a light greyish brown sandy silt with small to medium rounded and sub angular stone inclusions (104). The grave was cut into a mid orangey brown clay silt subsoil (102) at a depth of 0.19m below the modern ground surface, and was not investigated further. Further south the excavation did not extend beyond the depth of the topsoil, so no further grave cuts were encountered.

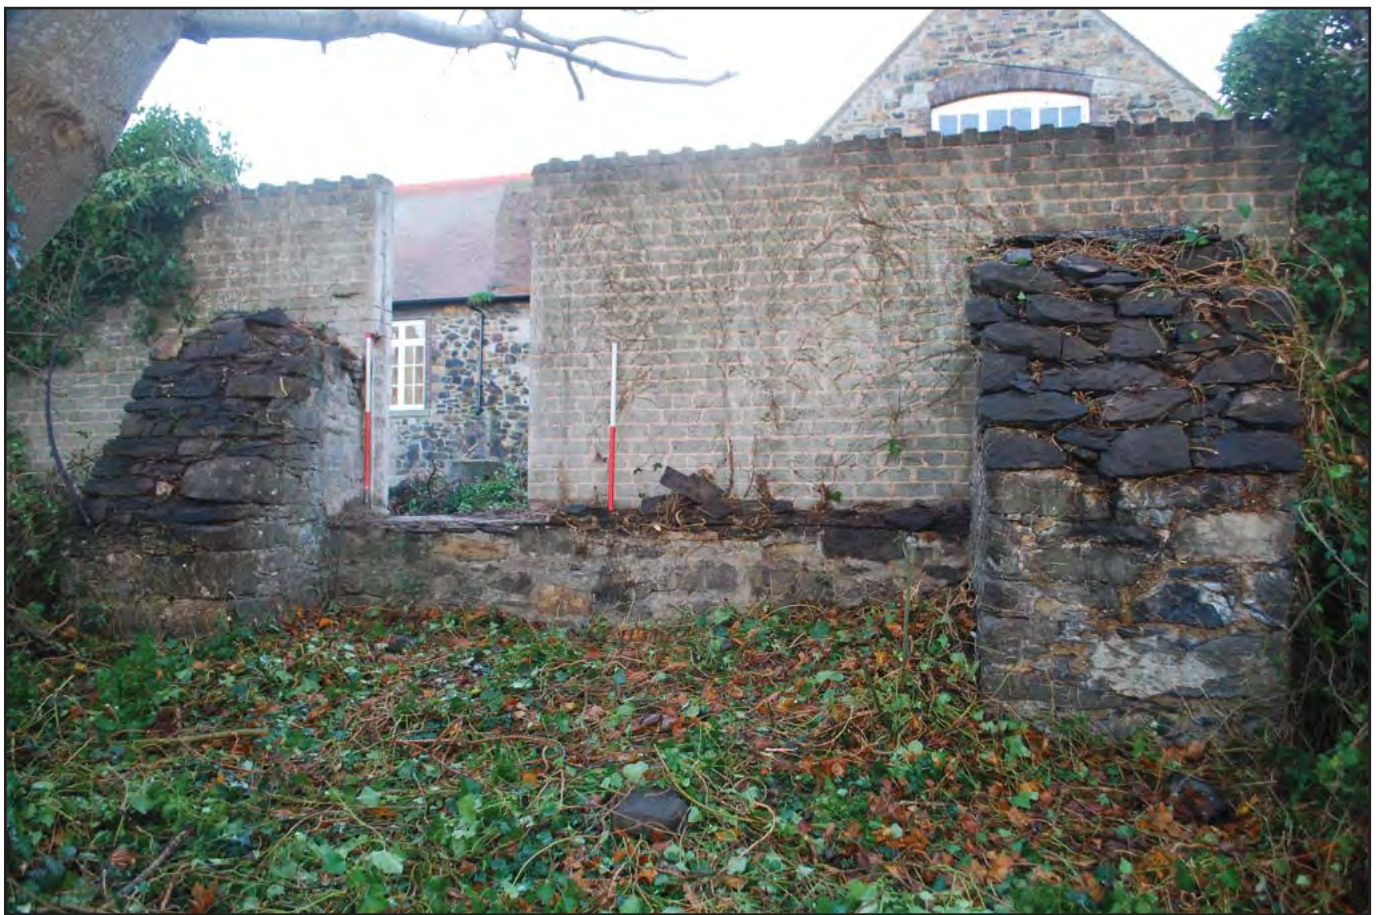
A breach 1.06m wide was made in this wall between the eastern and middle buttresses down to the level of the old wall on the graveyard side (Plate 3; Fig.2). The brick part of the wall was 0.25m thick and 0.45m wide.

**Plate 3: Breach in churchyard walls - Scales 1m**

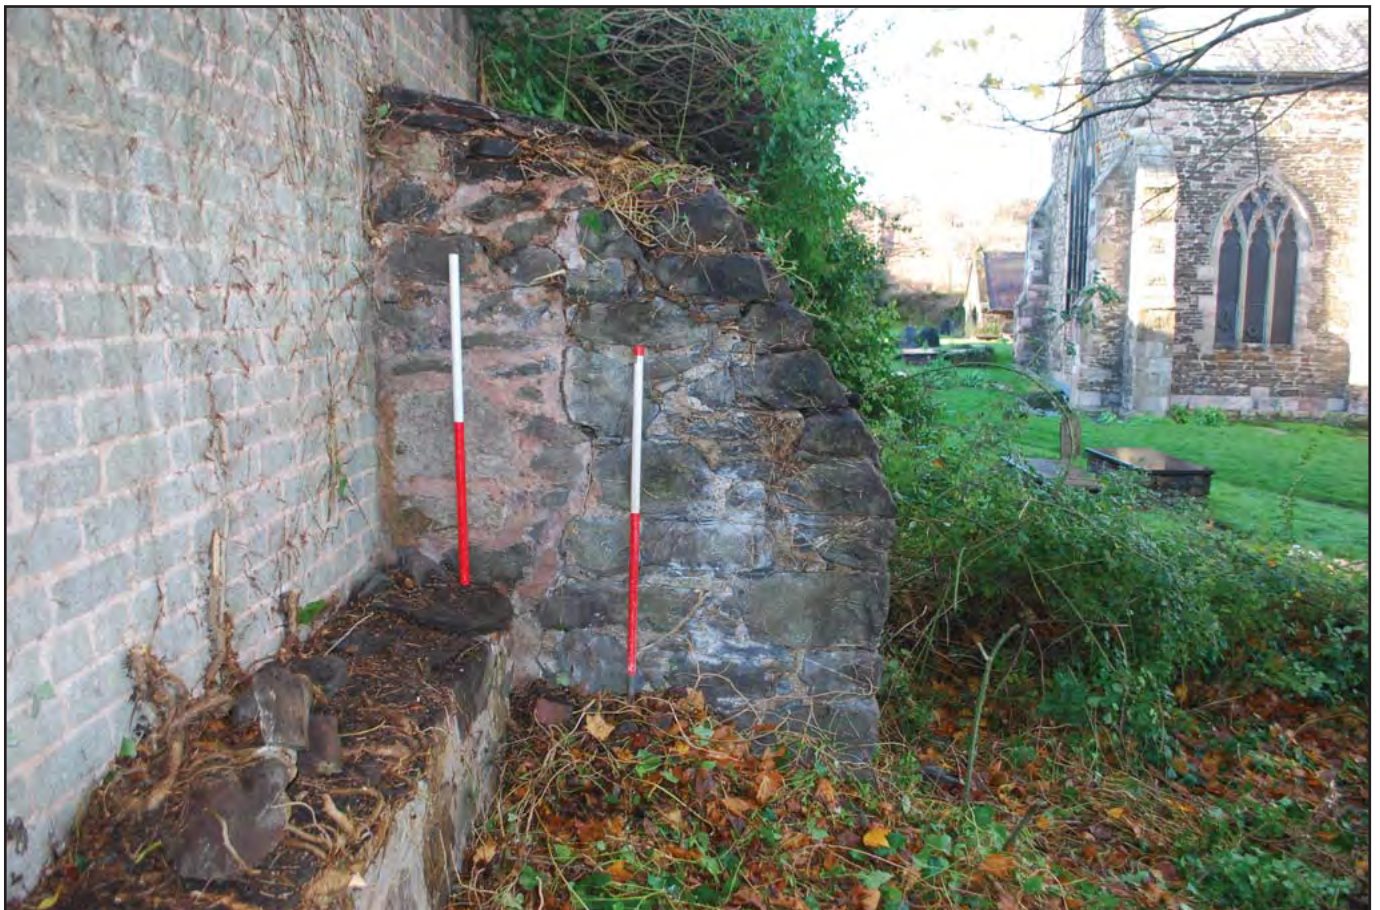
The churchyard boundary wall between the church hall and the churchyard of St. Mary's consisted on the churchyard side of 0.5m of rounded and angular shale blocks. These were topped by grey concrete bricks, making a total height for the wall of 2.9m on the graveyard side and 2.2m on the hall side, and the wall was supported by quarried granite buttresses, up to 1.2m high. The suggested interpretation of these is that there was a probable instability or collapse of an earlier churchyard wall, surviving now as

the bottom 0.5m on the churchyard side. This would initially have required the construction of the supporting buttresses and later the rebuilding of the wall at a height of greater than 0.5m (Plate 4). This suggests that the problem was a chronic one, and was probably the result of pressure from the church hall side of the wall, which was 0.6m higher than on the churchyard side. It would not have been possible to replace the lower courses of the wall as they formed a revetment for the hall yard.

**Plate 4: Buttress detail - View from South East - Scales 1m**

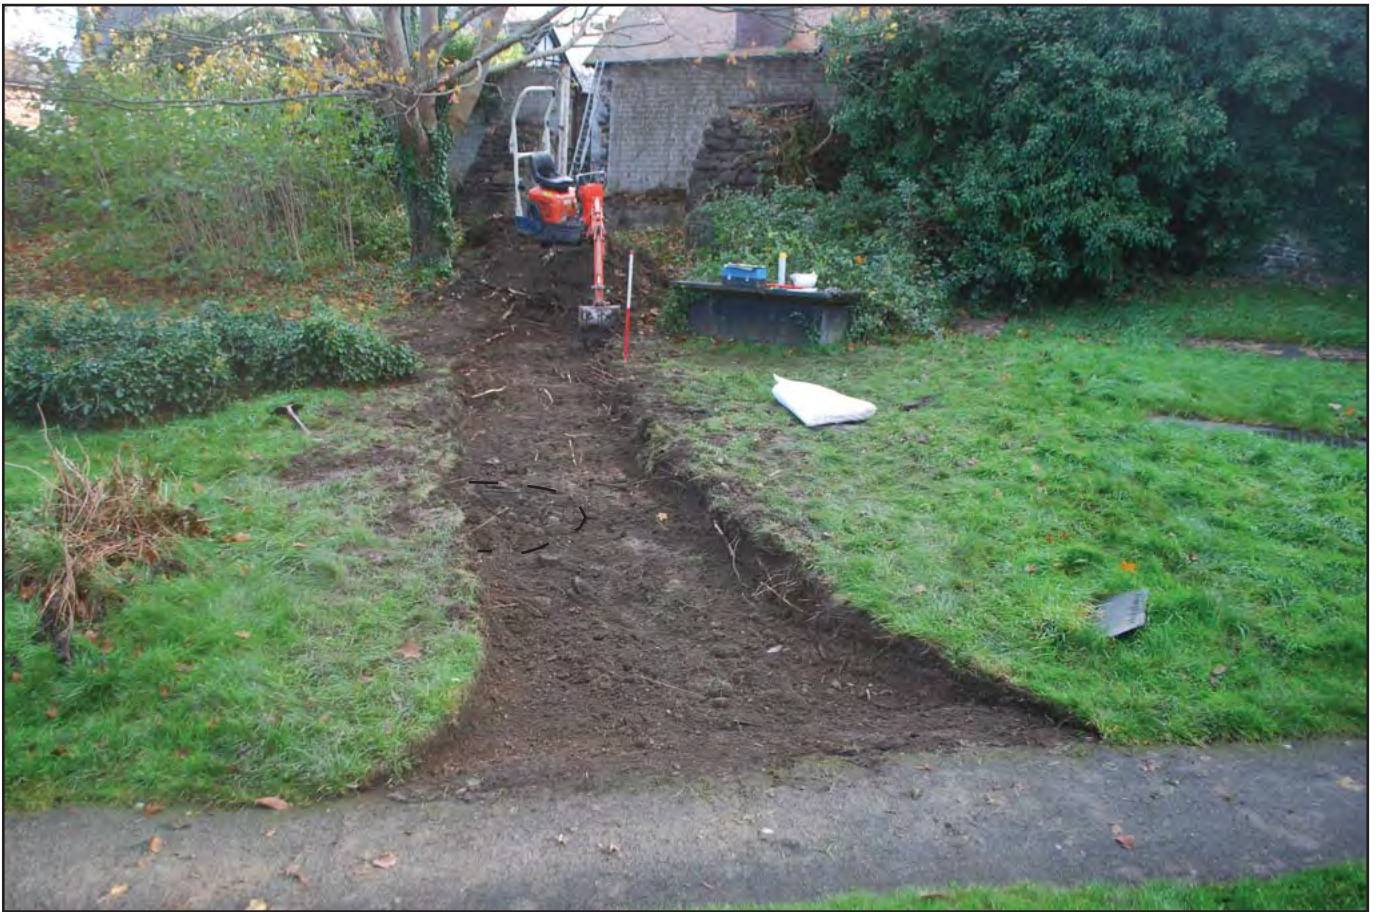
The new path from the churchyard to the church hall leads from the tarmac footpath at the east end of the church south-eastwards to the churchyard wall (Plate 5; Fig.2). It was dug through the graveyard topsoil to a depth of 110mm-200mm. The soil consisted of a dark greyish brown sandy silt, with occasional charnel fragments and small shale fragments (101), and overlay a mottled mid orangey brown clay silt, which was only noted close to the path edge.

**Plate 5: Top soil stripping for path - view from North East. Grave cut annotated with a black outline**

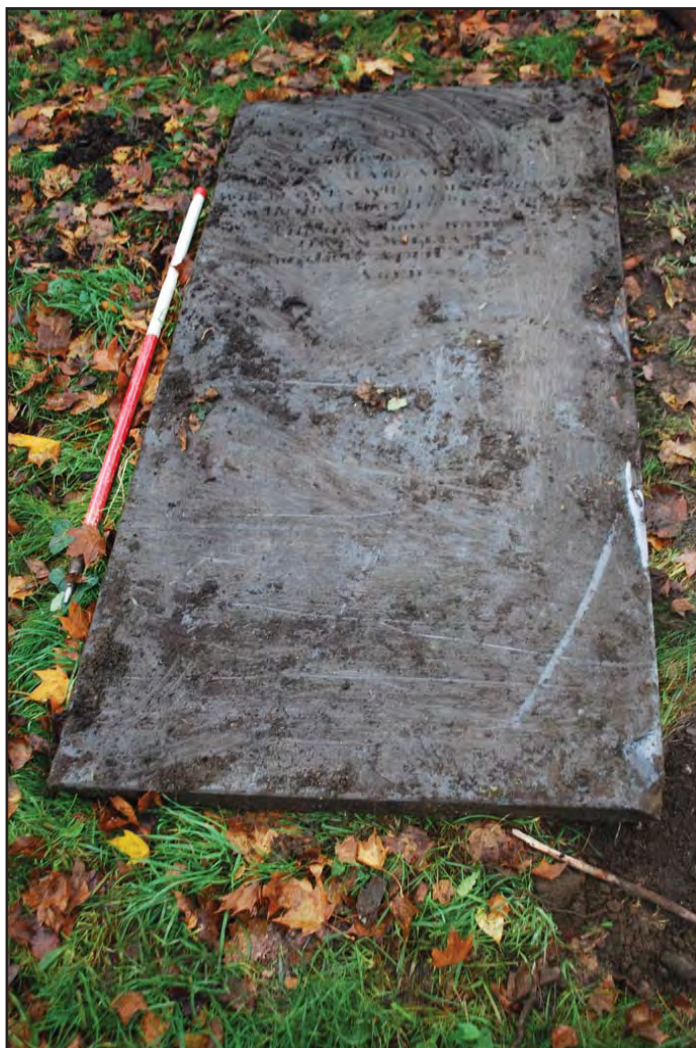
A number of gravestone and other fragments of material, including a side panel of a former box tomb (Mytum 2003) were uncovered within the topsoil along the route of the path. All the gravestones had been moved from their original positions, and were located within the topsoil deposits. A slate ledger grave slab 1.8m by 0.9m and 0.06m thick [105] was uncovered, clearly moved from its original location, possibly as part of the buttress construction (Plate 6). The inscription, on the upper part of the stone read:

**Plate 6: Grave stone [105] - Scale 1m**

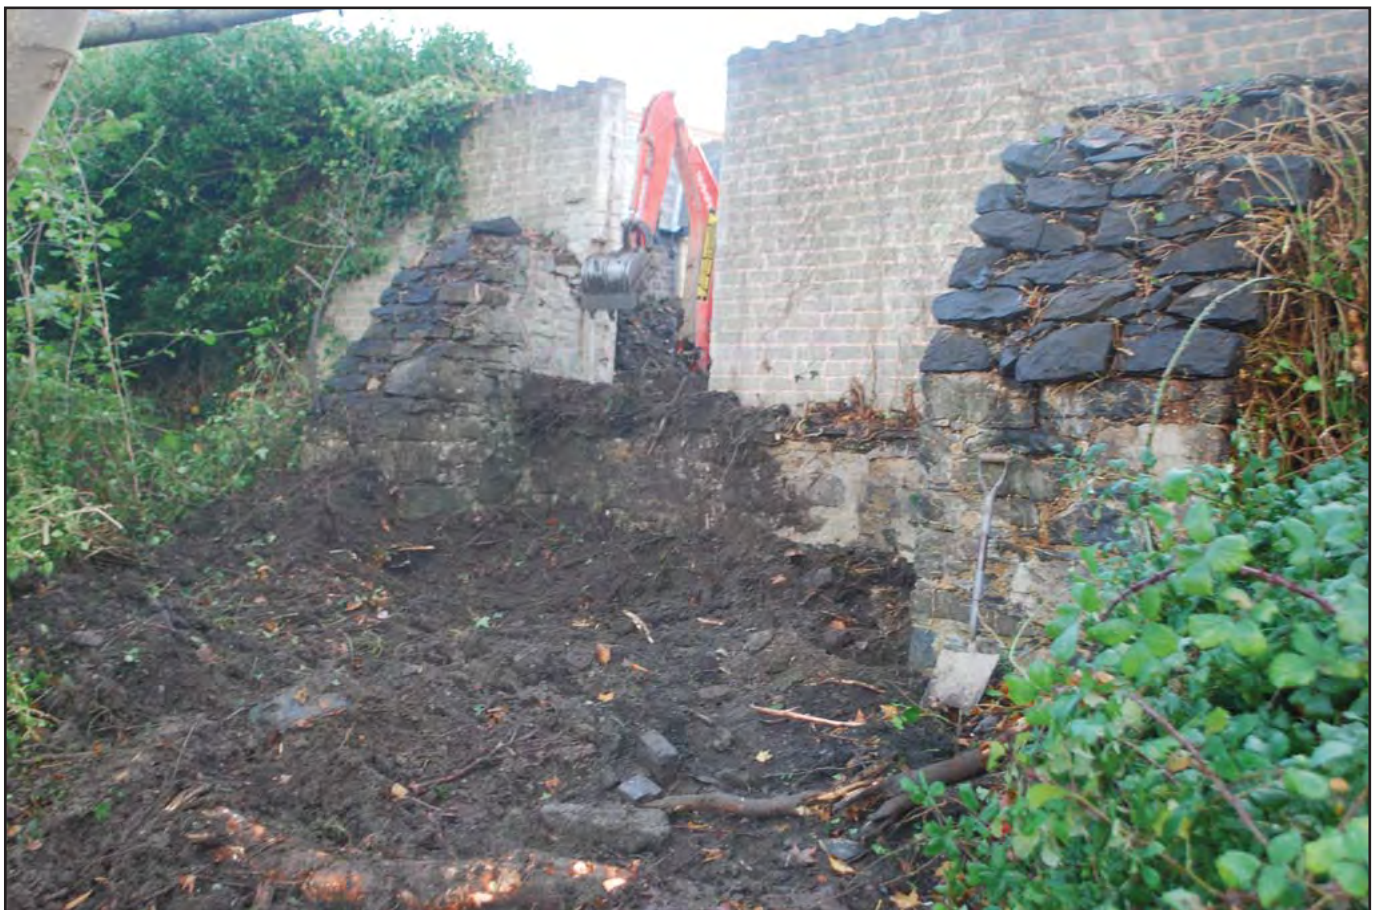
A loose fragment of former window tracery was uncovered within the rubble and topsoil material adjacent to the churchyard wall. It consisted of a single mullion fragment of red sandstone with an ogee profile, 0.3m by 0.28m. It was almost certainly removed from the church during 19<sup>th</sup> century restorations which are known to have been carried out on the building (Plate 1). The material was recovered from within the rubble against the churchyard wall, strongly suggesting the area of the churchyard was formerly used for clearance (Plate 8).

Plate 8: General view of wall area during excavation of soil build up

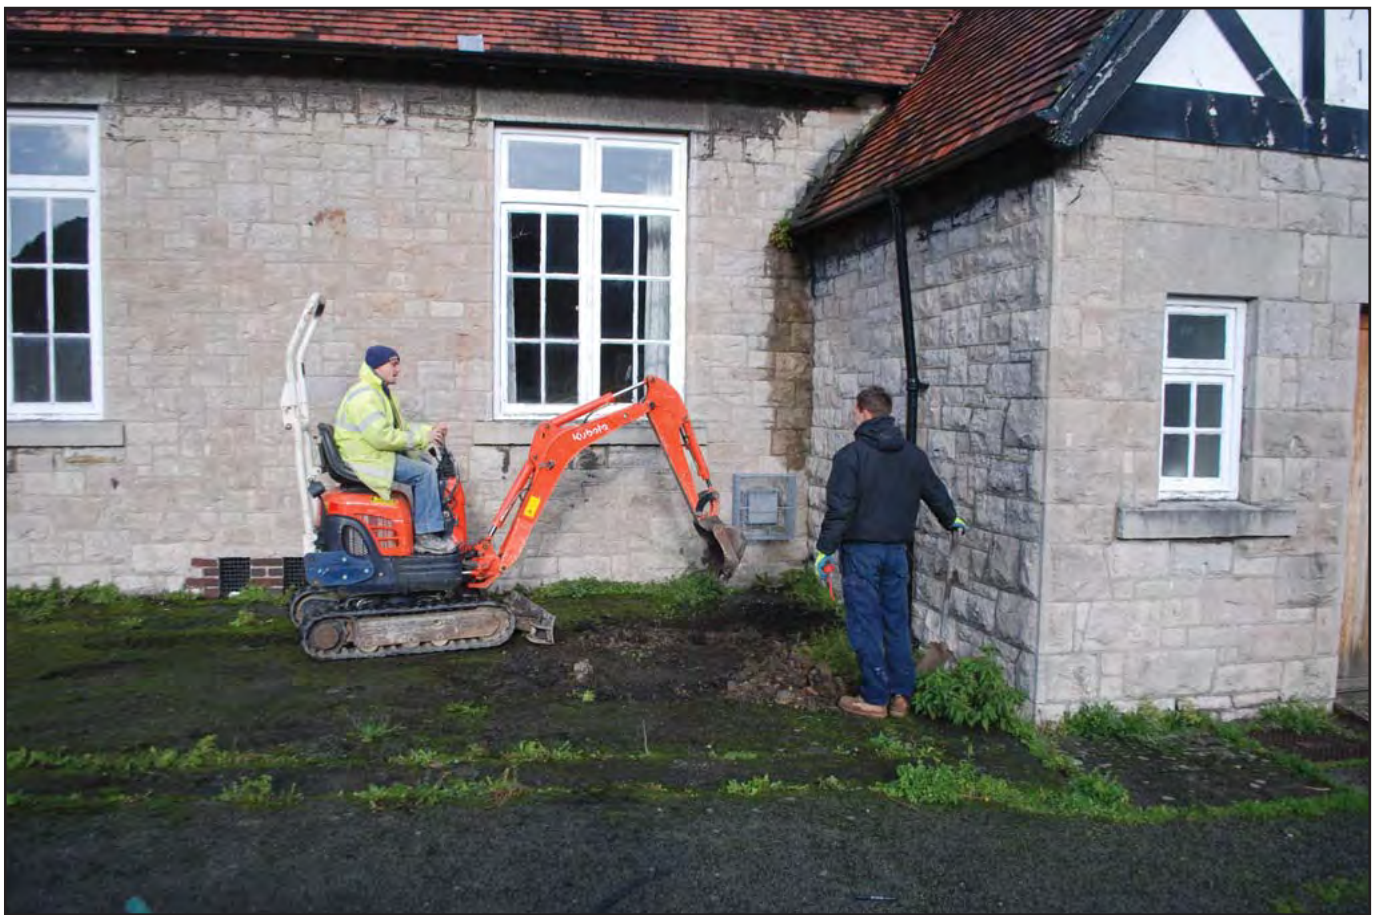
Excavations were carried out on the church hall forecourt to a depth of 0.3m on the south side of the hall (Plate 9; Fig. 2). The deposits consisted of 0.1m of tarmacadam overlying make-up layers of mid yellowish brown silty clay (002), within which was a service trench containing a drainage pipe. All deposits noted formed part of make up layers or service trenches cut through them, and there was no prospect of recovering any archaeological evidence. The concrete yard surface to the rear of the hall was undisturbed.

**Plate 9: Church hall during initial ground works - View from Rose Hill Street to the South**

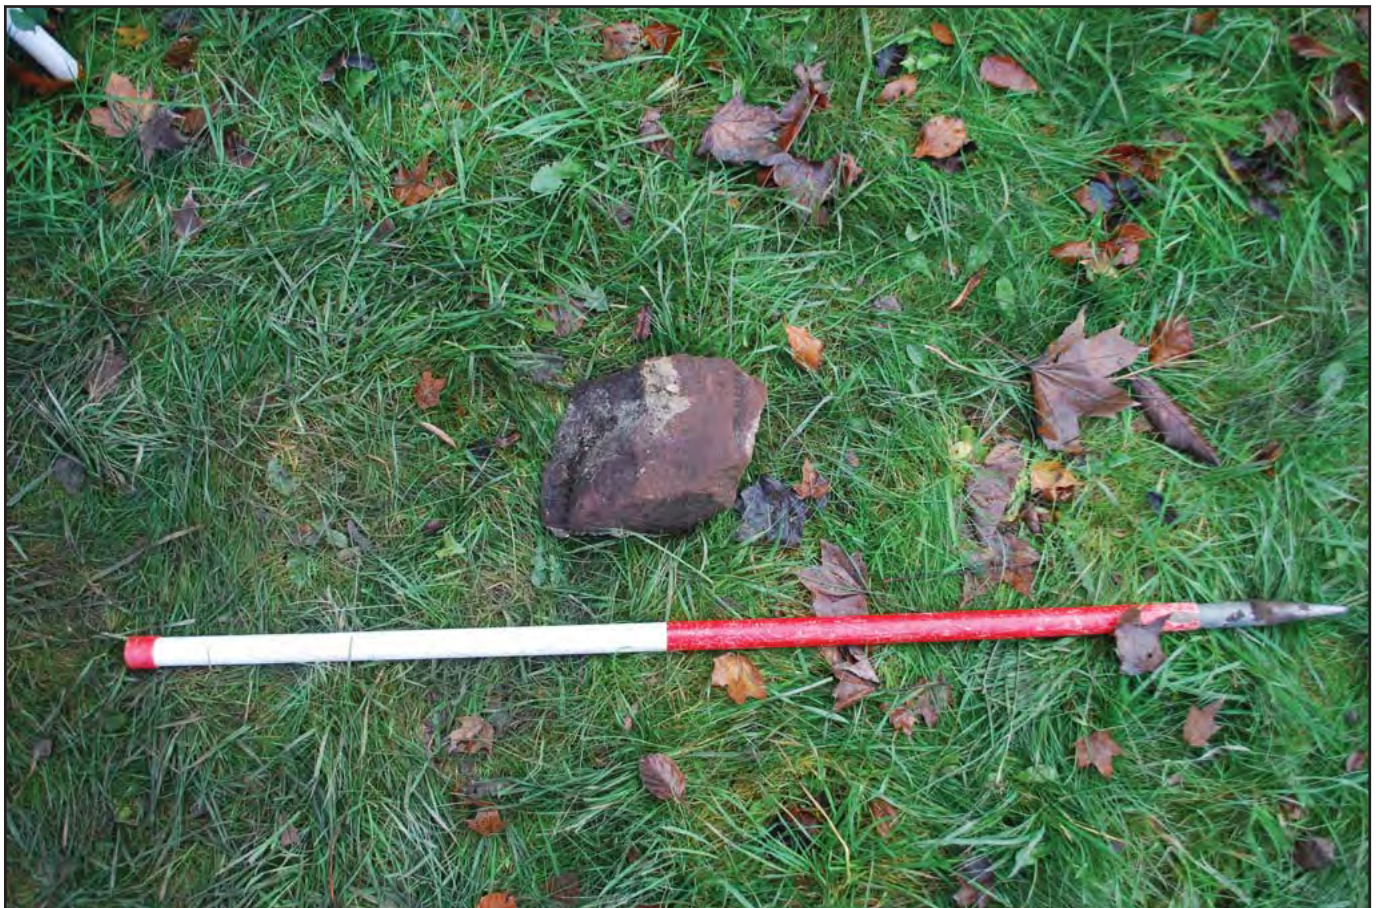
### **6.2.3 Medieval Window Tracery Fragments (Plate 10)**

**Plate 10: Fragment of medieval window tracery - Scale 1m**
