Melin Sguthan, Gaerwen Ynys Môn

Archaeological Building Record

Project No. G2221

Report No. 998

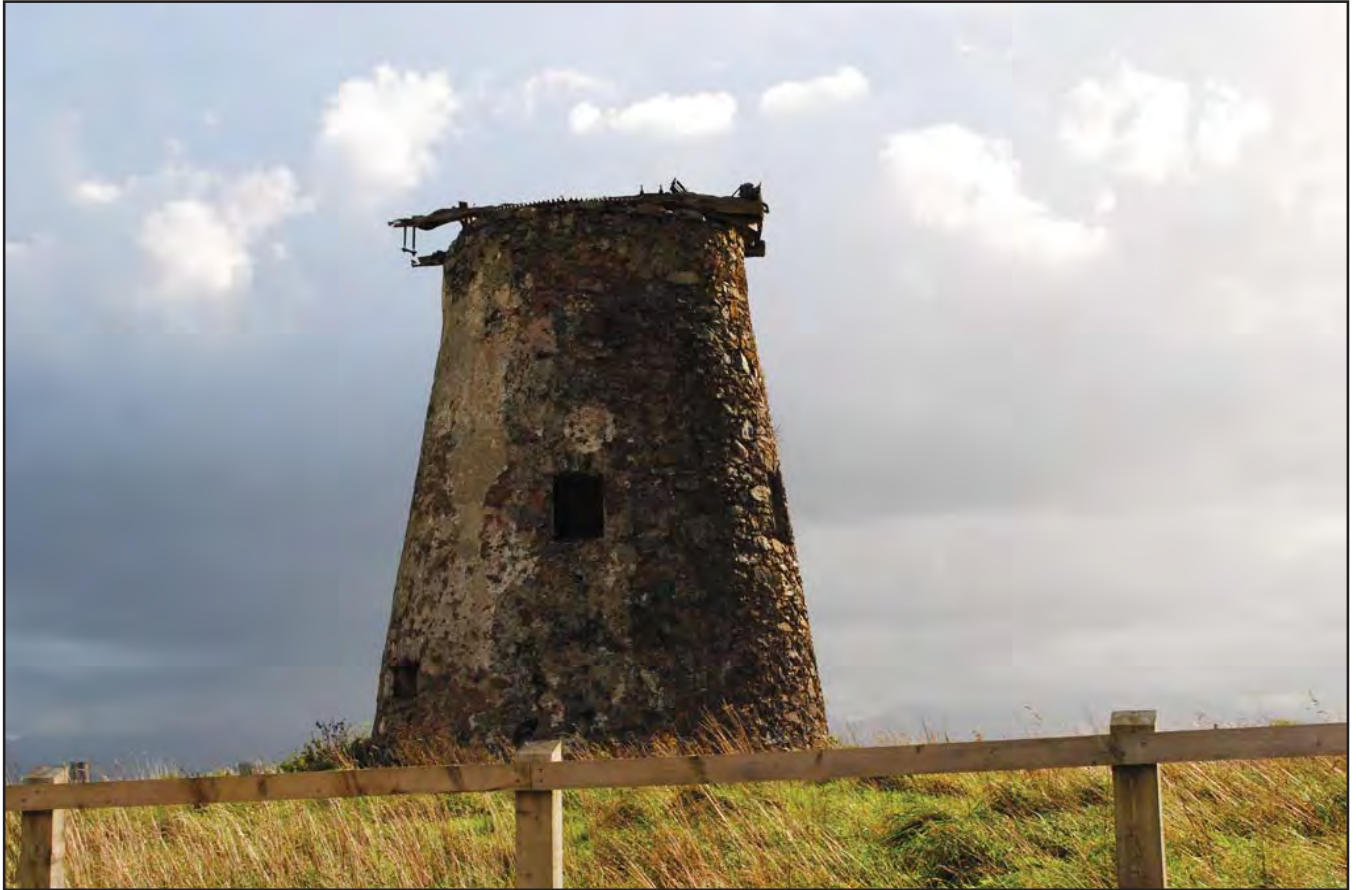
Plate 01: General view of Sguthan Mill as visited on 6th October 2011. Photograph taken from the west

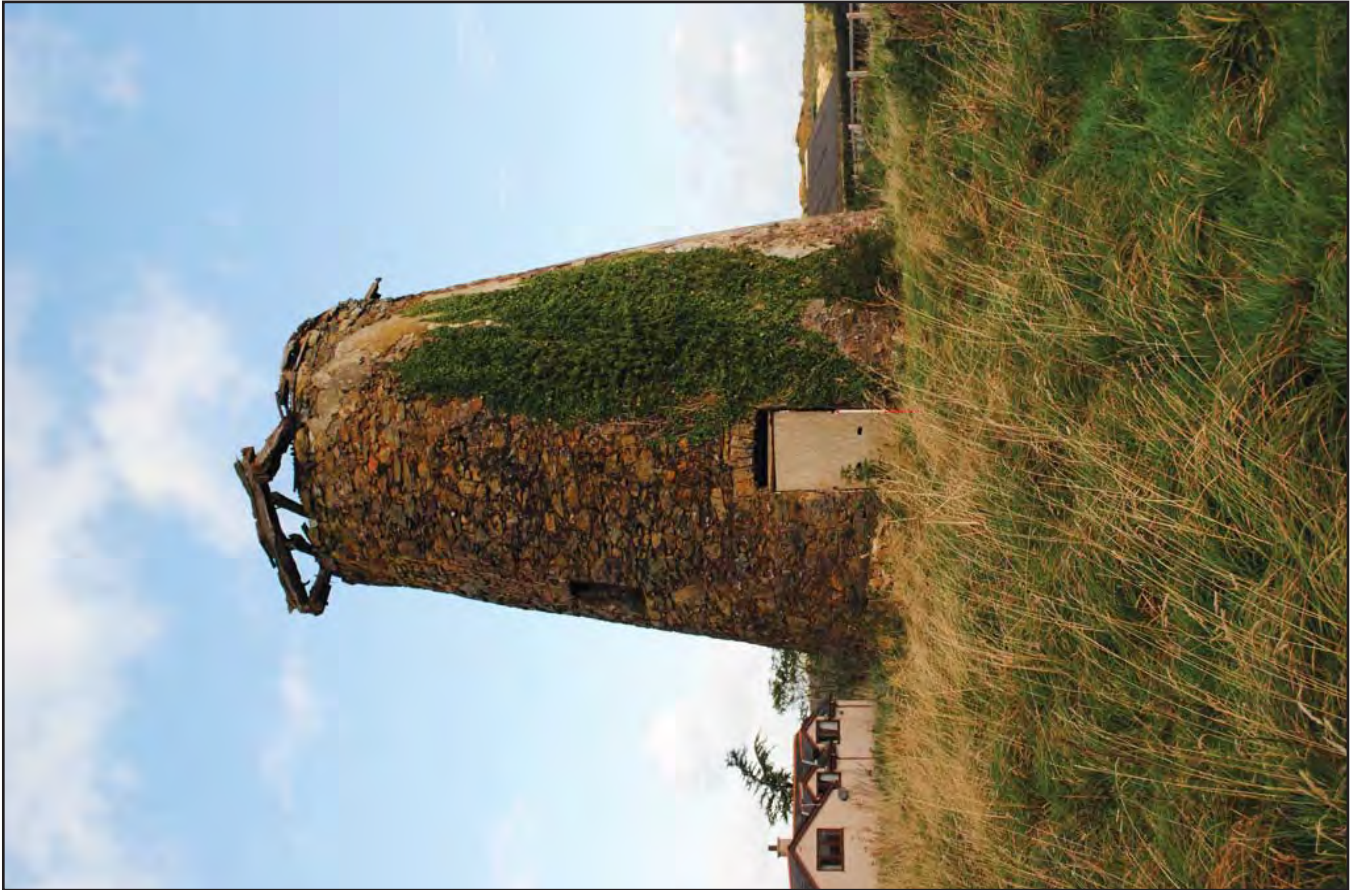
There is a single window opening at first floor level to the south west 5.0m above ground level (Plate 2, 22). There is a smaller window above it with a stone lintel at third floor level that has since been blocked up (Plate 9). There is a single window at the north west of the mill tower at first floor level (Plate 1). Above the chute there is a blocked window to the north east with a slate cill at first floor level, and there is a plain stone lintelled window at third floor level above it (Plate 8).

Plate 02: General shot of Sguthan Mill. Photograph taken from the south

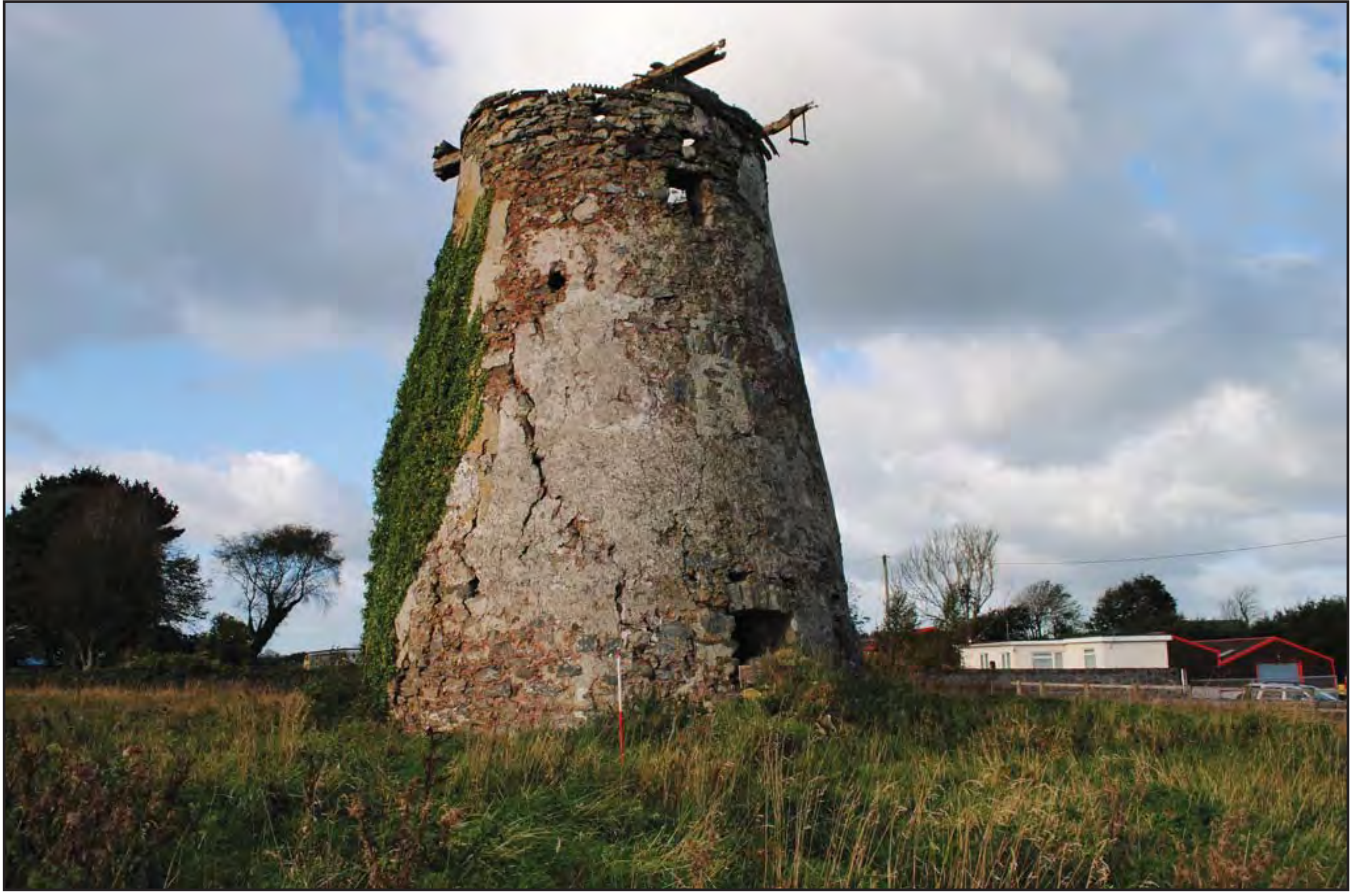
There is evidence that the building was partially rendered, and substantial structural cracks are present in the building to the east and west (Plates 3, 23). Remnants of the former turning cap and associated metalwork also survive at the top of the tower.

Plate 03: General view of Sguthan Mill. Photograph taken from the north east

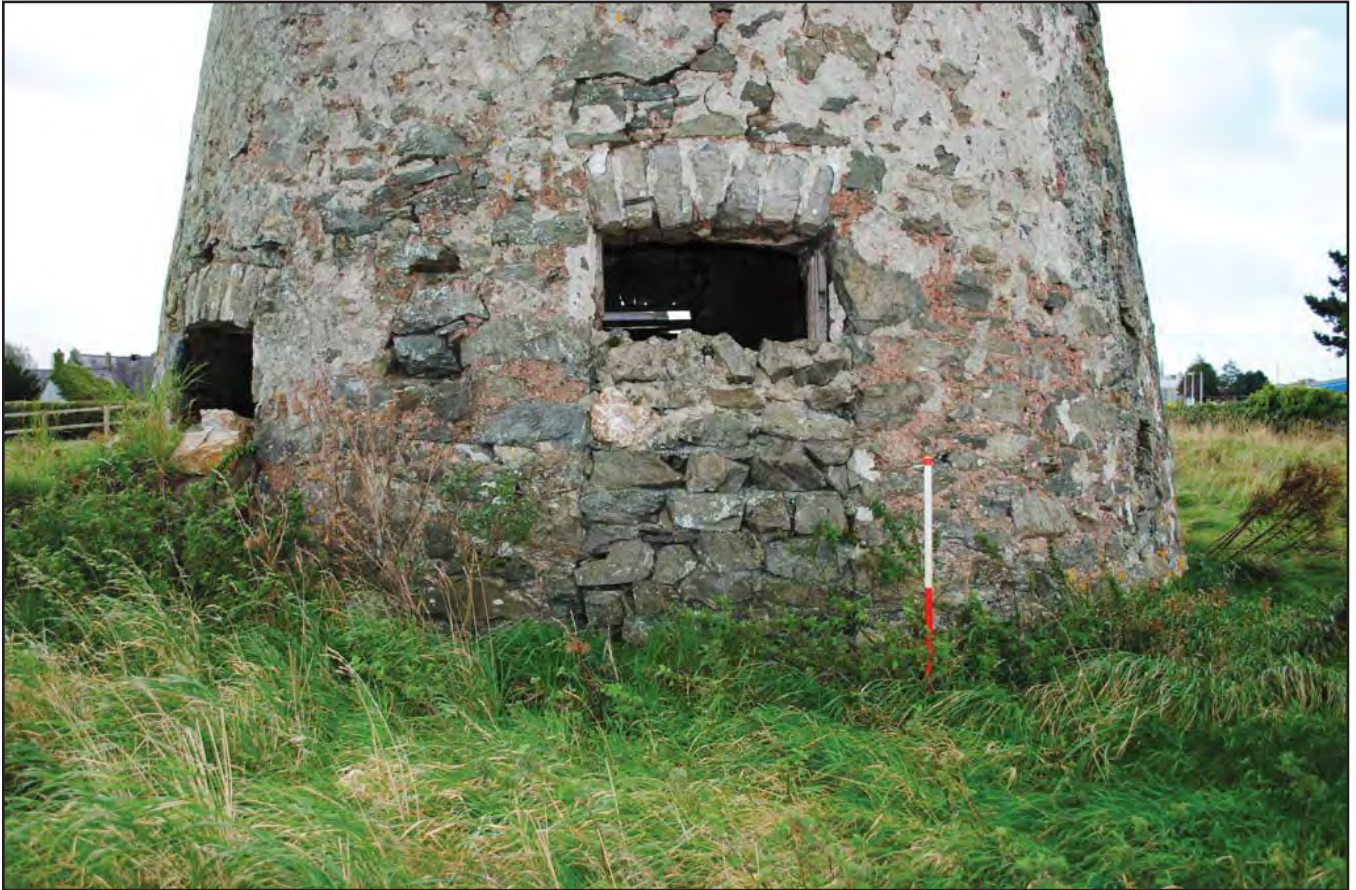
The mill tower survives to full height as a stone shell, with some parts of the frame and ring gear remaining on top of the tower. The tower is built of local rubble stone, and tapers from bottom to top. It is 9.1m high and 6.7m external diameter at the base, and the wall is approximately 0.9m thick. The external diameter of the top of the tower is 5.1m (Fig. 7; Plates 1-5). There are two segmental headed doors opposite one another orientated approximately north-south, each 1.2m wide and 2.1m high with a shallow voussoired arch. The north doorway has been blocked to two-thirds of its height (Plate 6, 16). The mill has an angled chute at its north east, 1.2m wide and 1.6m high with a voussoired lintel, which probably formed an opening through which the sacks of grain were attached to the hoist to raise them to the milling floor (Plate 6-7).

Plate 06: Shot detailing partially blocked doorway & sack hoist chute entrance to the left. Photograph taken from the north

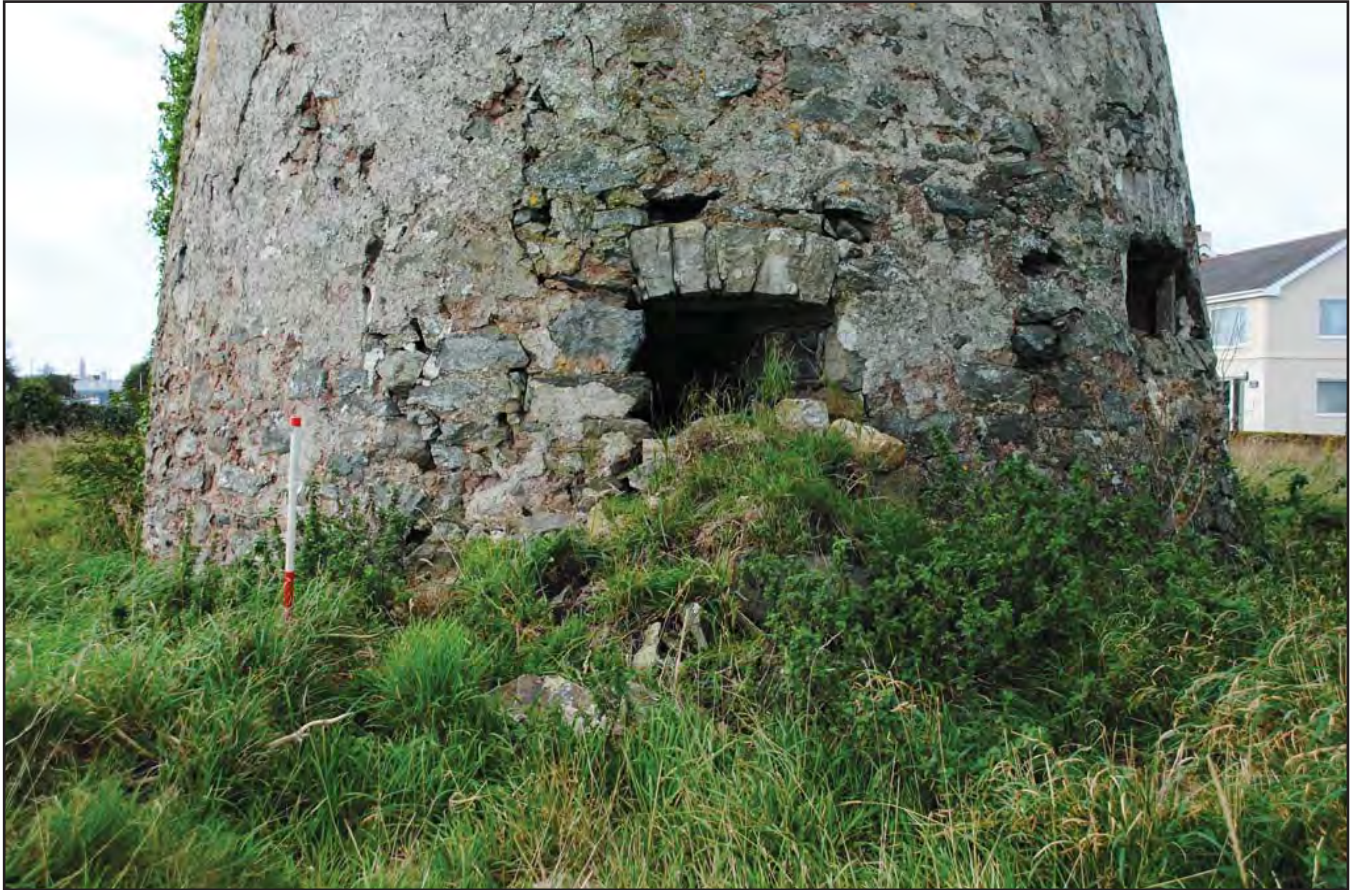
Plate 07: Shot of partially blocked sack hoist chute. Photograph taken from the north east

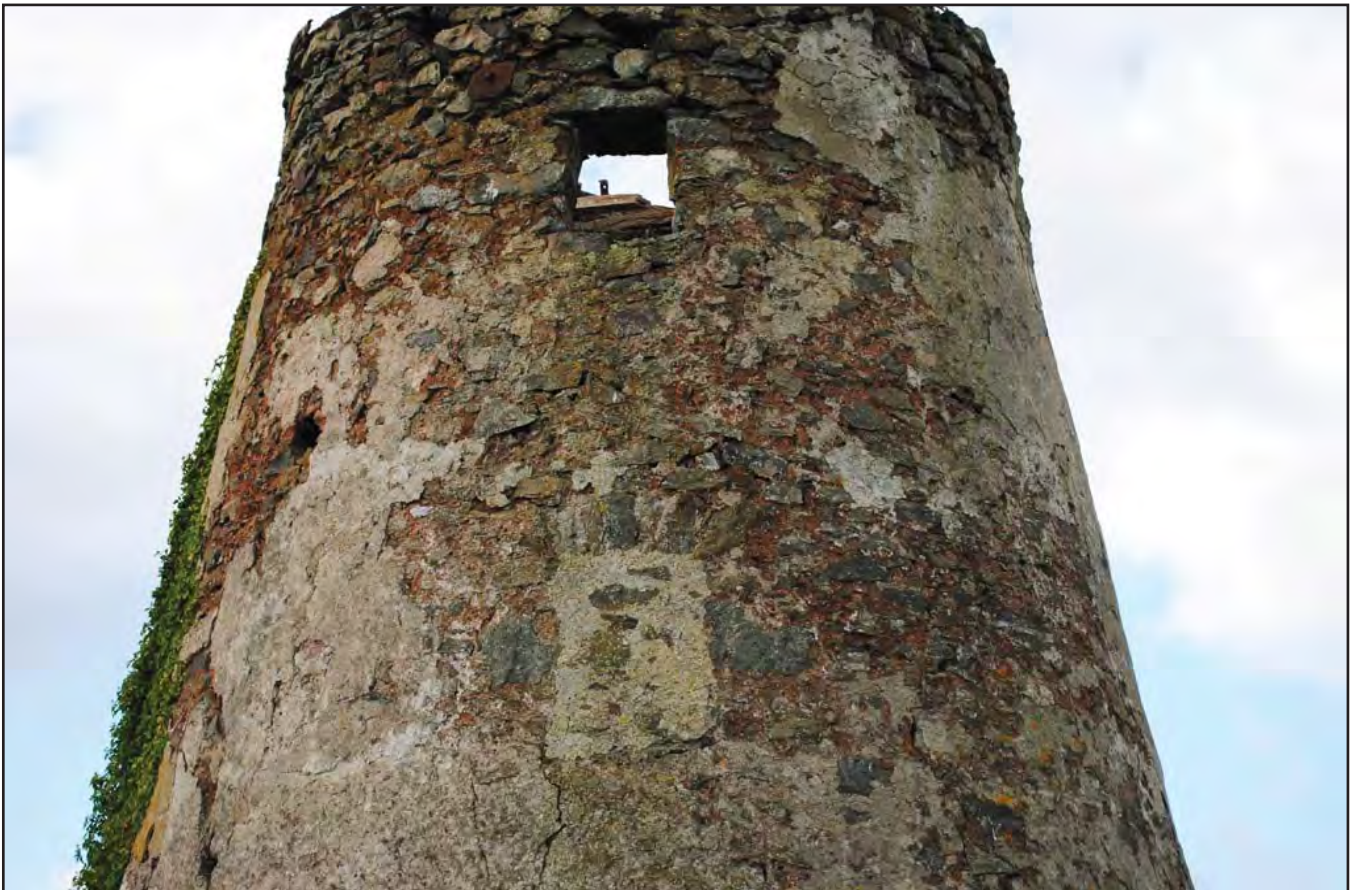
Plate 08: Shot looking upwards showing one blocked window on the 2nd floor & open window on the 3rd floor & significant surviving original lime render. Photograph taken from the north east

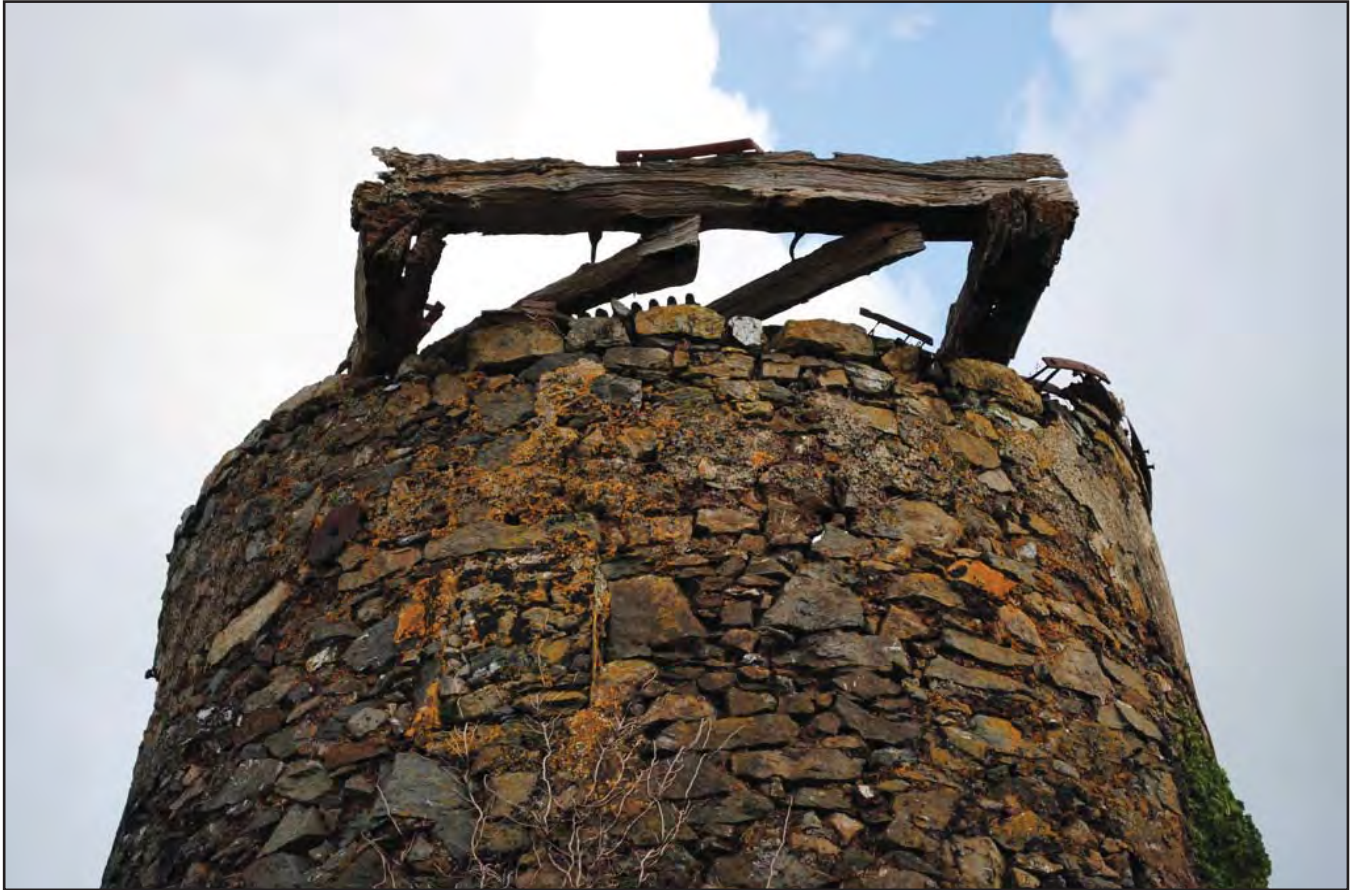
Plate 09: Shot of blocked window on 3rd floor & remnants of turning cap above. Photograph taken from the south

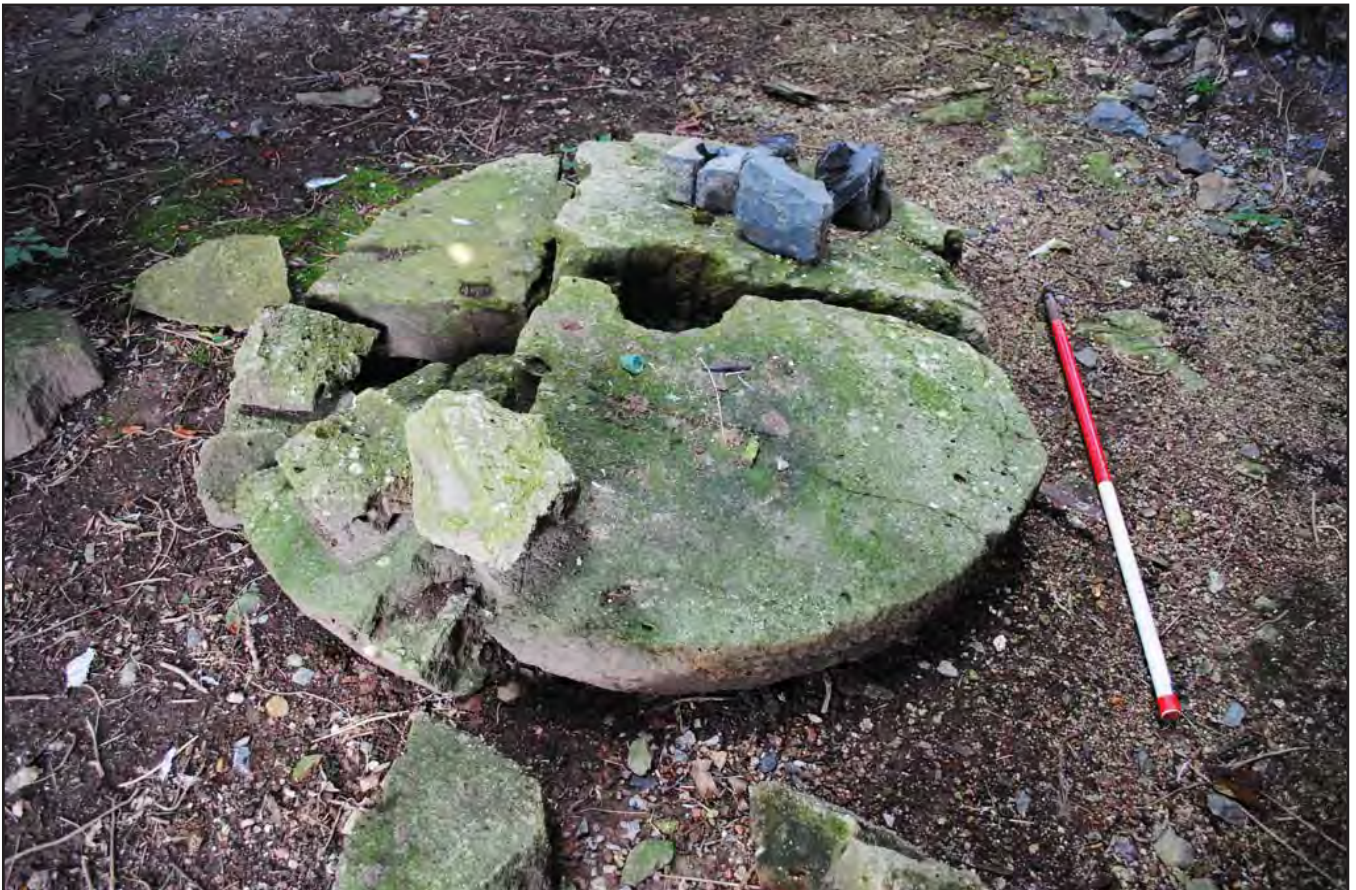
A broken millstone sits on the floor of the mill, which is fractured in such a manner as to suggest that it fell from its position in the mill on to the ground during the fire of 1917 (Plate 10), along with fragments of a second stone. There is further evidence of this fire having taken place in the form of charred ground and timber fragments. Horseshoes and domestic debris present indicate that some casual later occupation has taken place.

Plate 10: Shot of broken mill stone. Photograph taken from the south east

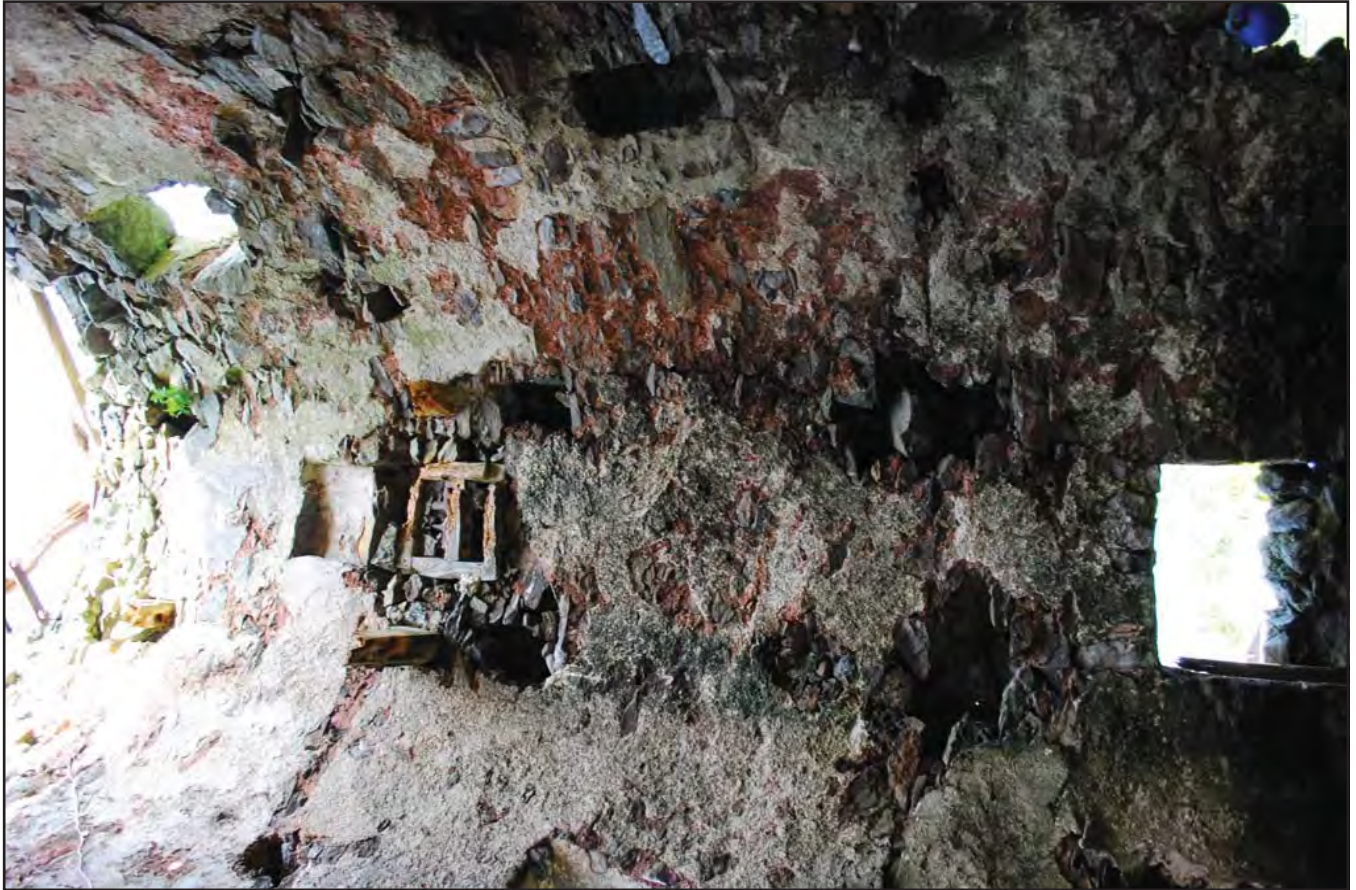
Plate 11: Shot looking upwards showing remnants of roof joist and other wooden structural elements. Photograph taken from the south

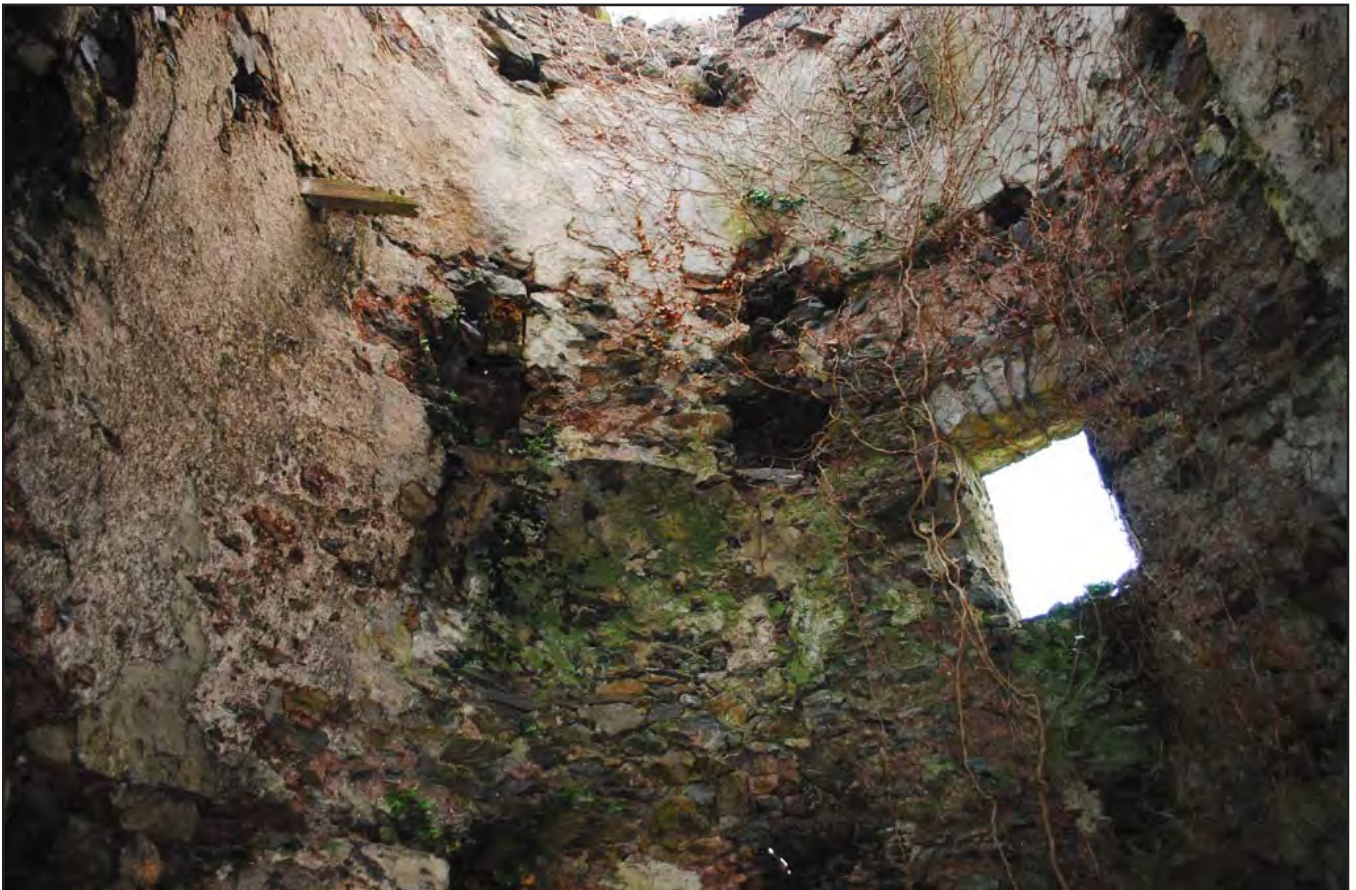
Plate 12: Shot looking upwards showing open window on the 2nd, and blocked window on 3rd floor, as well as roof joist holes. Photograph taken from the south

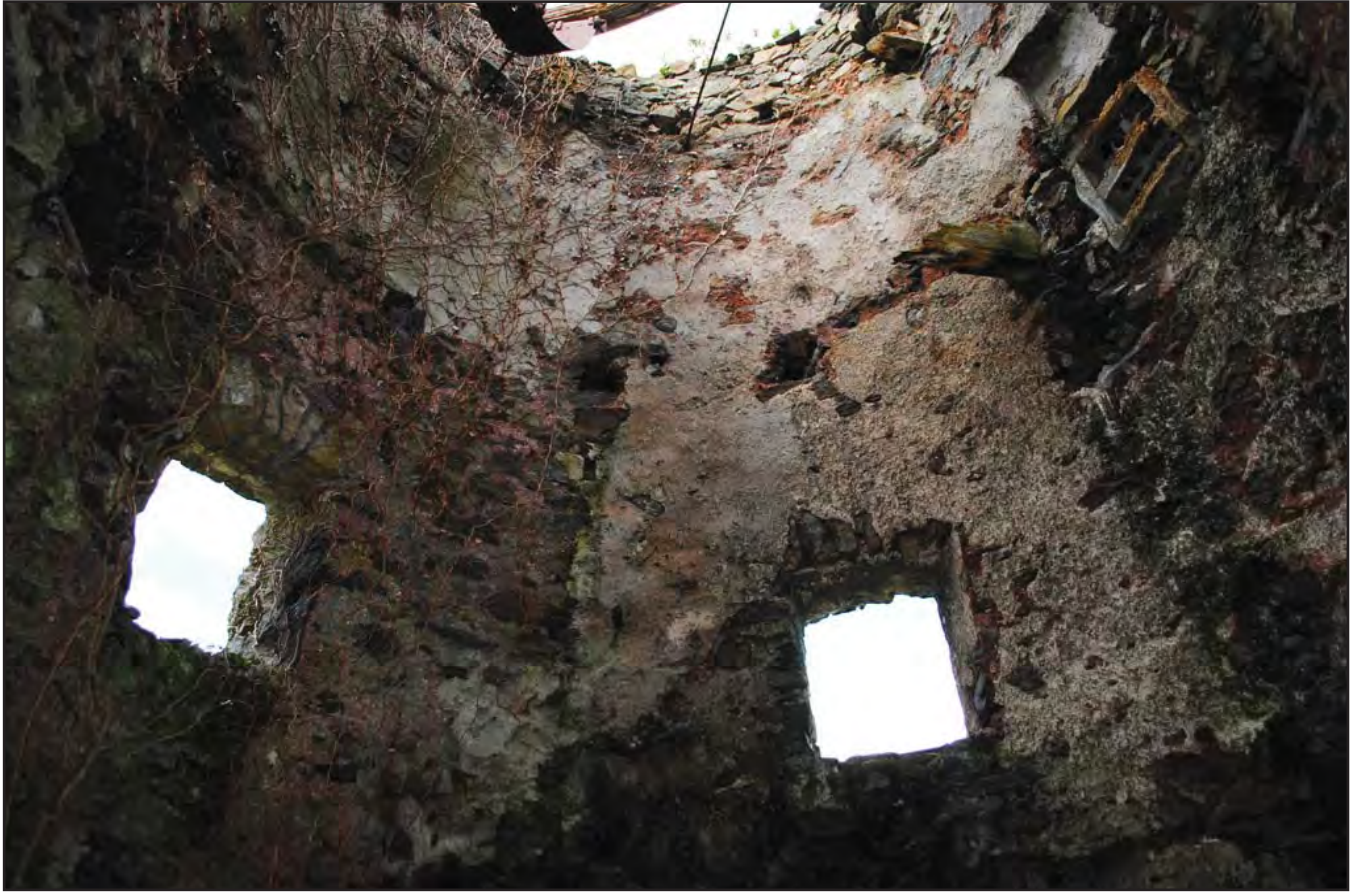
Plate 13: Shot looking upwards showing 2 open windows on the 2nd floor, blocked window on 3rd floor & remnants of roof joists and roof joist holes. Photograph taken from the east

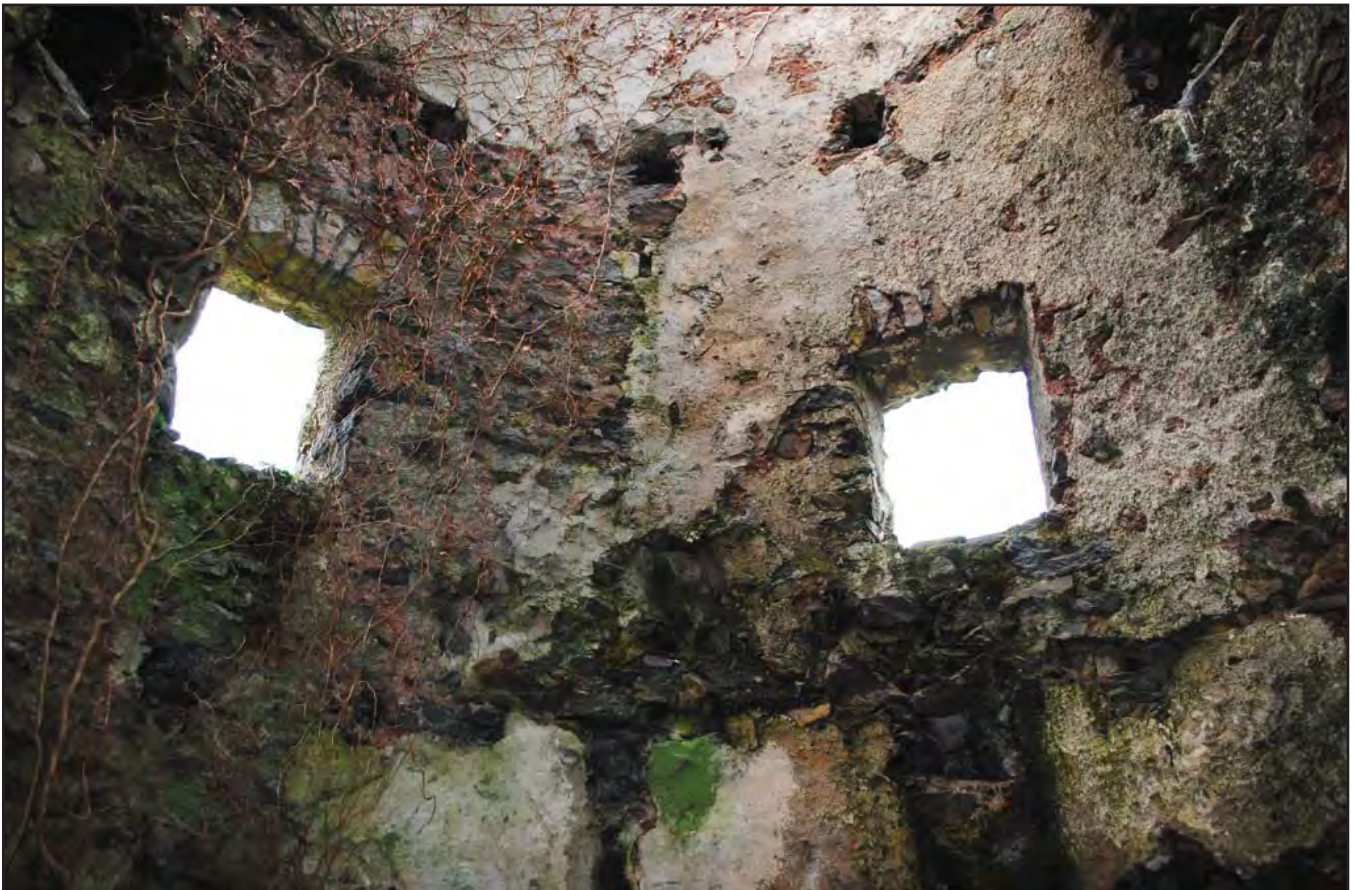
Plate 14: Shot looking upwards showing 2 open windows on the 2nd floor & roof joist holes. Photograph taken from the east

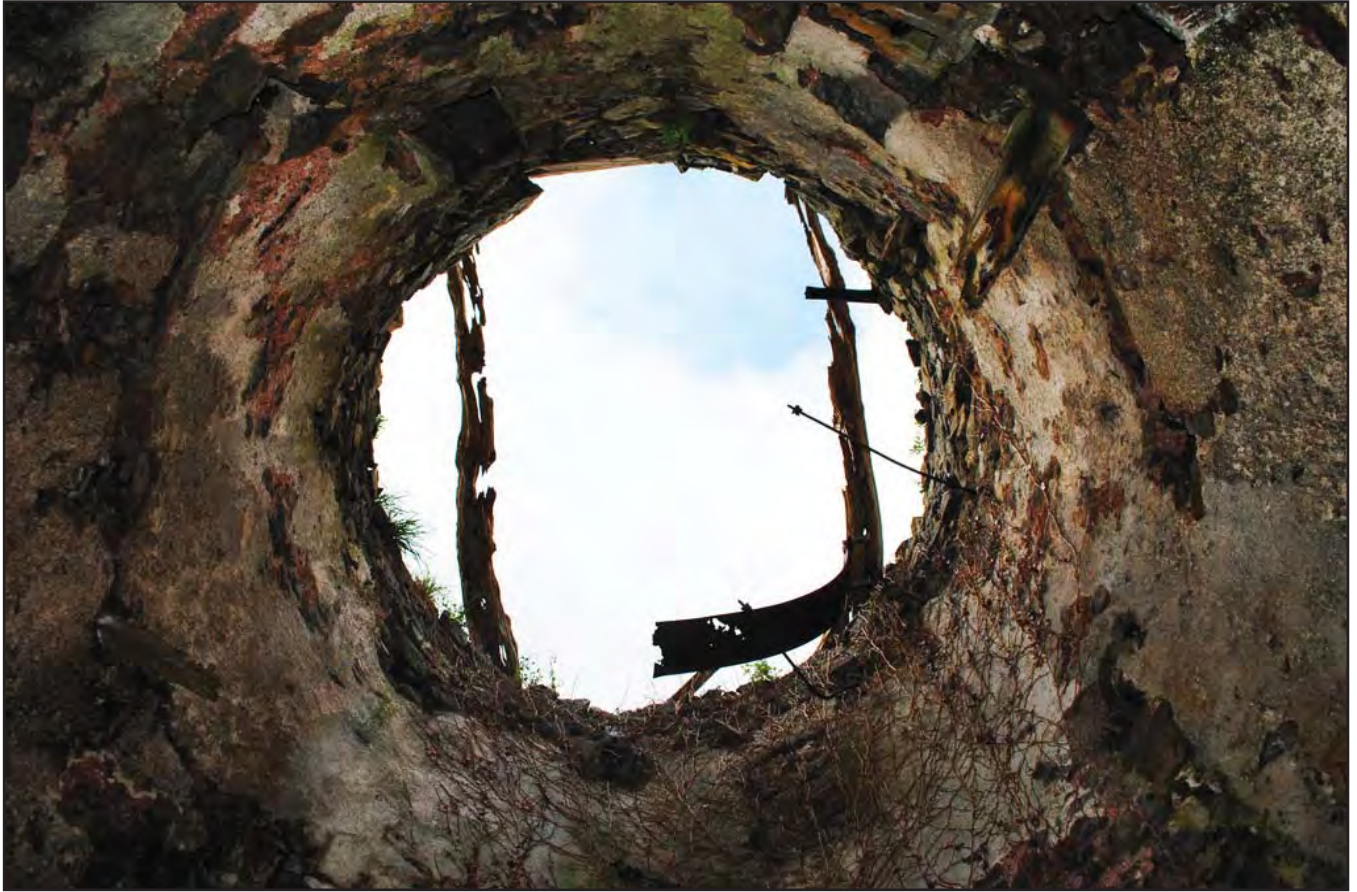
Plate 15: Shot looking directly upwards showing remnants of roof joists & turning cap

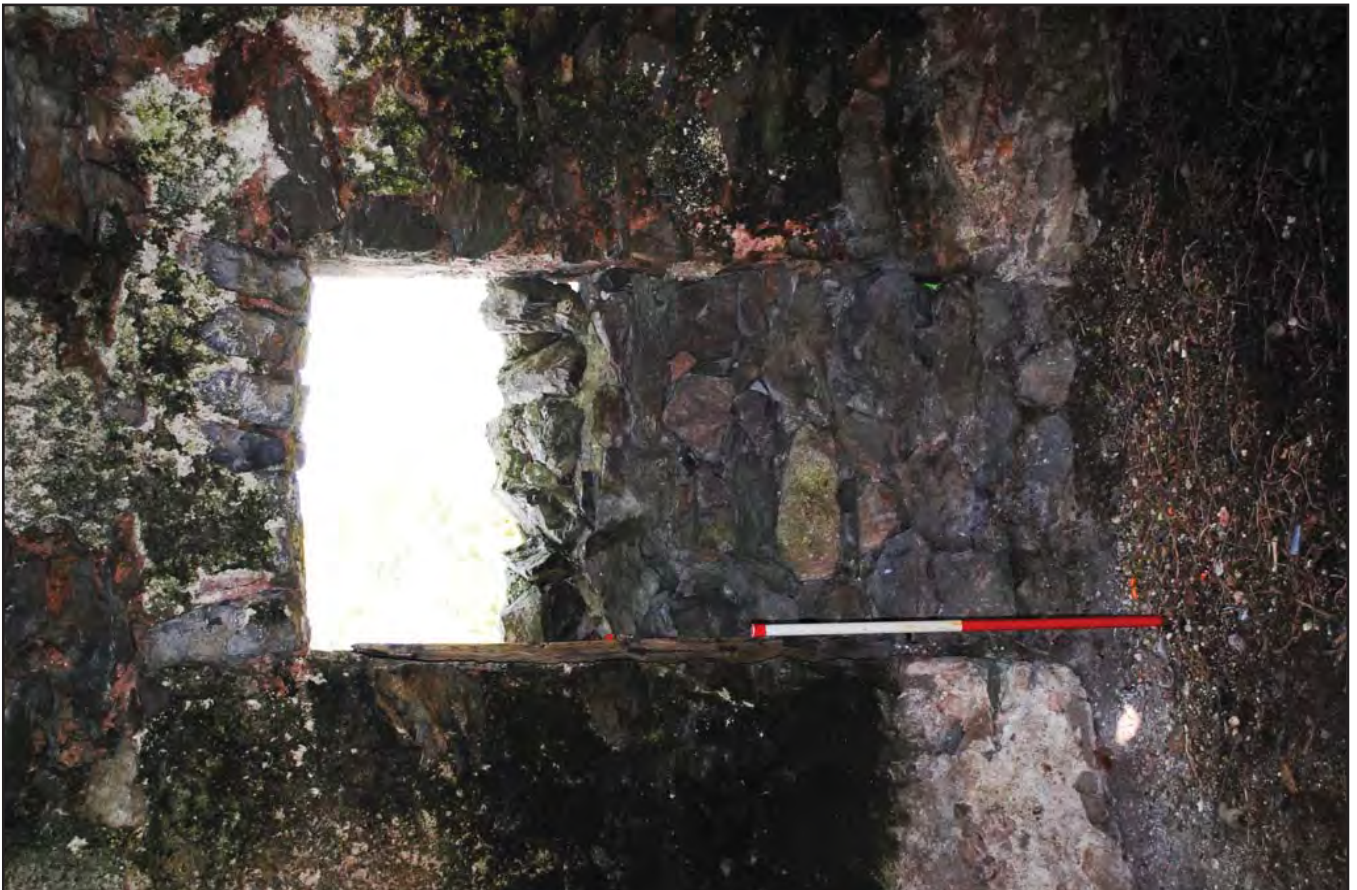
Plate 16: Shot of partially blocked doorway. Photograph taken from the south

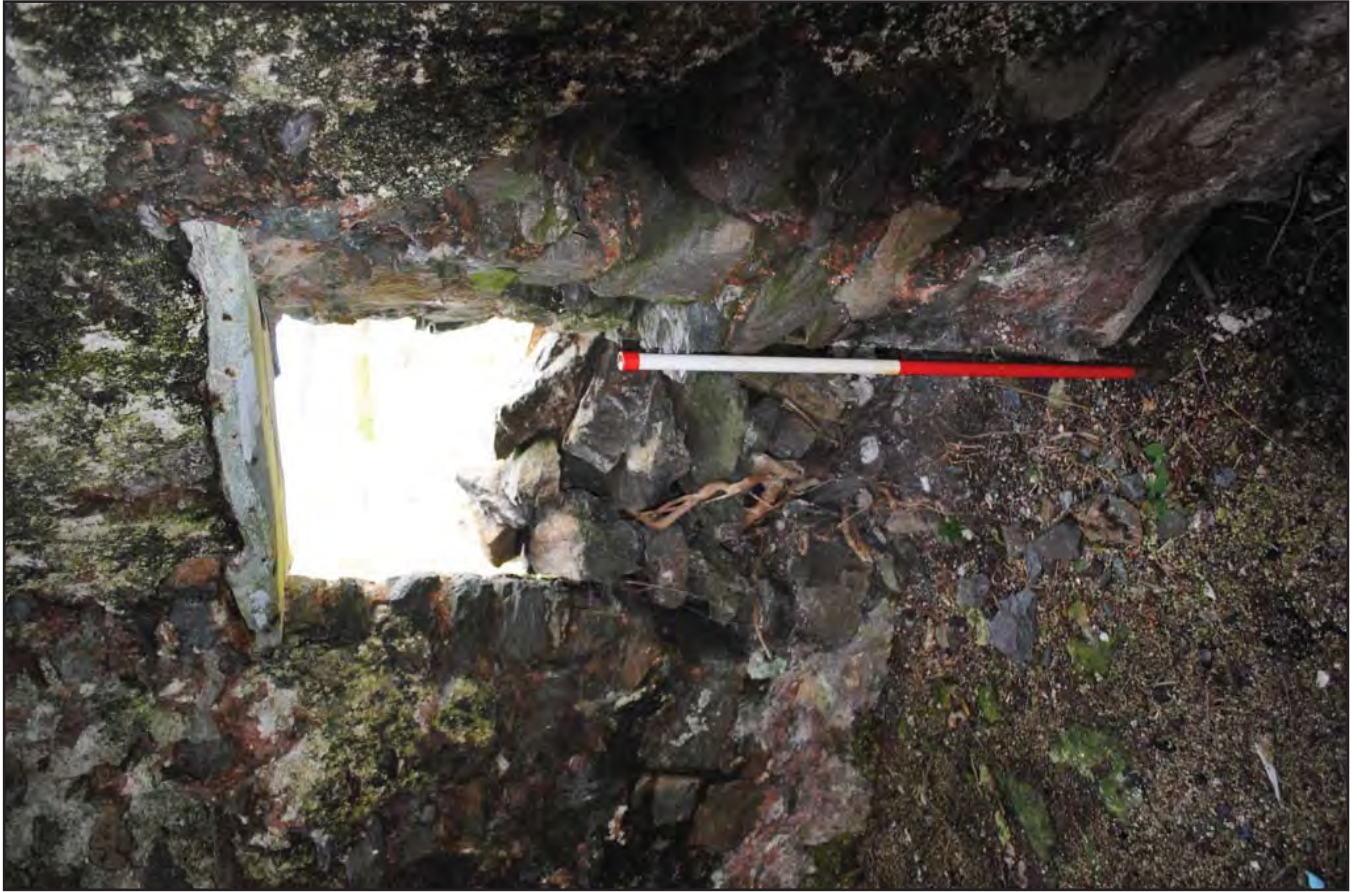
Plate 17: Shot of partially blocked sack hoist chute. Photograph taken from the south east

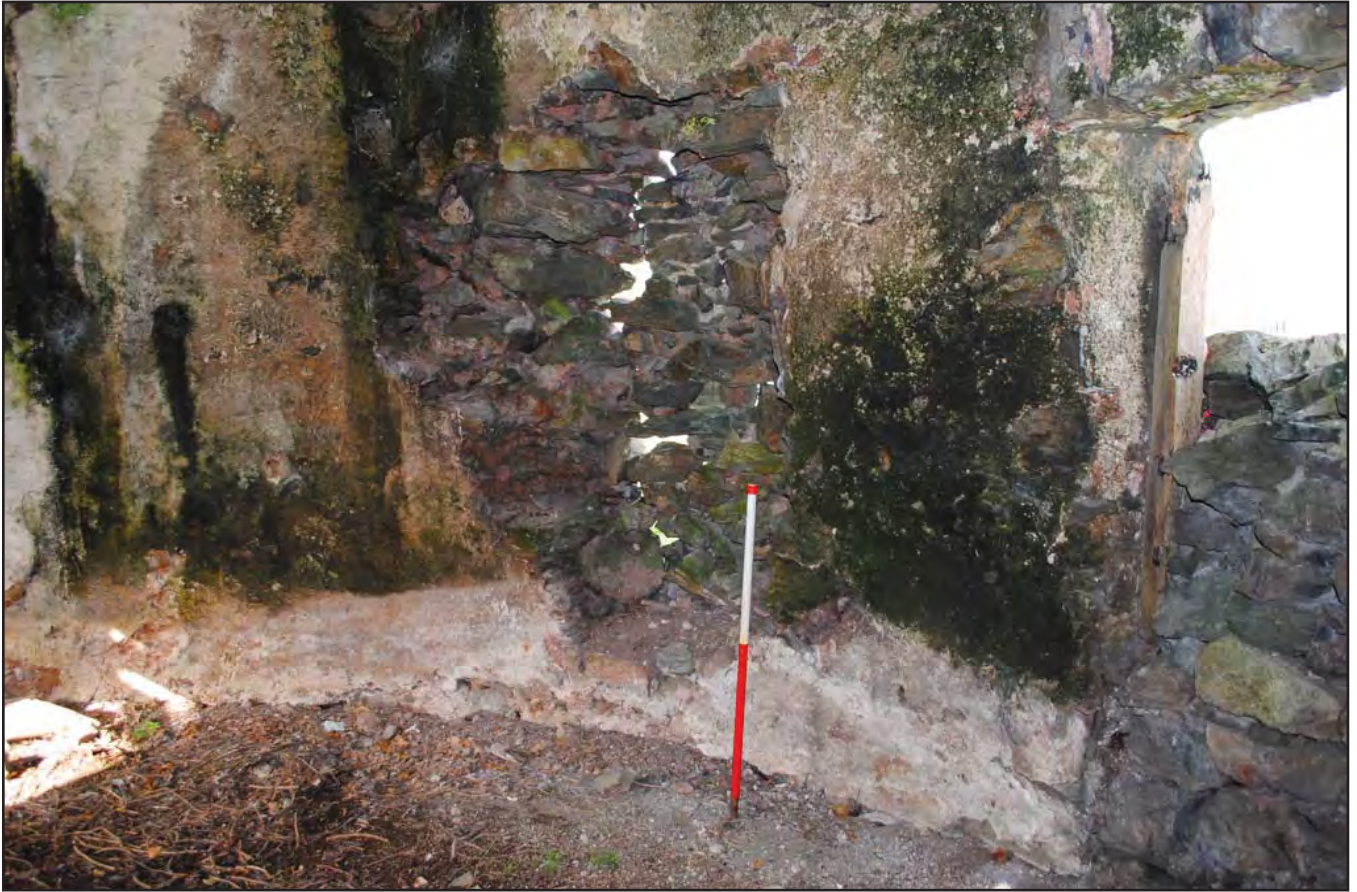
The internal surfaces of the tower walls were rendered, although much of this is now lost and there is much evidence for structural damage to the walls (Plate 18). Holes in the internal walls held pairs of beams, fragments of which survive, supporting floors at 3.05m, 6.05m and 8.1m above ground level (Fig. 6; Plate 11-15). At first floor level there was a small cupboard on the south east side of the mill (Plate 19). Extra beams supported the main shaft and great spur wheel, driving two pairs of stones on the second floor (Plate 14). An iron bearing journal in a wooden frame denoted the position of the horizontal shaft which drove the sack hoist (Plate 20), and recesses in the internal walls probably showed the positions of grain cleaning and flour dressing machinery. The main frame and other parts of the base cap are still in position (Plates 15, 23-28), as is most of the cast iron toothed ring which topped the stone tower. The cast iron ring was constructed in sections, jointed and pinned to a wooden wall plate (Plates 27-28). The wall plate forming a wooden circle at the top of the tower consists of

Plate 18: Shot detailing evidence of wall damage & wall render on undamaged surface. Photograph taken from the east

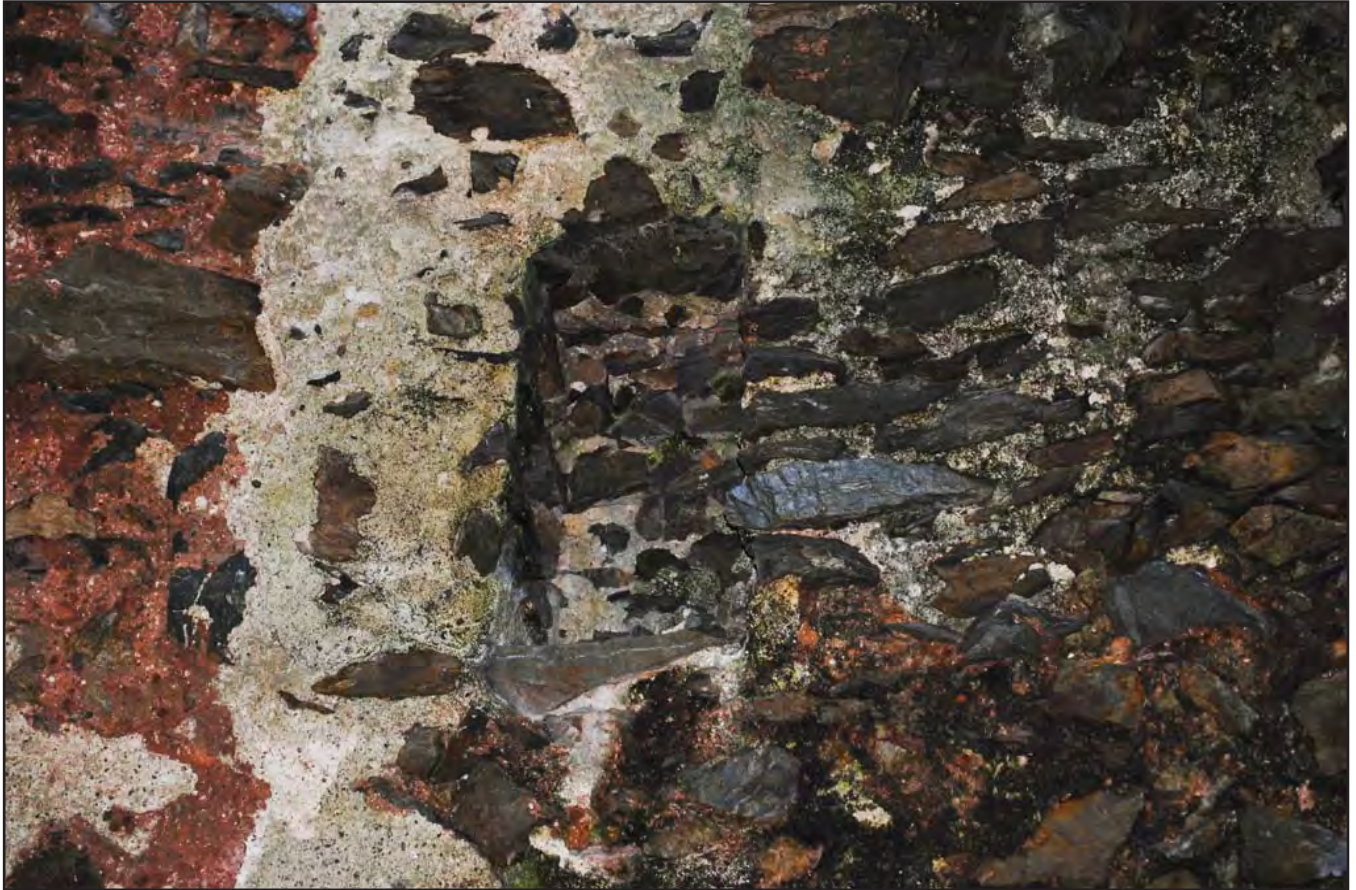
Plate 19: Detailed shot of small opening on the 2nd floor

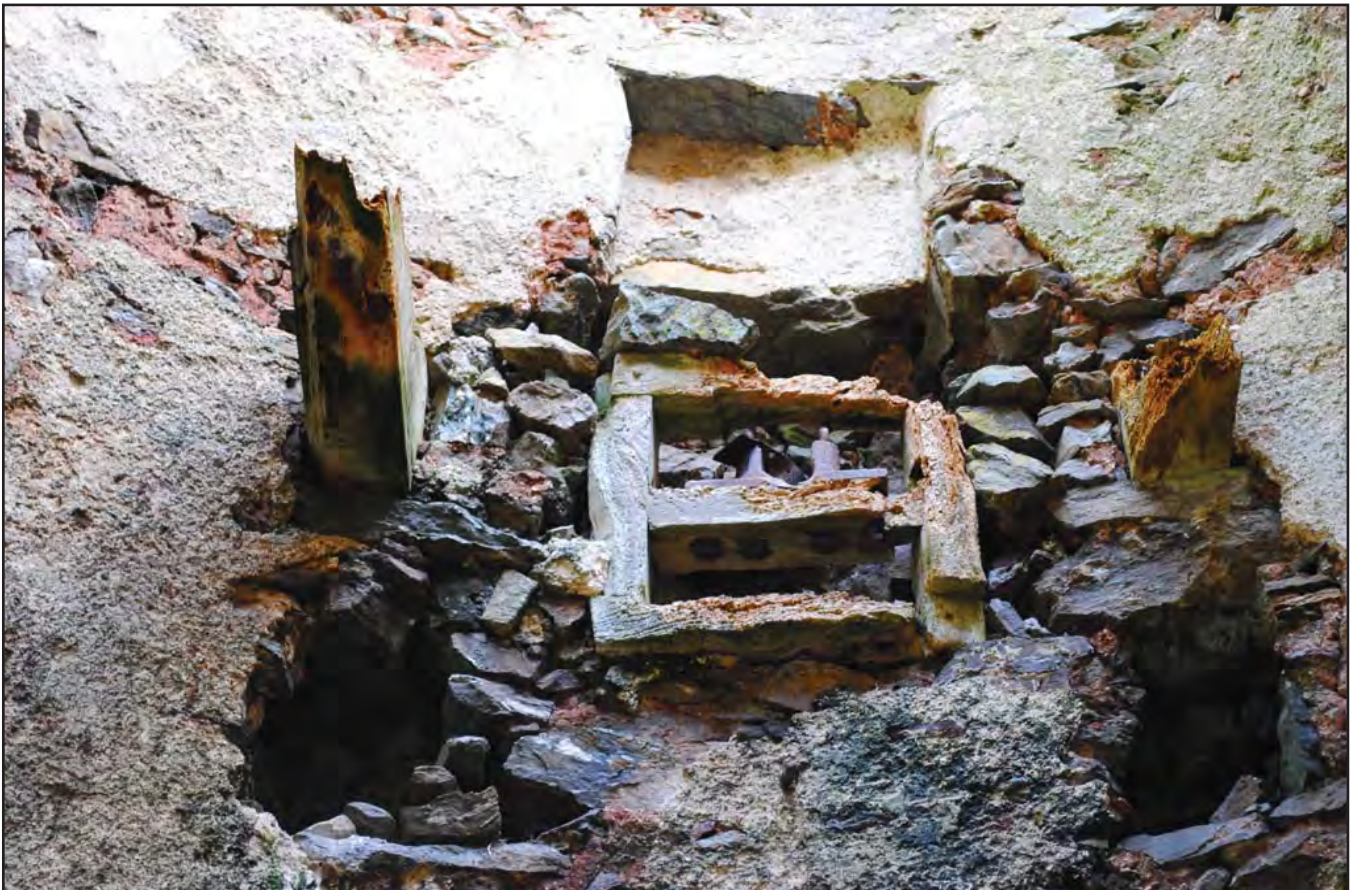
Plate 20: Detail of remnants of wooden structure on the 2nd floor. Photograph taken from the south
