Melin Sguthan, Gaerwen Ynys Môn

Archaeological Building Record

Project No. G2221

Report No. 998

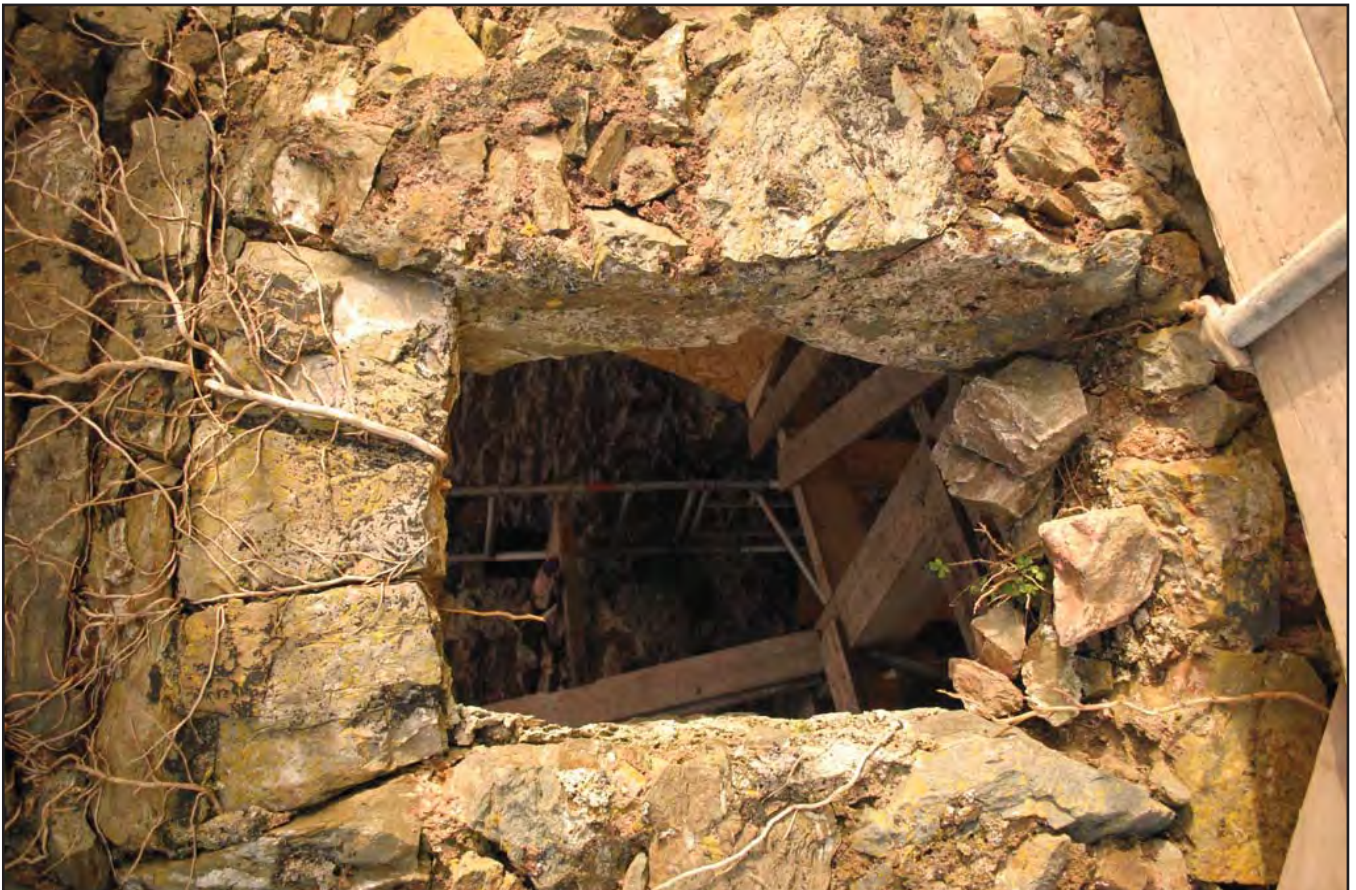
There is a single window opening at first floor level to the south west 5.0m above ground level (Plate 2, 22). There is a smaller window above it with a stone lintel at third floor level that has since been blocked up (Plate 9). There is a single window at the north west of the mill tower at first floor level (Plate 1). Above the chute there is a blocked window to the north east with a slate cill at first floor level, and there is a plain stone lintelled window at third floor level above it (Plate 8).

Plate 22: 2nd storey window detailing stone voussoirs. Photograph taken from the south east

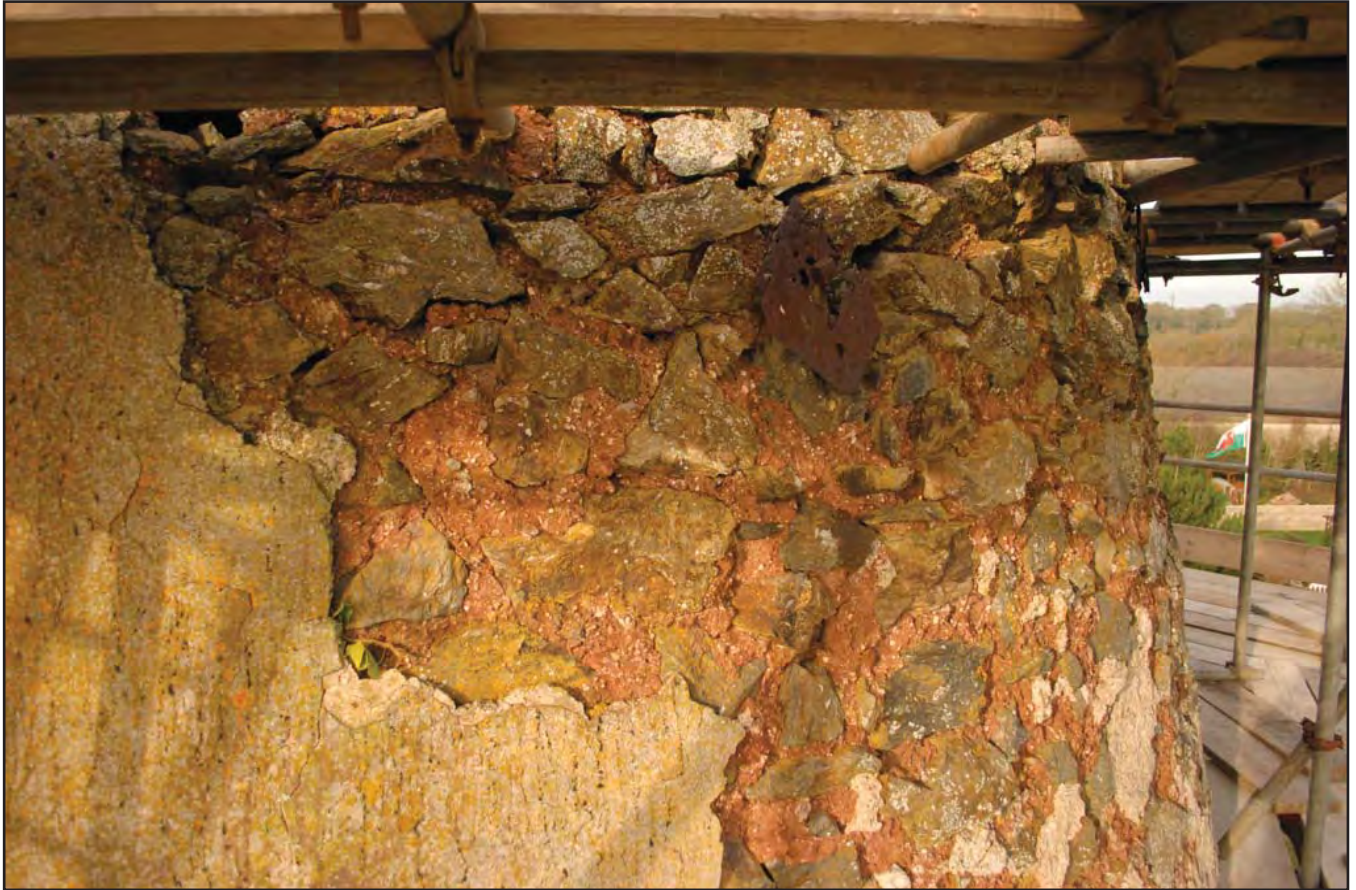
There is evidence that the building was partially rendered, and substantial structural cracks are present in the building to the east and west (Plates 3, 23). Remnants of the former turning cap and associated metalwork also survive at the top of the tower.

Plate 23: Detailed shot showing original lime render & metal tie plate on the 2nd floor. Photograph taken from the south west

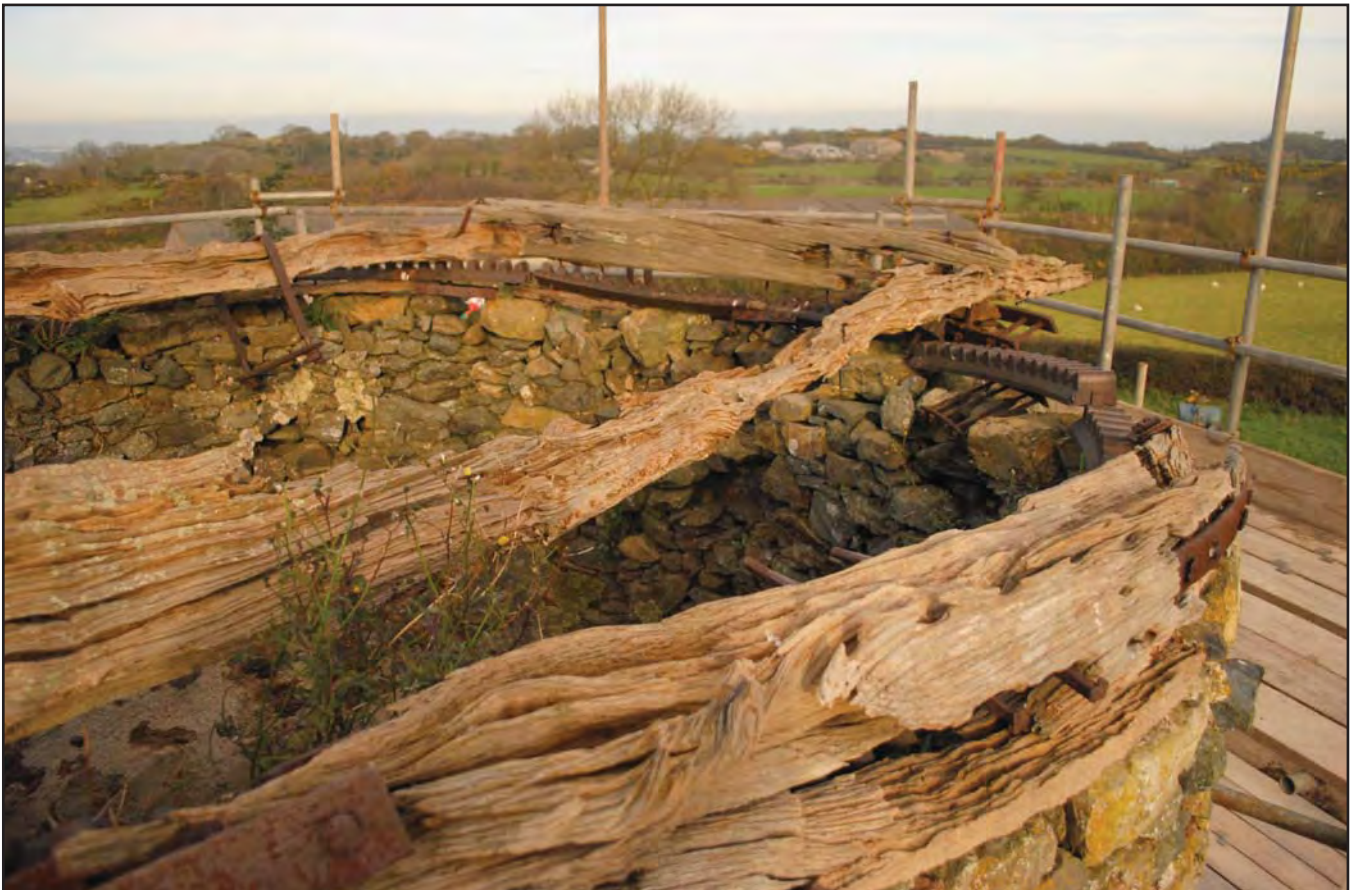
Plate 24: General shot of turning cap. Photograph taken from the west

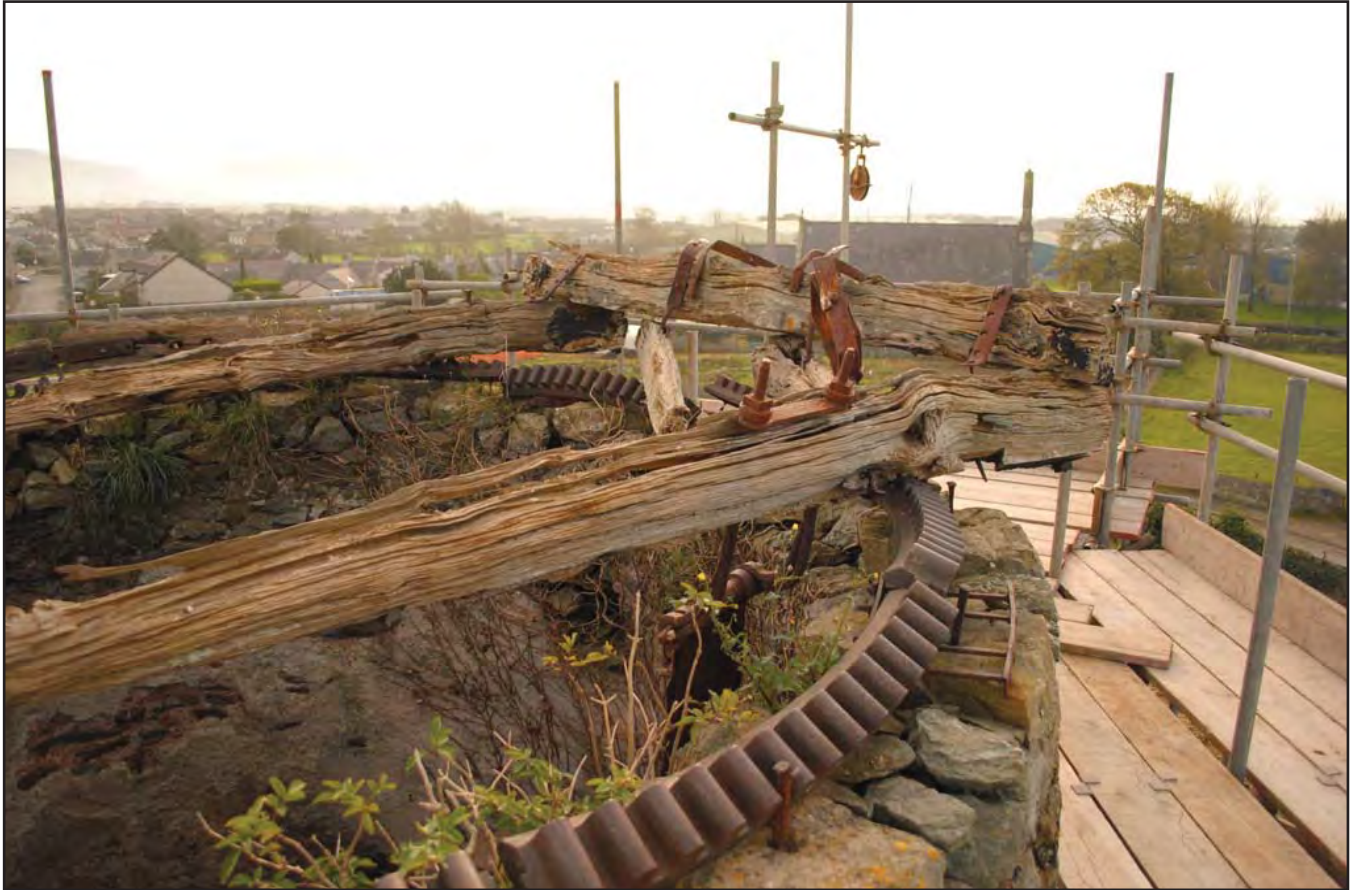
Plate 25: General view of turning cap. Photograph taken from the north east

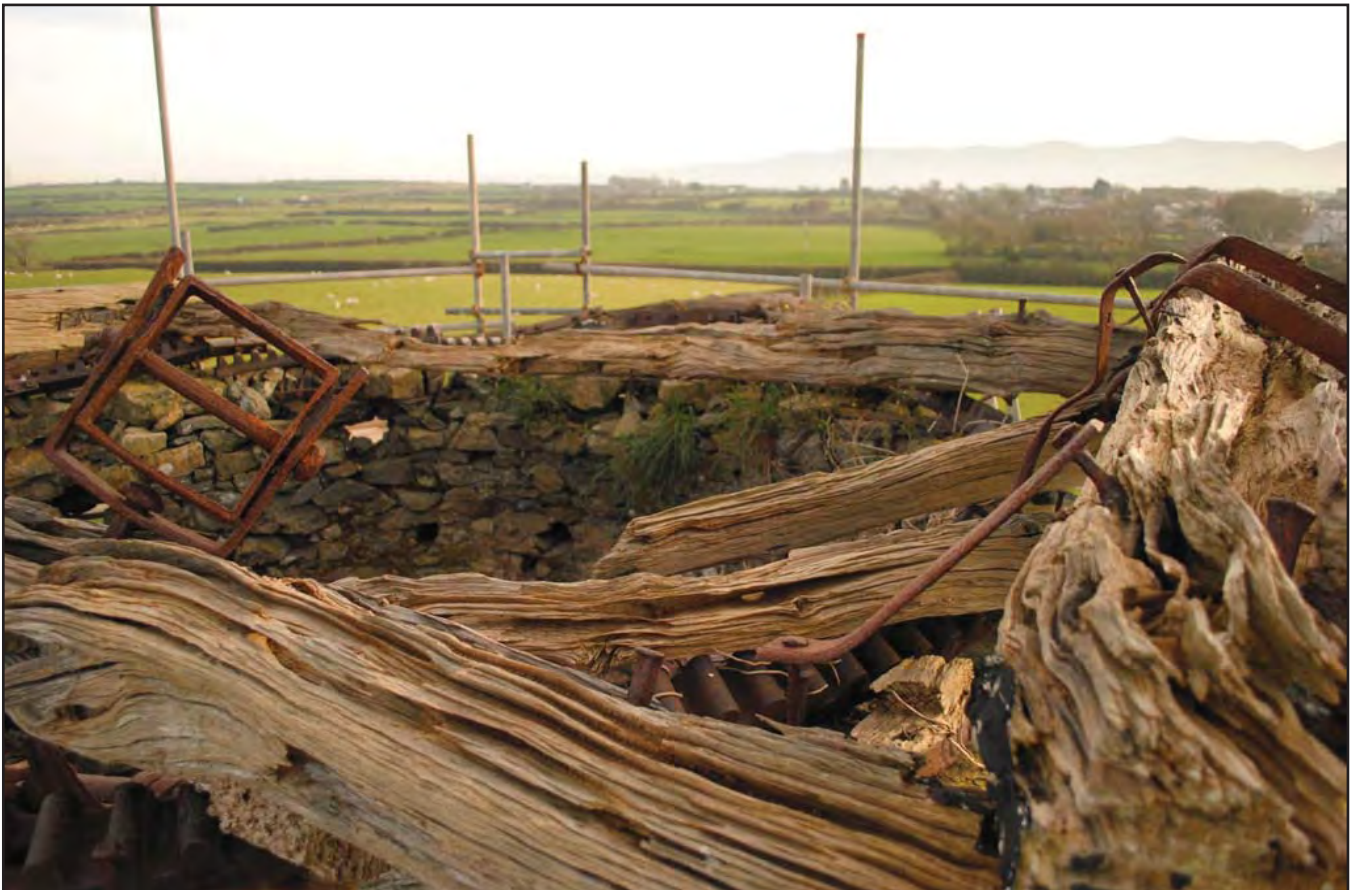
Plate 26: Detailed shot of turning cap revealing serious decay of both wooden and metal elements. Photograph taken from the east

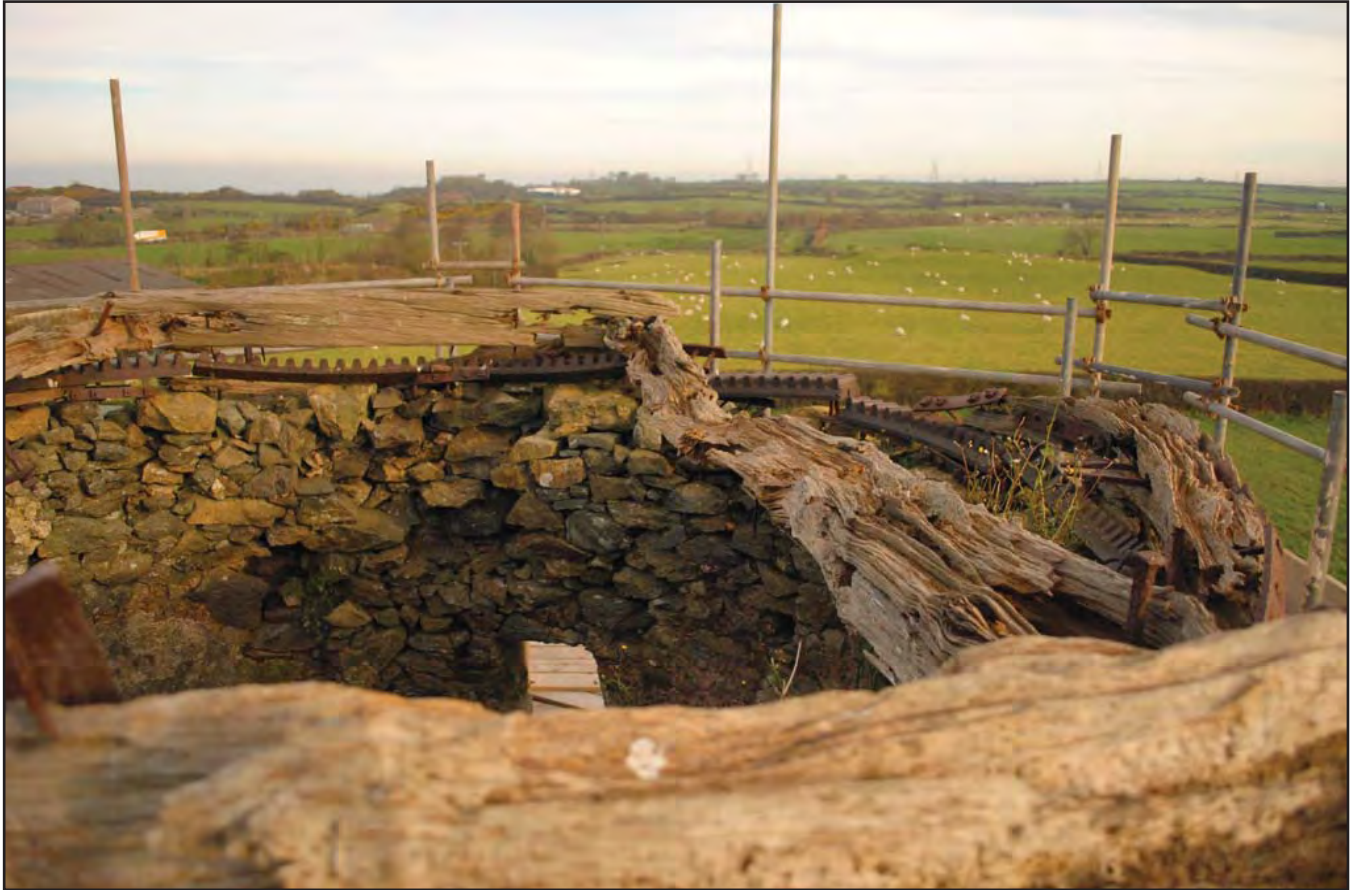
Plate 27: General view of turning cap detailing unstable upper wall & also revealing displaced cog wheel in segments. Photograph taken from the south

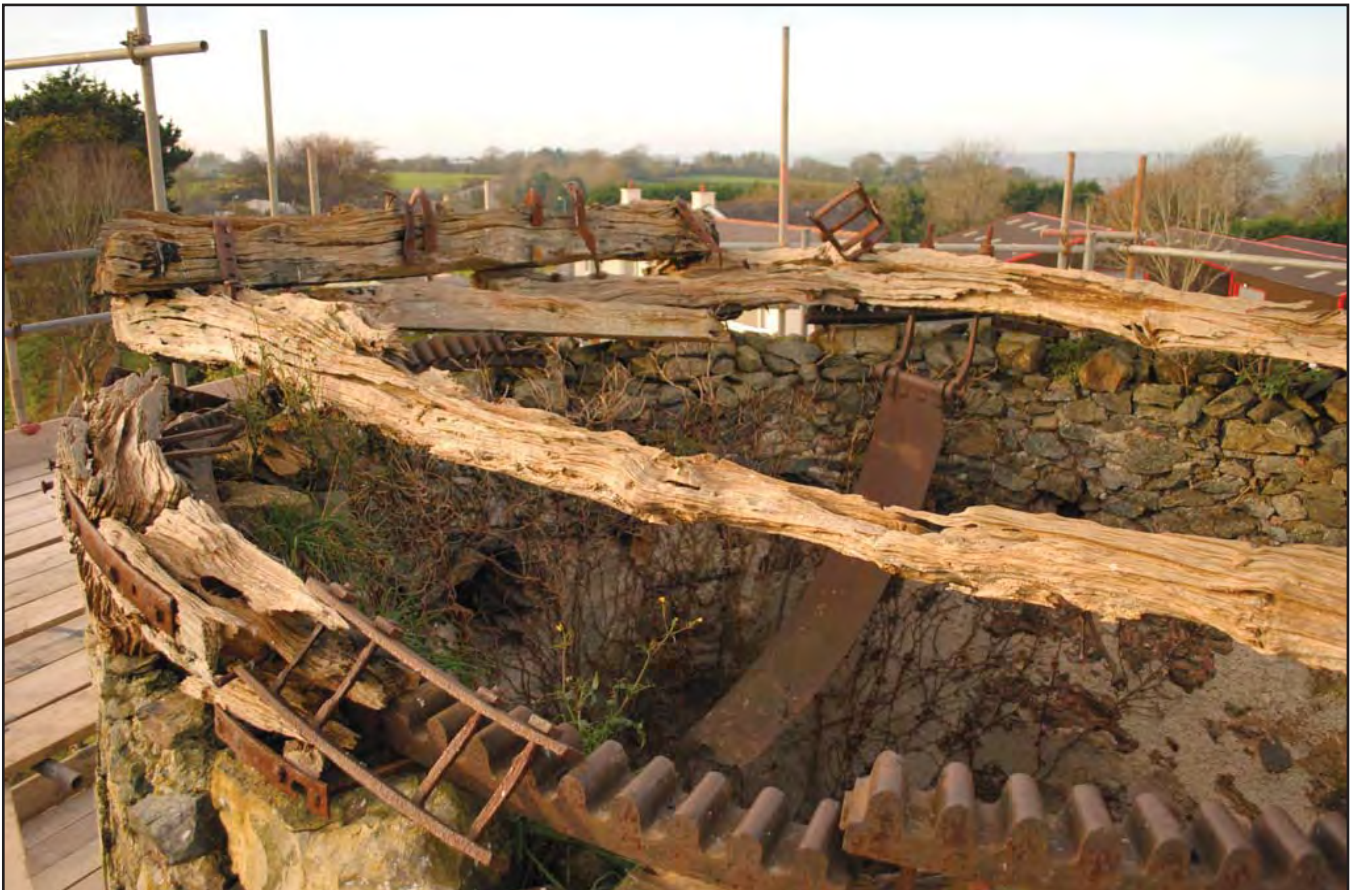
jointed lengths of timber, up to 2m long and held together by bolts and bands. Remnants of the skeleton of the turning cap frames survive in the form of a rectangular jointed box, and all the woodwork is now much weathered and separated from the cast iron ring. The iron band which once encircled the brake wheel still hangs precariously from the cap frame (Plate 28).

Plate 28: Shot of turning cap showing metal brackets attached to wooden elements of turning cap. Note the iron band which once encircled the brake wheel. Photograph taken from the north west
