## **Fferm Glanrafon, Ynys Môn / Glanrafon Farm, Anglesey**

Arolwg Ffotograffig / Photographic Survey

Rhif Prosiect / Project No. HD25-023

Rhif Adroddiad / Report No. 1830

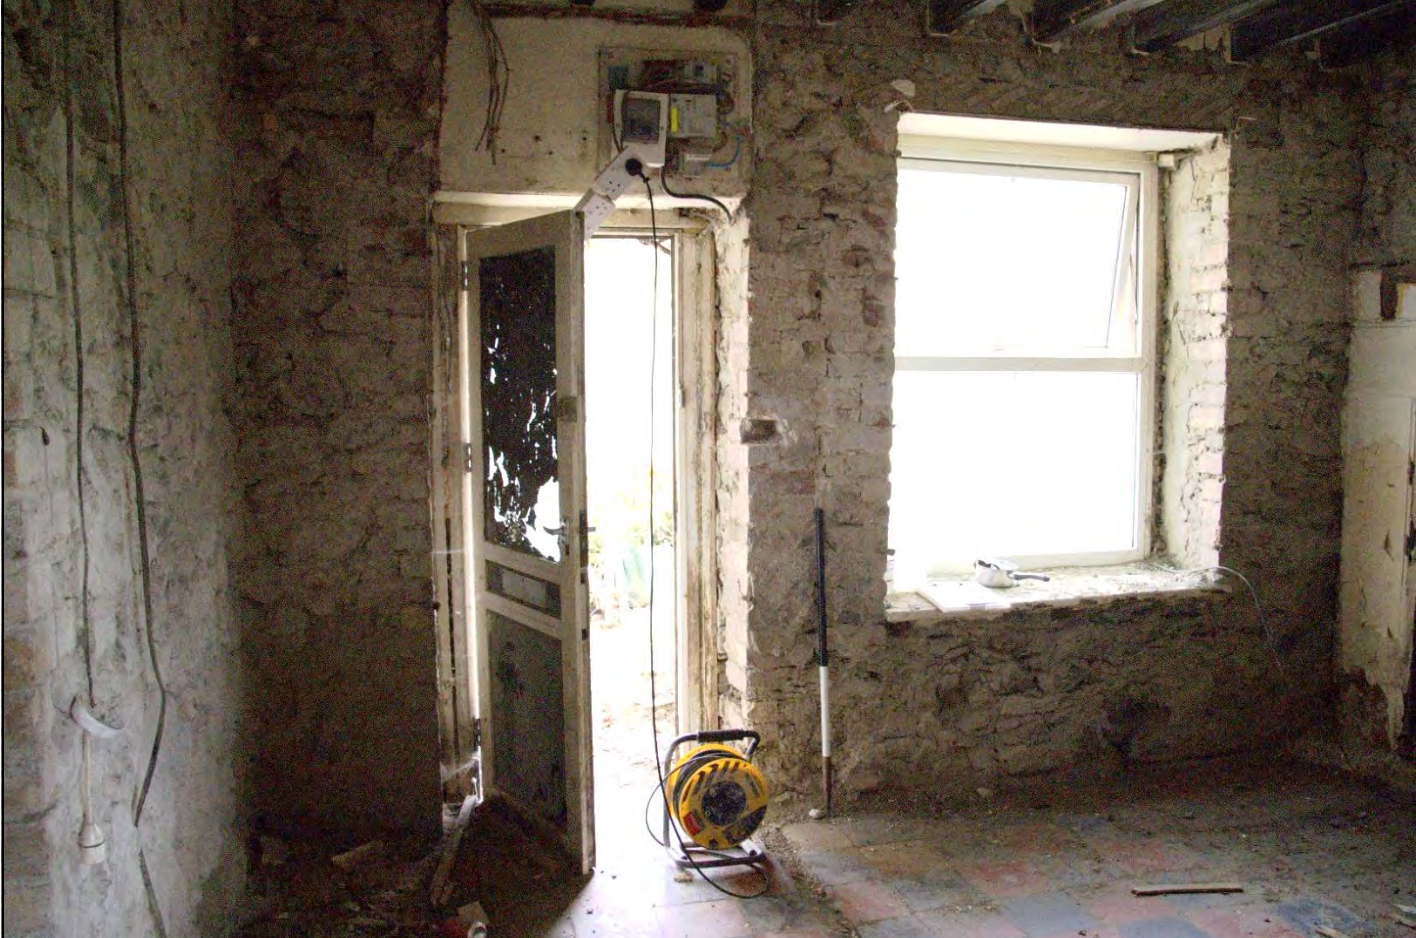
| <b>Location</b> | Ground Floor: Kitchen | <b>Photo ID No:</b> | E49630_09 |

| <b>Description</b> | View of the northeast wall of the kitchen showing window and doorway | | |

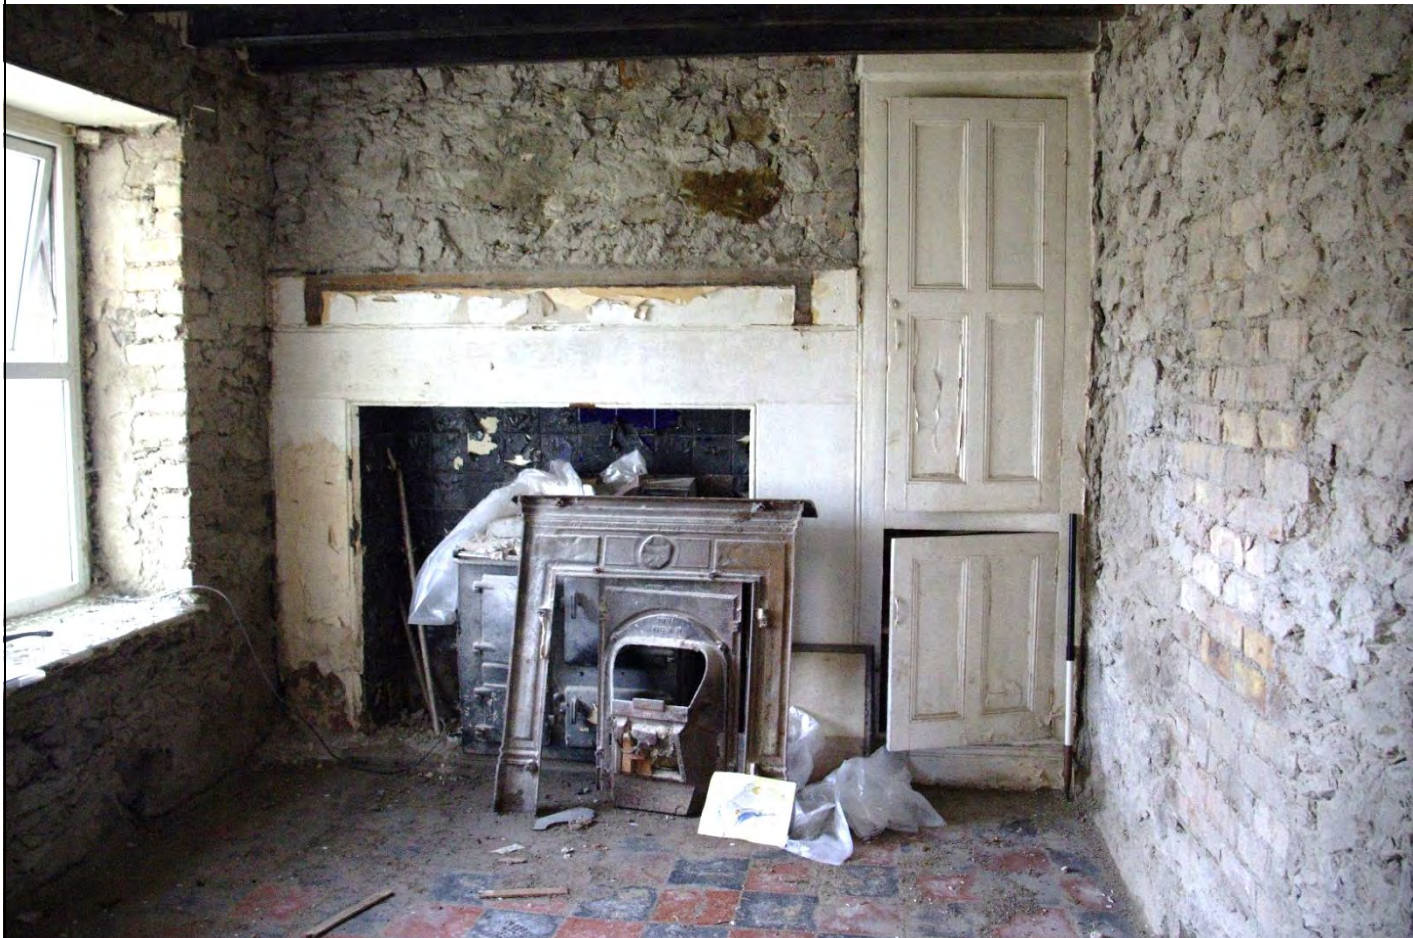
| <b>Location</b> | Ground Floor: Kitchen | <b>Photo ID No:</b> | E49630_10 |

| <b>Description</b> | East-southeast wall of the kitchen showing fireplace and cupboard | | |

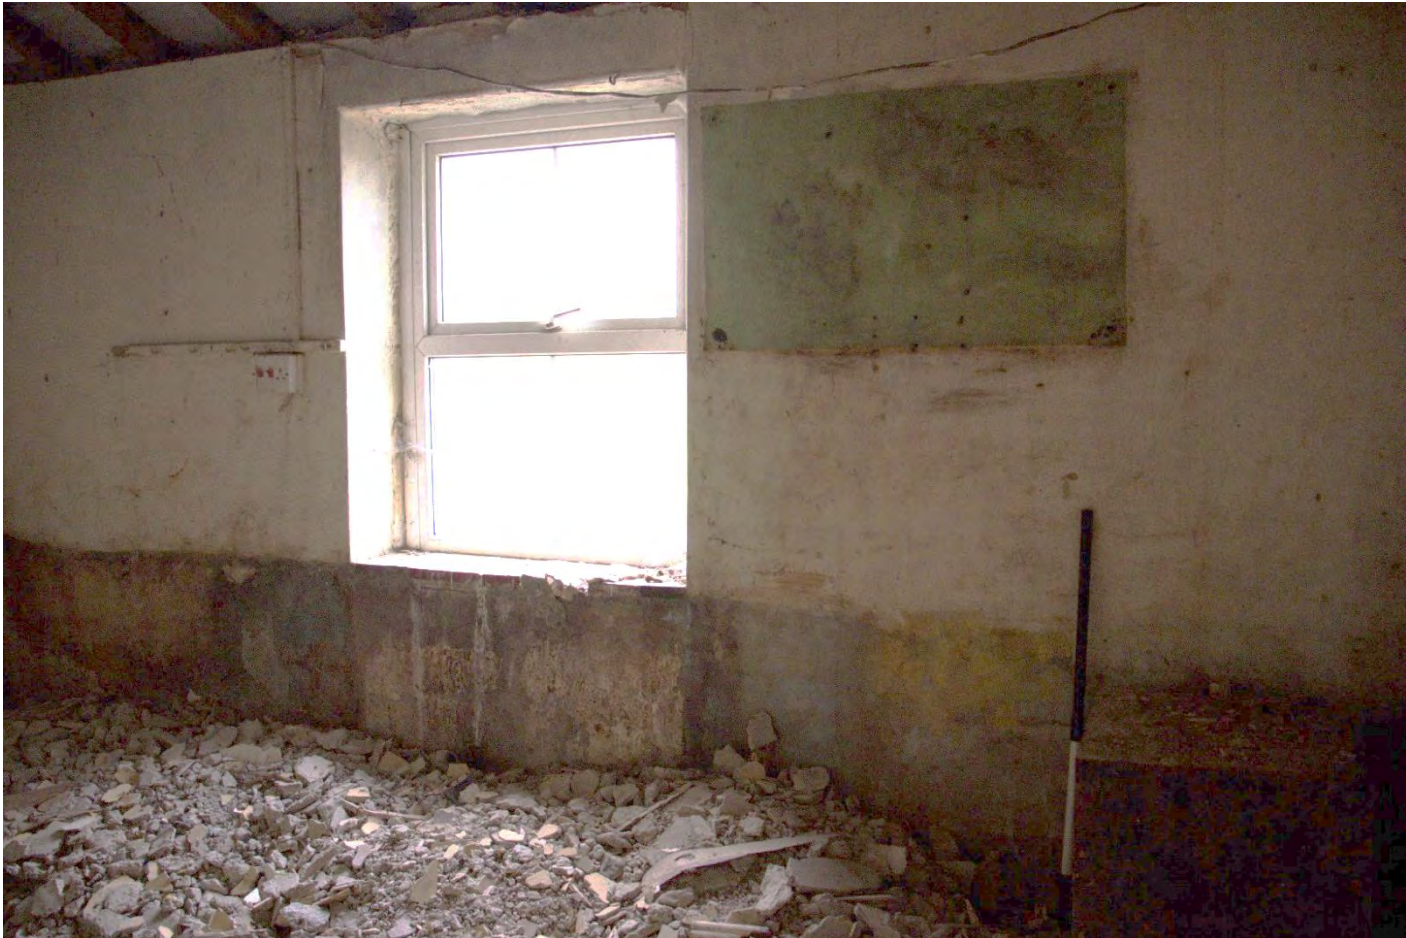
| <b>Location</b> | Ground Floor: Utility Room | <b>Photo ID No:</b> | E49630_13 |

| <b>Description</b> | Southwest wall of the utility room | | |

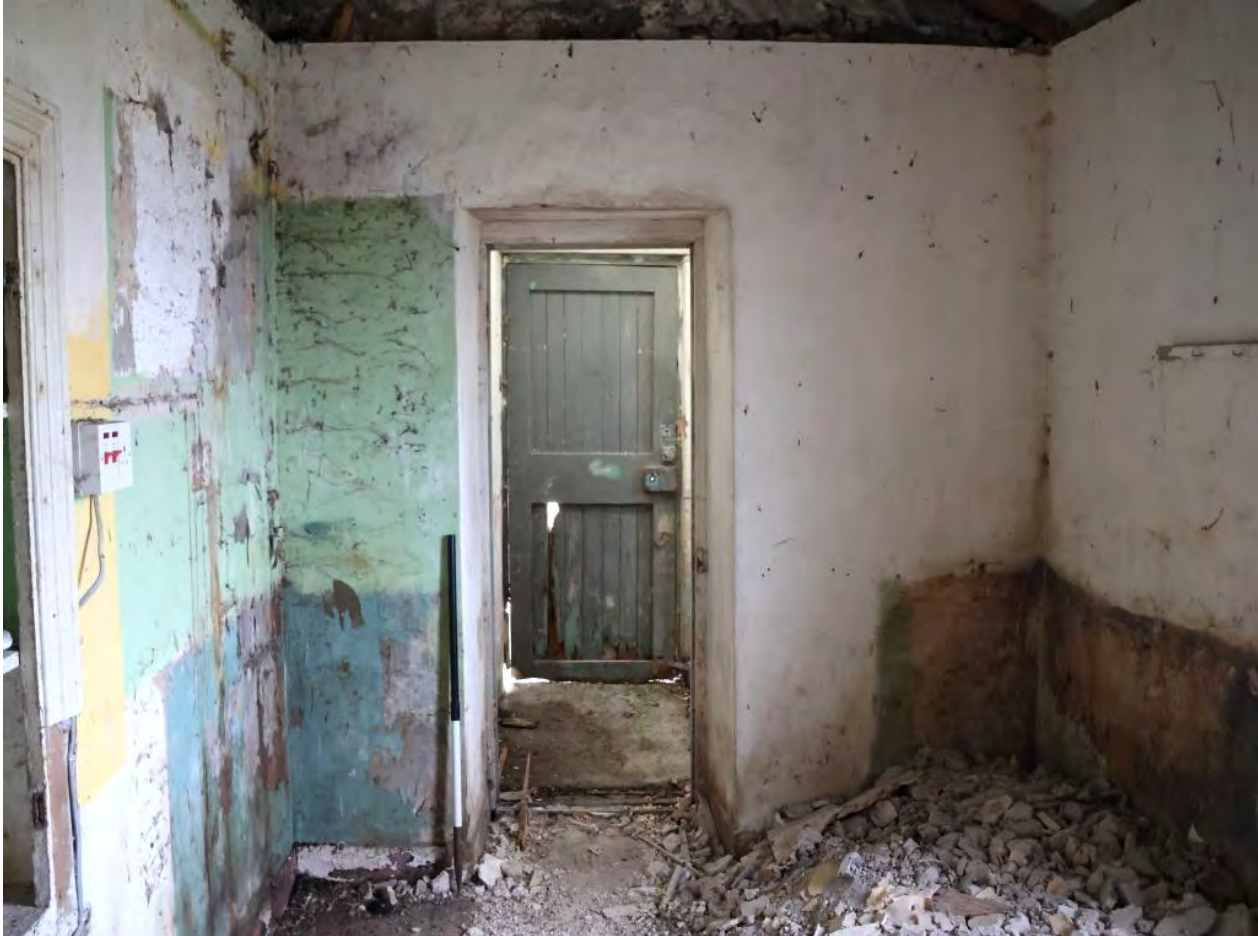
| <b>Location</b> | Ground Floor: Utility Room | <b>Photo ID No:</b> | E49630_14 |

| <b>Description</b> | East-southeast wall of the utility room showing doorway to the toilet block | | |

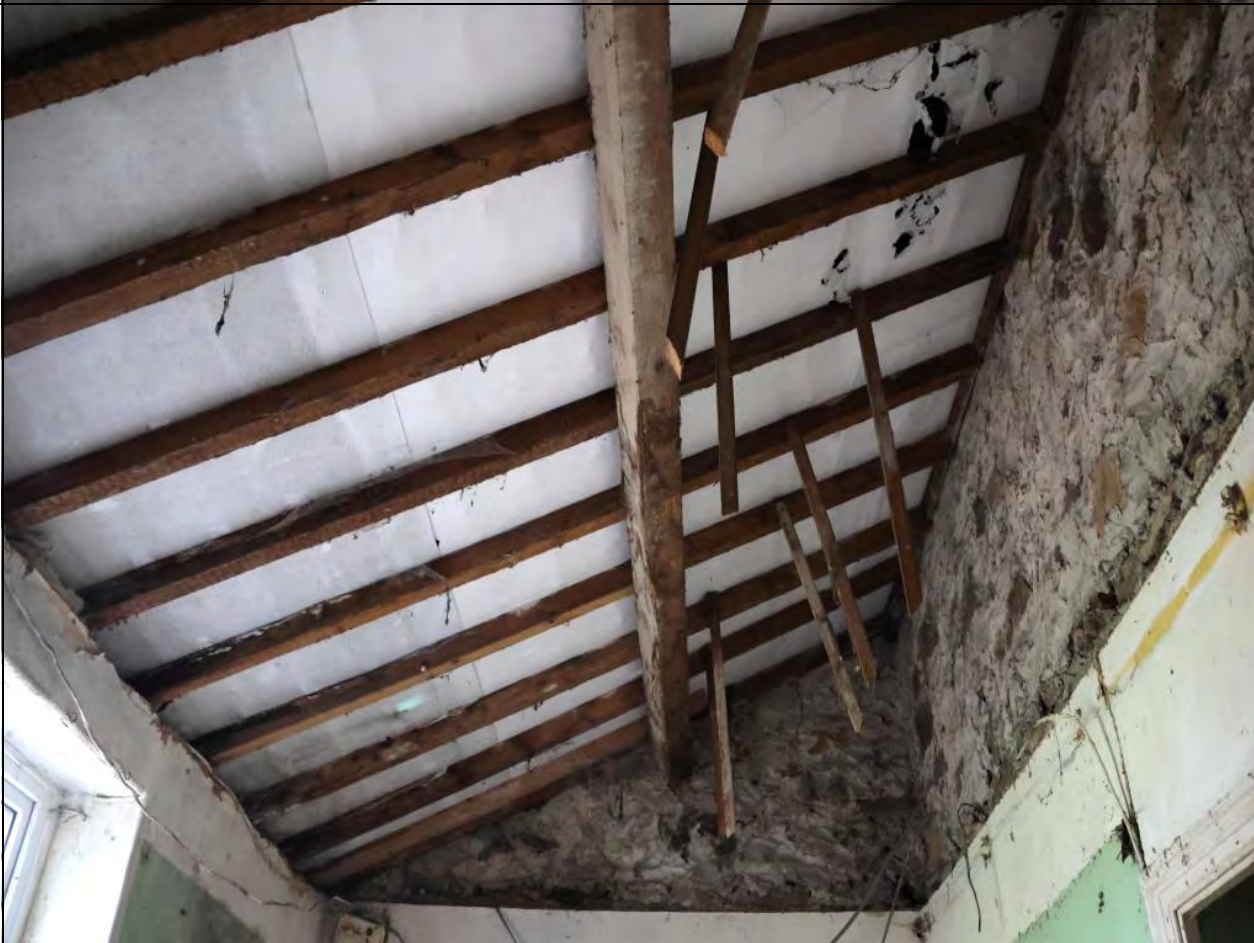
| <b>Location</b> | Ground Floor: Utility Room | <b>Photo ID No:</b> | E49630_19 |

| <b>Description</b> | Roof of the utility room | | |

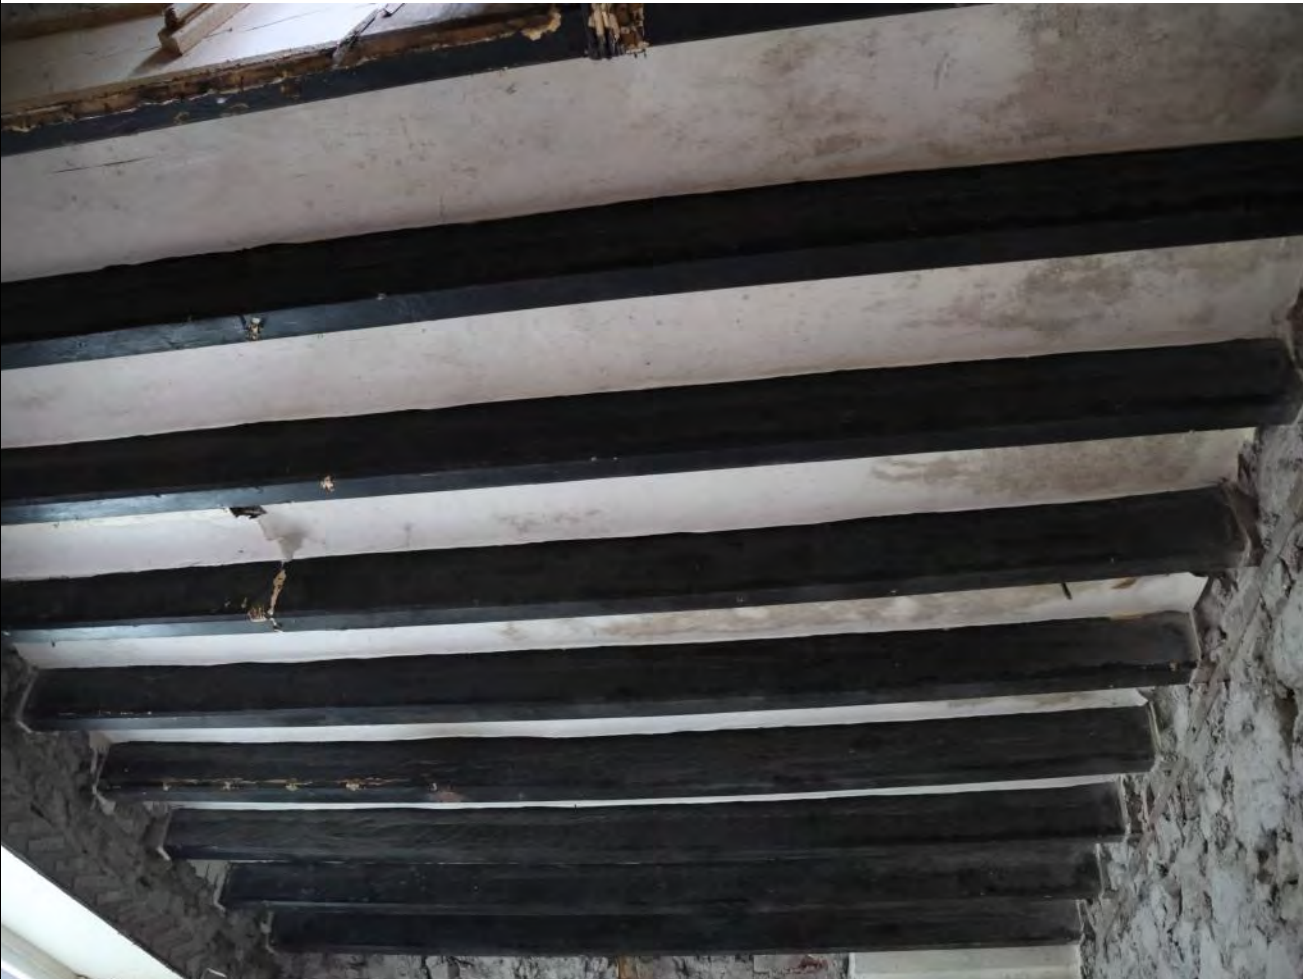
| <b>Location</b> | Ground Floor: Kitchen | <b>Photo ID No:</b> | E49630_21 |

| <b>Description</b> | Roof in kitchen showing beams | | |

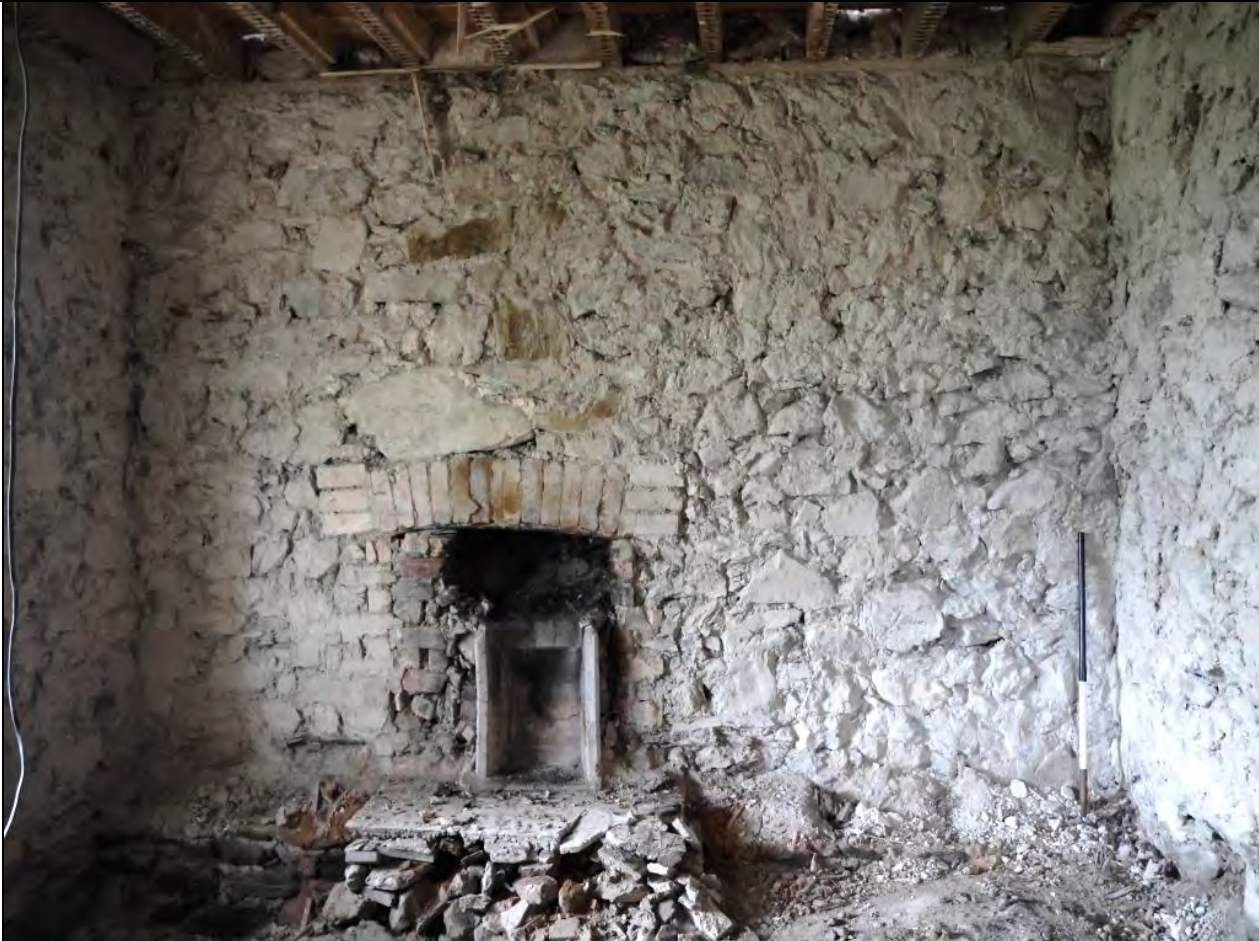
| <b>Location</b> | Ground Floor: Dining room | <b>Photo ID No:</b> | E49630_22 |

| <b>Description</b> | Northeast wall of the dining room | | |

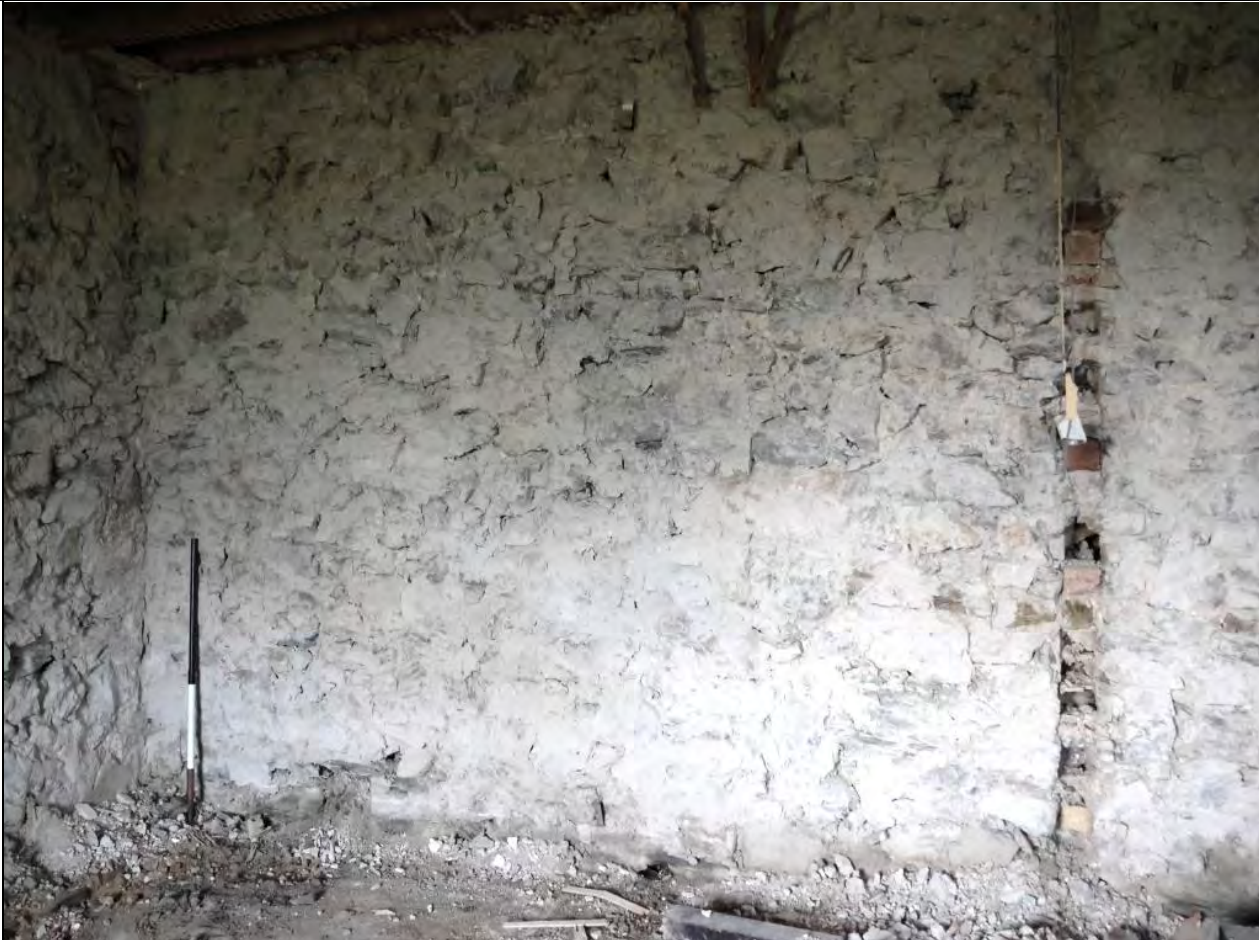
| <b>Location</b> | Ground Floor: Dining room | <b>Photo ID No:</b> | E49630_23 |

| <b>Description</b> | East-southeast wall of the dining room | | |

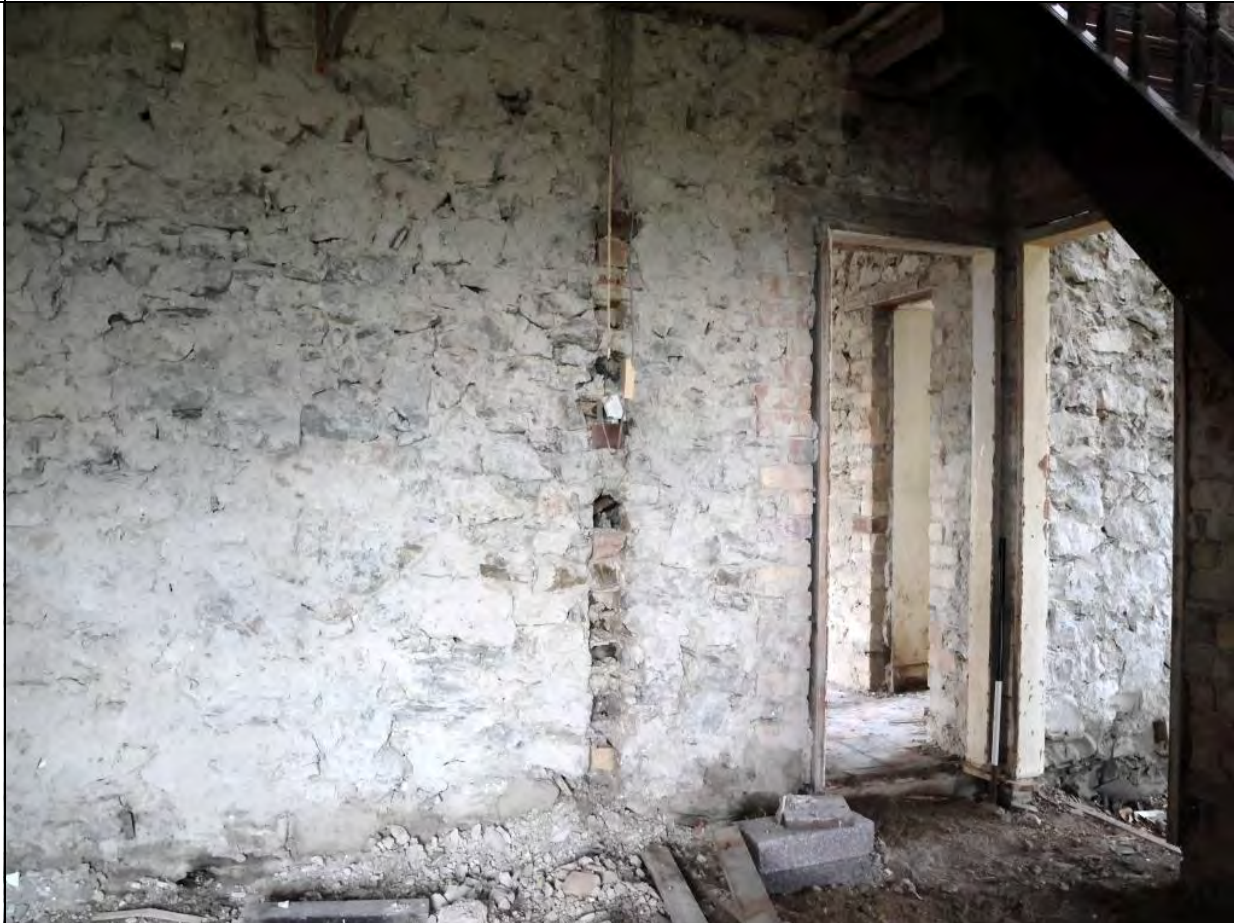
| <b>Location</b> | Ground Floor: Dining room | <b>Photo ID No:</b> | E49630_24 |

| <b>Description</b> | Eeast-southeast wall of the dining room (oblique) showing the doorway to the kitchen | | |

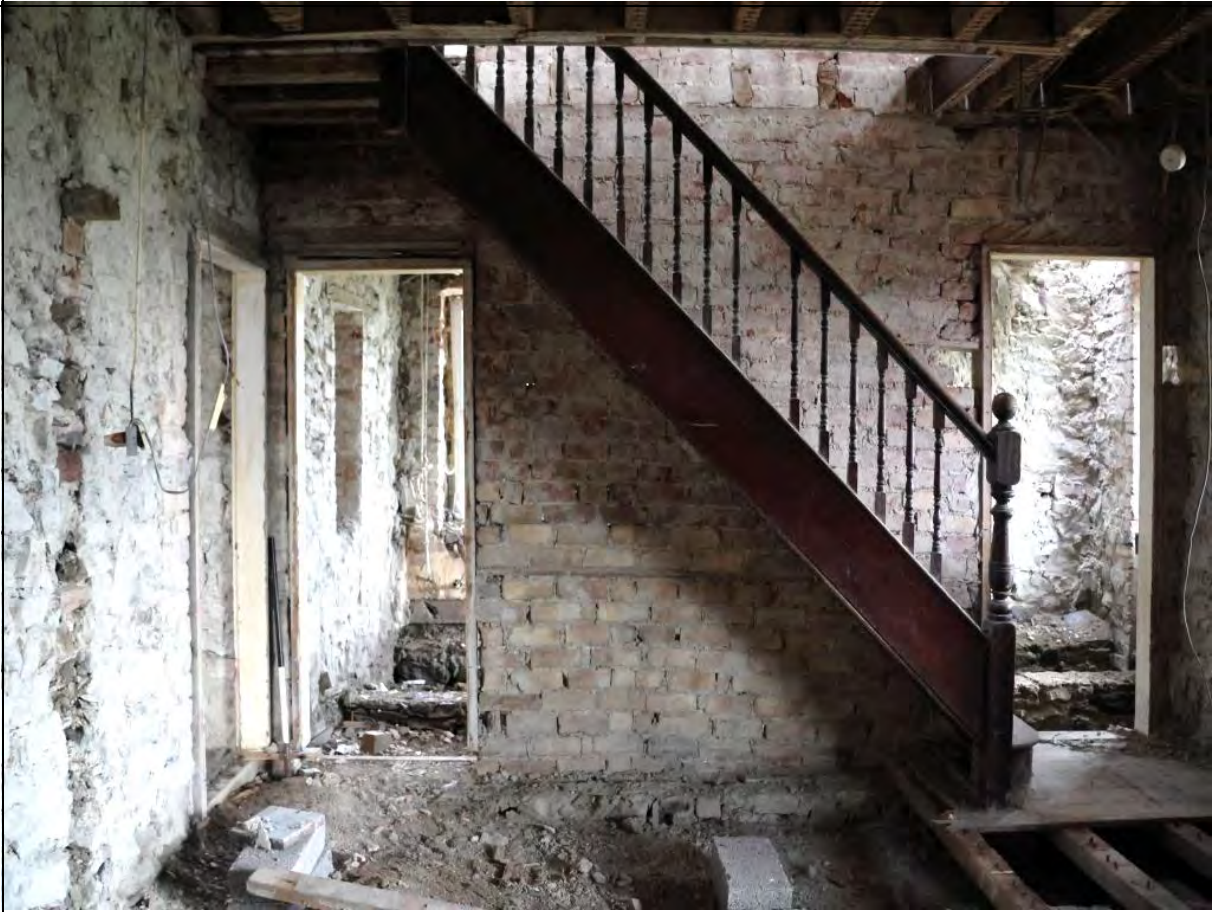
| <b>Location</b> | Ground Floor: Dining room | <b>Photo ID No:</b> | E49630_25 |

| <b>Description</b> | Southwest wall of the dining room showing staircase to the first floor | | |

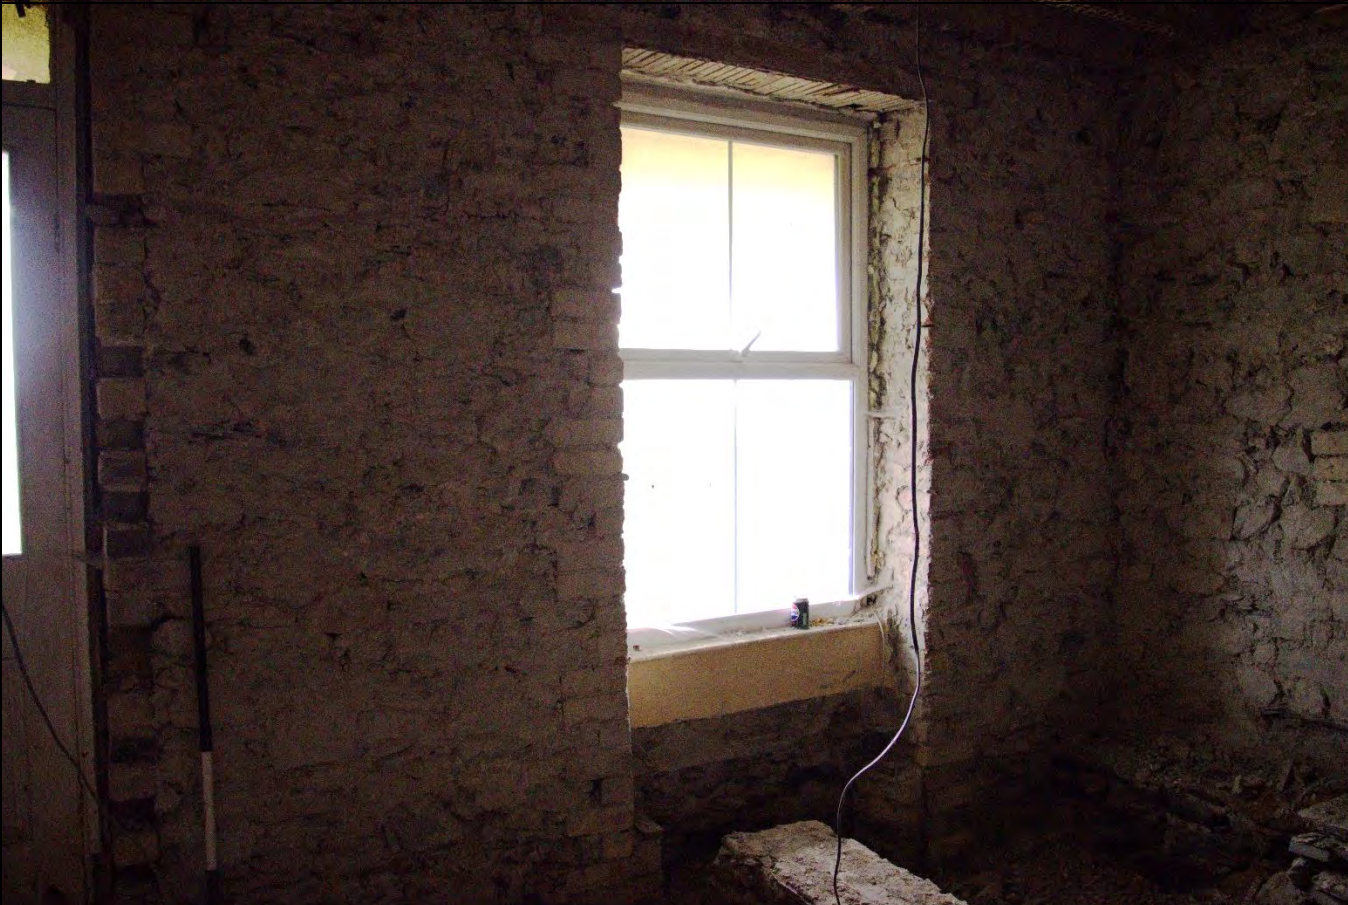
| <b>Location</b> | Ground Floor: Dining room | <b>Photo ID No:</b> | E49630_27 |

| <b>Description</b> | WNW wall of the dining room showing a window | | |

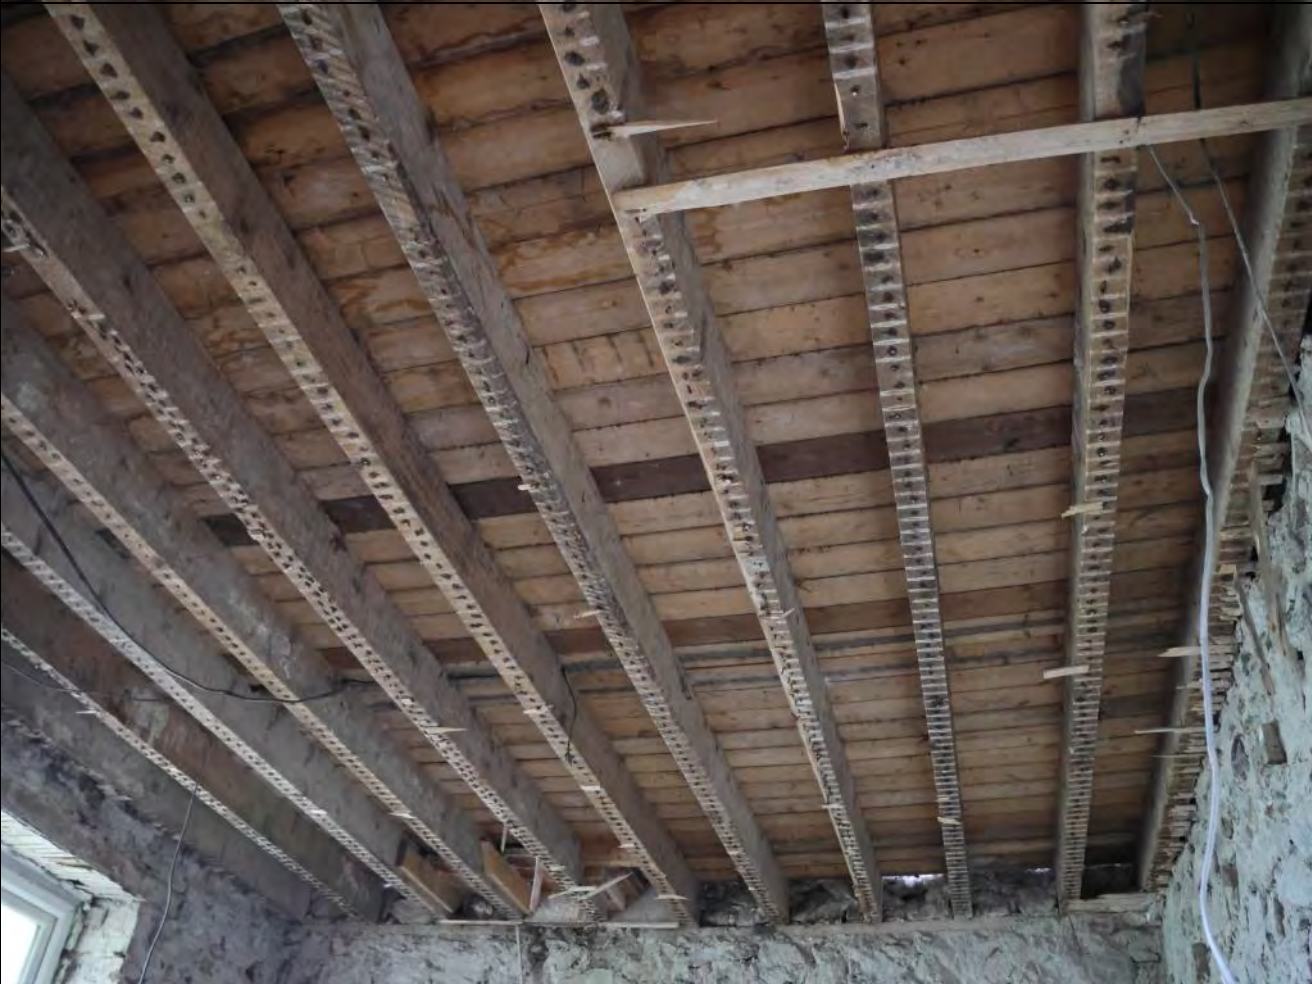
| <b>Location</b> | Ground Floor: Dining room | <b>Photo ID No:</b> | E49630_28 |

| <b>Description</b> | Dining room ceiling | | |

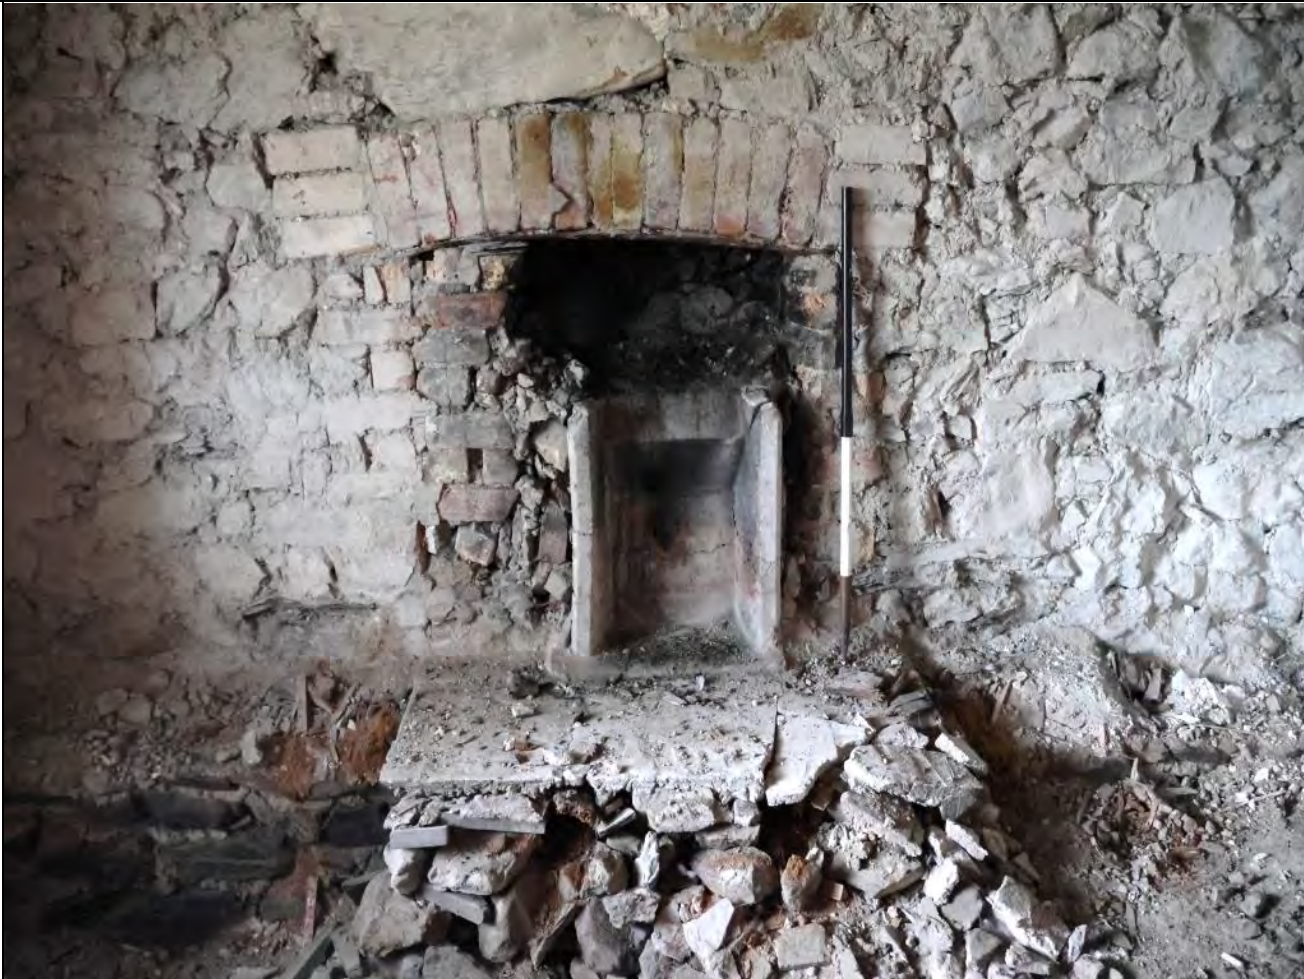
| <b>Location</b> | Ground Floor: Dining room | <b>Photo ID No:</b> | E49630_29 |

| <b>Description</b> | Close up view of fireplace in the northeast wall of the dining room | | |

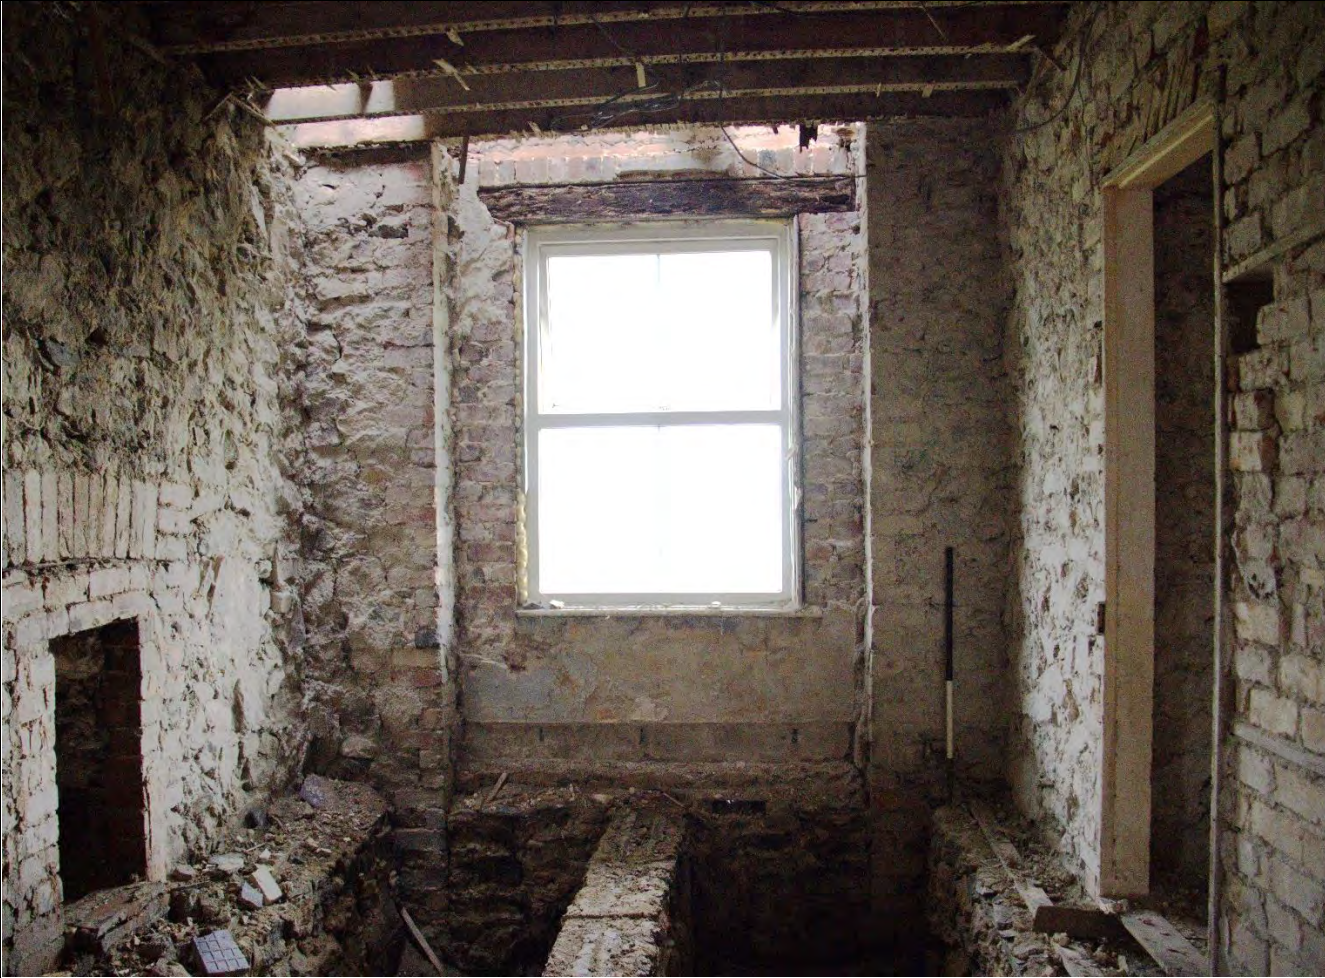
| <b>Location</b> | Ground Floor: Living Room | <b>Photo ID No:</b> | E49630_30 |

| <b>Description</b> | West-northwest wall of the living room | | |

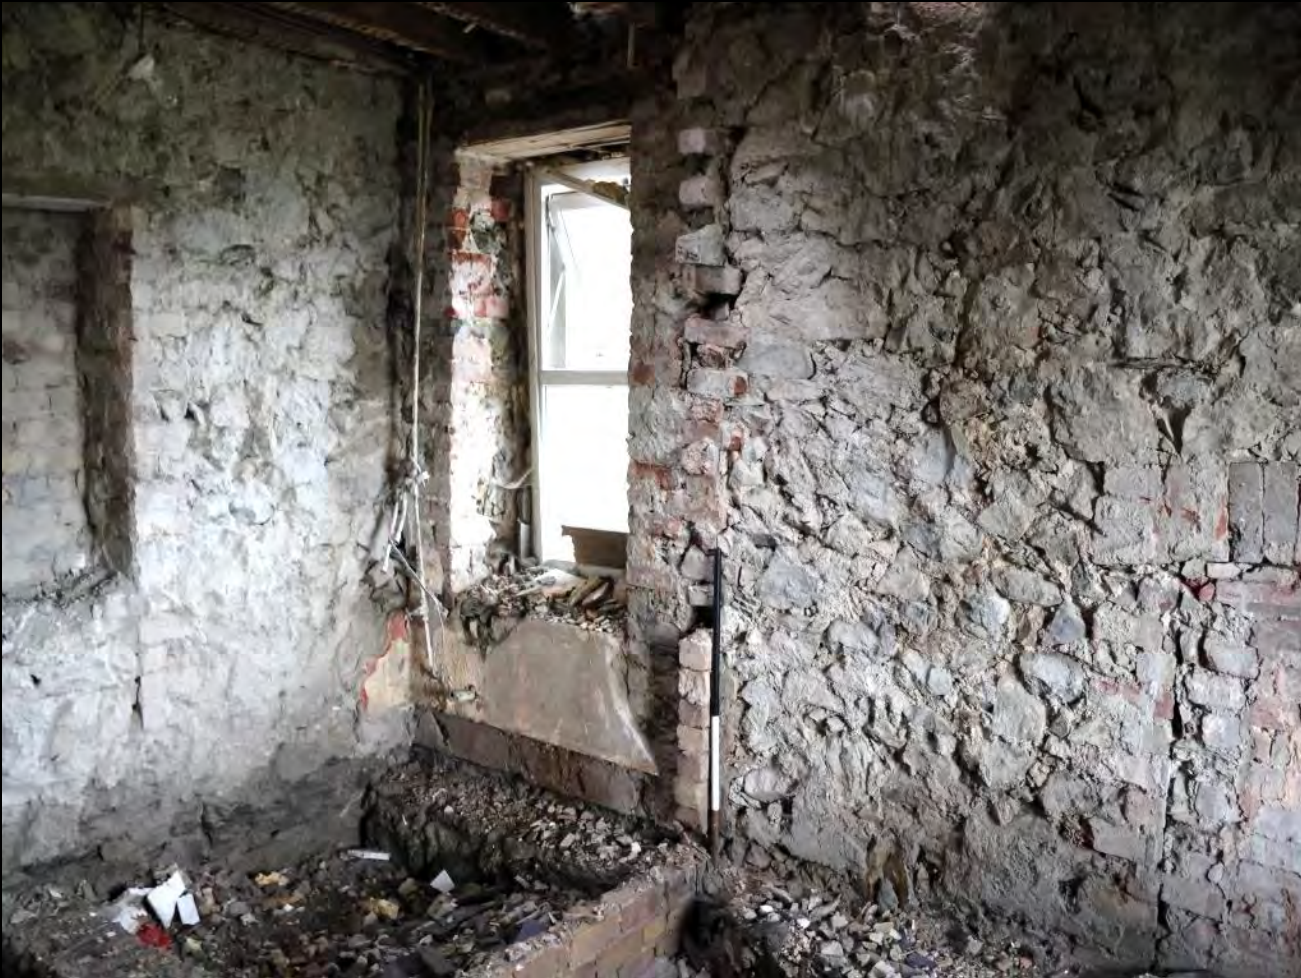
| <b>Location</b> | Ground Floor: Living Room & Pantry | <b>Photo ID No:</b> | E49630_32 |

| <b>Description</b> | Southwest wall of the living room and pantry showing window (oblique view) | | |

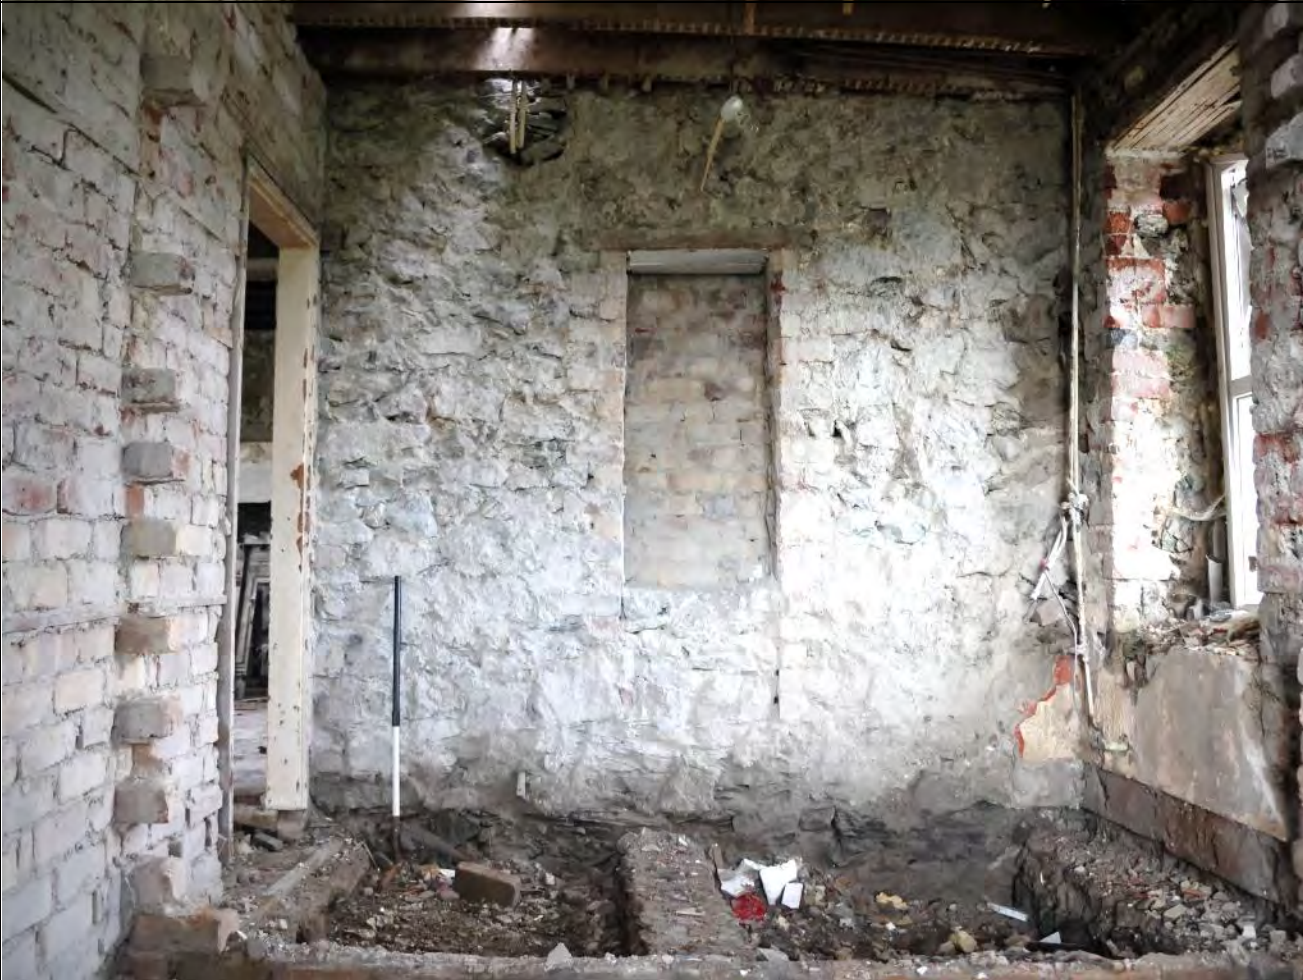
| <b>Location</b> | Ground Floor: Pantry | <b>Photo ID No:</b> | E49630_33 |

| <b>Description</b> | East-southeast wall of the pantry showing blocked up window and exposed floor supports | | |

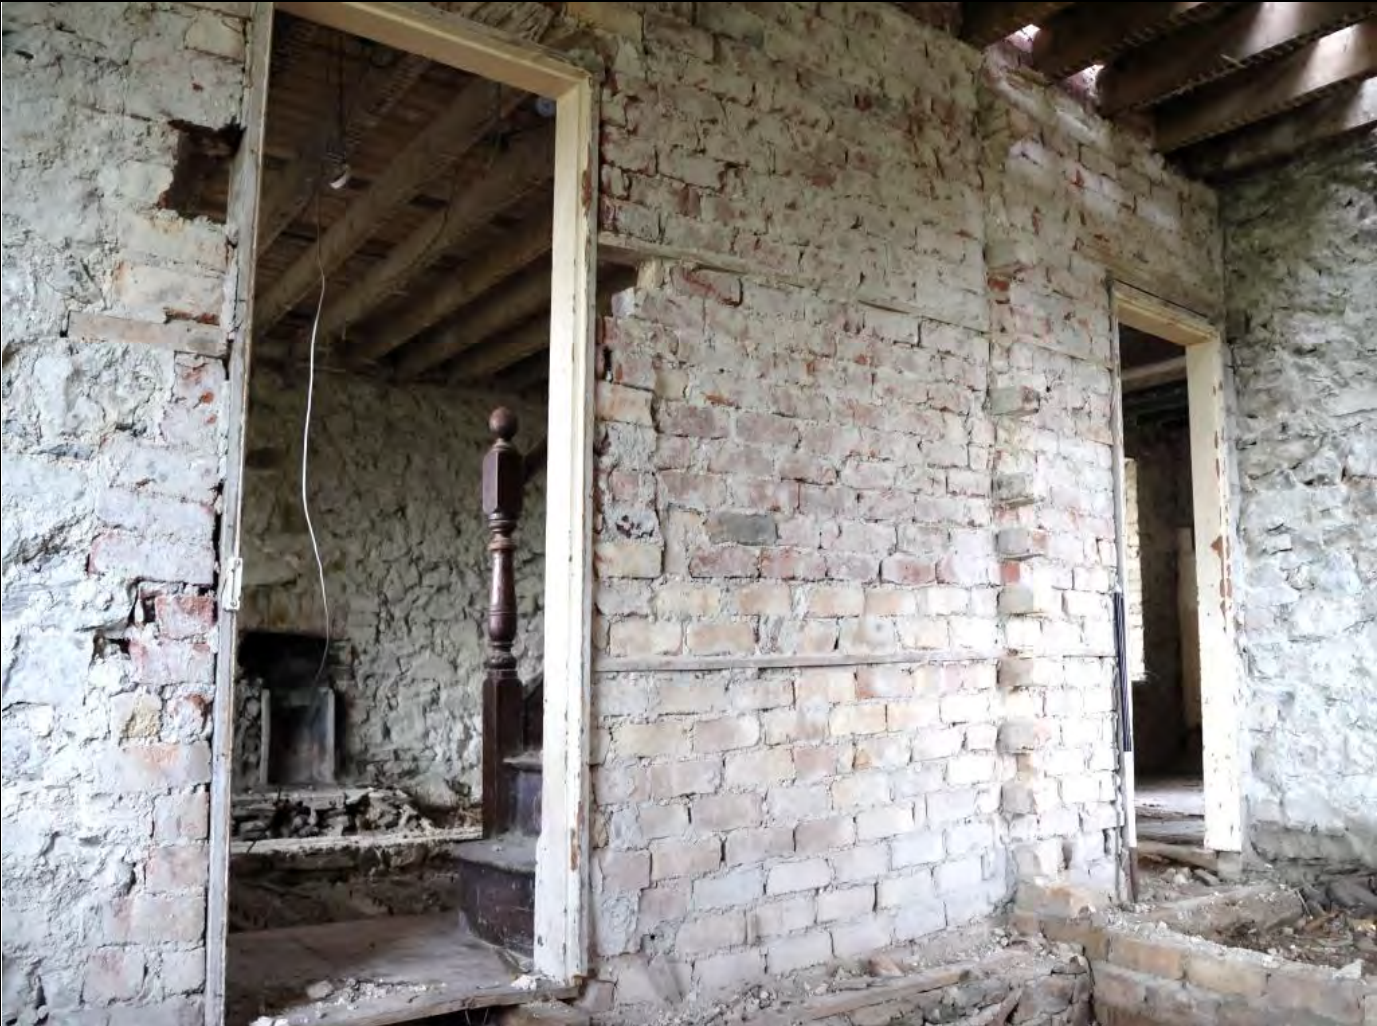
| <b>Location</b> | Ground Floor: Living Room & Pantry | <b>Photo ID No:</b> | E49630_35 |

| <b>Description</b> | View northeast of brick wall of the living room/pantry showing doorway to the dining room and previous wall (oblique) | | |

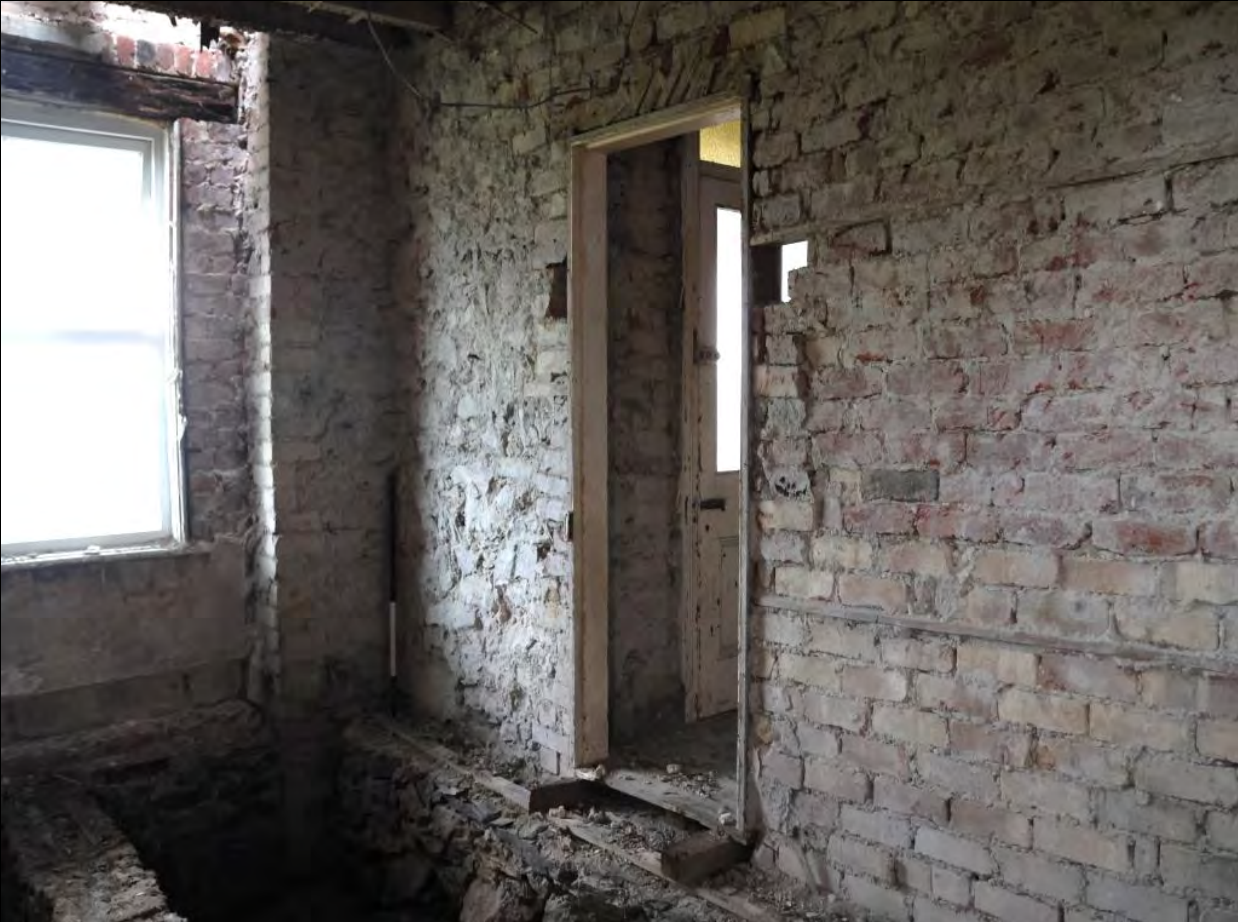
| <b>Location</b> | Ground Floor: Living Room & Pantry | <b>Photo ID No:</b> | E49630_36 |

| <b>Description</b> | View northeast of brick wall of the living room/pantry showing doorway to the dining room and previous wall (oblique) | | |
