## **Fferm Glanrafon, Ynys Môn / Glanrafon Farm, Anglesey**

Arolwg Ffotograffig / Photographic Survey

Rhif Prosiect / Project No. HD25-023

Rhif Adroddiad / Report No. 1830

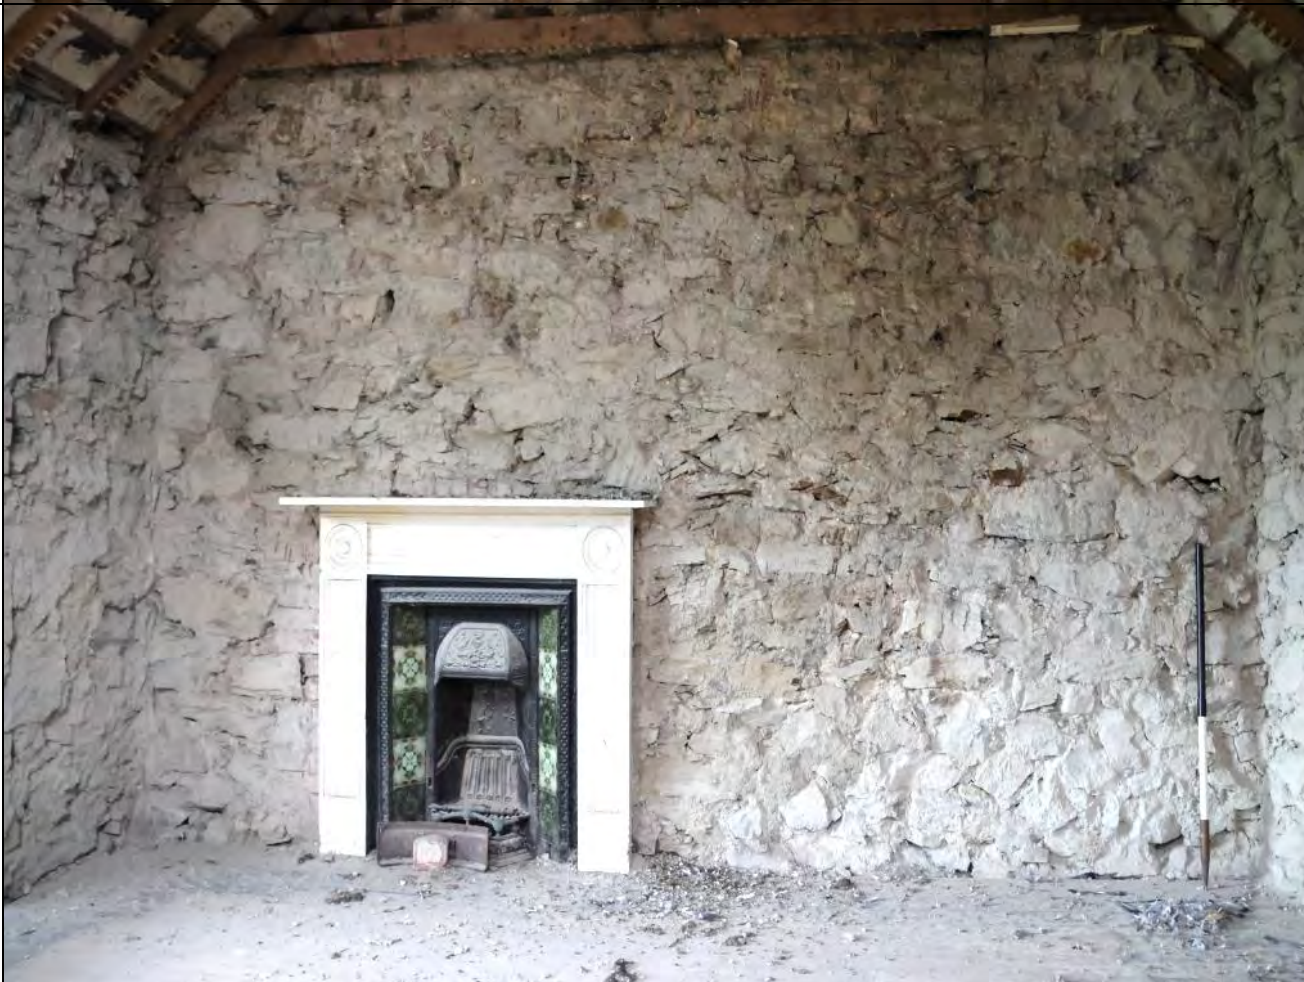
| <b>Location</b> | First Floor: Bedroom 2 | <b>Photo ID No:</b> | E49630_37 |

| <b>Description</b> | Northeast wall of bedroom 2 showing fireplace | | |

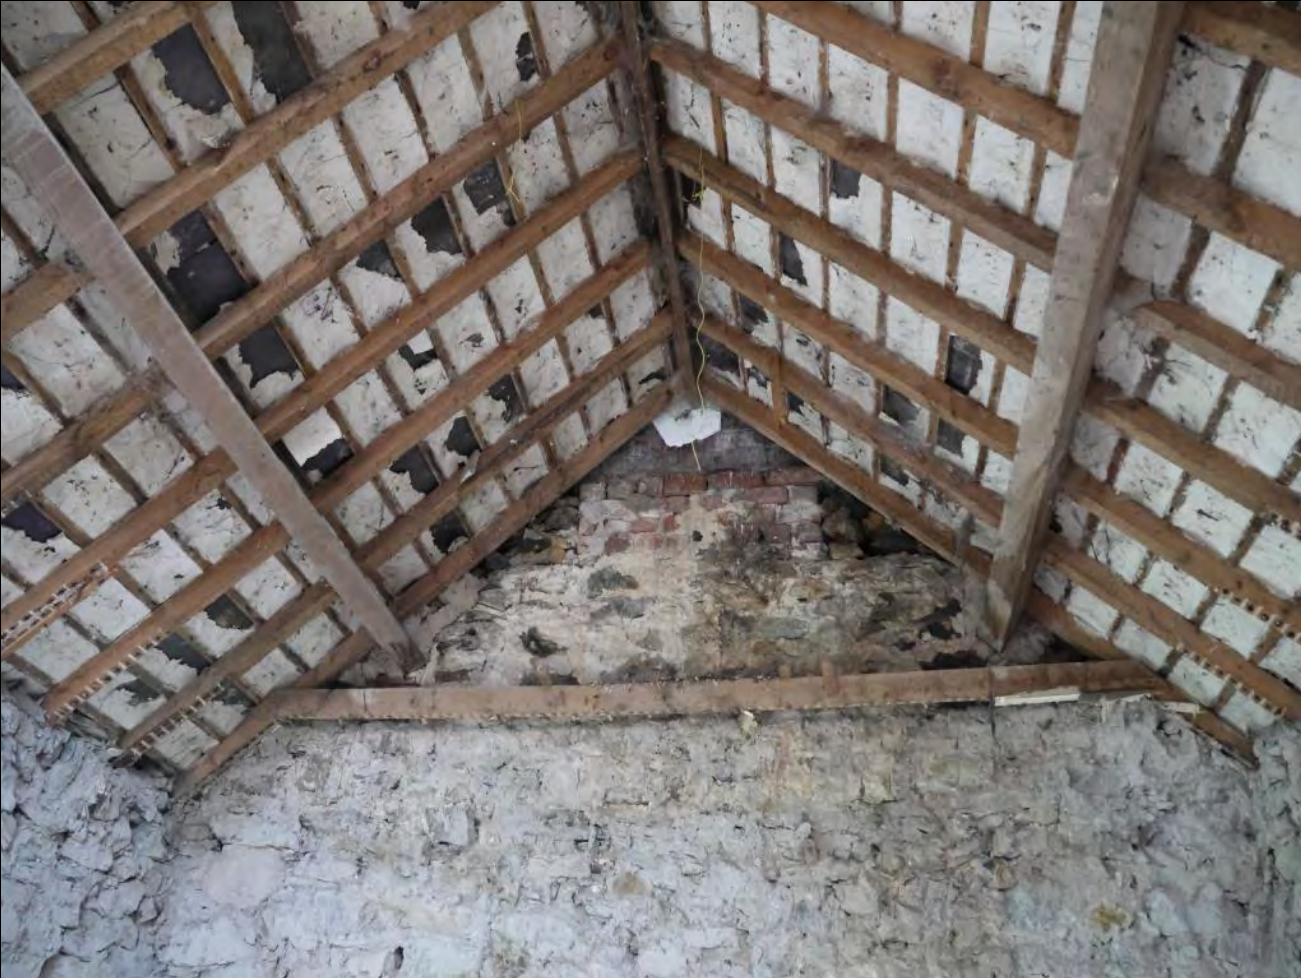
| <b>Location</b> | First Floor: Bedroom 2 | <b>Photo ID No:</b> | E49630_38 |

| <b>Description</b> | Northeast wall of bedroom 2 and roof detail | | |

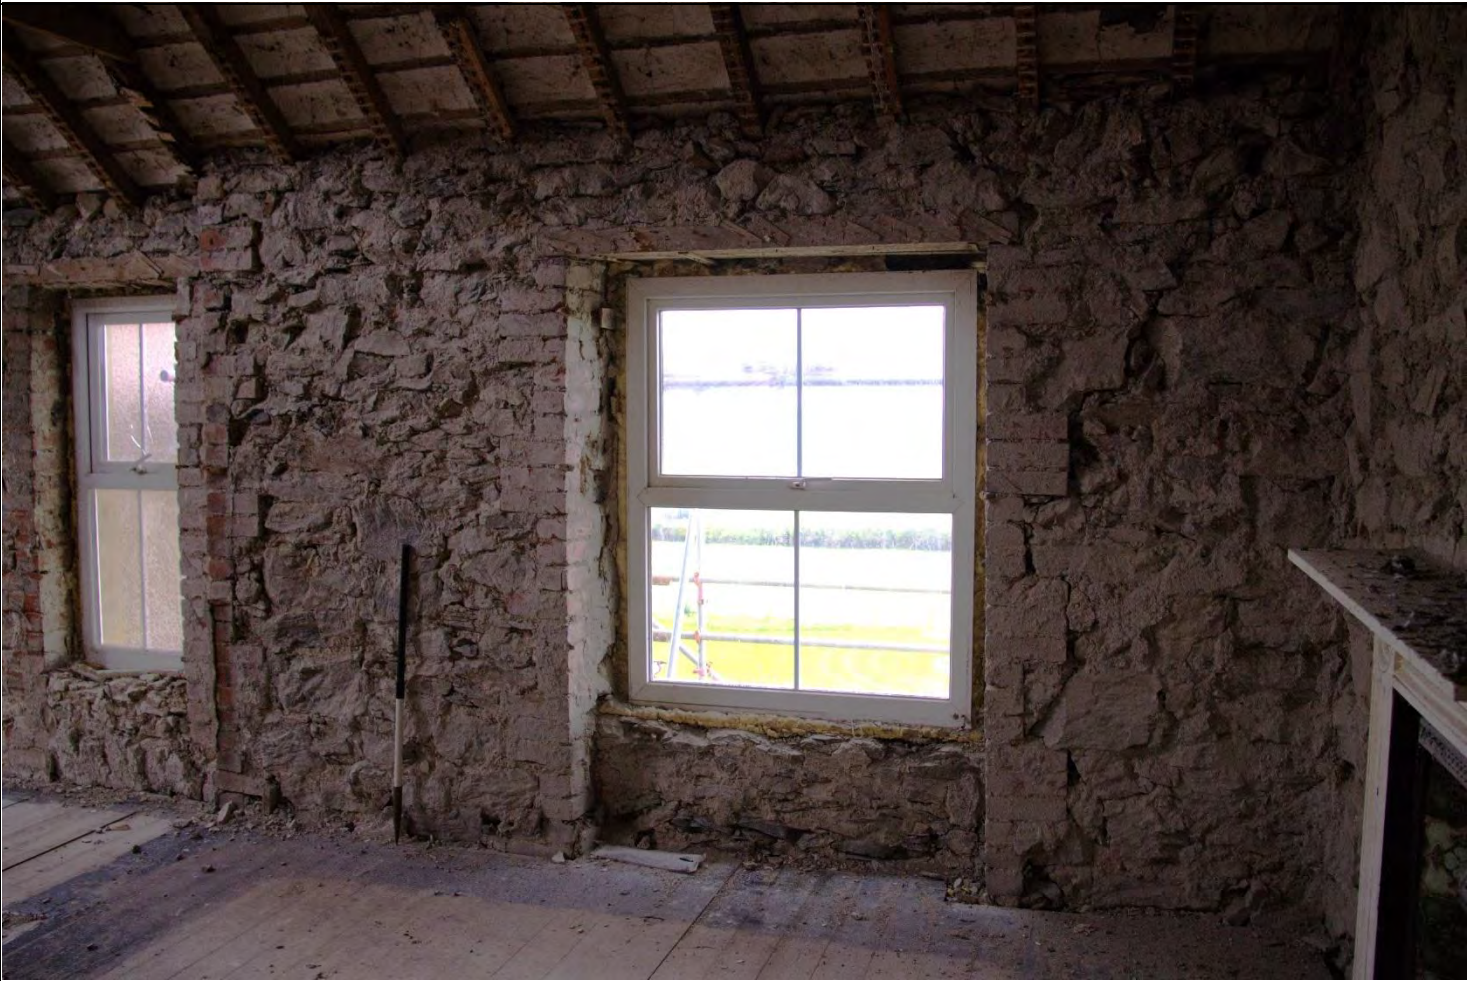
| <b>Location</b> | First Floor: Bedroom 2 | <b>Photo ID No:</b> | E49630_39 |

| <b>Description</b> | West-northwest wall of bedroom 2 | | |

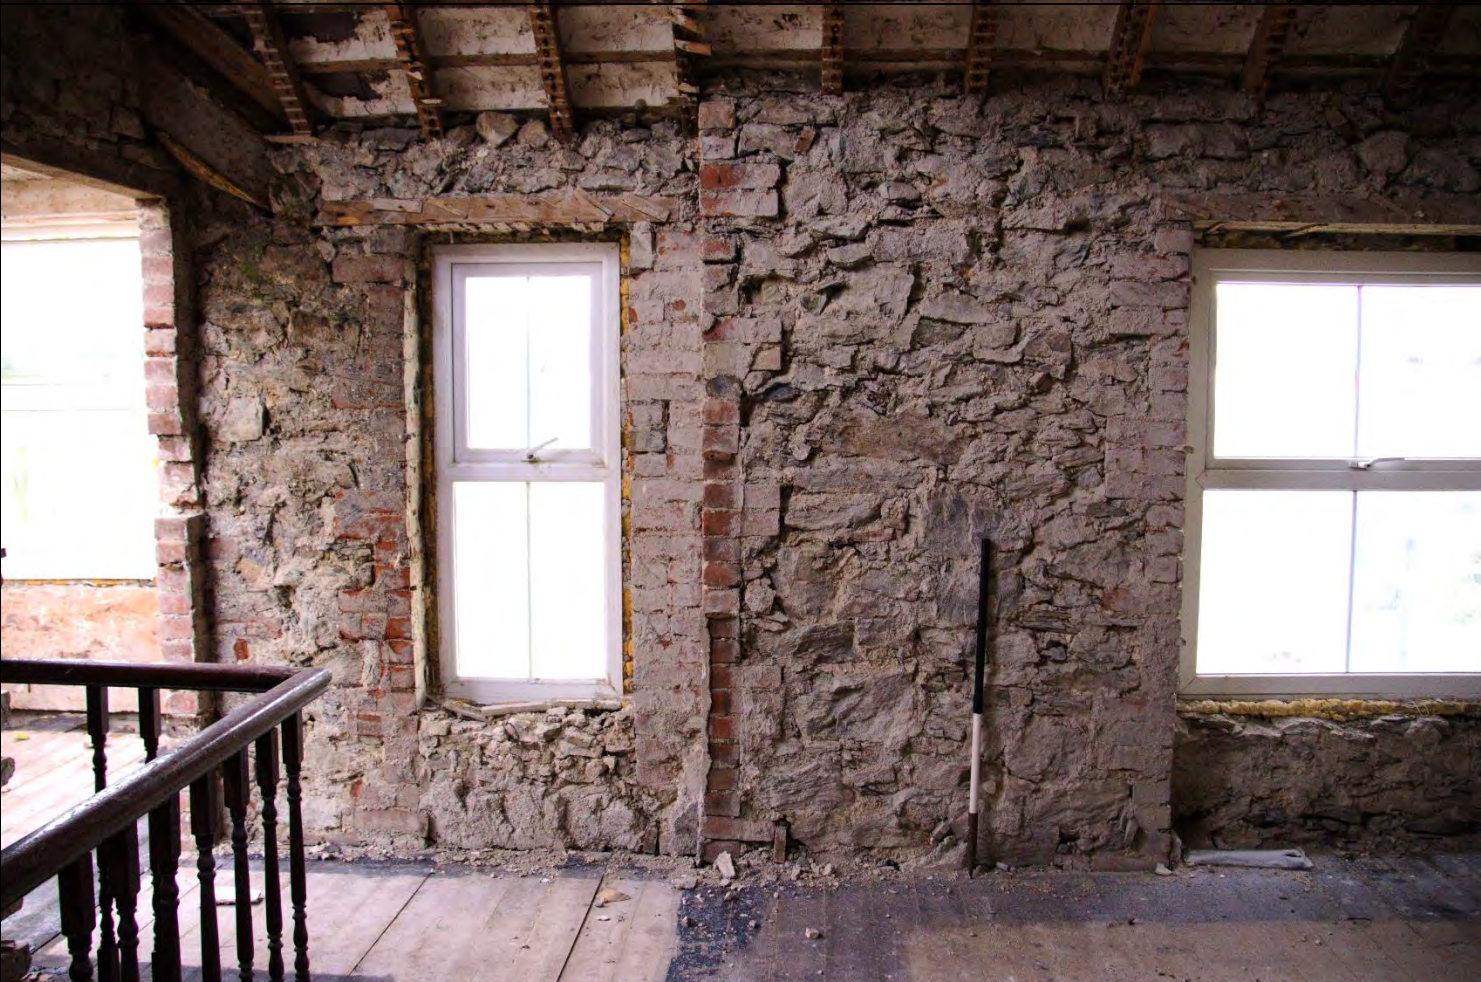
| <b>Location</b> | First Floor: Bedroom 2 | <b>Photo ID No:</b> | E49630_40 |

| <b>Description</b> | West-northwest wall of bedroom 2 | | |

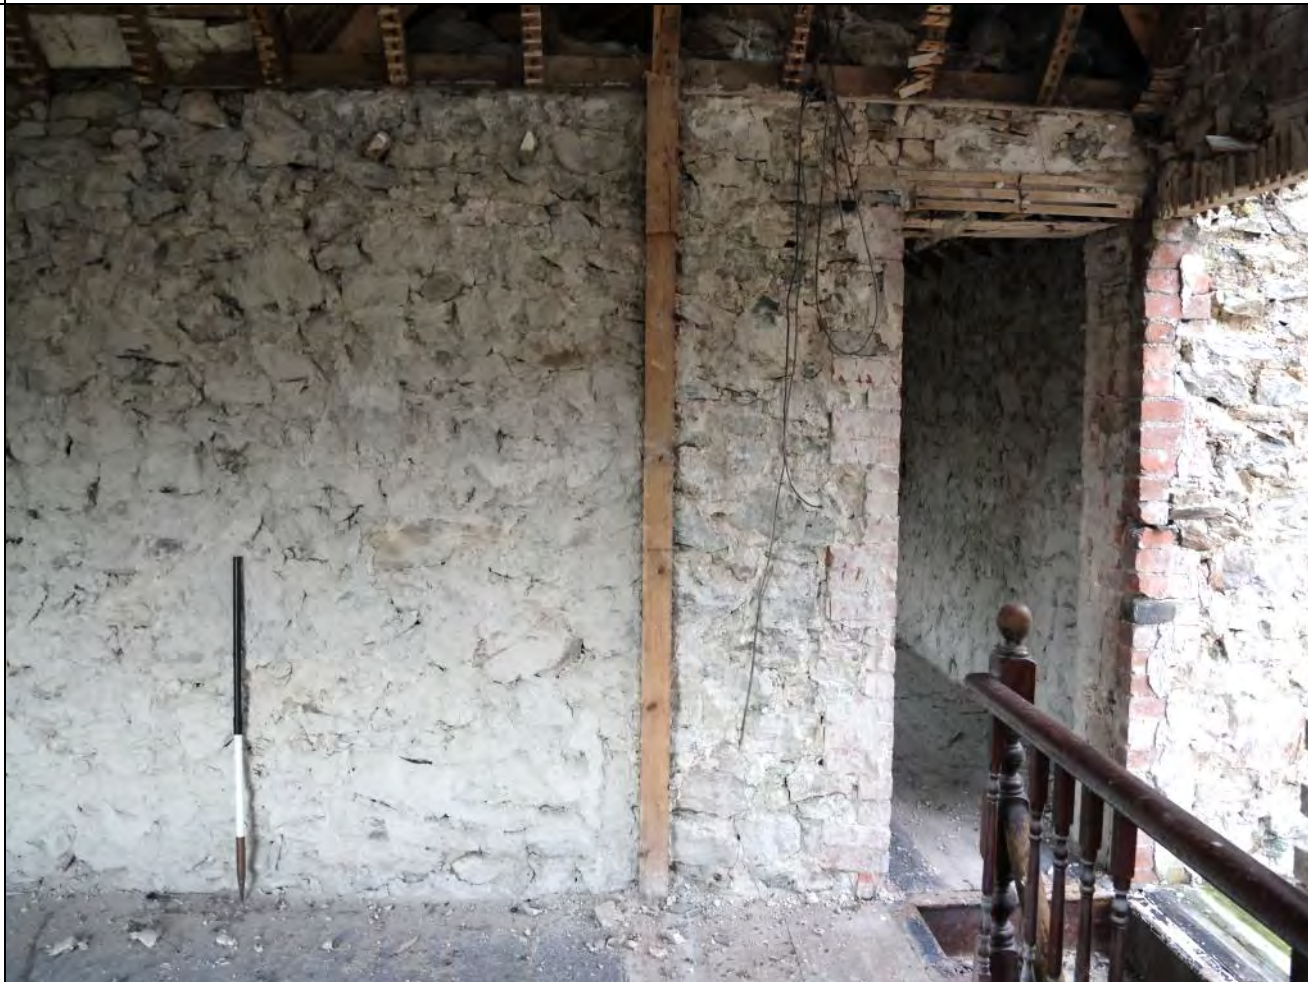
| <b>Location</b> | First Floor: Bedroom 2 | <b>Photo ID No:</b> | E49630_42 |

| <b>Description</b> | East-southeast wall of bedroom 2 | | |

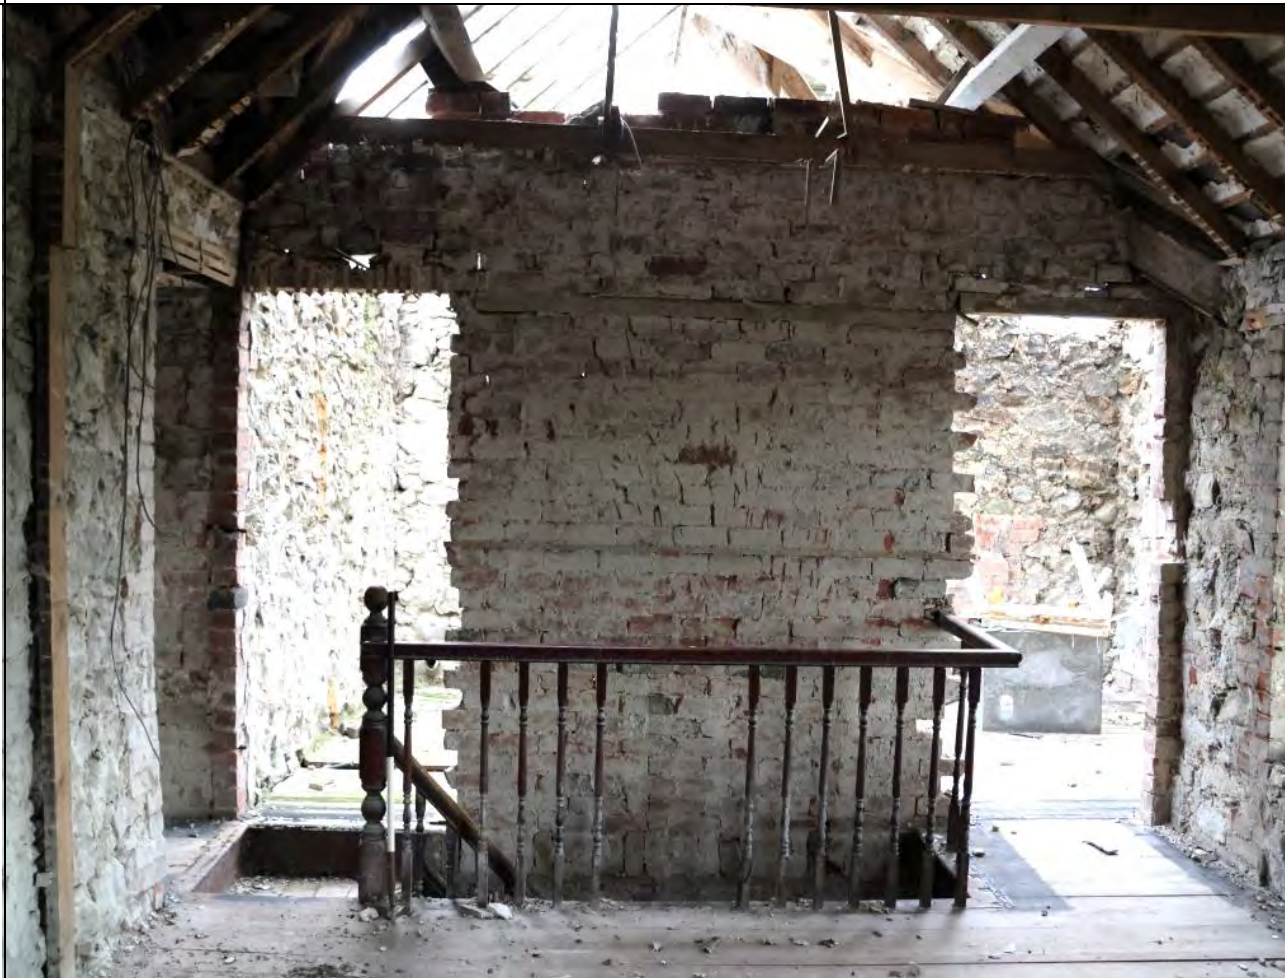
| <b>Location</b> | First Floor: Bedroom 2 | <b>Photo ID No:</b> | E49630_43 |

| <b>Description</b> | Southwest wall of bedroom 2 and staircase | | |

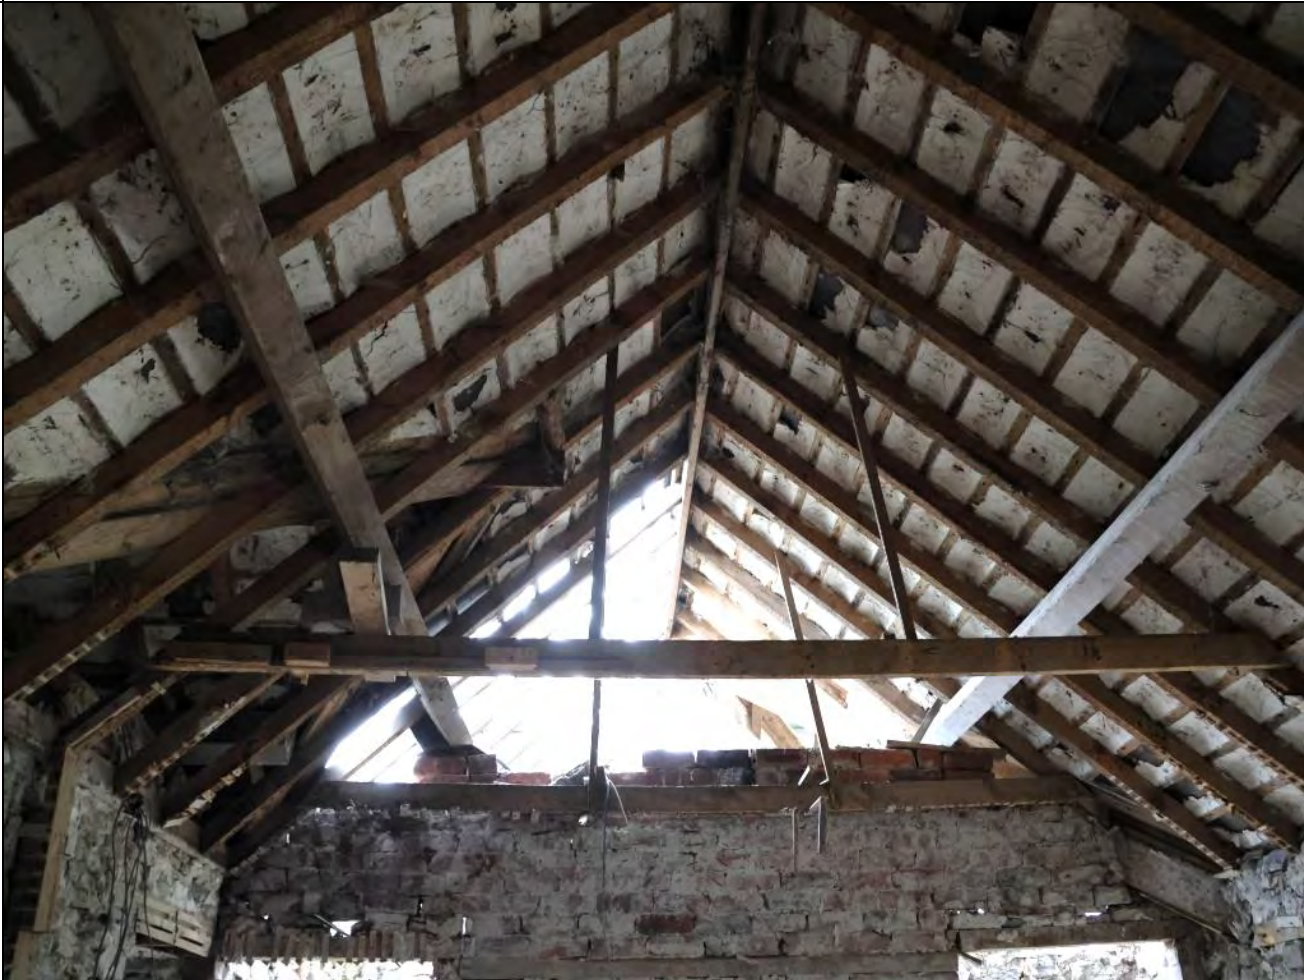
| <b>Location</b> | First Floor: Bedroom 2 | <b>Photo ID No:</b> | E49630_44 |

| <b>Description</b> | Roof detail within bedroom 2 | | |

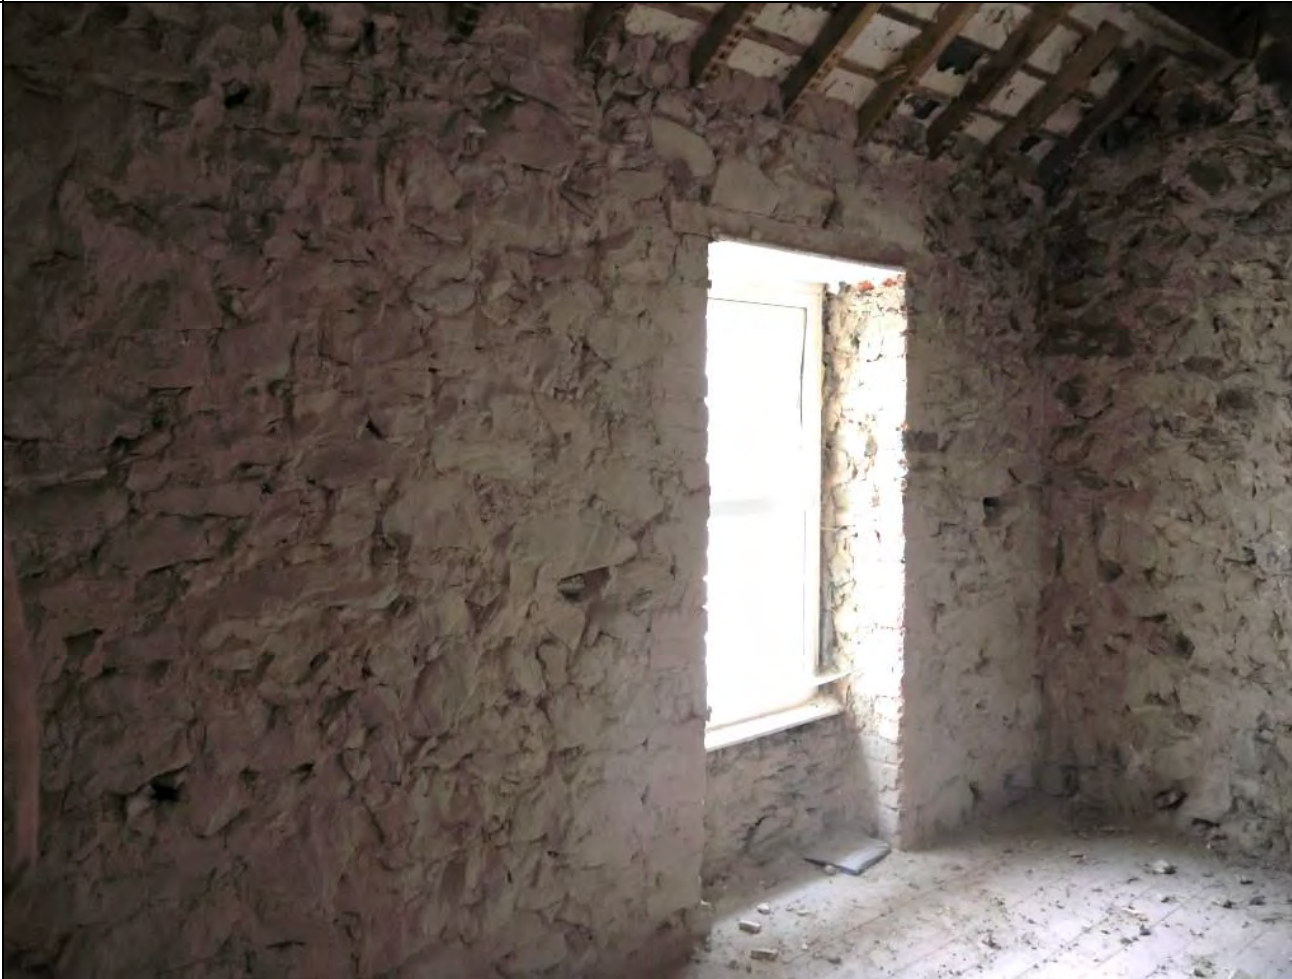
| <b>Location</b> | First Floor: Bedroom 1 | <b>Photo ID No:</b> | E49630_46 |

| <b>Description</b> | Northeastwall of bedroom 1 | | |

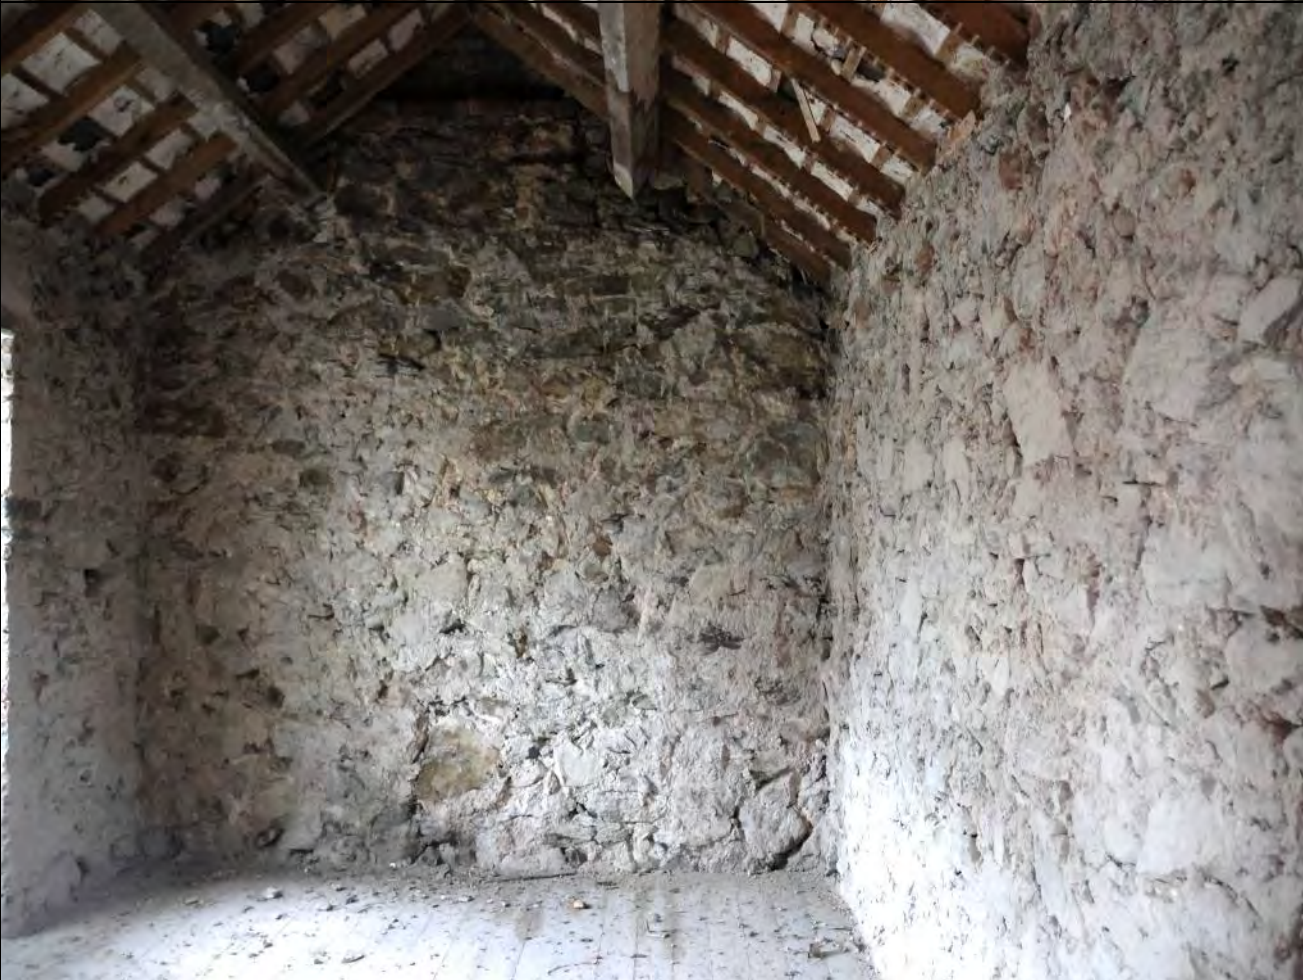
| <b>Location</b> | First Floor: Bedroom 1 | <b>Photo ID No:</b> | E49630_47 |

| <b>Description</b> | Eesat-southeast wall of bedroom 1 | | |

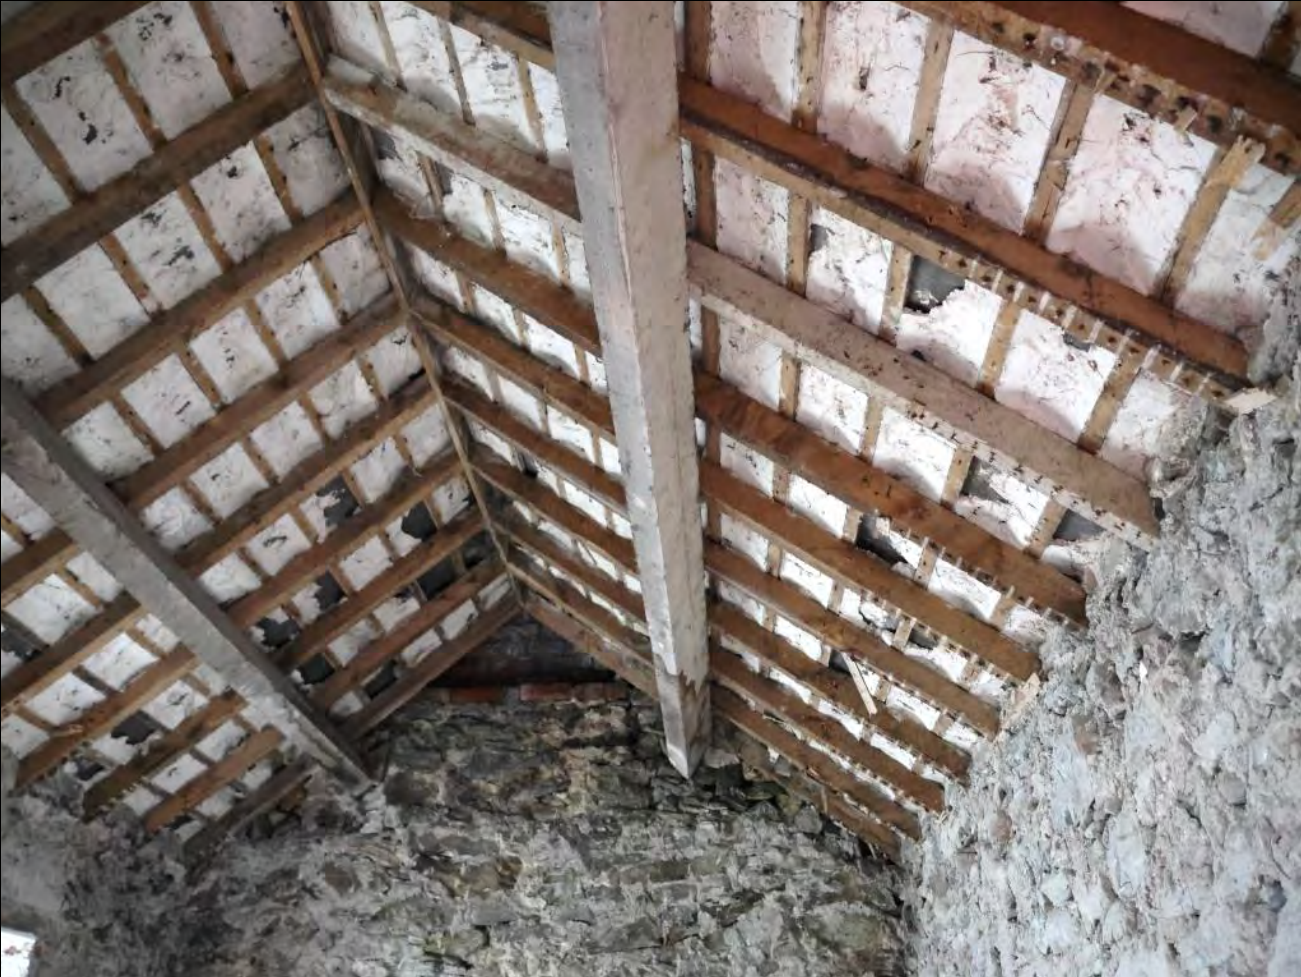
| <b>Location</b> | First Floor: Bedroom 1 | <b>Photo ID No:</b> | E49630_48 |

| <b>Description</b> | Roof detail in bedroom 1 | | |

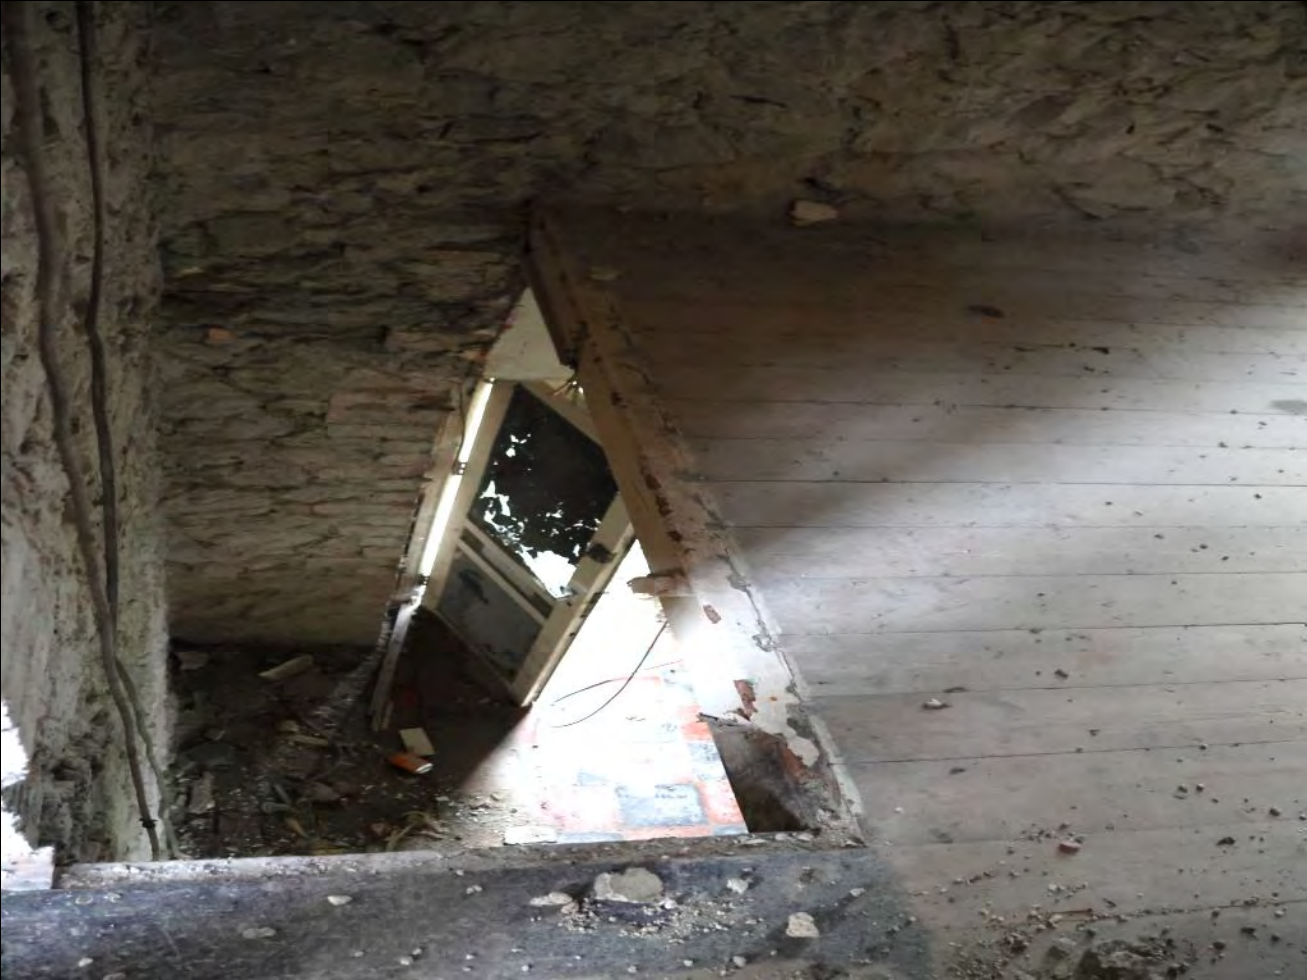
| <b>Location</b> | First Floor: Bedroom 1 | <b>Photo ID No:</b> | E49630_49 |

| <b>Description</b> | Location of removed staircase leading down to the kitchen from bedroom 1 | | |

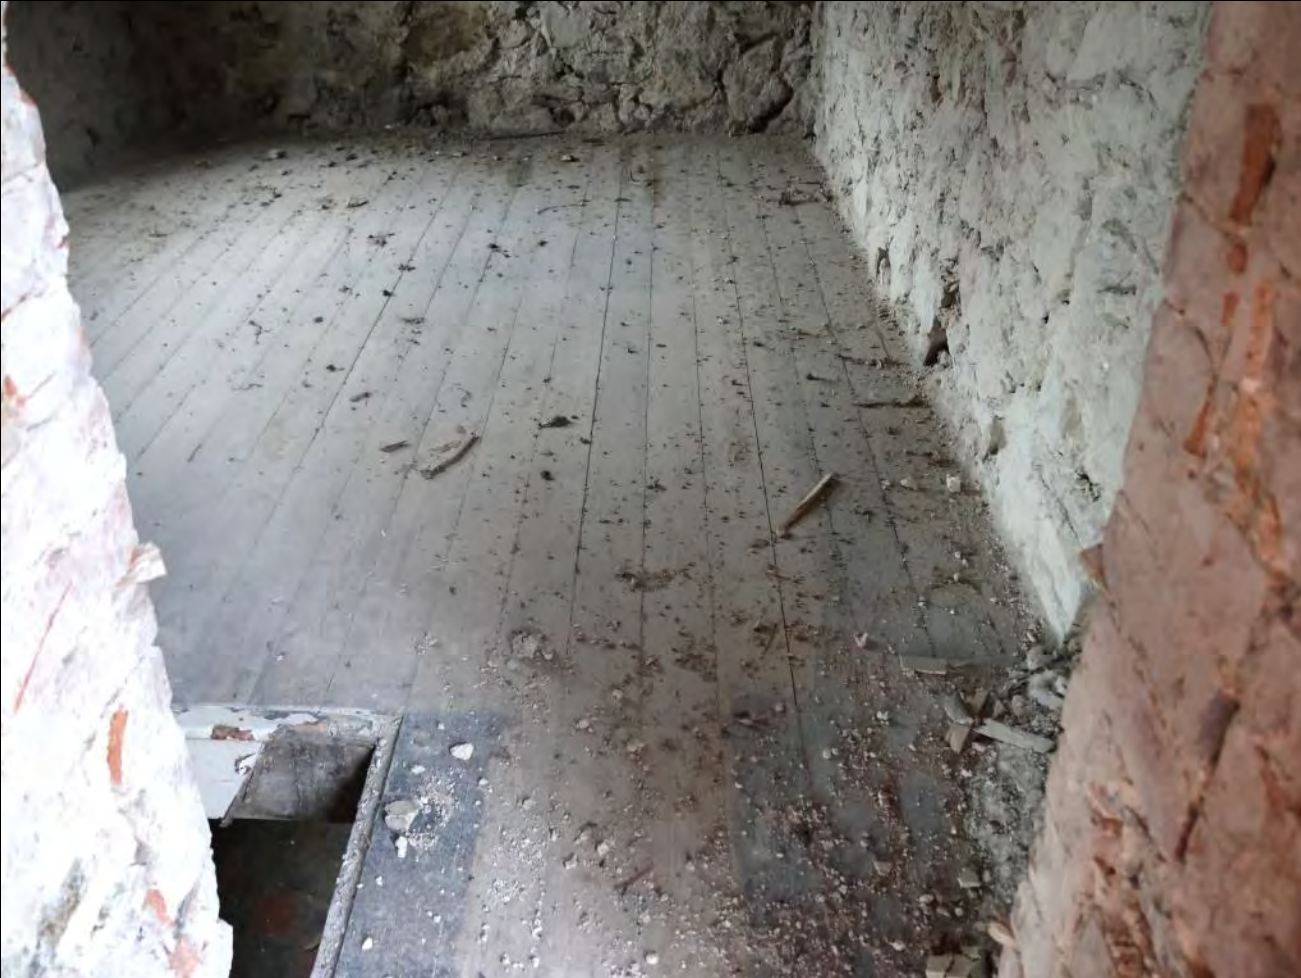
| <b>Location</b> | First Floor: Bedroom 1 | <b>Photo ID No:</b> | E49630_50 |

| <b>Description</b> | Floor of bedroom 1 | | |

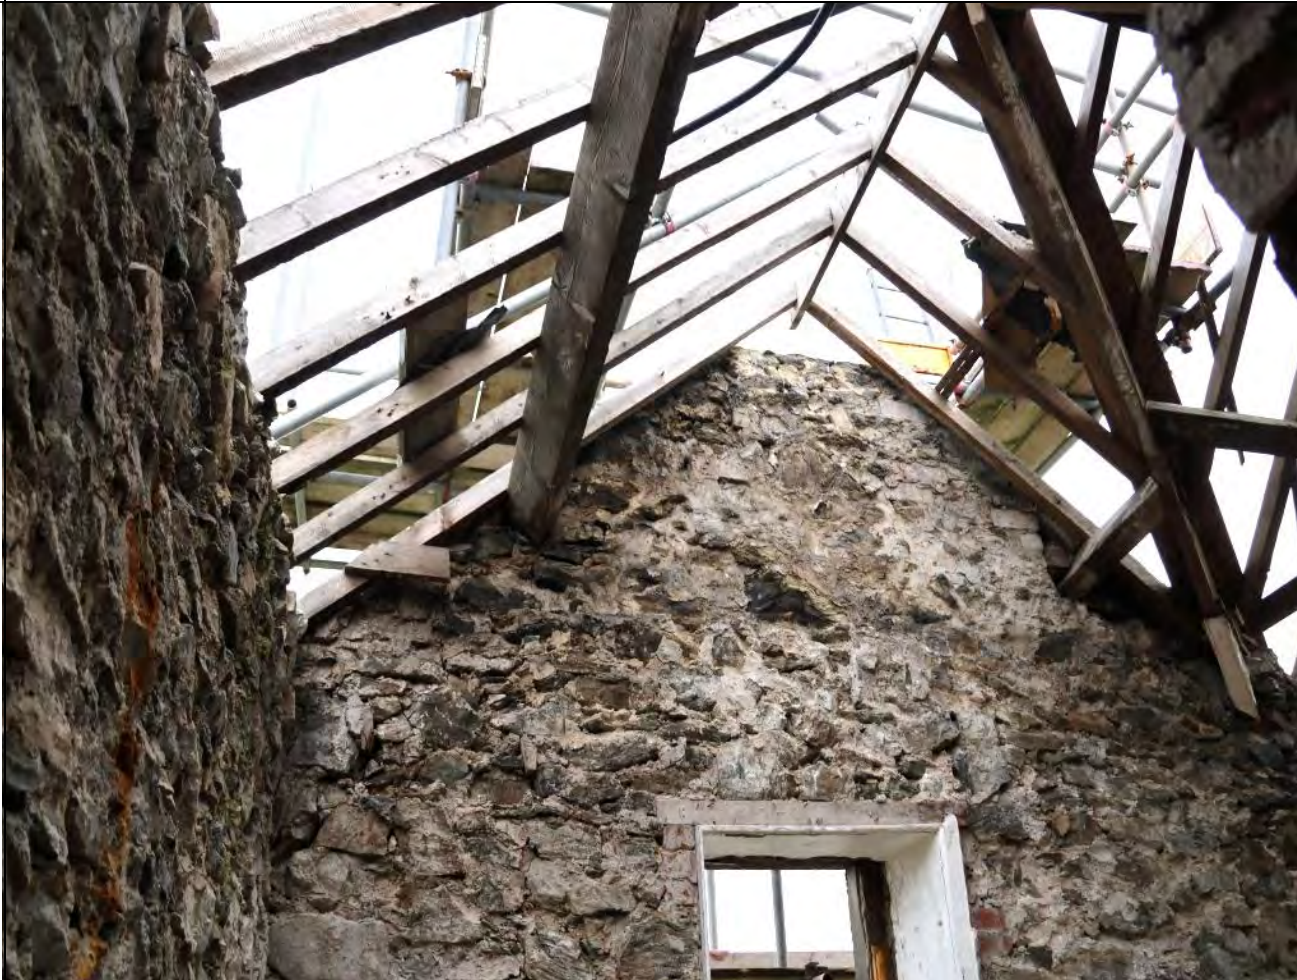
| <b>Location</b> | First Floor: Bedroom 3 | <b>Photo ID No:</b> | E49630_53 |

| <b>Description</b> | Southwest wall of bedroom 3 and bathroom showing the roof detail | | |

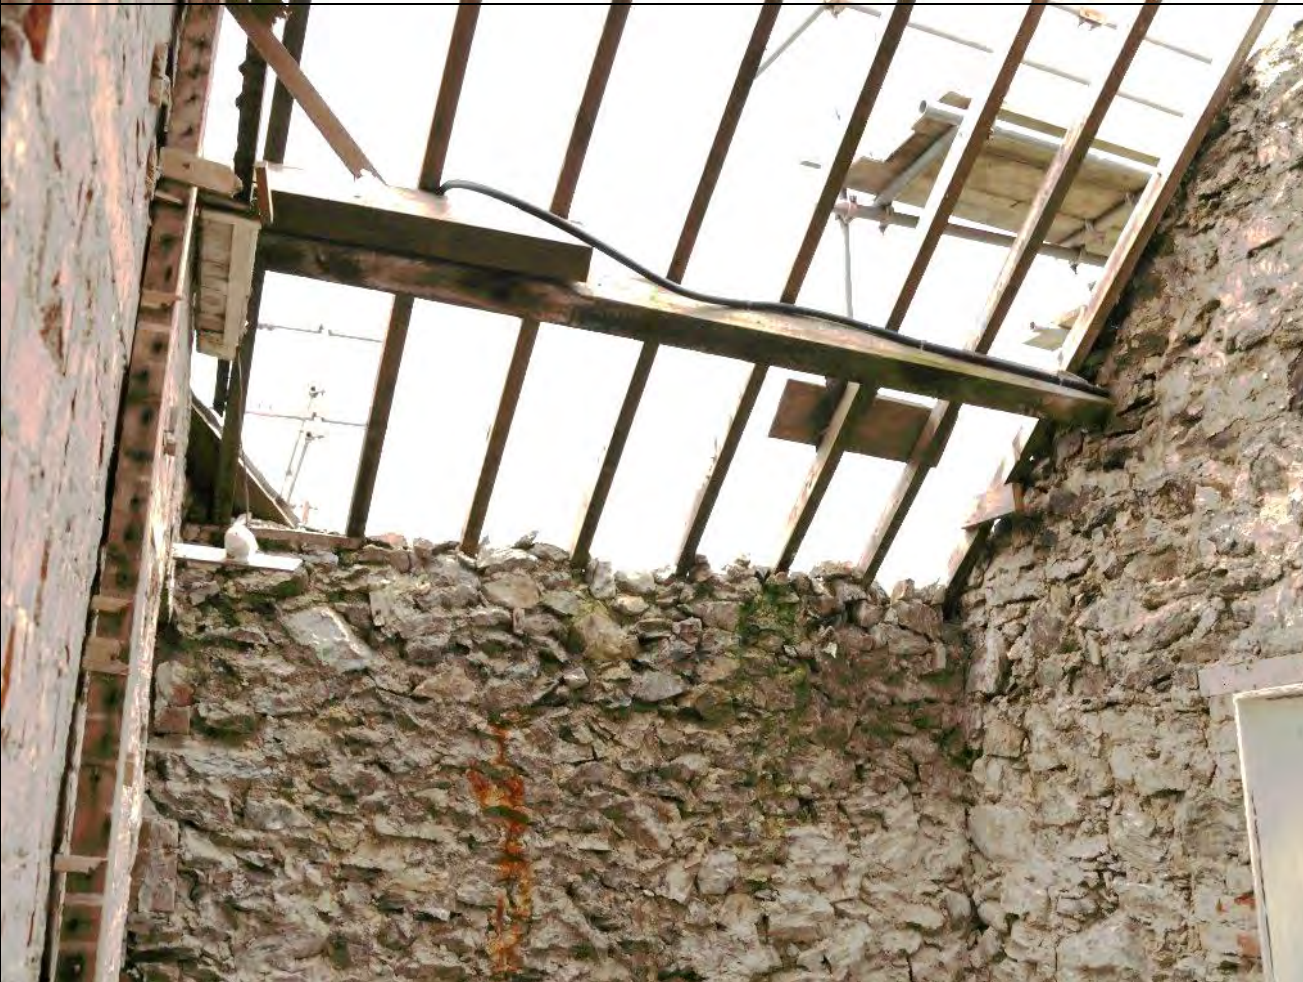
| <b>Location</b> | First Floor: Bedroom 3 | <b>Photo ID No:</b> | E49630_57 |

| <b>Description</b> | East-southeast wall of bedroom 3 and roof detail | | |

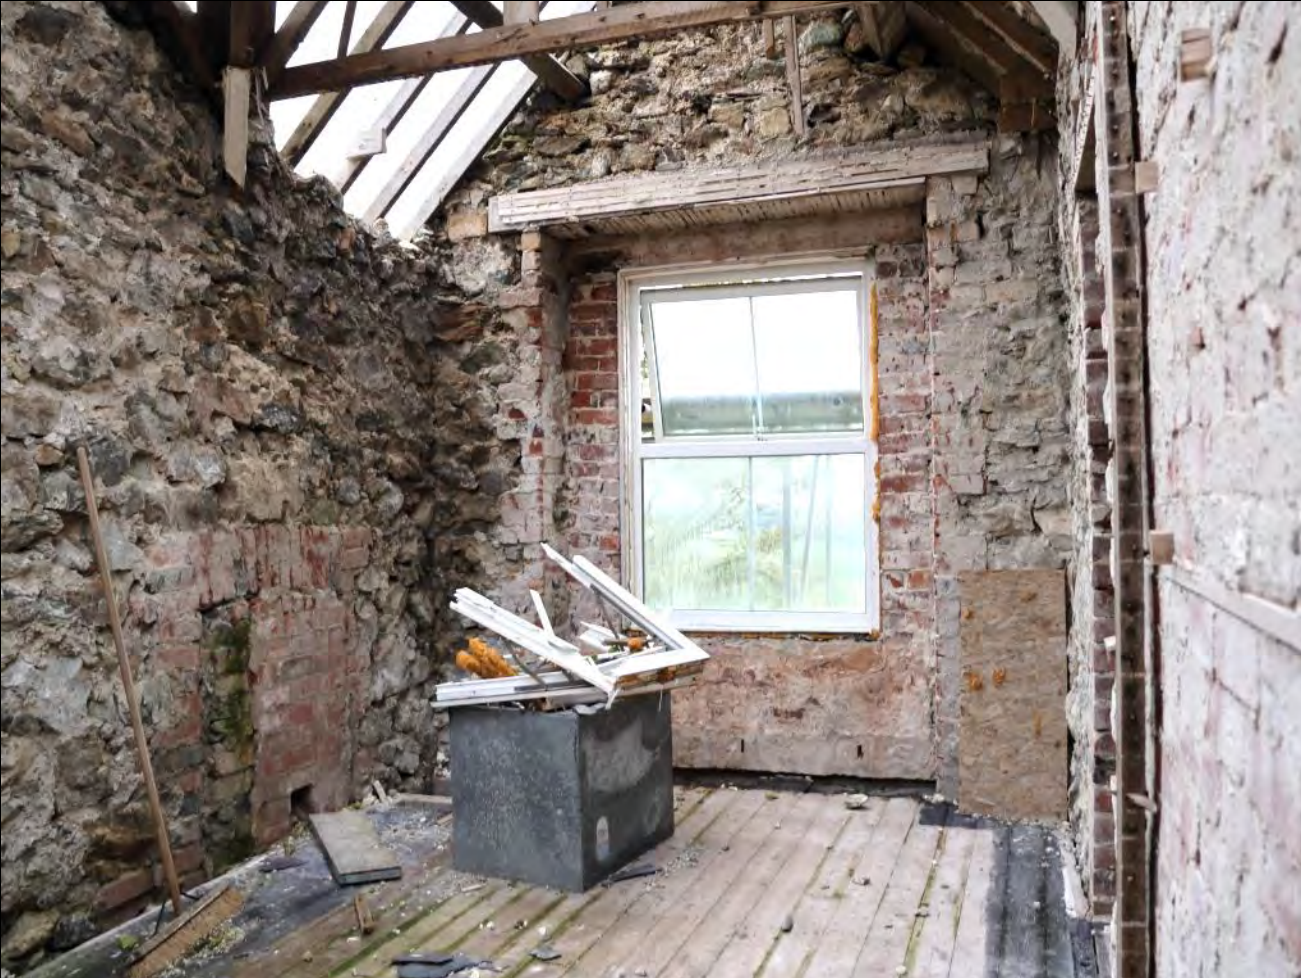
| <b>Location</b> | First Floor: Bedroom 3 | <b>Photo ID No:</b> | E49630_58 |

| <b>Description</b> | West-northwest wall of bedroom 3 | | |

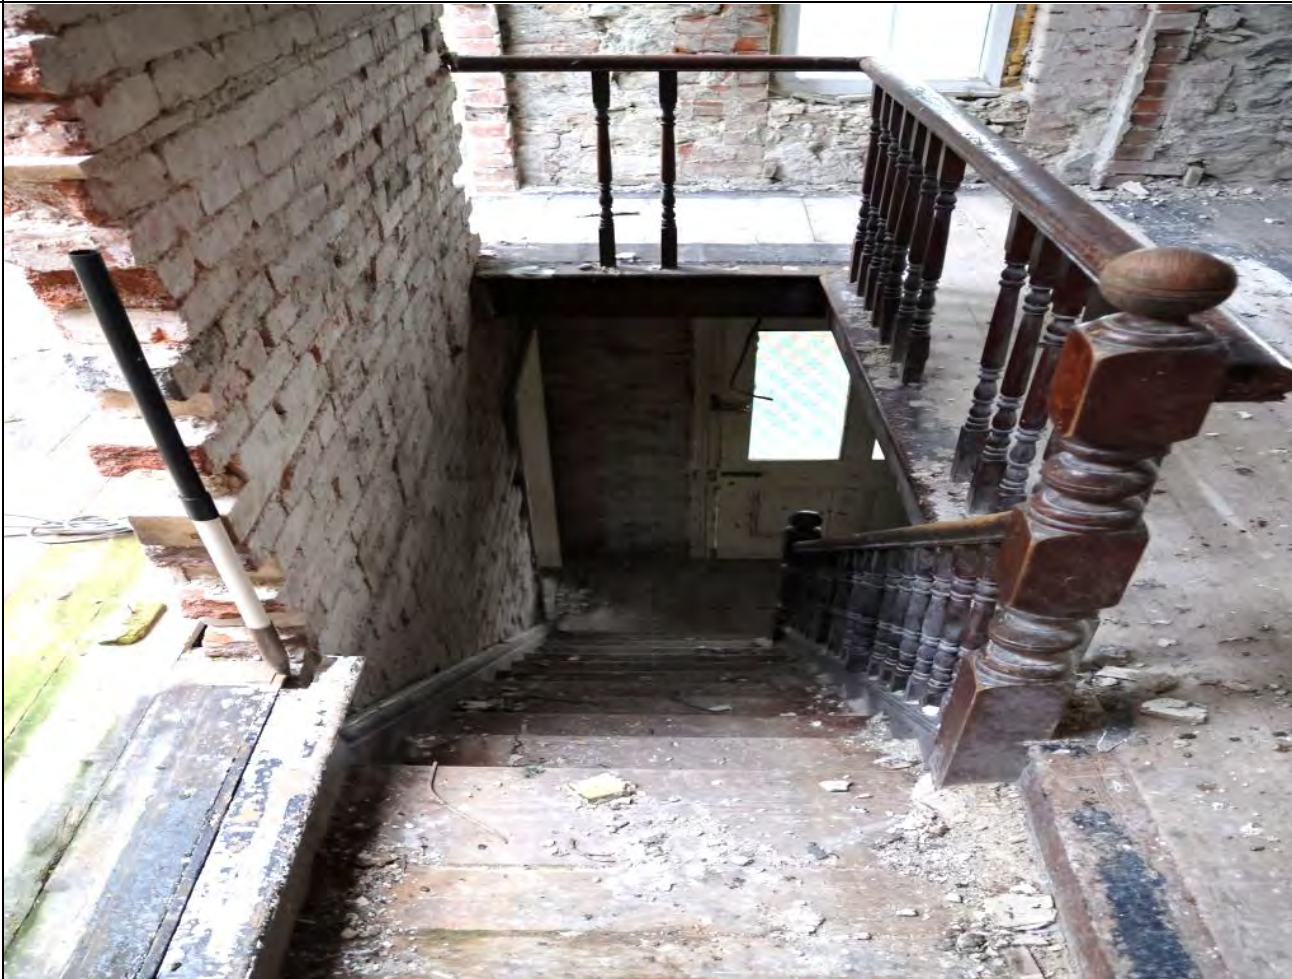
| Location | First Floor: Bedroom 2 | Photo ID No: | E49630_61 |

| Description | View down the staircase to the ground floor from bedroom 2 | | |

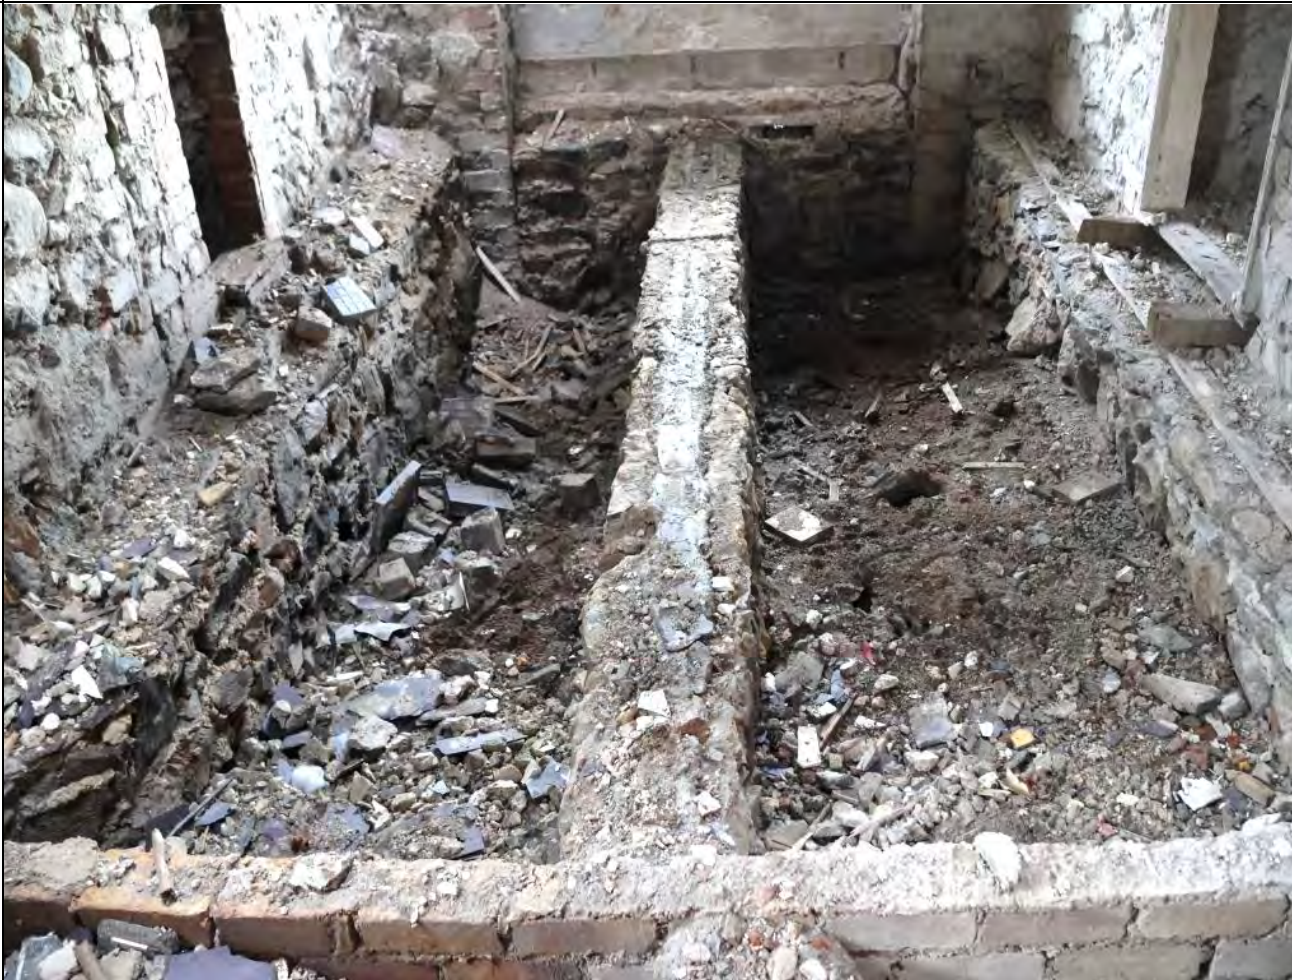
| <b>Location</b> | Ground Floor: Living room | <b>Photo ID No:</b> | E49630_63 |

| <b>Description</b> | Floor of living room | | |
