## **Fferm Glanrafon, Ynys Môn / Glanrafon Farm, Anglesey**

Arolwg Ffotograffig / Photographic Survey

Rhif Prosiect / Project No. HD25-023

Rhif Adroddiad / Report No. 1830

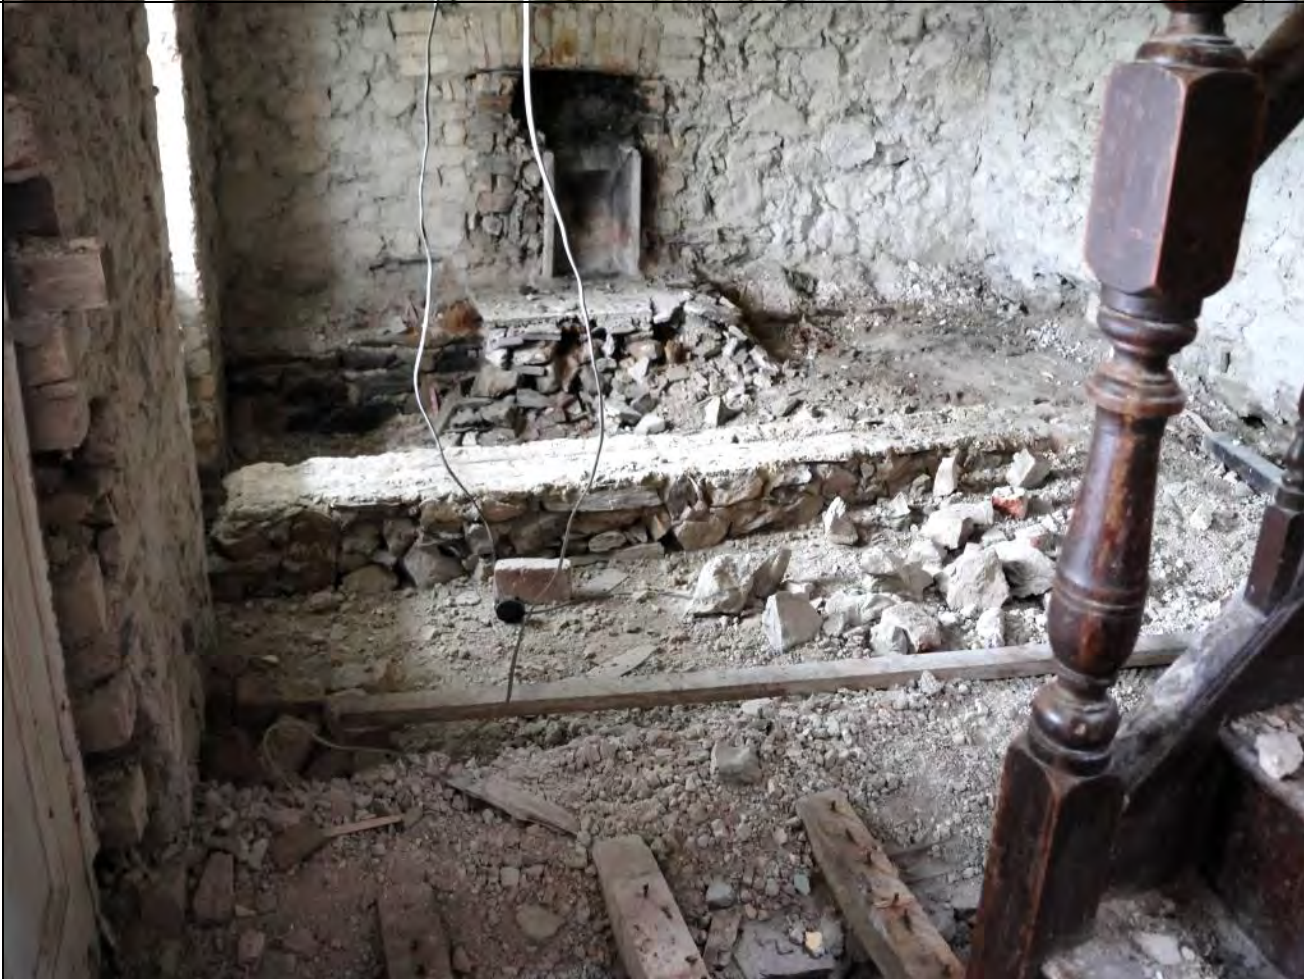
| <b>Location</b> | Ground Floor: Dining room | <b>Photo ID No:</b> | E49630_65 |

| <b>Description</b> | Floor of dining room | | |
