North West Wales Dendrochronology Project
DATING OLD WELSH HOUSES

Llawr-dref, Llangian, Gwynedd

ARCHITECTURAL RECORD

Llawr-dref, Llangian

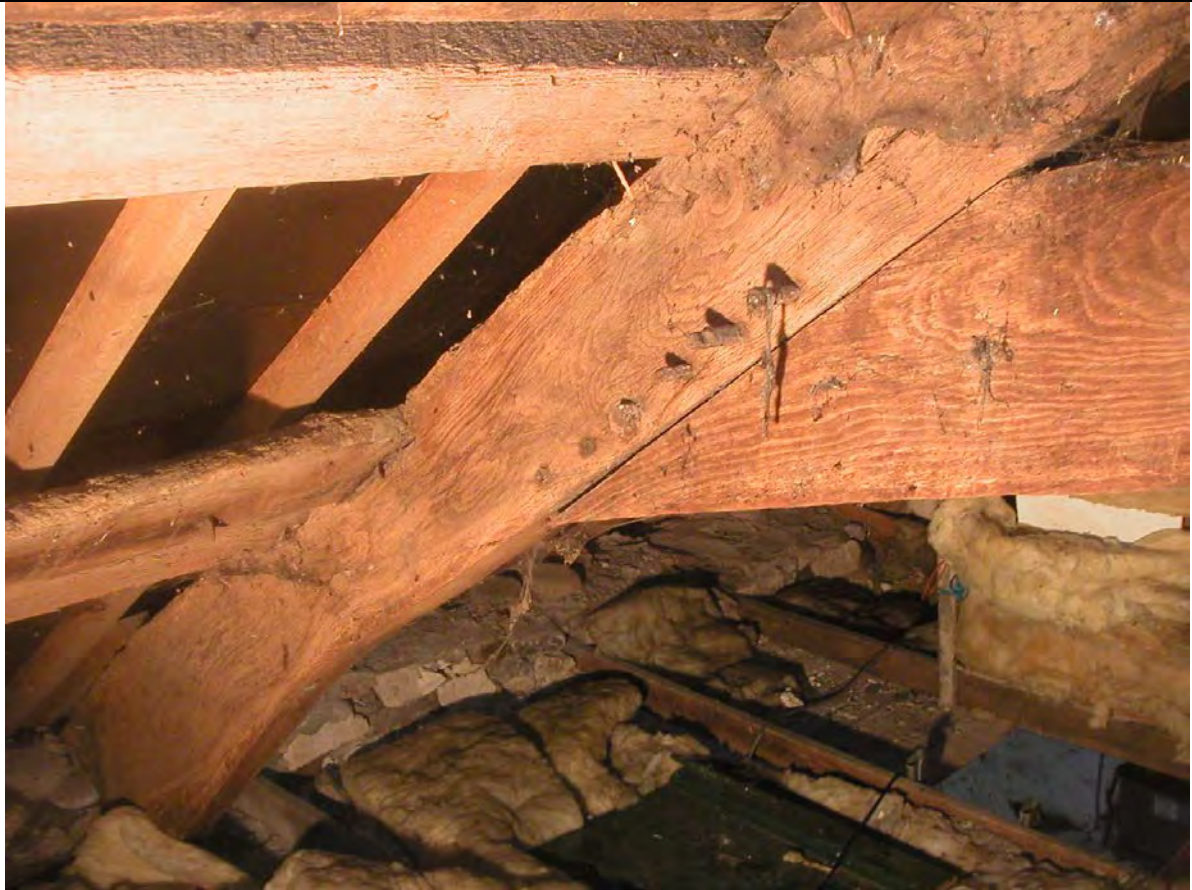
The inspection confirms that there are three oak trusses in the roof space, two with ornate cusping at and above collar level (Trusses 2 & 3) and one with a plain cambered collar without cusping (Truss 1). However, there are no wind-braces nor is there any evidence of any, for instance mortises in the purlins or trusses (this is contrary to Peter Smith's distribution map). Nor are there any holes for partition uprights in the collar and principals of the plain truss (Truss 1) - these might have been expected here, though not in the other two trusses.

Plate 3 Truss 1 (viewed from south)

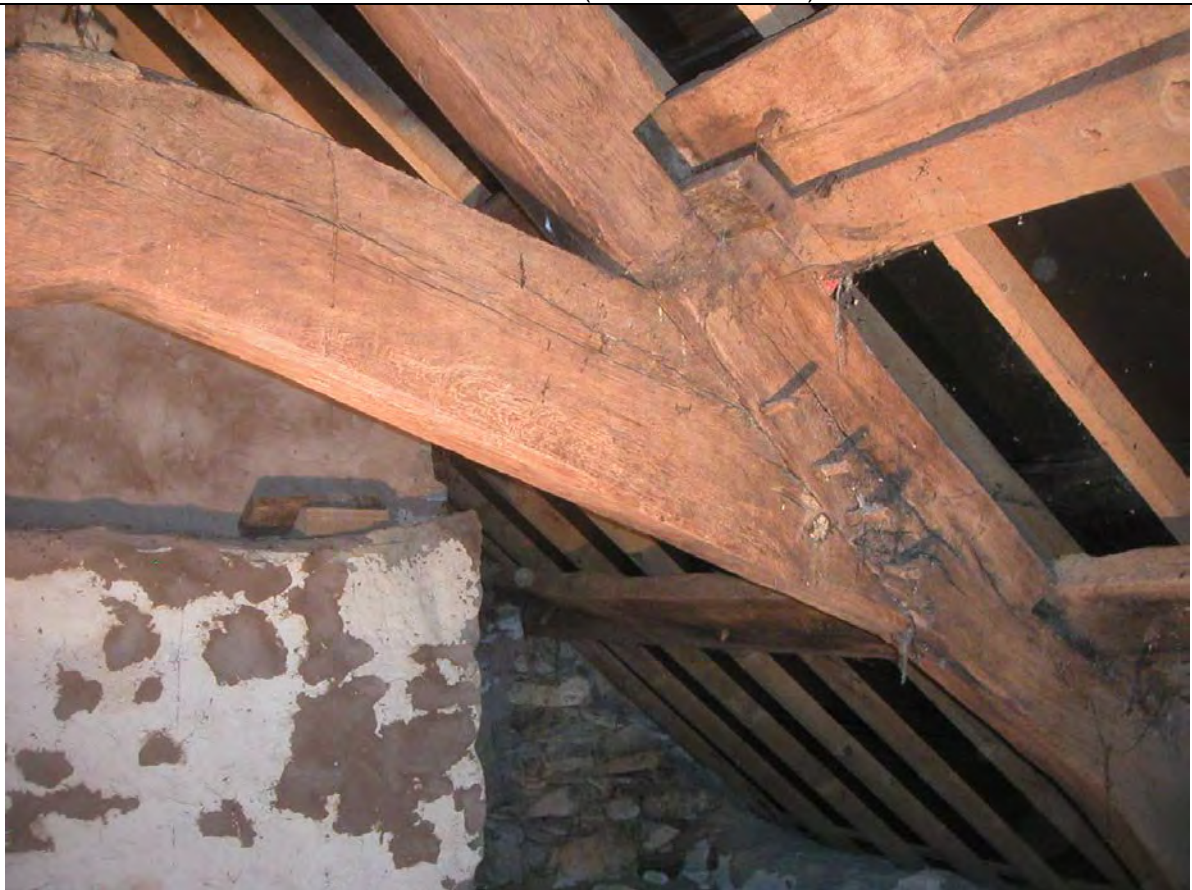
Plate 4 Truss 1 (viewed from south)

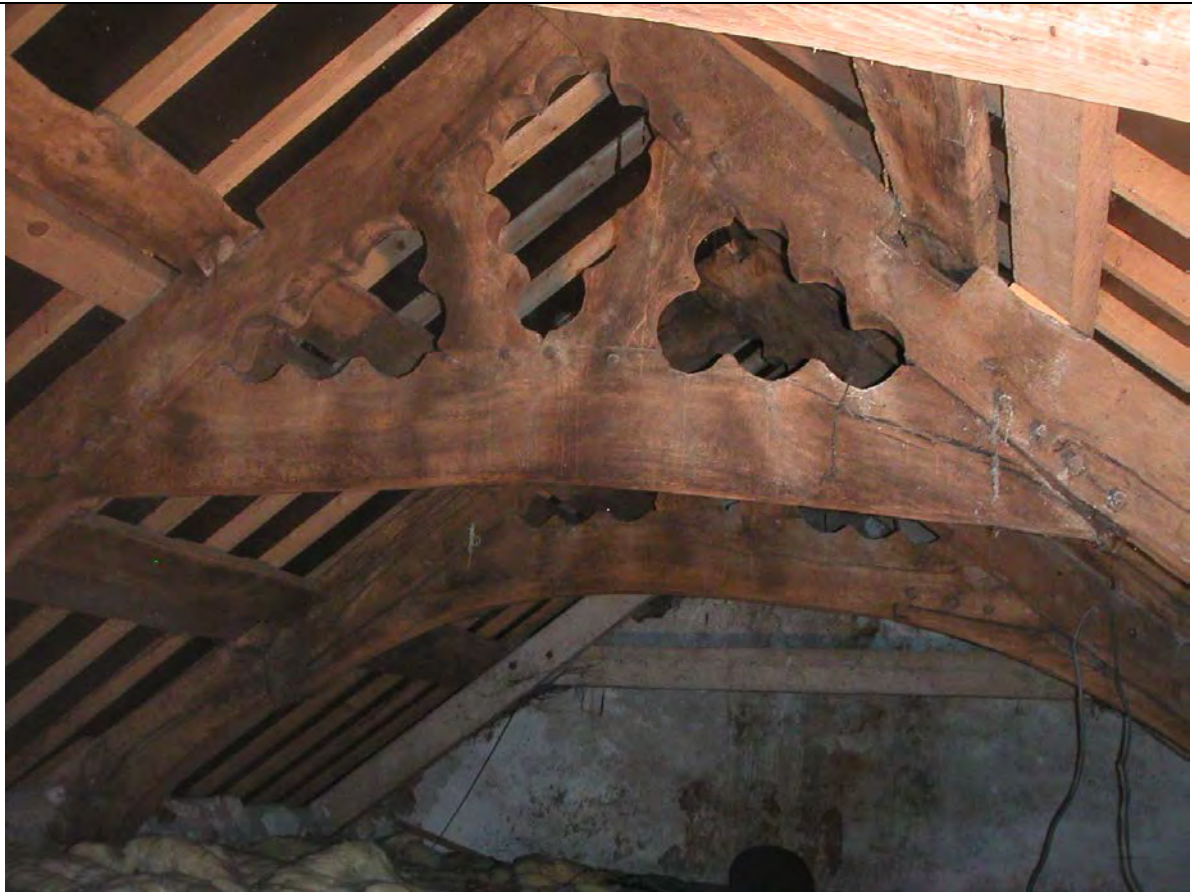
Plate 5 Trusses 2 & 3 (viewed from north - Truss 2 in foreground)

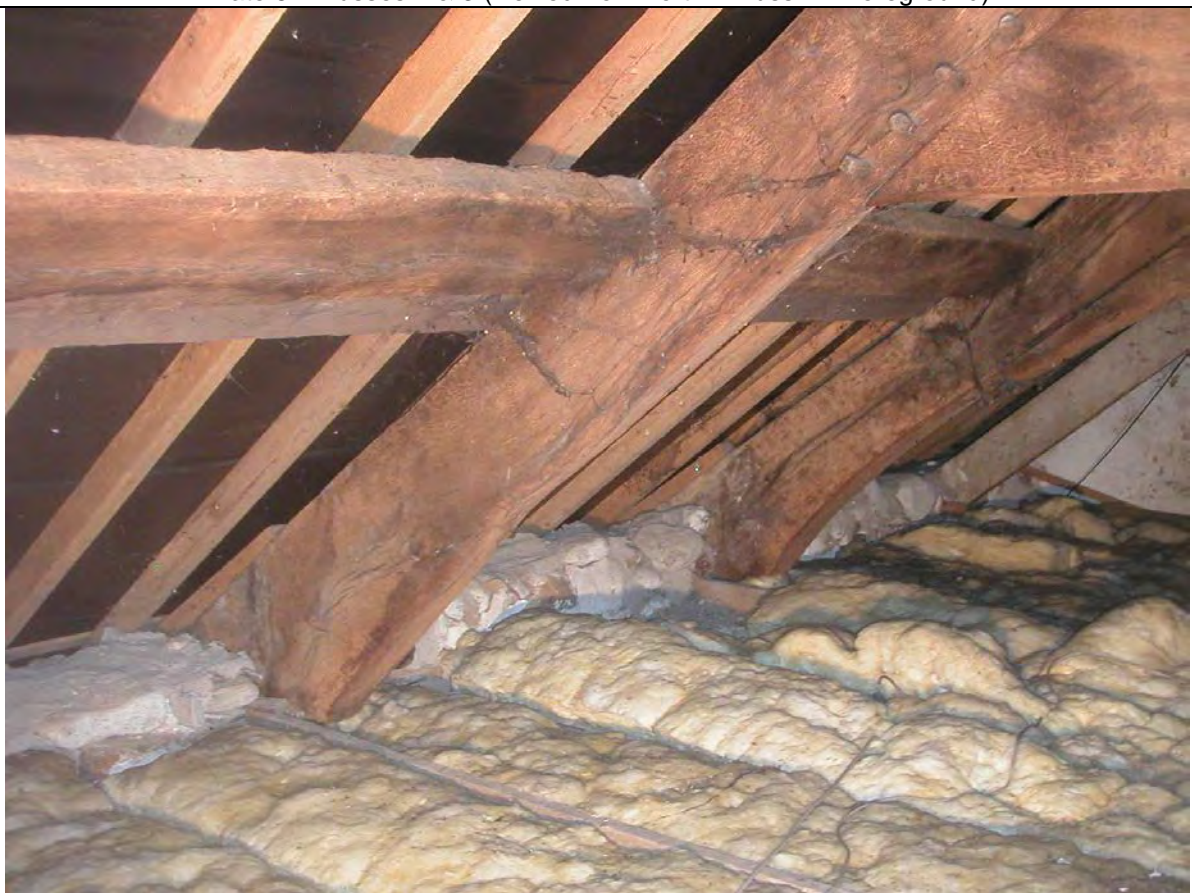
Plate 6 Trusses 2 & 3 (viewed from north - Truss 2 in foreground)

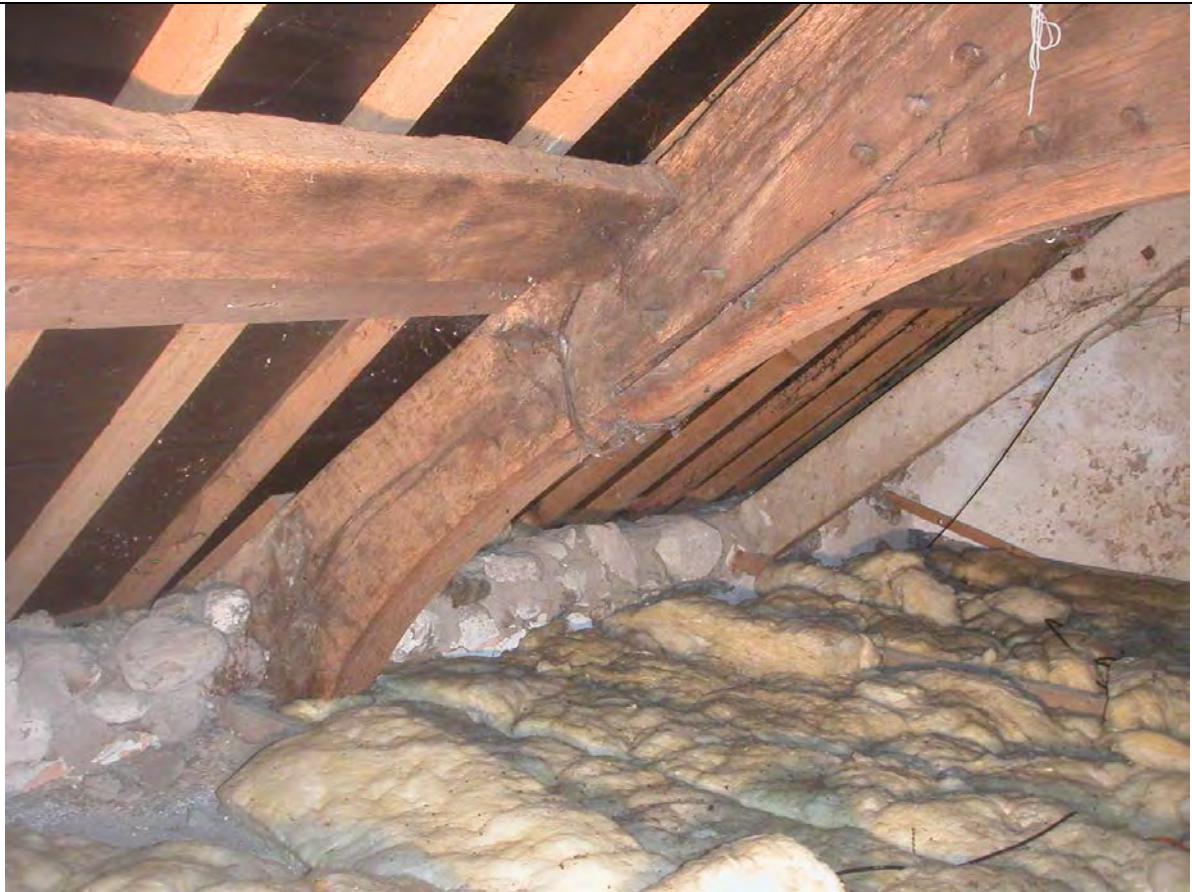
The original oak purlins survive but have been cut off in line with the C19 truss south of Truss 3. Modern purlins have been inserted above the oak ones, to re-align the roof to a regular line and to carry the modern slated roof. It is not clear why the south gable of the house has been rebuilt (probably in the C19) and a new softwood truss inserted.

Plate 7 Truss 3 (viewed from north)

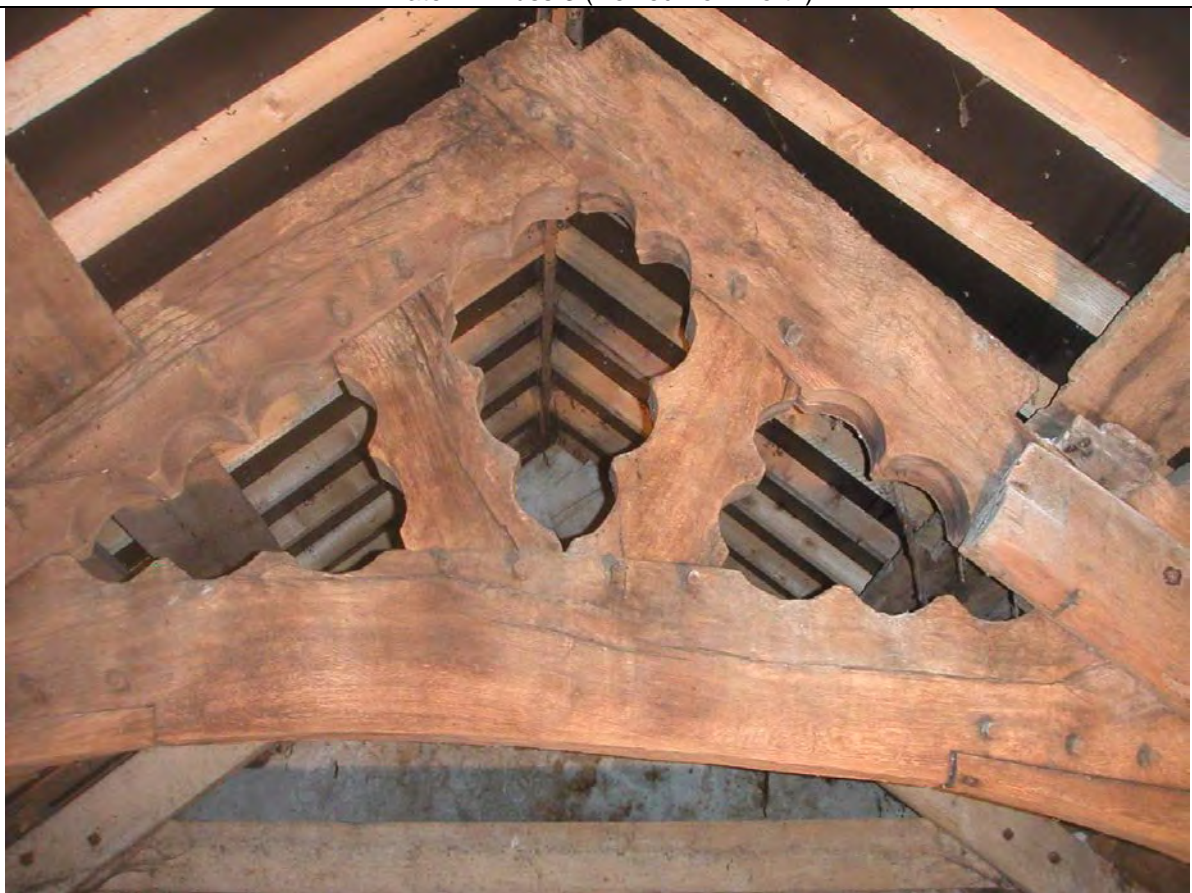
Plate 8 Truss 3 (viewed from north)

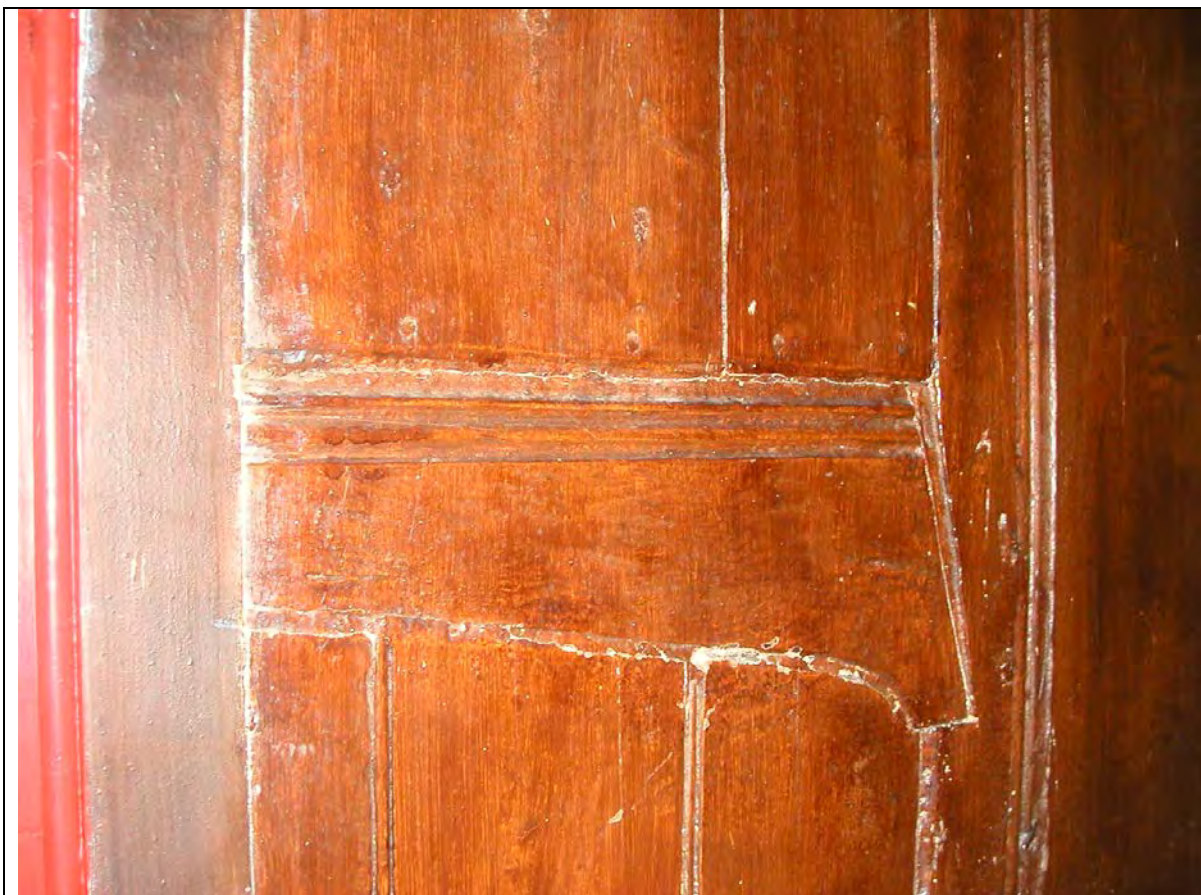
Plate 10 Partition (part of blocked doorhead)

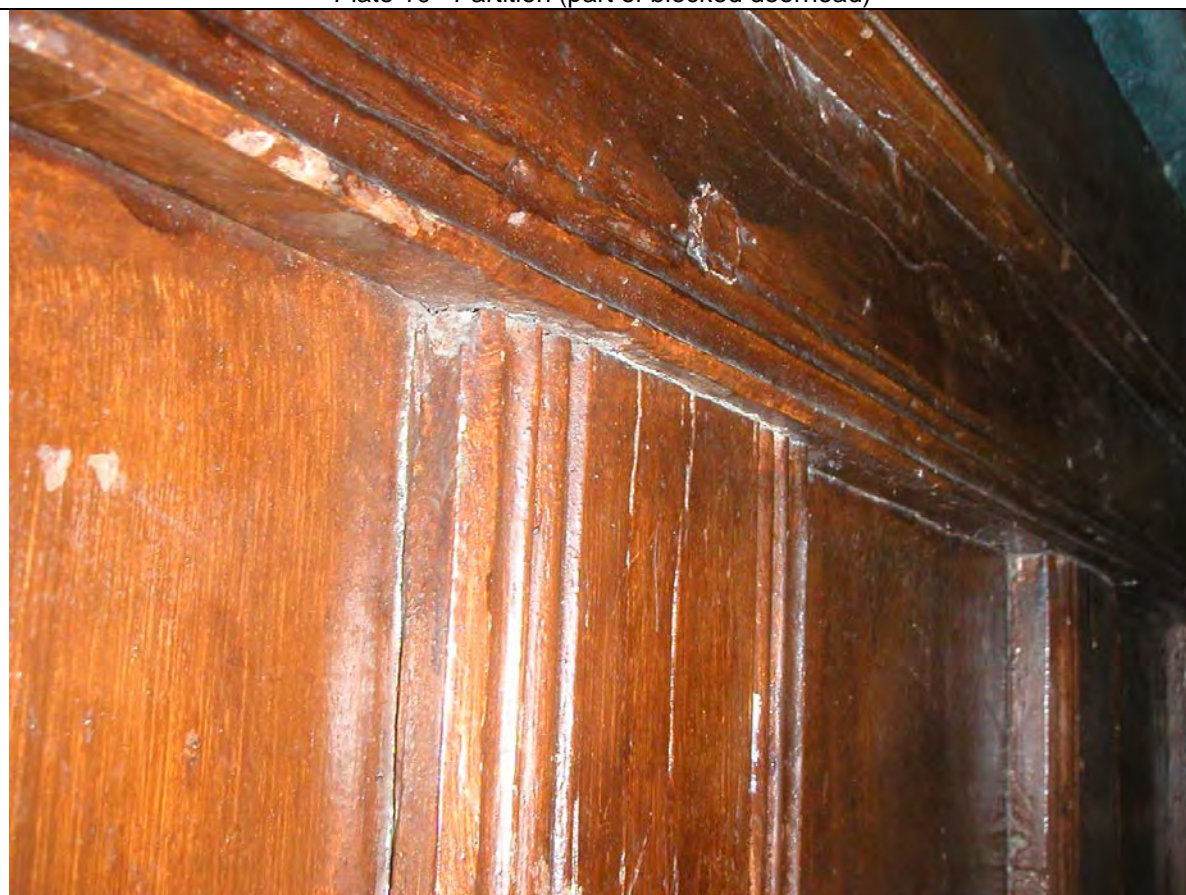
Plate 11 Partition (detail of post and head mouldings)

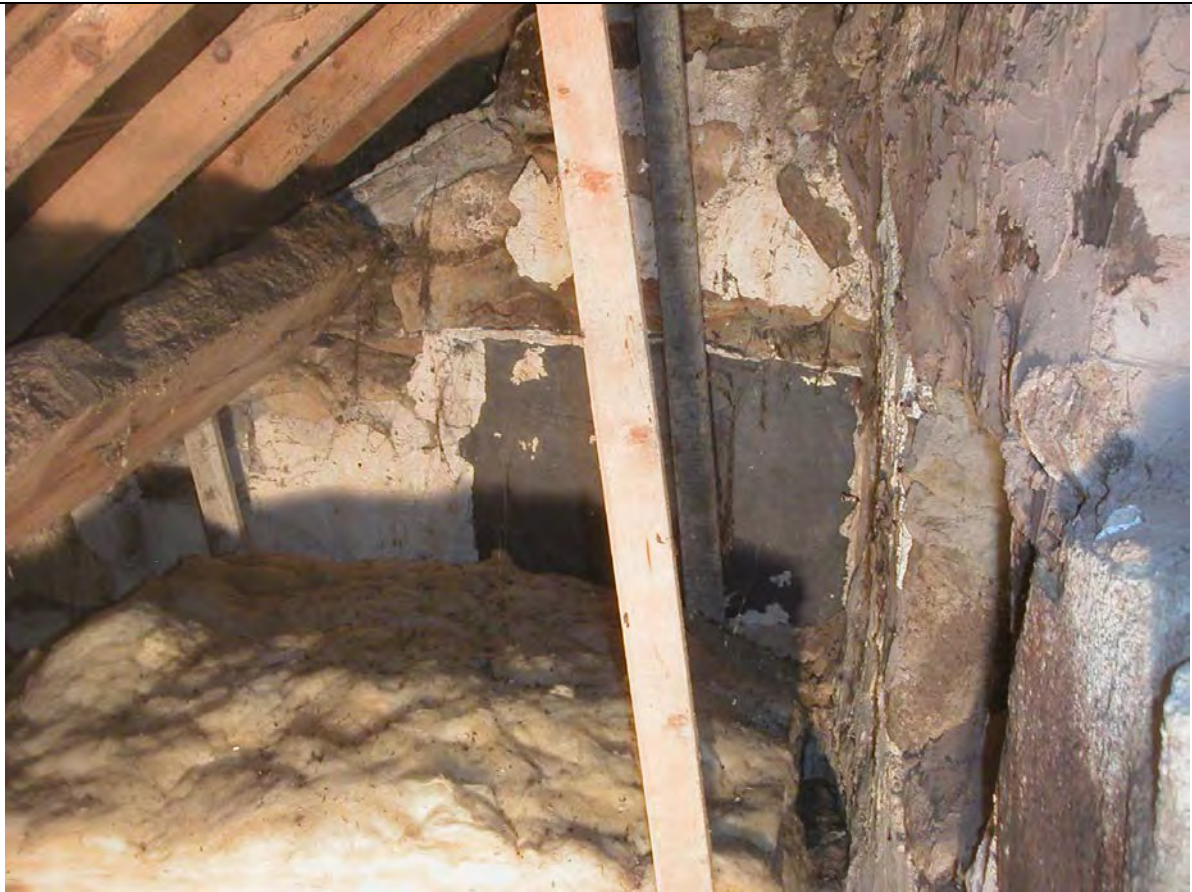
The remainder of the Cadw description appears to be accurate, but it omits (as does the RCAHMW description) the possible blocked window to the top of the former staircase, in the north gable. The high position of this window is unusual so it is possible that it is not original but was perhaps formed when the stonework above the former mural stair was removed. Stubs of stone projecting radially from the external north wall, in line with the window, give the superficial appearance that the stair might have once continued up to the roof-space, but this would be unusual and the stone stubs are more likely to be the ends of the stones forming the 'ceiling' above the mural stair. The most likely function of the window was to light the attic space when it was used for accommodation by servants or farm-hands (there are scraps of wall-paper evident on the south gable).

Plate 12 Possible blocked window in north gable

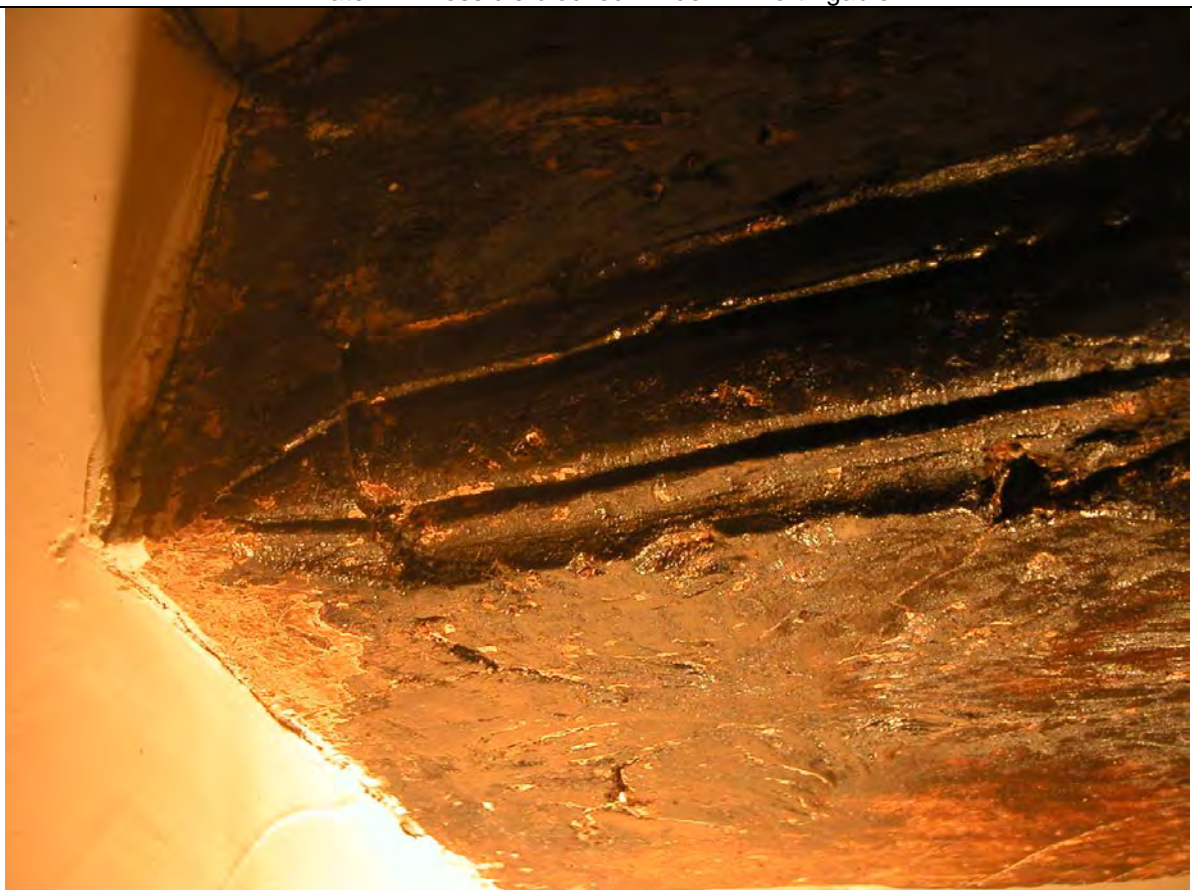
The RCAHMW states that there are no stops to the ground floor beams, but one does survive, on the south side of the main beam at its western end (in passage). The stop on the north side is less clear.

Plate 13 Stop to main beam (west end, south side)

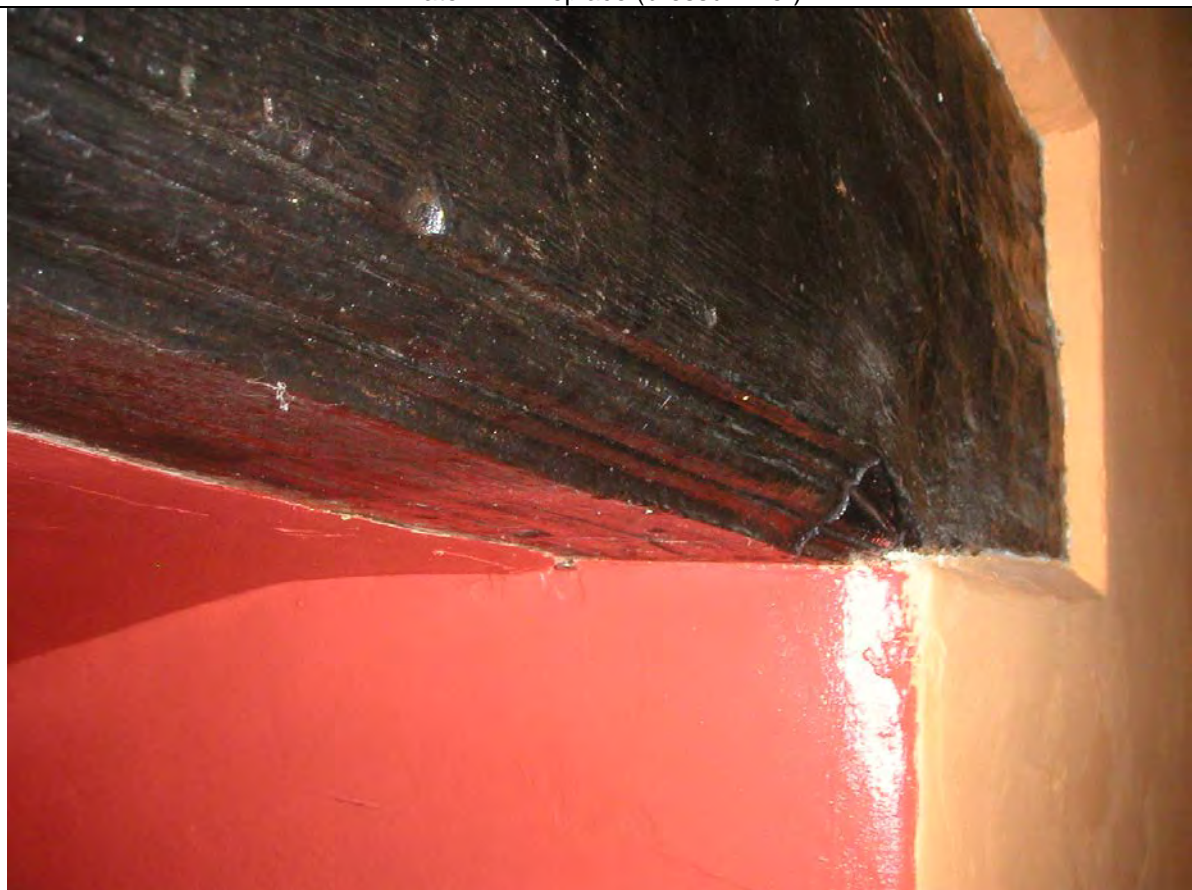
Plate 15 Stop at east end of bressummer
