CPAT Report No. 1728

St Grwst's Church and Gwydir Chapel, Llanrwst, Conwy

Archaeological Watching Brief

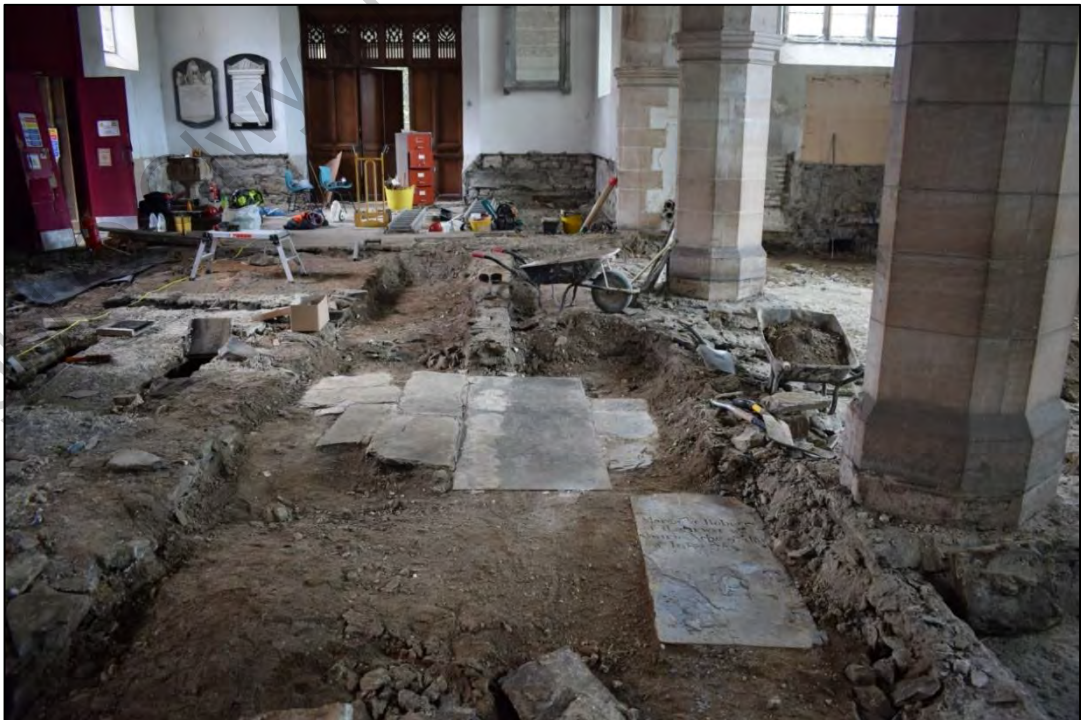
Fig. 5: The remains of the 18th-century floor within the nave, from the east. The John Williams ledger is the more distant of the two large slabs. CPAT 4679-0033

- 3.4. Further to the east within the nave, another area of this early floor was found in-situ (Fig. 5) though its surface was uneven. Two dated ledgers were revealed, of 1728 and 1767, and it seems likely that these were part of the same floor level identified in the corner of the church.

- 3.6. This section of the old floor was fairly uneven and the higher portions had to be removed to allow the new floor to be installed. The ledgers were slightly lower and this enabled them to be retained in their original positions.

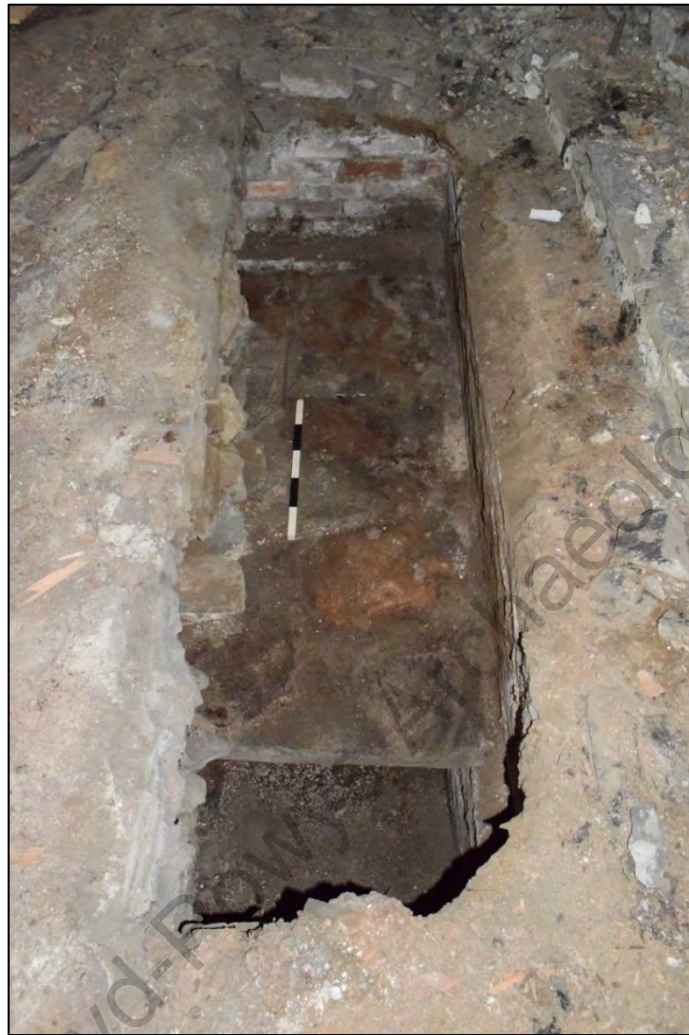
- 3.7. On the south side of the nave and almost opposite the John Williams ledger was a brick-lined vault (Vault 1; Fig. 7), aligned east/west. Its presence had been appreciated at an early stage owing to some subsidence of the overlying soil and the investigation of this structure had therefore been made a priority to ensure that the new floor was placed on a secure footing. It was partially overlain on its north side by a sleeper wall for the same type of wooden flooring that was taken up in the north aisle.
- 3.8. The reason for the subsidence was readily evident in that the slabs sealing the vault had not all been replaced, leaving the east and west ends open which had admitted soil into the interior of the vault. It was interesting to note the remains of a fabric covering (the brown-

coloured patches on Fig. 7) which had no doubt been placed on top of the slabs when the vault was last used.

Fig. 7: Vault 1, showing the incomplete slab and covering material, from the west. Partially overlying the north (left) side is a sleeper wall for the 20th-century floor of the church. CPAT 4679-0048

3.9. Although the vault was only large enough in plan for a single coffin, the likelihood is that it was of sufficient depth to allow for at least two and possibly three burials. This was demonstrated by a monument on the south wall of the nave to the likely occupants, Jane Hughes, her husband Thomas, and their daughter Jane, who died in 1729, 1733 and 1767, respectively. The inscription is given in full in Appendix 2 and its location is marked on Fig. 49. New slabs were used to seal the vault, which was then covered with a protective membrane before being filled. The outer walls were left untouched by the floor preparation works.

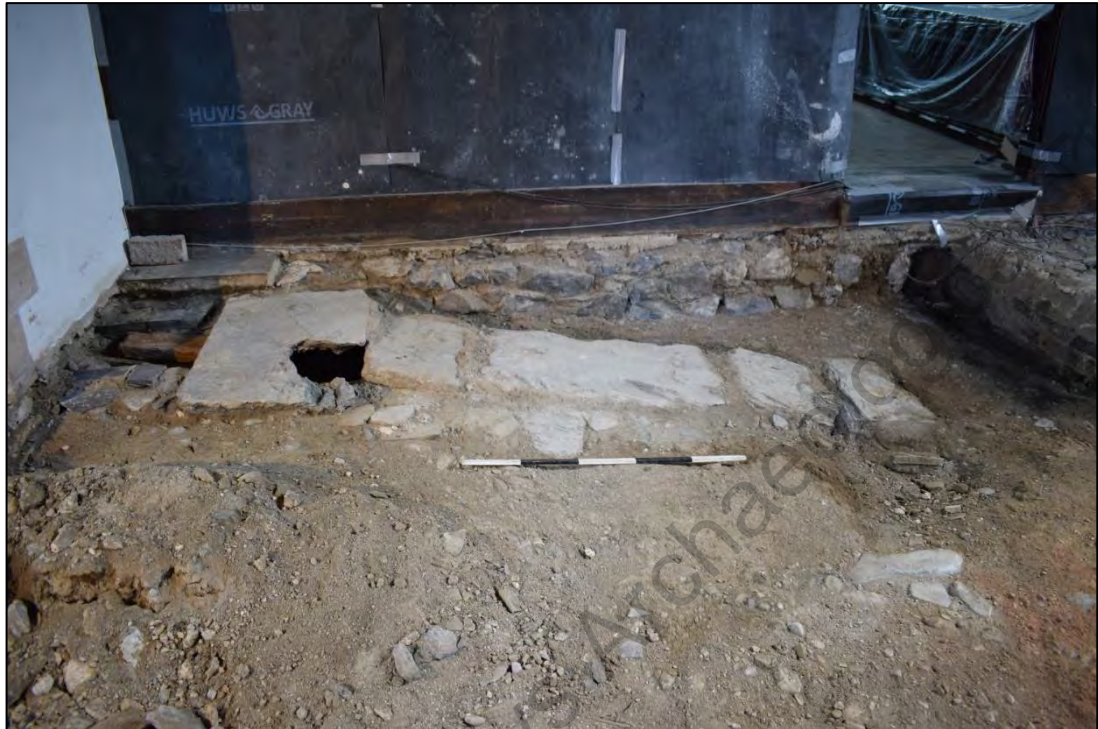
3.10. As the floor level was being lowered on the north side of the nave at its east end, a second vault (Vault 2) was revealed. This was of completely different character, comprising two approximately parallel stone sleeper walls running north/south with a covering of slabs (Fig. 8). Previous disturbance was evident as one slab was missing and another had been damaged, this could have taken place when the north aisle was built.

Fig. 8: Vault 2, running parallel with and adjacent to the rood screen, from the west. CPAT 4679-0072

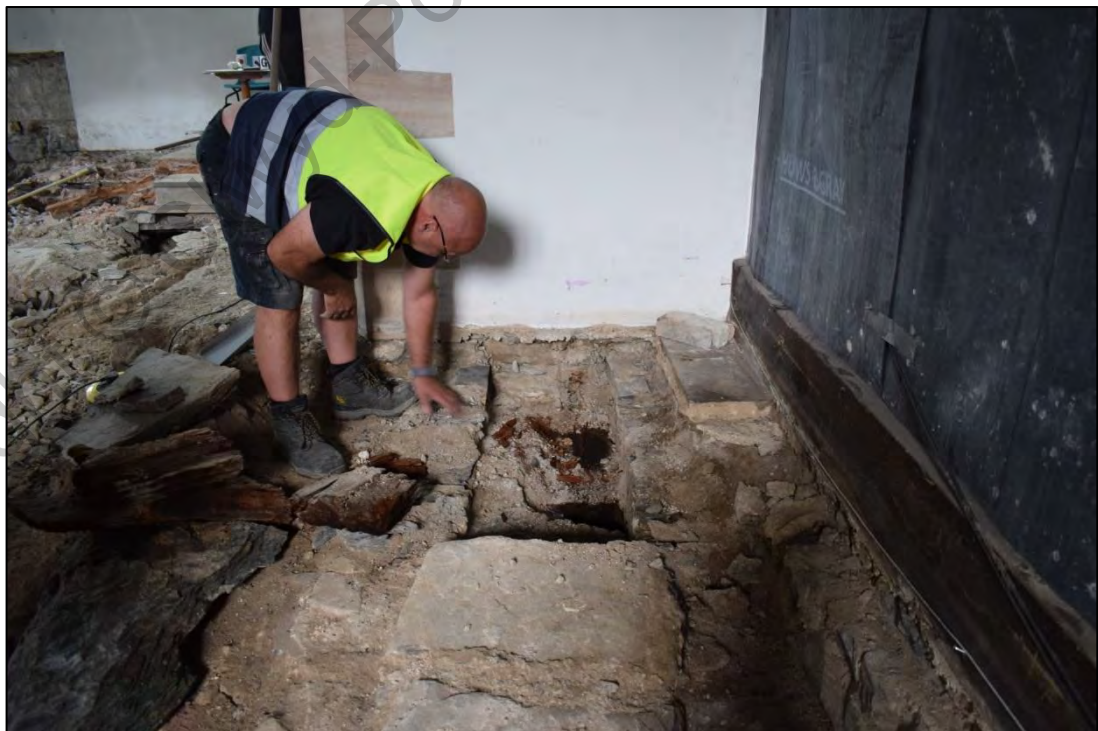
3.11. The vault had to be modified (see Fig. 9) as its upper surface was too high to allow the new floor to be of sufficient thickness. Accordingly, the two northernmost covering slabs were removed, the sleeper walls were lowered by about 0.2m and the vault was then capped with

three reused slabs from elsewhere, the old slabs being in poor condition. The interior of the vault was examined after the slabs had been removed and human remains were observed, though whether these were in-situ could not be determined. They were left in position. No evidence regarding the date of the vault or the potential occupant was observed.

Fig. 9: The reduction in the height of the sleeper walls of Vault 2, prior to the setting in place of new covering slabs, from the south. CPAT 4679-0082

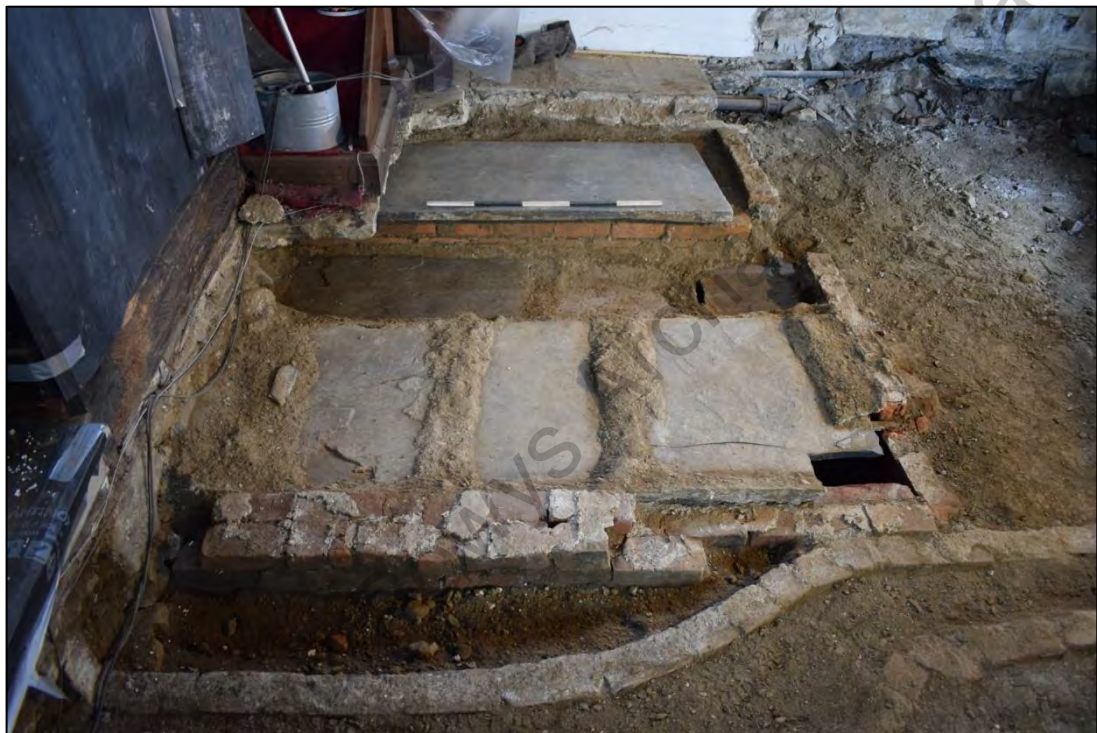
- 3.12. Also at the east end of the nave, but to the south of Vault 2 and partly beneath the pulpit, was a third vault (Vault 3). This was a large subterranean brick structure, capped by a number of slate slabs (Fig. 10). Immediately to the south was a displaced ledger (No. 22) supported on what seemed to be a brick extension of the vault; the ledger inscription dated to 1822. The slabs covering the northern part of the vault were removed, as they were insecure, revealing an iron supporting bar. Once the slabs were removed, it could be seen that the northern part was divided from the southern part by a brick wall running east/west at the surface but approximately 1.1m below there was a space which meant the two sections were interconnected. At least three lead coffins were seen within the northern part of the vault, in varying states of disrepair, and further coffins could be seen in the southern part. Red paint had been applied to the interior.

Fig. 10: Vault 3, adjoining the rood screen on the left, from the north. The ledger at the rear was as found, before it was lowered to allow the new floor to be installed. Note also the curved brick wall in the foreground, which is part of a duct associated with a 19th-century heating system (see Fig. 13 and para 3.15). CPAT 4679-0091

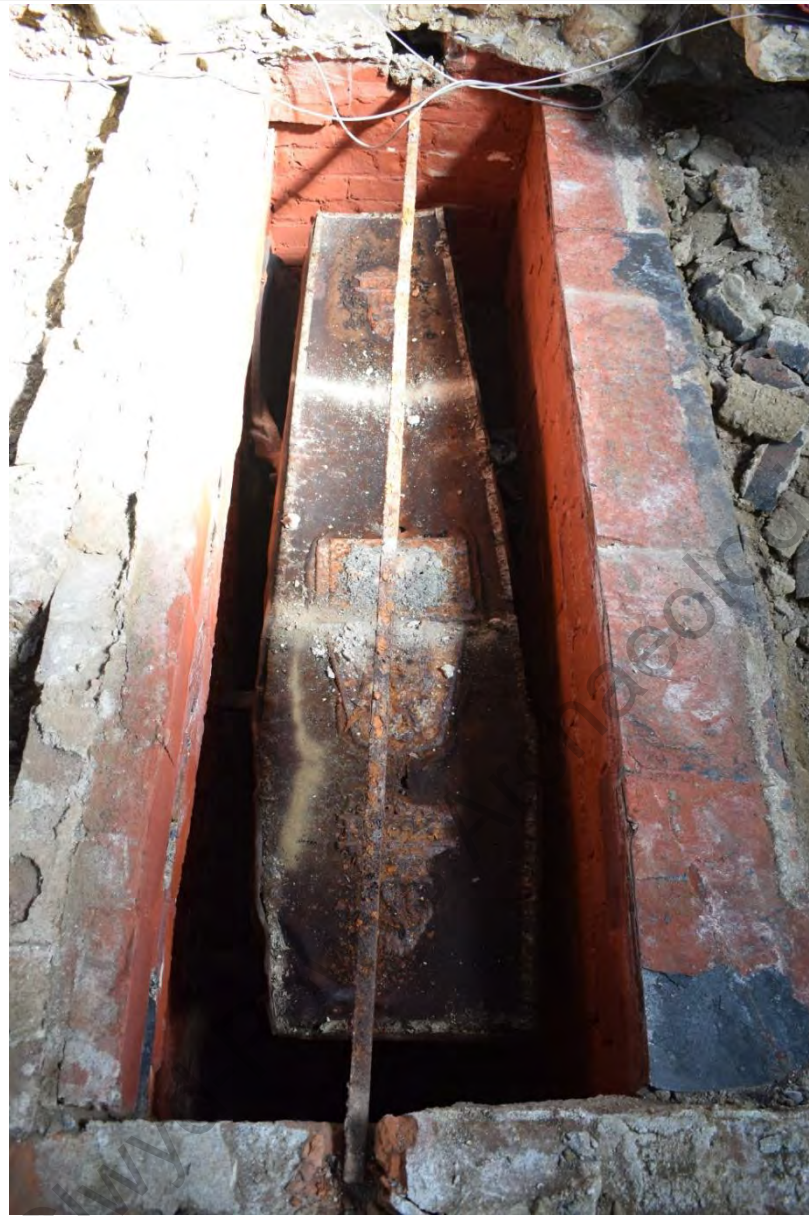
- 3.13. The uppermost coffin (Fig. 11) seemed to have had a fabric covering and a number of decorative plaques were applied to its upper surface; these were not decipherable but examination of a number of brass plaques attached to the rood screen nearby suggested that the burials represented were those of the Owen family of Pencraig and Hendre, dating between 1719 and 1852. The ledger inscription matched that on one of these plaques (these are included at the end of Appendix 2 for information). Another set of plaques relate to the Ellis family of Cyffty, the dates covering the middle of the 18th century to the early years of the 19th century. The bricks used in the vault were manufactured by Hancocks of Buckley, who operated in the 18th and 19th centuries.

Fig. 11: The uppermost coffin in the north part of the vault showing the iron supporting bar, from the west. CPAT 4679-0100

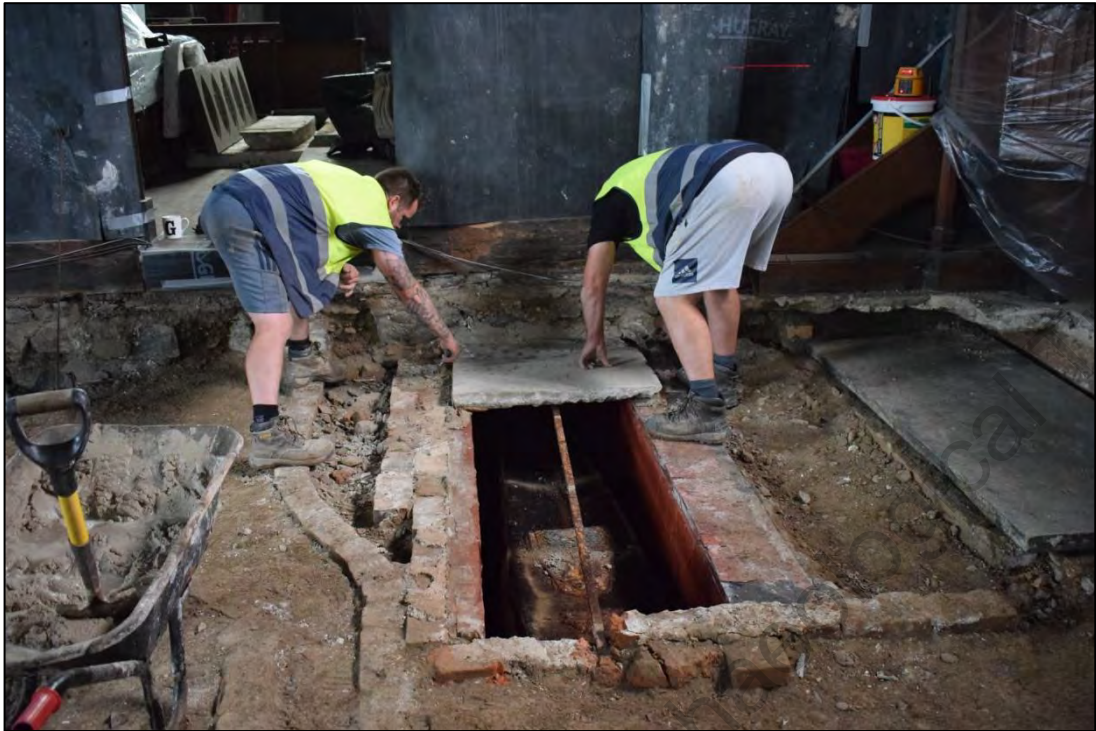
Fig. 12: The placement of the new capping stones over the north part of the vault. The ledger is in its lowered position. CPAT 4679-0105

- 3.14. In order that the new floor could be installed safely, the thin slabs capping the north side of the vault were replaced with thicker material (Fig. 12). The ledger on the south side also needed lowering and to this end it was moved out of the way, a number of brick layers were removed and the ledger then replaced in its correct position. No grave contents were revealed or disturbed.

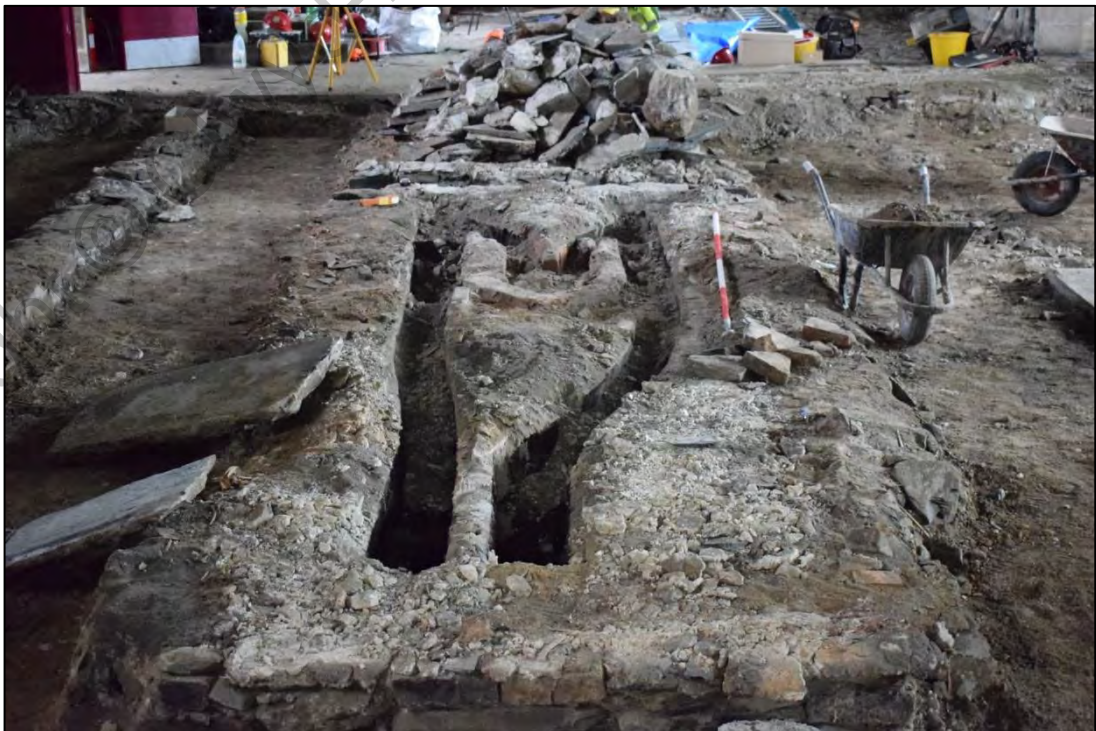
- 3.15. The only other feature of interest in the floor was the remains of a series of underfloor ducts (Fig. 13) likely to relate to a 19th-century heating system. These originated in the area of the tower and passed under the floor of the nave, continuing beneath the rood screen and into the chancel. The structural remains of these were retained in-situ, where possible; they have only been recorded in plan where they relate to earlier features of the church interior.

Fig. 13: Underfloor ducts in the nave, most likely from a 19th-century heating system. CPAT 4679-0057

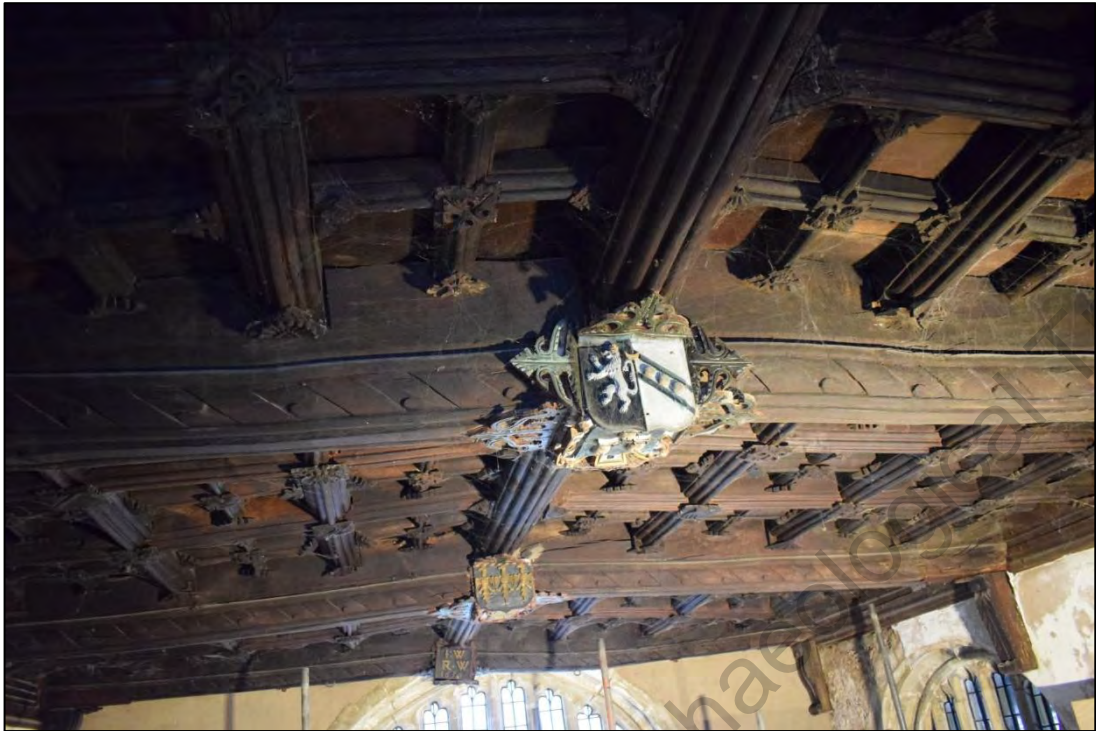
- 3.22. Close observation demonstrated that the roof of the chapel (Fig. 20) had been subject to fairly extensive repair, probably owing to deterioration of the timbers. The places where major beams rested on wall brackets seemed to have been particularly susceptible, the beams often having metal reinforcement added to their ends to support the roof structure (Fig. 21).

Fig. 20: The chapel roof. CPAT 4679-0156

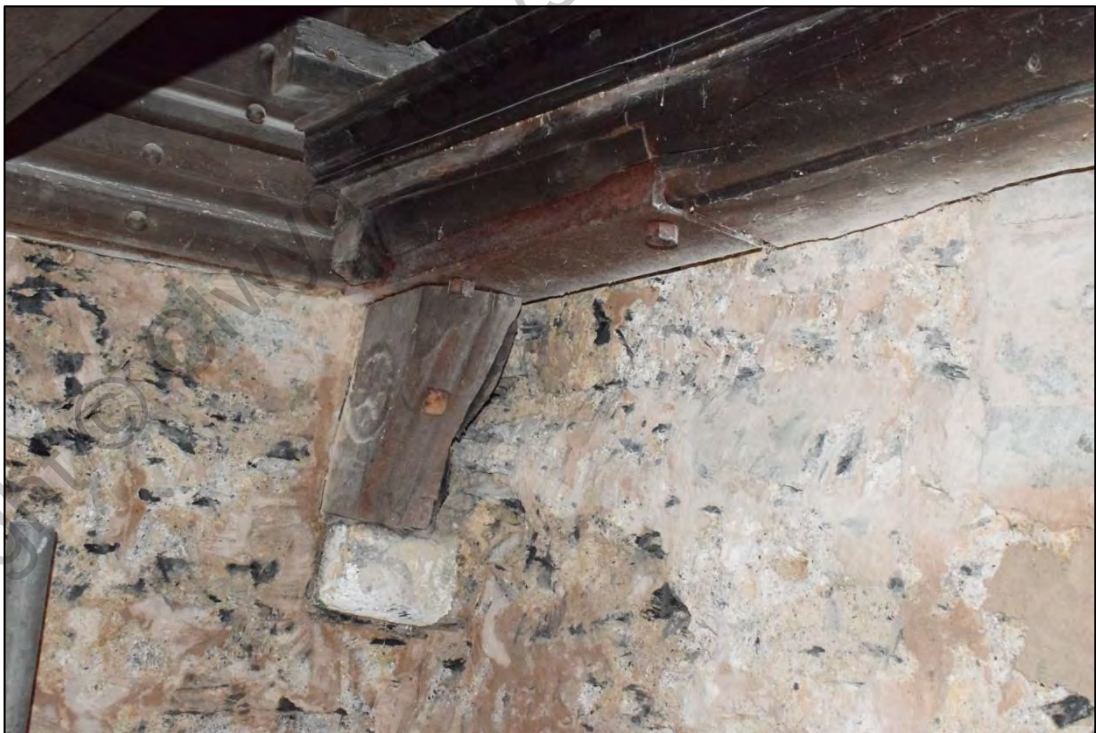
Fig. 21: Repairs at the south-west corner of the chapel roof. CPAT 4679-0162

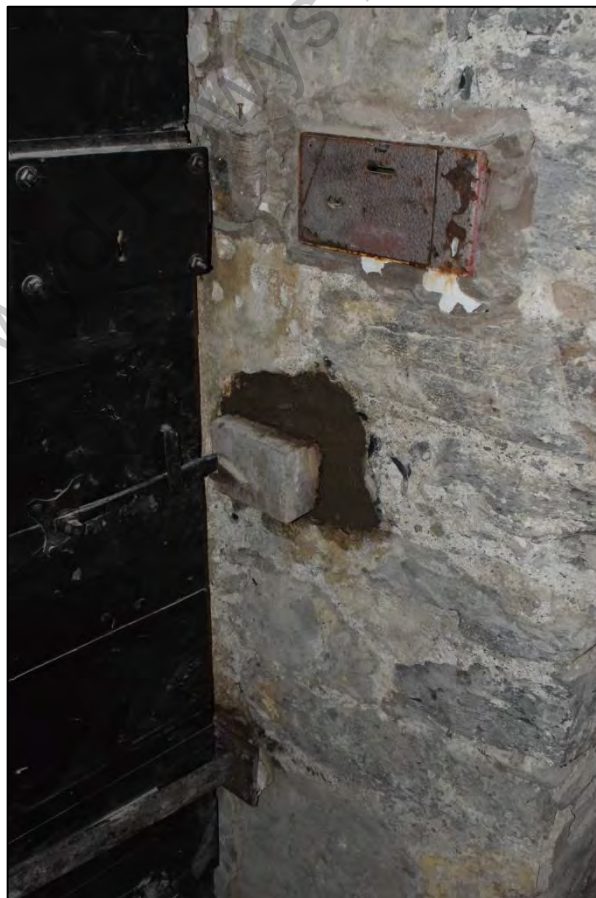
- 3.23. Little additional information was forthcoming from the repointing, the only evidence that had not been recognised related to the west (external) doorway of the chapel, where the stone arch (Fig. 22) forming the doorhead was exposed and a slot in the wall was identified which seems to have been used to permit a wooden bar to be inserted in the wall which could then be drawn across the internal side of the door to secure the entrance (Fig. 23).

Fig. 23: The location of the (repointed) wooden drawbar slot on the external door of the chapel. CPAT 4679-0171

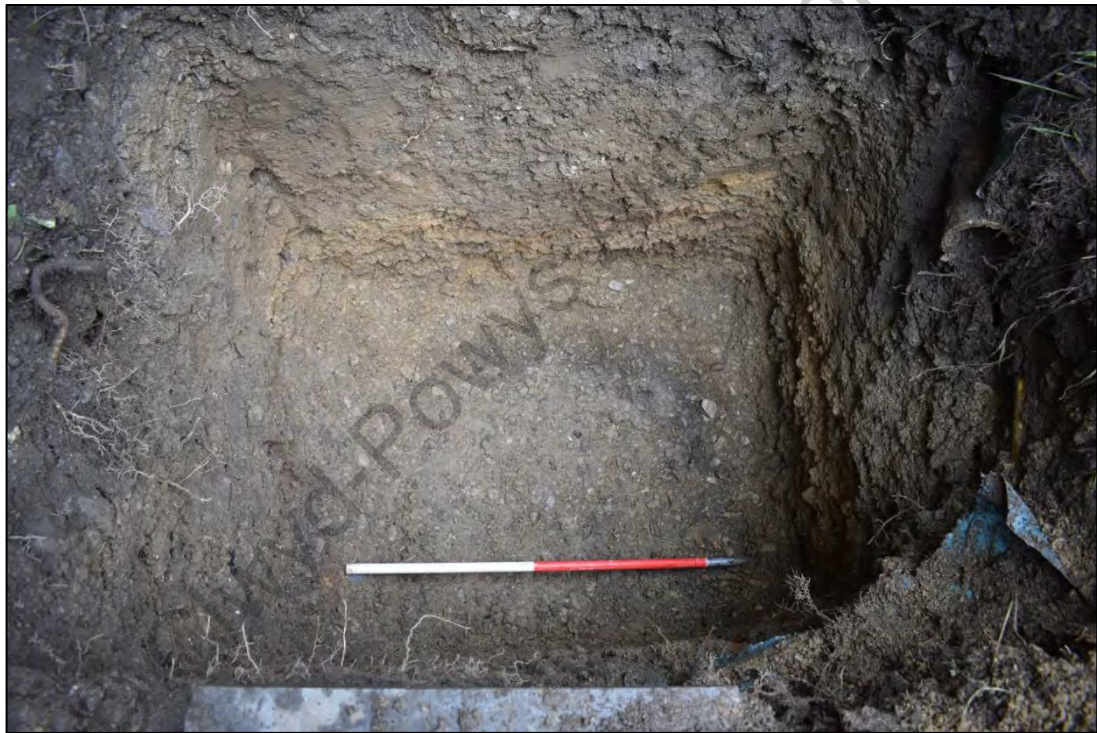
- 3.25. Immediately to the south of the tower, a trench was excavated to place a new sewage treatment plant, measuring 1.2m by 1.2m and 1.4m deep, which necessitated the moving of a ledger (No. 15) a short distance to the south-west. The outline of the east end of a grave and traces of a wooden coffin presumably relating to the ledger could be seen in the base of the trench (Fig. 24). The dates on the ledger were from 1844 to 1911, though the appearance of the grave suggested it was earlier than the latest of these dates.

Fig. 24: The trench excavated to place the new sewage treatment plant, showing the outline of the grave, from the west. The end of the repositioned ledger 15 is visible in the foreground. CPAT 4679-0120

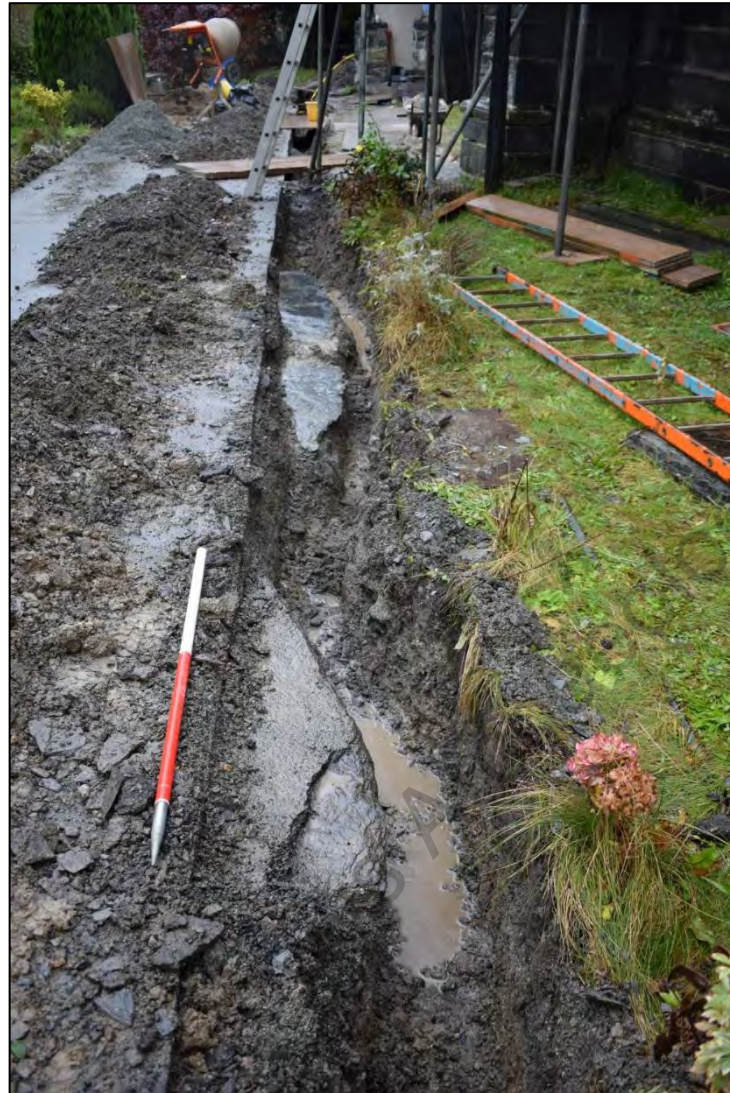
- 3.26. A narrow trench, no more than 0.5m wide, was then excavated from the treatment plant, following the church path towards the ornamental gates to the east. As noted above, a number of ledgers were revealed beneath the path, some of which had 18th-century dates. As the trench neared the gates, it turned across the path to run south to its outlet into the local sewage system. A number of ledgers were seen in the sides of the southern section of trench but these were left in-situ and no search for inscriptions was made.

Fig. 25: Ledgers visible in the side of the trench for the waste pipe leading from the sewage treatment plant and following the line of the church path. CPAT 4679-0138
