**Results of Archaeological Works at**  
**10 & 11 Lower Gate Street,**  
**Conwy**

**Project Number CR135-2016**

<b>Planning Application Number:</b>	N/A
<b>National Grid Reference:</b>	SH 78186 77716
<b>Client:</b>	Ms Jan Tyley
<b>Report Author:</b>	Catherine Rees
<b>Report Number:</b>	CR135-2016
<b>Date:</b>	20/12/2016

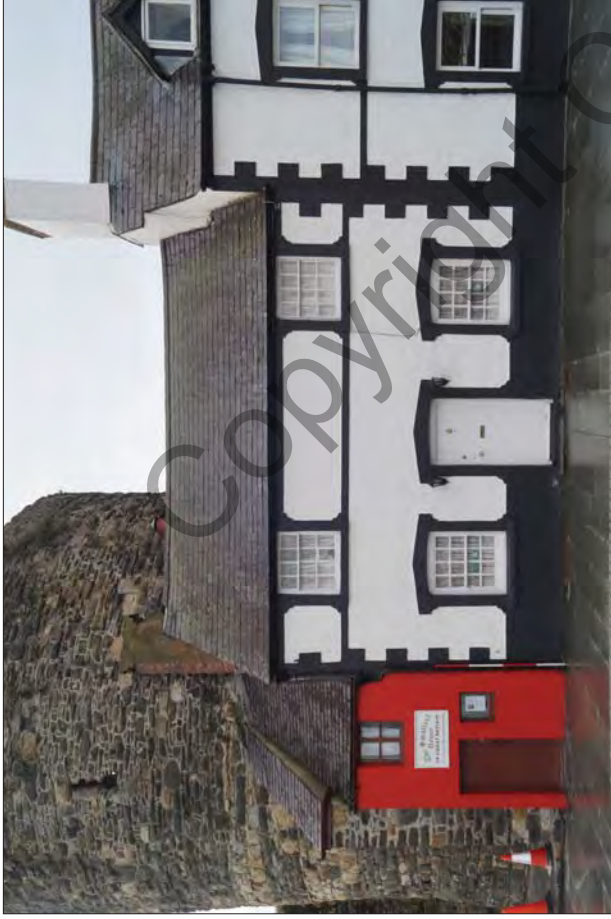
**Plate 1.** 10 & 11 Lower Gate Street Front Elevation

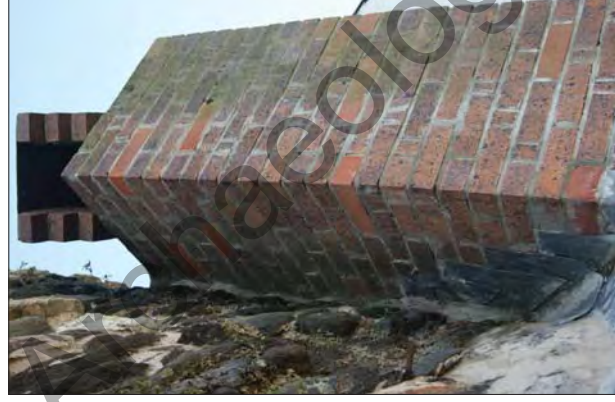
**Plate 4.** Smallest House  
Brick Chimney Stack

There is little to add to this legacy text other than the brick chimney stack (plate 4) was rebuilt to the earlier design in the 1960's or 1970's. The window at first floor level is currently a small 4-pane casement window rather than a horizontal sash and it would seem more likely that this is a replacement, which is roughly contemporary with the chimney stack, than an error in the Listing description. It was heavily overpainted and could not be examined in detail. The change in window design had proved problematic as the casement window has leaked over an extended period of time causing damage to the area below the window. This has been rectified during this phase of works.

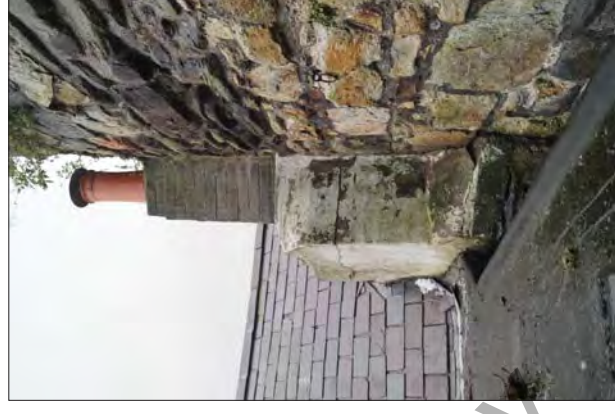
**Plate 5.** Number 11  
Chimney Stack

This description is largely accurate although the comment on the stacks having been removed needs qualification. The fireplace within this property is located at the rear of the south-eastern bay of the main cottage and there is a chimney stack which runs up the side of the Town Wall tower. Figure 3 shows the full height of this stack which previously stood at almost the full height of the tower. This height has been significantly reduced but the lower section of the stack still survives (plate 5). Only the extension to the rear of the property is actually built against the Town Wall and there is a small yard area to the building rear. The extension is shown on the 1889 First Edition Ordnance Survey map of Conwy.

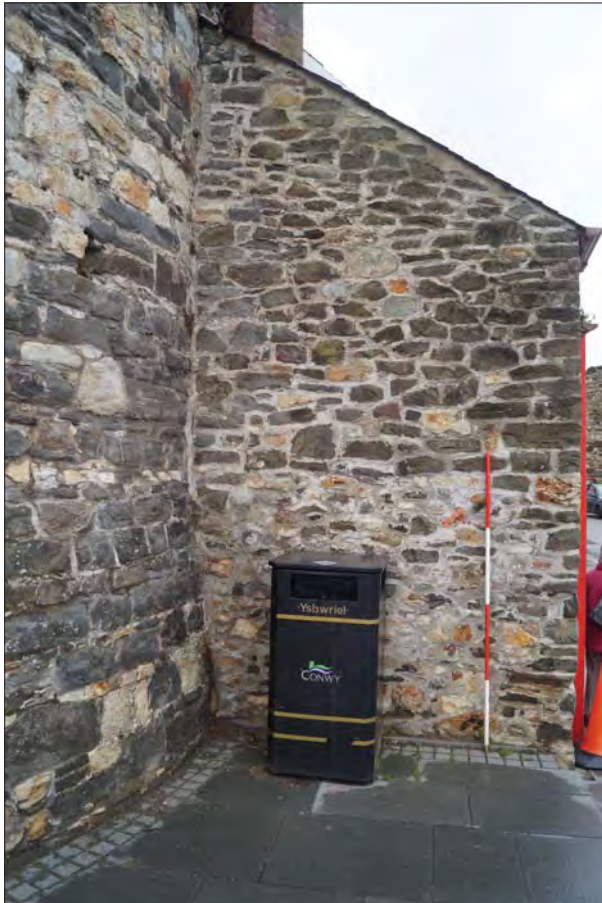
**Plate 6.** South-Eastern Gable  
Of 10 Lower Castle Street

The rear and north-western elevations of the Smallest House adjoin other structures - the rear of the property is against the Town Walls and Number 11 adjoins the property to the north-west. The south-eastern gable elevation, although exposed is not strictly speaking the gable of the smallest house. It is the surviving gable of the demolished adjacent property which was left standing so as not to damage the structural integrity of the Smallest House. The surviving gable is of stone construction (plate 6).

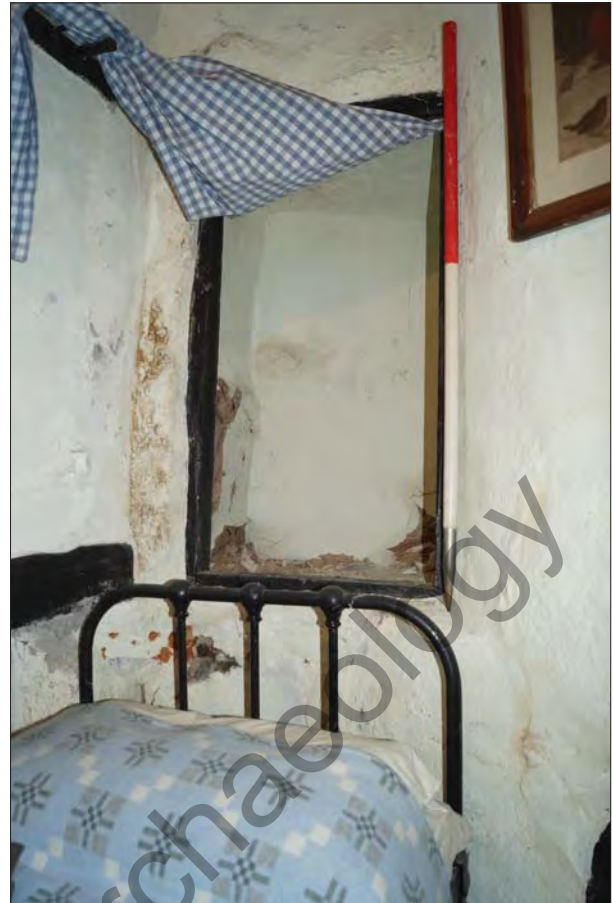
**Plate 7.** First Floor Bedroom in  
10 Lower Castle Street Prior to Works

Plates 7 – 14 detail the property prior to the commencement of works and show the water damage to the first floor. Plates 15 – 22 detail the first floor following the stripping back of the plaster. No works were undertaken to the ground floor level.

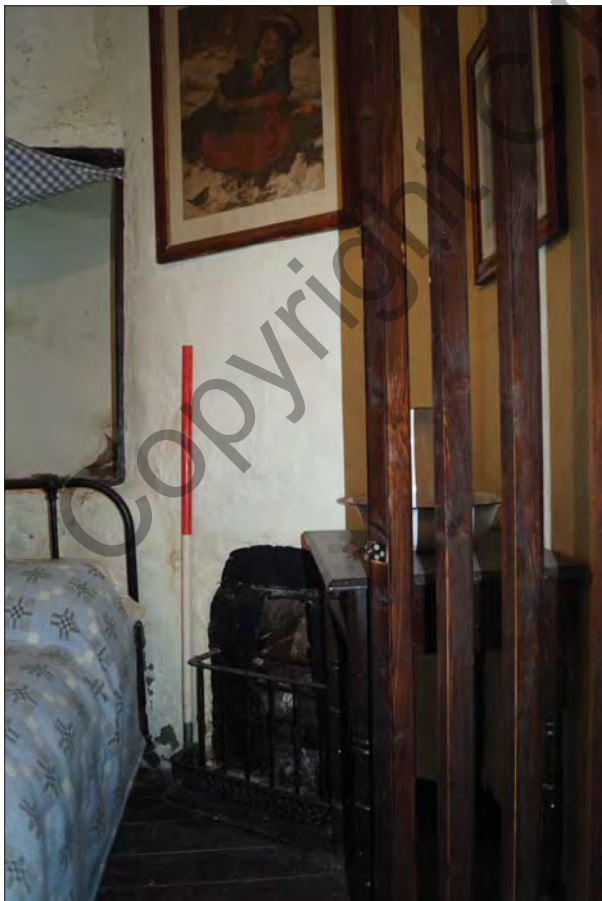
**Plate 8.** First Floor Bedroom in  
10 Lower Castle Street Prior to Works

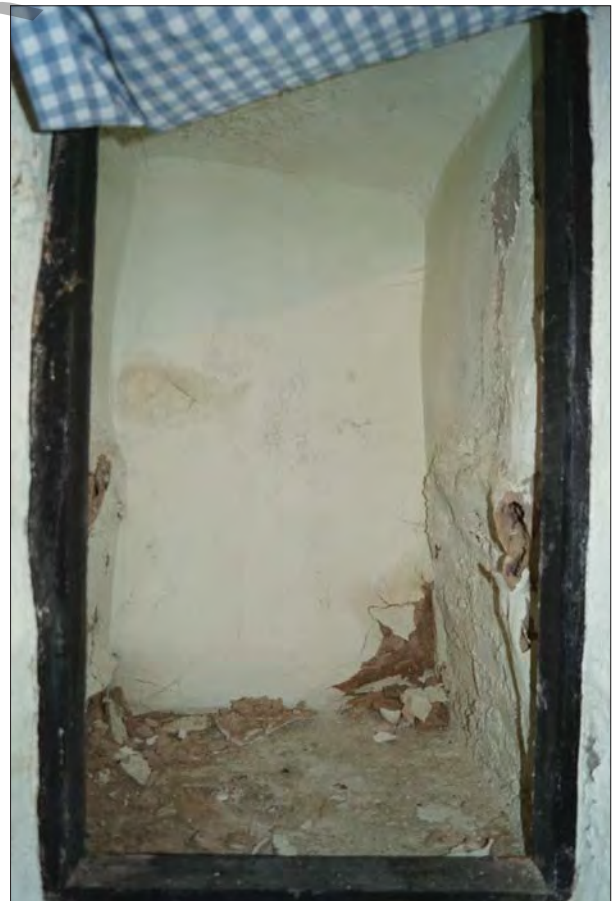
**Plate 9.** First Floor Bedroom in  
10 Lower Castle Street Prior to Works

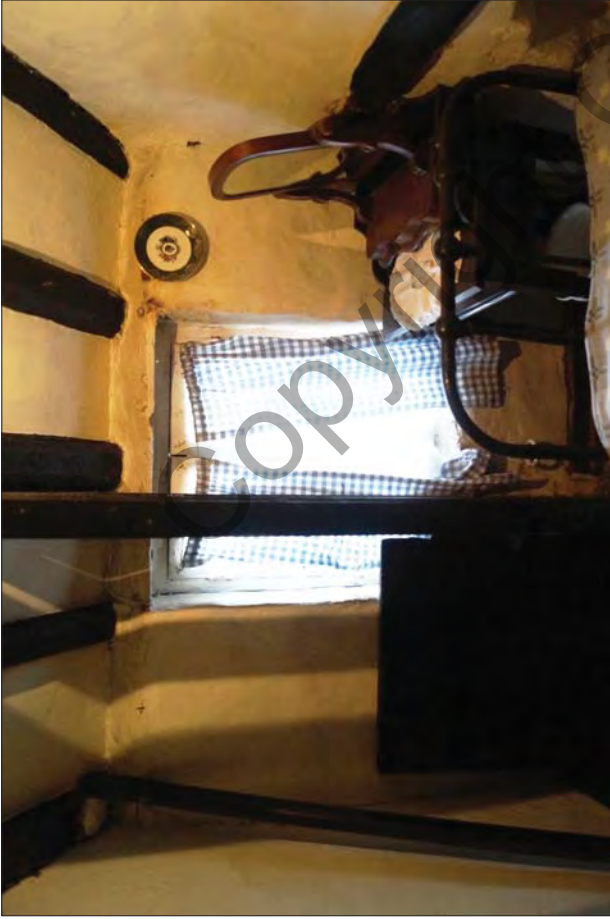
**Plate 10.** 10 Lower Gate Street First Floor Before Works

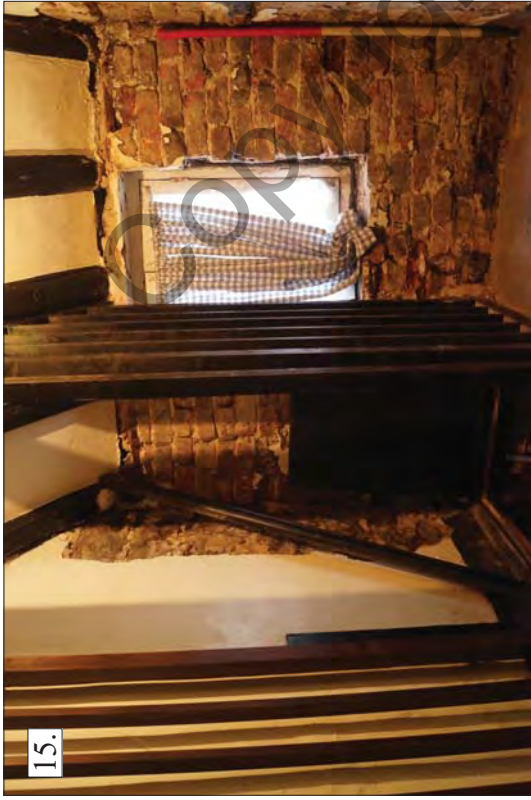
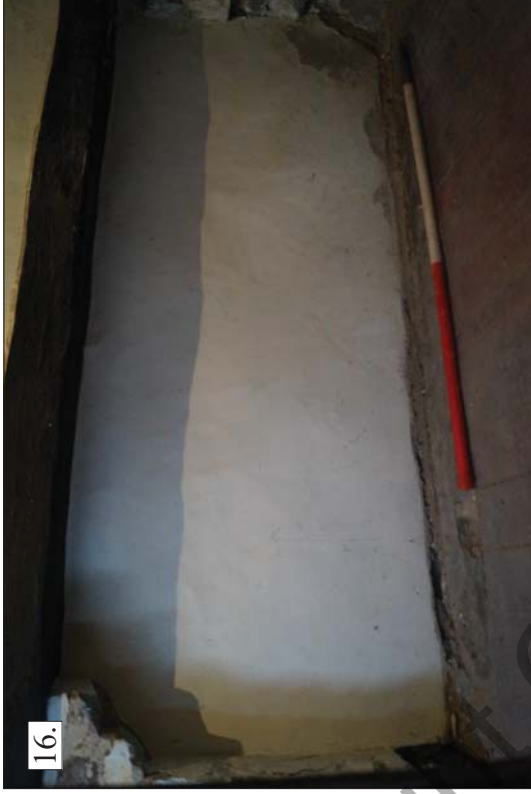
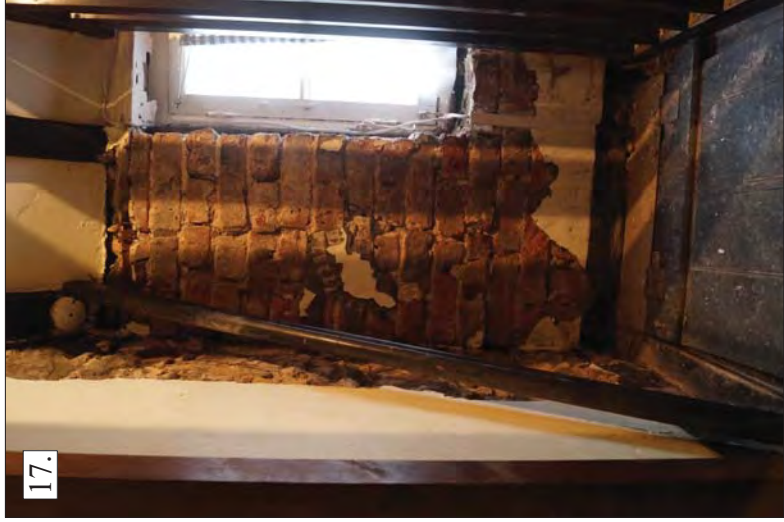
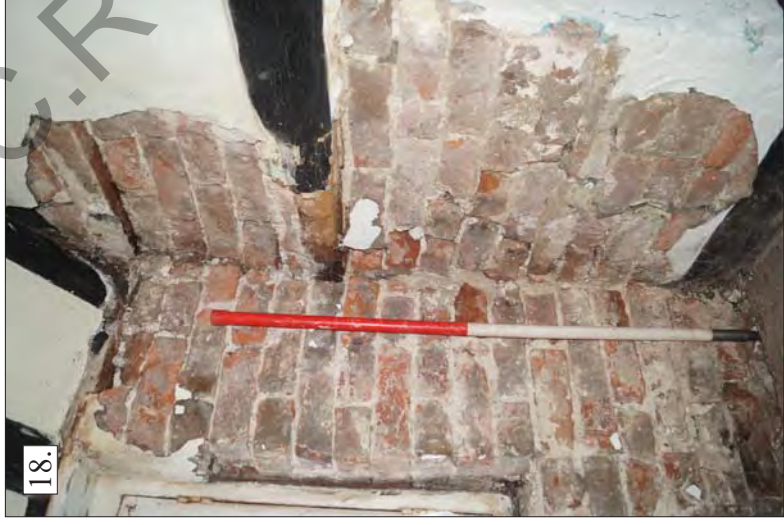
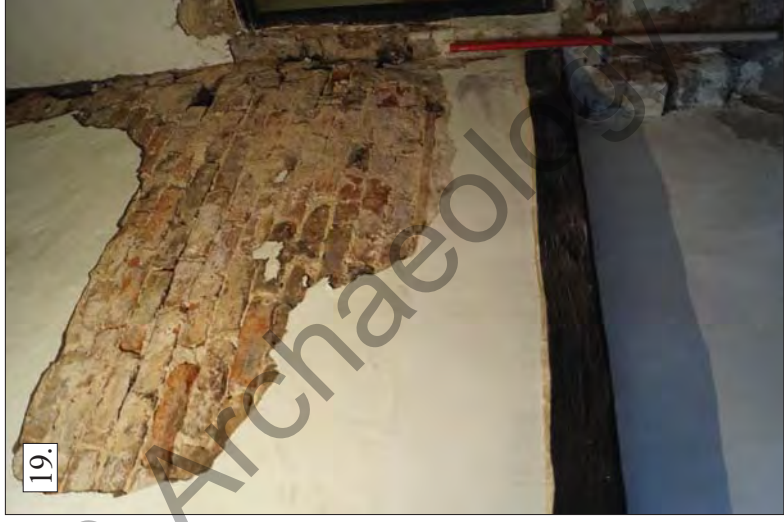
**Plate 15.** Front (North-Eastern) Elevation Following Removal Of Plaster

**Plate 16.** Alcove in South-Eastern Gable. The Purpose of The Space Is Uncertain but it May Have Simply Been Created to Allow A Bed to Fit Within the Space

**Plate 18.** Front (North-Eastern) And Gable (South-Eastern) Elevations Following Removal Of Plaster. Demonstrates That House has not Been Constructed By Simply Adding the Front Wall And a Roof

**Plate 19.** Gable (South-Eastern) Elevation Following Partial Removal of Plaster

When areas of the plaster were removed from the first floor level the smallest house was found to be of brick construction. The house had been inserted between two existing structures but it had been built as a complete shell rather than simply consisting of a front wall and roof as has been suggested elsewhere.

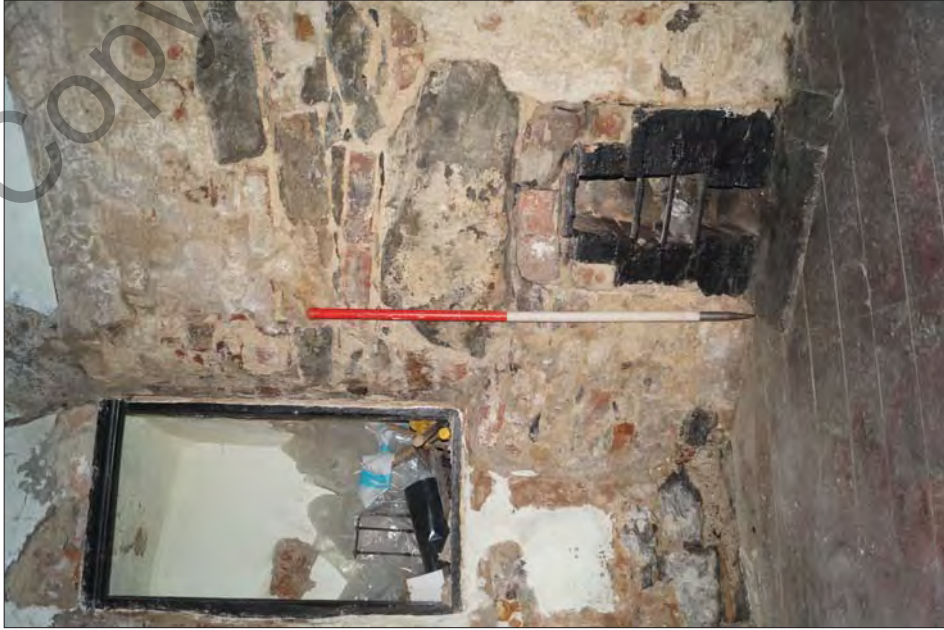
**Plate 20.** South-Western Elevation  
Following Removal of Plaster

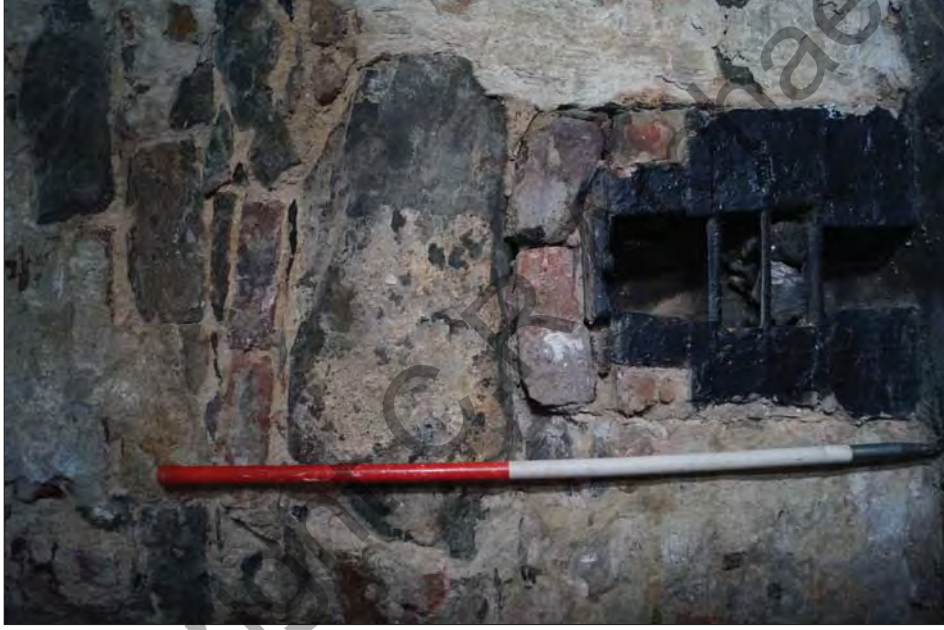
**Plate 21.** Fireplace and Chimney Breast  
Following Removal of Plaster

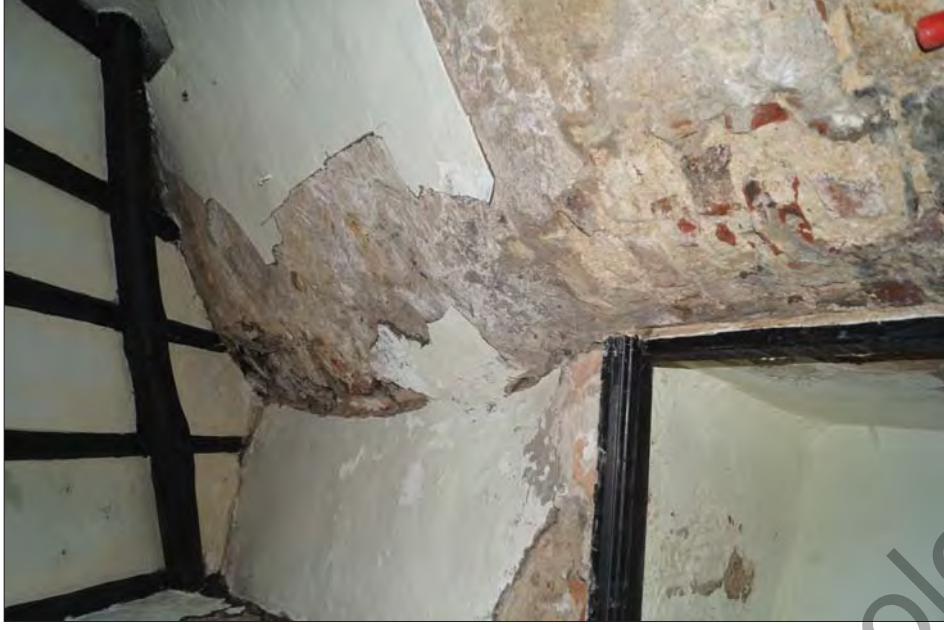
**Plate 22.** South-Western Elevation  
Following Removal of Plaster

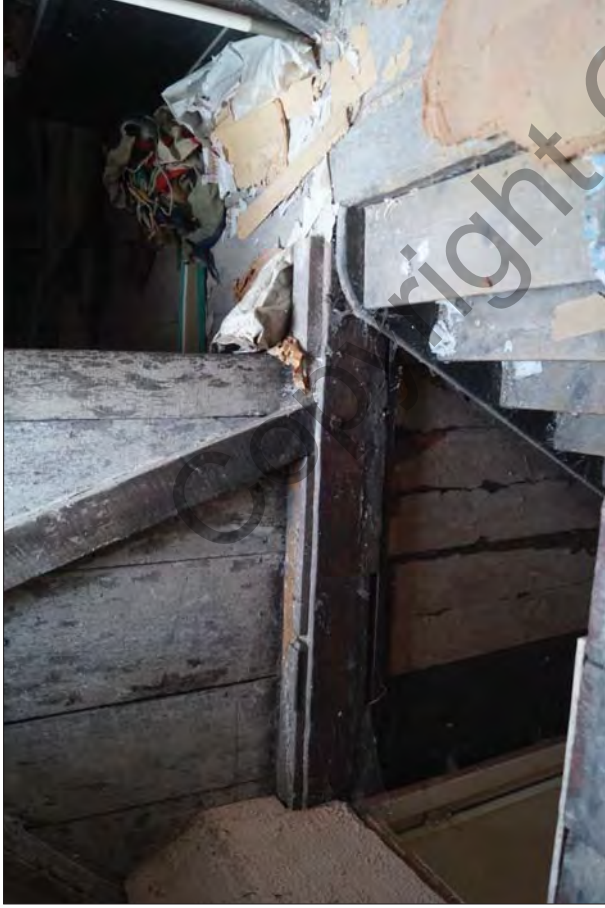
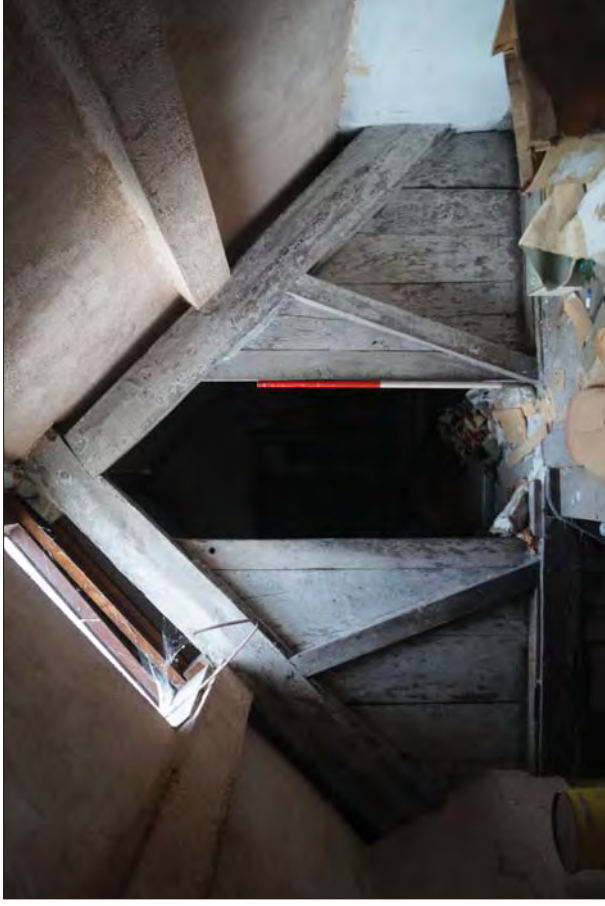
**Plate 23.** 11 Lower Gate Street, Attic Level Facing Towards North-Western Gable Showing Wooden Room Division

**Plate 24.** 11 Lower Gate Street, Attic Level Facing Towards North-Western Gable Showing Wooden Room Division

The attic is divided into two rooms by a wooden partition (plates 23-4). Lathe and plaster had been utilised to form low walls within the eaves of the roof structure on the front and rear elevations, other than the rear wall in the room against the Smallest House which was rendered stone. The space created under the eaves in the front elevation was likely to have been utilised for storage and could be accessed via an opening shown in plate 34. The lathe and plaster on the rear wall was almost flush against the stone.

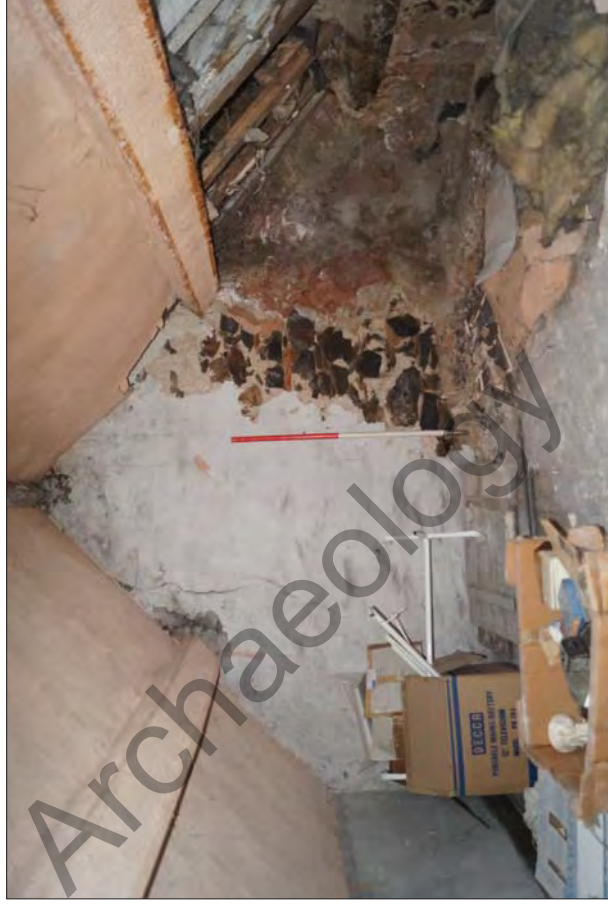
**Plate 26.** 11 Lower Gate Street, Attic Level Room Facing South-Eastern Gable. Conway Town Wall Tower in Corner

There was a small area of the Town Wall tower identified in the south-eastern corner of the attic (plates 26 – 31). No architectural features were identified on this structure and the wall construction does not differ from that observed elsewhere around the wall circuit.

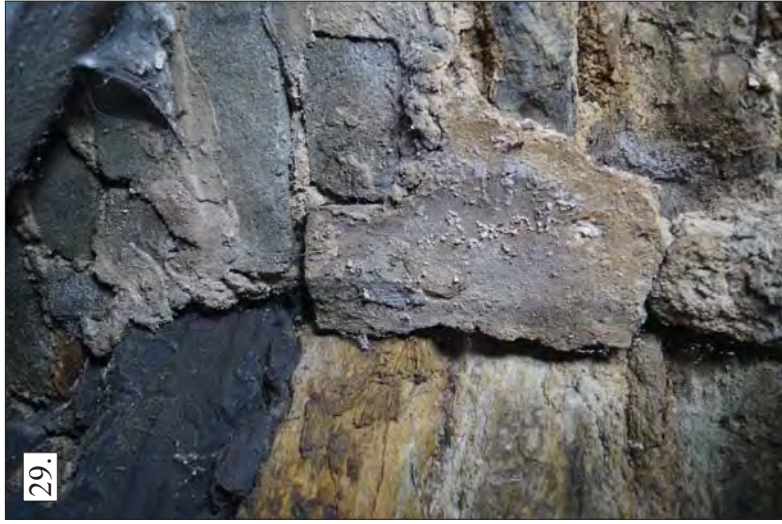
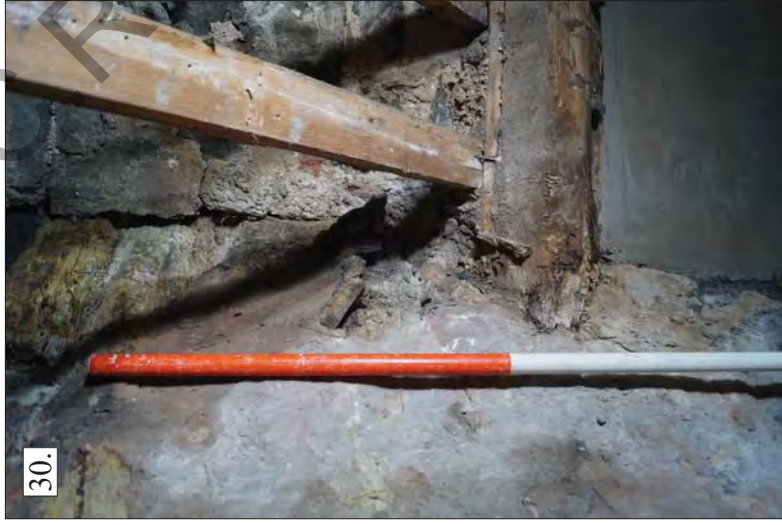
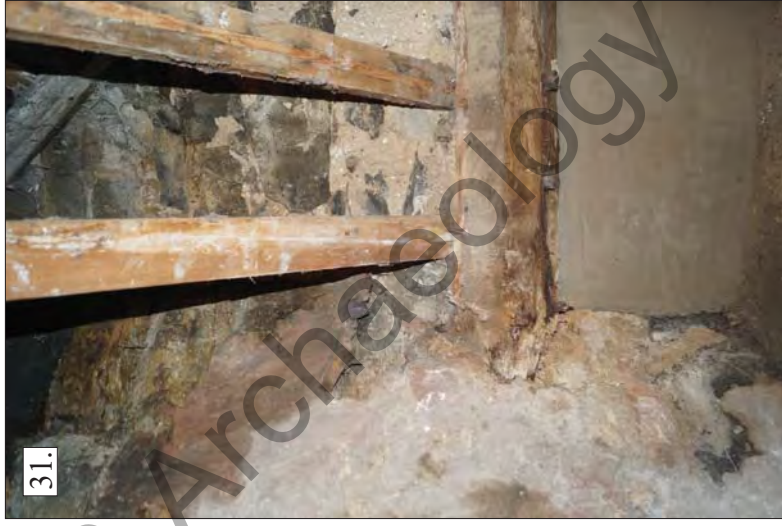
**Plate 29.** Small Portion of  
Medieval Tower Visible in  
Corner of Room

**Plate 30.** Small Portion of  
Medieval Tower Visible in  
Corner of Room

**Plate 31.** Small Portion of  
Medieval Tower Visible in  
Corner of Room

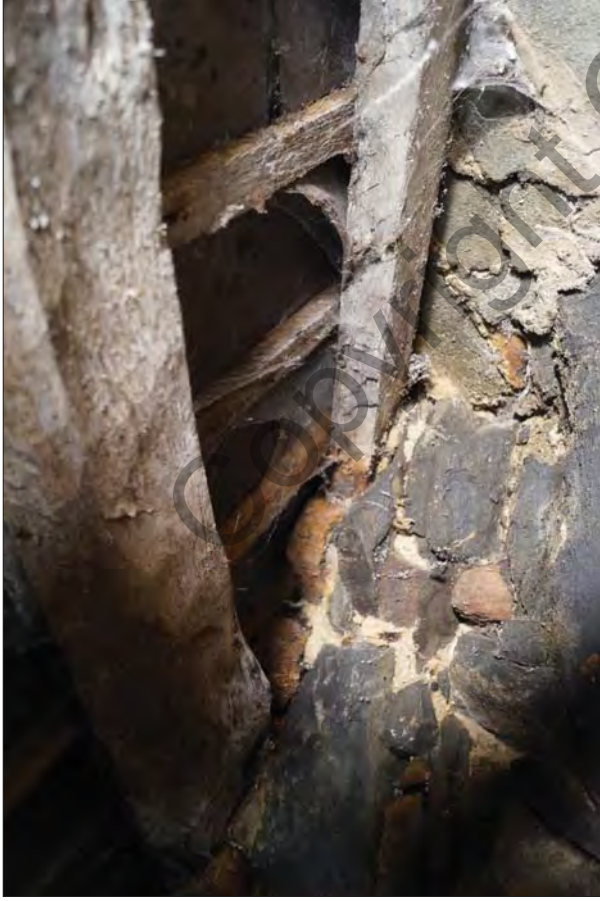
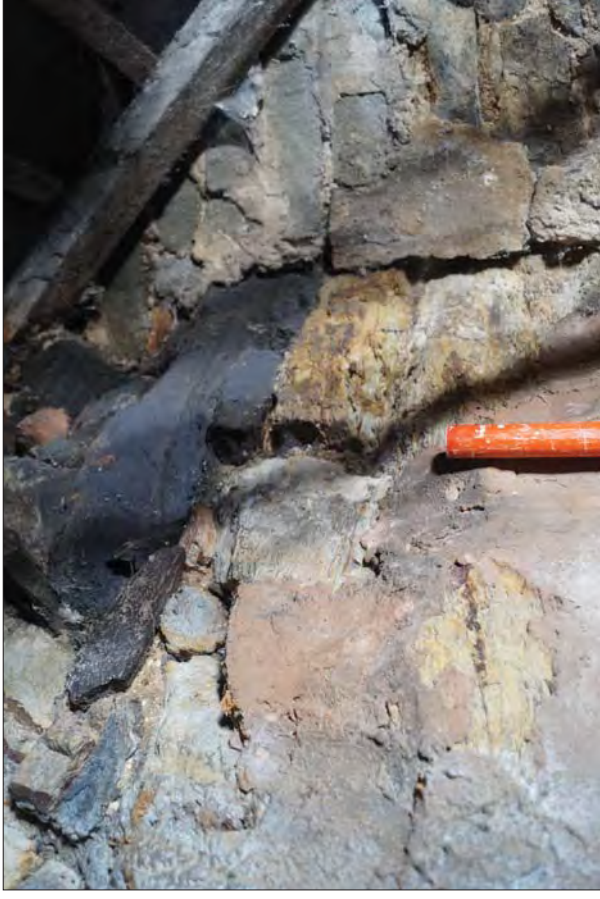
**Plate 32.** Junction Between Town Wall and  
Number 11 Lower Gate Street

**Plate 33.** Junction Between Town Wall and  
Number 11 Lower Gate Street

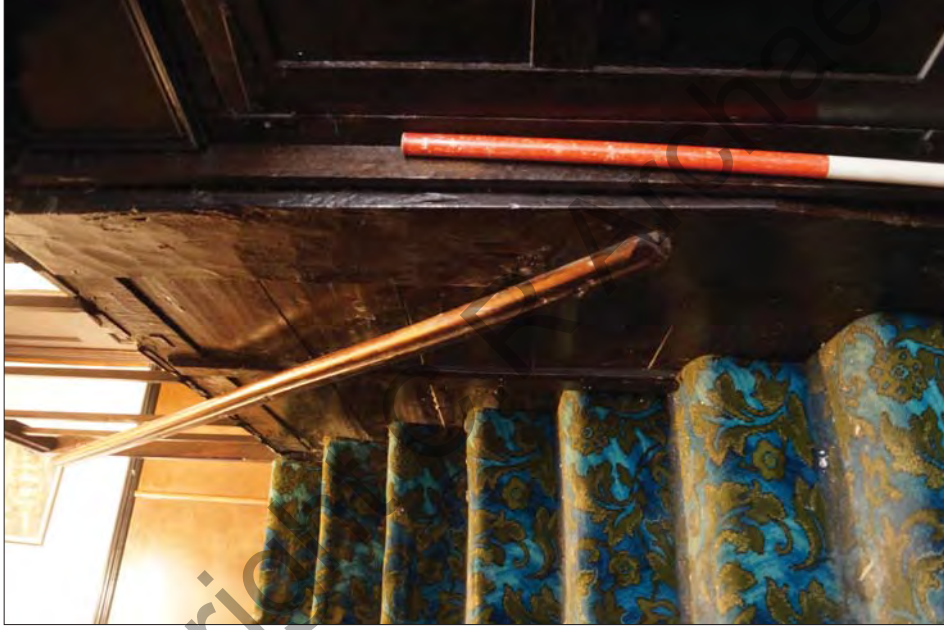
**Plate 37.** Original Wooden Division  
At Ground Floor Level
