**Porth Mawr, Caernarfon
Archaeological Assessment**

EAS Client report 2017/01

Porth Mawr, Caernarfon
Archaeological Assessment
Commissioned by
Donald Insall Associated for Cadw

Grid Reference:	SH 47901 62823
Listed Building No.	3869
Scheduled Monument reference number	CN034
NPRN	302416
PRN	3098

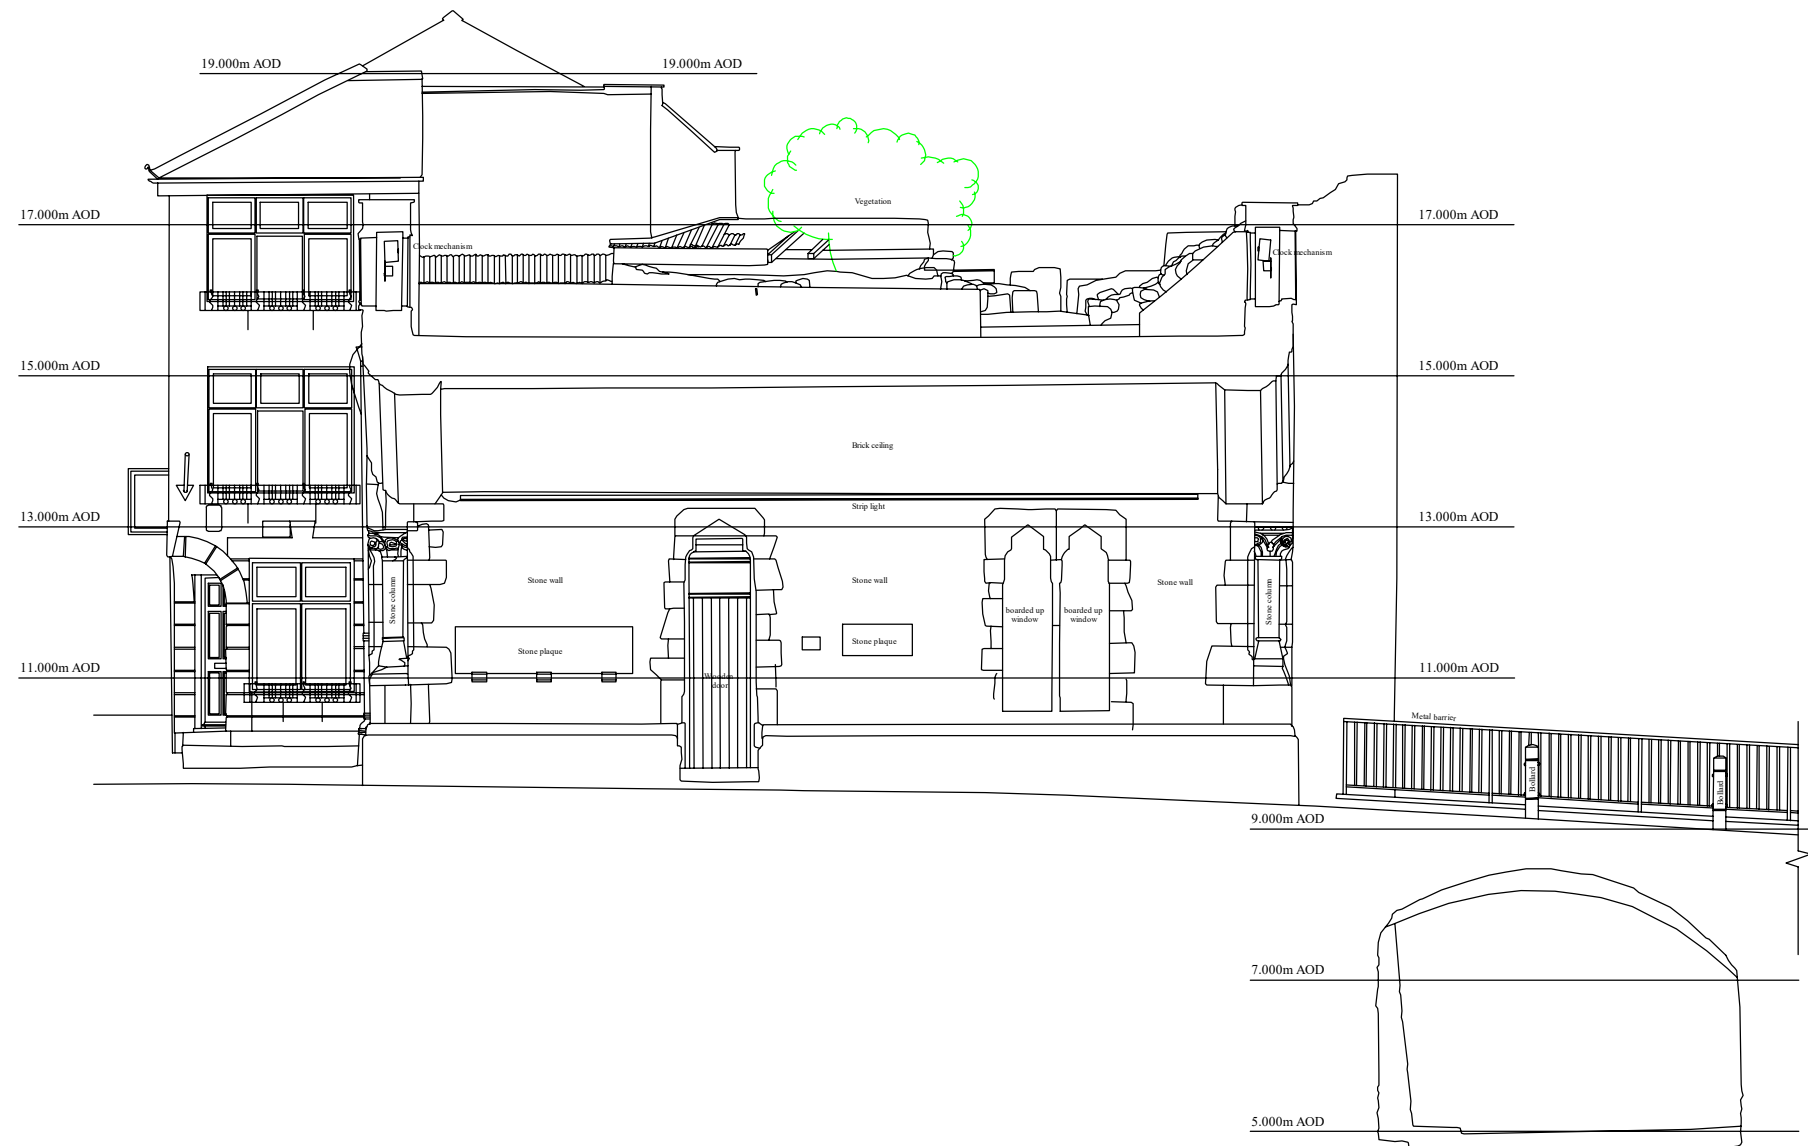
Figure 5: Elevation of the North Side of the Entrance Passage
Scale 1:100

The northern elevation of the passageway (Plate 14, Figure 5) has a plinth of dressed sandstone blocks over which the walling is of random, squared limestone. At the top of the wall is a band of sandstone blocks arranged in a random pattern, with some rough rustication on their surfaces. There is a double window towards the eastern end of the wall (Plate 15), above the plinth. Both opening have Caernarvon arches and are separated by a chamfered,

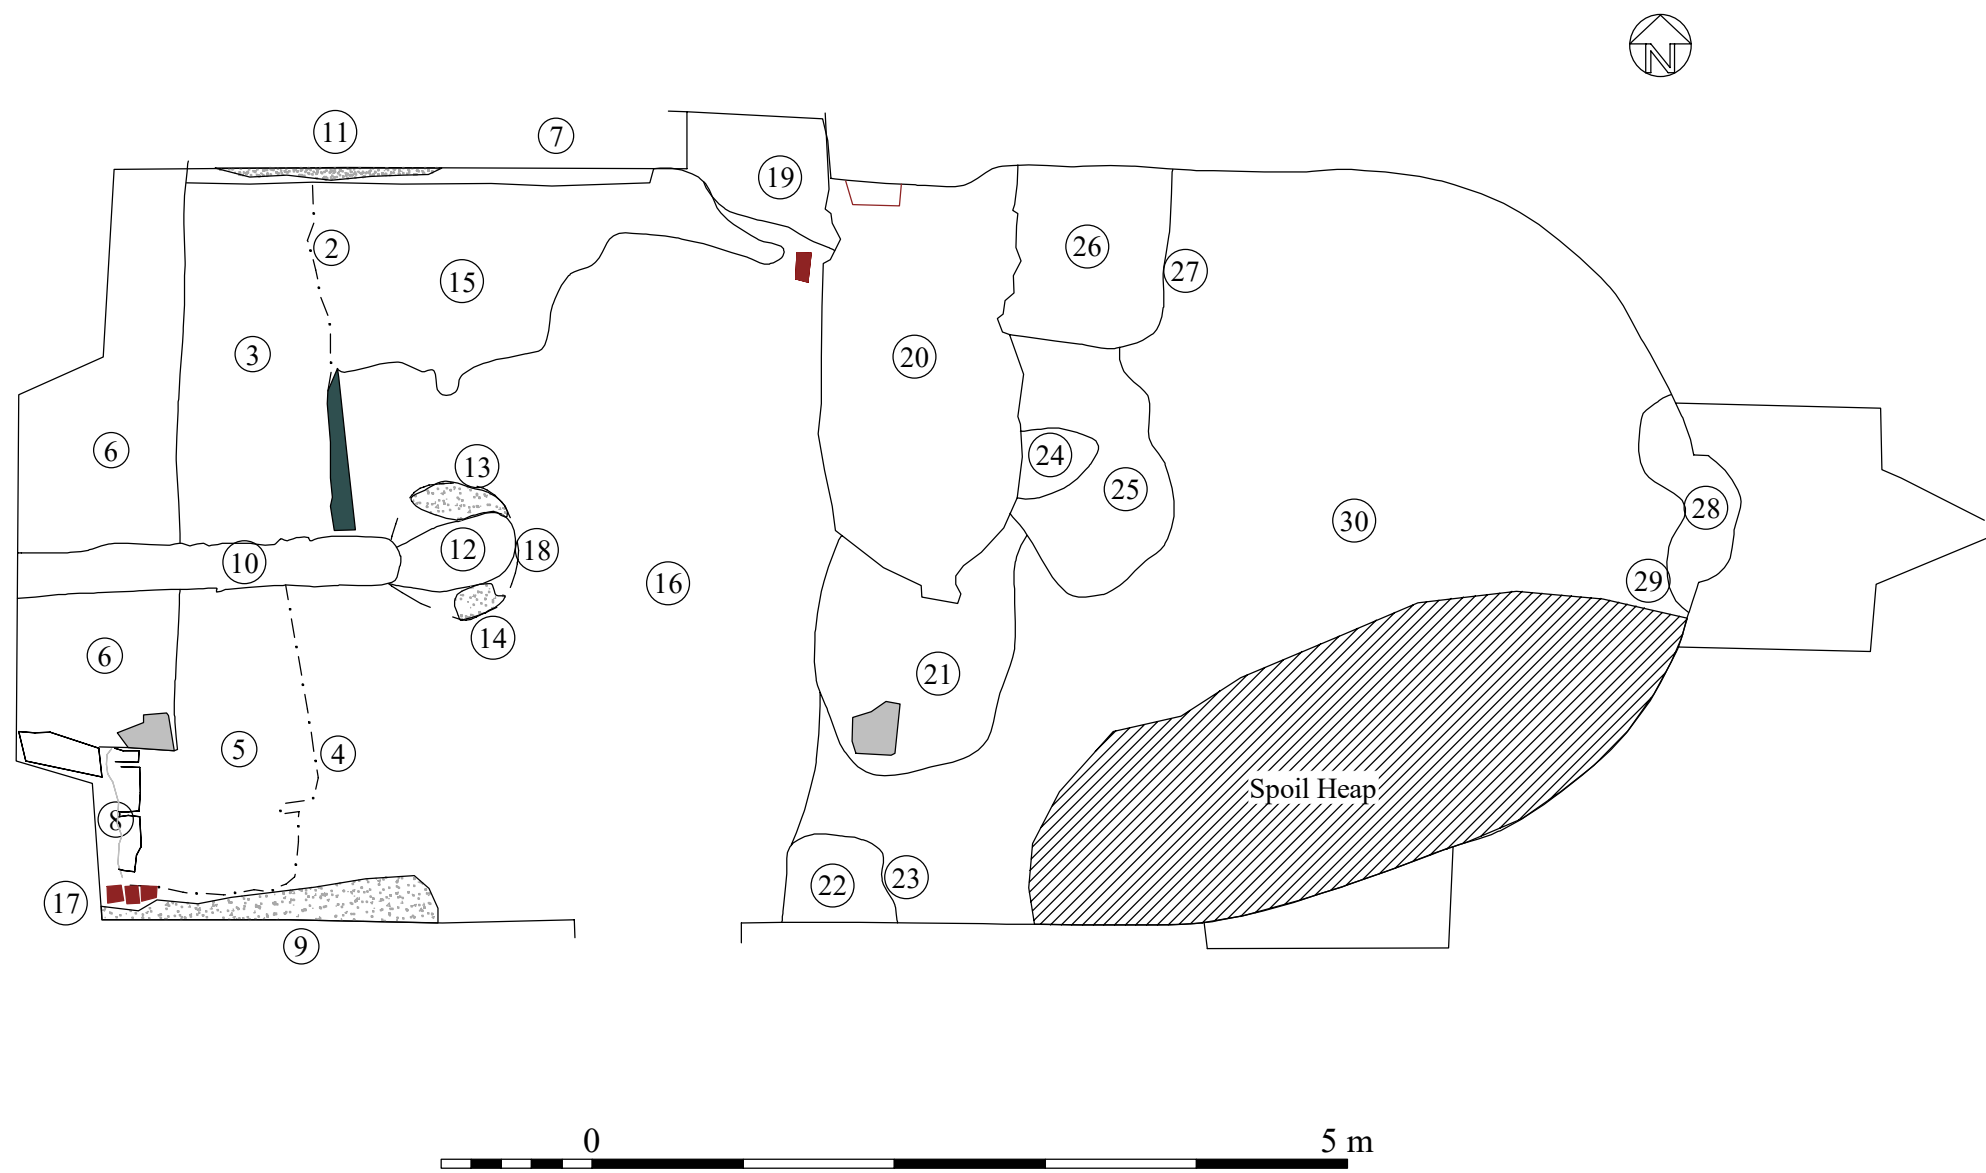
Figure 11 : Plan of the archaeological feature revealed by the removal of the gravel
Scale 1:50

Two wide (approximately 1.3m) walls have been defined (Context 6 and 20, Figure 11) within the northern chamber of the gatehouse, which are assumed to be part of the original medieval structure. Context 6 (Plate 72) runs under both the northern and western walls of the gatehouse and has a return at its southern end marked by faced stone block. Possibly associated with this return are a series of worn stones (Context 8, Plate 73) continuing the line of the wall, but set back by 0.25 m. The heavily worn top faces of these stones suggest they may have served as a threshold for a passageway.

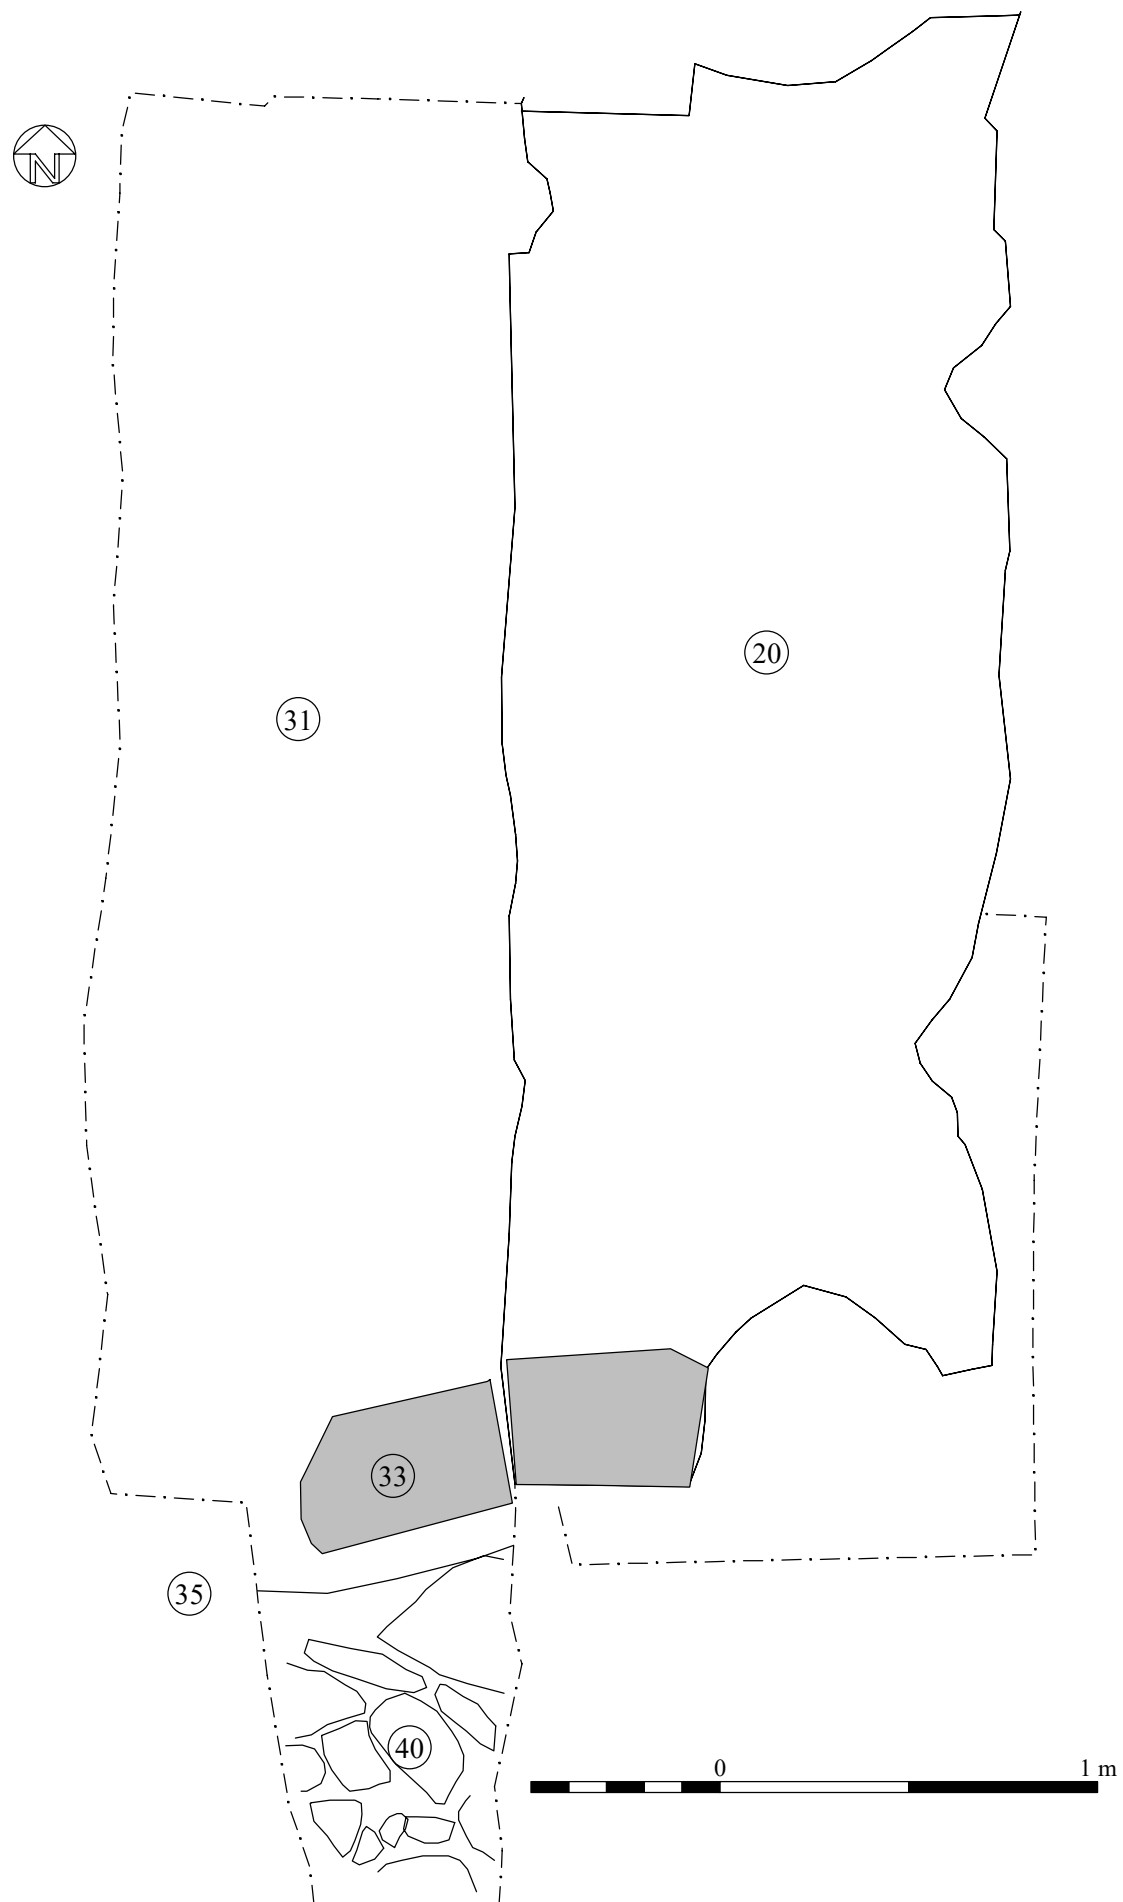
Figure 13: Plan of the upper cobbles
Scale 1:20

At the southern end of the trench Context 31 gave way to a relatively clean orange brown gritty, sandy clay which was clean with no finds (Plate 85). This layer was 0.2 m deep lying over an area of rough cobbling (Context 40, Figure 13, Plate 86). This layer of cobbling is clearly at a higher level than the other cobbled surfaces recorded in the trenches and is therefore later. One possibility is that it relates to the worn block (Context 8) thought to be a threshold, however they are 0.36 m lower than the top of the worn blocks.

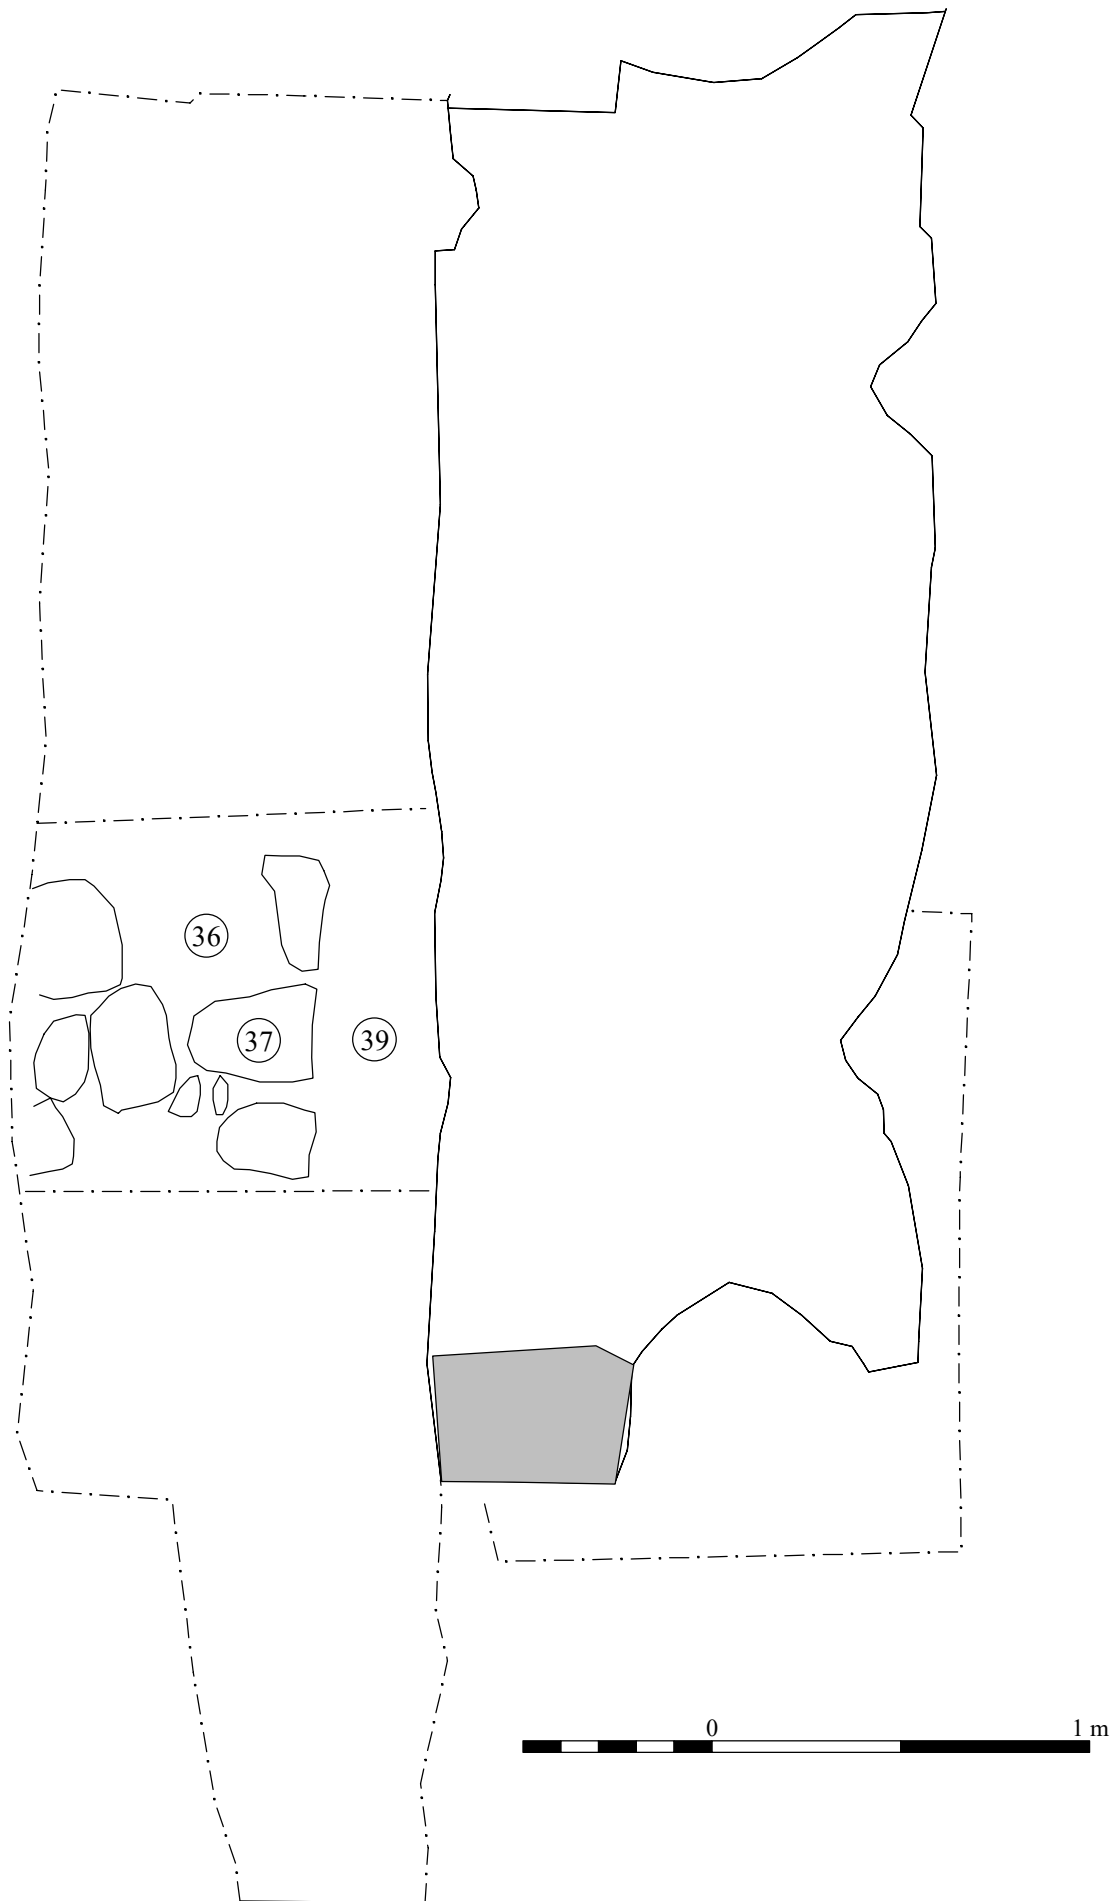
Figure 15: Plan of the cobbles (Context 37)
Scale 1:20

In order to test the deposits below this cobbled surface, a sondage, was dug through Context 36. This was approximately 1 m long and was the full width of the trench. Context 36 sat immediately over a second surface (Context 37, Figure 15, Plate 88). This was a relatively rough surface made up of sub angular to rounded cobbles and up to 350 X 300 x 100 mm in size with a smooth, worn surface forming a rough surface. This were set in an orangish brown clayey silt with many small fragments of slate (both purple and grey) fleck of mortar and coal which possibly suggest the accumulation of debris before the surface was hardened up using the cobbles. This layer sat on top of a layer which was high in coal fragments (Context 39) which formed a band approximately 340 mm wide and up to 100 mm deep alongside the wall Context 20. This would suggest that the gatehouse was used for the storage of coal at some point, possibly contemporary with the cobble surface below this layer.

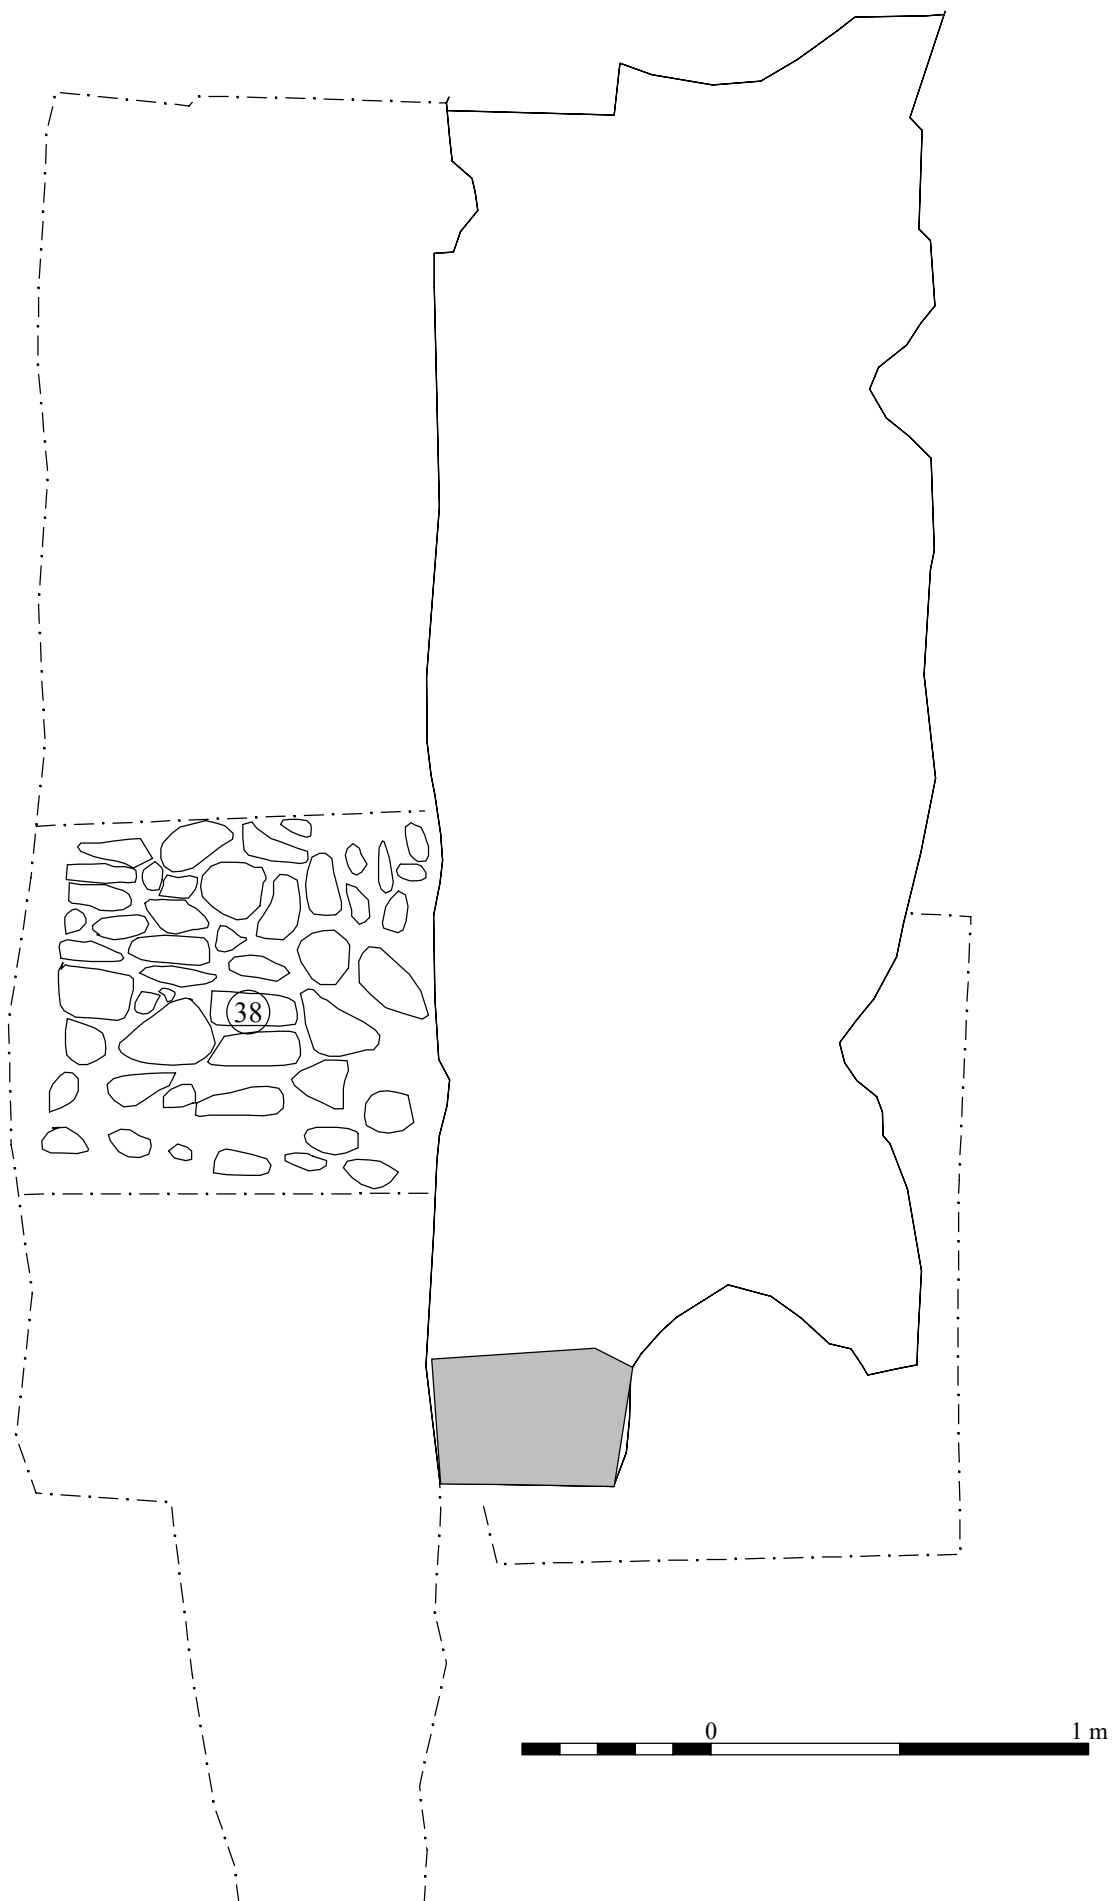
Figure 16: Plan of the cobbles (Context 38)
Scale 1:20

The lowest layer of cobbles exposed (Context 38, Figure 16, Plate 89) was more consistent. Even within the small area exposed it was possible to suggest that there may be a gully running at right angle to the trench and the surface to the north of this appeared to be cambered. This pattern of a longitudinal gully and slightly raised area adjacent is common within agricultural building where animals are stalled and if the pattern from this small exposed area is accurate it is possible that the building was being used as stables at this point. Two sherds of pottery were found pressed into the cobbled surface, one of which was dated to the late 1500's or early 1600's (See below).

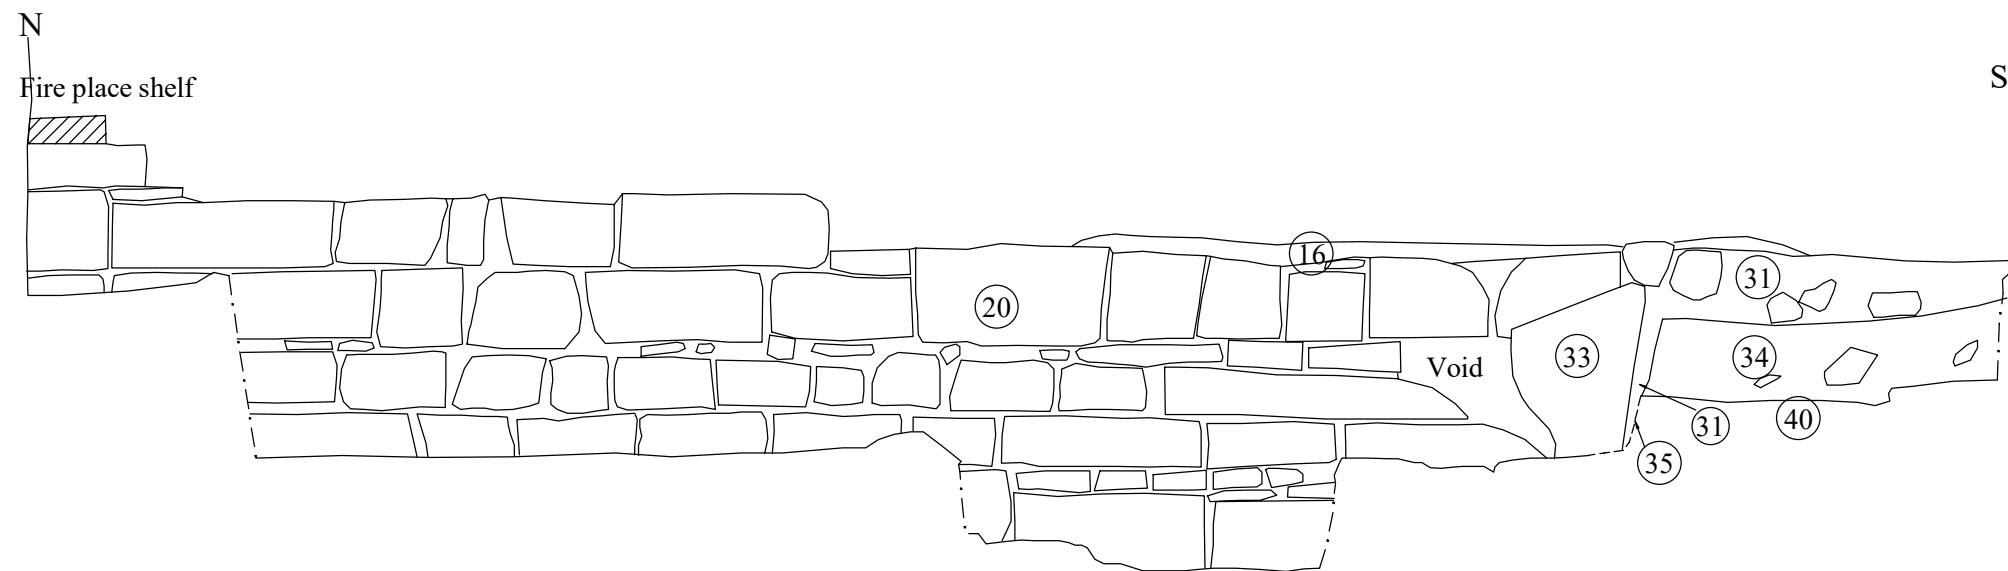
Figure 17: Sections
Scale 1:20

The tramples surface (Context 16) covered the whole of the top of the trench reaching a depth of 50 mm over much of the area (Figure 17). This was clearly a relatively modern layer as it incorporated a plastic button and a fragment of 35 mm plastic film. Below this layer was a deposit of loosely packed, mortar rich material (Context 31). Over the majority of the trench this layer was up to 0.38 m deep, however at the southern end of the trench it was only 0.17 m deep. This disparity is explained by a cut (Context 35) which had removed approximately the top 0.4 m of the deposits over most of the width of the gatehouse. This cut would have been approximately 3.80 m wide leaving only 0.9 m wide baulk along the southern wall of the gatehouse. The fill, Context 31, proved to be relatively modern, incorporating fragments of a reinforced concrete beam, possibly a window lintel, suggesting a twentieth century date. Whilst this deposits had some large stones within, there was a concentration of large stone blocks (Context 33, Plate 84) along the line of the cut (Context 35). At least two of the block within Context 33 are large, rectangular, faced blocks similar to

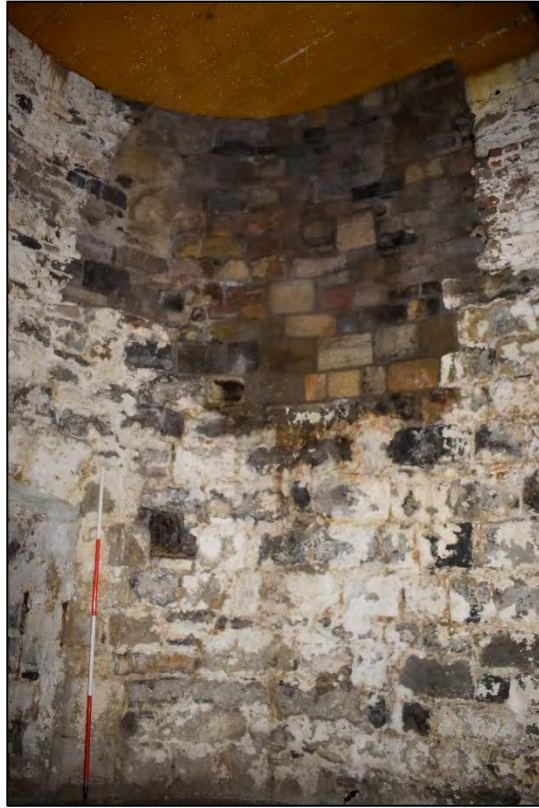
Plate 39: Repair to the southern gatehouse

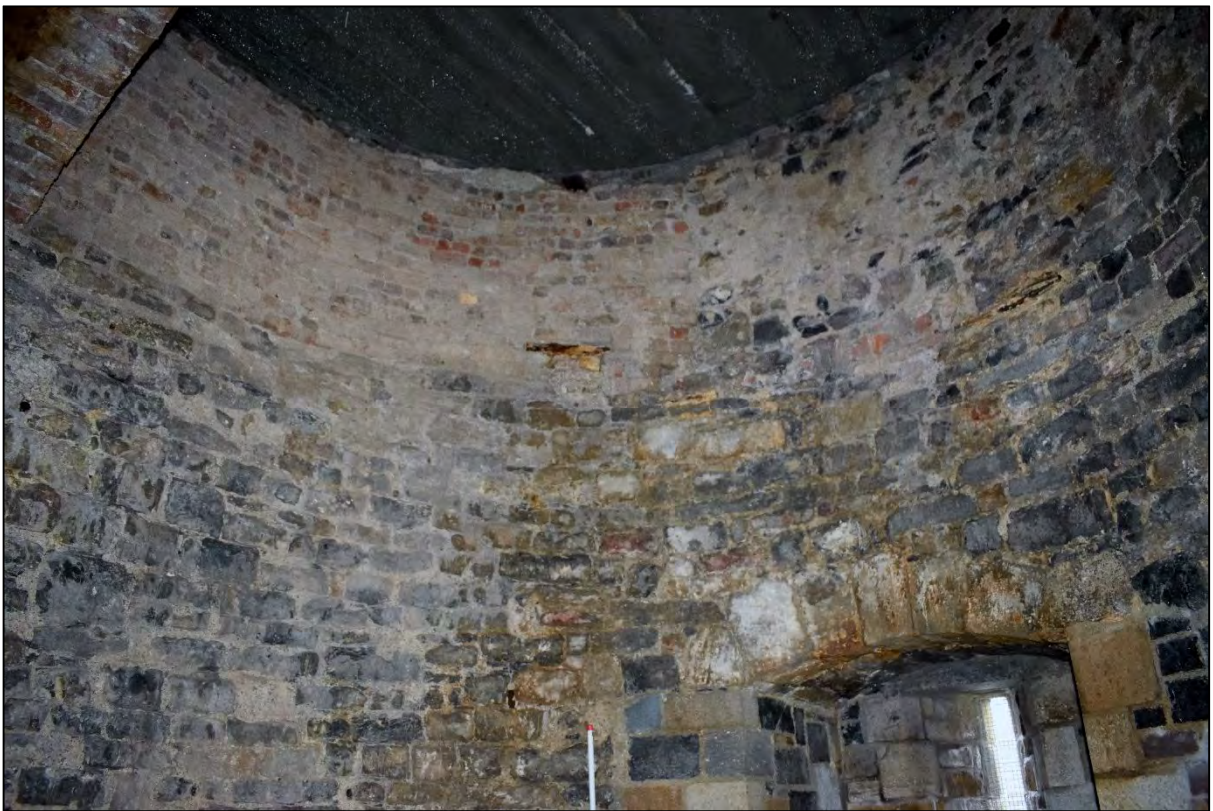
The norther gatehouse consists of a single room, now open to the roof level (Plate 53 and 54). The ceiling is supported by two brick arches (Plate 55) and consist of a series of concrete beams laid longitudinally. There is also a concrete wall plate around much of the building. The upper part of the gatehouse is supported by a rolled steel joist, presumably inserted to prevent the upper portion of the walls moving after the upper structure of the gatehouse was removed. Some modern repair in brick are also evident in the eastern end of the building (Plate 56). Further modern (20th century) repairs are evident to the embrasure and arrow slit (Plate 57).

Plate 56: Modern brick repair in the eastern end of the northern gatehouse

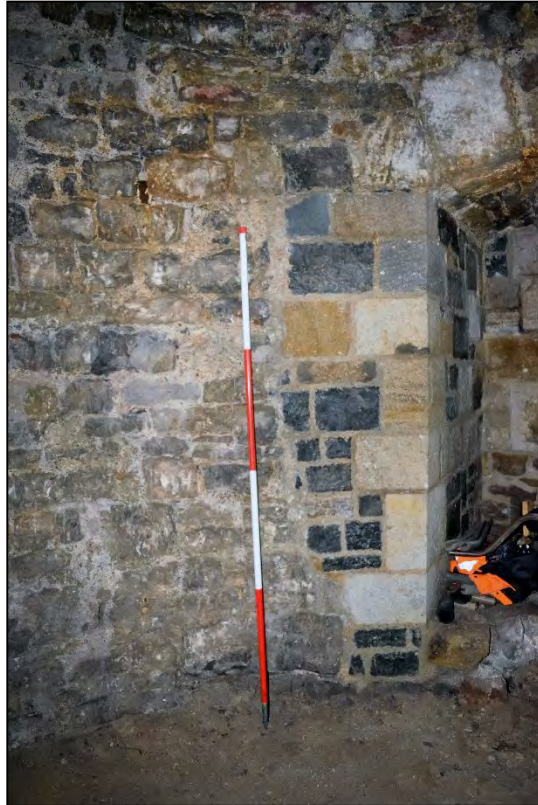
Plate 57: Modern repairs to the embrasure
