Ty'r Wern, Llan Ffestiniog
Desk Top Study and Building Record

Commissioned by
Rhys Llwyd Davies

EAS Client Report 2023/05

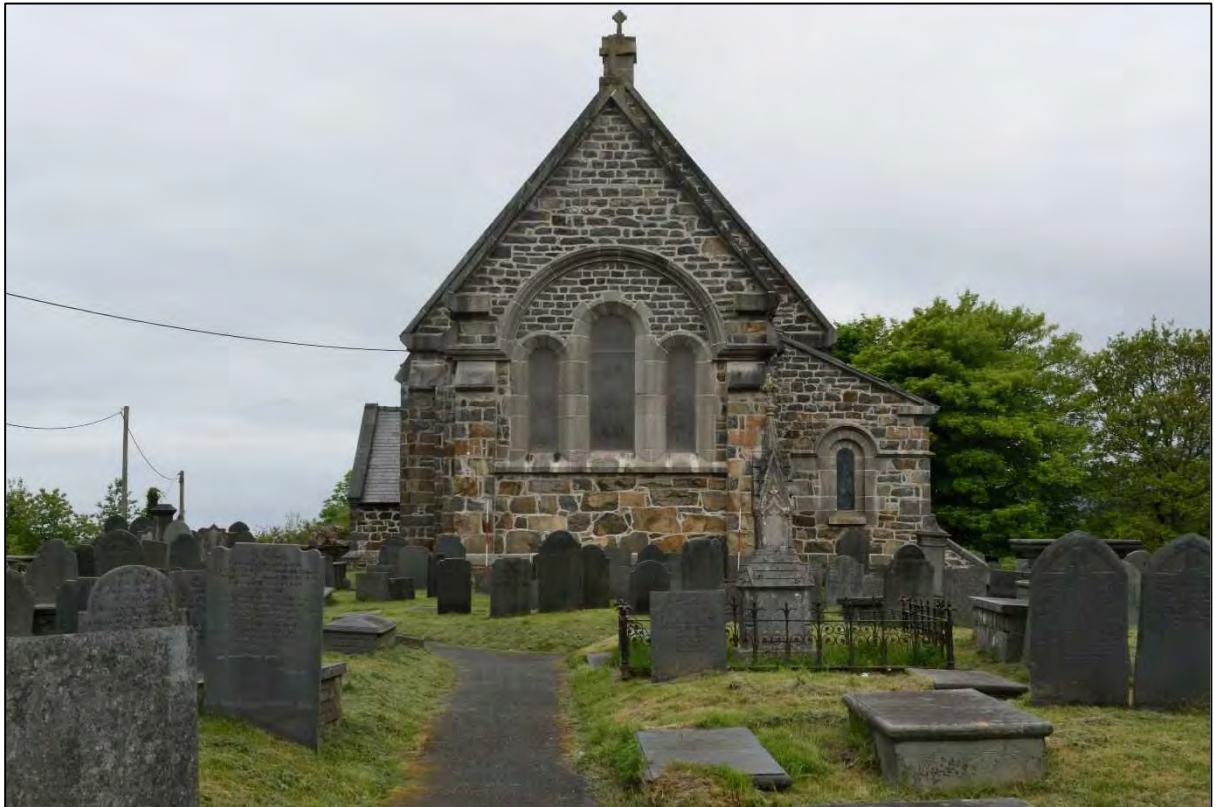
Plate 1: Ty'r Wern, looking west

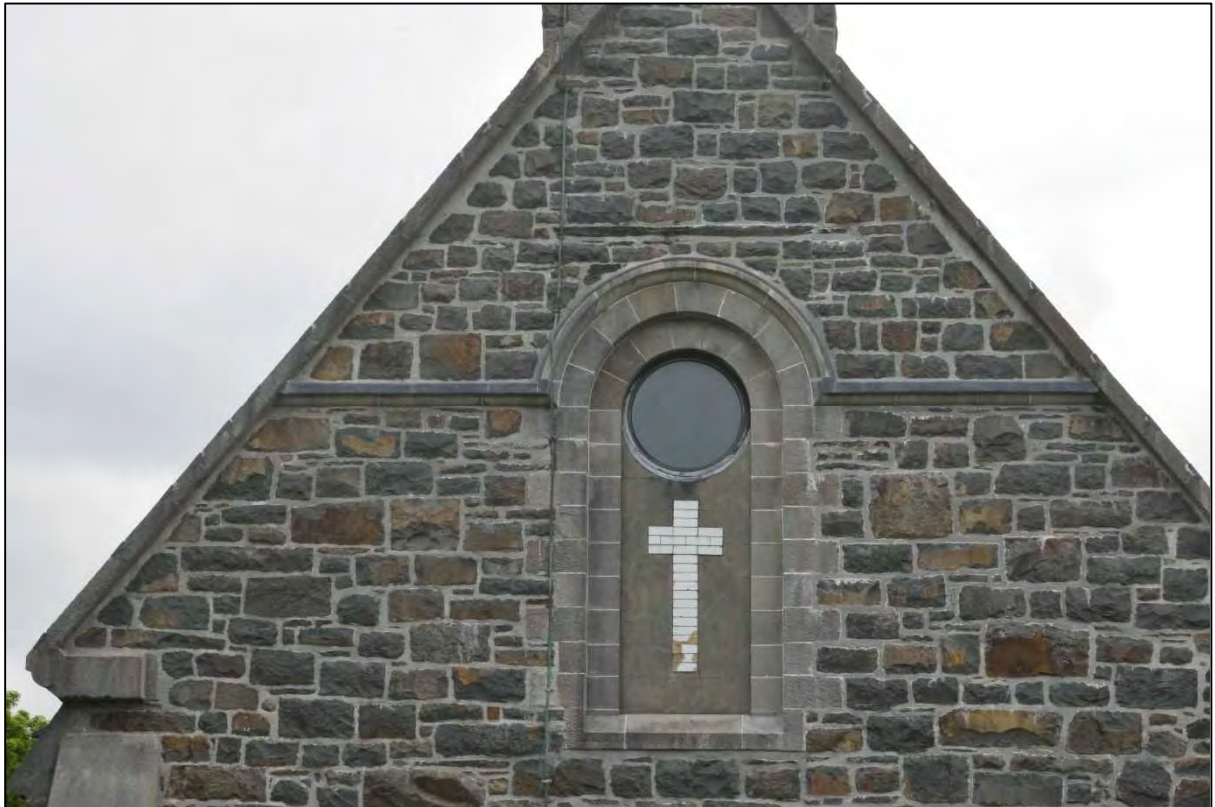
Plate 11: Detail of the blocked window in the western gable

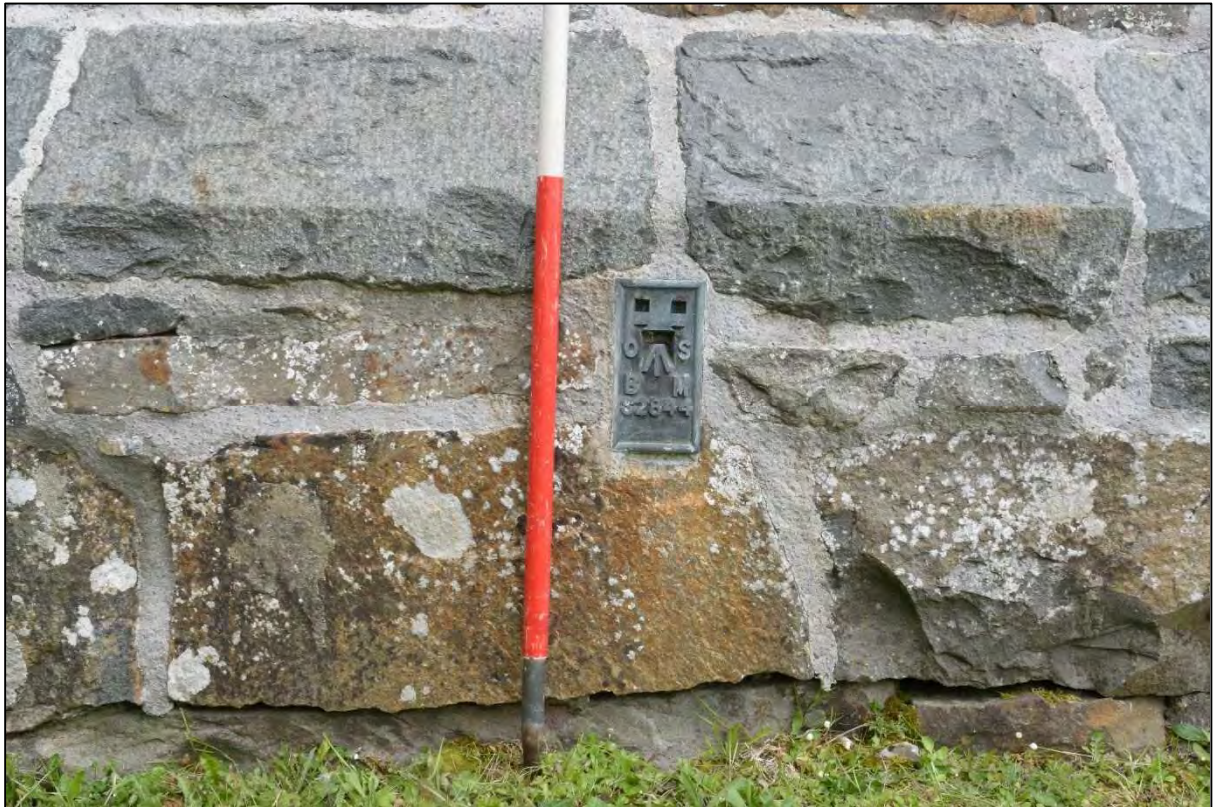
Plate 13: Bench mark on the western gable

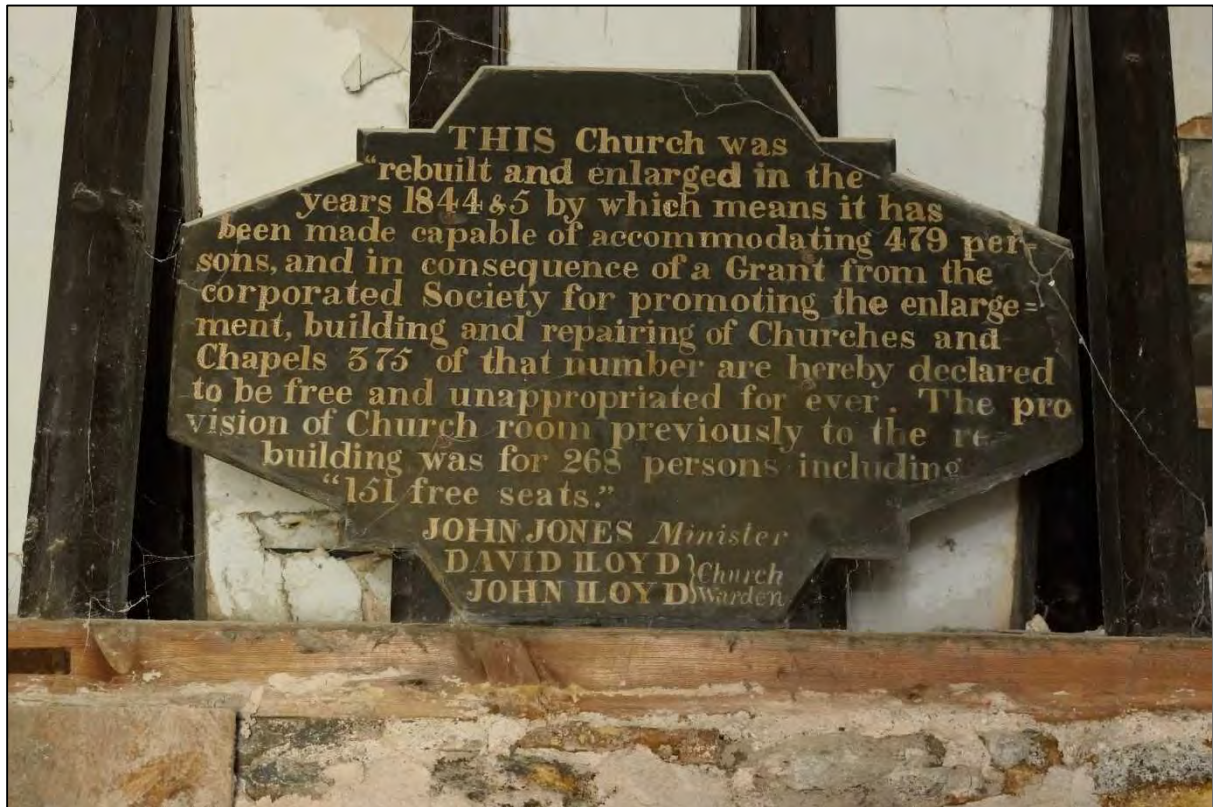
The porch also contains two plaques, propped up on the eastern wall plate. Both commemorate grants given for the construction of the new church and set out the conditions for those grants. One is from the Incorporated Society for Promoting the Enlargement, Building and Repairing of Churches and Chapels (Plate 31). It reads:

This Church was
rebuilt and enlarged in the
years 1844 & 5 by which means it has
been made capable of accommodating 479 persons, and in consequence of a Grant from the Incorporated Society for promoting the enlargement, building and repairing of Churches and Chapels 375 of that number are hereby declared to be free and unappropriated for ever. The provision of Church room previously to the rebuilding was for 268 persons including
“151 free seats.”

Plate 31: Plaque celebrating a grant from the Incorporated Society for Promoting the Enlargement, building and Repairing of Churches and Chapels

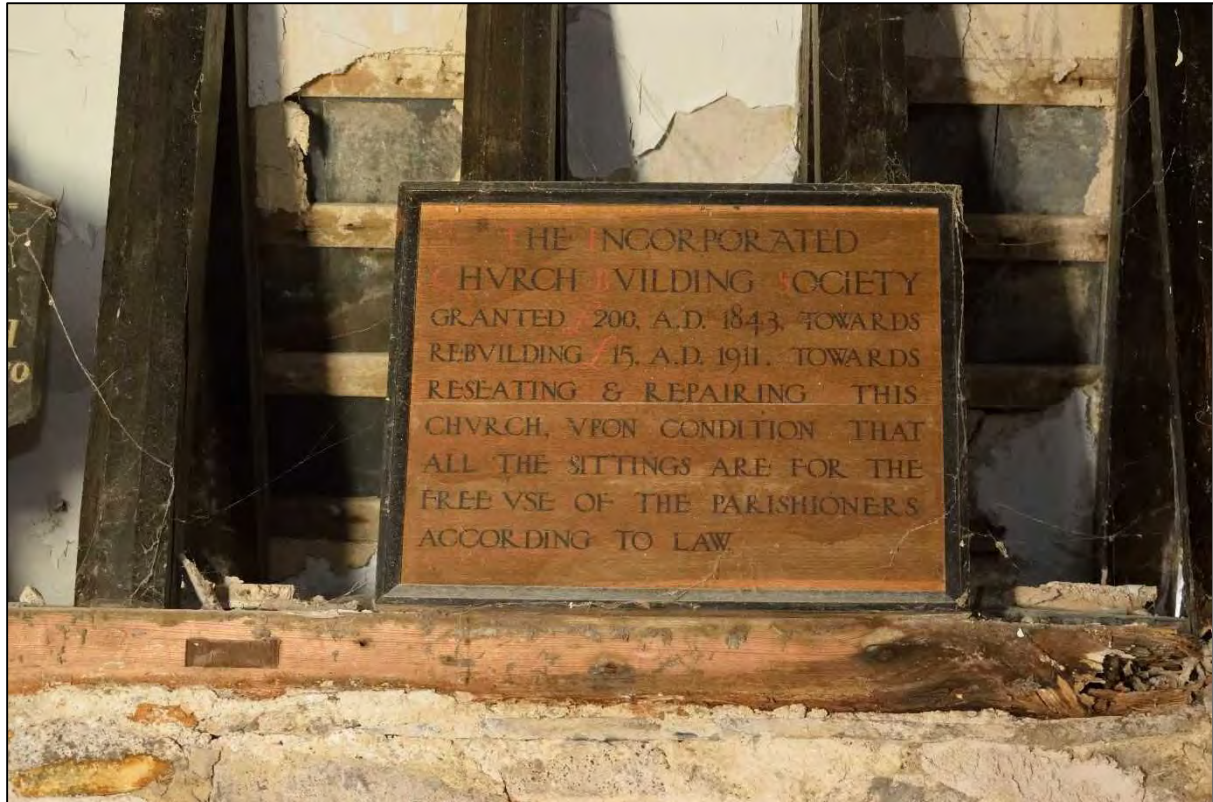
THE INCORPORATED
CHURCH BUILDING SOCIETY
GRANTED £200, A.D 1843, TOWARDS
RESEATING & REPAIRING THIS
CHURCH UPON CONDITION THAT
ALL THE SITTINGS ARE FOR THE
FREE USE OF THE PARISHIONERS
ACCORDING TO LAW

It is curious that both societies felt able to impose these conditions considering that they each gave a grant of only £200 less than 6% of the total cost of £3239.15.5 (Caernarfon XD2/23267).

Plate 32: Plaque celebrating a grant from the Church Building Society

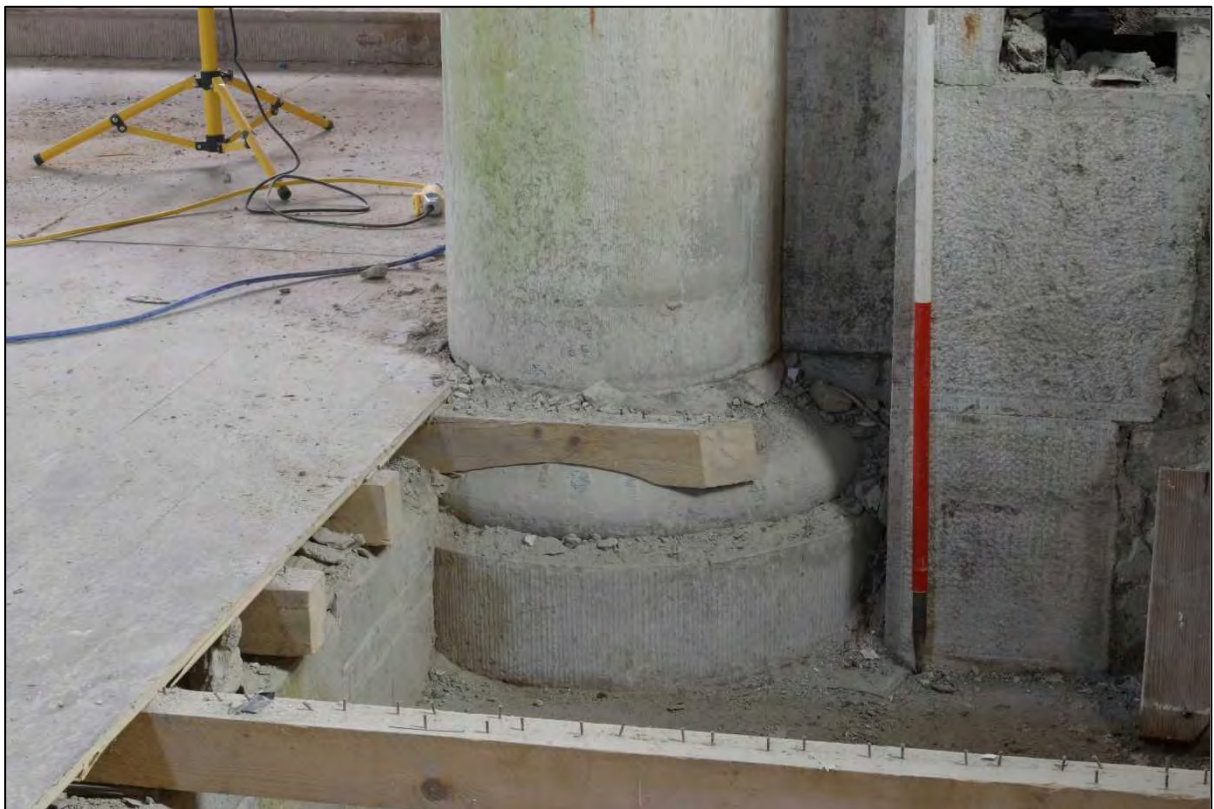
Plate 58: Base of the chancel arch hidden below the current floor

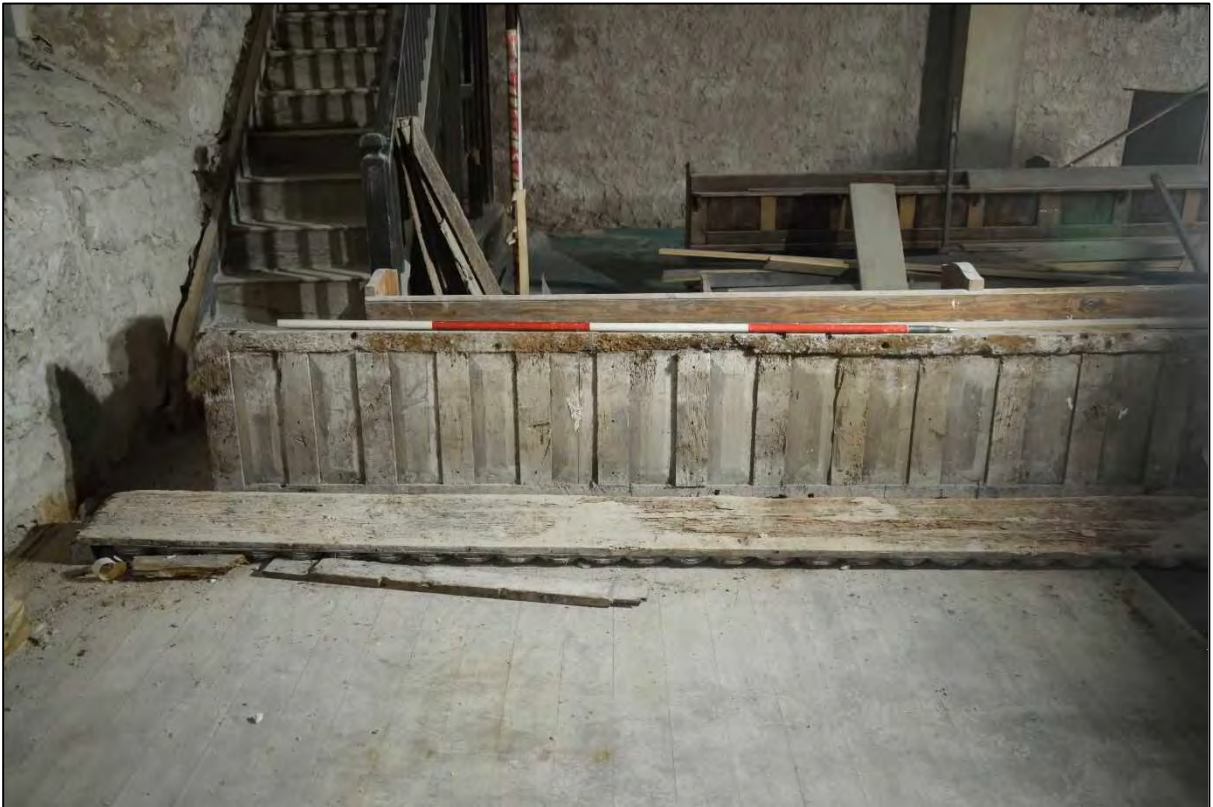
Plate 61: Panelling stored in the nave

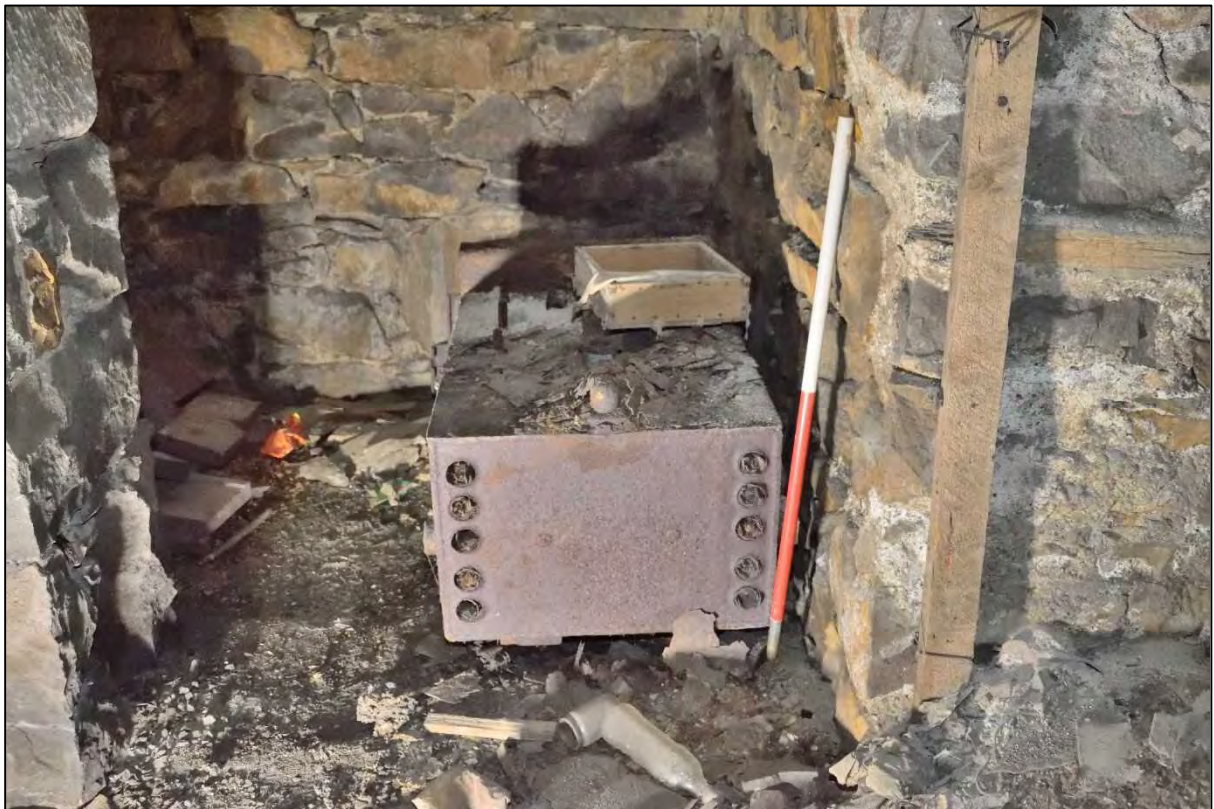
Plate 81: Part of a disused heating system in the cellar

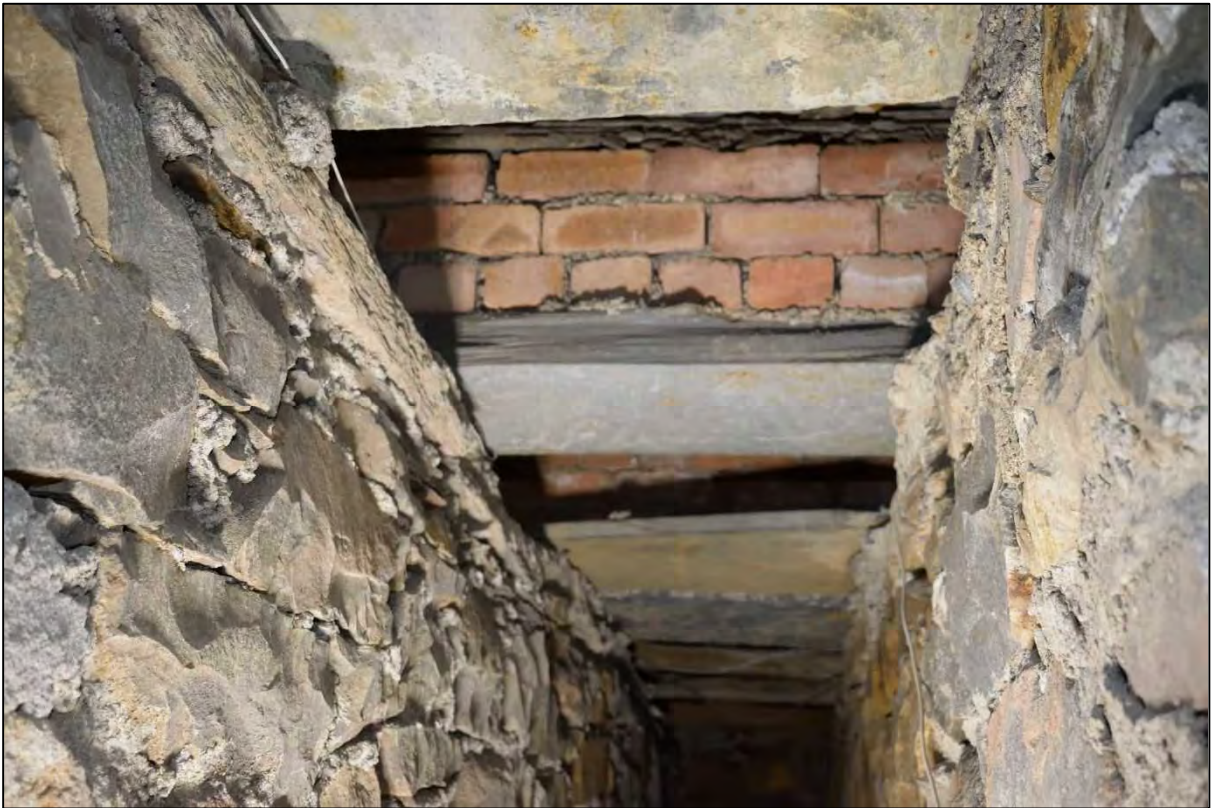
Plate 86: Brickwork over the northern passage.
