**BRYN SEIONT HOSPITAL, CAERNARFON
LEVEL 3 RECORDING**

Client: Mario Kreft

September 2013

Govannon Report GC318

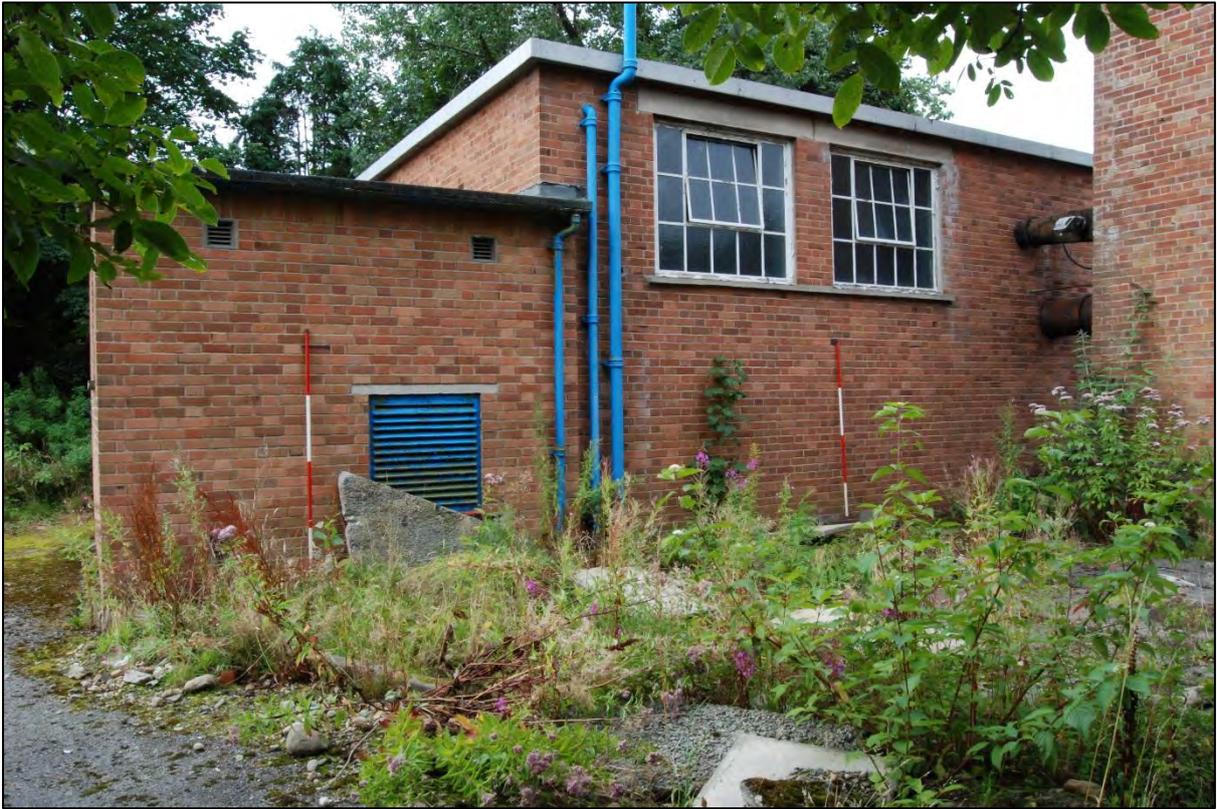
It was not possible to gain access to the room to the east of the Boiler House; however it is labelled as a 'Generator' on Plan 981/18/972 and the presence of a louvered screen on the northern wall of this building (Plate 43) would tend to confirm this function.

Plate 43: The eastern extension to the Boiler House (Generator House)

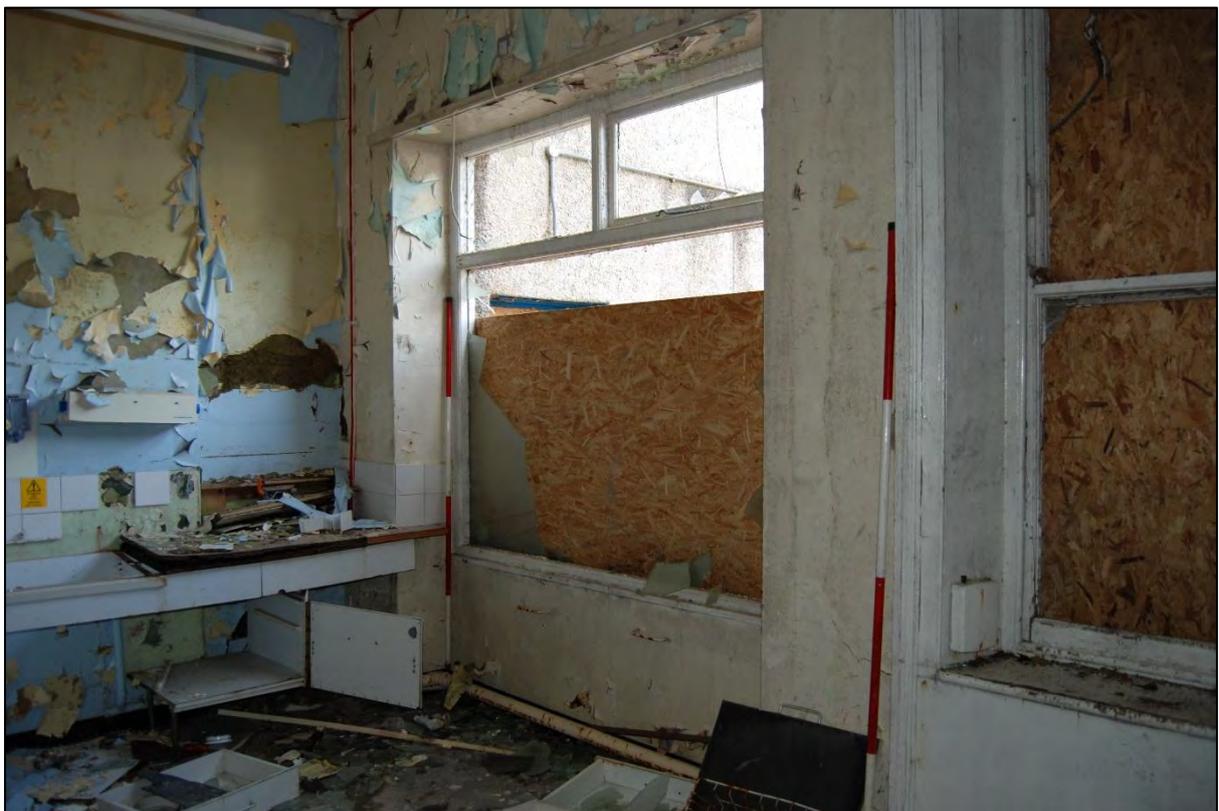
To the west of the lobby (Room 3, Plate 80) is a room which in its last phase of use was a kitchen, however it is within the footprint of the house and was probably a study/office in its original use. This would allow clients/workers to consult the owner without having to enter the main house. The room is heavily modified, however the one of the original windows (Plate 81) survives as does the door frame. The second window is clearly a modern replacement, probably replacing two similar windows to the one surviving window. The surviving window is a tall, narrow sash window with a three-quarter round moulding around the frame. The frame is set back within a panelled reveal. The doorway has a slightly moulded doorframe. Although now one room, in the 1970s this room was divided into a telephone room, in the north east corner, and a dental surgery.

Plate 80: Room 3, looking north

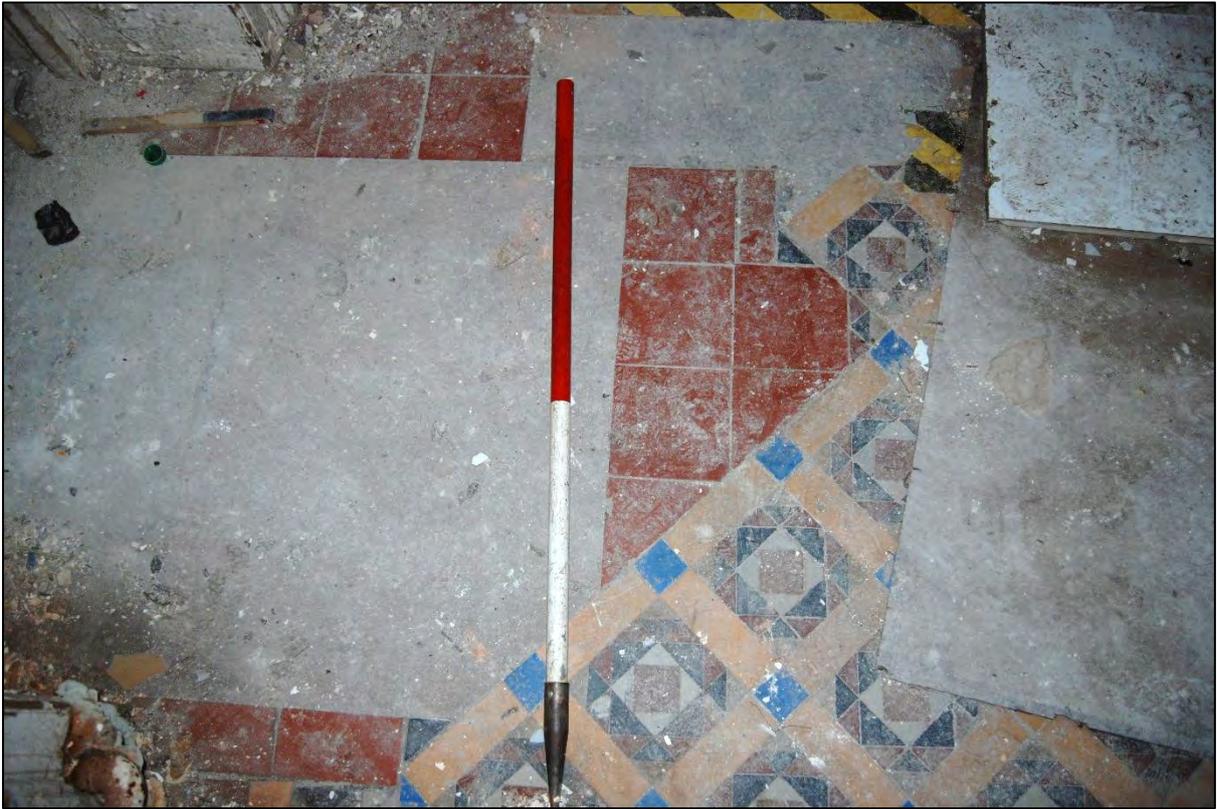
The Hall (Room 4, Plate 82) is relatively large space with a moulded ceiling of similar type to the lobby (Plate 83). It has a polychrome tile floor with a yellow and red banded border (Plate 84) which has been disrupted in the SW corner of the room with the use of red quarry tiles. This is the route between the service passage and the Dining Room, possibly marking the position of a partition across this corner, however it is equally possible that this area was subject to excessive wear and was replaced by the cheaper quarry tiling after Bryn Seiont became a hospital. Centrally placed on the southern wall is a blocked fireplace (Plate 86). This has been moulded to represent either a house or possibly a classical tomb. Within the 'roof' area of the fireplace is a shield with a chevron. Unfortunately this has been painted white so that the original colours are not discernable. Although

Plate 85: Repair in the SW corner of the Hall

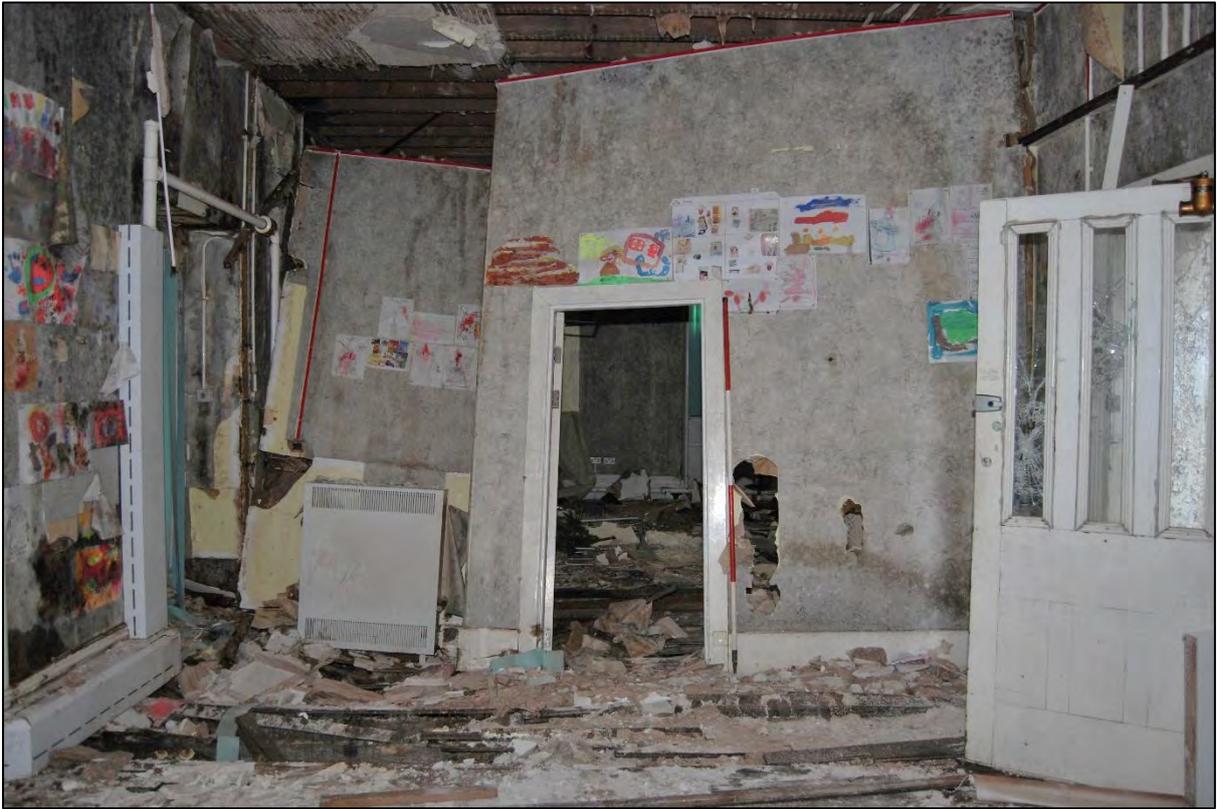
The Ballroom/Drawing Room (Room 6) runs across the whole width of the house, now divided into two rooms by a stud wall partition (Plate 89), however, the continuous run of the skirting boards suggest this was originally one room. The presence of two doors into this room, however, may suggest the possibility of dividing the room with a temporary screen. Unfortunately the ceiling within this room has been replaced with a plain ceiling. The floor has also collapsed near to the fire door in the eastern wall and in doing so the partition wall has also partly collapsed. A missing section of plaster on the western wall shows that although this wing is faced with brick the internal construction is of a stone rubble. During the 1970s this room was divided into two Female Wards.

Plate 89: The partition dividing the Ballroom/Drawing Room

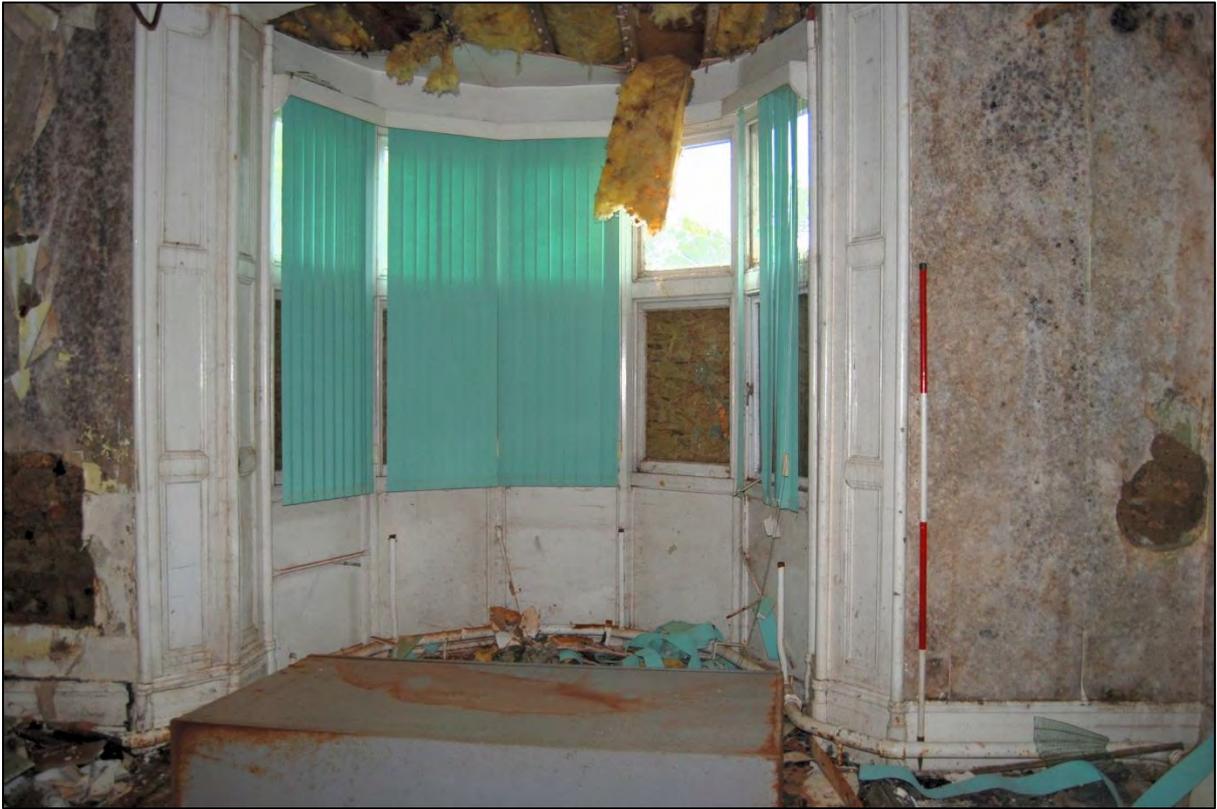
The southern end of the Ballroom/Drawing Room (Room 6B) has two narrow sash windows, either side of a blocked fireplace on its southern wall (Plate 94) and a bay window on the eastern wall (Plate 95). The two sash windows have three-quarter round column mouldings together with panelling within the reveals (Plate 96). The 'columns' extend over the window. Similar mouldings surround the bay window (Plate 97); however as with the bay window in Room 6A, the window itself is a later replacement.

Plate 95: Bay Window in Room 6B

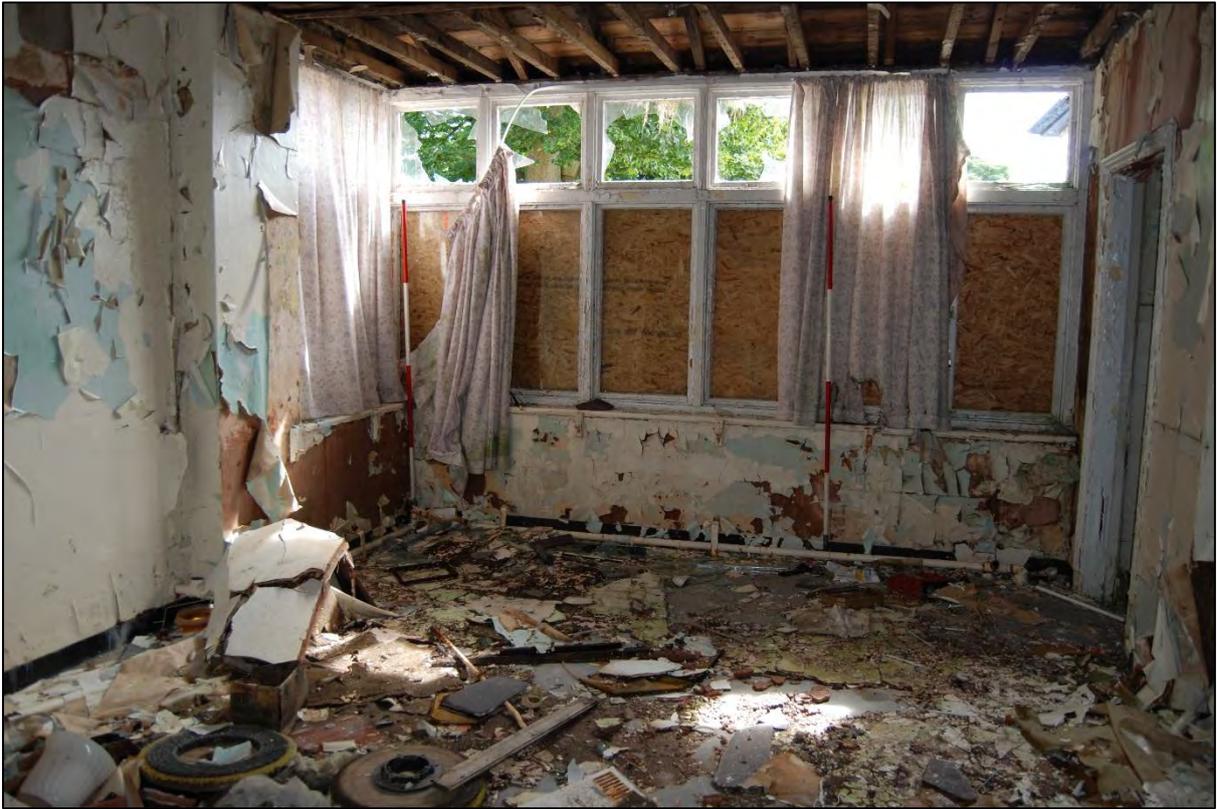
Room 8, is found at the eastern end of the ground floor service passage (Plates 105 and 106). In the 1970s it served as a Nurses' Dining Room; however its original function is not clear. It appears to be associated with the service passage way and may therefore have been a House Keeper's Parlour although this is not certain. Few original features have been retained in this room, indeed the southern end of the room (Plate 105) has been replaced with a bay window late in the development of the building. In the north western corner there is a built in wooden cupboard (Plate 107) which probably relates to an earlier use of this room.

Plate 105: Room 8 looking south

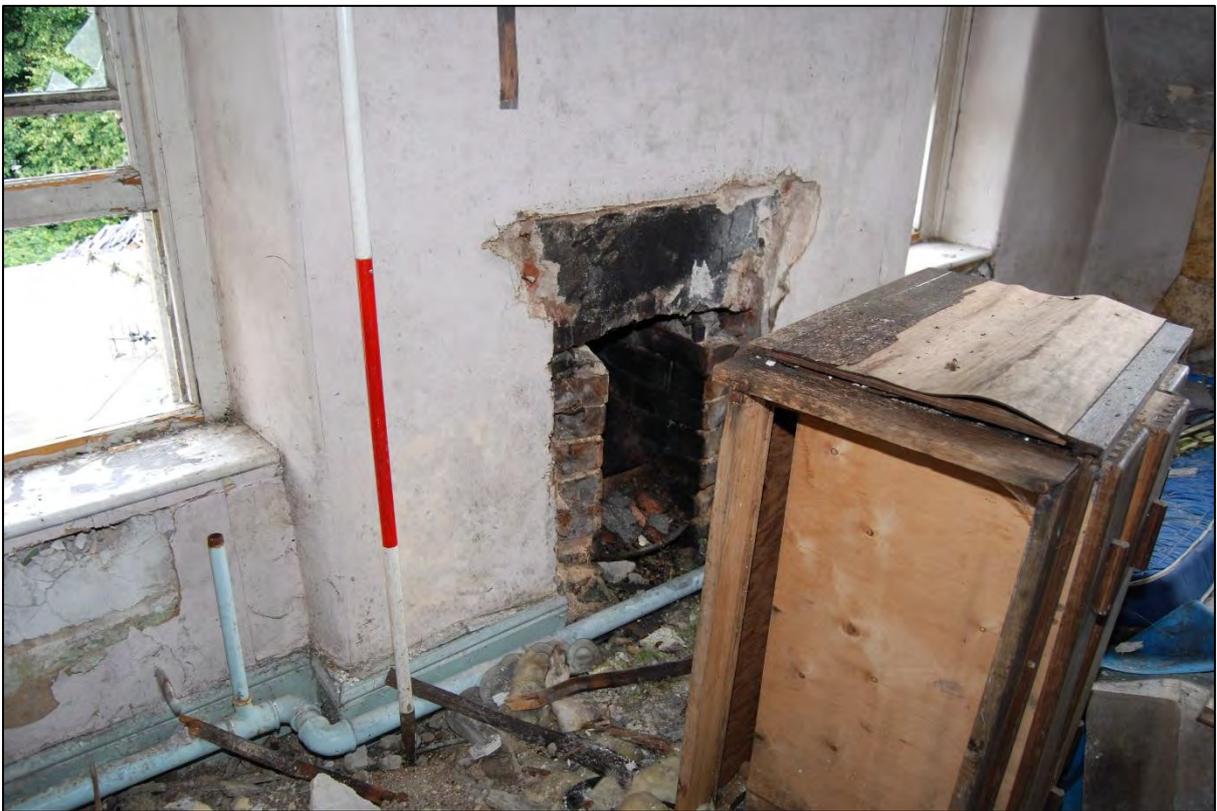
Room A10 is the only other attic room to include a fireplace (Plate 179). It is placed on the northern gable wall of this range and is flanked by sash windows which appear to be part of the 1872 house design (Plate 180). Unfortunately the fire surround in this room is missing. The position of the hearth would suggest that it relates to a room which was much bigger than the current size of A 10 and confirms that the current layout of rooms in this range is a relatively modern arrangement.

Plate 179: Fireplace in Room A10

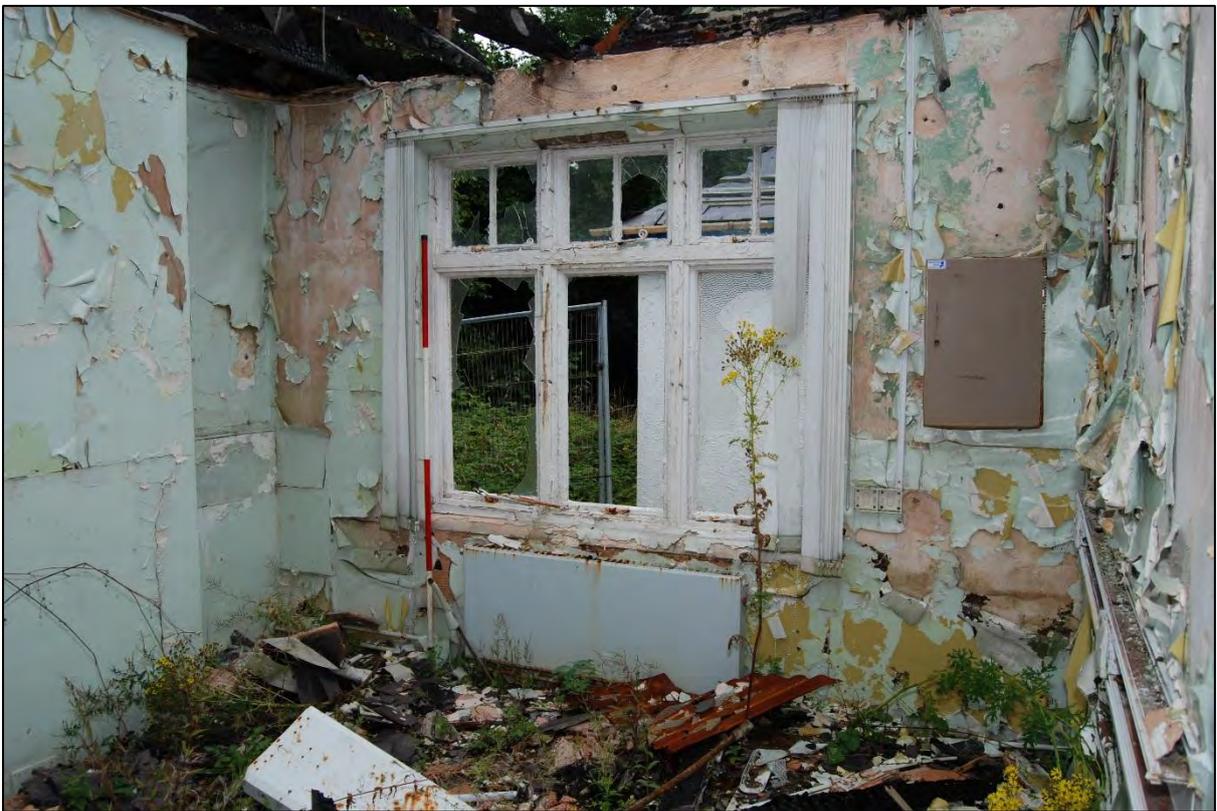
on Plan 24-1. Room 54 (Plate 204) contains no distinguishing features, however its description as an office on Plan 24-1 seems apt. Room 55 (Plate 205), however has been modified, described as a ward on Plan 24-1 this room was converted to part of the corridor to the extension to the Terminal Care Unit built in 1975. Finally in this range Room 56 (Plate 206) has been heavily burnt, but was probably a single bed ward in its final use.

Plate 204: Room 54, looking east

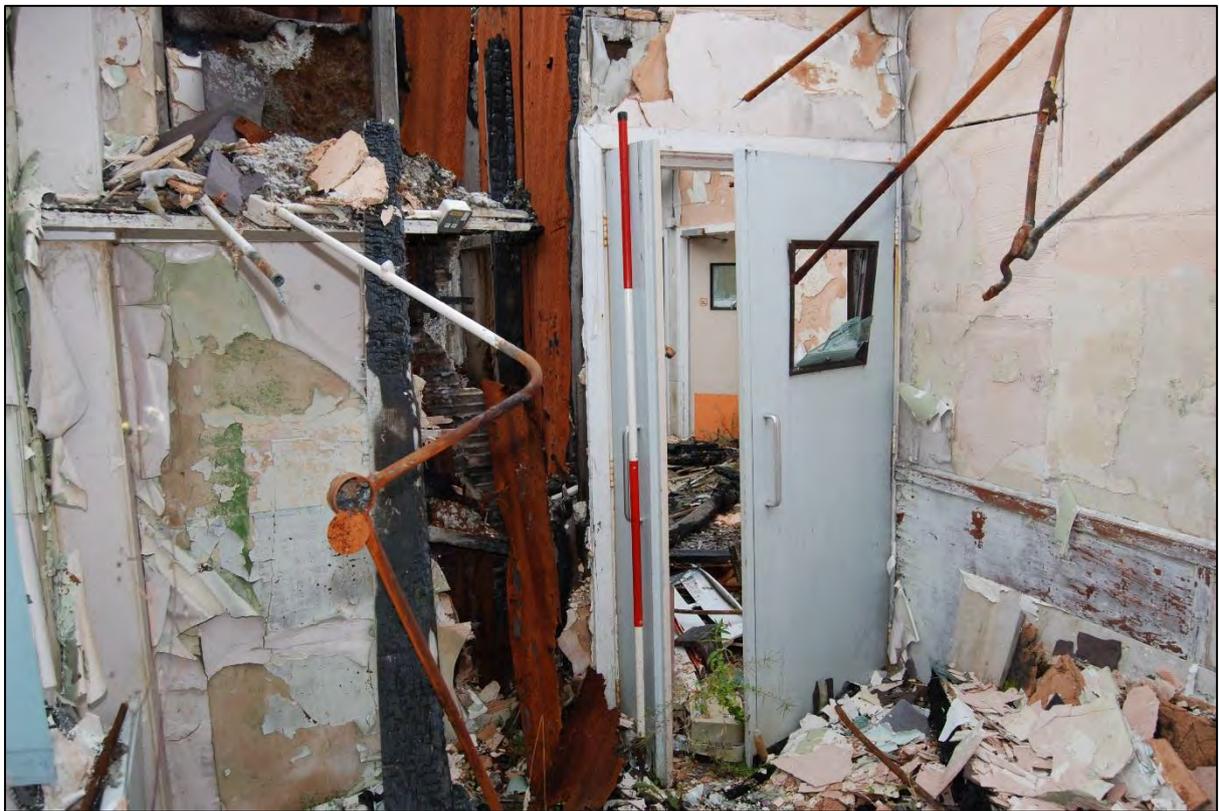
Plate 206: Room 56, looking west
