NORTH WEST WALES DENDROCHRONOLOGY PROJECT 2009-2012

Bron Y Foel Isaf, Dyffryn Ardudwy, Gwynedd, LL44 2ZH

ARCHITECTURAL RECORD /COFNOD PENSARNIOL

Standing Building Record

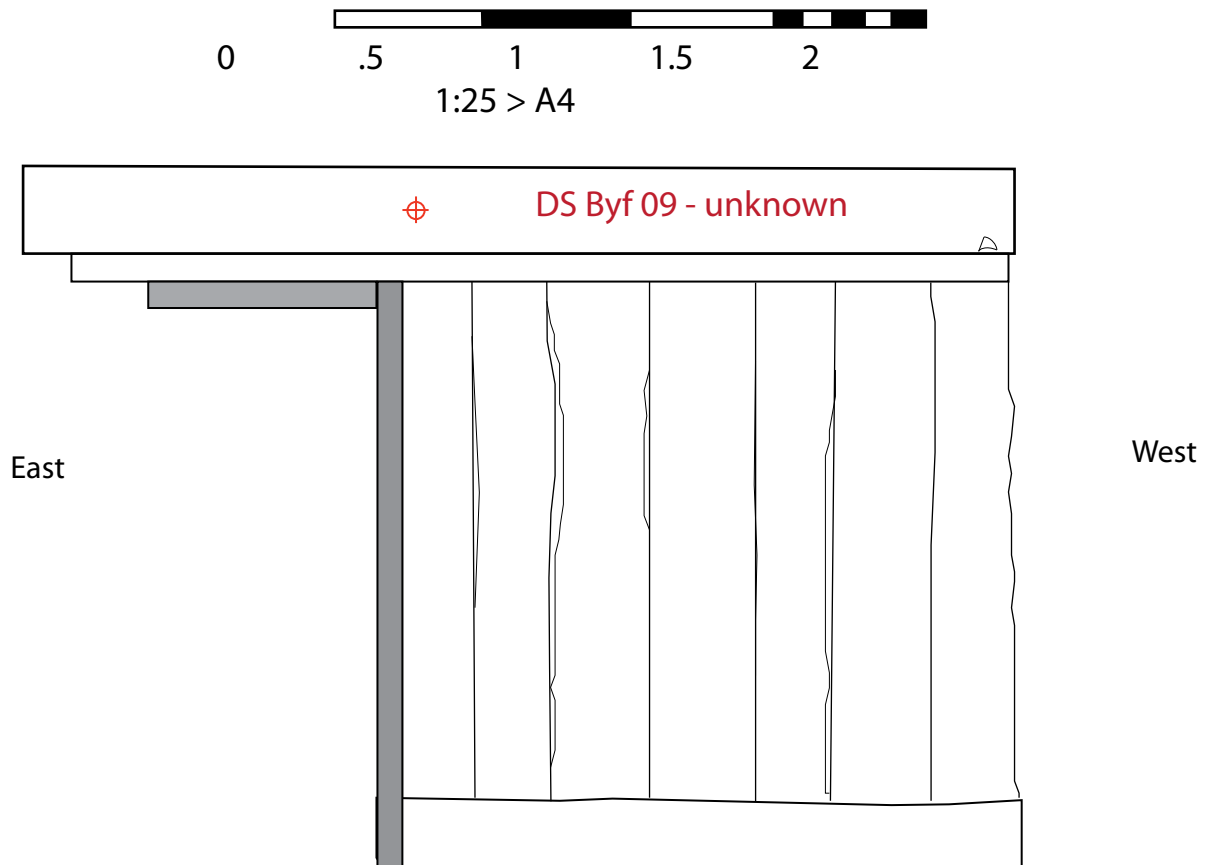
Figure 6: Ground Floor Screen - part.

Screen in service room. Floor level raised so this screen may be re-fitted but likely primary. Timber is of inferior work compared to re-used part of screen elsewhere e.g. enclosure for basement entry.

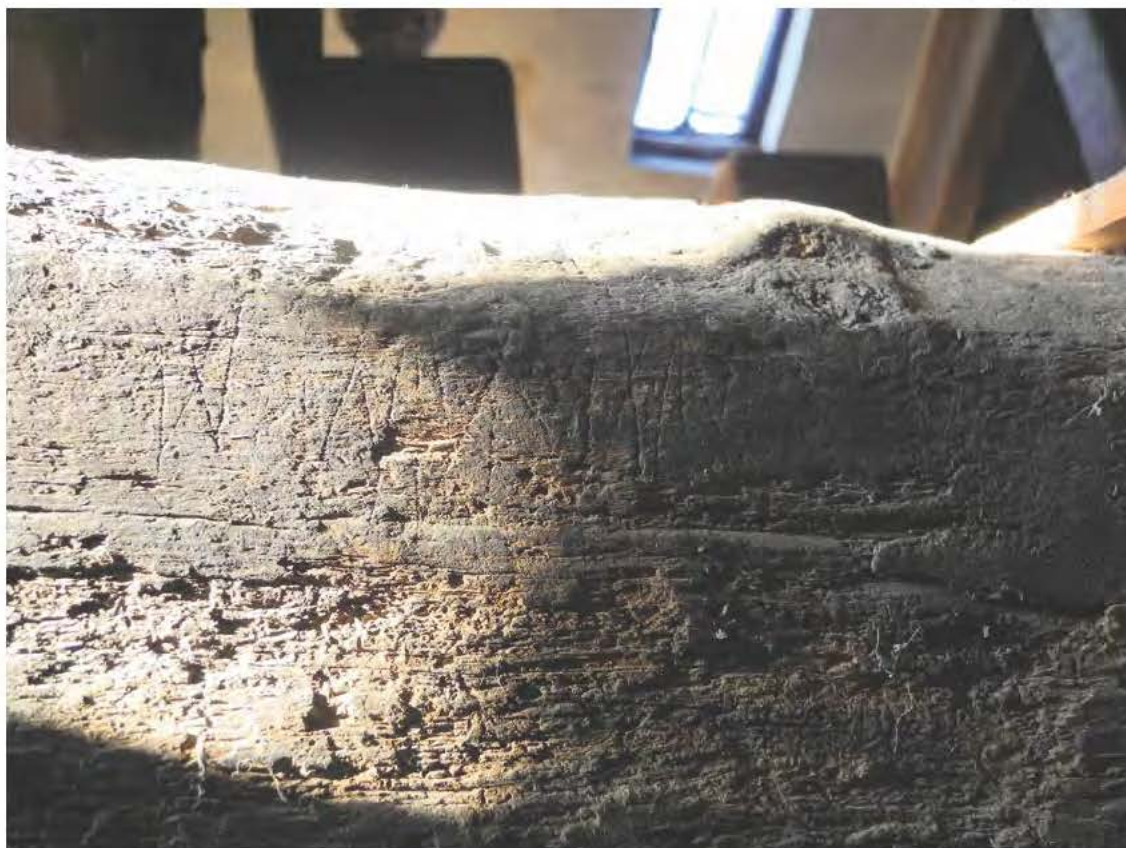
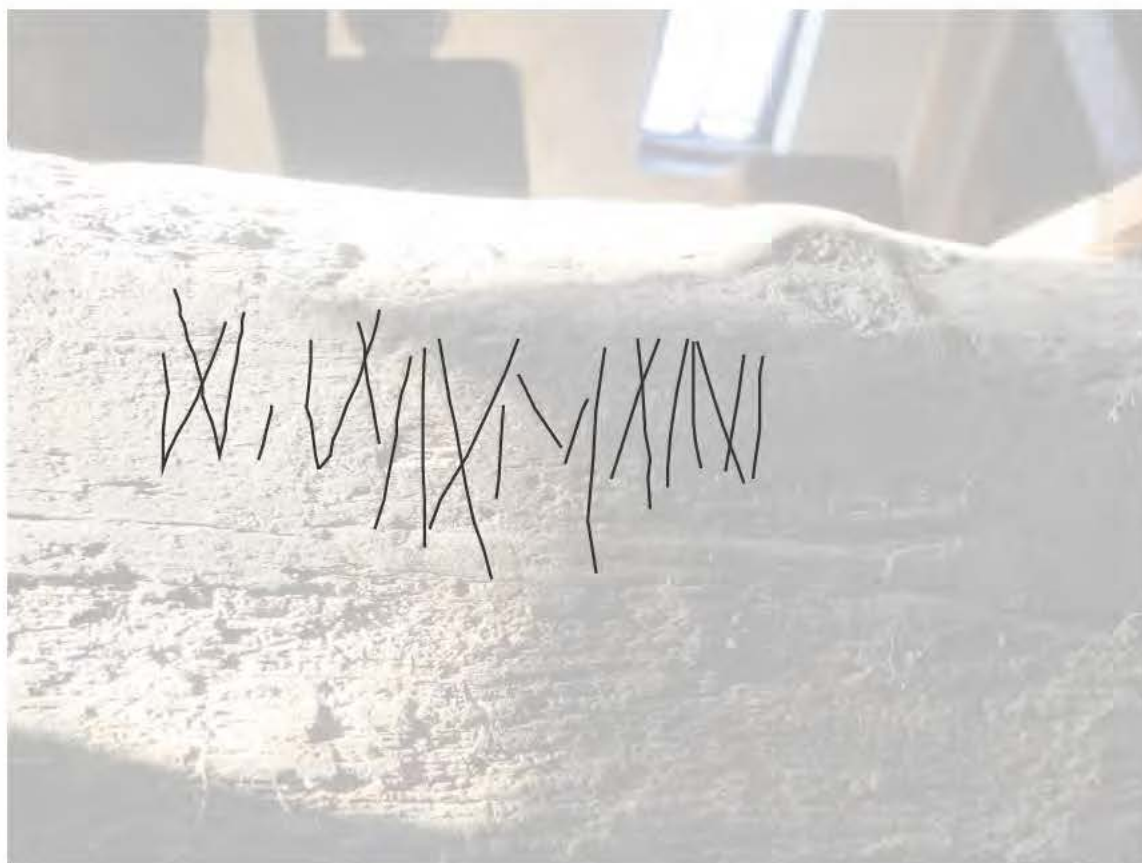
Figure 12 : Apotropaic scratch marks

Large beam protruding from first floor ceiling faced from top of staircase (south gable). Scratch marks discerned that have distinct similarities with apotropaic, ritual marks, used to avert witches. (Hall, 2005)

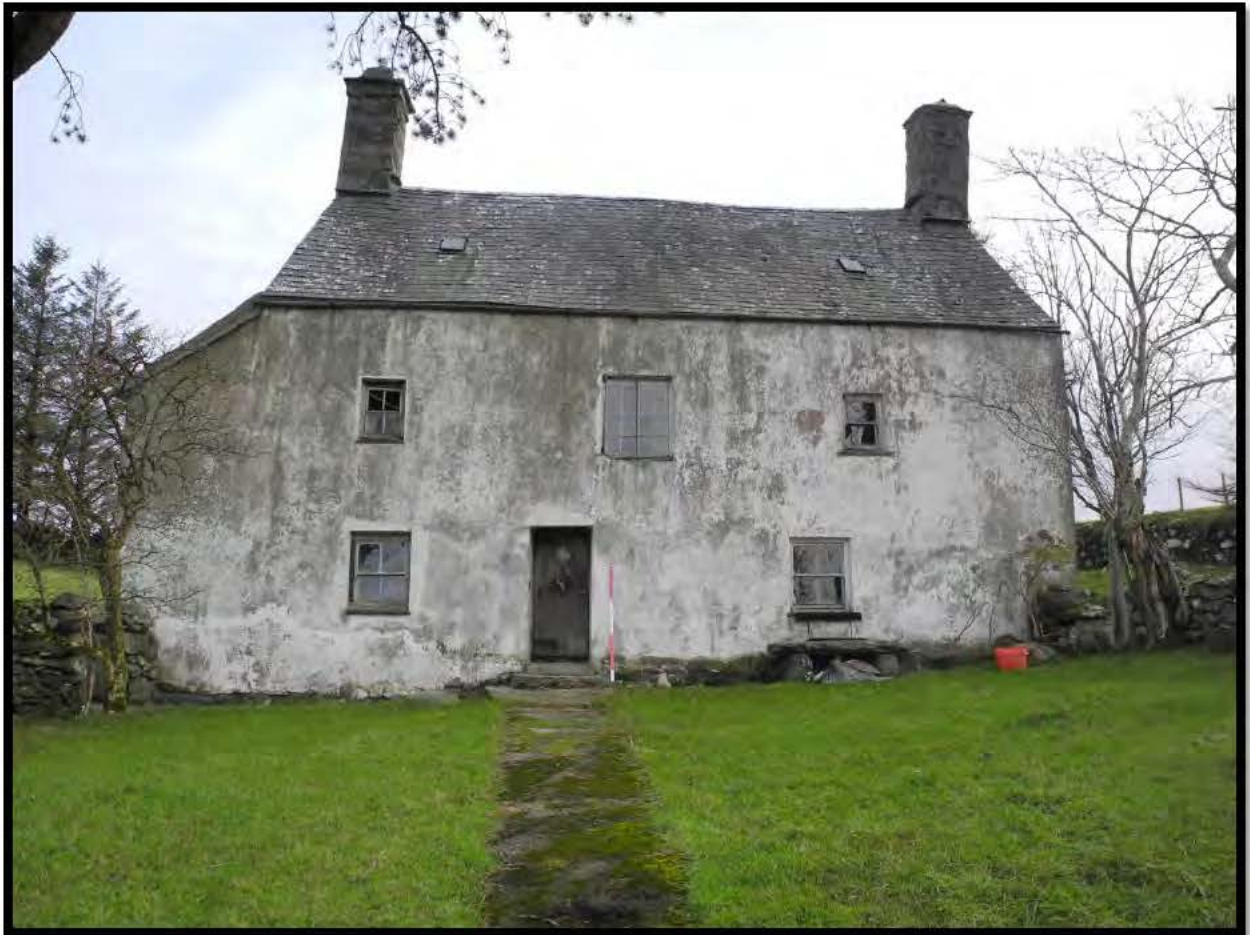
4.1.2 The (W) elevation (**Plate 1**) has been rendered and it is not now possible to discern alterations. However, the walling sits on top of a level plinth of larger, rougher boulders that run to the south of the doorway but not so discernible to the left and width of the building. The elevation nevertheless reveals its origin as a sub-medieval building of standard type. The front door opposes a blocked doorway in the rear (E) elevation to form the typical cross passage, situated between the service end to the left and the hall to right. The doorway was blocked, first to form a window which was in turn completely blocked when the later stairway was inserted. It is stated in the NMR that the doorways had cyclopean door heads (shaped arch from one piece of stone) but the front doorway is now re-rendered, covering the lintel, and the rear, east, blocked doorway actually displays a flat lintel.

Plate 1 - Front elevation Bron Y foel

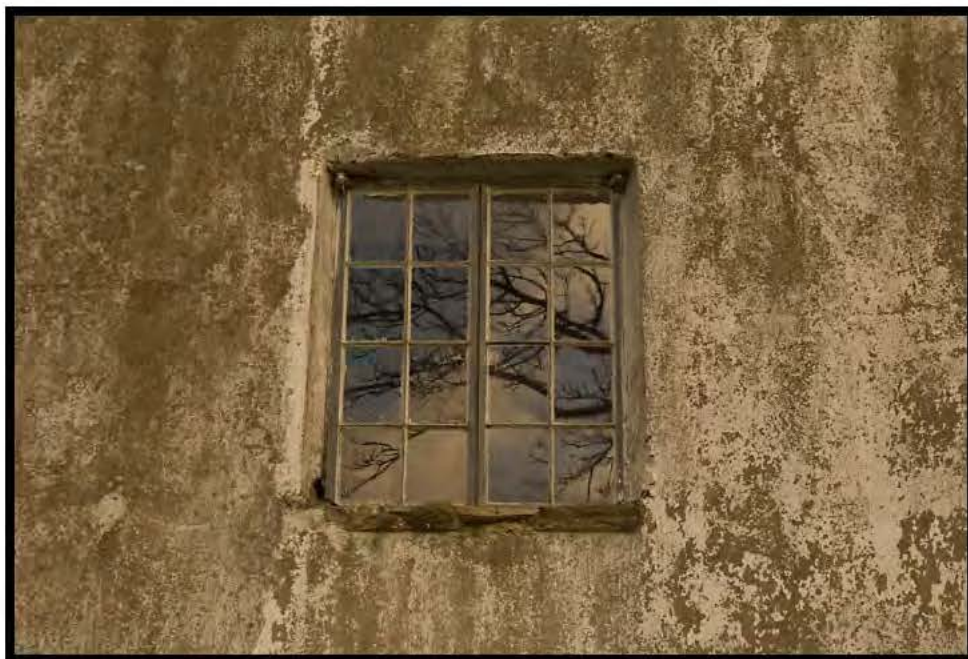
The front façade has been altered with the insertion of later sash windows, the central first floor window now being slightly enlarged, with a metal casement window (**Plate 2**) replacing a sash window according to photographs in the possession of the owner. It is possible that the first floor window was a later insertion but this is conjectural. The positions suggests the windows replaced earlier mullion windows. Windows may have been introduced to light the rooms once the partitioning was inserted in the first floor.

Plate 2 - metal casement, front elevation.

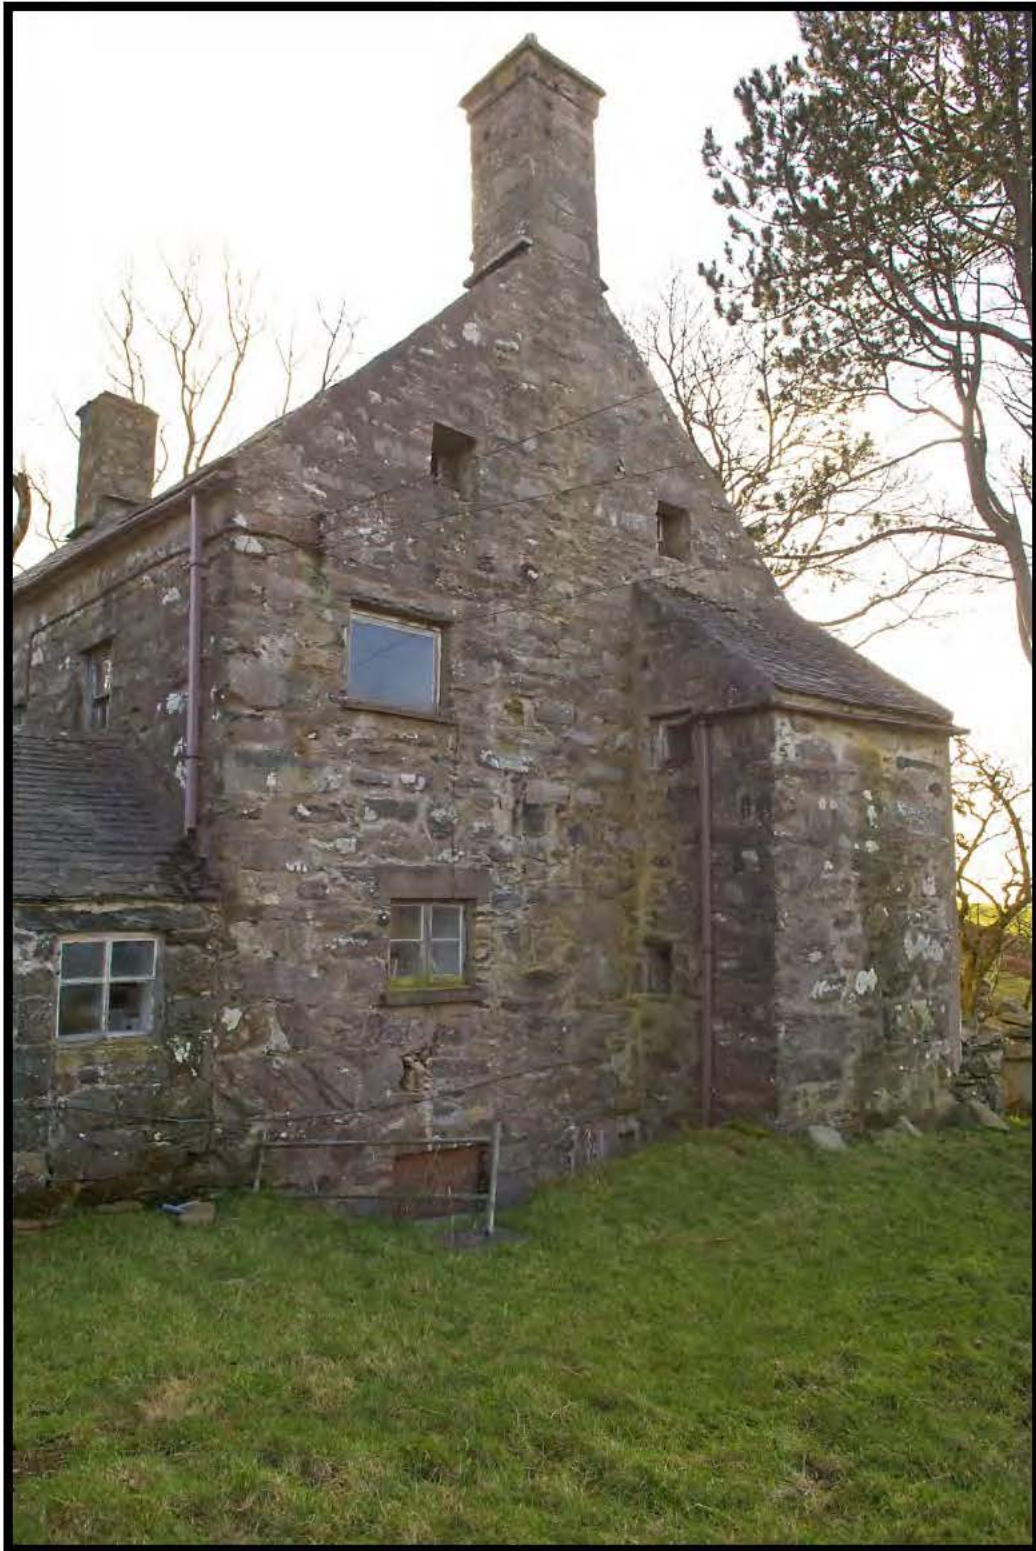
Plate 4 - North gable revealing fenestration and the latrine block.

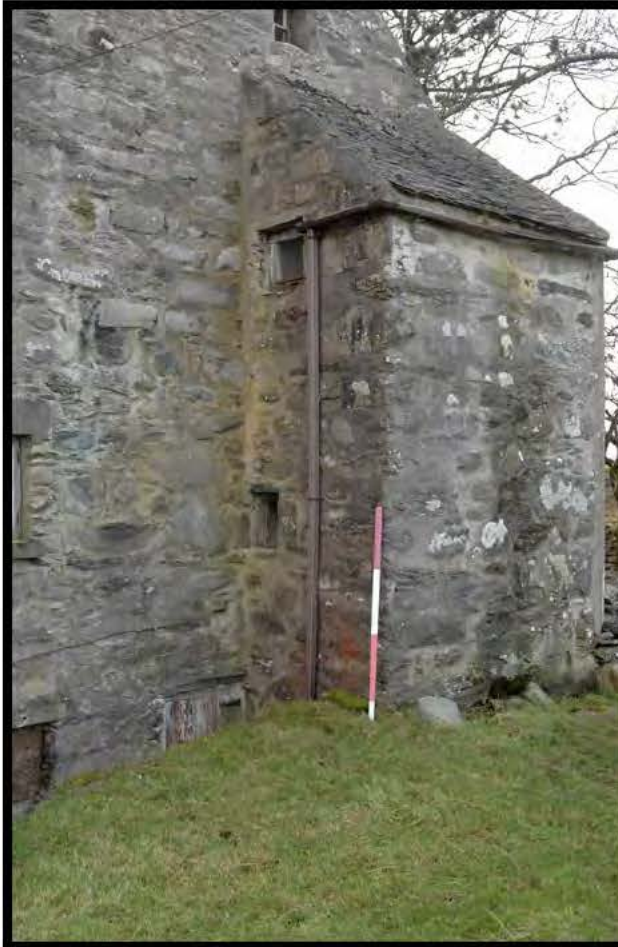
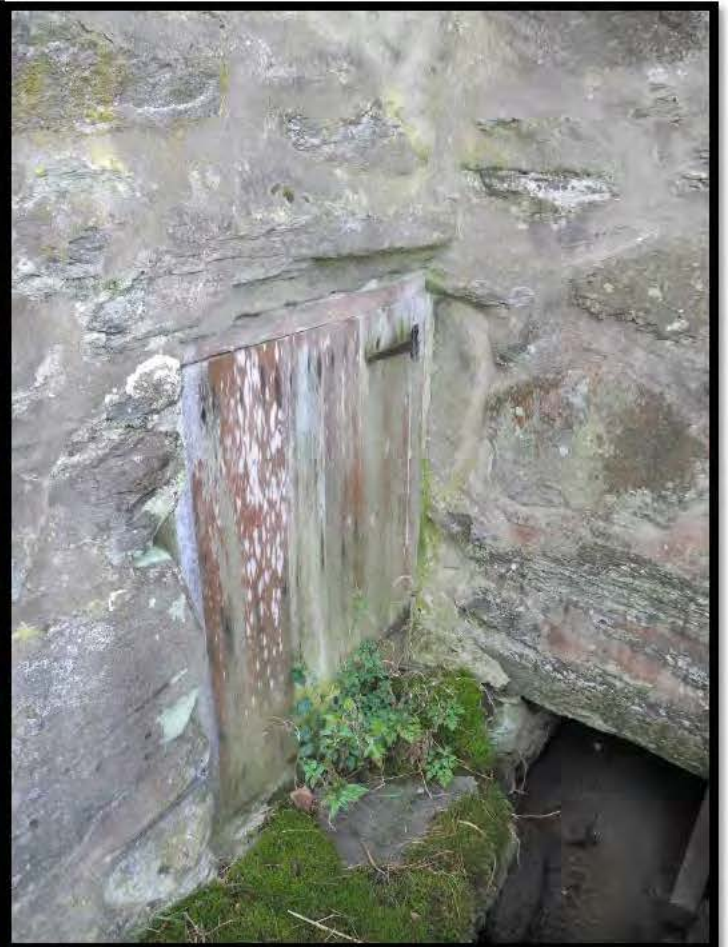
Plate 5 - Latrine block and basement with later door

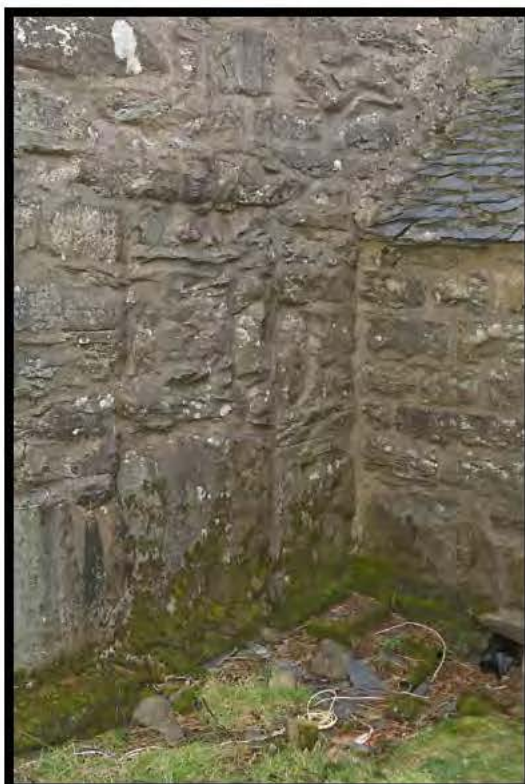
Plate 10 - Cross passage blocked doorway

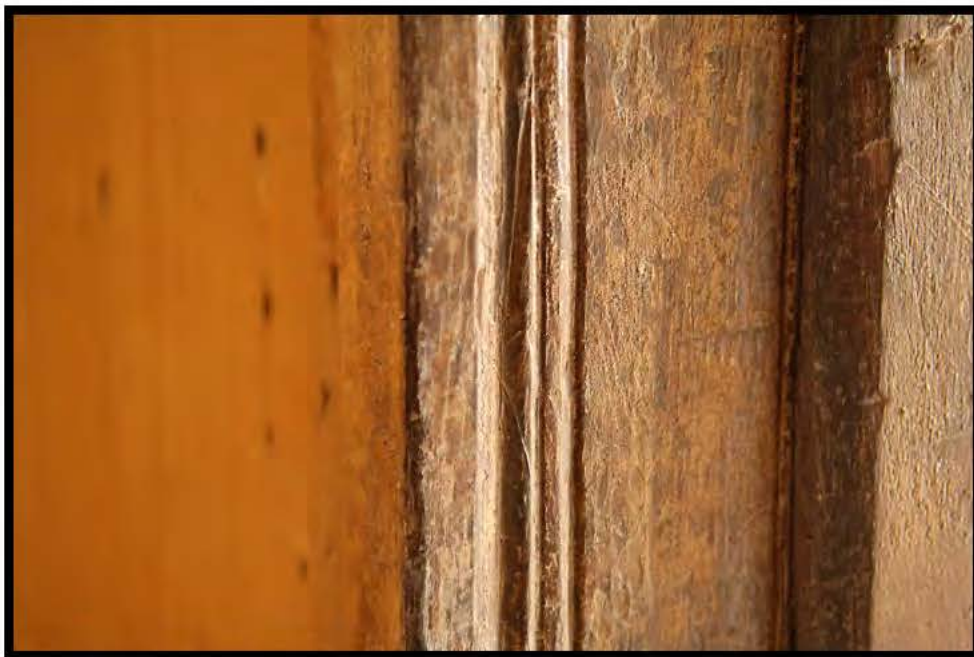
Plate 13 - door post south screen remnant. Moulding typical of 16th C

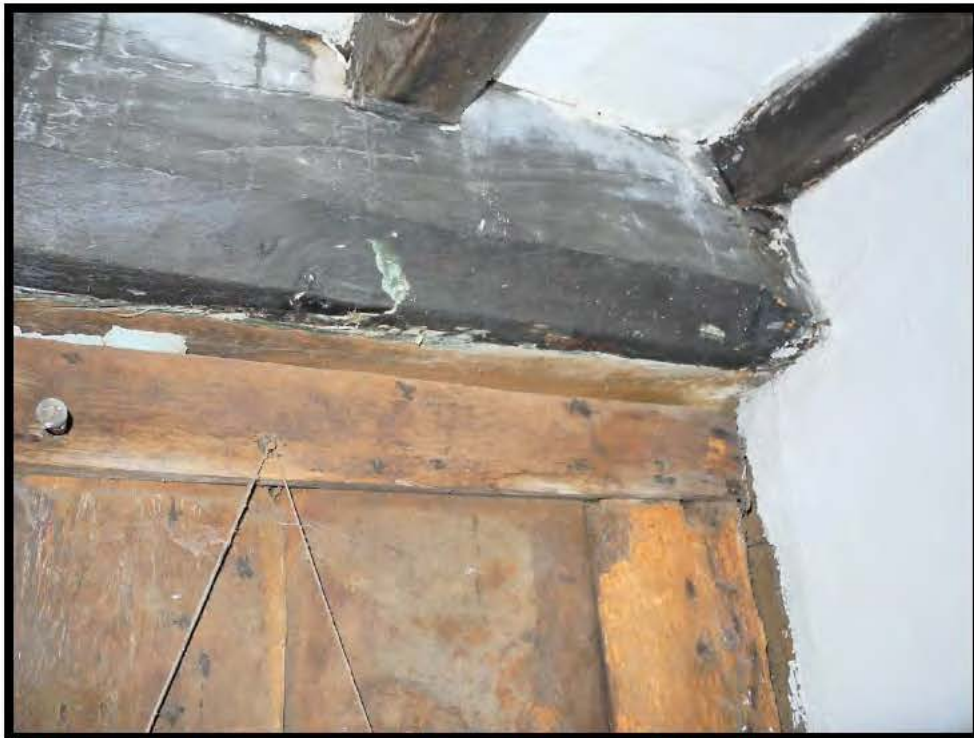
principal beam above the partition screen, which displays a 70mm chamfer, stepped, curved, run out as stops. **(Plate 16)** and a beam of 300mm square with 70mm chamfer with similar stops placed against the gable wall (N). Joists have small, plain chamfers with simple stops.

Plate 16 - Main beam over screen, chamfer & stop. No Mortise.

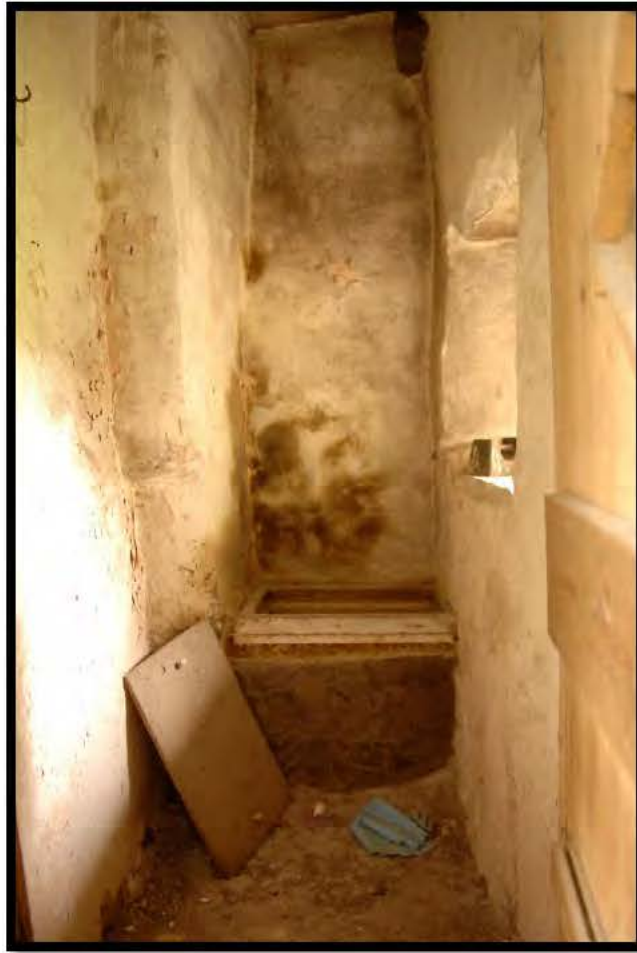
The latrine or garderobe is a simple cubicle formed in the two storey lean-to and is constructed in stone and plastered internally **(Plate 17)**. The chute is of a simple square construction of unsmoothed masonry with the exit dropping into a small diverted stream (plates 19). The latrine room is lit by a mullion window that still retains the oak frame but the central mullion is now gone **(plate 18)**. This window provided the ventilation for the latrine. The chute for the first floor latrine is concealed in the masonry constructed to left.

Plate 17 - Latrine or garderobe

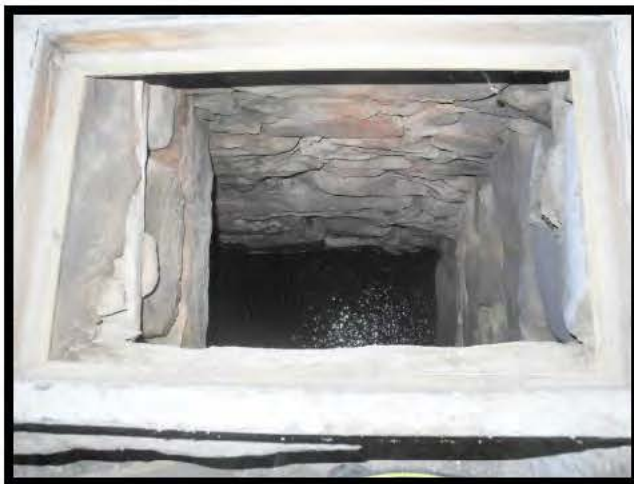
Plate 19 - Latrine chute directly over stream.

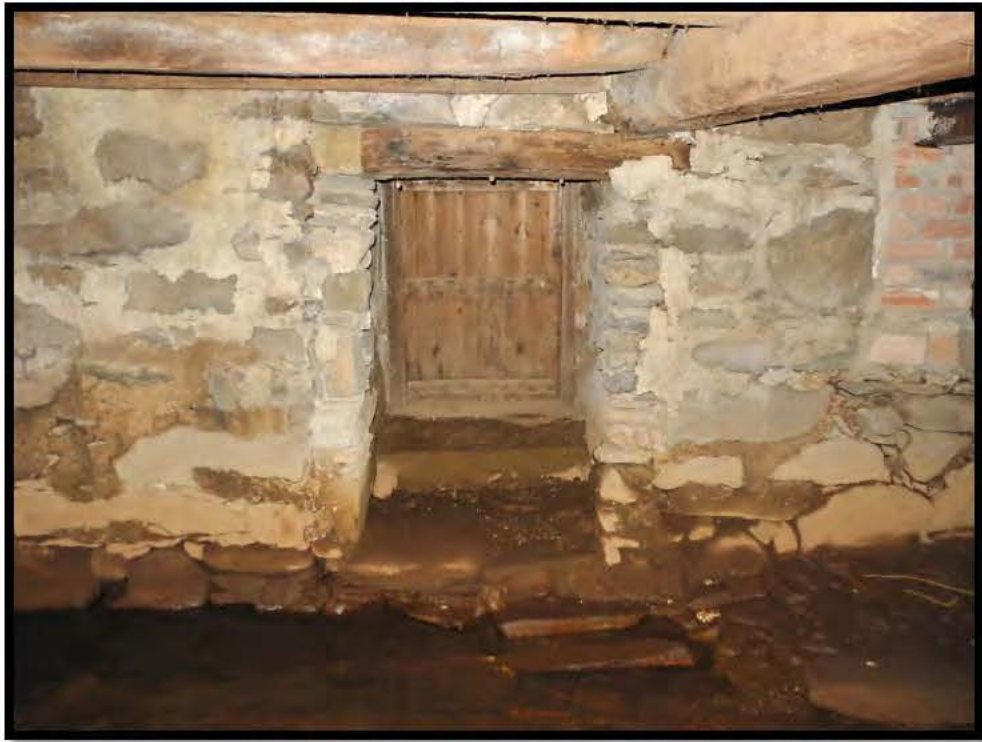
Plate 20 - Basement - external door, remodelled doorway south gable

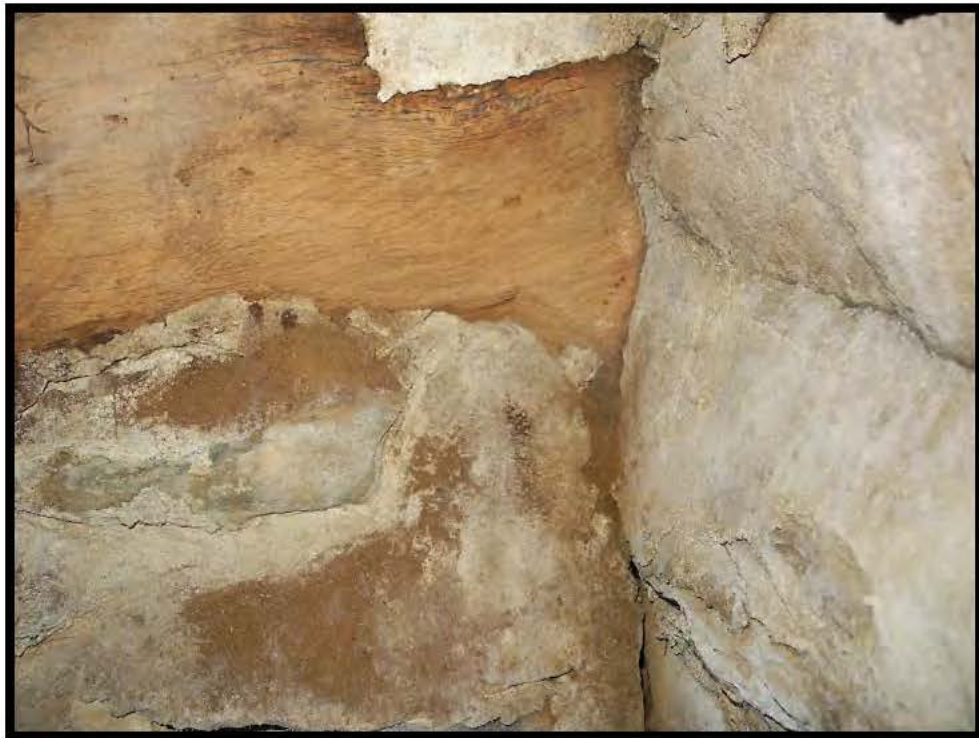
Plate 21 Basement -south end of main beam. Chamfer & stop just visible and fully located in wall with later supporting pillar underneath to the left.

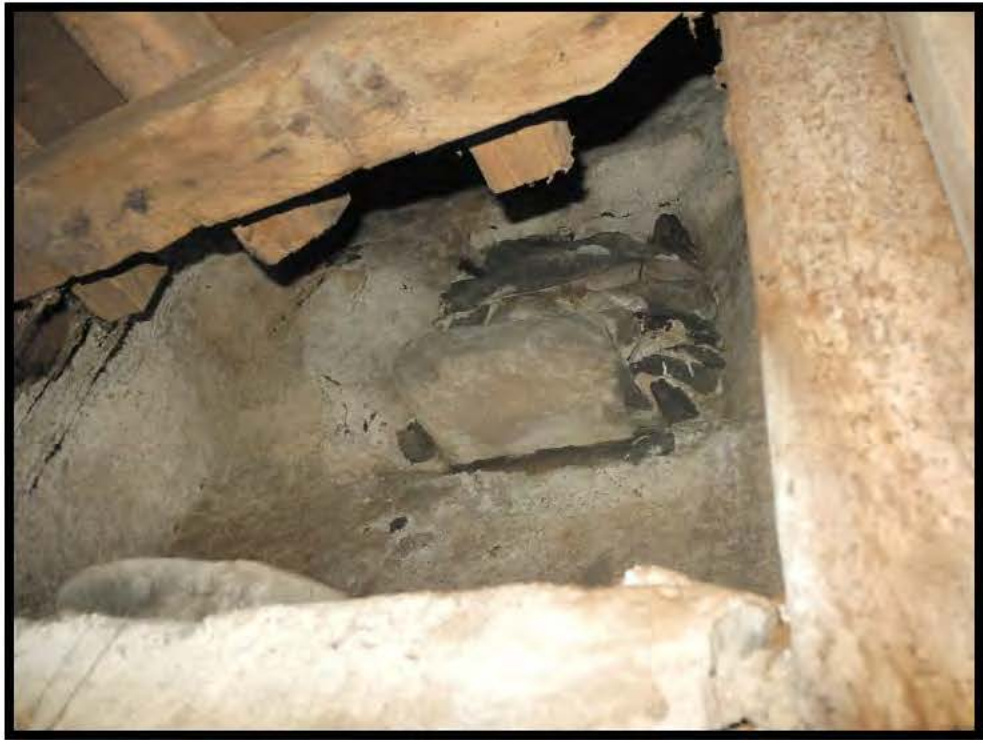
small window inserted (**Plates 22**). There is a clear distinction between the doorway being blocked and reduced in size initially, and plastered to the reveals of this window and at a later date, and with the insertion of the staircase in the late 18th or early 19th century, this opening was crudely blocked (**Plate 23**). It appears that the early oak doorframe sit on the inner edge of the former doorway, possibly relocated. It was possible to examine this on a second visit.

The conclusion must be that the cross passage was dispensed with for some reason, but a window retained. This doorway was completely blocked when the staircase was inserted. Could the door (E) from **[GF2]** have been made to facilitate this change after the primary phase but before the insertion of the staircase? The masonry link being added later and enclosing this door.

Plate 22 - Blocked cross passage door. This doorway appears to have been reduced in size leaving a small window, which can be seen has been filled in roughly with stones.

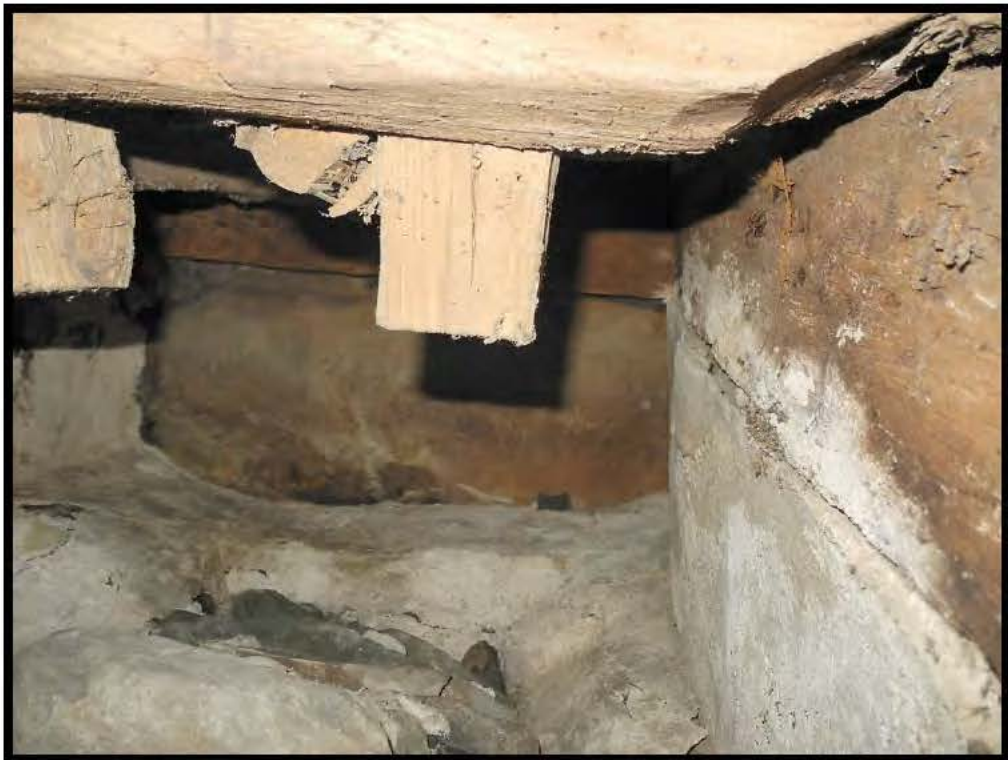
Plate 23 - In this image an oak frame is clearly seen, including head and the plaster can be seen applied to the reduced doorway.

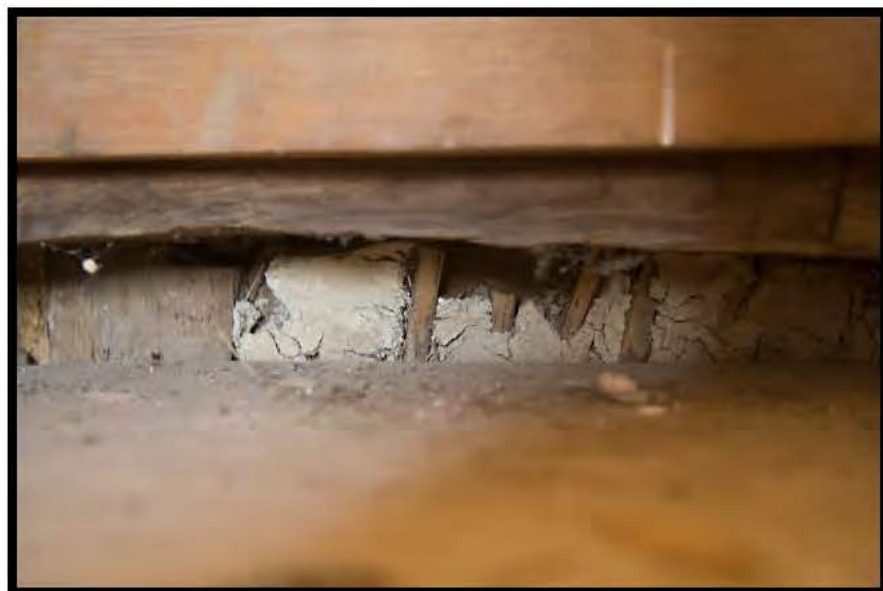
The stair continues to the loft in modern timber, a replacement for a similar version but this cannot be claimed with certainty. The stairwell to the loft is finely worked and circular but there is no sign of masonry steps or timber fixings. An oak newel post completes the stair to the loft from the first and is attached to a purlin in the loft. The post is notched for earlier steps. These stairs, where they enter and exit the first floor, have a double door set in a timber framed wall to separate the stairs from the first floor **[Figure 9] (Plate 26)**. The wattle and daub in this screen has been repaired in places but there are areas of original hazel wattle, of small dimension, remaining *in situ* (plate 27).

Plate 27 - Wattle and daub screen.

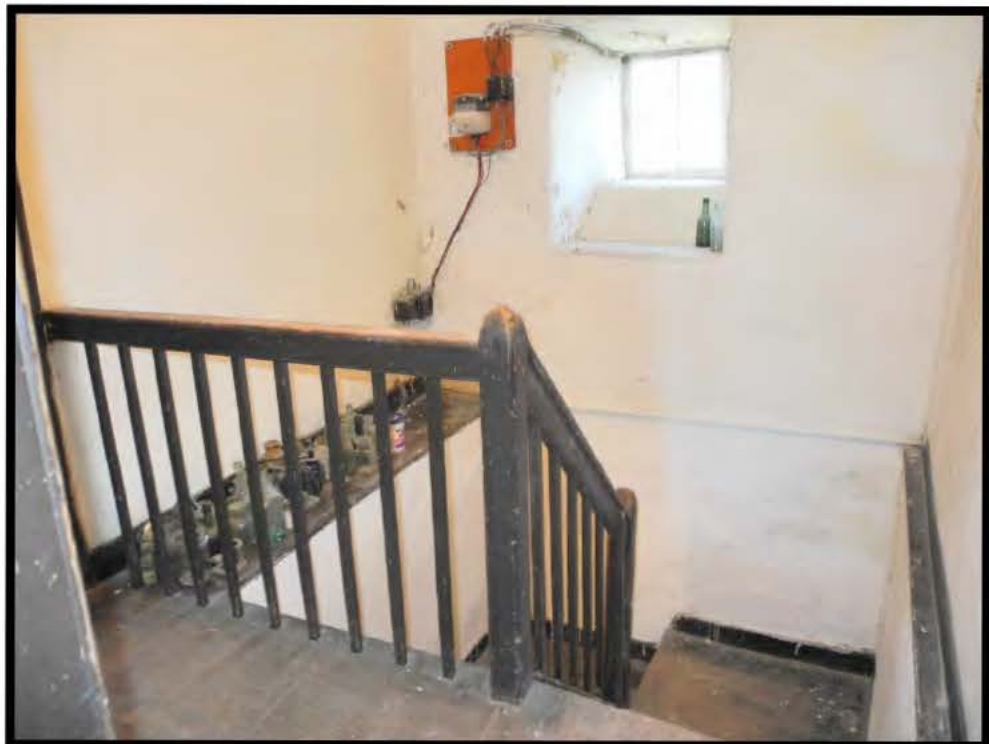
Plate 29 - 18th - early 19th C inserted staircase

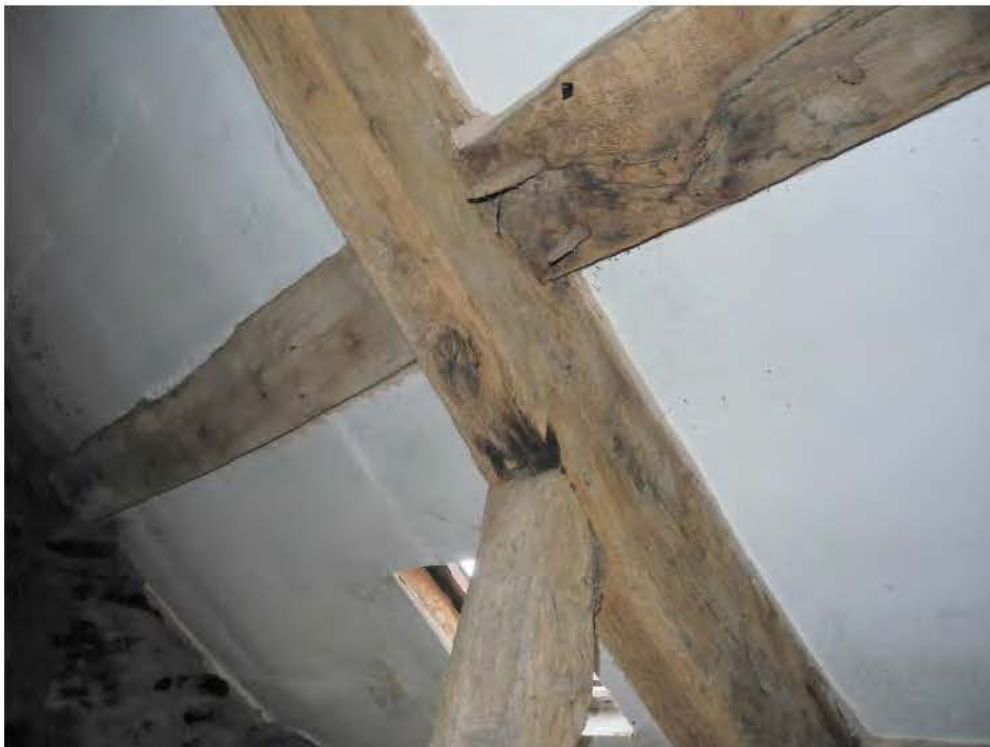
Plate 31 - Purlins scarf jointed with raking strut support below. Note scorch marks.

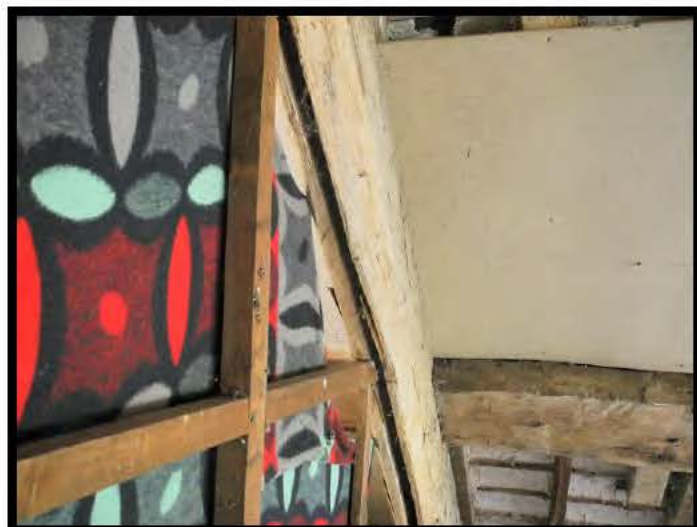
The central truss is mortised on all inner visible faces (**Plates 32, 35**) to house a boarded partition. This has now gone but simple, undecorated boards are placed horizontally above the collar, now with a batten nailed to hold them in place. A simple shallow arch has been cut from the bottom of the collar, centrally, to decorate a doorway, now gone (**Plate 36**).

Plate 35 - mortise on principal rafter truss 2

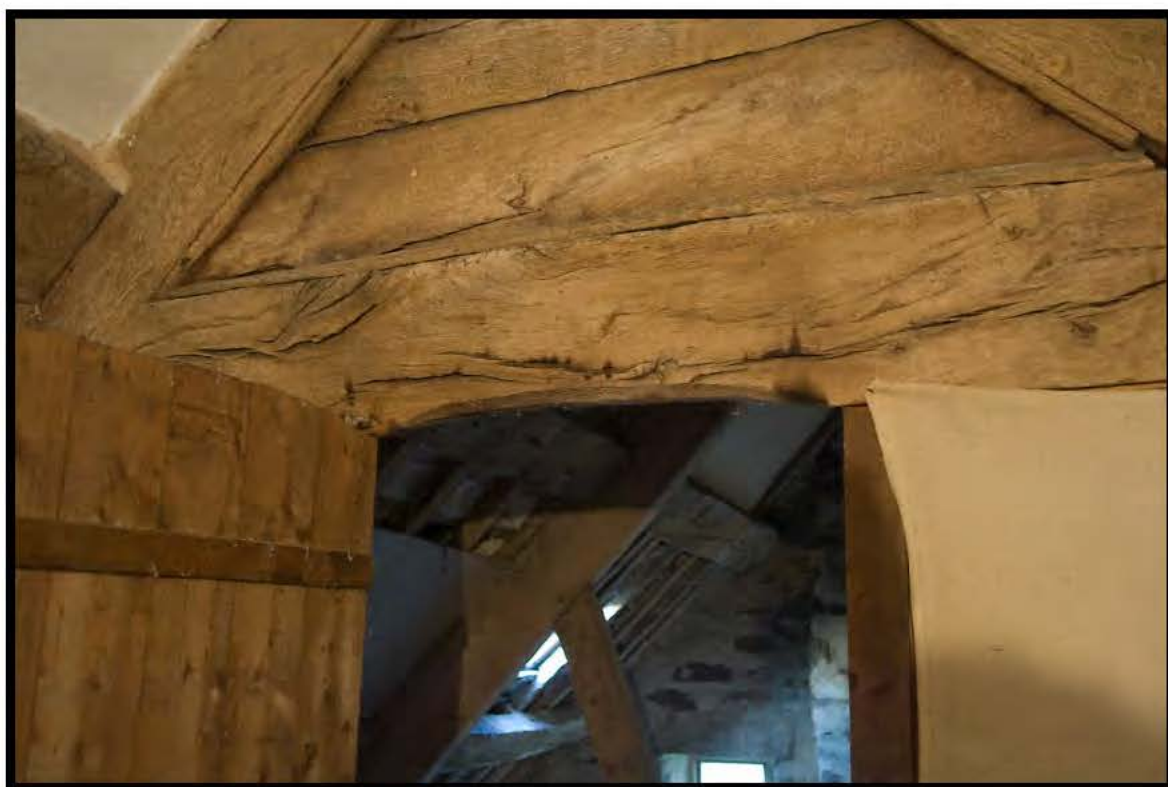
Plate 36 - Truss 2 collar door head
