Historic Building Assessment of

ST DUNSTAN'S OUTBUILDINGS

For St Dunstan's Enterprises Ltd

Doc Ref: LPI264C-HBA-v1.4

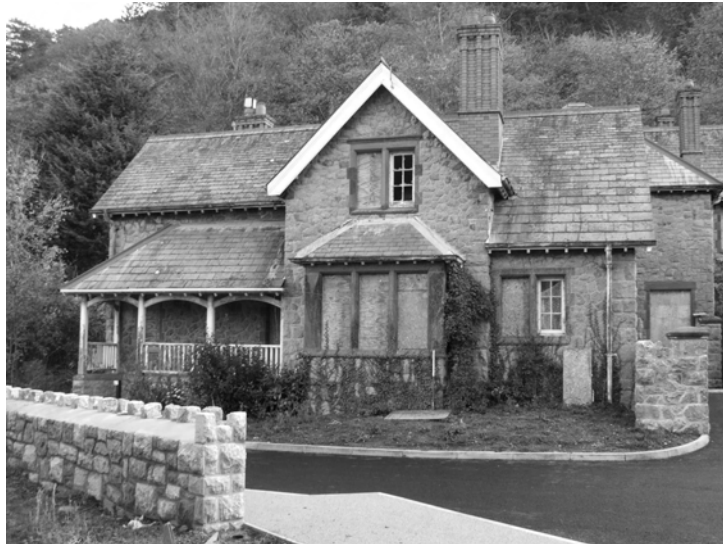
Plate 4 - Western elevation of gate lodge, 1m scale

4.3.1. The gate lodge is located to the north of the main building at the northwestern entrance to the estate, off Fferm Bach Road (FIGURE 3). The structure is a two storey stone structure in a cottage style. It lies along a north south alignment with a slate roof in Dutch lap style with red ridge tiles. A link dormer extends above a gabled cross wing to the west, located off centre towards the south of the western elevation (PLATE 4).

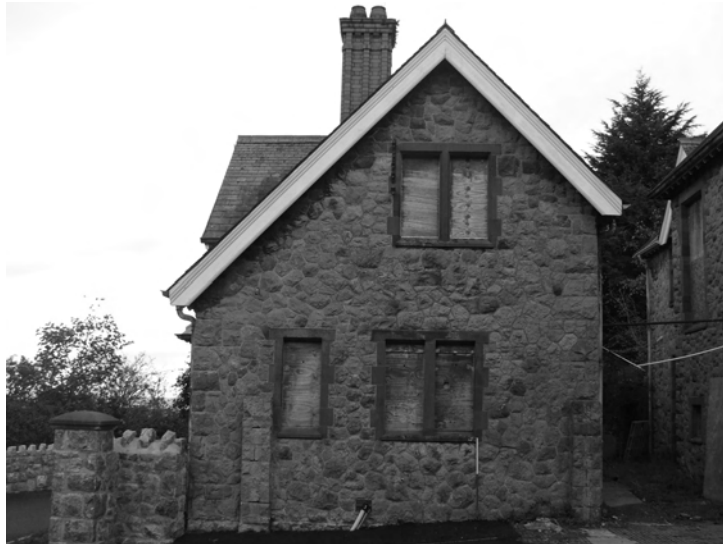
Plate 5 - Southern elevation of gate lodge, 1m scale

- 4.3.6. Two chimneys can be seen rising from the roof. These are red, decorative moulded, brick chimneys.
- 4.3.7. The southern elevation was of random coursed rock faced grey brown stone with three sandstone dressed windows and two half height stone buttresses (PLATE 5).

- 4.3.8. The window form of the southern elevation could be seen to match that of the western elevation, noted above.
- 4.3.9. The eastern elevation overlooks the laundry block forming a narrow access route to both structures (Plate 6).

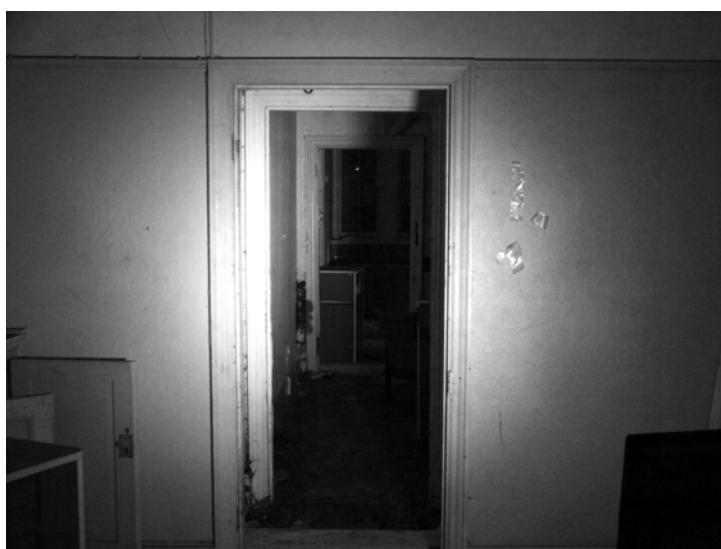
Plate 8 - Doorway between L3 and L4, looking north

4.3.17. To the north of the kitchen is a small dining room (L4). The layout of the building means that from the kitchen the doorways align to the north to form an open corridor. The door frames between L3 and L4, L4 and L5 and L5 and L6 are all original and are of decorative wooden architrave (PLATE 8).

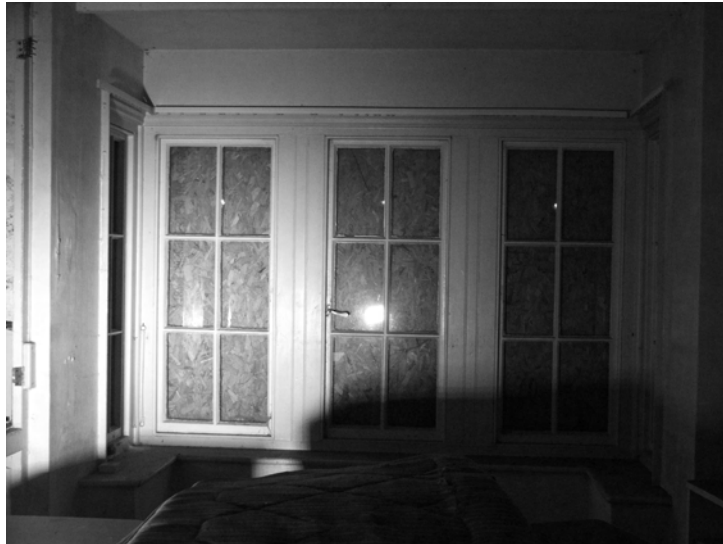
Plate 9 - Squared bay window in L4, looking west

4.3.18. This room extends further to the west than the kitchen into the squared bay window. The wooden window frame is of the correct style for an early Edwardian building, however the casement windows and latches are thought to be late 20th century replacements (PLATE 9).

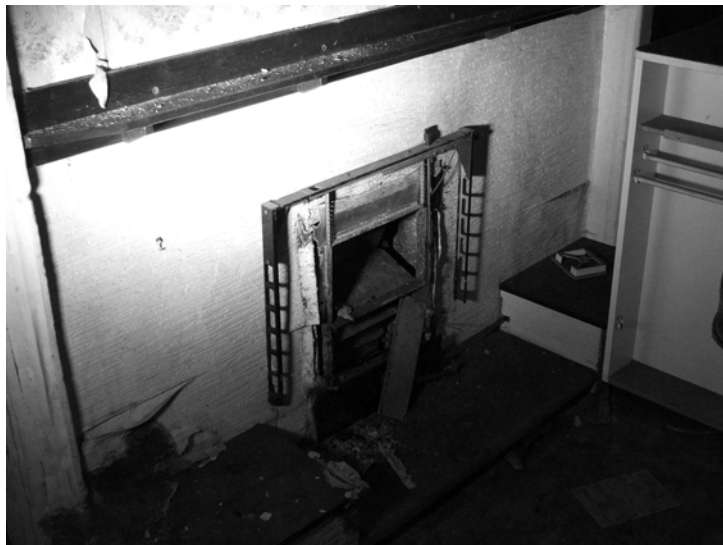
Plate 10 - Fireplace in L4, looking southwest

4.3.19. A fireplace is located on the south wall, showing evidence of modification. It appears that a gas fire had been inserted in the late 20th century, however this has since been removed (PLATE 10). The remaining metal frame does contain a register grate, which could be a remnant of the original fireplace.

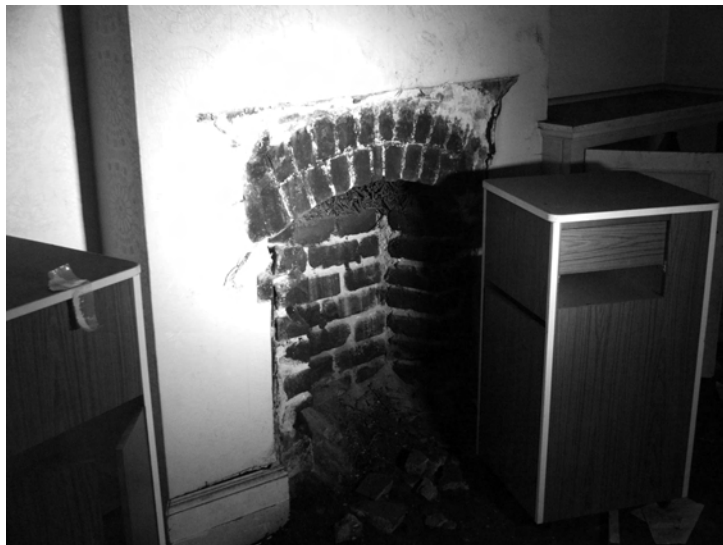
Plate 12 - Fireplace in L6, looking east

4.3.22. On the eastern wall of L6 is a chimney breast which has the ghosting of a removed fireplace. The fireplace had a double header chimney arch (PLATE 12). The scar of the removed fireplace shows a common style of the Edwardian era with flared overmantle.

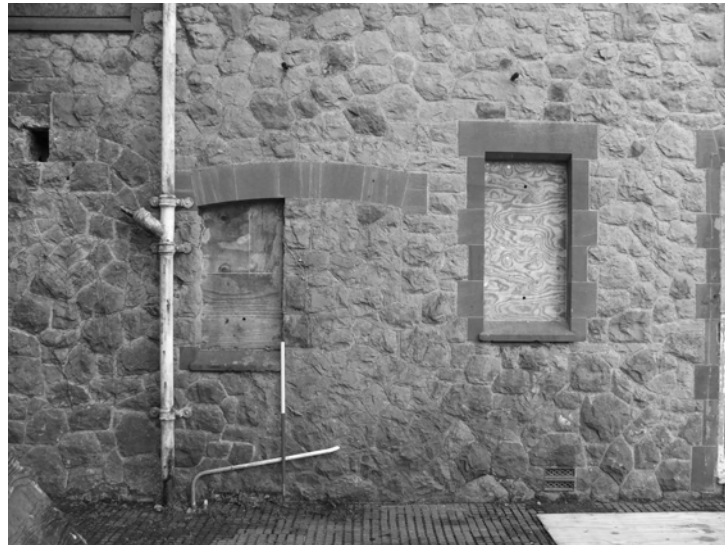
Plate 14 - Eastern window on north elevation of stable block

double the width of the window and the sill has been cut off to the west. The stonework in the wall, although close to the original material, is of a different standard and coursing (PLATE 14).

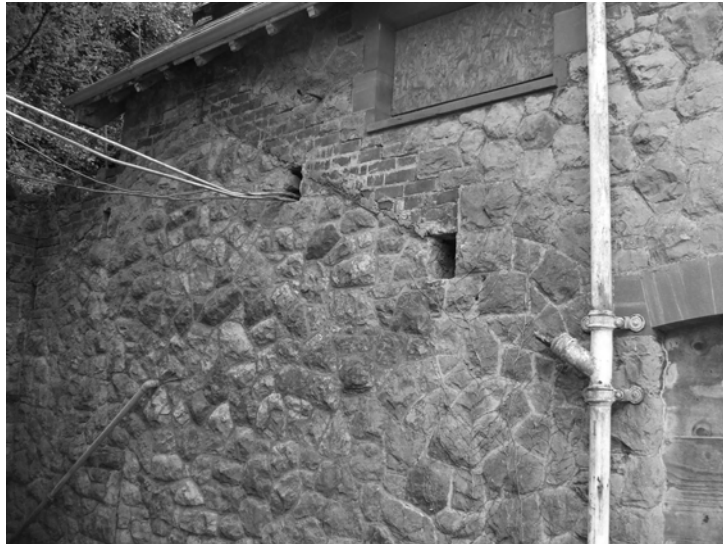
Plate 15 - Roof scar on stable block, looking southeast

- 4.4.6. At the very eastern end of the northern elevation is a large building scar relating to a demolished structure (PLATE 15). A row of engineer bricks form a gable end of a removed roof structure. Below the brickwork a series of voids relate to removed purlins. There is no evidence of an upright wall associated with this roof structure and it is assumed that this was a covered area between the stable block and laundry block. Cartographic evidence indicates that this was constructed between 1919 and 1937. As this is not an original feature the brickwork must be inserted material. The quality of the work and the proximity to the eastern window could suggest that these modifications were contemporary relating to the change of use of the structures.

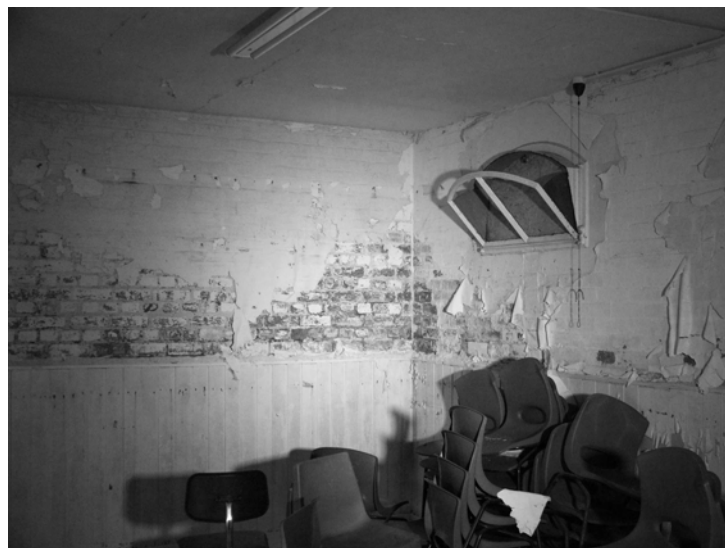
Plate 20 - S1, east and south walls, looking southeast

4.4.18. The north wall is of brick construction in English bond. The east, south and west wall are half panelled. The lower half of each of the walls has vertical wood panelling, whereas the upper half of the walls is in English bond brickwork (PLATE 20).

4.4.20. The room had been painted white on numerous occasions, however the covering had decayed allowing the construction form to be seen.

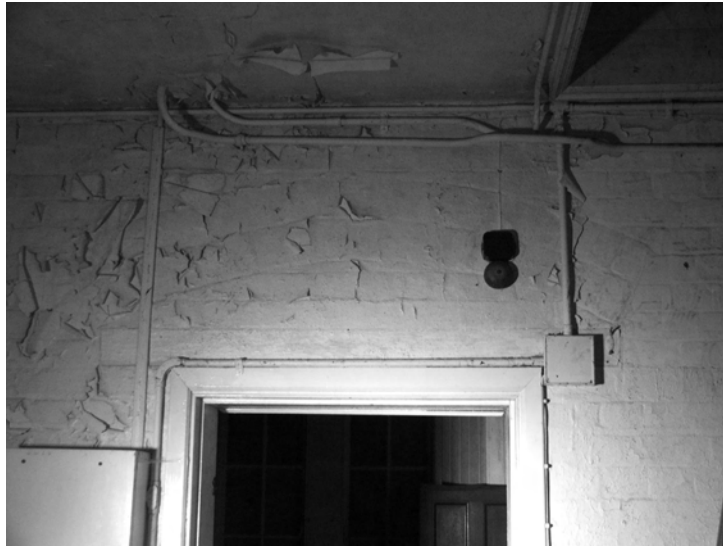
Plate 21 - Brick arch over doorway between S1 and S2, looking west

4.4.21. On the western wall two features were identified. Above the door leading to S2 a brick arch could be seen. This was formed by two header courses and is typical of architectural features seen in workshops and stables of this date (PLATE 21).

4.4.22. The doorway below the arch appears to be a later modification. The lintel and frame are typical of the later 20th century.

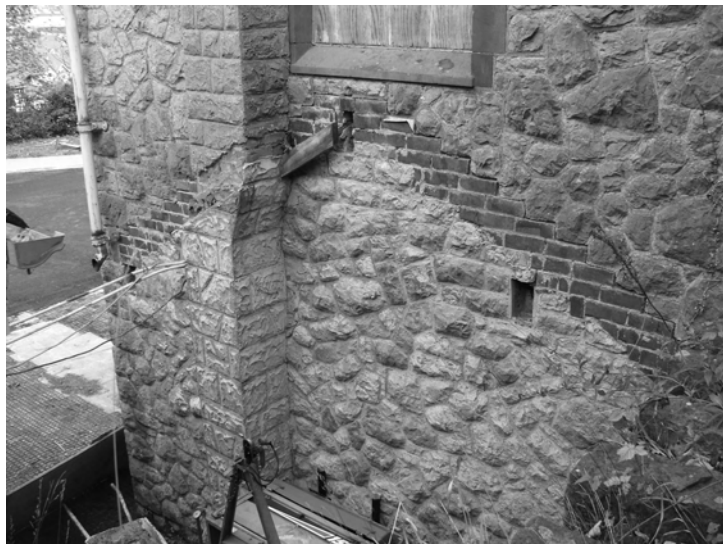
Plate 30 - Southern elevation of laundry block

4.5.13. Below the window a building scar could be seen respecting that identified on the stable block, noted above. The same brick had been used and the voids for the purlins were also visible on this face (PLATE 30).

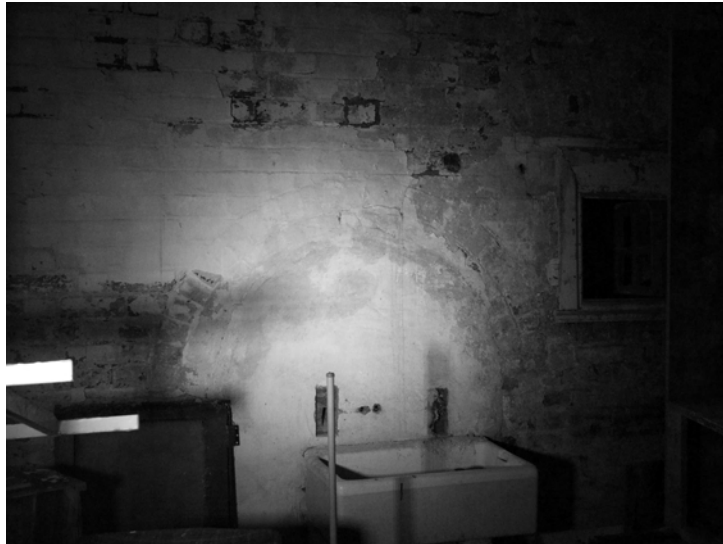
Plate 32 - Blocked arch in E3, looking north

4.5.17. To the east of E2 was a room used for storage, E3. This had brick walls in English bond and concrete floor. At the northeastern corner of the room was a blocked brick arch and a small window looking into E5 (PLATE 32). These appear to be functional, relating to its original use as a wash room for staff.

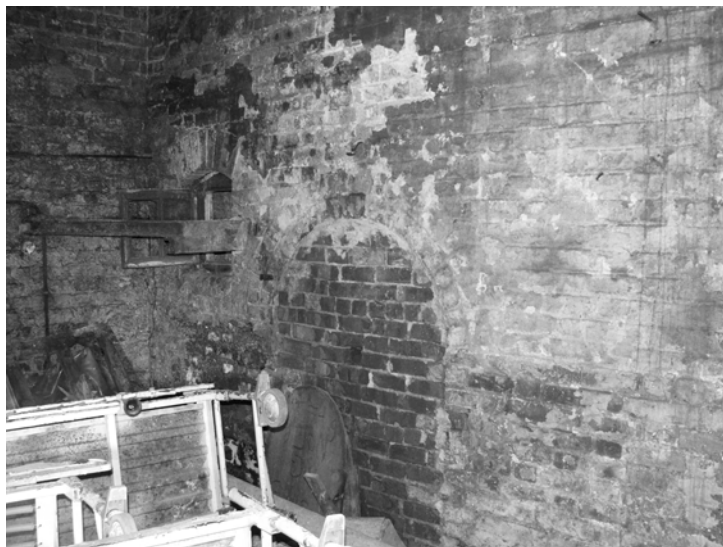
Plate 37 - Blocked arch between E5 and E3

4.5.25. The blocked arch and window seen in E3 are clearly visible in E5 (PLATE 37).
