Heritage.Prn: SA008

WATERWAY: SWAN

BUILDING1: LOCK

ADDRESS\_1: LOCK NO 12, YNYSMEUDWY

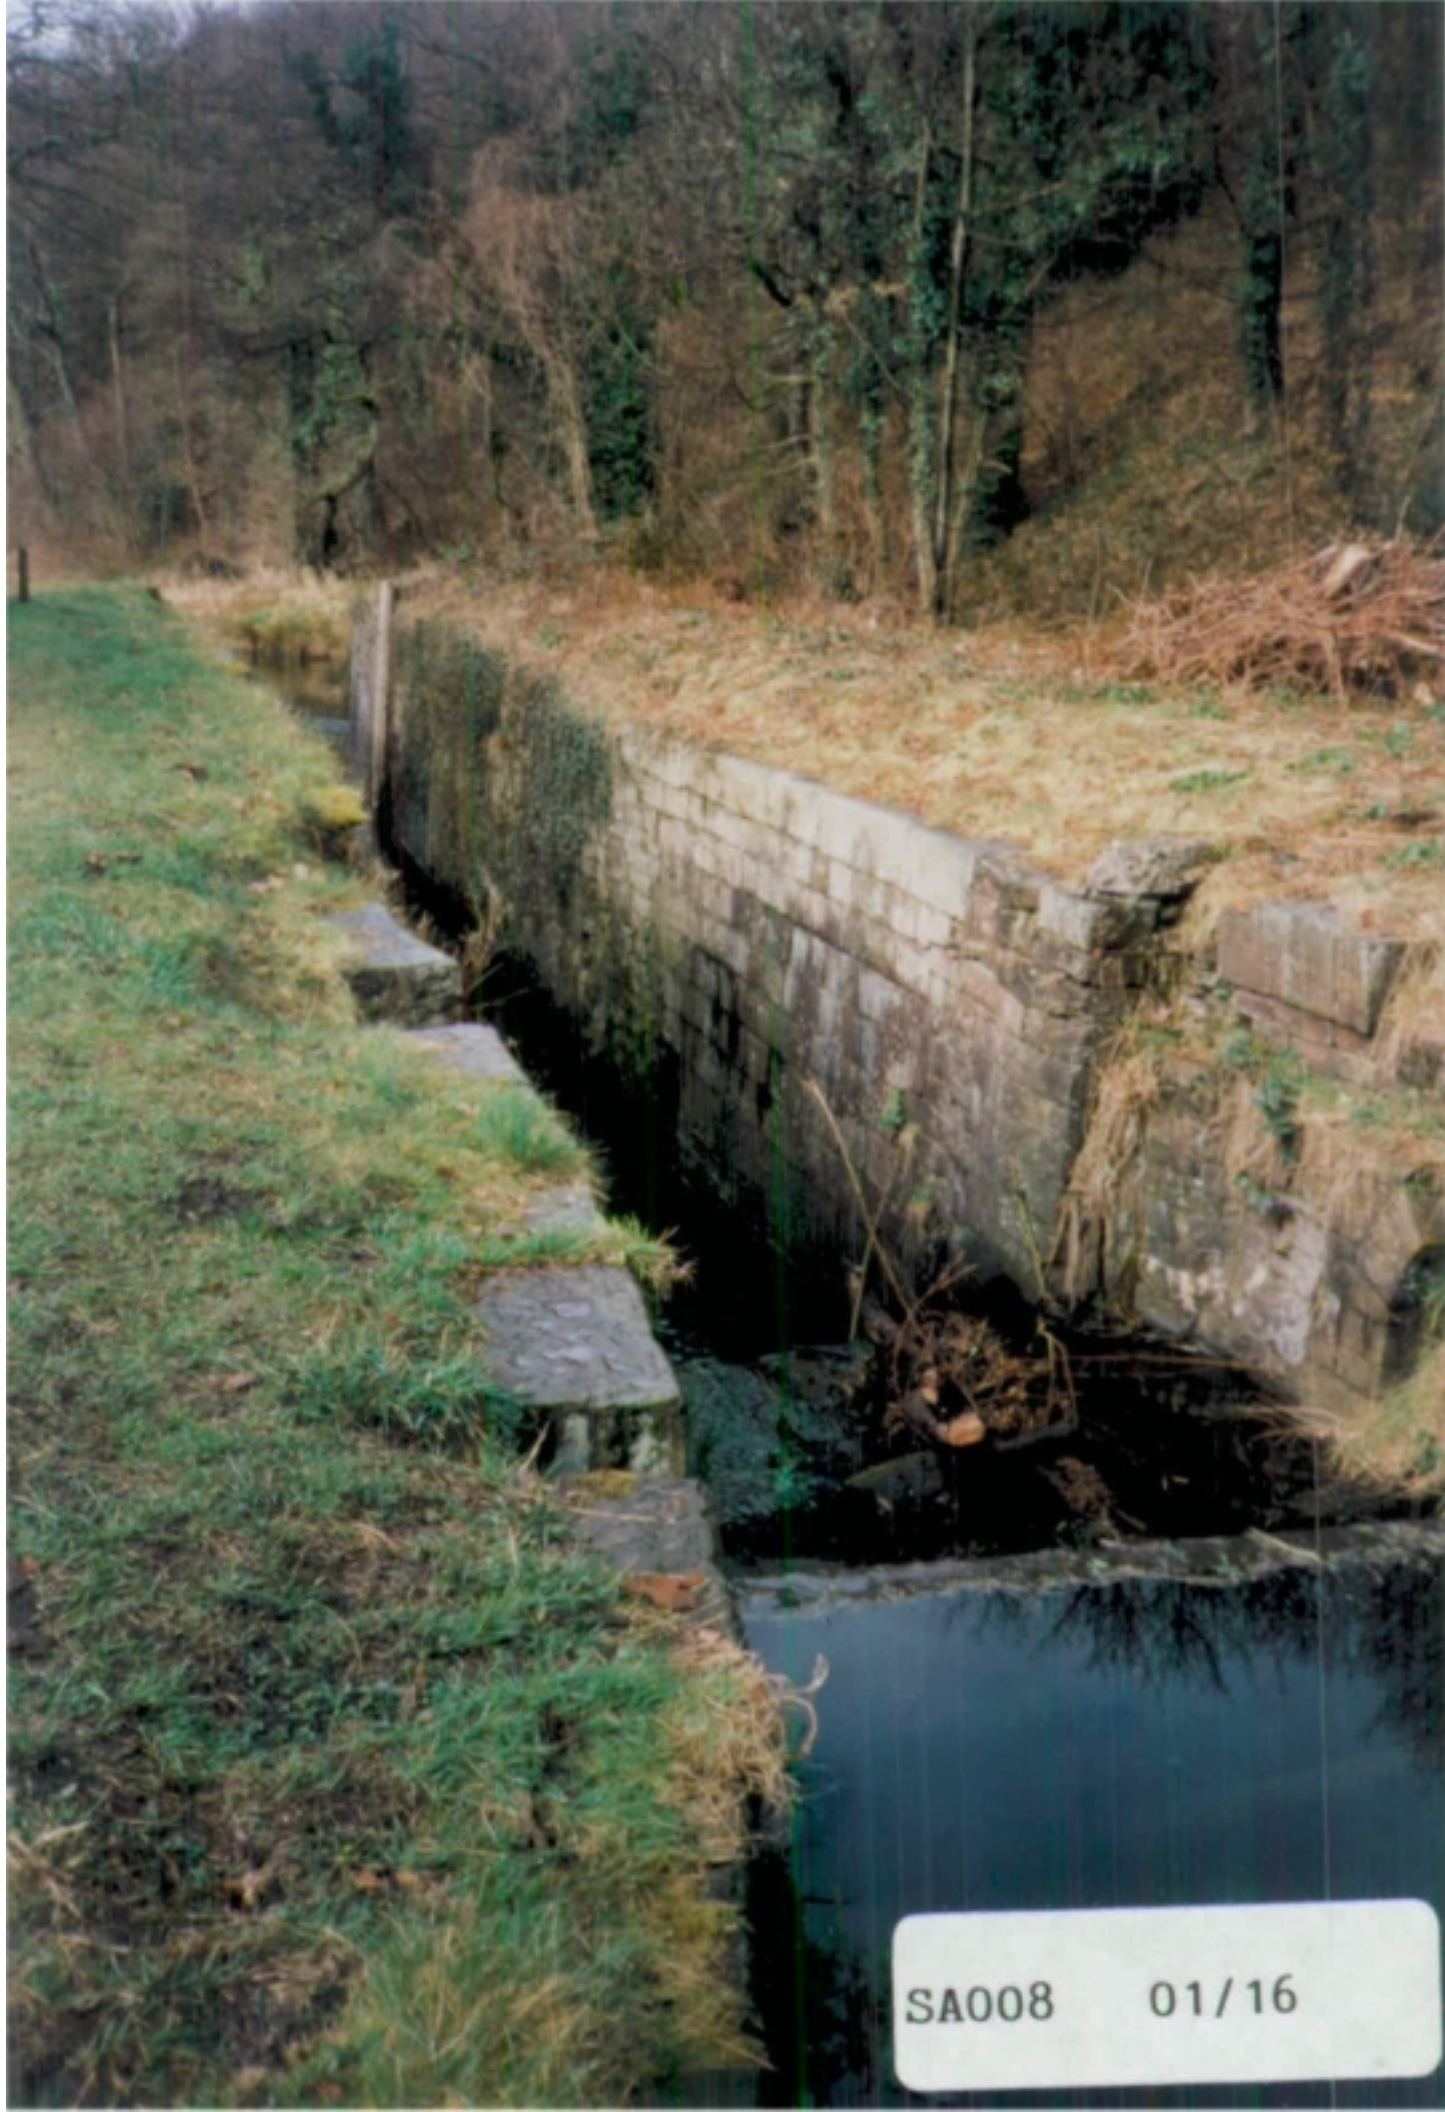
01/16

Dressed limestone coped stone chamber, some parts fallen away  
from water control mechanism. No gates or gearing remain.

Timber hinge post remains at lower gate. Wing walls patched and  
repaired with engineering brick. Stone quadrant and steps.
