BW Region	Mtsw			PRN	179
Waterway	M +BC			OS Sheet	v - (
BW Struc No				NGR	
Side	TOW O	FF CEN	() ()	Photo Neg No	13/1
BW Owned	Y	U/K	N	MMS/PMS -	
County	GWENT			Alt Address	
LA District	Mistroo	out -	Torfaer	^	
Parish	· ·	-			-
Address	CANAL	COTTAC	TE + STAB	LES, GOUTRE	WHARF
Date Listed				SAM No	
Grade	1	<u> </u> *	(1	Protected Area	NP AONB CA SSSI
Serial No				Structures in Item	-
Design Integ	A B) с	D	Context	VIL - URB ISO GRO
		_	_	Condition	
Setting	A B) с	D	Condition	A (B) (C) D
Setting Group Value	A (B)) C N	D	: 	
	A B		D	Present Use -	A BOOCO B STIOP, FAULITIES, HOVSE
Group Value	Υ Υ	N _N	D TE + STABI	Present Use	STIOP, FAULITIES, HOVSE
Group Value	Υ Υ	N _N		Present Use	STIOP, FAULITIES, HOUSE 3)C19, CZO
Group Value - Listable Building Type	Y CAN AL	N _N	TE + STABI	Present Use	STIDP, FALILITIES, MOUSE
Group Value Listable Building Type Date	Y CAN AL	N _N	TE + STABI	Present Use	STIOP, FAULITIES, HOUSE

F Site Notes/List or Scheduling Description

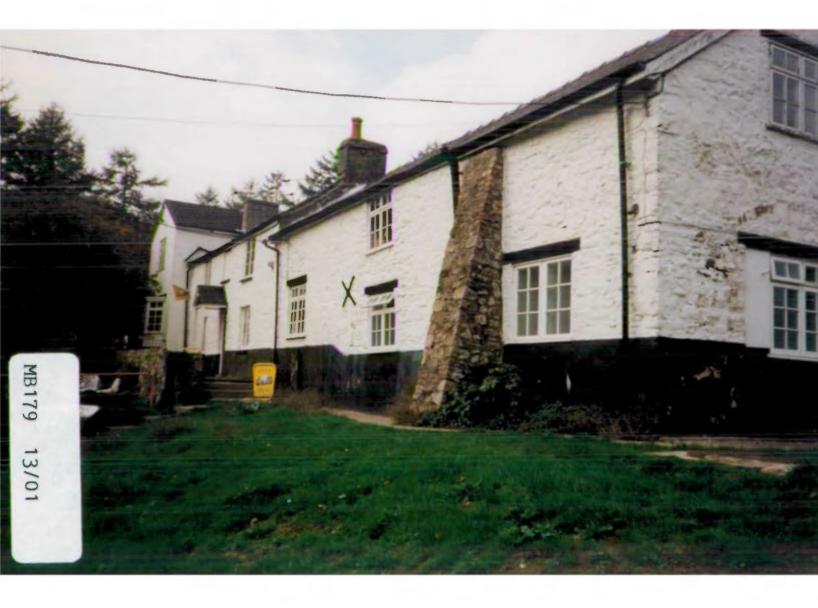
> Canal cottage and stables, converted into shop, kitchen and toilet facilites. E-MC19 with later additions and alterations. Coursed rubble sandstone, rendered and painted white with a black plinth. Pitched slate and tiled roof. Two storeys. Rectangular plan; original cottage (now shop) with parallel stable extension. Front elevation; cottage has central entrance with porch, two six-paned windows to each storey, and central blind window. Stone gable chimneys, rebuilt. Left side of block is extension to the house, and has tie plate where internal wall separates house from stable. Irregularly spaced windows, LC20 casements with glazing bars. C20 rubble stone buttress adjacent to right window. Gable end shows trace of earlier segmental-arched opening, now with LC20 casement windows to ground and first storeys. Back elevation much altered, for toilet facilities.
