CEFN SIDAN WRECK RECORDING PROJECT

PROJECT No. ~~32088~~ 56958

Report prepared  
by  
**Nigel Page**

Cadw: Welsh Historic Monuments

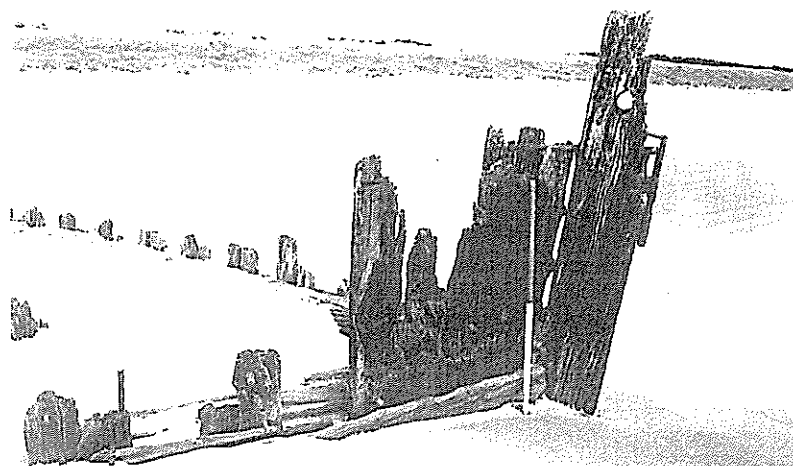
Plate 1: stern arrangement (PRN 30086).

The six timbers of the stern, the planking and stern post, were the most well defined part of the visible structure, a metal plate survives on the stern post. (Fig 3; plate 1).

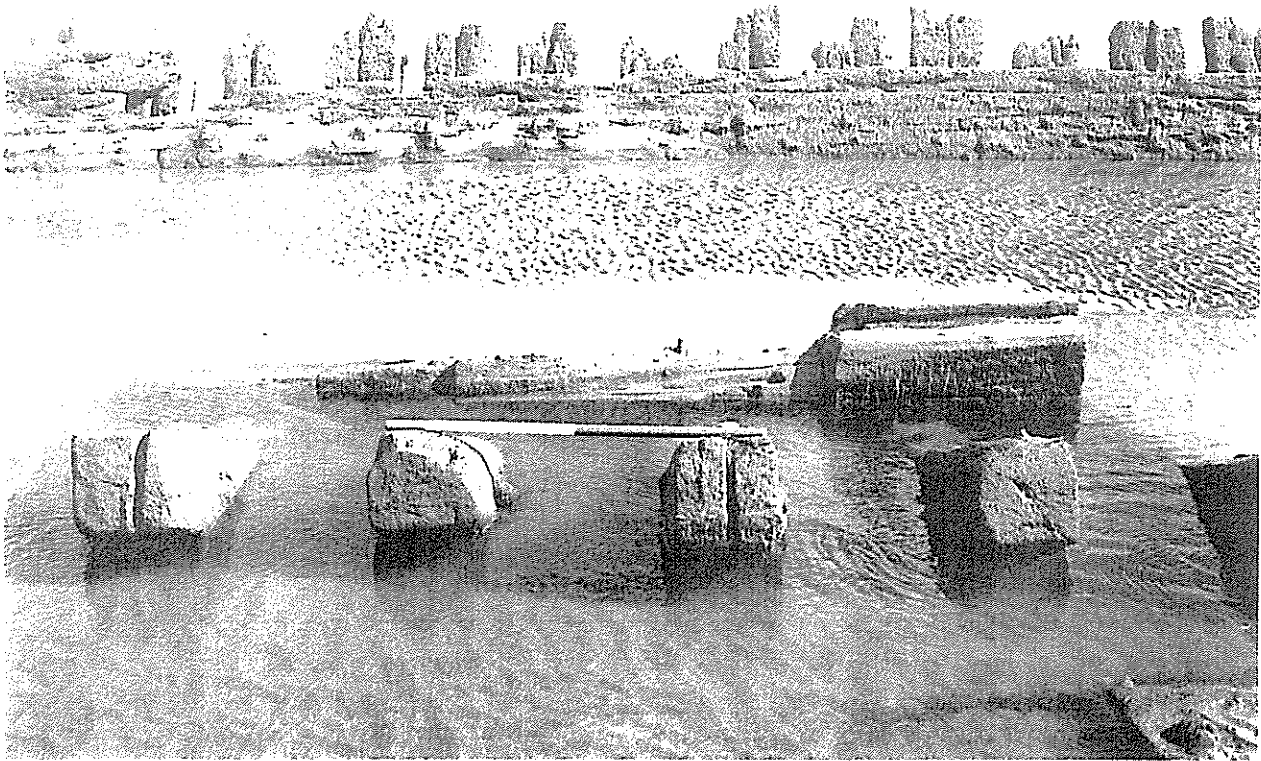
The frames are oak (*Quercus*) and paired. The distance between pair centres ranges from 650mm to 850mm; the average was between 680mm and 710mm; scantlings varied between 200mm and 300mm square. Of the *in situ* sections planking was only visible on the starboard side; hull and ceiling planking survives. Only ceiling planking was visible on the detached section of the port side. The planking is soft wood, possibly pine (*Pinus*). The planking was fixed to the frames by iron fixings and trenails. Where iron fixings protrude through the inner planking they were covered in pitch. Several of the starboard side ceiling planks had scarf joints. The lack of planking on the *in situ* portion of the port side may have been because the side was deliberately removed to facilitate recovery of the cargo. It was common practice to remove a section of the side of a vessel to quickly recover cargo between tides (John Buglass *pers. comm.*). To do that it would have been necessary to remove all the planking and saw through the frames. That this may have taken place is also indicated by some of the *in situ* port side frames that have clearly been sawn across leaving impressions of iron fixings visible in the top (plate 2). Only the 'b' frames had been sawn; the 'a' frames were butt jointed just below this point, providing a natural weak point.

Plate 2 In-situ port side frames showing the sawn-through fixing holes. Photo DAT.

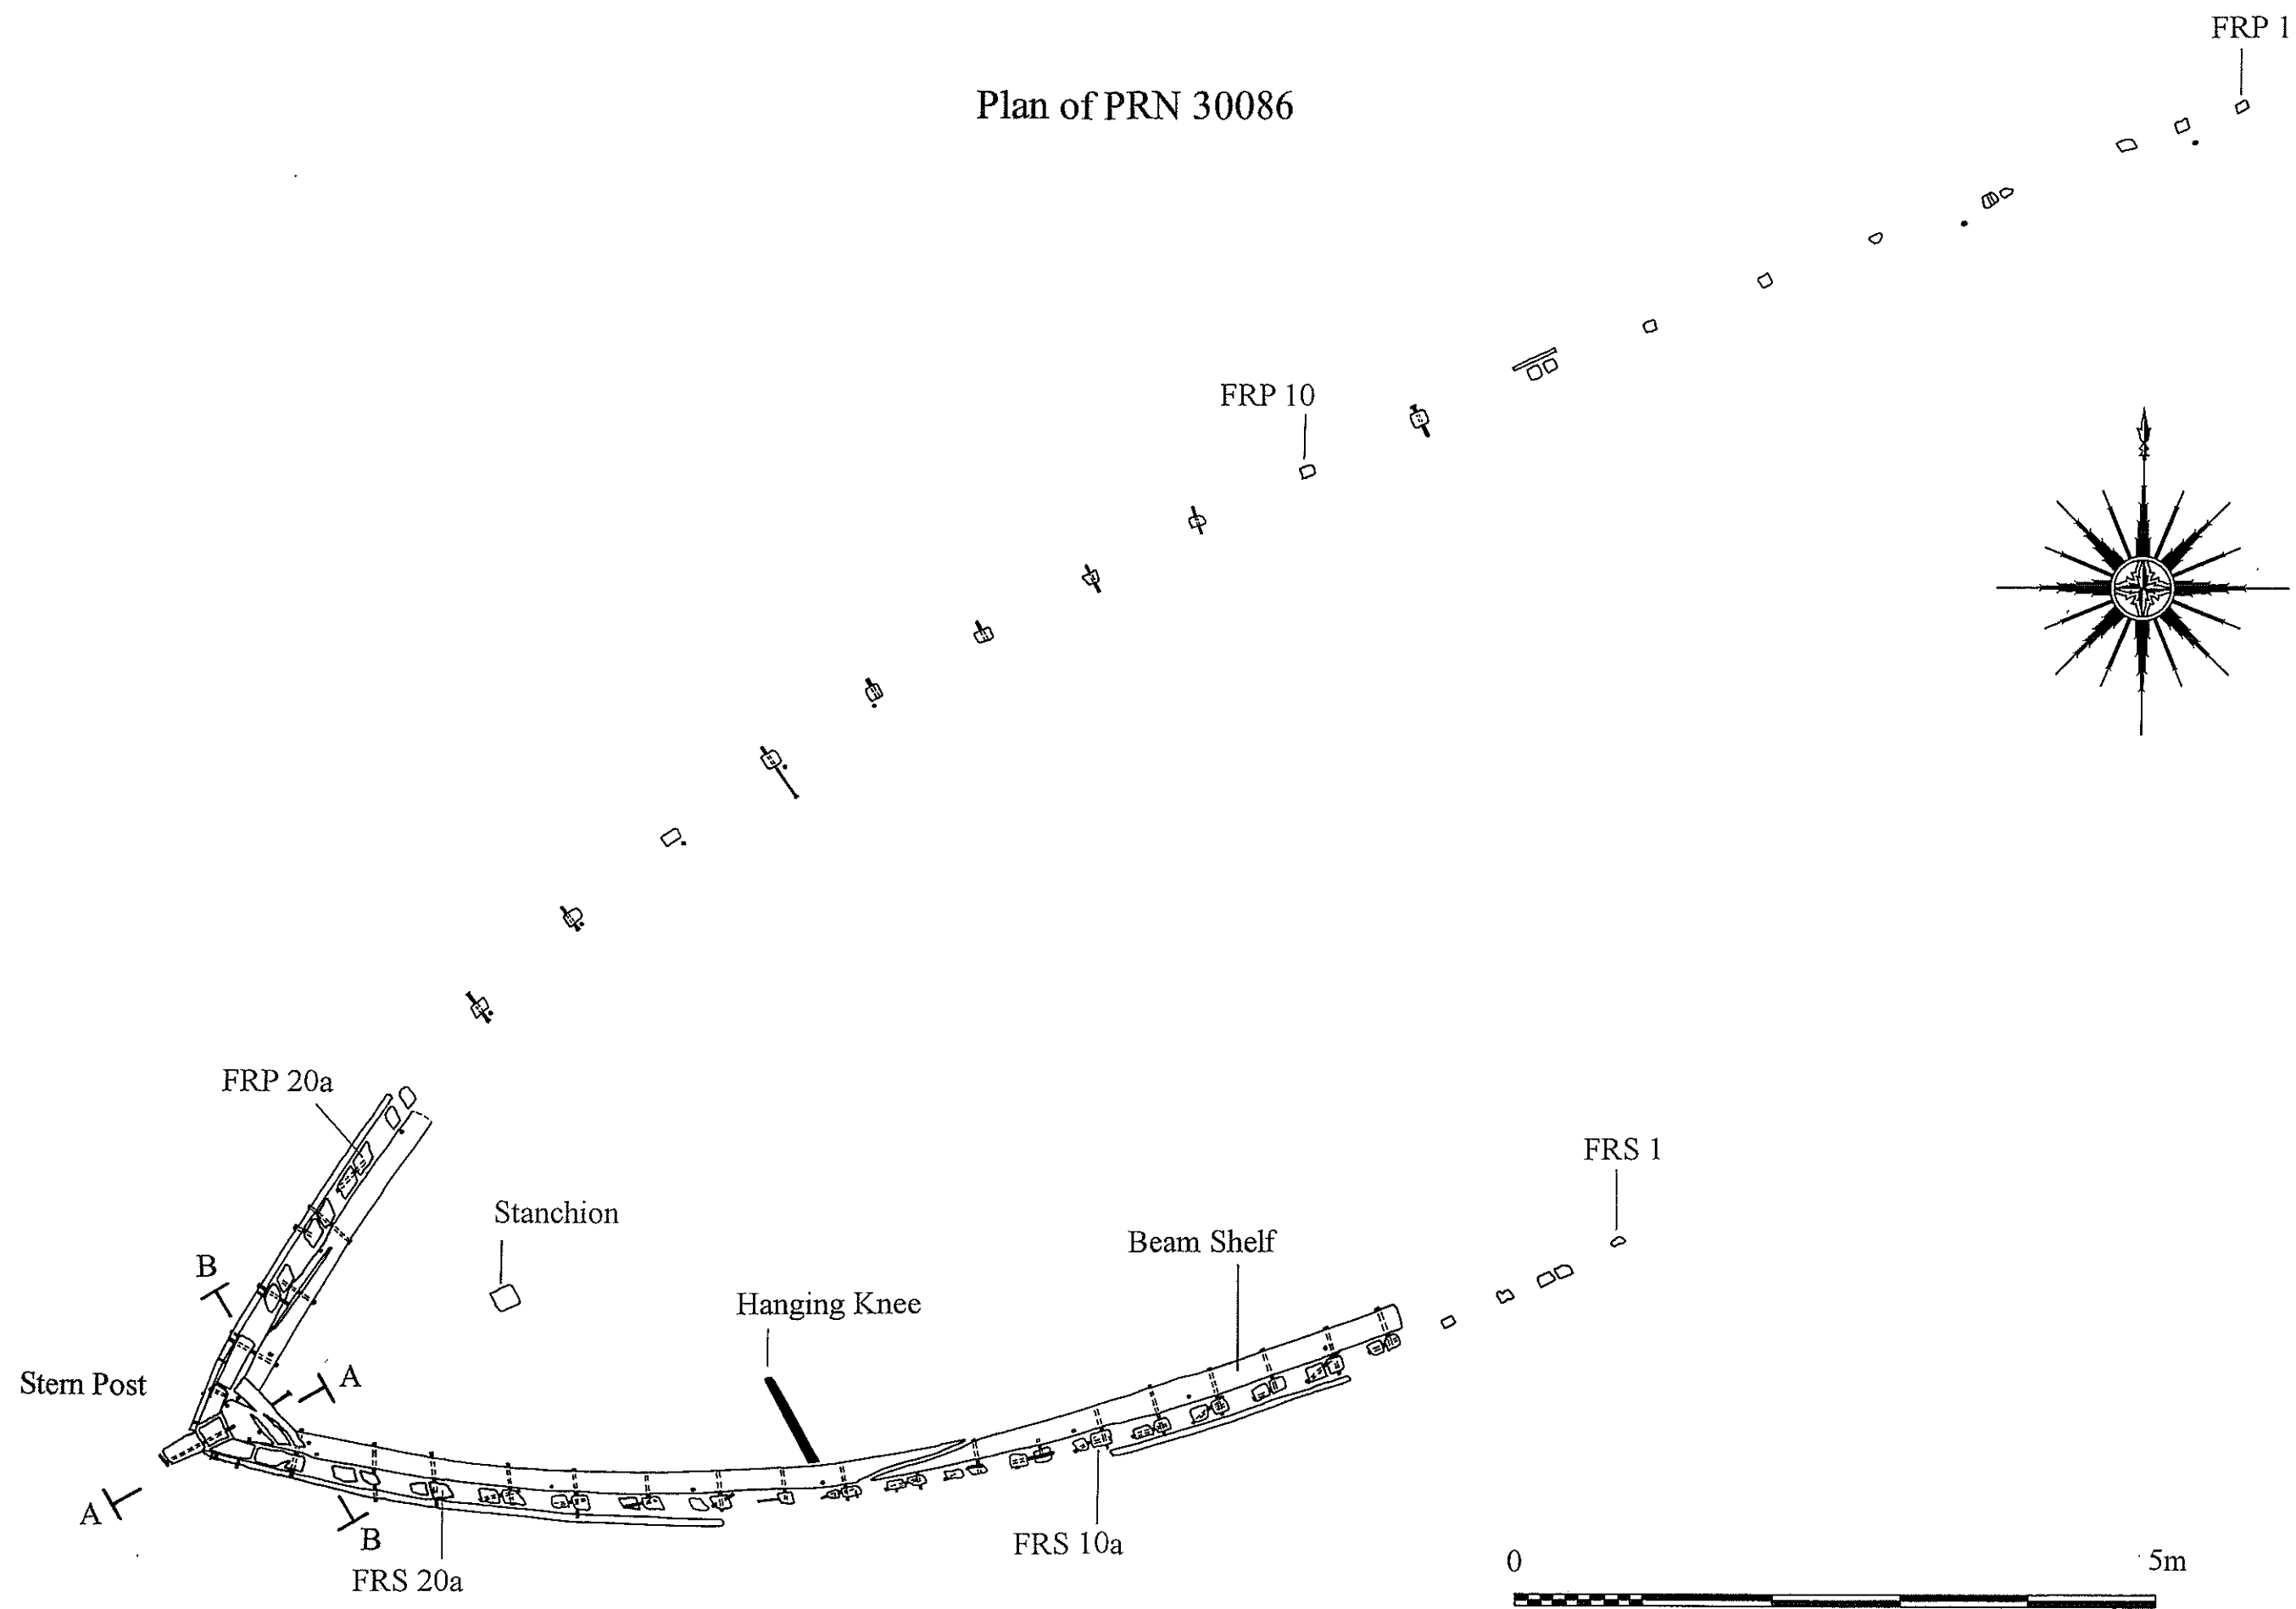
Figure 2

Another northeast-southwest aligned hulk. Using the same estimating procedure as for PRN 31412, and assuming that the midships station is somewhere around FR P 7 or FR P 8a the original length of the vessel was in the order of 28m (c. 98 feet) with a beam of 7.5m (just over 21 feet). As these are estimated dimensions and the sizes are near enough to those of PRN 31412 it is reasonable to suggest that they were a similar size and type of vessel.

The frames were oak (*Quercus*) and set in pairs. The centres between the pairs varied between 480mm and 560mm. There was more variation in scantlings than those of PRN 31412, varying between 60mm to 110mm moulded and between 90mm and 130mm sided. How much this variation was the result of erosion is unclear without uncovering more of the vessel to check the sizes of the frames lower down in the structure. A beam shelf comprising two scarfed-jointed beams on the starboard side was secured by iron fixings to the interior of the frames. It measures between 180mm and 200mm thick on its upper surface (the only bit exposed). Hull planking was present on both sides of the vessel; the planking was fixed with square-sectioned nails driven from outboard. On some of the frames larger iron fixings pass through the planking, frames and beam shelf as at FR S 18a; FR S 20a; FR S 21a. At the visible height only the 'a' frames were fixed to the deck support beams; this was the same for both the port and starboard sides. The frame pairs were connected by iron fixings. A metal hanging knee survives on the starboard side between FR S 14b and FR S 15.

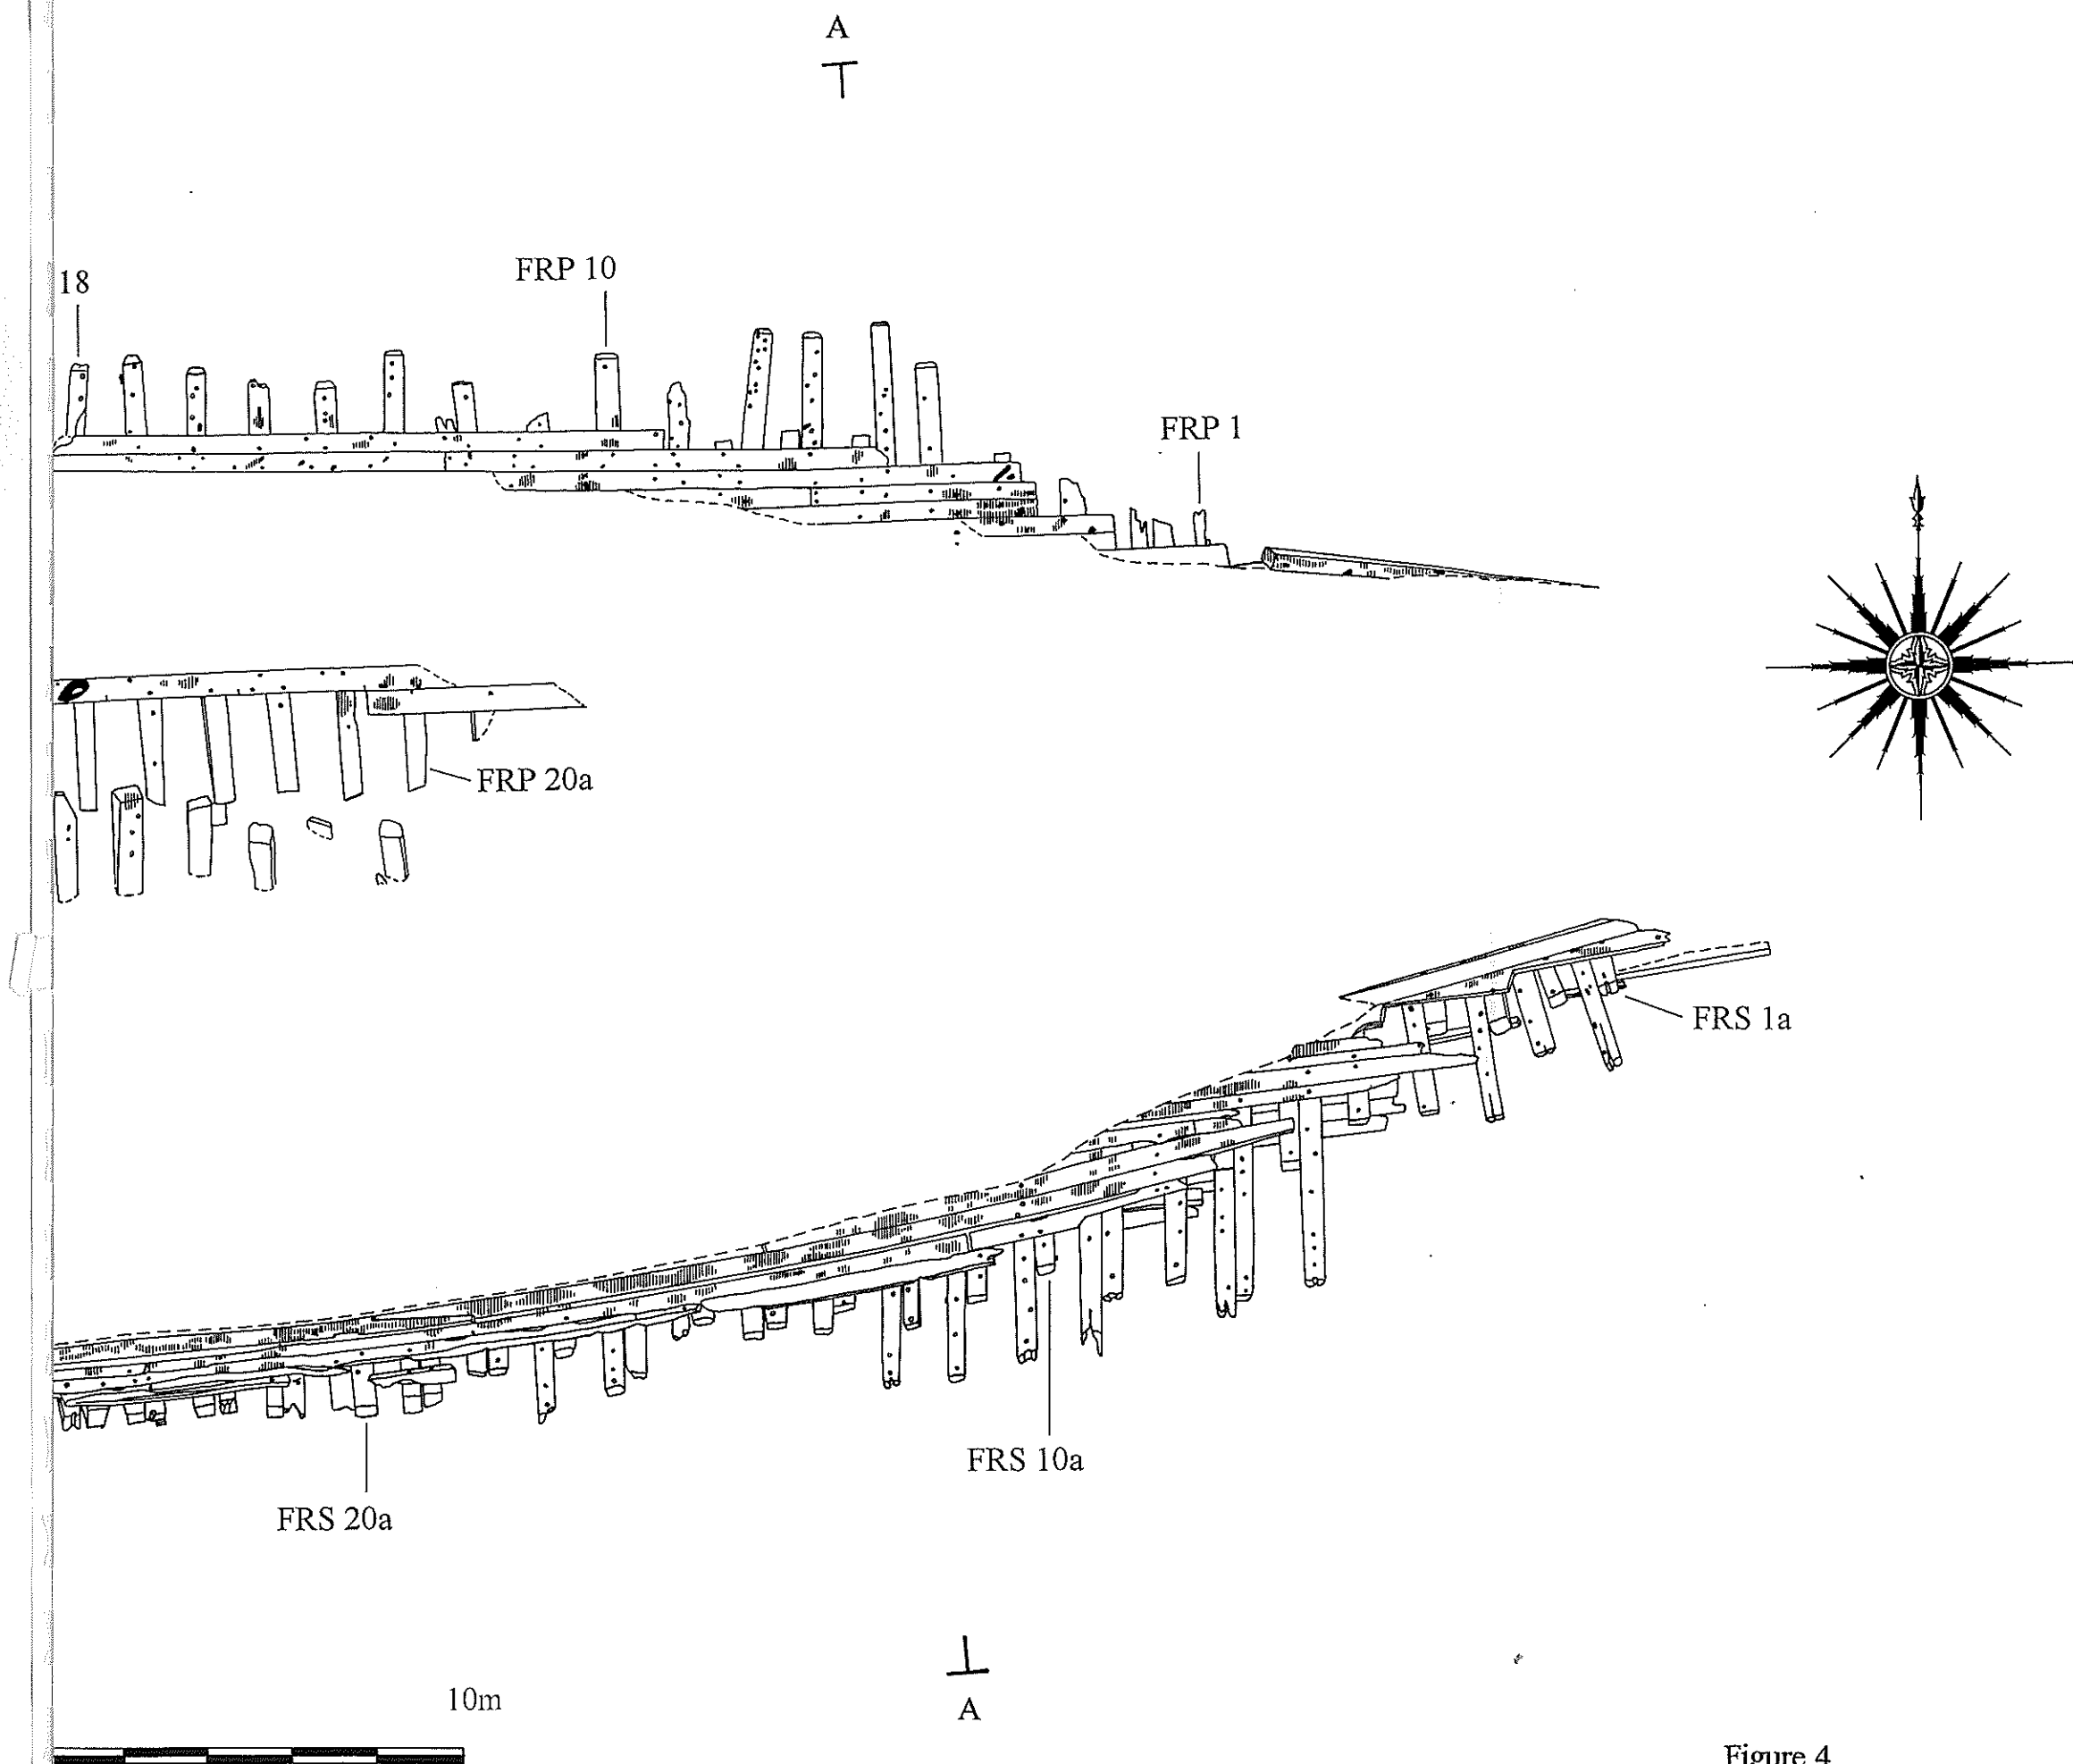
Figure 4

By far the most massive of the three wrecks surveyed. A carvel-built ocean-going vessel. As with PRNs 31412 and 30086 it was aligned northeast-southwest. Parts of the vessel survive to a height of 2.5m; it is estimated that there was up to 0.75m-1m of sand covering the keelson at any one time. Because the surviving section was so low in the ship it is difficult to estimate its original beam. The wreck length (at the time of recording) was c.50m (164 feet). A large section of the port side structure had been removed and lay alongside.

Bricks visible between the inner and outer planking on the starboard side may have been permanent ballast and a spread of stone between FR P 20 and FR P 23a may also have been taken on as ballast. They were uncovered and re-covered quickly so it was not possible to see the full extent of the spread or to remove any for analysis, but with the sediment moving continually it should be possible to retrieve some at a later date.
