11 Site Name
PONT NEHYDD (NORTH)

CADW:WELSH HISTORIC MONUMENTS

**Full Management Report - Internal Use
SAM Information Section 1 (General Information)**

SAM Name: Pont Newydd (Northern)

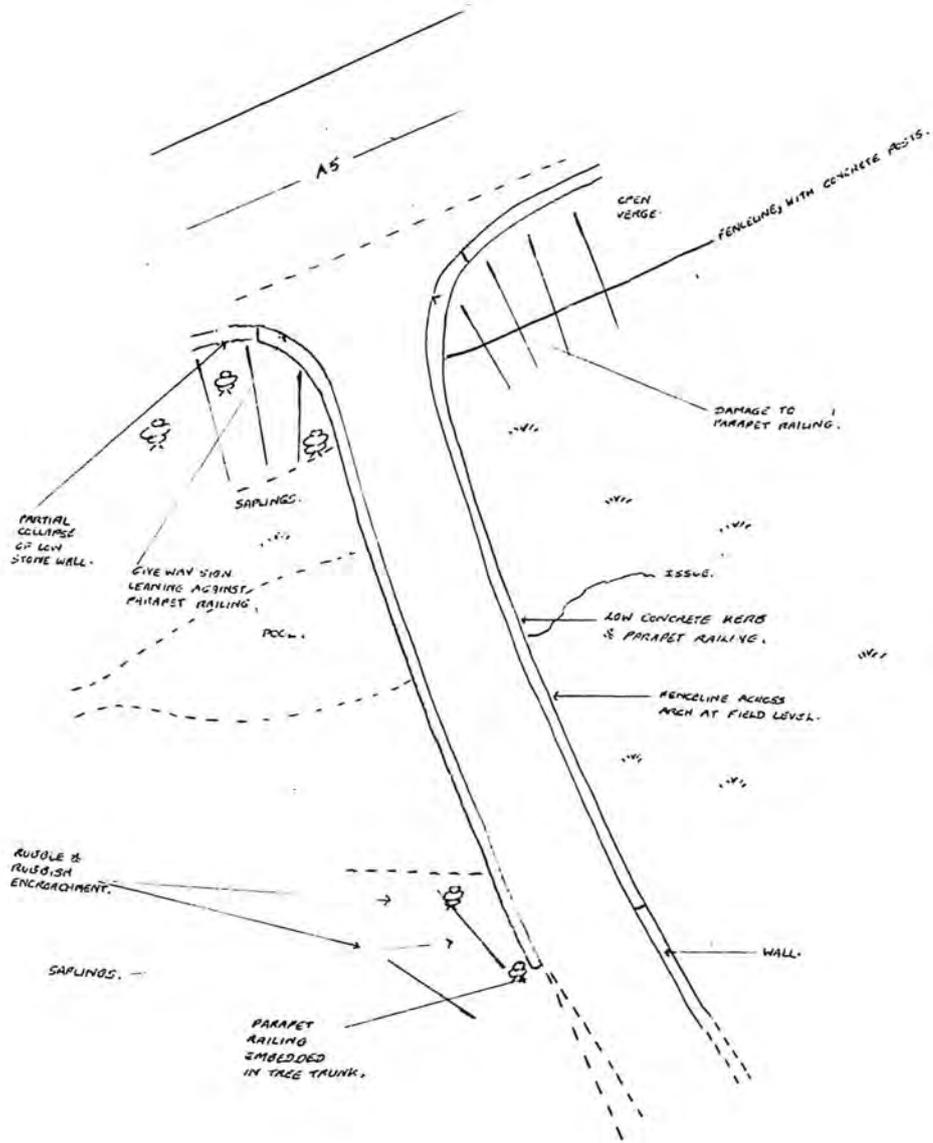
The parapet railing at the north end of the bridge along the eastern side has sustained damage to the second and the uppermost rail. The join in the top rail has broken through, and the second rail has parted from the vertical supporting bar. On the western side of the bridge, the Give Way sign is leaning against the parapet railing. The railings would benefit from repainting. Slight damage has also been incurred to a low drystone wall alongside the road, at the northern end of the bridge. Rubbish is tending to encroach generally towards the south end of the bridge, from a clearing in the copse. The pool to the west of the bridge is showing signs of silting. The roadway across the bridge is well maintained. <1.>
